# **CHURCH OF SAINT LAURENCE, EAST HARPTREE, PROJECT NEWTON**

**Summary Report on the Archaeological Monitoring &  
Recording of Access Improvements to Churchyard, South  
Porch & Rebuilding of South Entrance Pathway Wall**

**OASIS Ref No: 2-507963**

**Prepared March 2023 for**

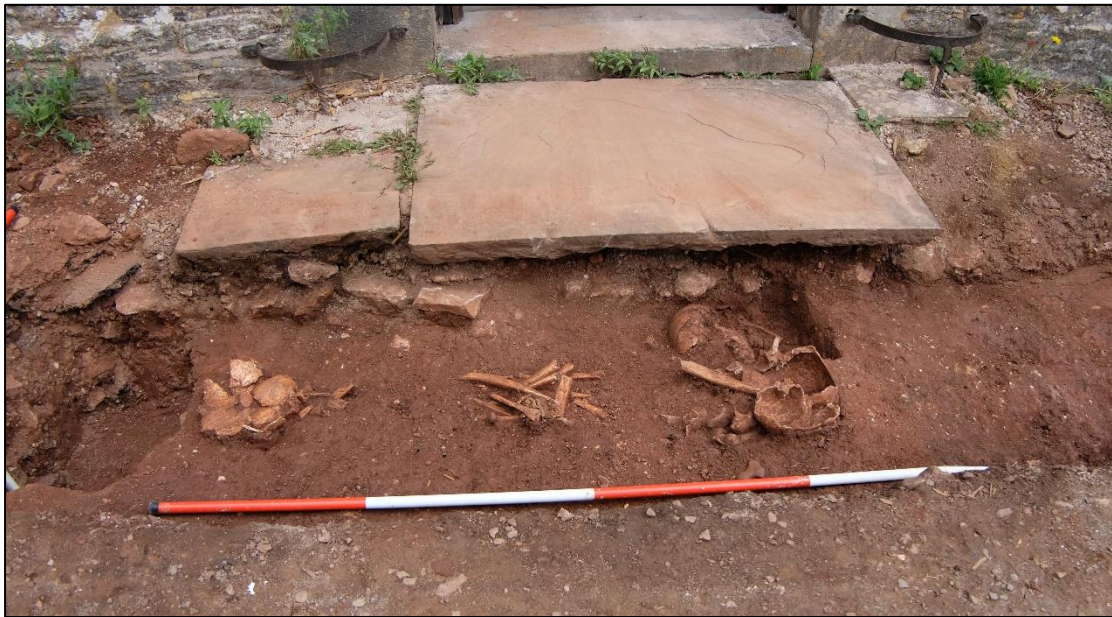
Three charnel deposits were uncovered outside the entrance (Fig. 1) and the complete skeleton of what appeared to be an adult female was revealed just east of the entrance (Fig. 2). Excavation and removal of the charnel deposits uncovered a further burial on the north side of the most easterly charnel deposits (Fig. 3). No clear grave cuts were observed but the female skeleton appeared to have cut through an earlier burial (Fig. 4). A few small sherds of medieval coarseware pottery were found within the deposits surrounding the burials.

**Figure 1.** Charnel deposits outside South Porch: facing N, 2m scale.

The charnel deposits were recorded and removed to enable the level access into the church but the complete skeleton was left in-situ as it was possible to obtain the required levels without causing further disturbance. The charnel deposits were reburied within the east end of the original trial trench, but the widening of this area revealed a further burial (Fig. 5). After recording the exposed burials were covered with sieved soil (Fig. 6) before being further protected using a breathable membrane.

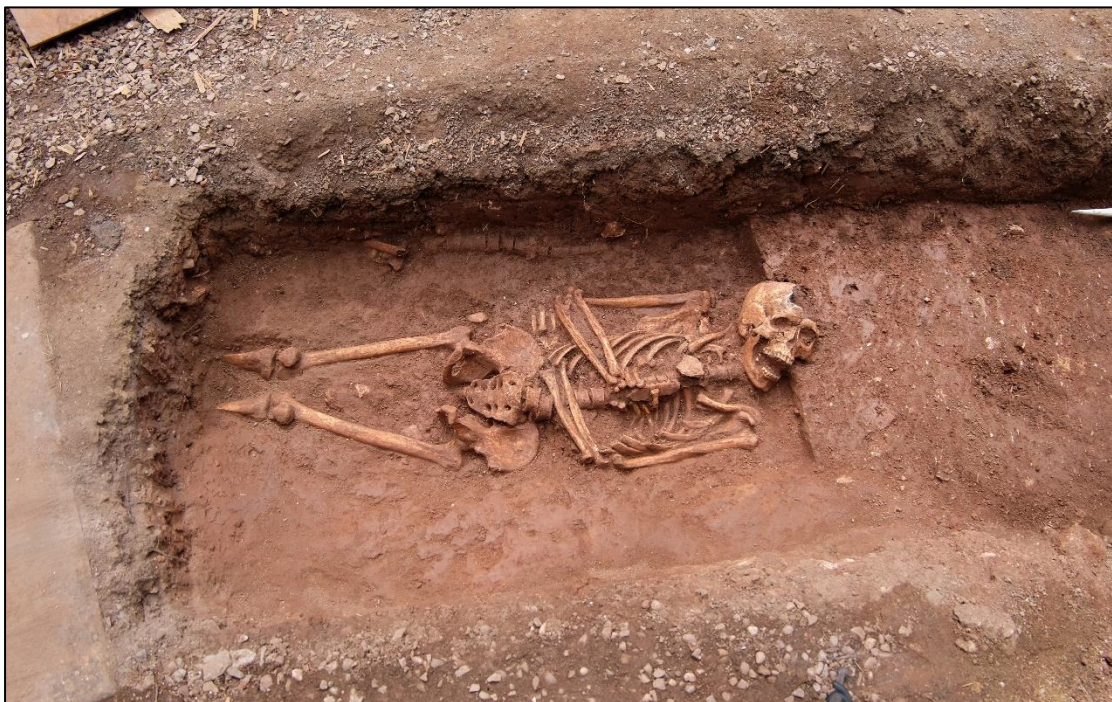
**Figure 2.** Female skeleton, E of South Porch: facing N.

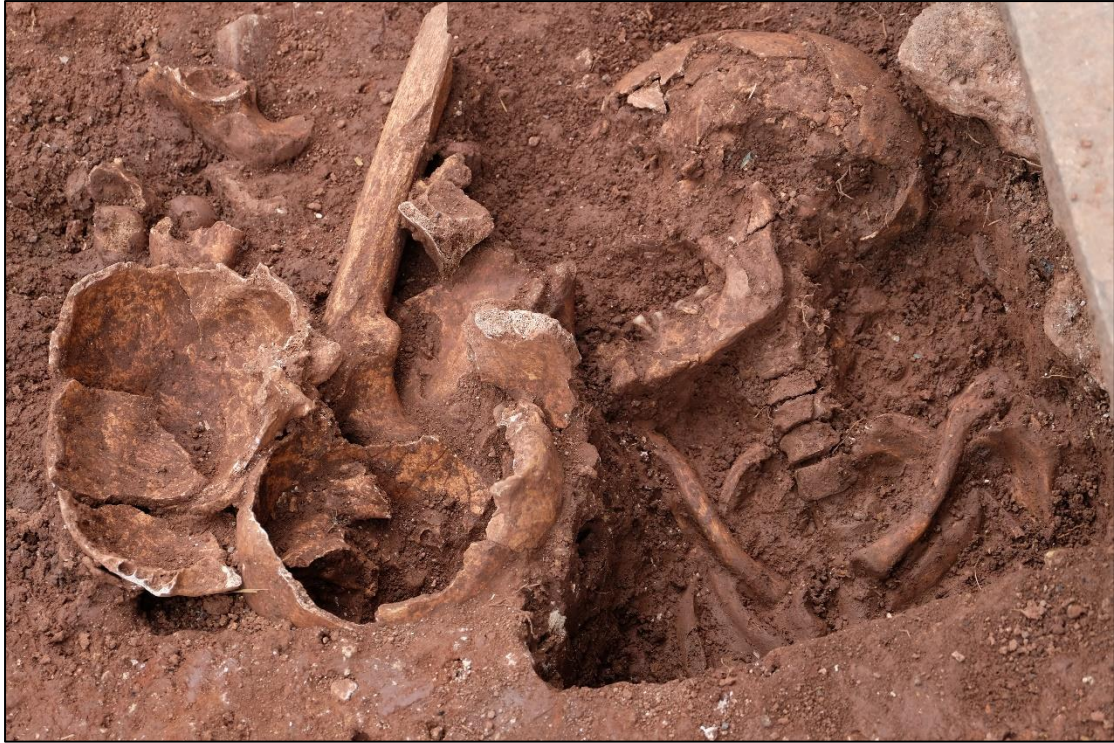
**Figure 3.** Burial on N side of charnel deposits: facing W.

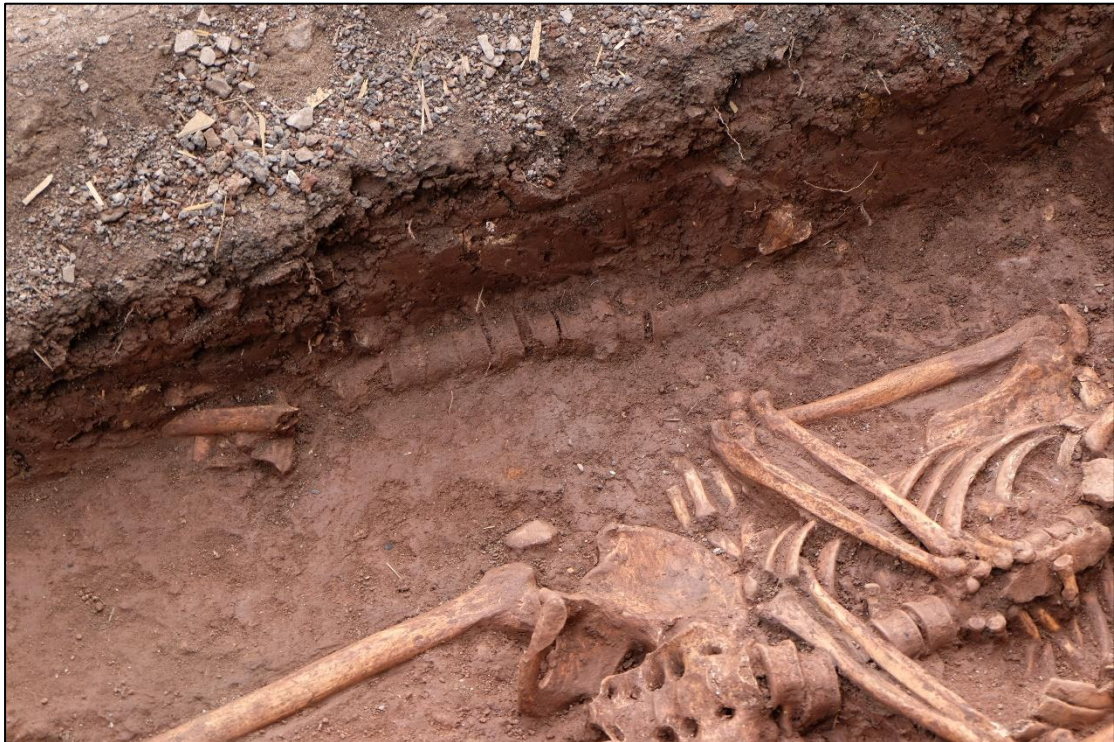
**Figure 4.** Remains of burial in S side of trench, cut through by female skeleton: facing SW.

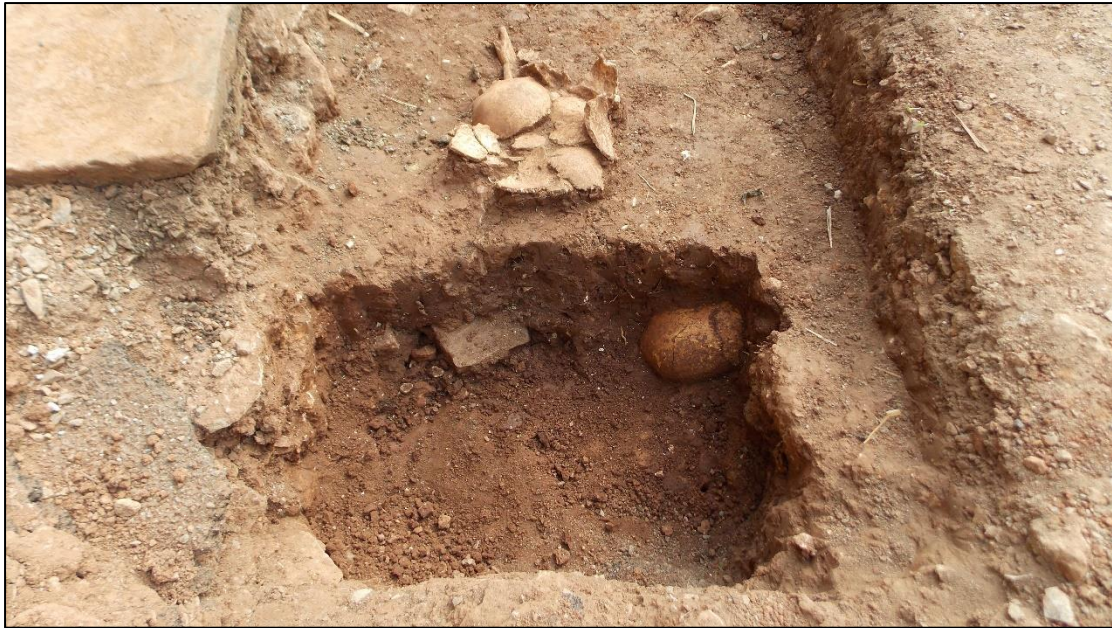
**Figure 5.** Burial in east end of original trial trench: facing E.

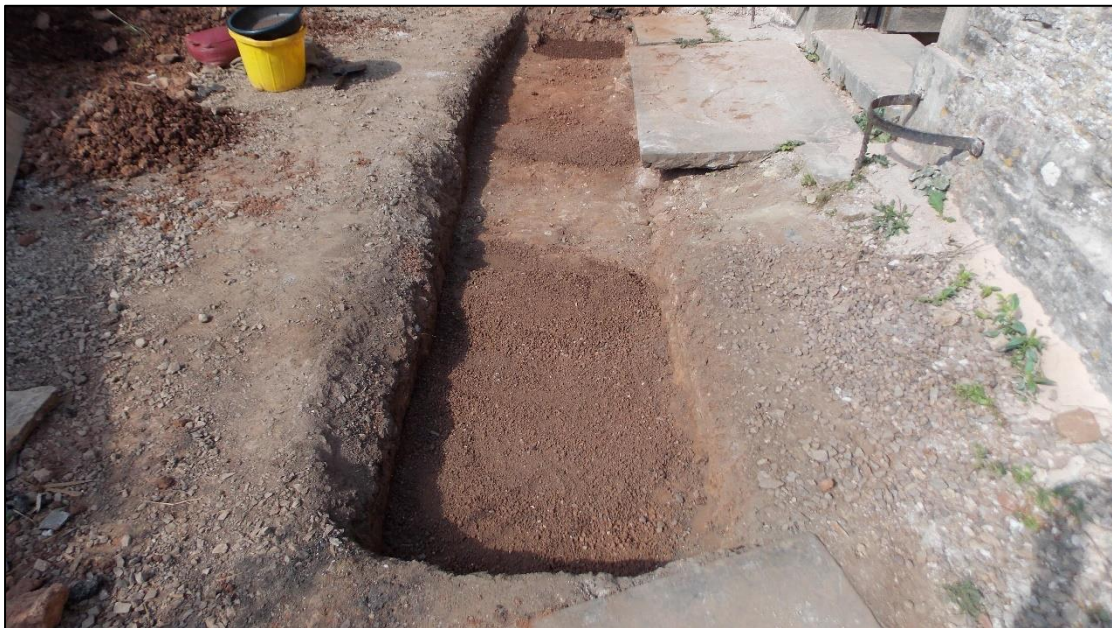
**Figure 6.** Burials covered with sieved soil: facing W.

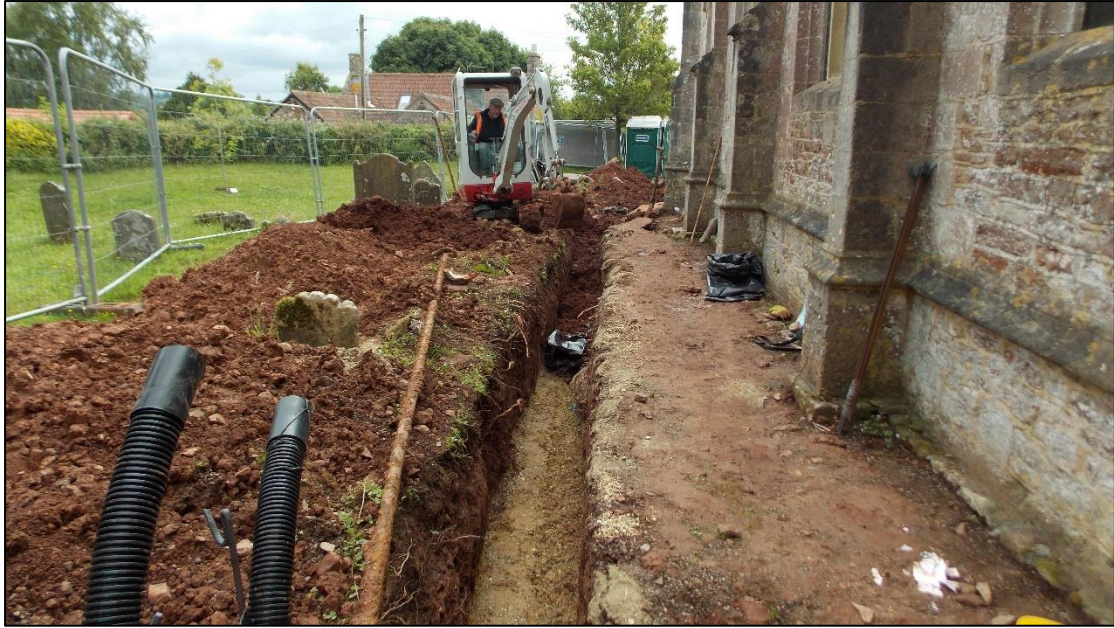
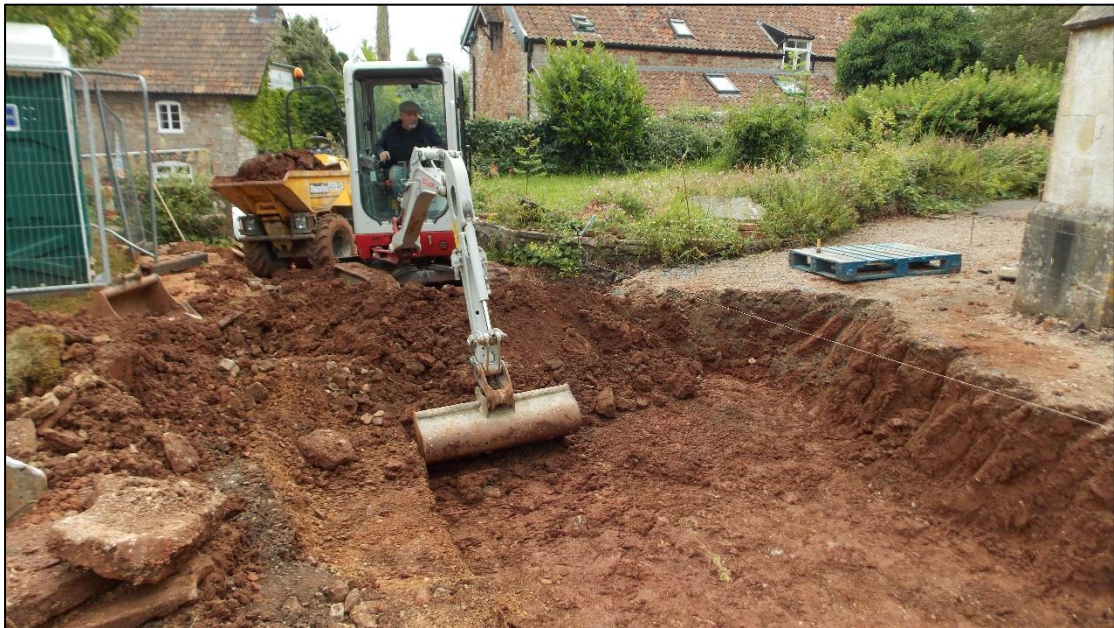
The removal of the existing pathways along the north side of the church out to the east gateway (Figs. 7 & 8) only revealed modern landscaping deposits, modern service pipes, mixed red silty clays, and previously disturbed burials. The red clay appeared to be the usual mixed deposits containing frequent human bone fragments that you would expect to observe in churchyards.

**Figure 7.** General view of removed path and service trench: facing E.

**Figure 8.** Pathway reduction in progress at east end of site: facing E.

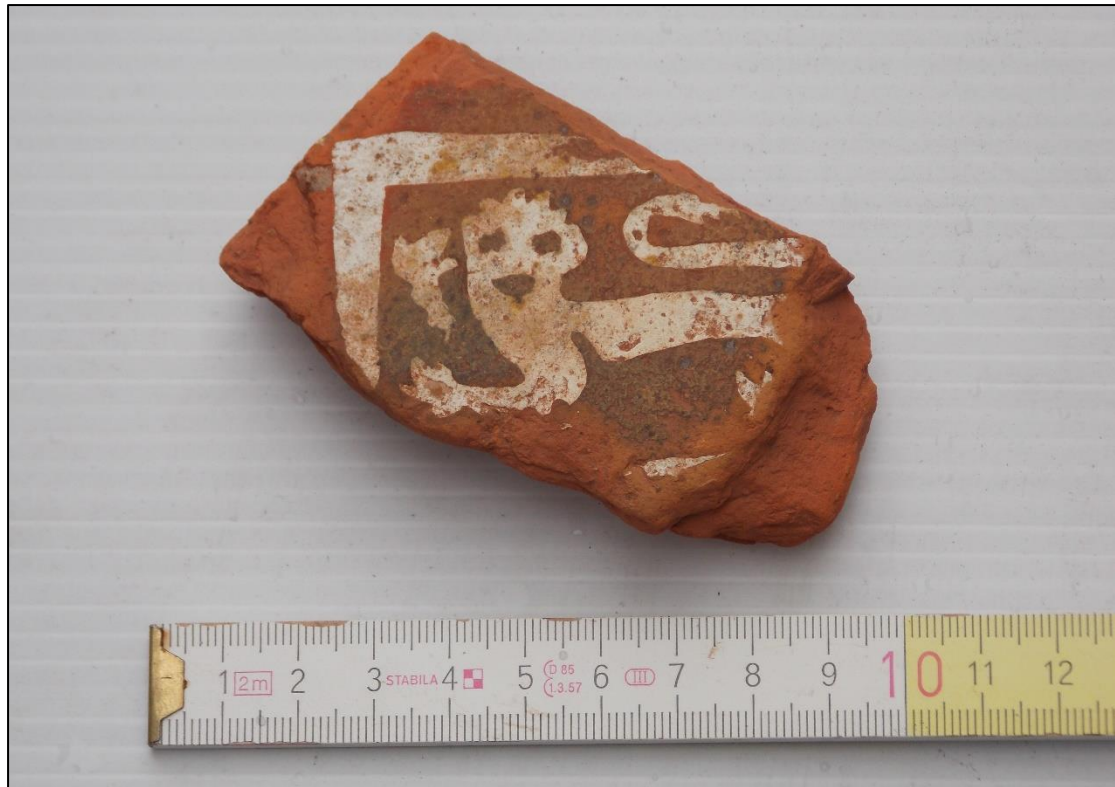
Fragments of decorated and plain medieval floor tiles were found within the red clay at the east end and north side of the Chancel and at the west end of the North Aisle. One of the tiles recovered from the west end of the North Aisle shows the top lion within a shield set diagonally (Fig. 9), representing 'England', and dating from the late 13<sup>th</sup> early 14<sup>th</sup> Century.

**Figure 9.** Medieval tile with lion decoration.

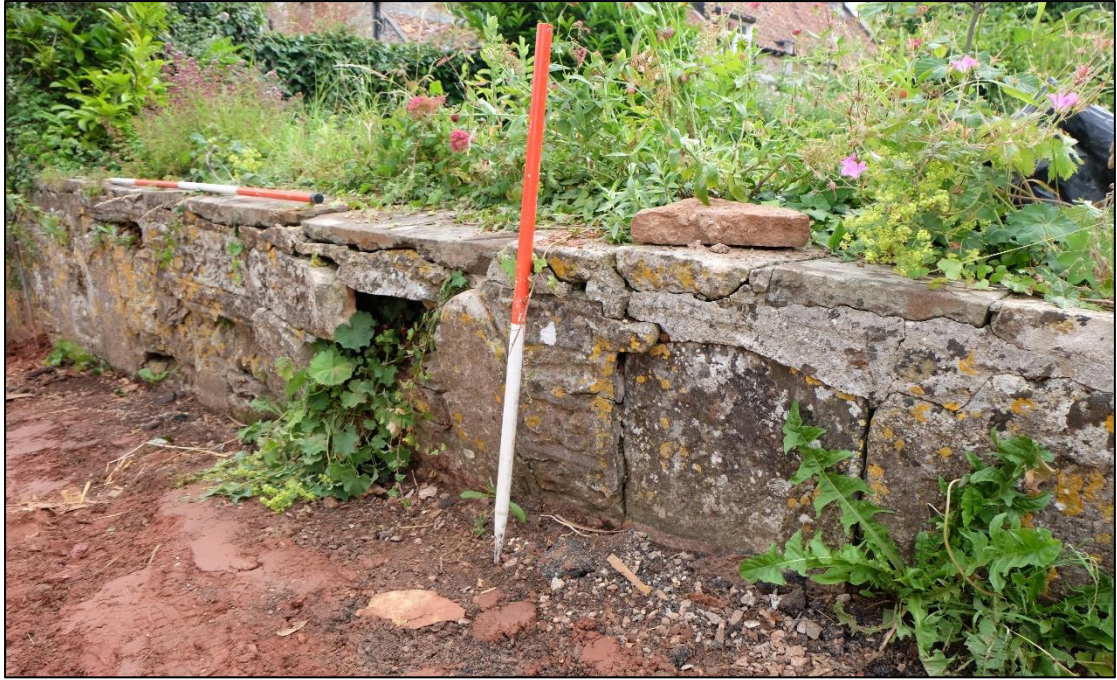
The existing wall was in a very poor state of repair (Fig. 10) and part of the new works required it to be dismantled and rebuilt. Prior to the commencement of the works the exposed face of the wall was known to contain 17<sup>th</sup> Century gravestones and various architectural fragments including Romanesque style voussoirs.

**Figure 10.** East gateway to South entrance wall: facing SE, 1m scale.

The dismantled wall appeared to be of a 19<sup>th</sup> Century construction and was roughly built from local limestone faced with various architectural fragments that must have become redundant and had been kept within the churchyard.

It was originally envisaged that most of these items would be built back into the new wall, but once removed it became apparent that some of the stones were significant enough to be moved into the church to stop any further deterioration. A catalogue of stones for potential display has been produced for the PCC (Faxon 2022).

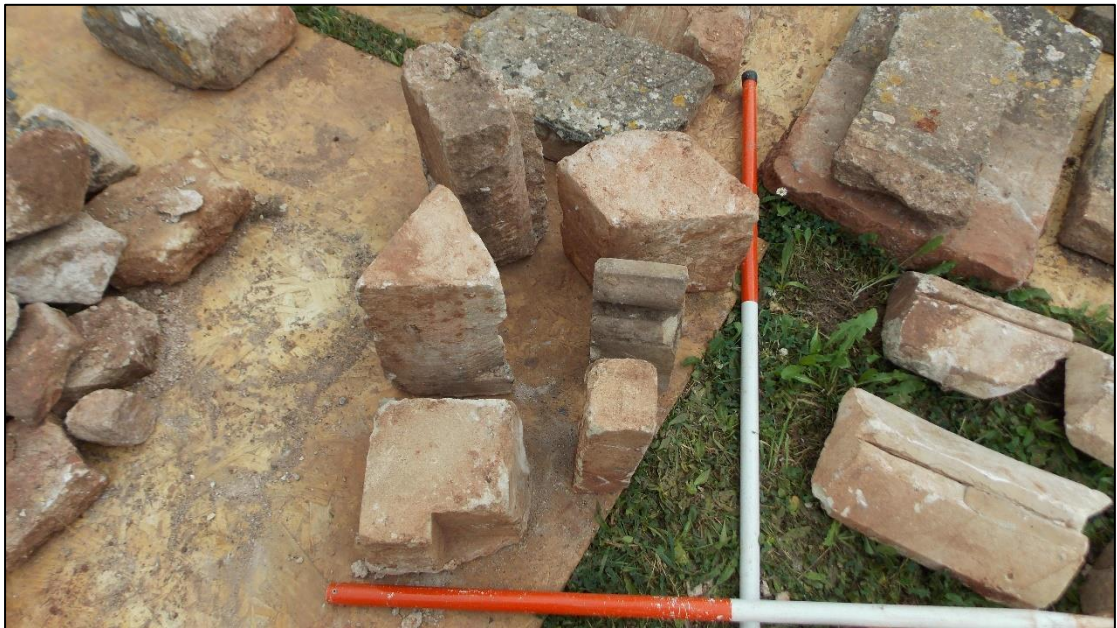
During the dismantling of the wall numerous, previously unseen architectural fragments were recovered from the wall foundations and these included window mullions, window tracery, hood mouldings, jambs, a corbel, and 18<sup>th</sup> Century chest tomb fragments (Fig. 11). All these items were removed and put into storage as they potentially represent earlier construction and modification phases of the church's fabric.

**Figure 11.** Selection of architectural fragments from wall foundations.

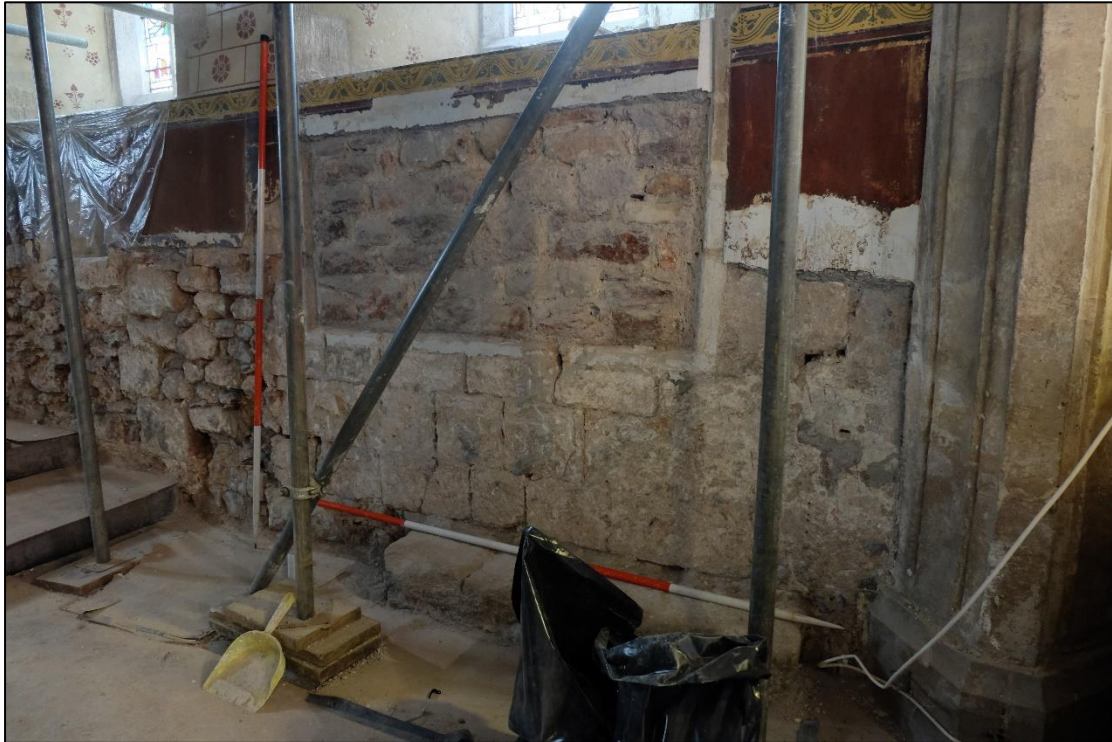
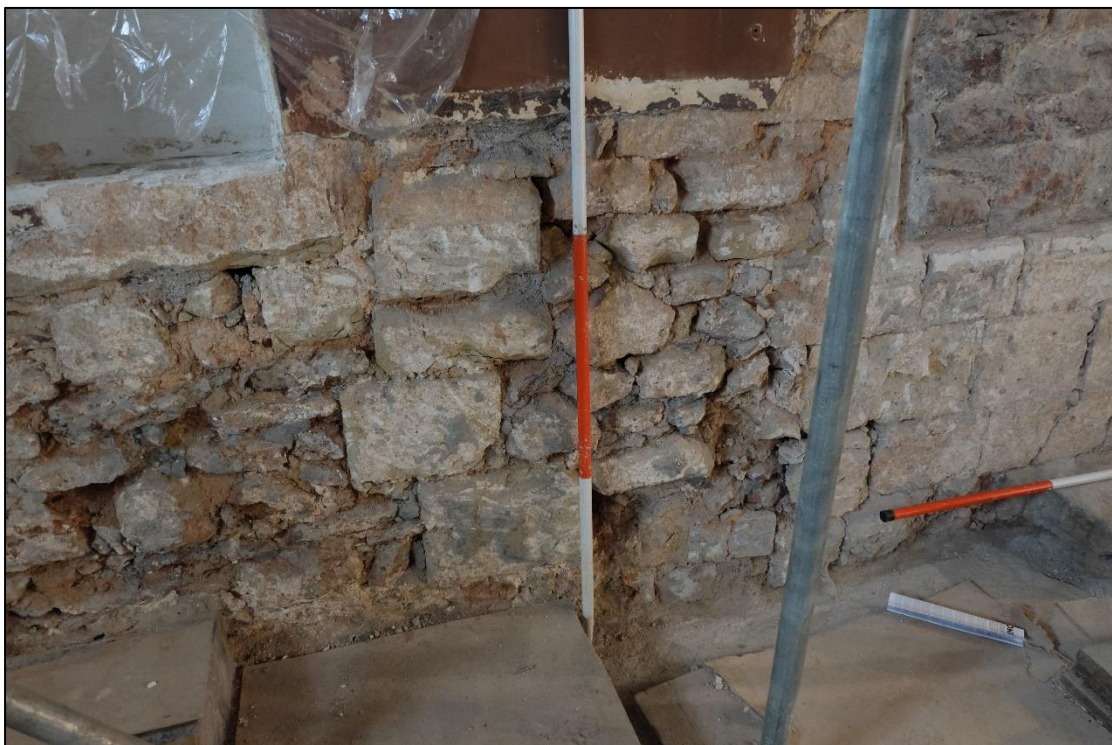
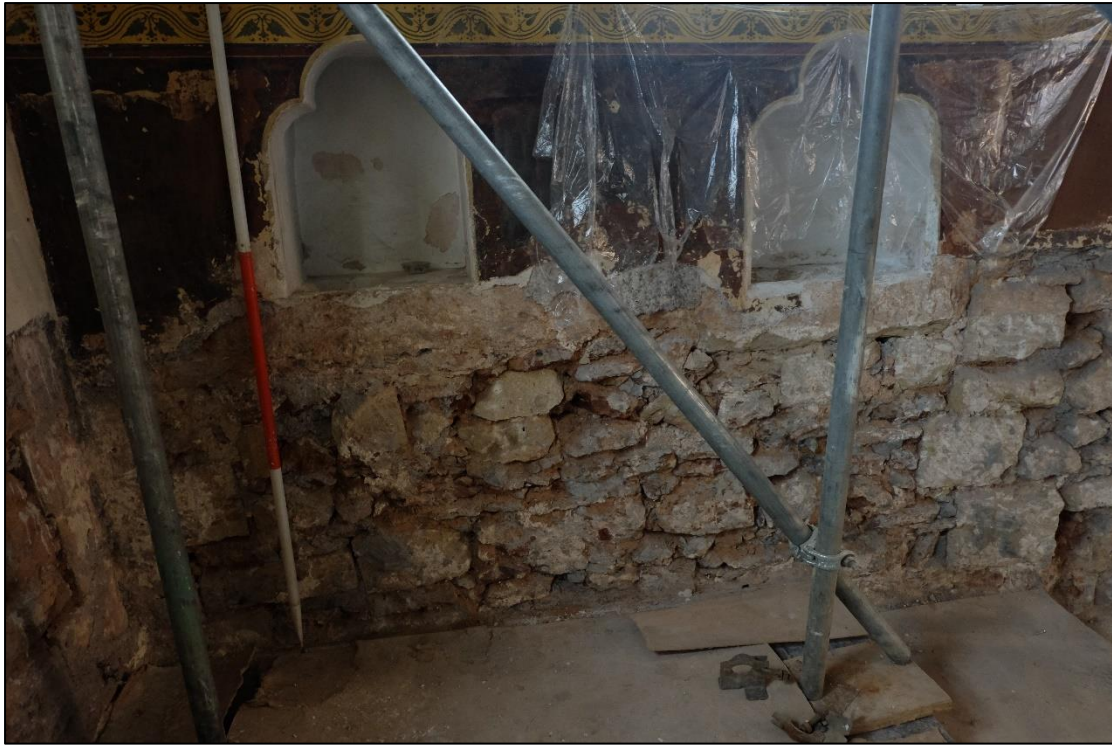
The removal of deteriorating plaster from the lower section of the south Chancel wall revealed at least seven phases of construction and infilling. The various phases included the blocked up lower section of the west window, a section of Bath Stone ashlar at the west end, areas infilled with brick and tile, sections constructed from local limestone and Douling Stone rubble and a small section of Douling Stone ashlar (Figs. 12, 13 & 14).

**Figure 12.** Chancel wall, W end: facing SE, 2m scales.

**Figure 13.** Chancel wall, central section: facing S, 1.5m scale.

**Figure 14.** Chancel wall, E end: facing S, 1.5m scale.

A scaled section drawing was made of this exposed wall, but further documentary research will be required to assist with the potential interpretation of the various phases of activity.
