St Laurence's Church, East Harptree, Somerset (Diocese of Bath and Wells)

Monument of Sir John Newton d. 1568

Conservation Treatment Report

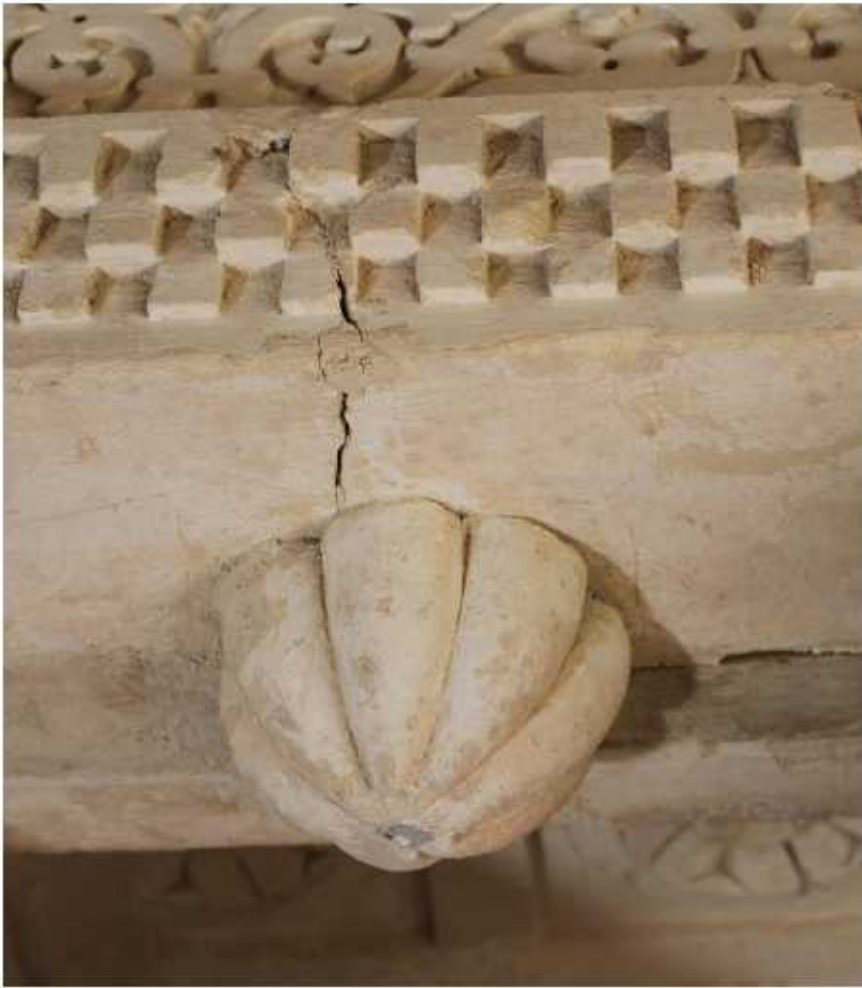
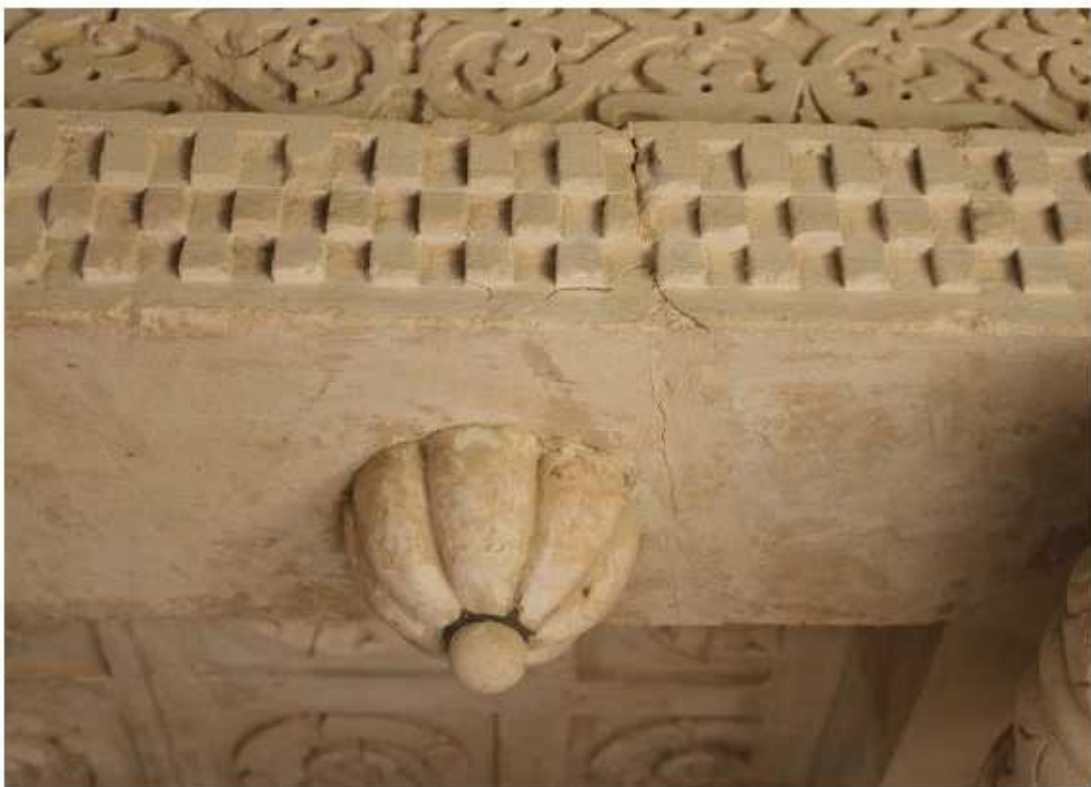
A network of fine cracks, some at least caused by the ferrous elements mentioned above, was to be seen in the entablature; these cracks were pointed following the removal of the ironwork, with hot-mixed lime mortar matched to the surrounding stonework. These filled joints will allow future monitoring of the stability of the monument; frankly it is not expected that any serious movement will manifest in the near future.

1, 2. Examples of cracking along joints, found in the structure

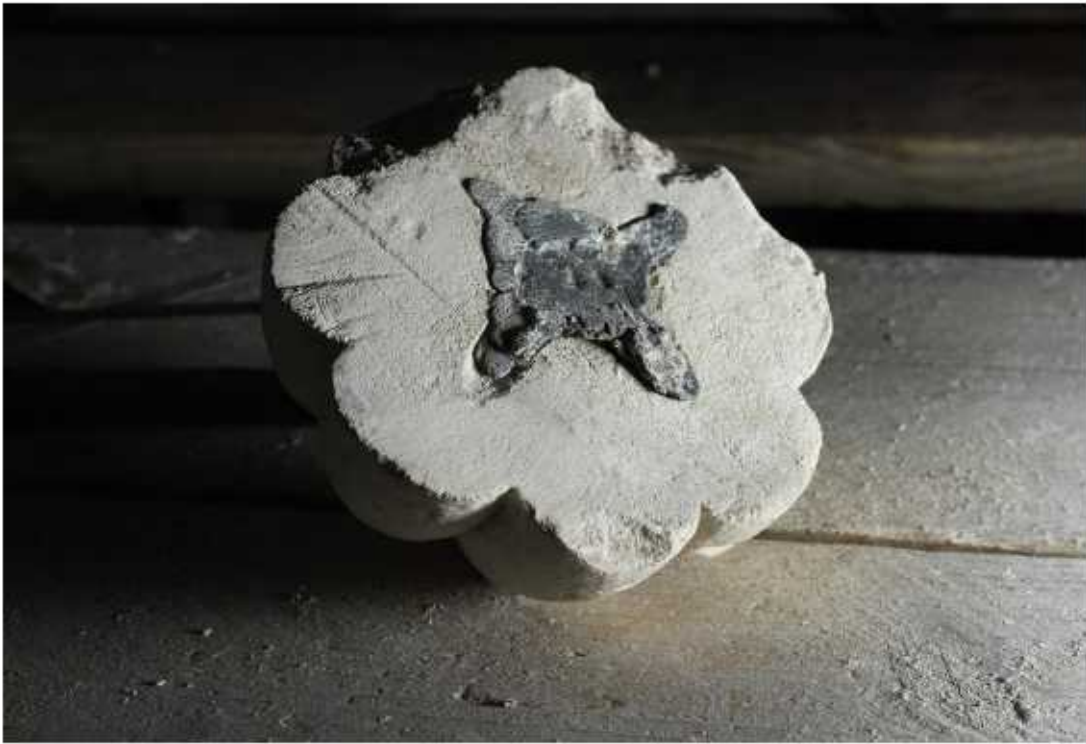
One pendant on the soffit was removed, and was found to have been fixed with non-ferrous metal (as the meter had indicated). This was re-fixed with a small phosphor bronze pin secured with polyester resin and re-pointed with lime mortar.

3. Above: lead plug found in removed pendant

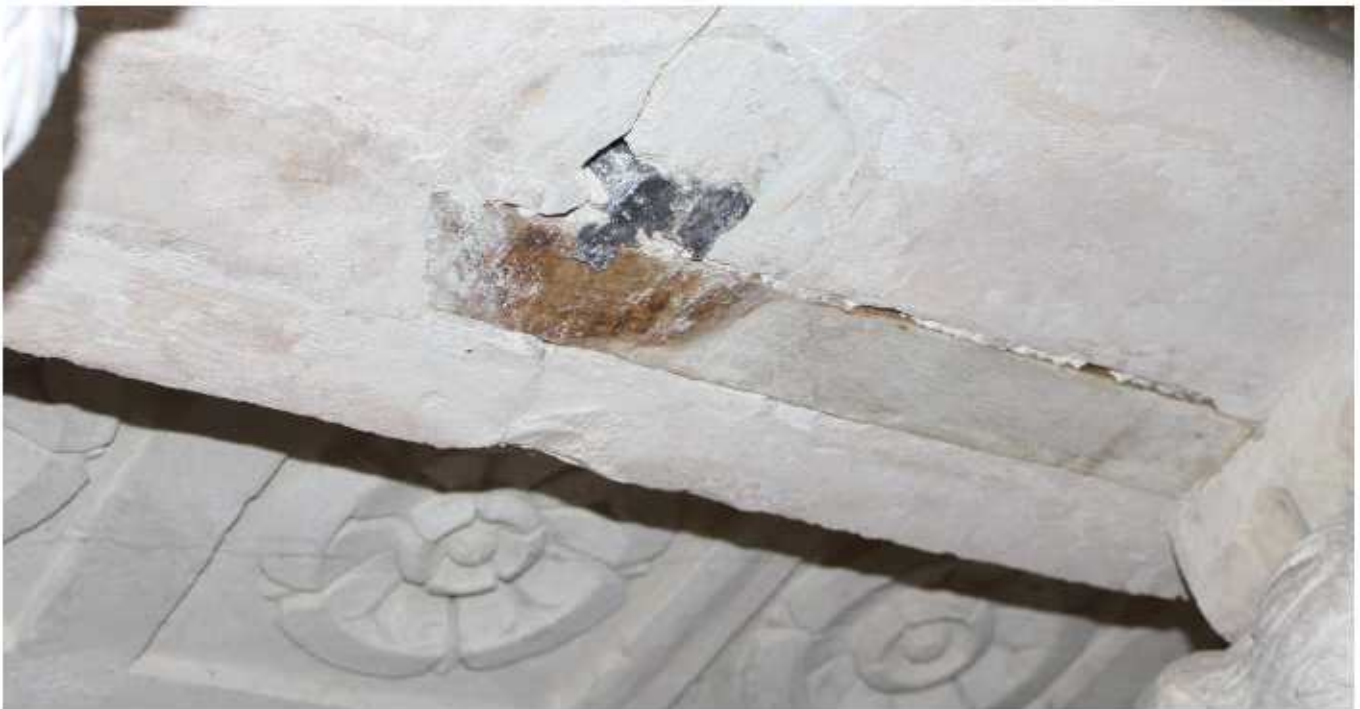
4. Below: the remnant of the lead plug in the soffit

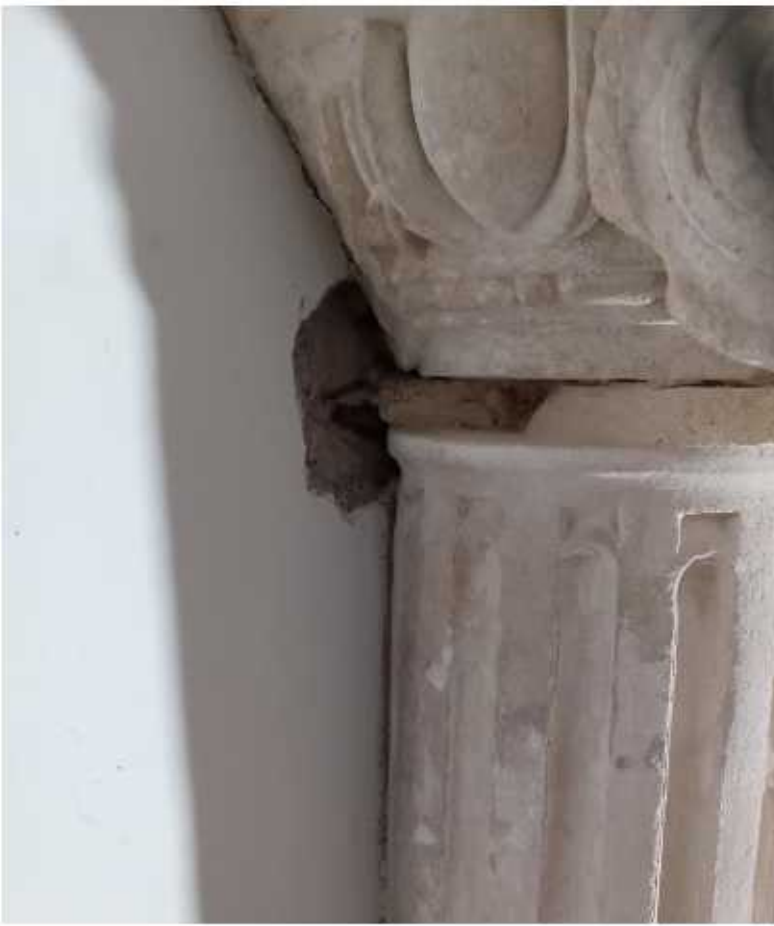
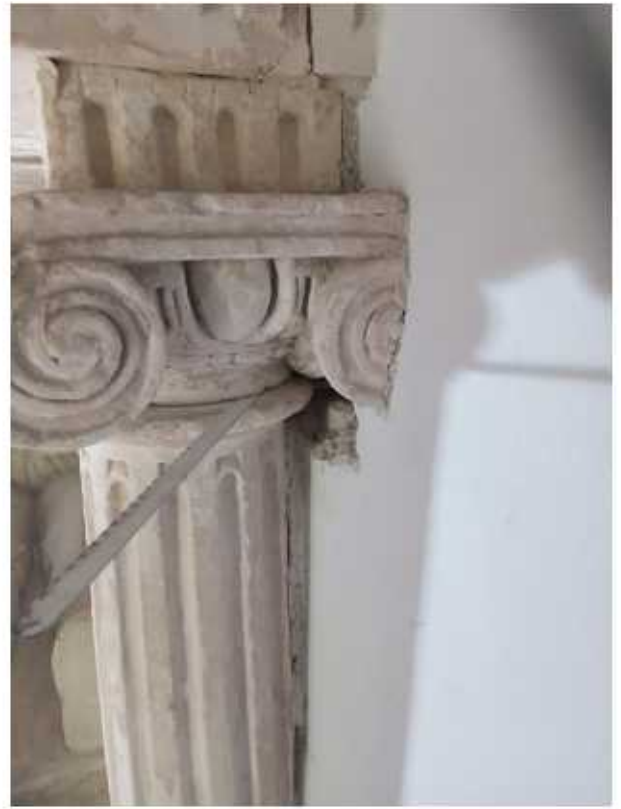
A new discovery, as mentioned above, was the presence of ferrous cramps restraining the eastern columns to the wall. These cramps had cracked the astragal moulding at the top of the columns and made some disruption in the stonework. Fine drills were used to free these cramps in the wall and the column, and they were then removed and replaced with cramps of stainless steel. These were secured in the wall with polyester resin and into the column with lime mortar packed around the cramp. The cracked sections of stone were then reinstated.

5, 6, above. Opening up at the rear of the columns to identify rusting ironwork.

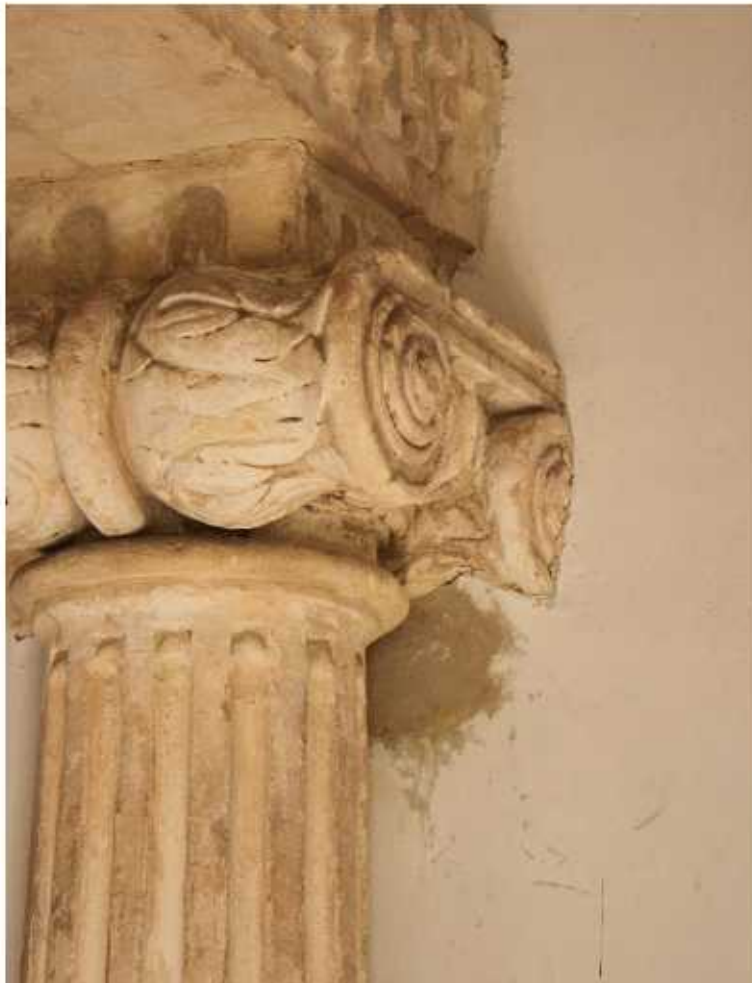
7. Area fixed with new cramp and replastered.

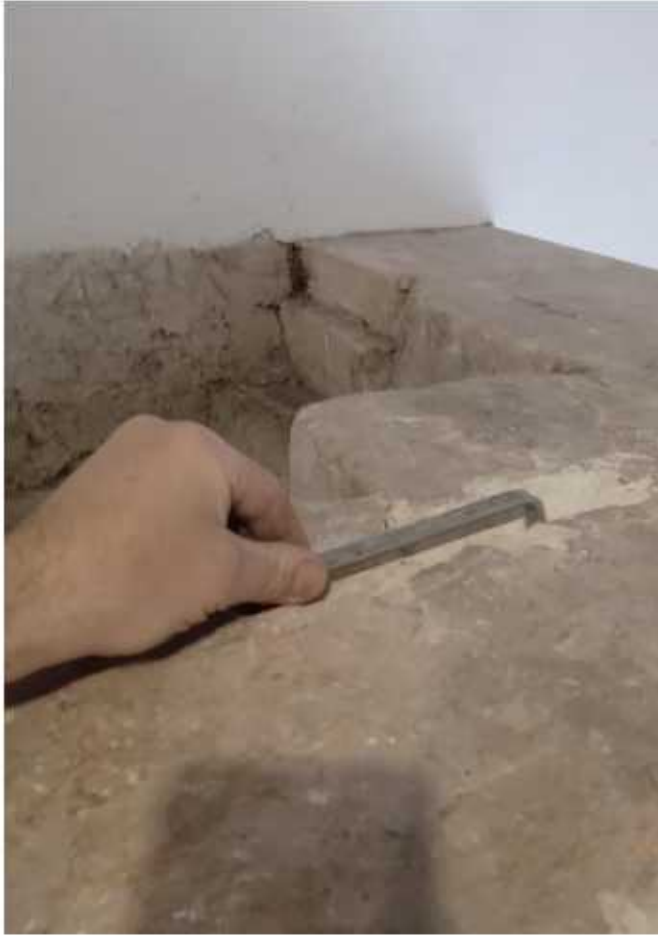
8. Replacing cramps in the cornice with Stainless steel

Two of the cramps in the top surface of the cornice stones were found to be corroded and disrupting the surrounding stonework; these were also removed and replaced with stainless steel cramps of similar size.

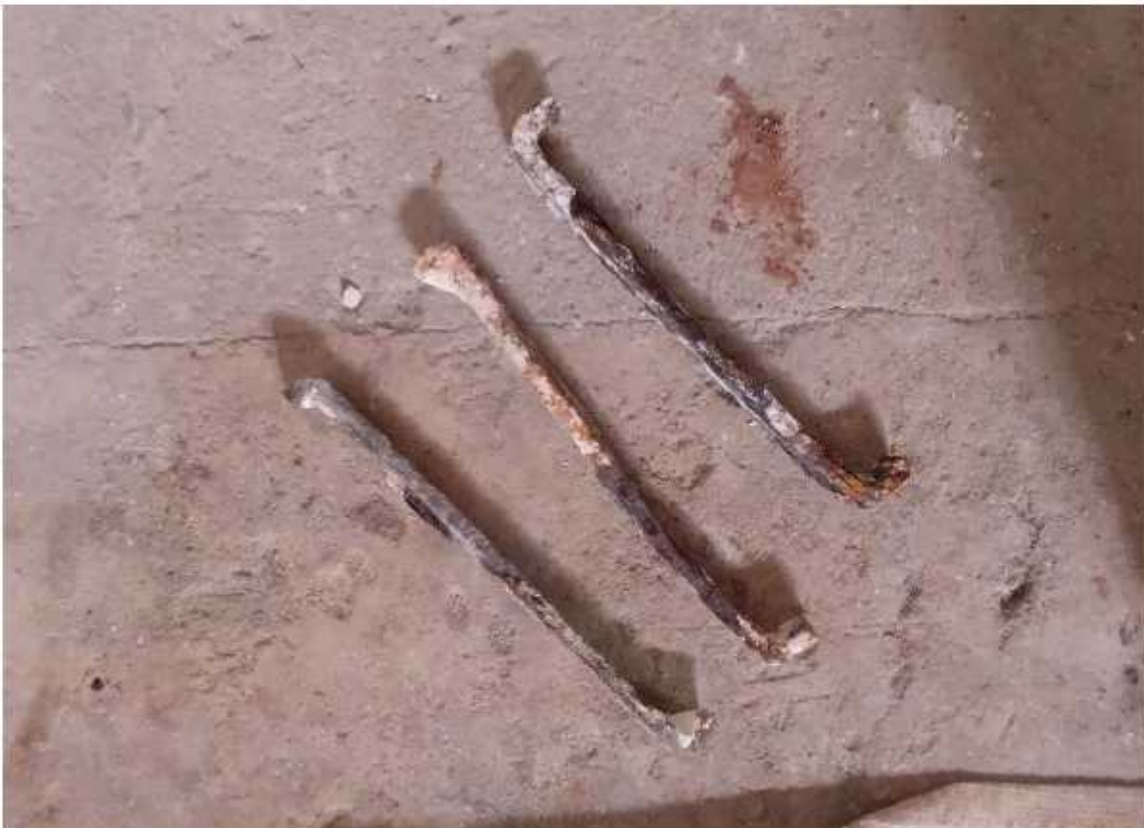
9. Sample of corroded cramps removed from the monument

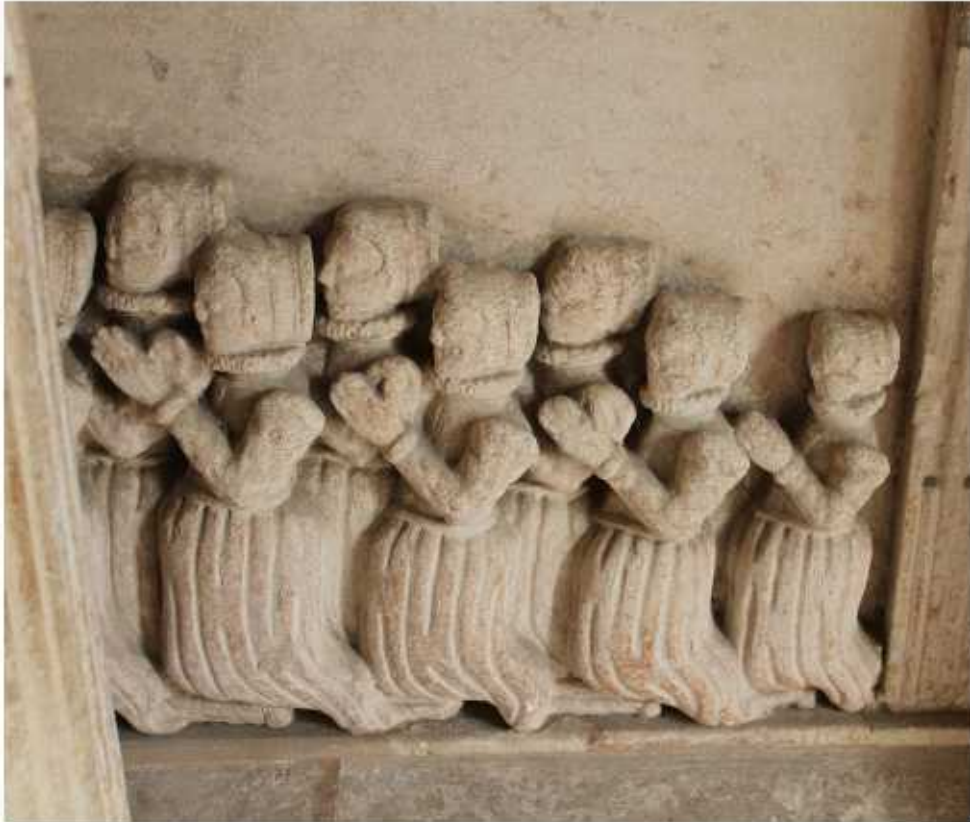
10, above. Weepers on the tomb chest, after cleaning.

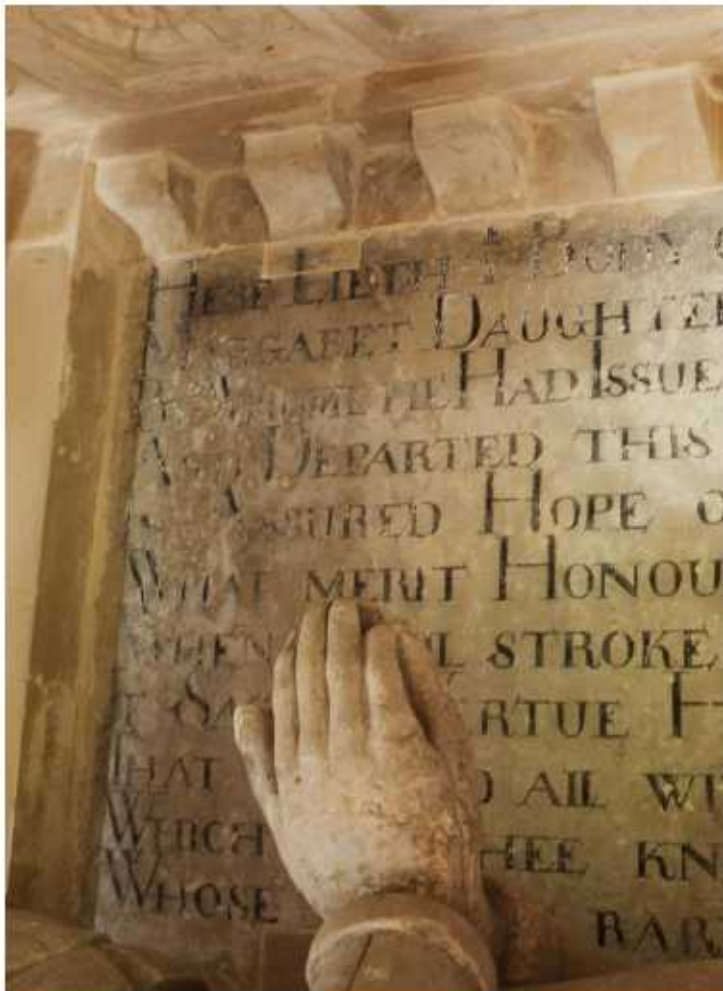
The inscription had been most affected by deterioration, most probably due to some water penetration through the east wall of the porch (external repointing was undertaken by the main contractor during our work). This had led to loss of parts of some letters and difficulty in reading the inscription. There were similar problems in parts of the lower inscription on the south end of the tomb chest.

11. Damage to the lettered inscription on the rear wall.

The inscriptions were lightly cleaned and fragile areas of lettering were consolidated with Primal B60a acrylic dispersion, diluted to 10% in water. Some minor lacunae in the support were filled with lime mortar, and retouching of the lettering was undertaken with dilute black Winsor and Newton acrylic paints (somewhat appropriately). The inscription was thereby rendered legible once more. The 19th century paint of the heraldic elements was cleaned with deionised water and cotton wool swabs.

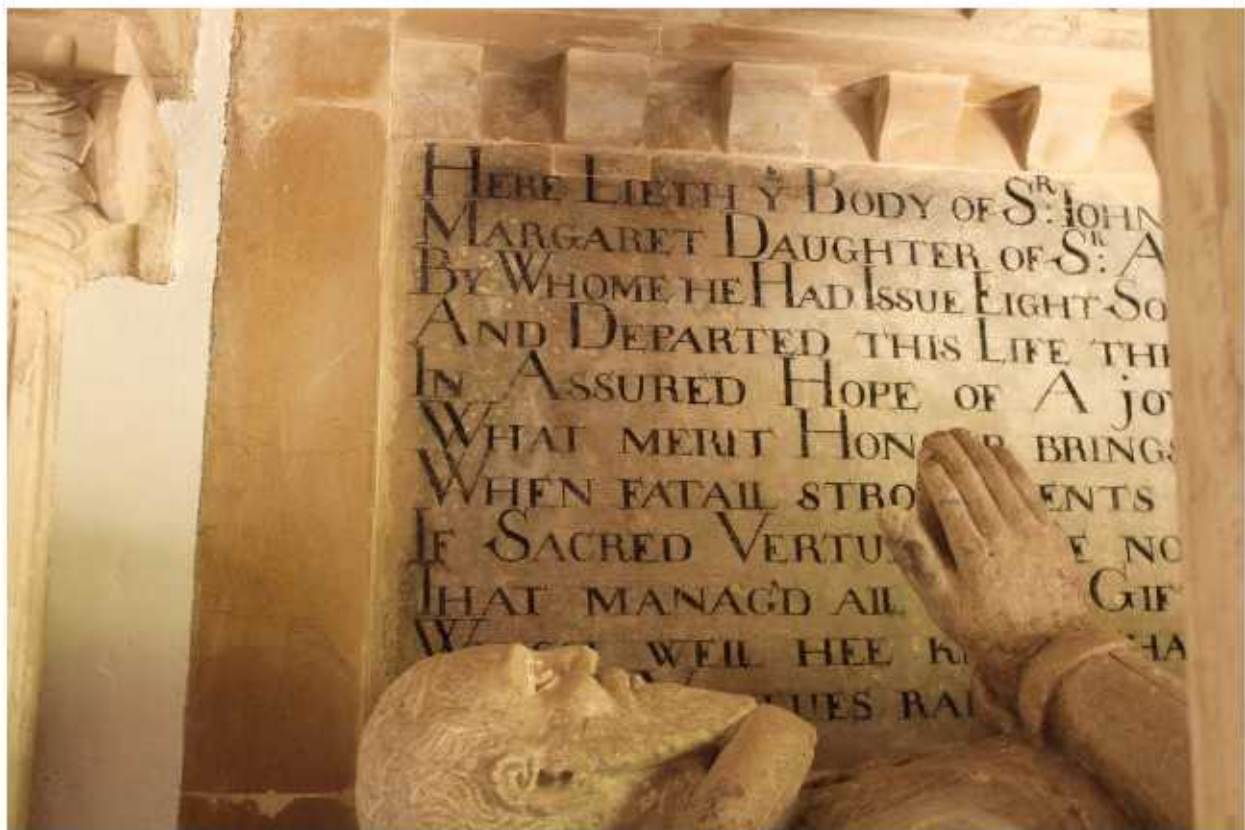
12. Northern end of the inscription, after cleaning and retouching

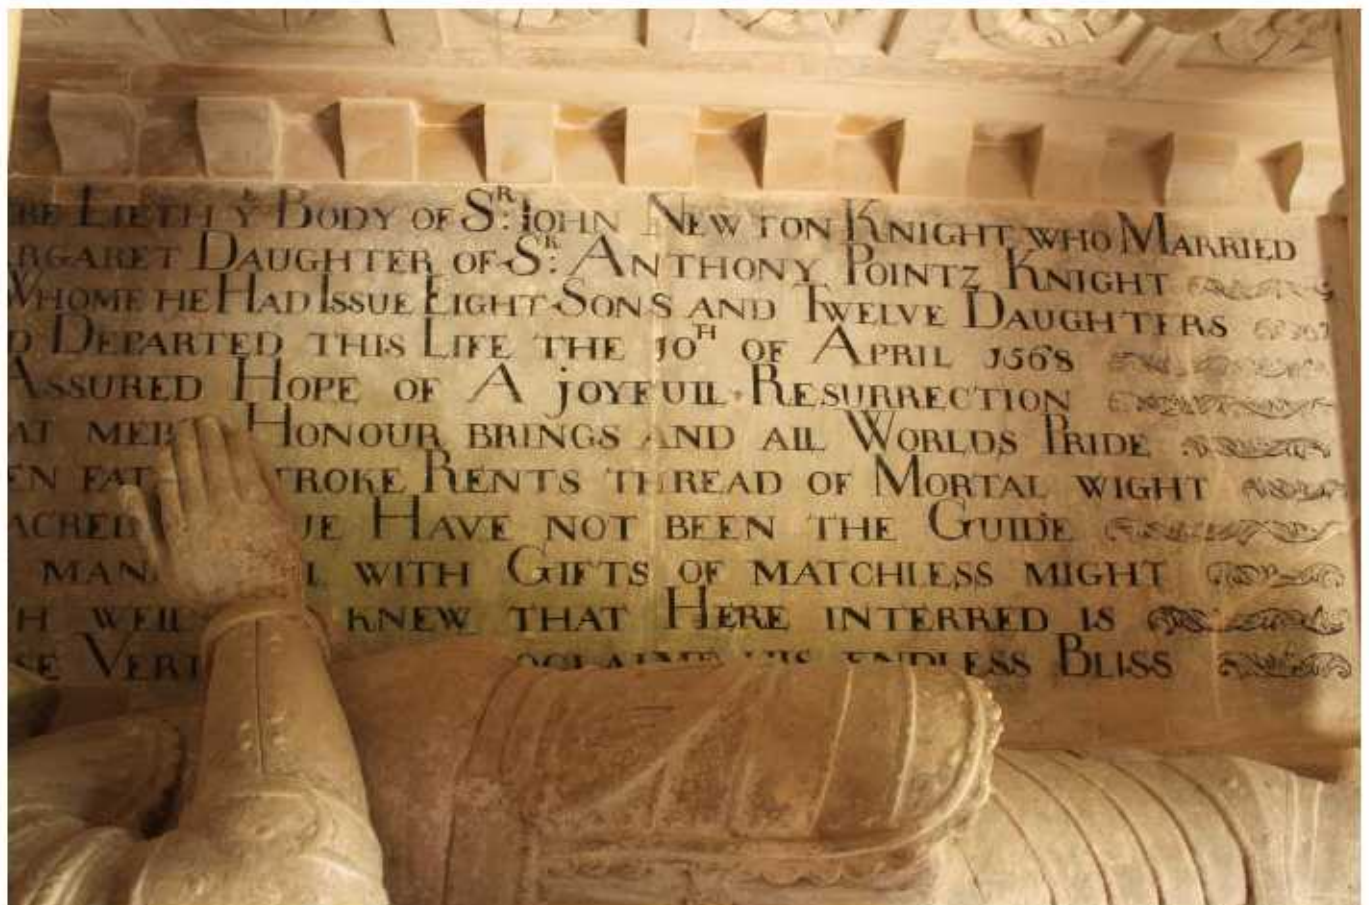
13. Southern end of inscription after cleaning and retouching

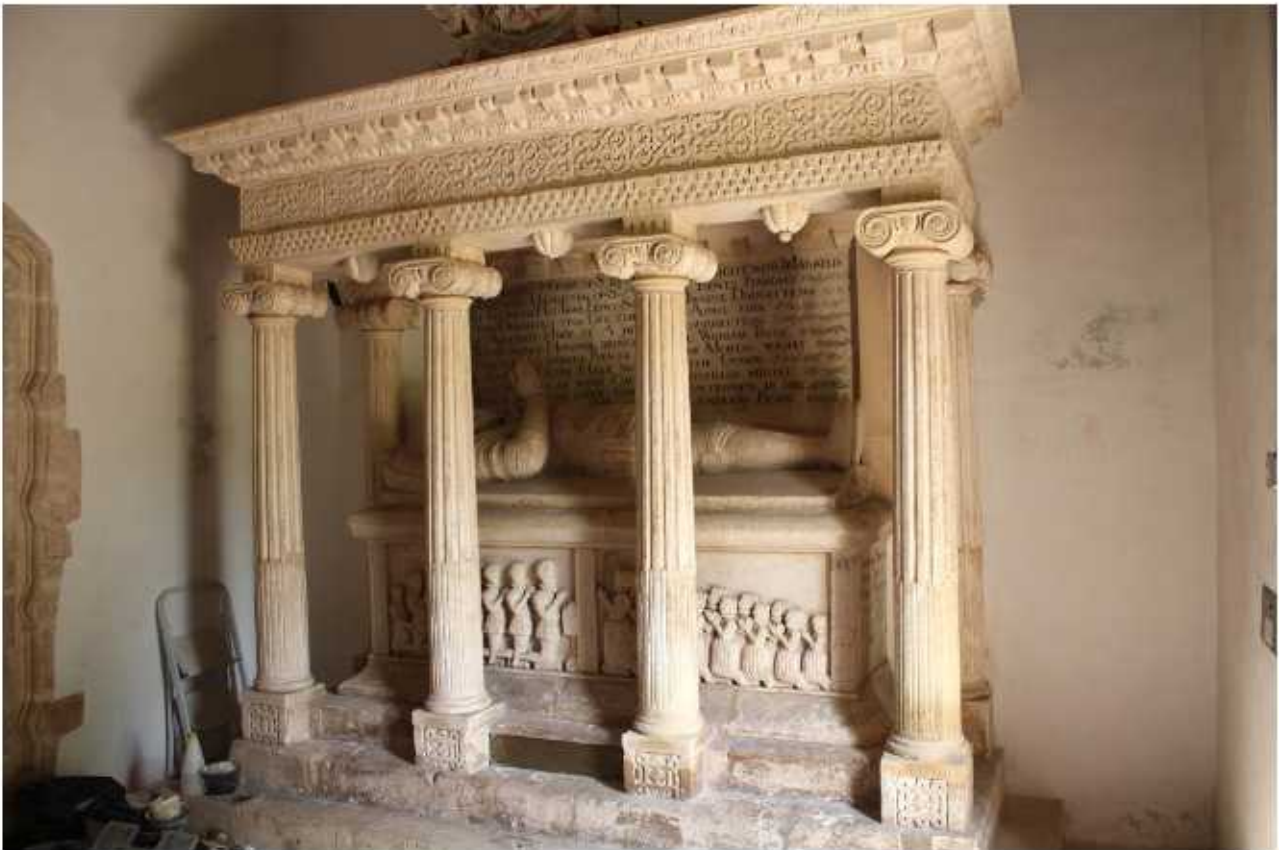
14. Monument after work was completed

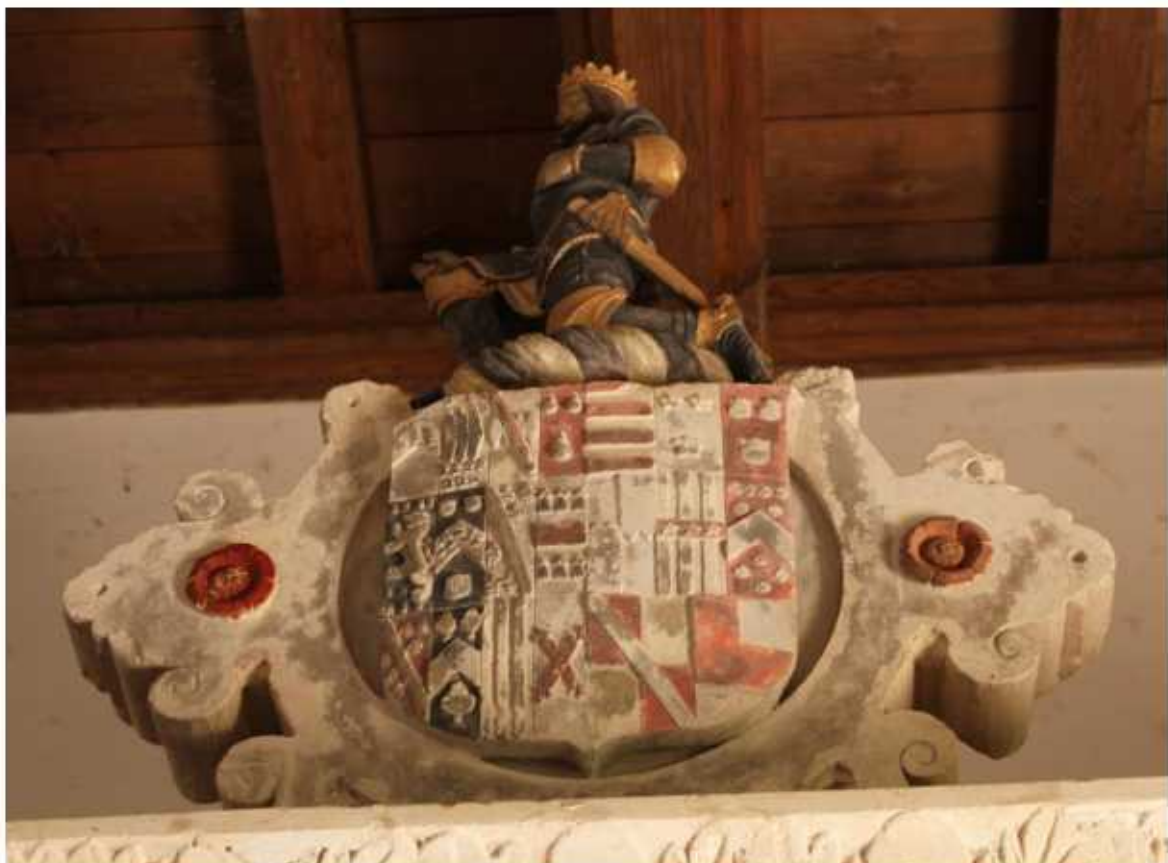
15. the topmost cartouched after cleaning and minor consolidation

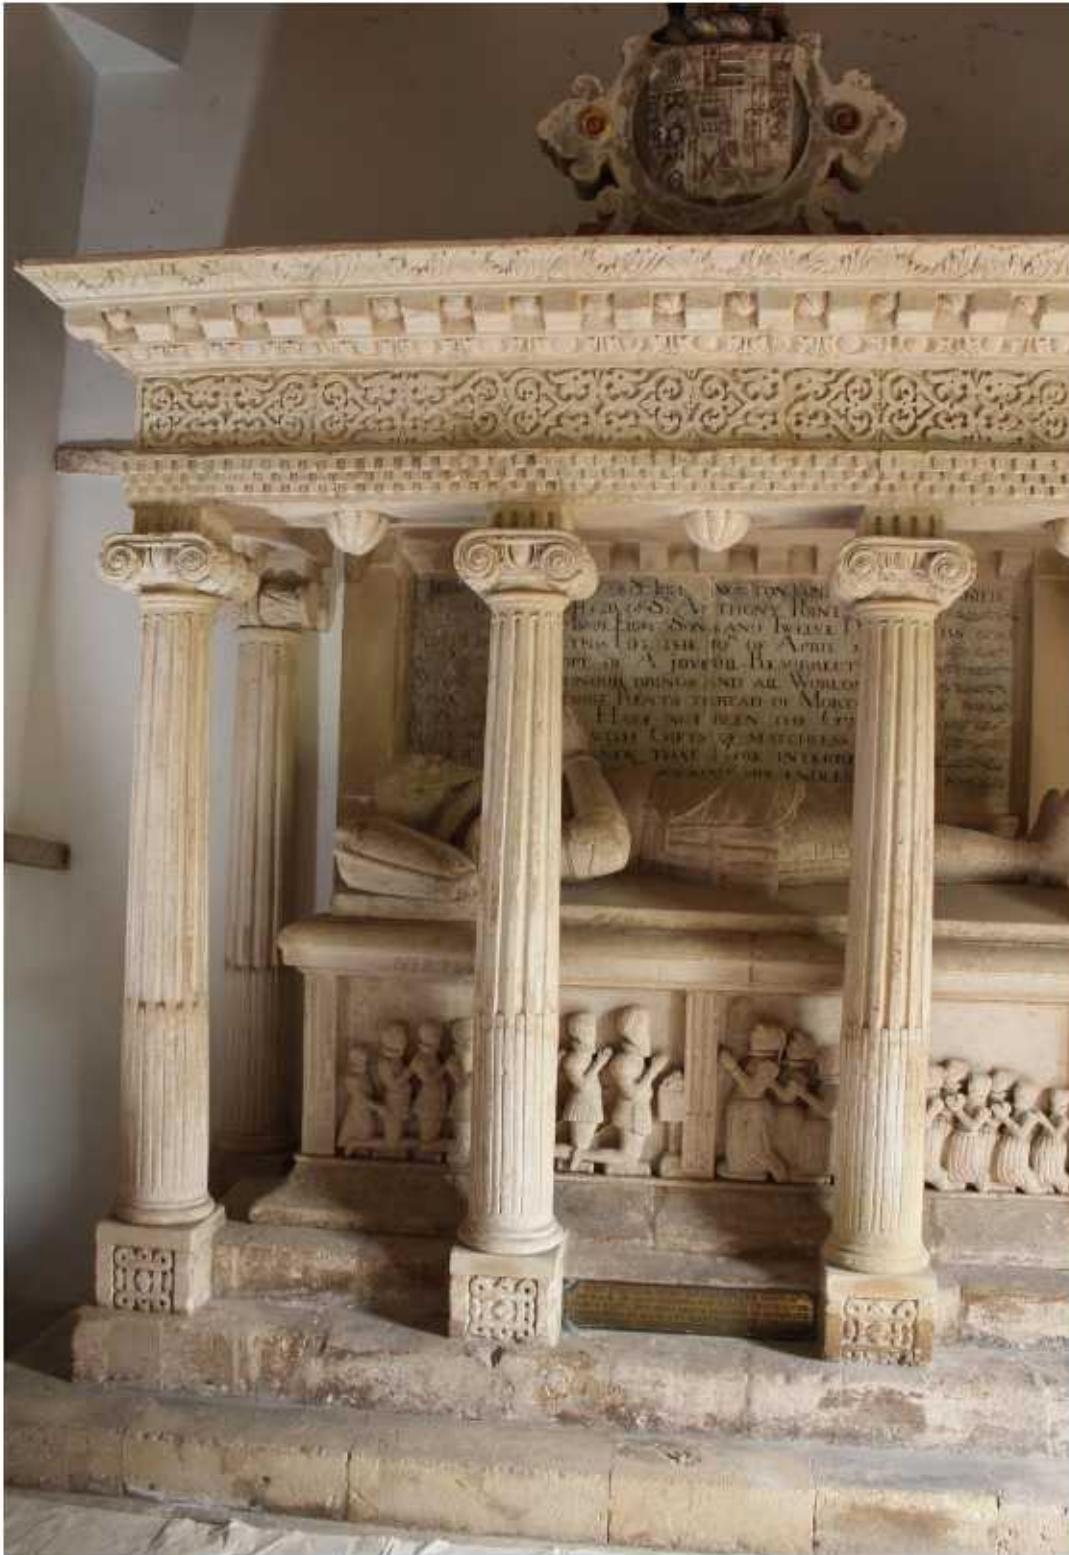
16. Northern end of monument after work

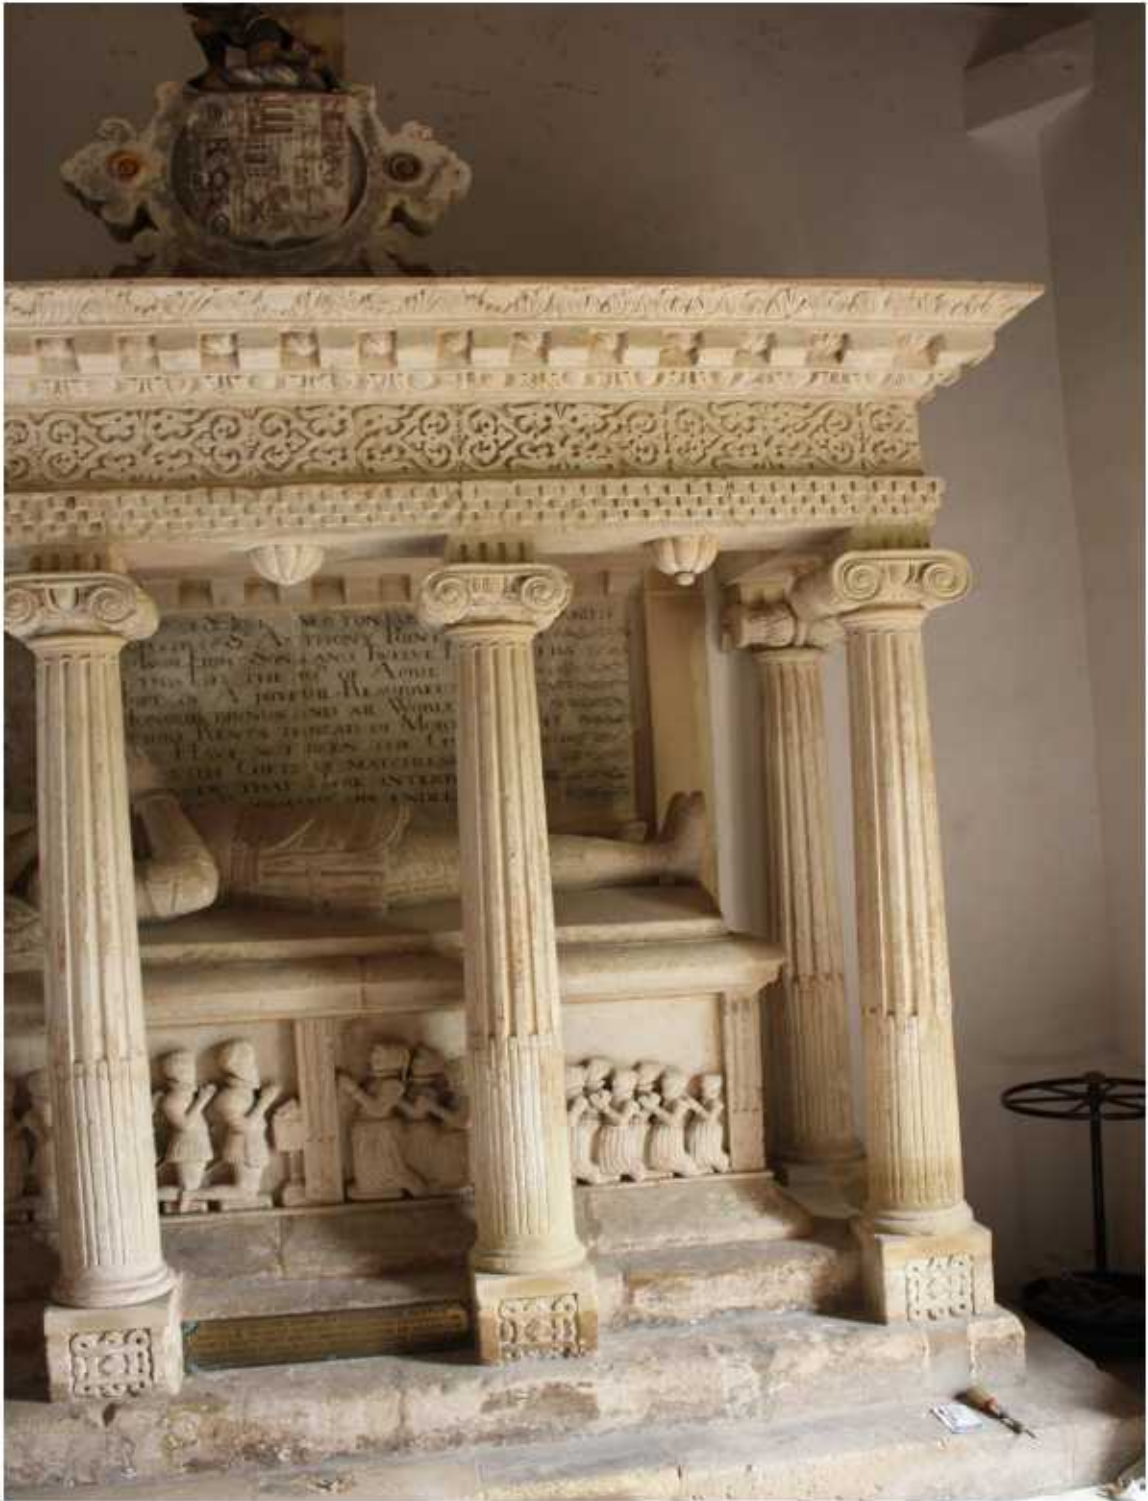
17. Southern end of monument after work
