St Michael and All Angel's Church, The Street, Hartlip, Kent ME9 7TL

Archaeological Watching Brief Final report

Project Code: WB SMCH24
Planning Ref: N/A
NGR: TQ 583922 164284 (centred)
Archive No.: 5258
CAT Ref.: 2024/167

December 2024

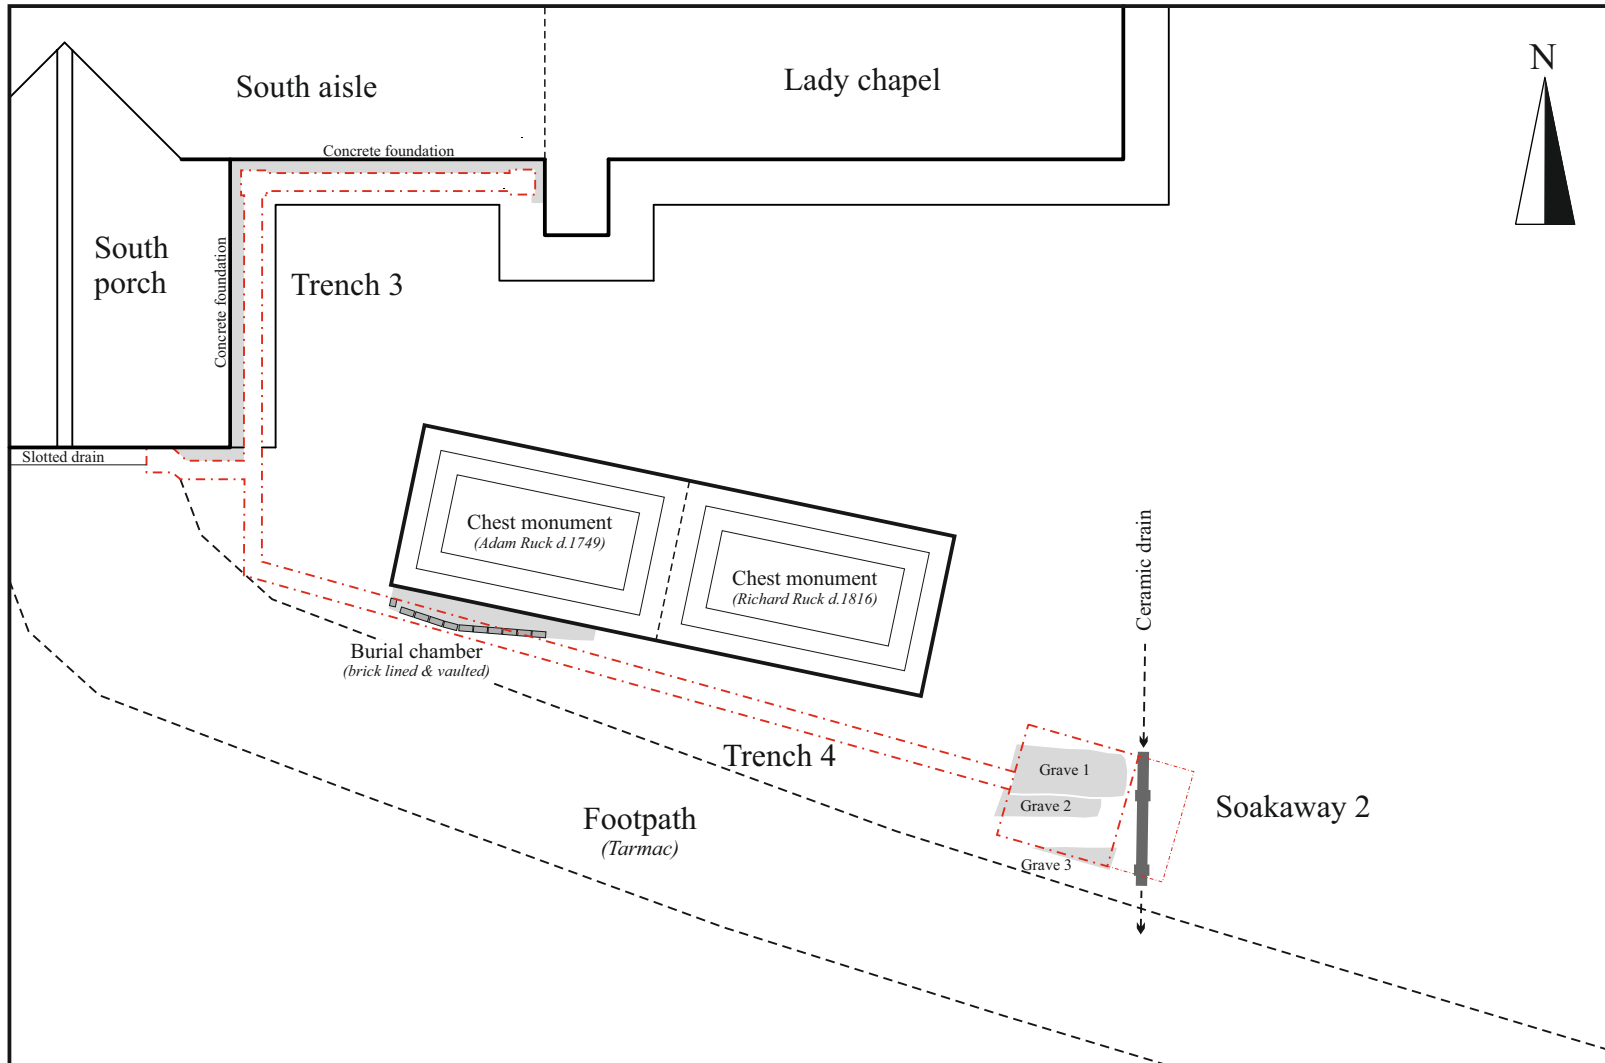
Figure 3. Detailed plan showing alignments of Trench 3 and 4 with Soakaway 2 with grave positions (Grave 1, 2 & 3) with portion of a brick lined, and brick vaulted, burial chamber revealed along Trench 4 adjacent to later double table monument.

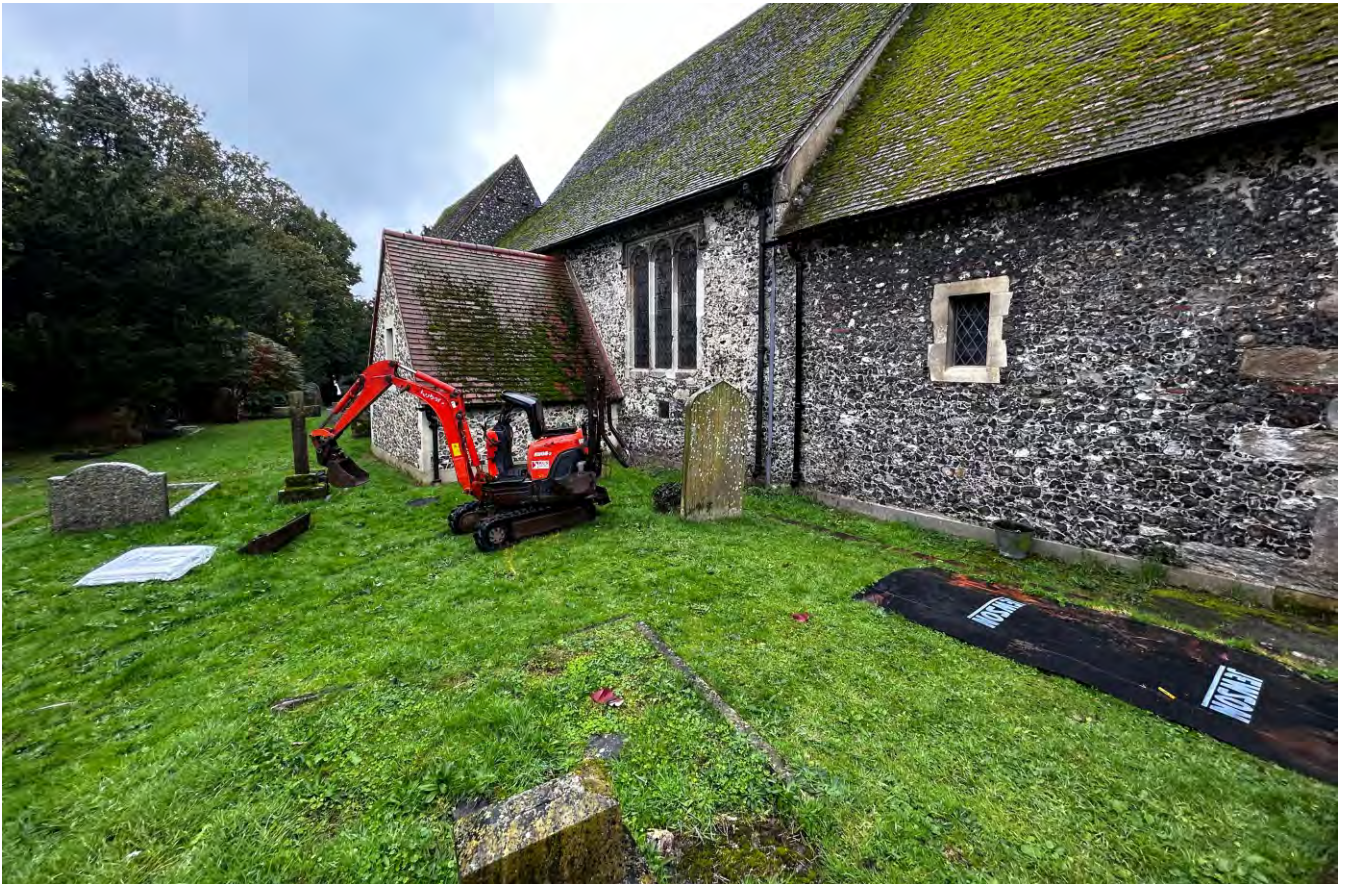
Plate 1. General view looking southeast towards the northern side of St Michael and All Angel's Church, The Street, Hartlip showing the area of Trench 1 and Soakaway 1.

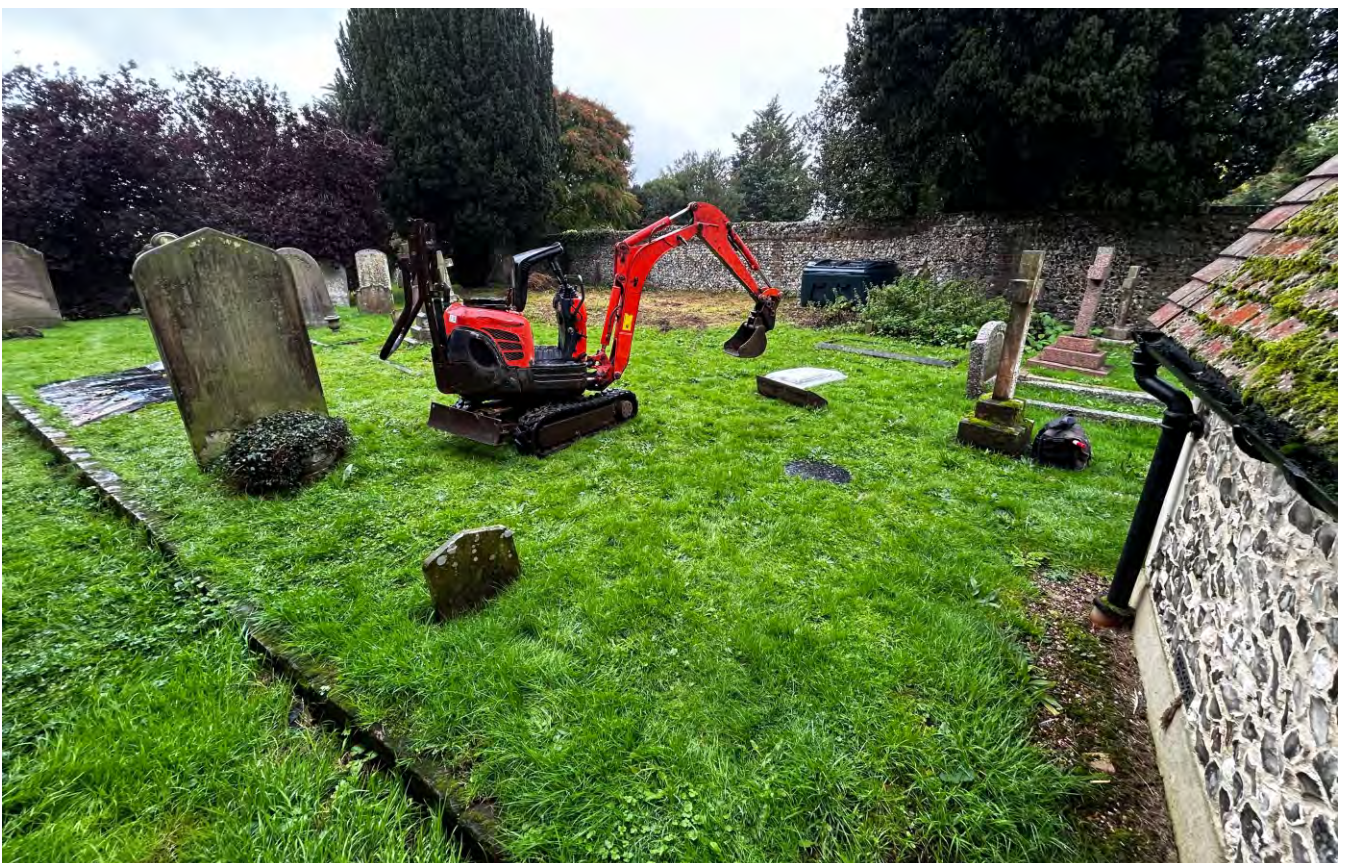
Plate 2. General view looking northeast from the north side of the church across the site of Trench 1 and Soakaway 1.

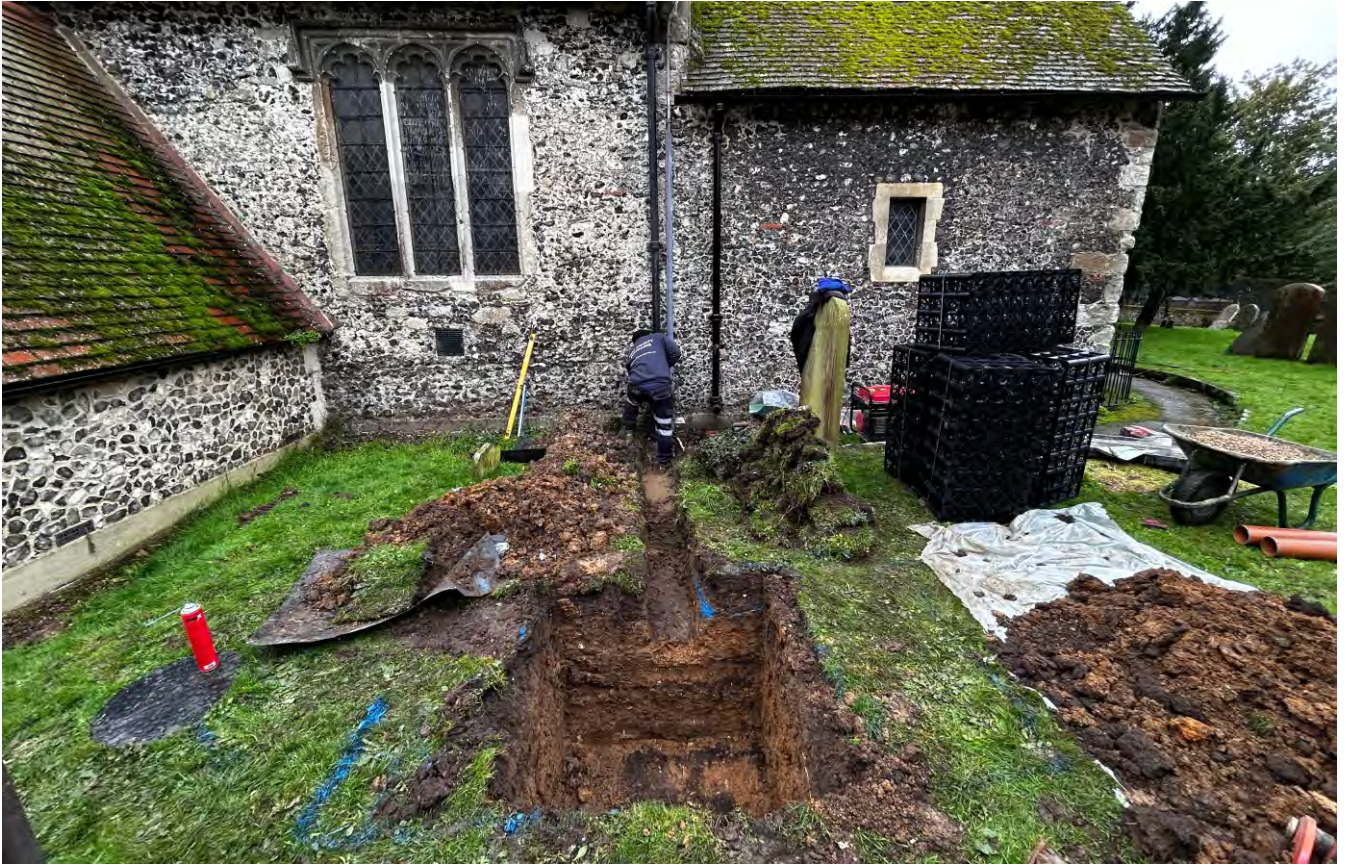
Plate 3. General view looking south along Trench 1 line with Soakaway 1 at its northern end in relation to the nave's northern wall with suggested former anchorite chamber on its western end (*note: side wall of recent extension against the nave's north wall (left).*)

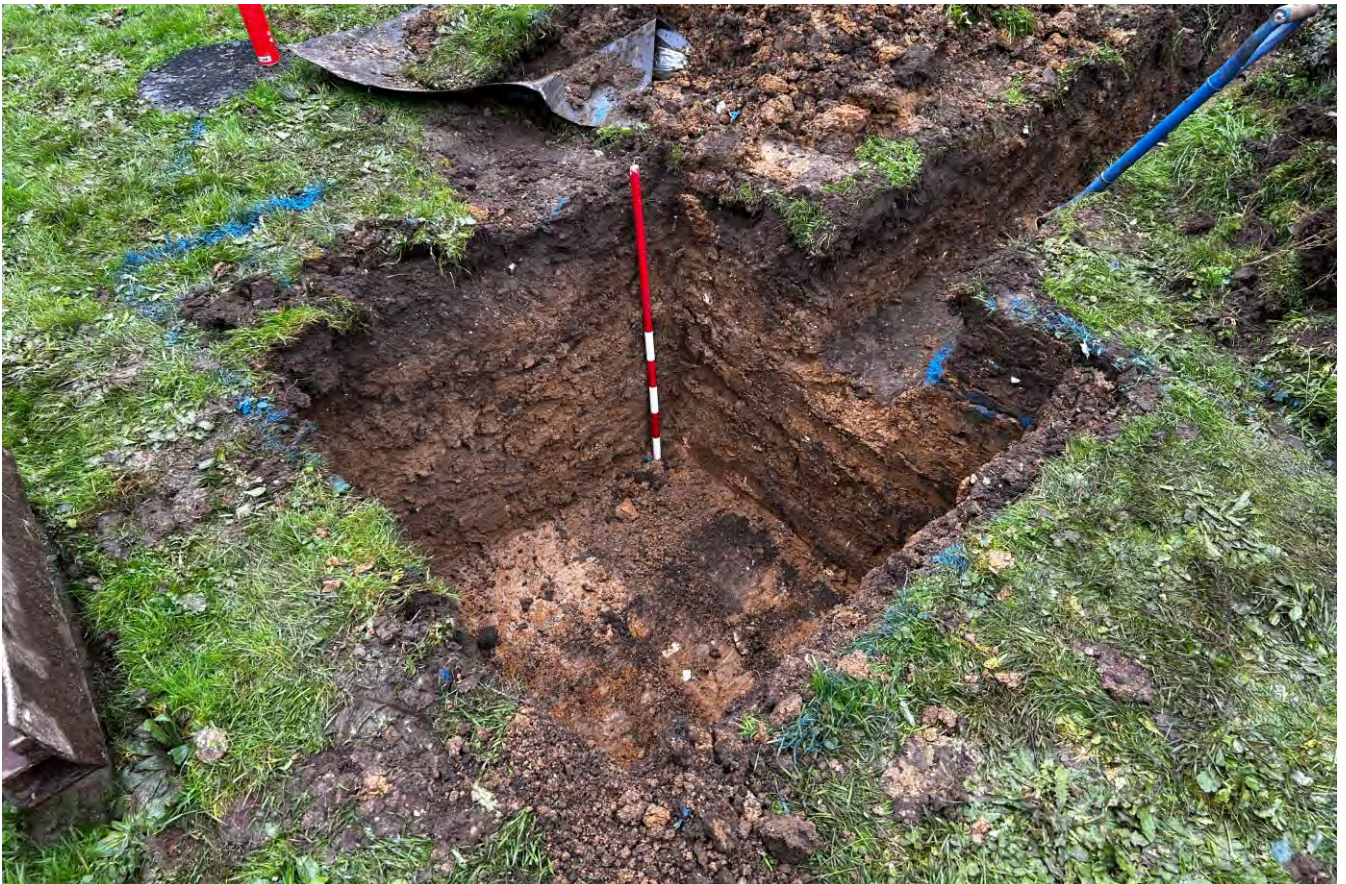
Plate 4. Detailed view looking southeast of Soakaway 1 excavation pit showing topsoil sealing disturbed graveyard soils to depth overlying Superficial geology (*note: disturbance of geology by deeper infilled graves.*)

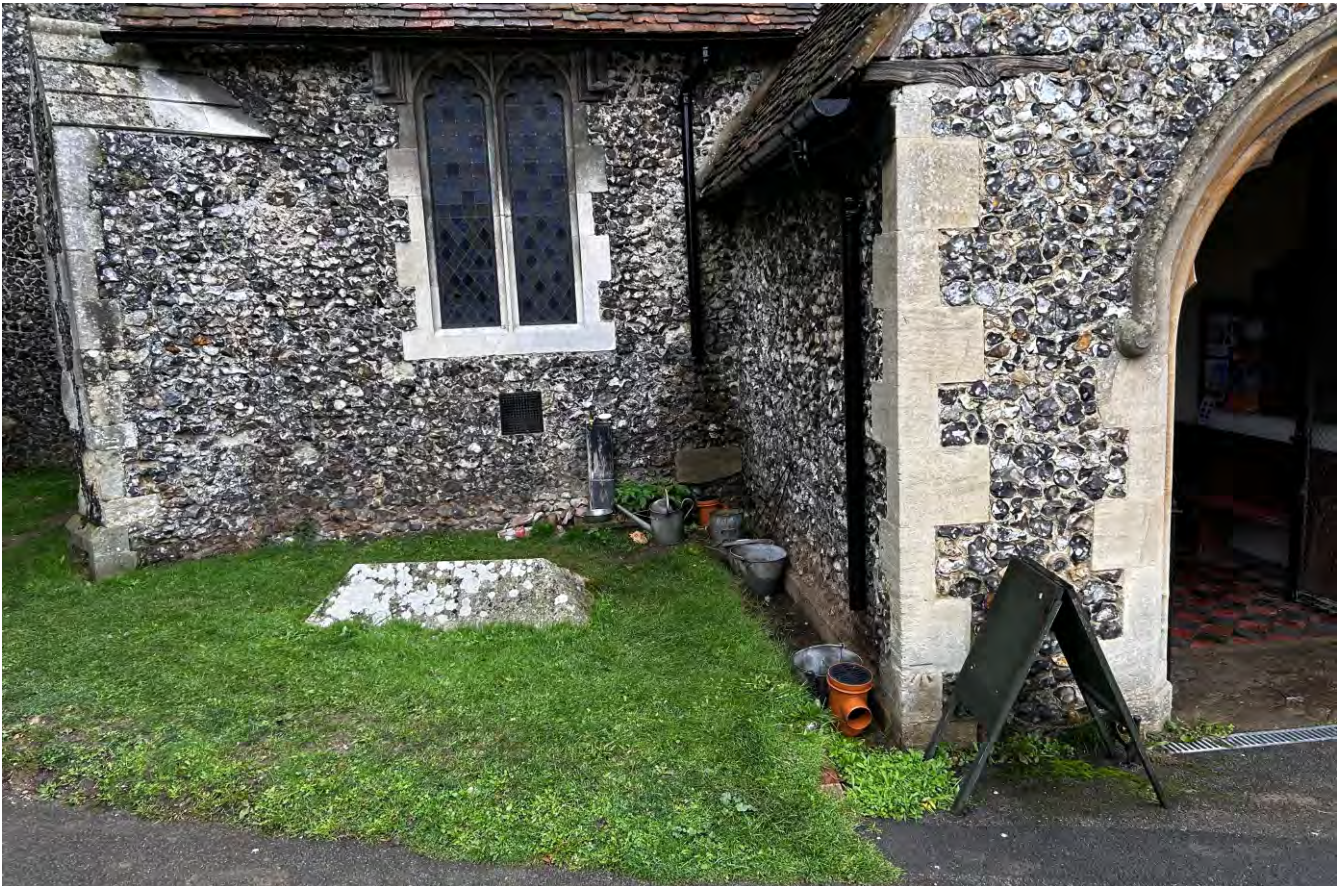
Plate 5. General view looking north along the proposed line of Trench 2 at the base of the South porch's western wall base from its junction with the south wall of the south aisle to the edge of the churchyard footpath (note: existing 'French drain' along the base of the porch's side wall).

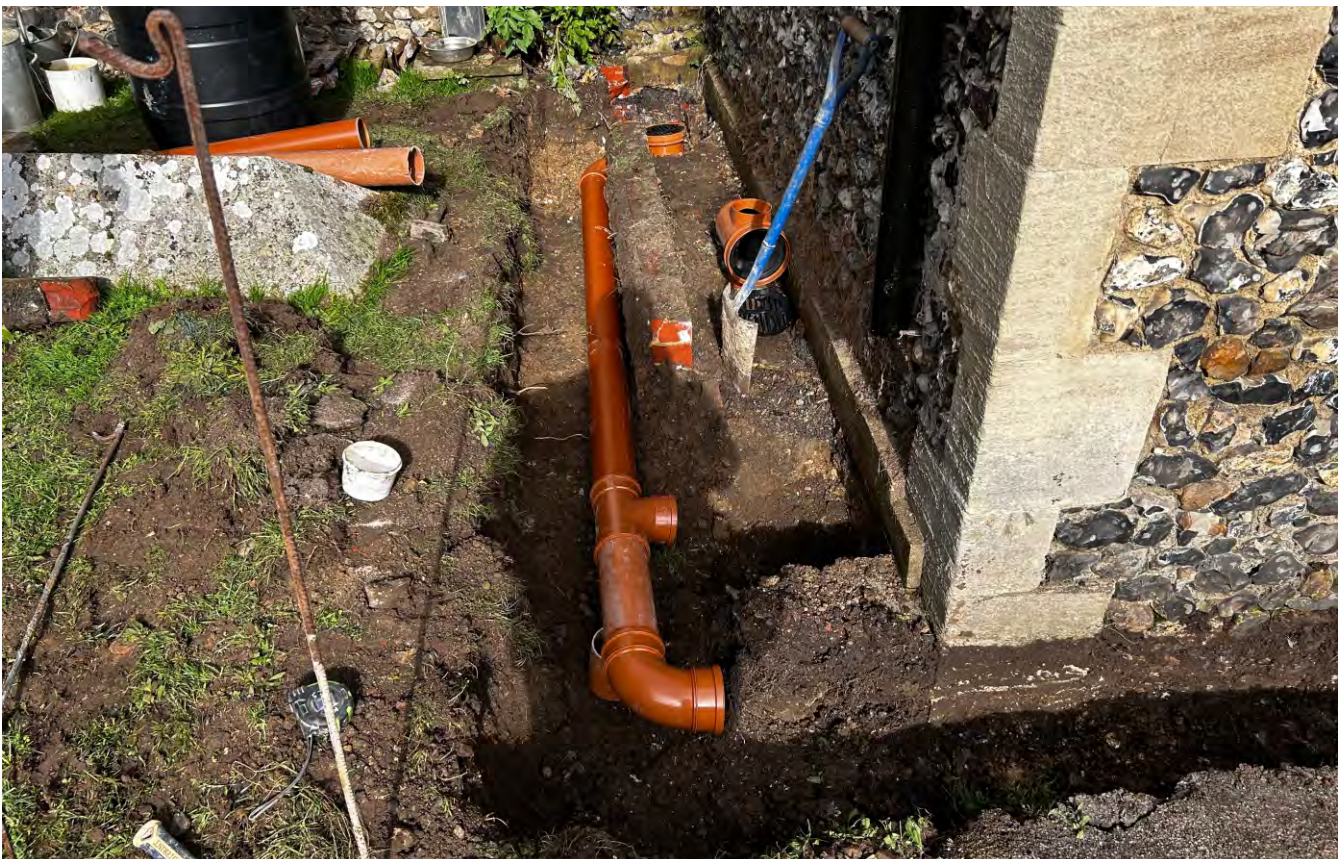
Plate 6. Detailed view looking north along the line of Trench 2 showing its route through the grassed area adjacent the existing 'french drain' with connections to existing rainwater down pipes..

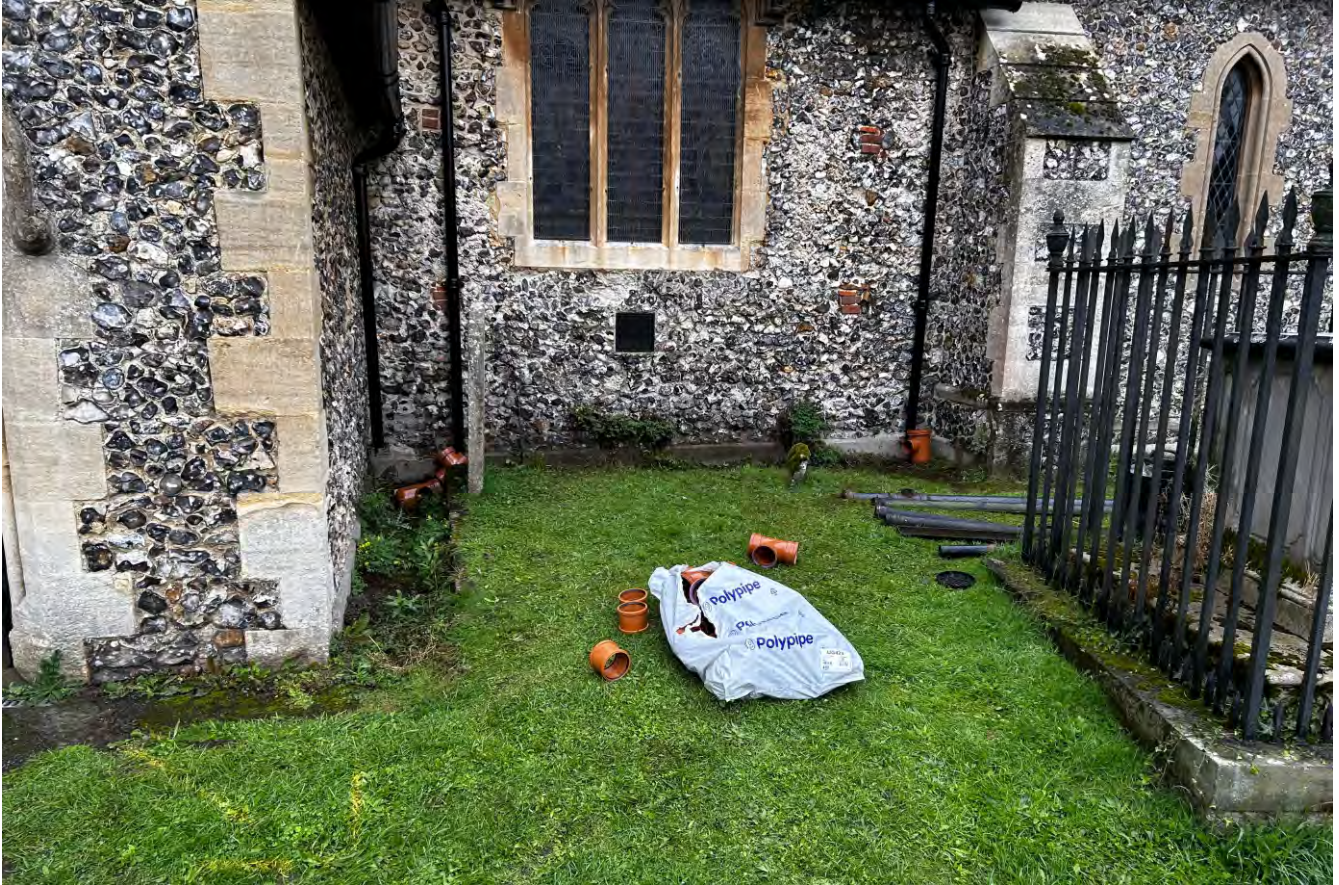
Plate 7. General view looking north across the site of Trench 3 proposed to extend along the base of the South porch's east wall and along the base of the South aisle's south wall base.

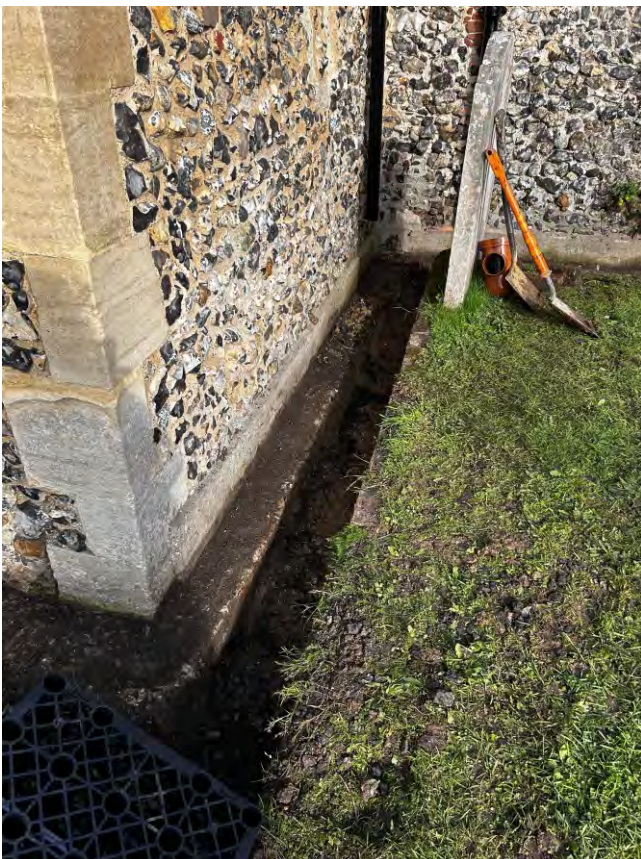
Plate 8a. Detailed view looking along the line of Trench 3 showing C.19th concrete porch foundation addition.

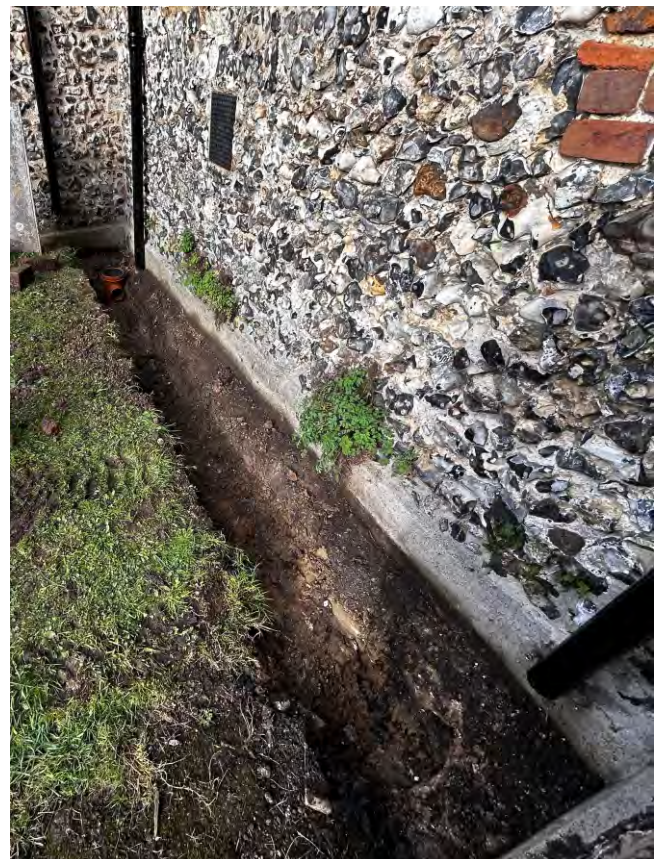
Plate 8b. Detailed view looking northeast along the line of Trench 3 showing C.19th concrete foundation addition.

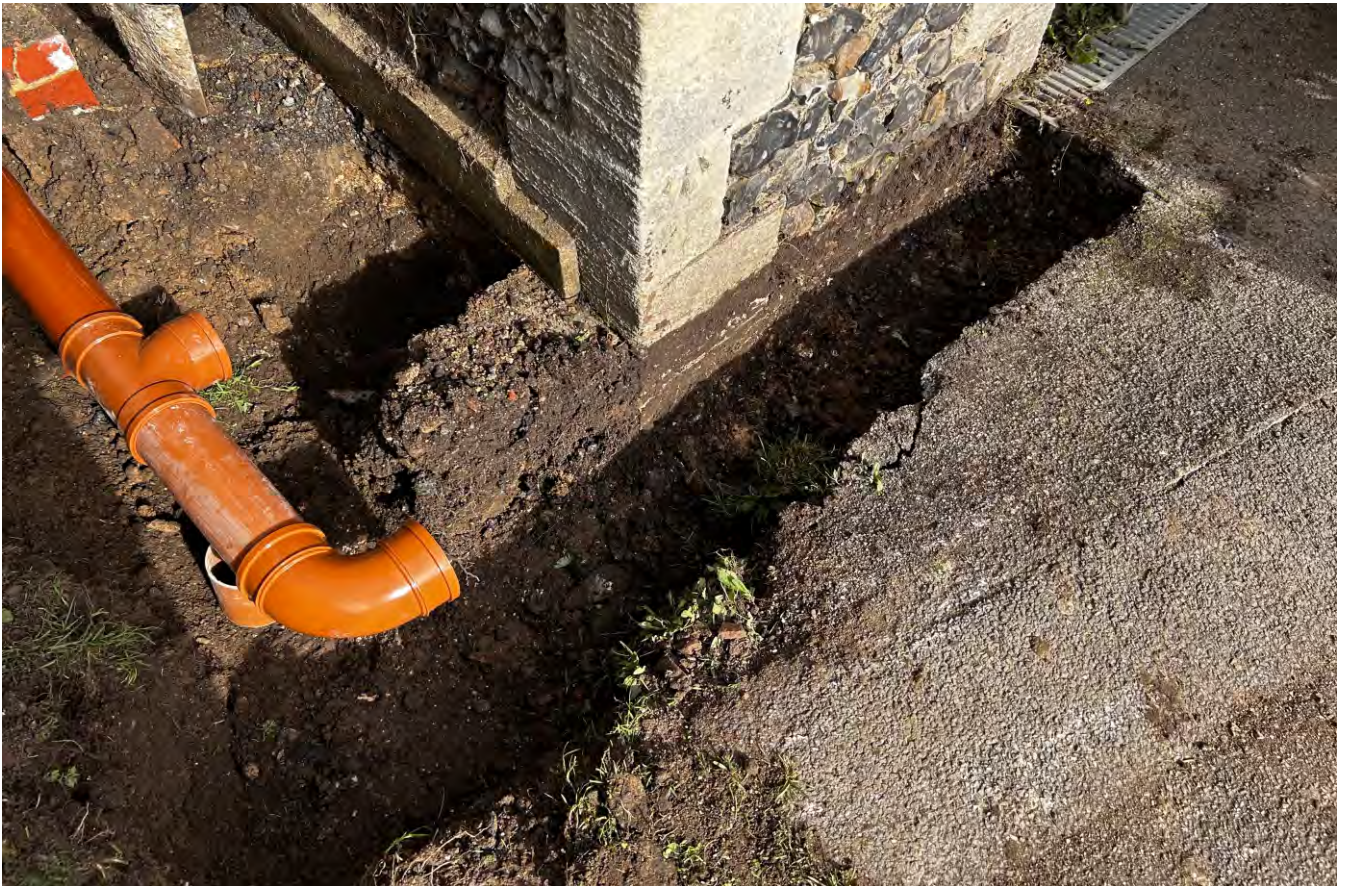
Plate 9. Detailed view looking northeast showing the southern end of trench 2 connecting with the slotted drain across the threshold of the South porch door (top right) (*note: concrete foundation addition to the porch's southern wall base*).

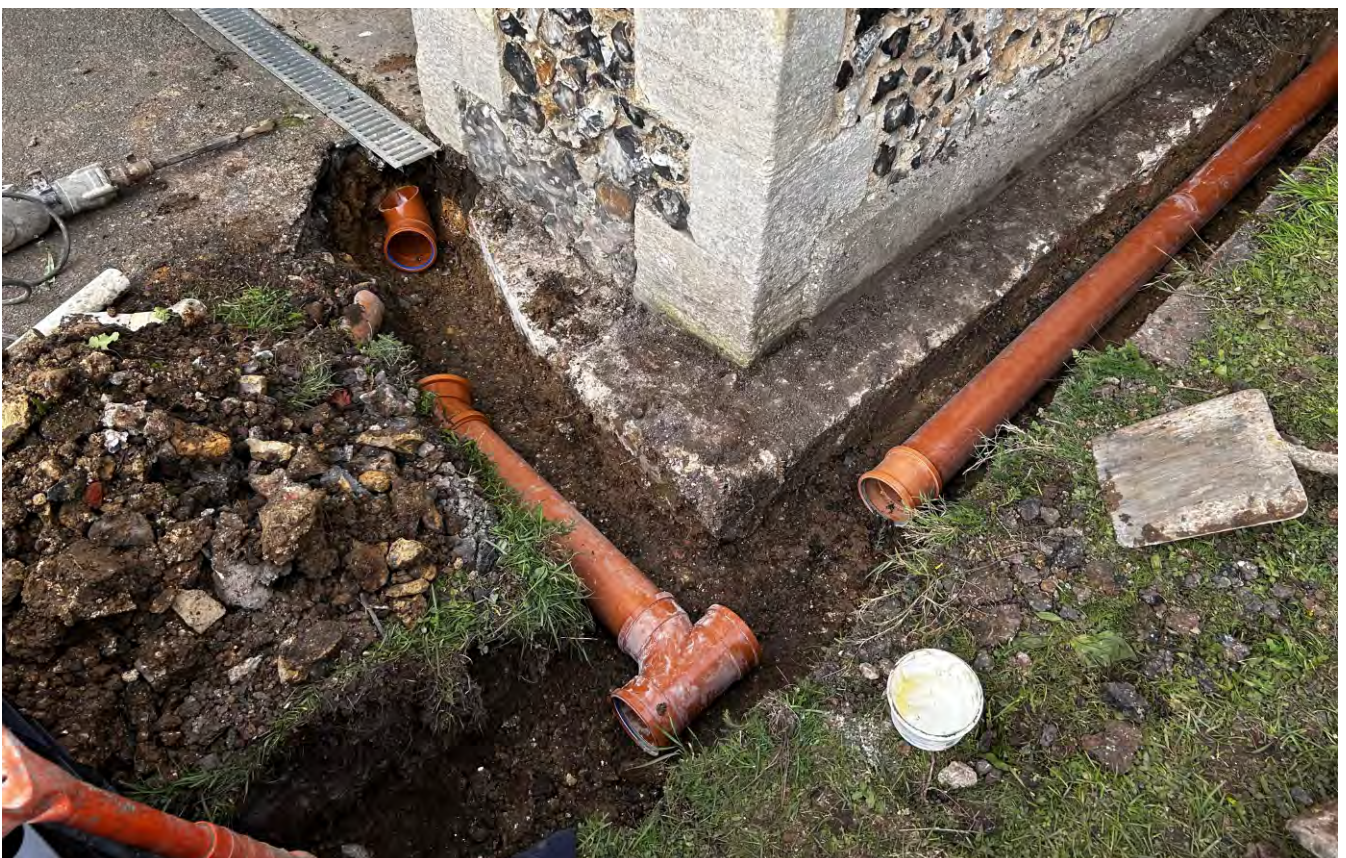
Plate 10. Detailed view looking northwest showing the southern end of Trench 3 connecting with the slotted drain across the threshold of the South porch door (top left) and continuing south to adjoin with the western end of Trench 4 (*note: concrete addition to porch's eastern wall foundation extending along the base of its southern front wall also*).

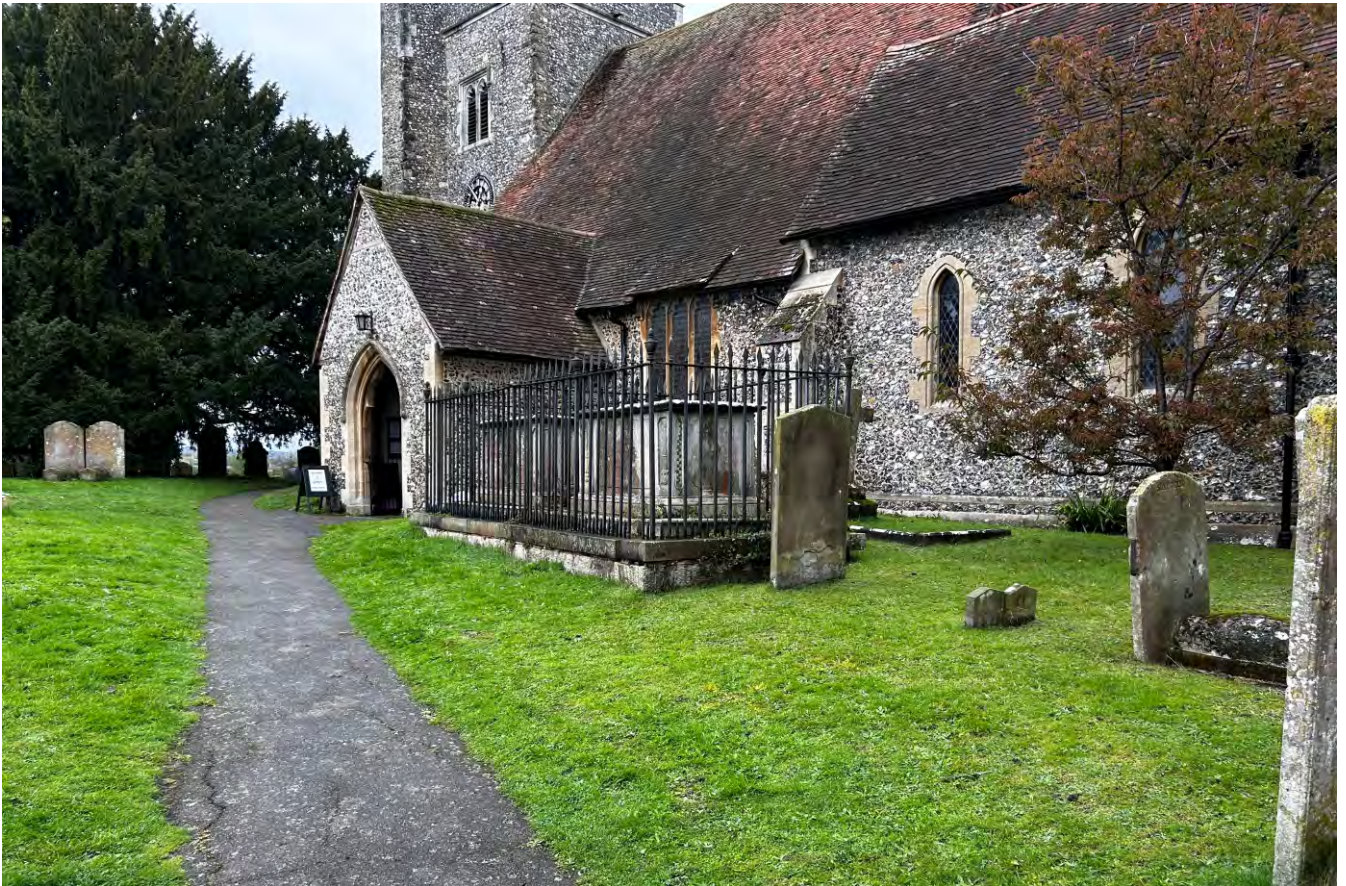
Plate 11. General view looking northwest along the line of the churchyard tarmac footpath showing the proposed alignment of Trench 4 to culminate in Soakaway 2 near the memorial head and foot stones (*note: the double chest monument to the Ruck family members c.1816 and c.1749*).

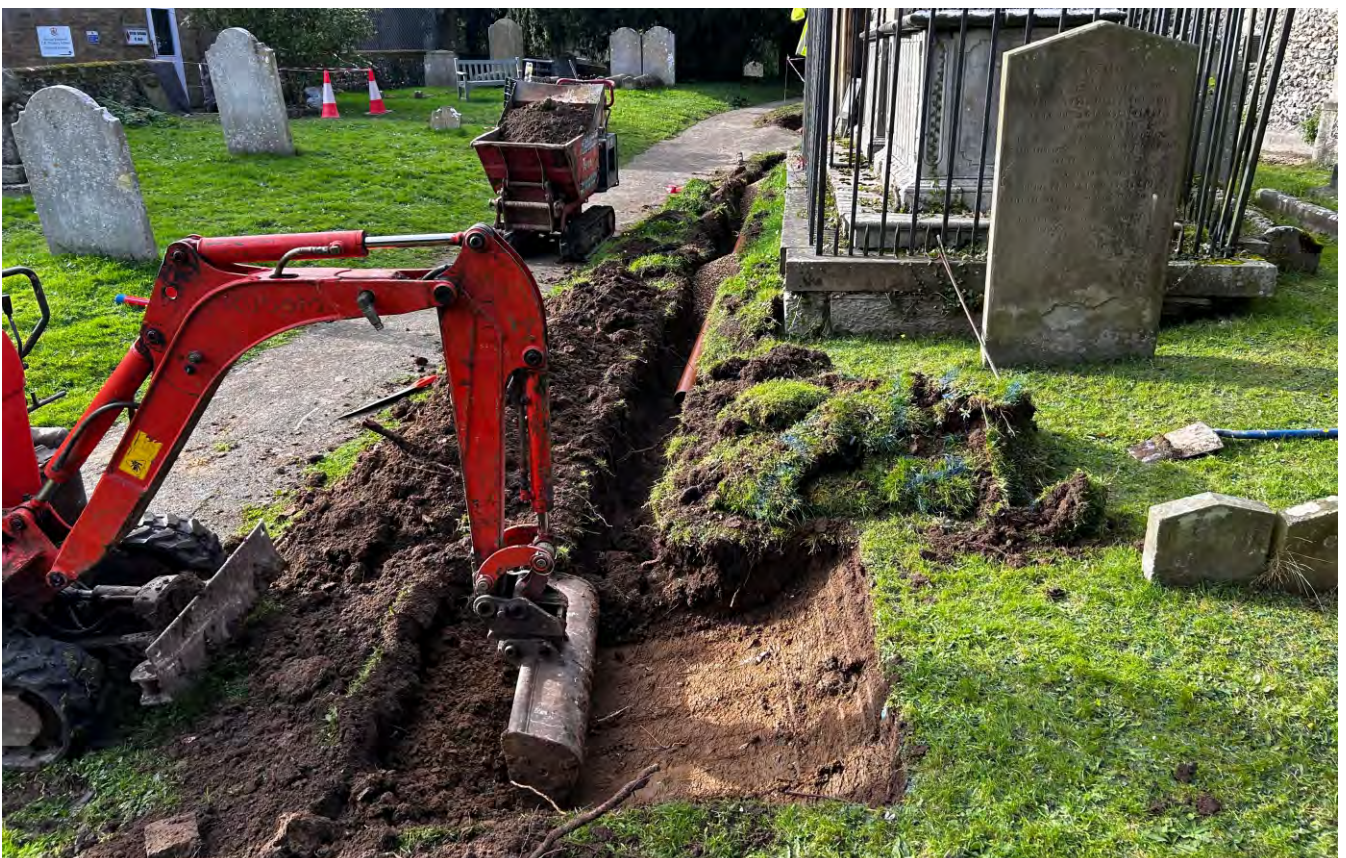
Plate 12. General view looking west along the line of Trench 4 showing Soakaway 2 being excavated adjacent the churchyard footpath.

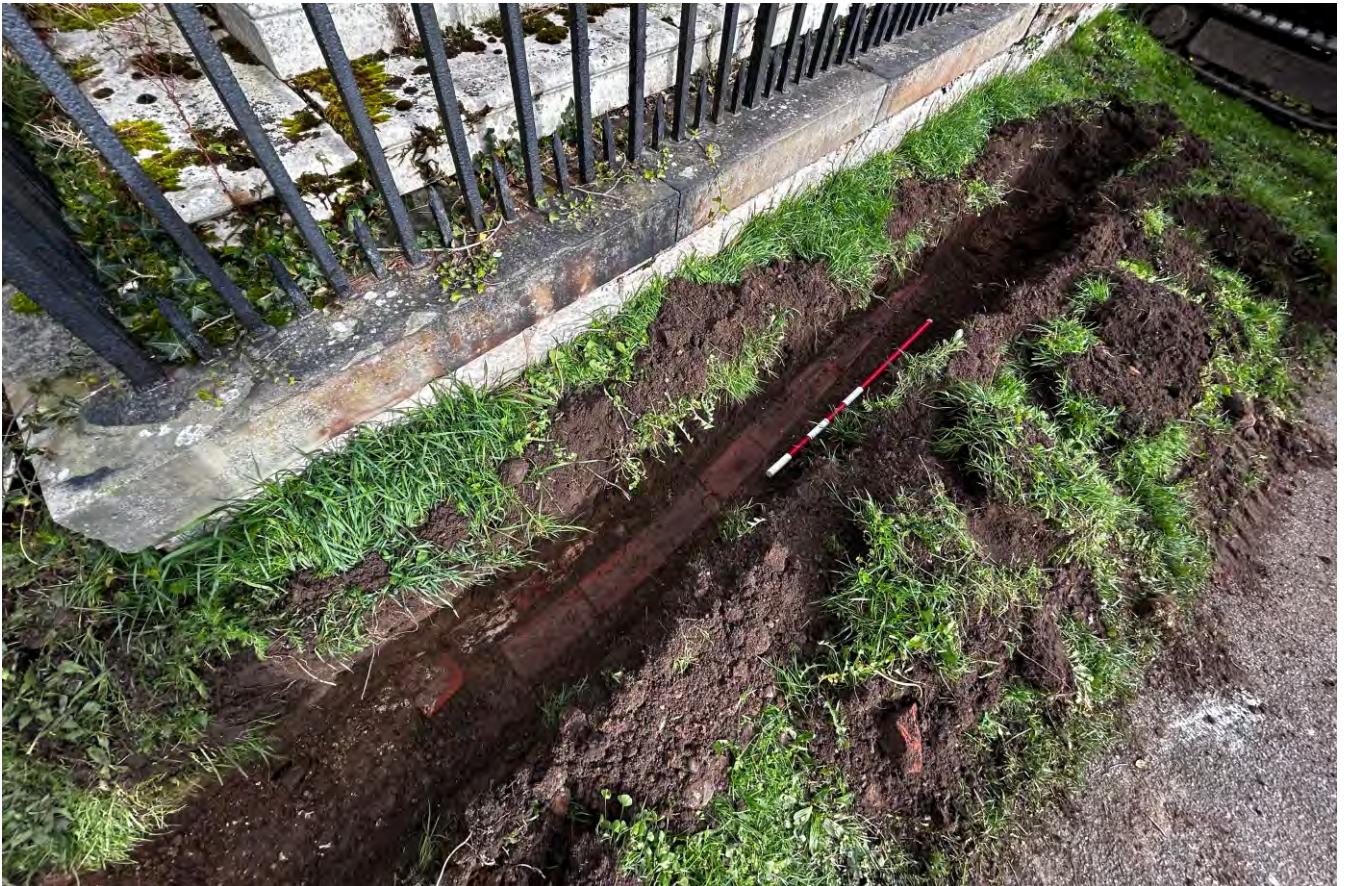
Along the line of Trench 4, which followed the northern edge of the church footpath and the southern side of the double chest monument to the Ruck family the encountering of the remains to a brick lined burial chamber with vaulted roof was unexpected. However, examination of period drawing dated 1807 of Hartlip church from the southeast predates the construction of the Ruck monument and clearly shows a row of typical headstones with body stones extending to the east and culminating in smaller footstones. Suggestively these may have been individual graves to the Ruck family arranged within a family plot, each possibly possessing a singular lined burial chamber beneath. When in 1816 (the recorded death of Richard Ruck) the eastern chest monument was constructed with a presumed sizeable vault beneath, the construction of an eastern monument to his ancestors may have seen the exhumation of their graves for placement in the new family vault, or the construction of a new second vault beneath western monument. However, it is also possible the former ancestors' graves were left insitu and the monument raised over with the details of the earlier headstones transposed to the chest monument sides.

Plate 13. Detailed view looking into Trench 4 line showing southern side of brick lined and vaulted roof burial chamber exposed along the trench base extending beneath the western Ruck (d.1749) family chest monument (*note: iron railed stone plinth to the chest monument*).

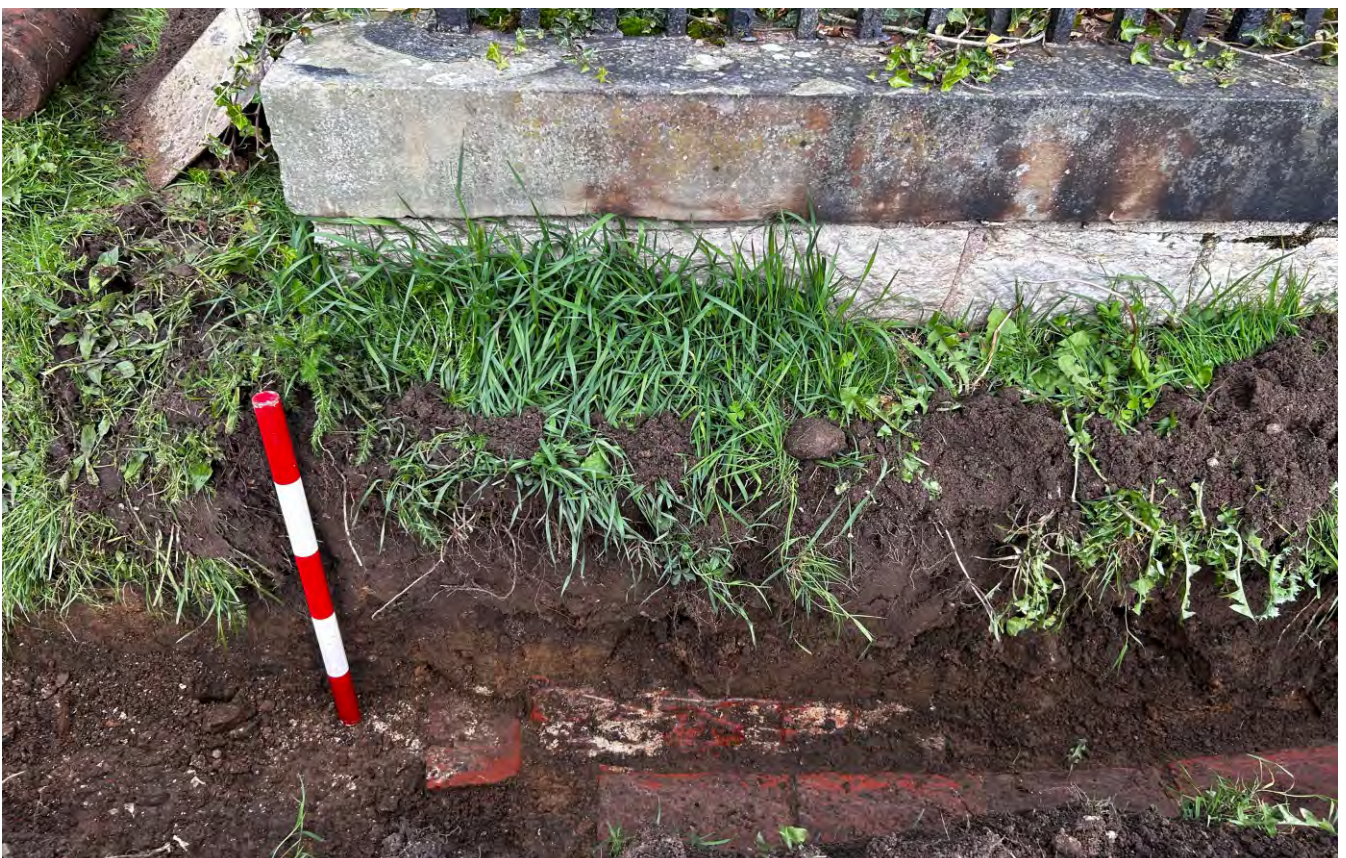
Plate 14. Detailed view looking into Trench 4 showing the brick lined burial chamber and vaulted roof extending beneath the stone plinth to the western Ruck family chest monument.

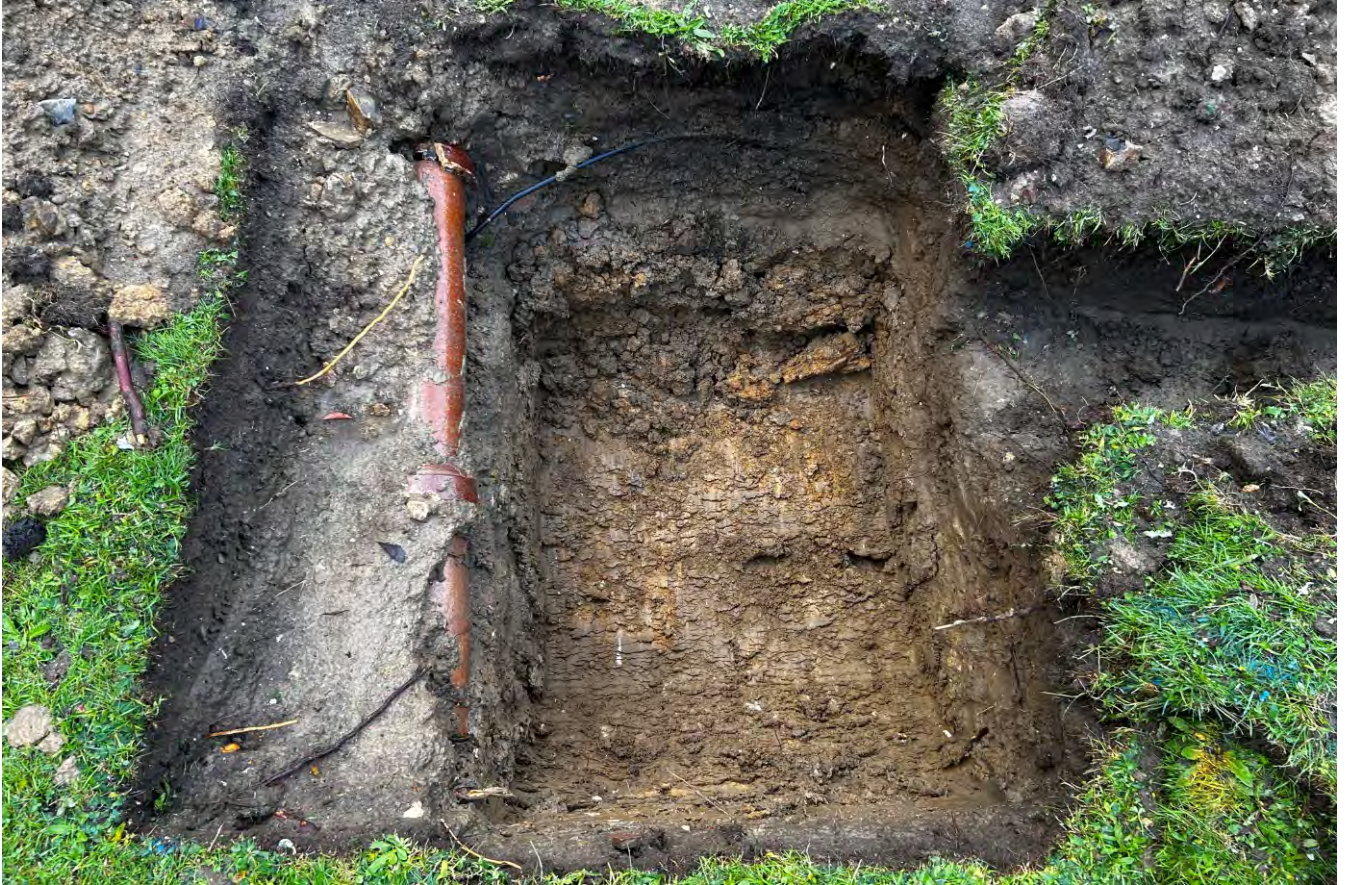
Plate 15. Detailed view looking into Soakaway 2 during its initial excavation showing ceramic drain to earlier drainage system causing the soakaway excavation position to move to the west.

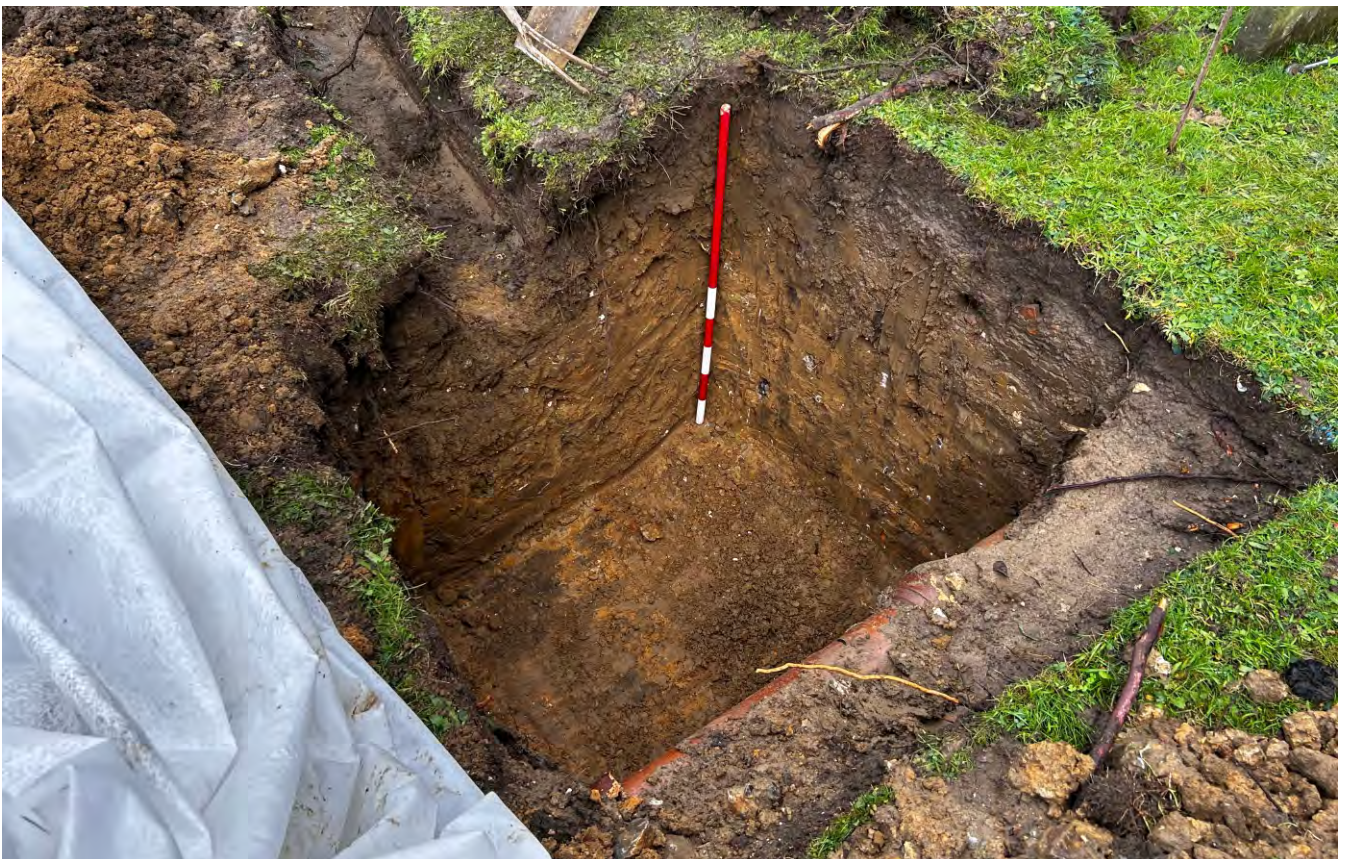
Plate 16. Detailed view looking into Soakaway 2 showing topsoil over disturbed churchyard soils sealing Superficial geology beneath with infilled graves extending beyond the excavation base.

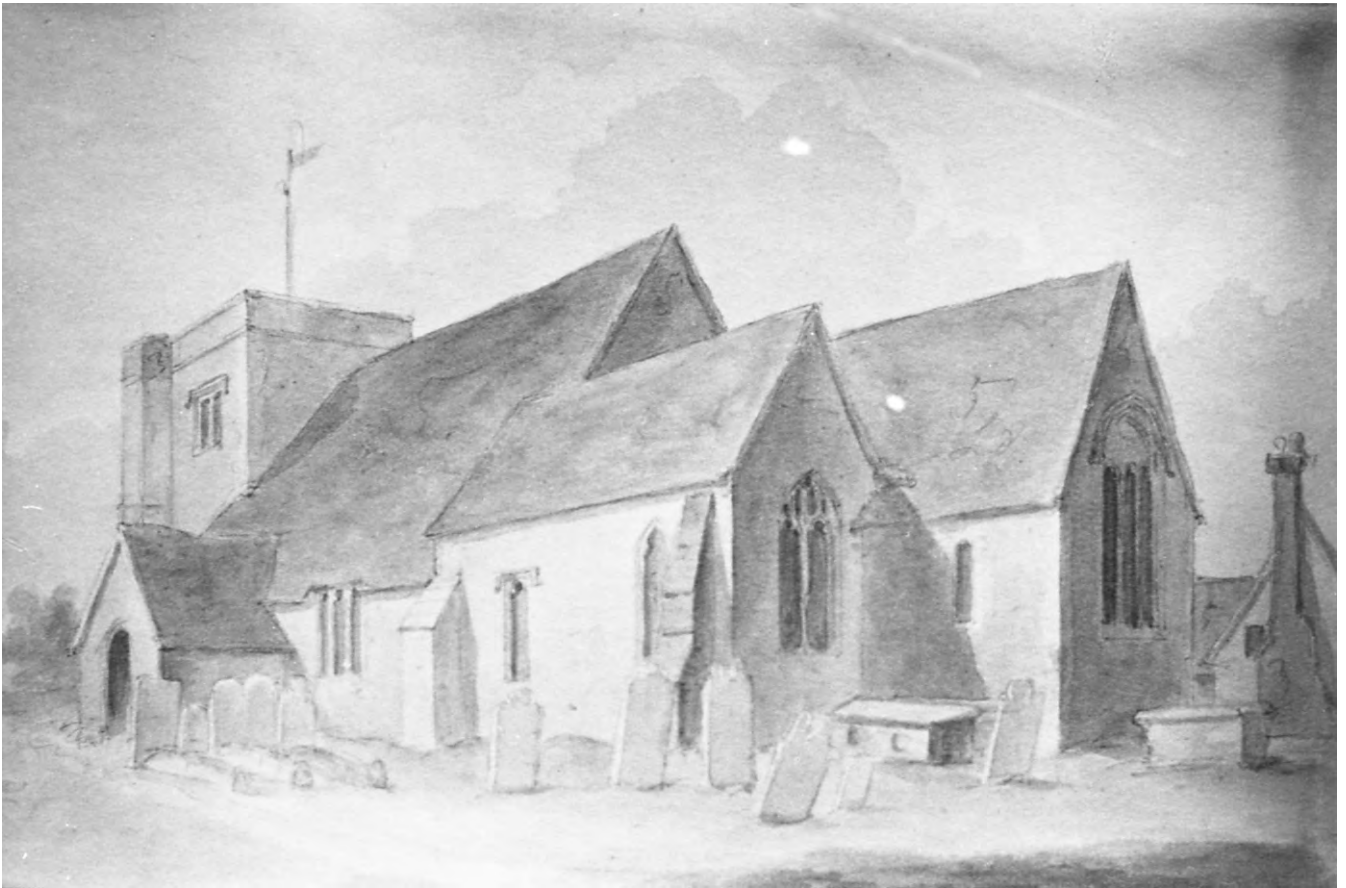
Plate 17. Historic view c.1807 looking northwest of St Michael and All Angel's Church, Hartlip showing head, body and foot stone burial memorials (possibly of earlier Ruck family members?) in the southern churchyard across the site of the later Ruck family chest monument.
