St Michael and All Angel's Church, The Street, Hartlip, Kent ME9 7TL

Archaeological Watching Brief Final report

Project Code: WB SMCH24
Planning Ref: N/A
NGR: TQ 583922 164284 (centred)
Archive No.: 5258
CAT Ref.: 2024/167

December 2024

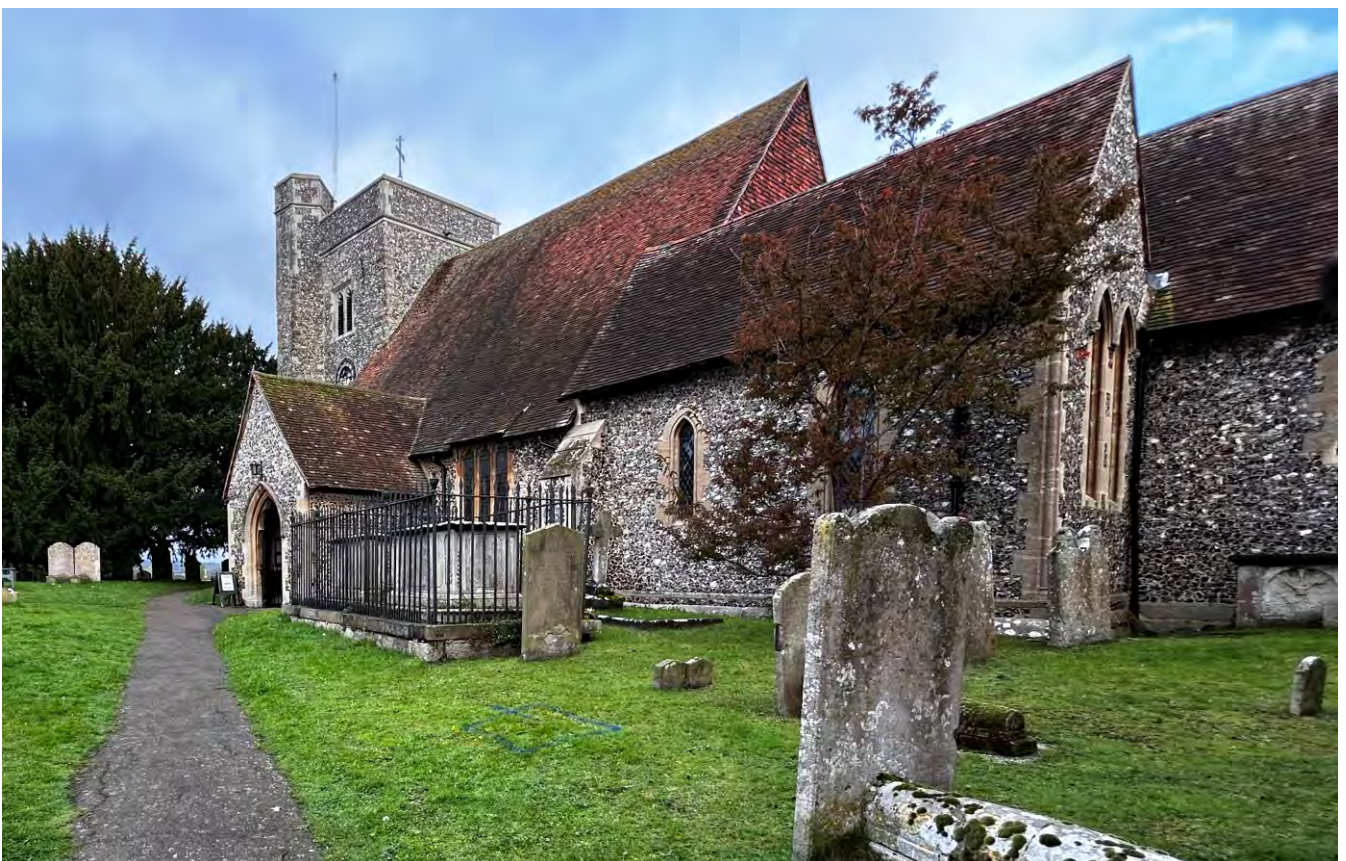
Plate 18. Recent view looking similar to above showing the double Ruck family chest monuments on the site of the earlier tradition graves, one of which was encountered in the base of Trench 4.
