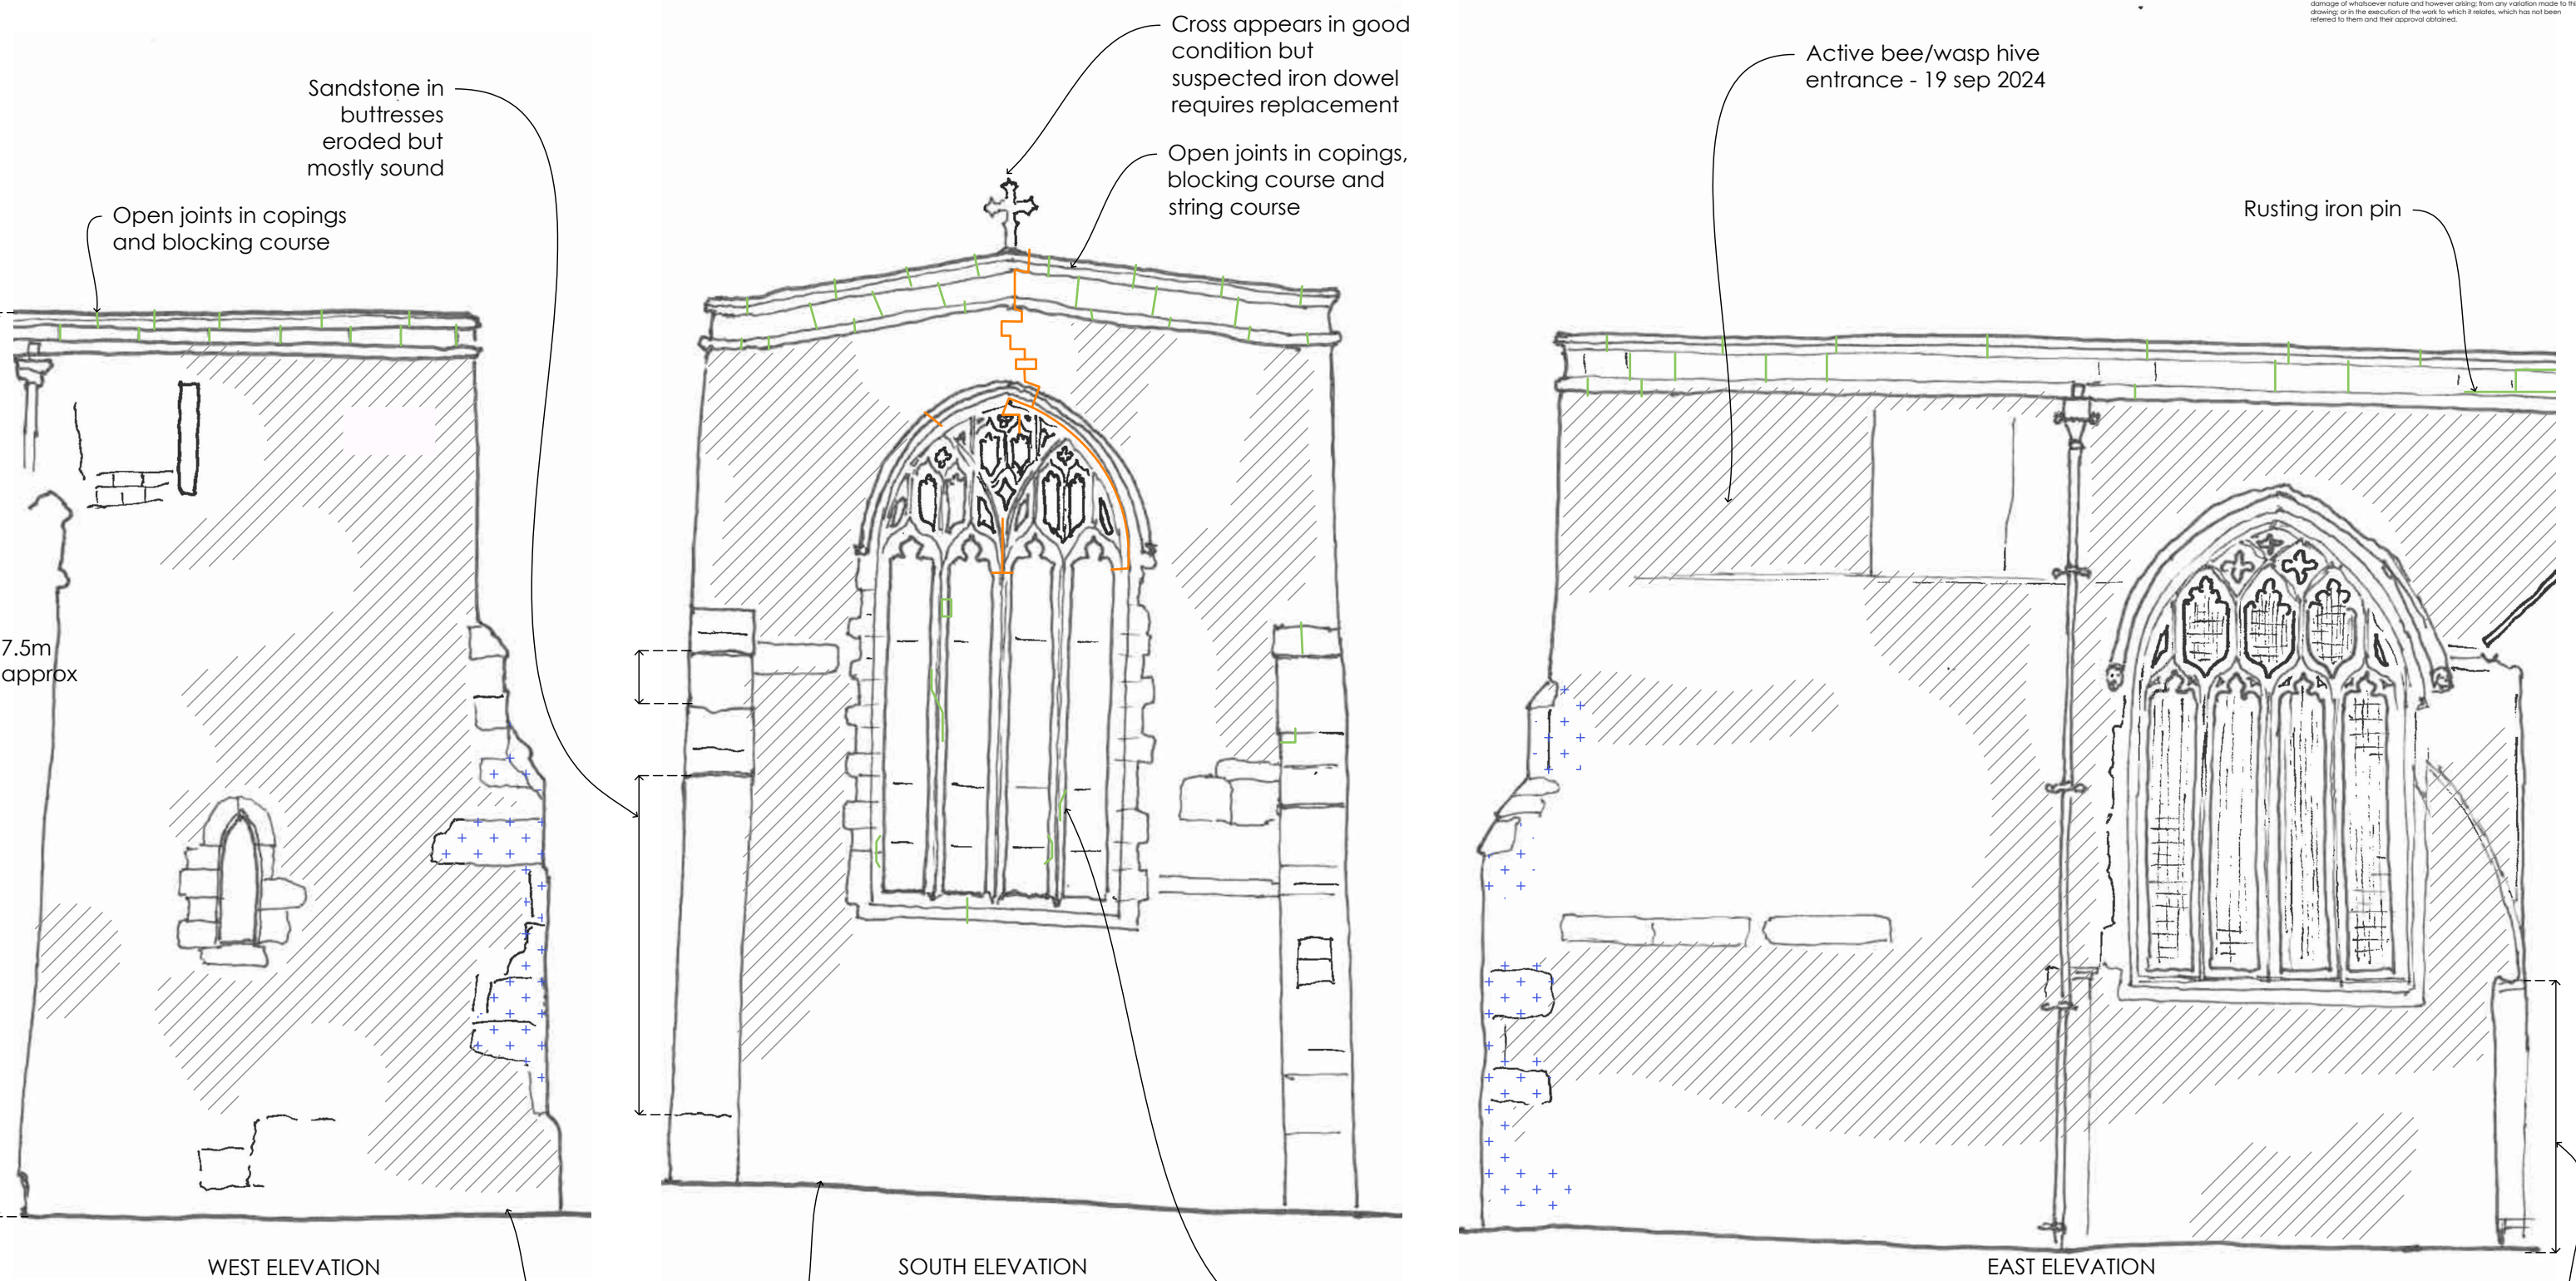
Existing pointing is cement throughout
 50% of Lias requires defrassing
 50% of joints are failed/open

Drain channels in poor condition.
 Loose and dislodged blocks with vegetation

Existing pointing compromised of a hard grey cement
 20% of Lias above cill level requires defrassing to remove water traps where fracturing and delamination has occurred.

Mullions fractured and some failure of perimeter groove pointing

This elevation mostly pointed in cement with some areas of lime

Wide, shallow lime smear pointing also failing

- Structural fracture
- Open joints
- Failed pointing
- Eroded sandstone
