Project: Church of St Mary, Chedzoy

Date of visit: 8th May 2024

Report No: 12299-MNW-XX-XX-
RP-S-0401

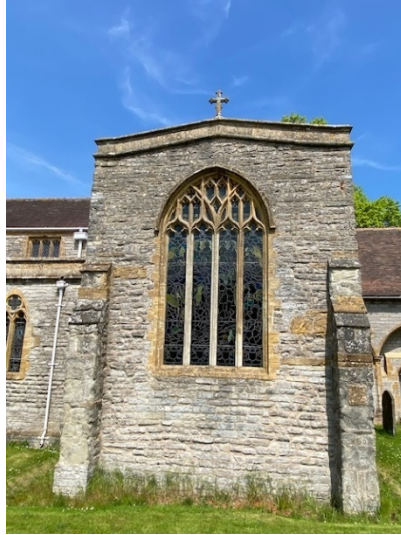
- 1.04 The south wall of the transept is constructed in coursed rubble stone masonry (predominantly Blue Lias but with some Ham Stone). The elevation has a single large window with limestone ashlar tracery divided into four main window panes by three mullions (Photo 1).

Photo 1 – South Elevation of South Transept

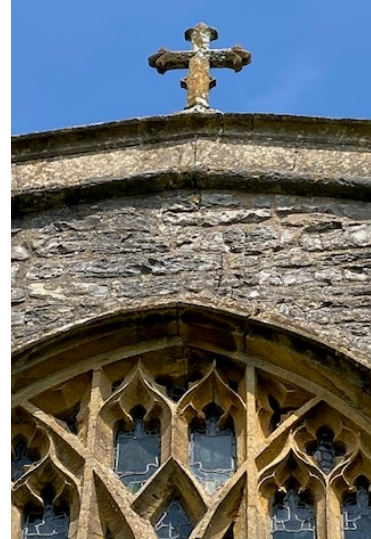
- 1.05 Structural movement is evident extending down through the parapet through the keystone at the head of the window (Photo 2). Movement is predominantly focused around bed and perp end joints. Internally, the fracture is evident continuing down the eastern reveal of the window (Photo 3). The tracery over the central mullion has displaced leaving daylight visible through the junction. The fracture at above the head of the window is also open through to the interior of the church, promoting water ingress. Reassuringly, little sign of masonry movement / fracturing was noted below cill level of the window.

- 1.06 The pattern of movement suggests that historically there has been settlement of the east and west flank walls of the South Transept, relative to its south elevation. It appears this has resulted in the movement concentrated to the side of the window and above its head. We suspect that whilst movement may be ongoing, this will only be to a limited extent. We also suspect that where historical fracturing has occurred, this has only been superficially face pointed in the past with the mortar prone to dropping out and exposing the deeper fracture through the core.

Photo 2 – Fracturing above head of window and displacement of window tracery

- 1.07 We advise that the fractures identified be raked out and deep pointed in a suitable lime mortar. The fracturing through the core of the wall should also be fully filled with lime grout. A similar approach is considered appropriate for the window tracery. In order to help reinstate some integrity to the masonry above the arch, we would suggest installing stainless steel sprio ties in the bed joints. These should extend across the fracture on both inner and outer stone faces.

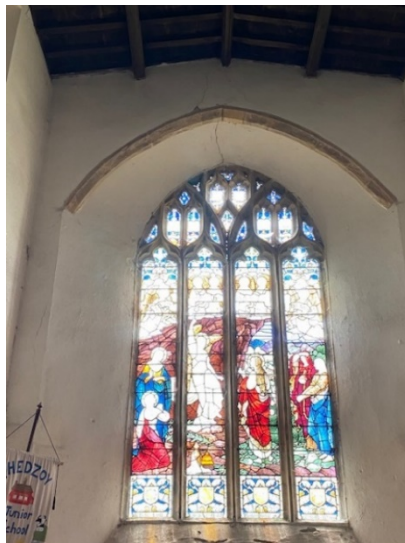
Photo 3 – South Transept, south window (internal view). Fracture through head of window extending down east reveal.

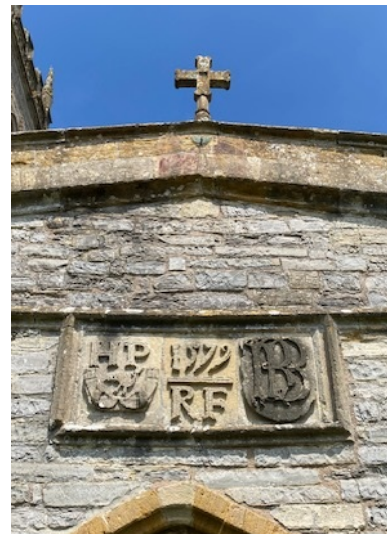
- 1.08 The cross at the head of the elevation is likely fixed down into the parapet with a ferrous dowel which will result in damage to the stonework as it corrodes and expands. Given its location, this has potential to exacerbate the fracture above the head of the south window. This should be investigated as part of the work with the dowel drilled out and replaced in Grade 316 stainless steel (subject to findings on removal). Similar works are required to the cross above the parapet on the south elevation of the porch, which whilst we understand to be loose shows no appreciable evidence of fracturing from ground level (Photo 4).

Photo 4 – Cross above the south entrance porch.

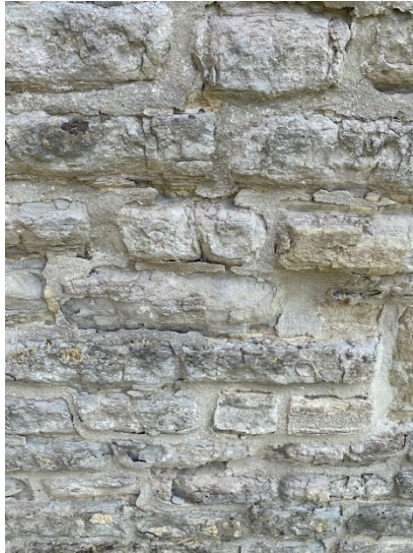
- 1.09 The elevations of the South Transept (as a whole) would benefit from some repointing and localised brushing back of friable sections of the stone. The elevation is predominantly face pointed in cement pointing which is now failing and should be removed (Photo 5). In some areas it is evident that this has accelerated damage to the stonework (predominantly Blue Lias) and a lime mortar replacement is needed.

Photo 5 – Failure of cementitious face pointing and degradation of stonework.

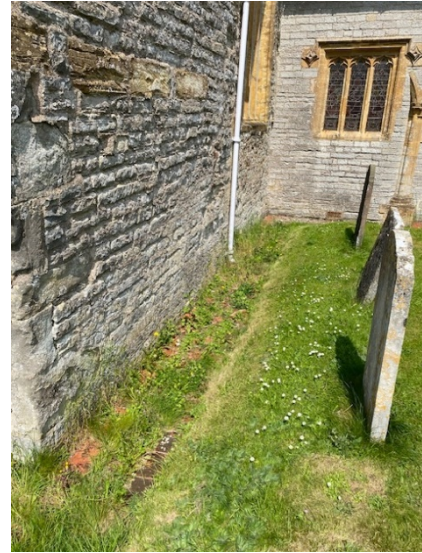
- 1.11 We note that at ground level, the perimeter of the church has a drainage channel formed in clay tiles with intermittent gullies (Photo 6). The tiles are displaced and uneven which will allow local concentrations of water going to ground. Concentration of water going to ground has the potential to locally soften founding soils and result in foundation movement. Note with reference to British Geological Survey online mapping, the church is underlain by superficial deposits of sands and gravels over a bedrock geology of Mercia Mudstone (dominantly red mudstone). It is possible near to surface level ground bearing capacity is relatively poor with the potential for clays to be present. Clays close to surface level would likely be sensitive to shrinkage / swelling with changes in moisture. The existing below ground drainage arrangement should be determined insofar as practicable and consideration should be given to upgrading the below ground drainage system such that each rainwater pipe discharges into its own gully.

Photo 6 – Fractured / displaced drainage channel to perimeter of church

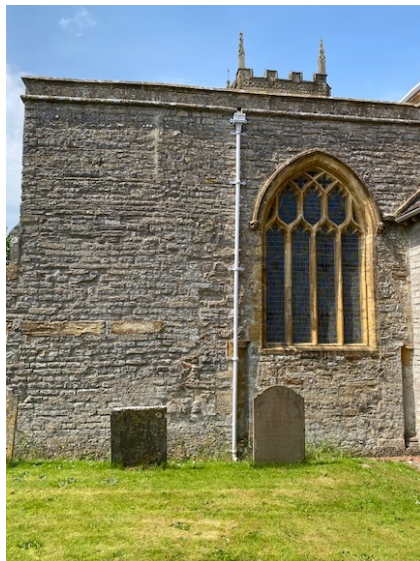
- 1.12 The east wall of the South Transept (Photo 7) also shows signs of structural movement. This elevation has been much altered. Earlier stone columns are expressed in the external face of the east wall along with remnant of a masonry arch (Photo 8) that are cut through by the later window tracery. Weakness in the elevation will be present due to a combination of construction joints in both the foundations and the masonry superstructure.

Photo 7 – East elevation of South Transept

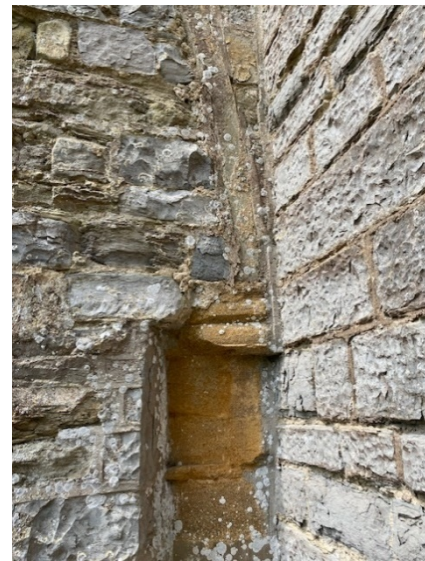
Photo 8 – East elevation of South Transept. Column and arch relating to earlier layout.

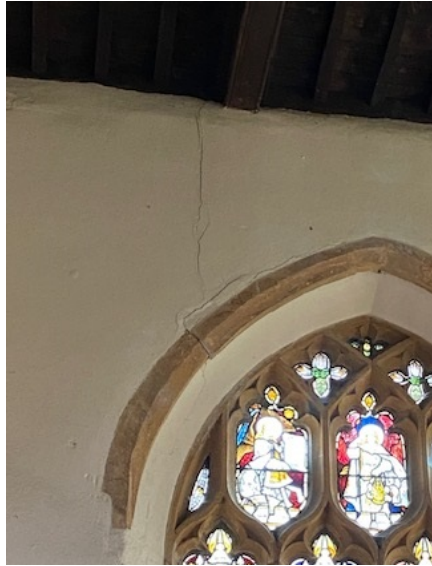
- 1.13 Internally, movement was evident around the head of the main window of the South Transept east wall (Photo 9). An ashlar voussoir has dropped within the arch owing to differential movement and a fracture has opened up in the internal face of the wall above. The open joint in the voussoir requires raking out before being fully filled in a combination of slate and deep pack pointing. The fracture in the masonry above should be stitched with stainless steel spiro ties let into the bed joints. Other fractures to the internal face of the wall can be deep pointed and this utilised as a means of future monitoring. This includes the deep fracture to the south reveal of the high level window recess (historically the window has been infilled with masonry on the external face of the wall only). During our visit we observed and active bees nest in this location.

Photo 9 – Fracturing of East Window of South Transept with displacement of Voussoir.

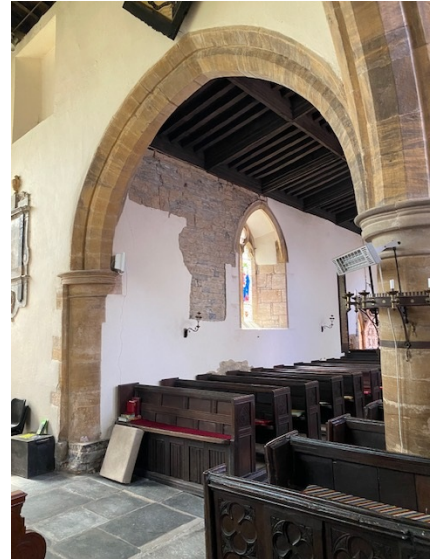
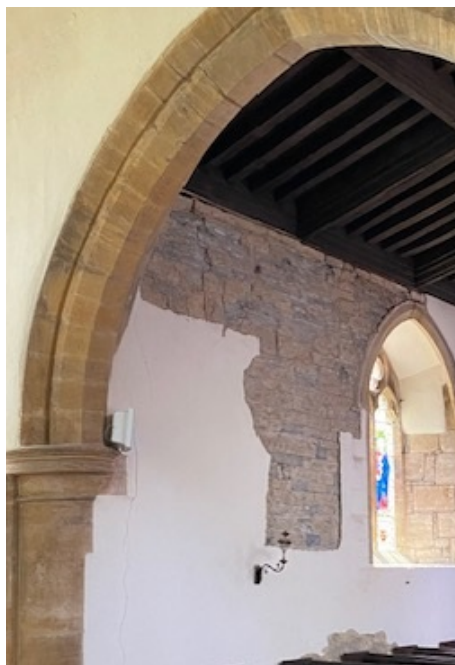
- 1.15 As the west wall of the South Transept returns through the arch to meet the south wall of the South Aisle, there is notable fracturing beyond the expressed column (Photos 10 and 11). We anticipate this fracturing is likely a consequence of increased loading historically being applied to the arch when the south transept was constructed altering the earlier aisle. Movement is consistent with settlement of the column at this junction owing to increased loading on existing foundations. It is considered that these historical weaknesses have never been repaired. Plaster is currently missing in this area; the exposed coursed rubble masonry shows some local movement in the bed and perpend joints (Photos 10 and 11). We would suggest that deep pointing and grouting of the fractures in this area would be appropriate. Where plaster is to be reinstated use of a Telling Lime Brick Mesh could be considered to improve resilience against future fracturing. However, we understand that currently reinstatement of areas of lost plasterwork will be a low priority.

Photo 10 – Fracturing of South Aisle south wall adjacent intersection with South Transept.

Photo 11 – Fracturing of South Aisle south wall adjacent intersection with South Transept.
