Saint Mary and All Saints, Hampton Lovett

Treatment Report

June 2023

**Treatment of
Pulpit and adjacent tile
floors.**

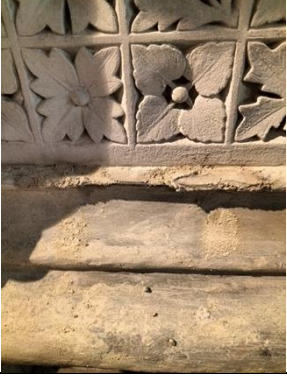
- The surface of the Pulpit at the base from the floor to the carved decorative panels all exhibited blistering of the surface and loss on extreme edges of detail. These stones showed discolouration and we suspect a linseed oil surface preparation common in Edwardian and mid 20th century had been applied.

A photograph showing the ornate, Gothic-style stone moulding of a pulpit before any restoration work. The moulding features intricate carvings and a pointed arch design.	  A close-up photograph of a small, cylindrical metal dowel, 8mm in diameter, used for securing the stone moulding.
<p>Figure 1. Moulding before works</p>	<p>Figure 2. 8mm dowel</p>
  A photograph showing the stone moulding of the pulpit after it has been secured in place with the dowels.	  A photograph showing the surface of the pulpit before restoration work, appearing weathered and discolored.
<p>Figure 3. Moulding fixed</p>	<p>Figure 4. Pulpit surface before works</p>

- The blisters were removed from the surface and holes and missing edges were filled and brought into 'line' with a lime putty, Cotswold and Horton brown stone dust repair mortar (1 lime 2 Cotswold ¼ Hornton). Large missing moulding sections were built around three millimetre stainless steel armatures set in polyester resin.

- The upper decorative panels were considered to be in good order and the surface unblemished but there was a distinct division between this stone and the blemished stained stone below. To unify this, contrast a lime wash was applied to the lower blemished orders that matched the Caen stone above.

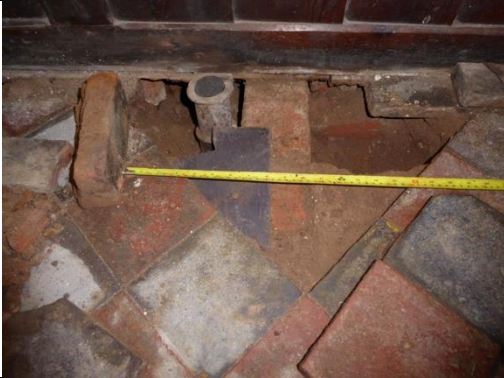
<p>Figure 7 Pulpit tiles removed</p>	<p>Figure 8 Pulpit tiles re-fixed</p>

- The loose tiles were mapped, numbered and removed to safe storage.
- With the substrate exposed the appointed archaeologist George Nash was asked to excavate and ascertain whether the area needed archaeological investigation or if works could proceed (see separate report).

- The survey found nothing of interest and works proceeded excavating the substrate to one hundred and fifty millimetres and the material carted away.
- The substrate was replaced with one hundred millimetres of type 1 ballast that was well tamped. This was followed by an NHL 3.5 and 3 coarse flooring sand bed onto which the tile was re-laid in their original position.

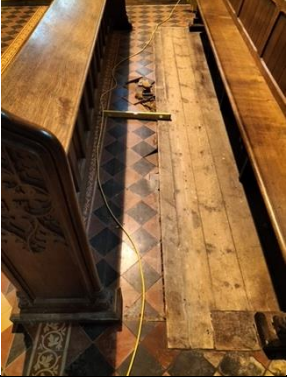
<p>Figure 9 nave pulpit area before work</p>	<p>Figure 10 nave pulpit area after work</p>
