## **Job No 0281 – STOCKLAND BRISTOL St Mary Magdalene**

QQ Inspection 2024

Date of this survey: 30 April 2024.

Survey and report prepared by Marcus Chantrey, RIBA, AABC, SCA

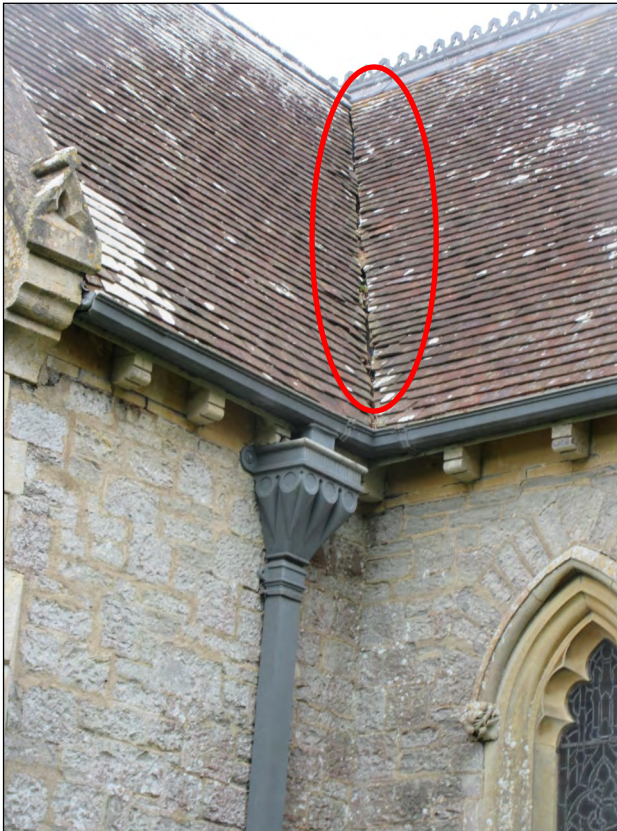
001 Disturbed slates in the valley between the chancel and South Chapel

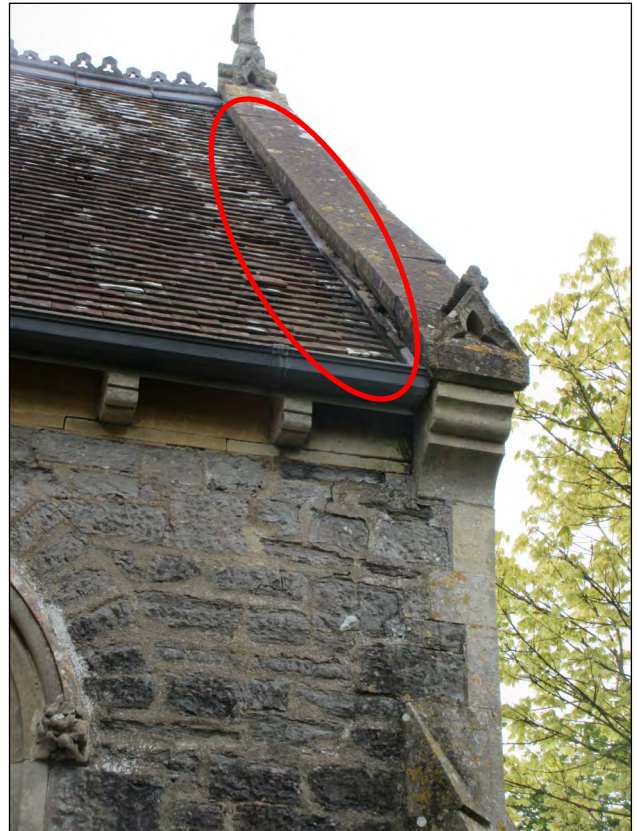
| 7 | Roof coverings | Priority |
|---|---|---|
| 7.6. | Some form of 'secret' gutter appears to be present at the east gable. To the south slope, the mortar pointing has fallen out (Photo 002). On the north side, the leadwork appears to be appropriately wedged but the mortar pointing has worked loose. | <b>2</b> |

002 Detaching flashings on the chancel roof.

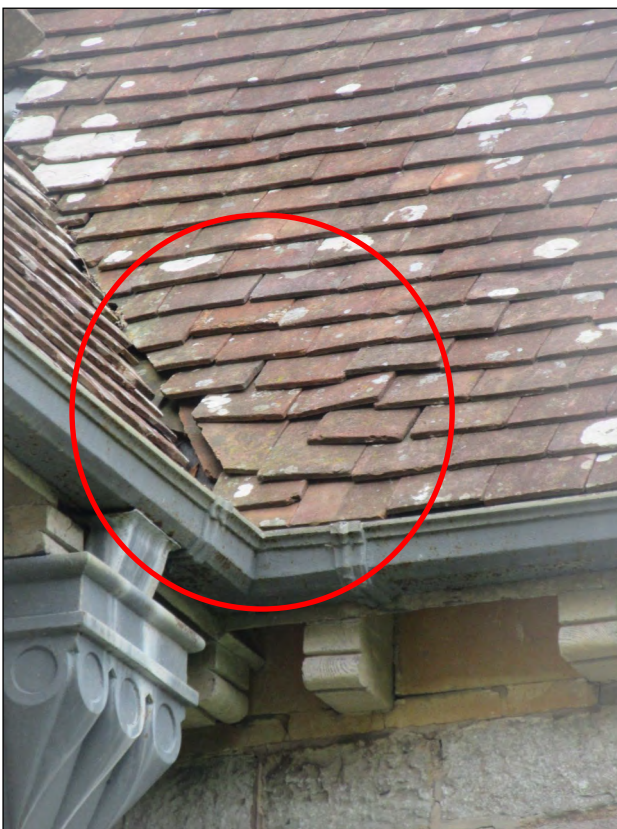
003 Disturbed tiles at the base of the west slope of the South Chapel roof.

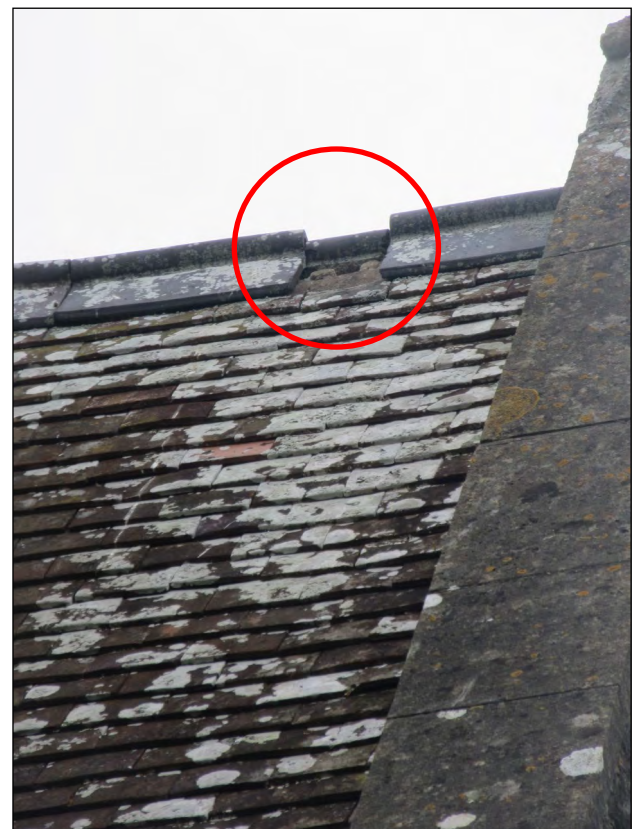
| 7 | Roof coverings | Priority |
|---|---|---|
| 7.10. | The ridge condition is fair but one of the ridge tiles has split and the west facing section is now exposed to the weather. Open joints are present between the ridge tiles (Photo 004). | <b>2</b> |

004 A damaged ridge tile on the South Chapel roof.

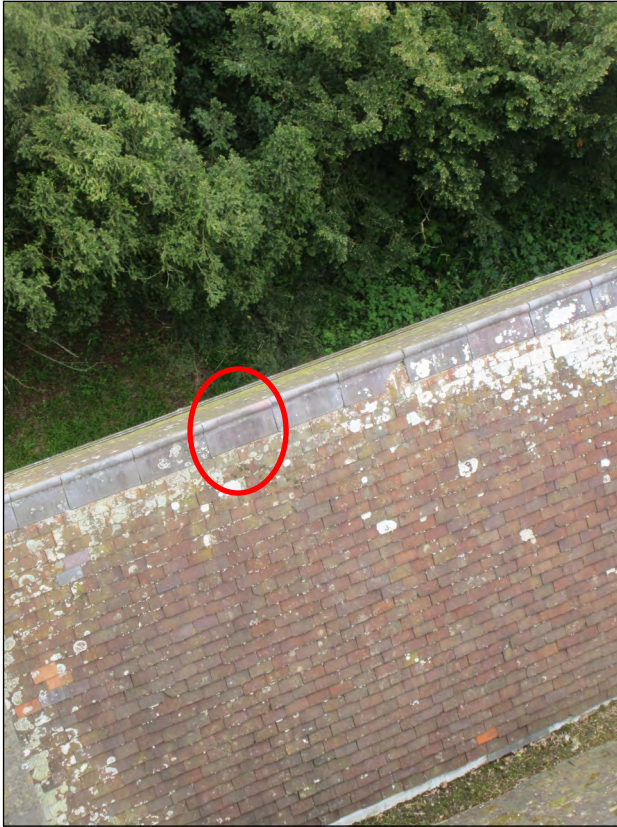
| 7.21. | The blue plain clay ridge is mostly in good condition but there are open joints between the tiles and one ridge tile is damaged and needs to be replaced (Photo 005). | 4 |

005 A cracked ridge tile on the north aisle roof.

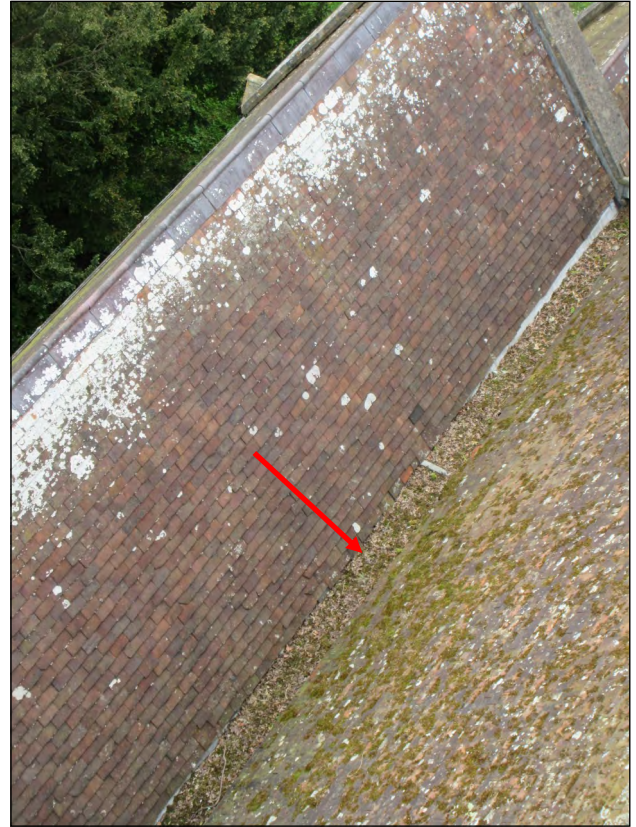
| 7.19. | There is a lead valley between the north aisle and nave roofs and here the roof is full of leaves and urgently needs clearing. From the tower roof, it appears that the gutter lengths are on the long side. It is not known what the step heights are, but the relaying of this lead gutter may be necessary if defects are found in the leadwork following clearing (Photo 006). | M |

006 The central valley needs clearing.

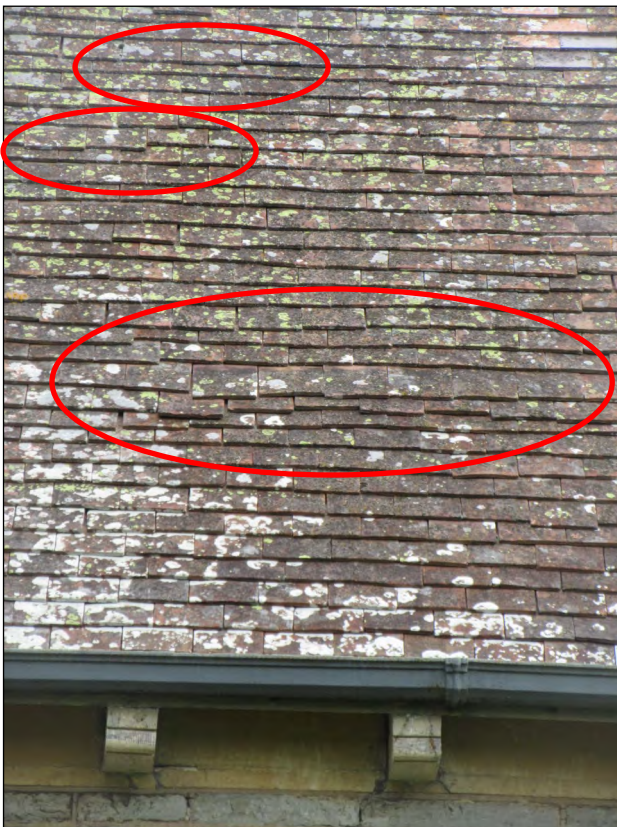
| 7.15. | The south slope of the nave on first impressions appears to be in fair condition but there are at least two areas where the coursing of the tiling has slipped. This movement indicates either batten fixing decay or a missed length of nails when the roof was installed. The latter option is unlikely and significant further slippage cannot be ruled out. (Photo 007) In other areas, there are a couple of slipped tiles and also one rotten moss-covered tile which should also be replaced. The tiling is a little untidy at the valley junction with the south chapel. This slope needs relaying. | 4 |

007 Slipped tiles on the nave roof are indicative of nail batten fixing failure.

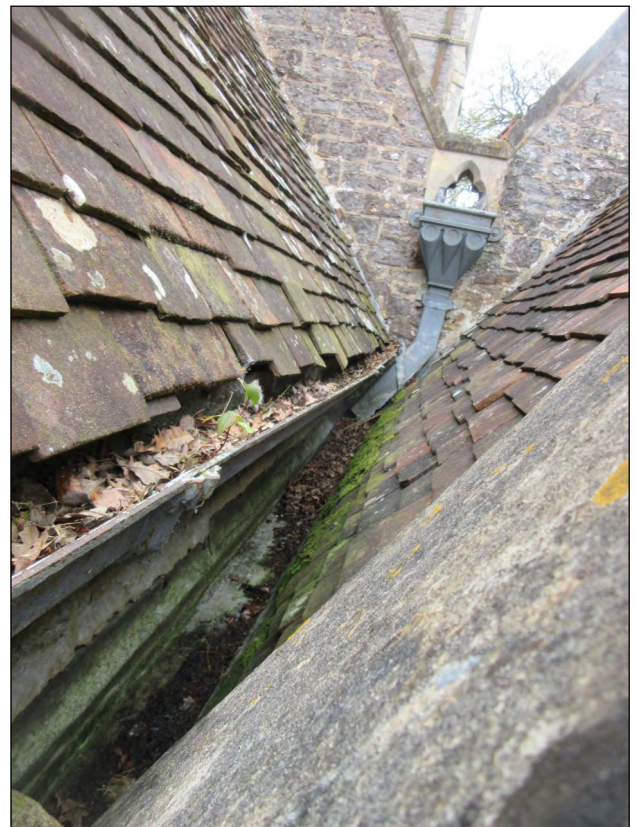
008 The narrow back gutter between the chancel and vestry roof.

| 7.25. | The south slope by comparison is in poorer condition with various dislodged tiles and possibly batten slippage. This small roof slope probably needs relaying, but a close inspection was not possible. The narrow leadwork back gutter was viewed from a ladder leant against the north wall of the chancel and here the leadwork needs to be cleared and a check for defects undertaken (Photo 008). | 4 |

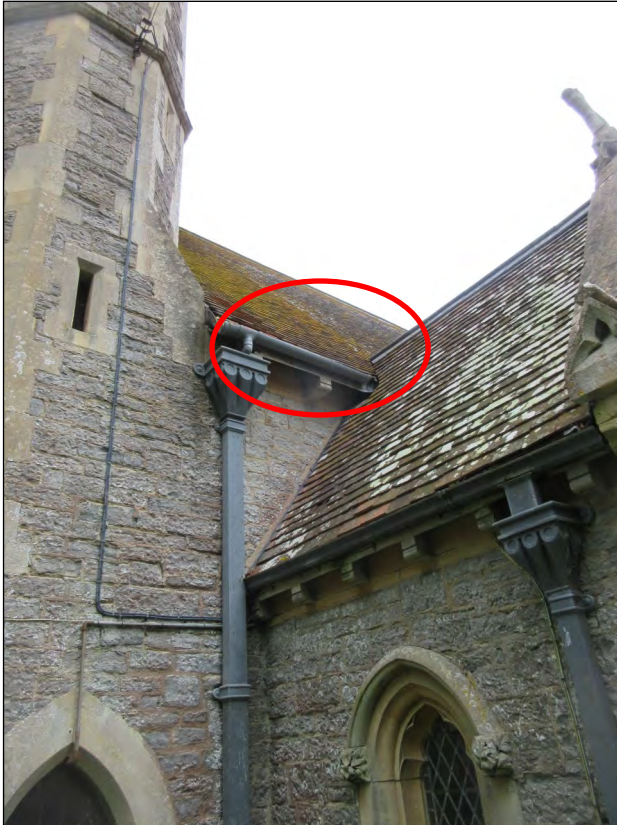
009 A section of uPVC guttering on the south side of the nave roof.

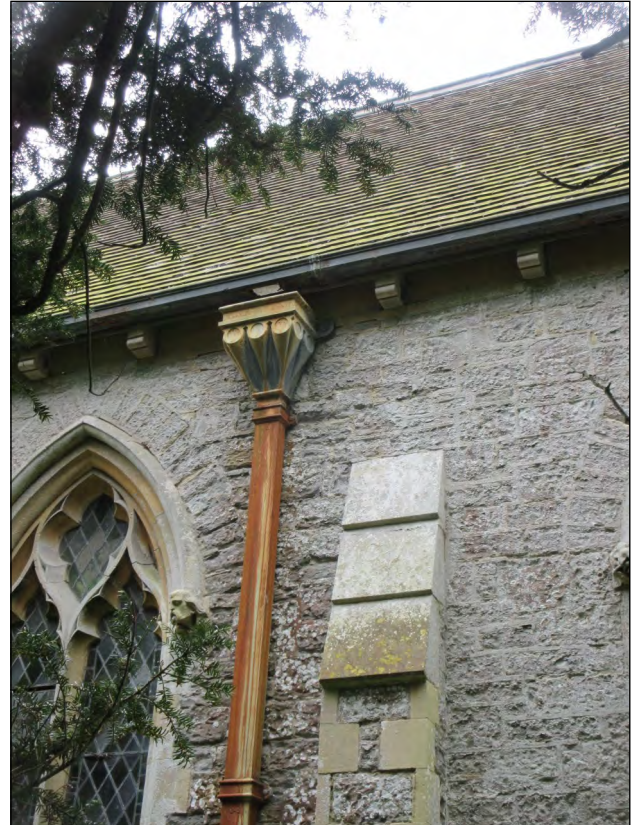
010 Rust staining caused by a blockage in the downpipe.

| 8.16. | The downpipe condition is good, but the downpipe is very rusty it its upper section as a result of a blockage which may, or may not, have been fixed. (Photo 010) A number of the lower downpipe fixing ears are missing and ideally these should be reinstated. | <b>4</b> |

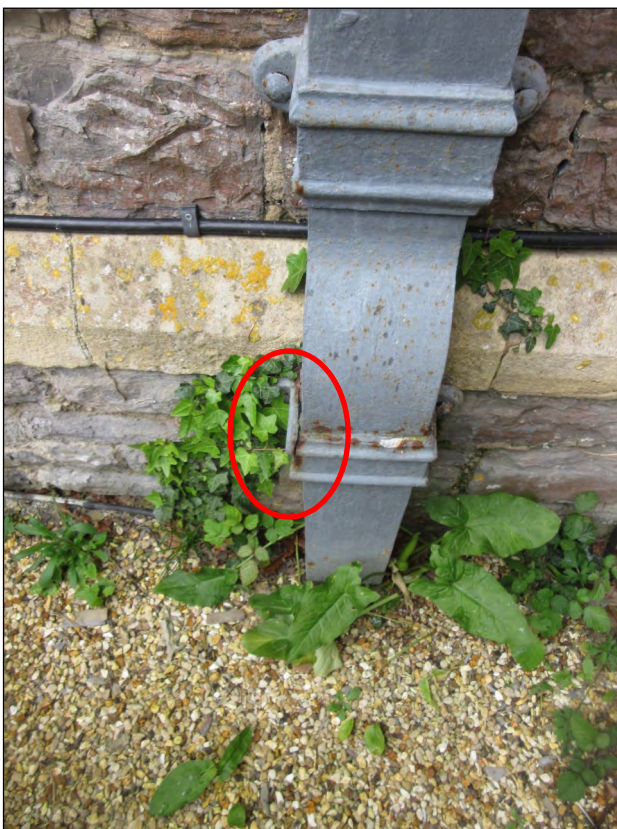
011 A fractured collar to the downpipe.

| 8.8. | The downpipe associated with the east elevation of the south chapel has a fracture in the collar to the lower section (Photo 011) and 3no wall fixing bolts are also missing and need to be replaced. The decorative floral collar around the downpipe is missing. | <b>4</b><br><b>5</b> |

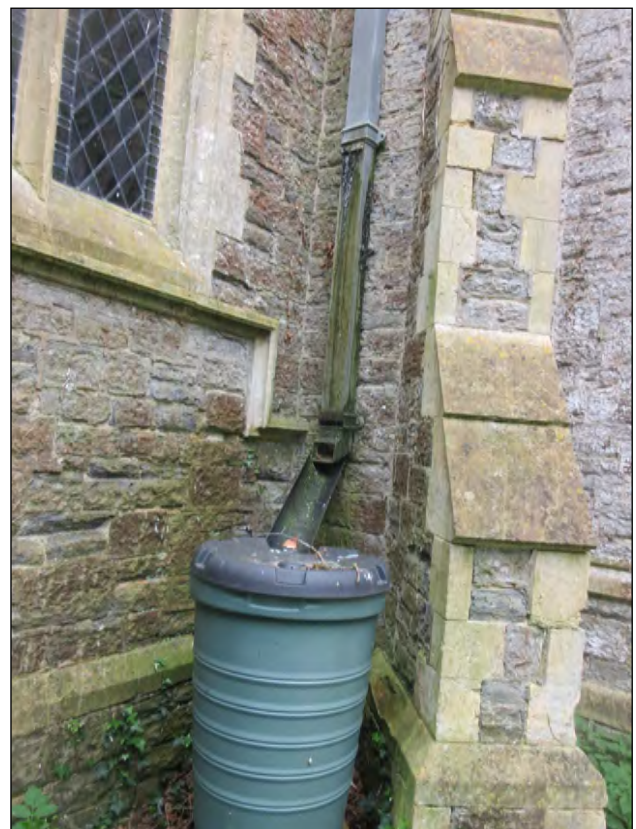
012 The water butt at the west end of the north aisle.

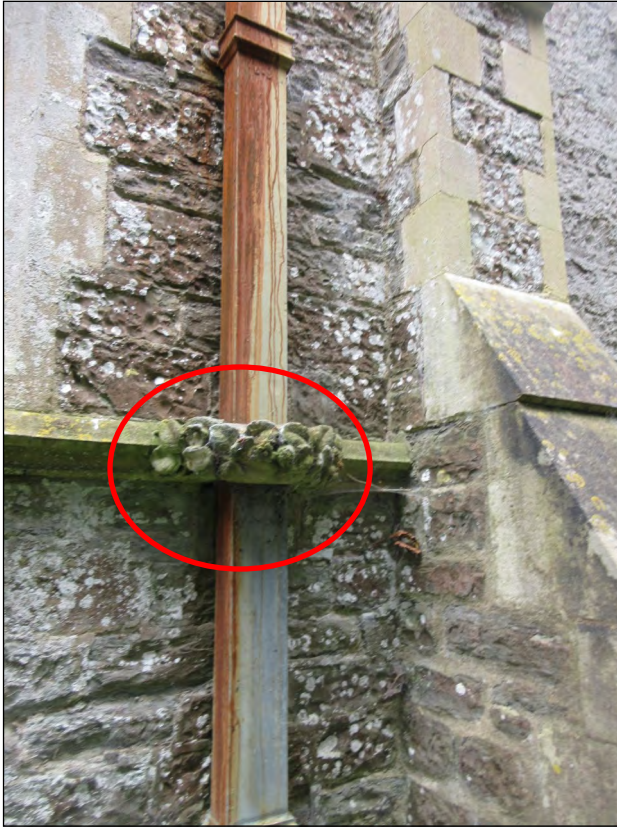
| 8.3. | There is an unusual floral stone collar to the string course which wraps around the downpipe. Where missing, it would be good if this could be reinstated. (Photo 013) | 5 |

013 The last remaining downpipe collar.

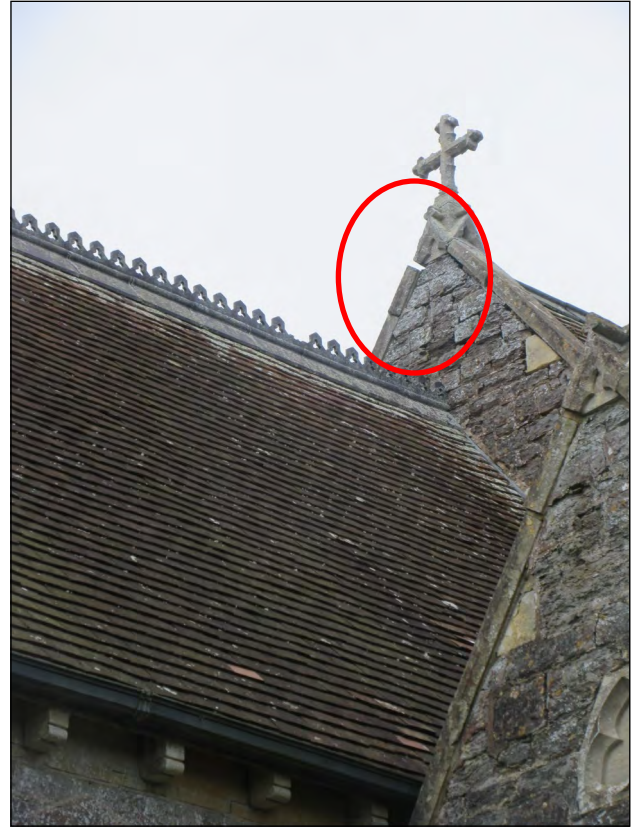
014 Open joints in the chancel arch coping.

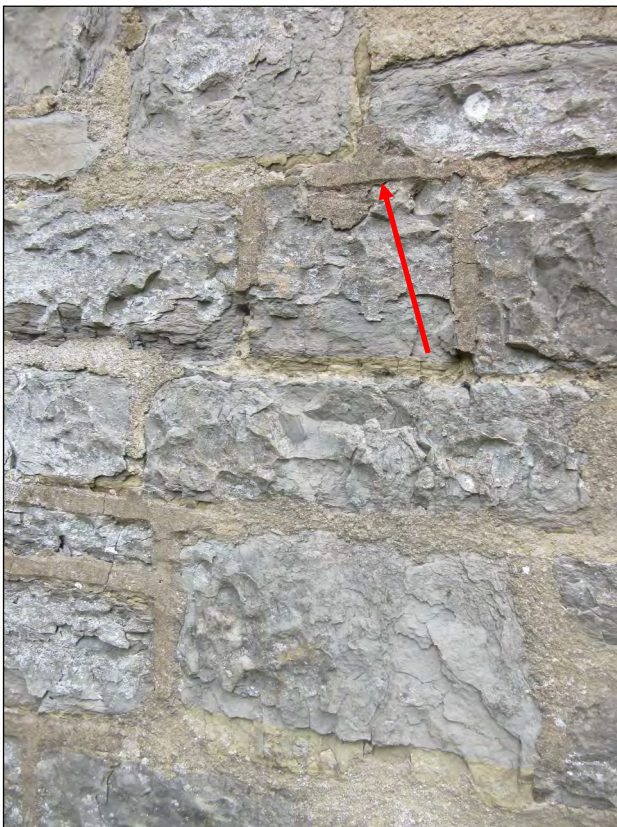
015 Typical cement pointing to the blue lias stone-work.

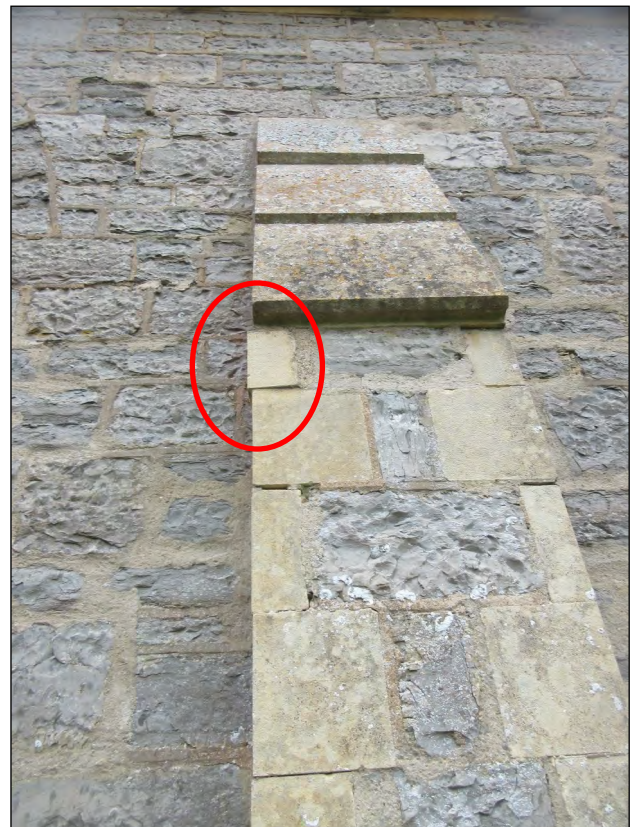
016 A typical disturbed quoin.

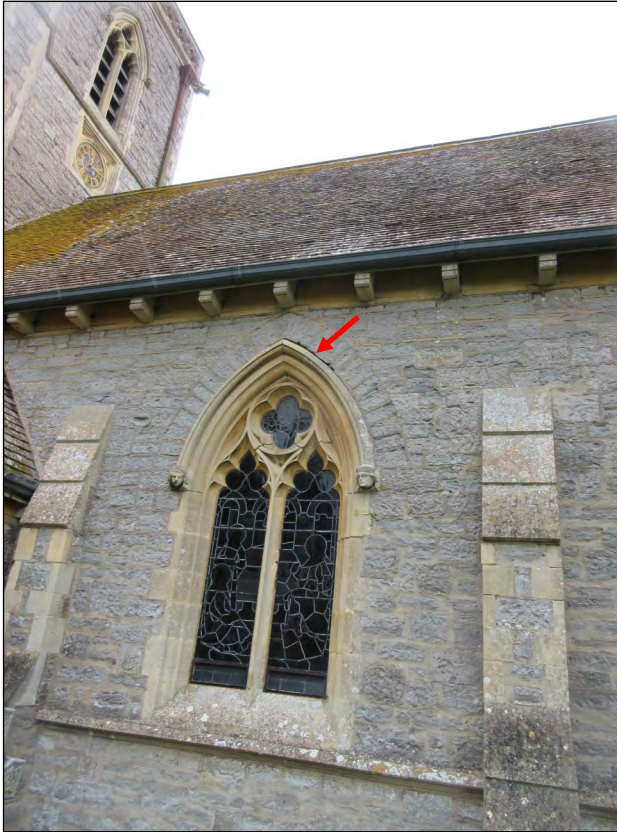
017 The open joint above the hood mould to the windows.

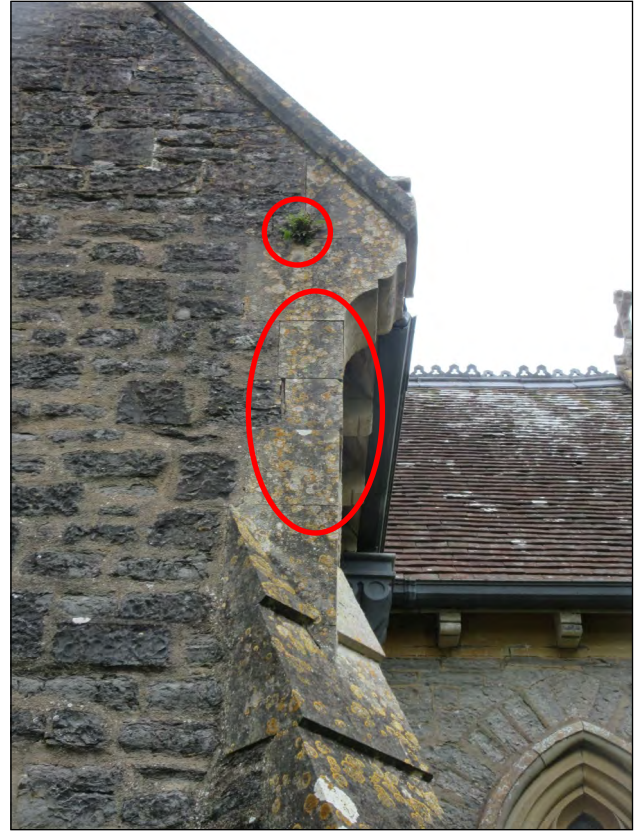
018 Disturbed quoins on the South Chapel. Vegetation above needs to be removed.

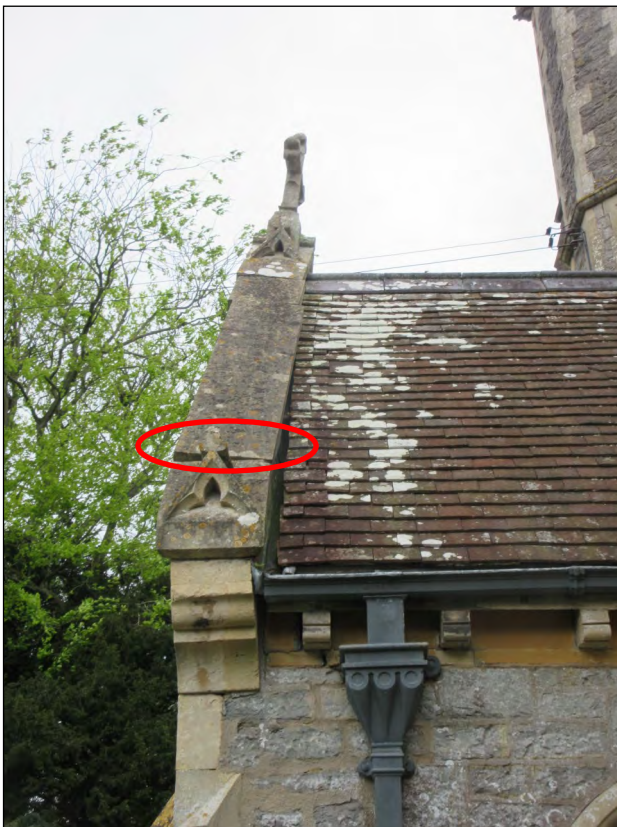
019 The backward leaning cross on the South Porch and the disturbed copings capping the wall below.

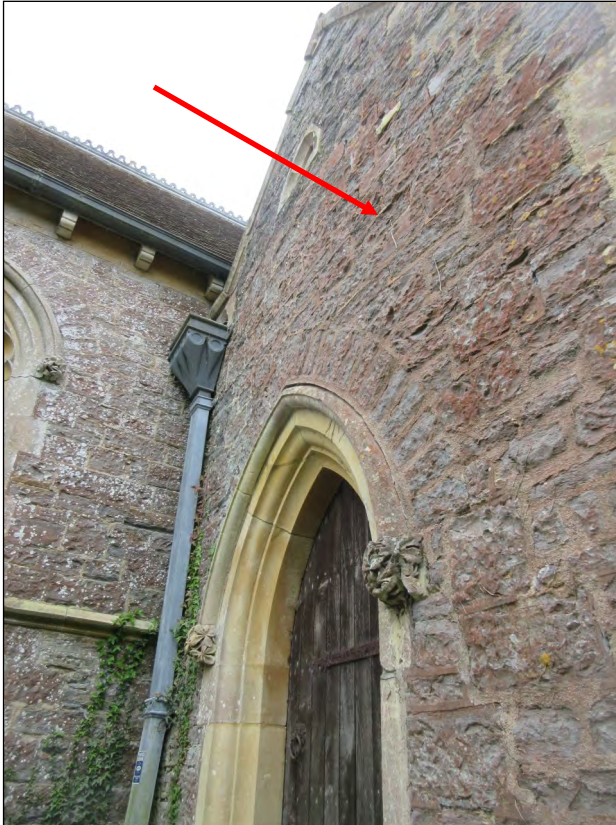
020 The bulging east gable of the vestry.

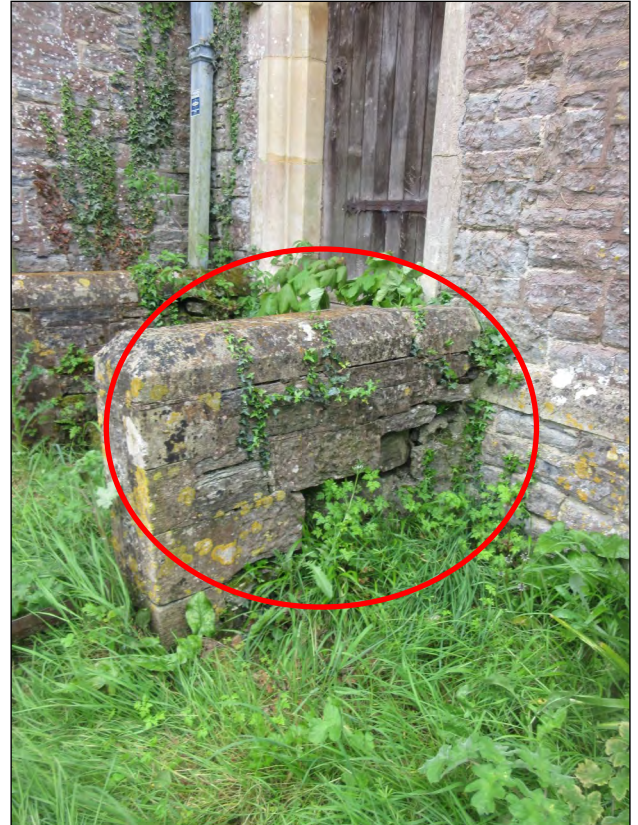
021 The flanking walls to the vestry steps need to be rebuilt.

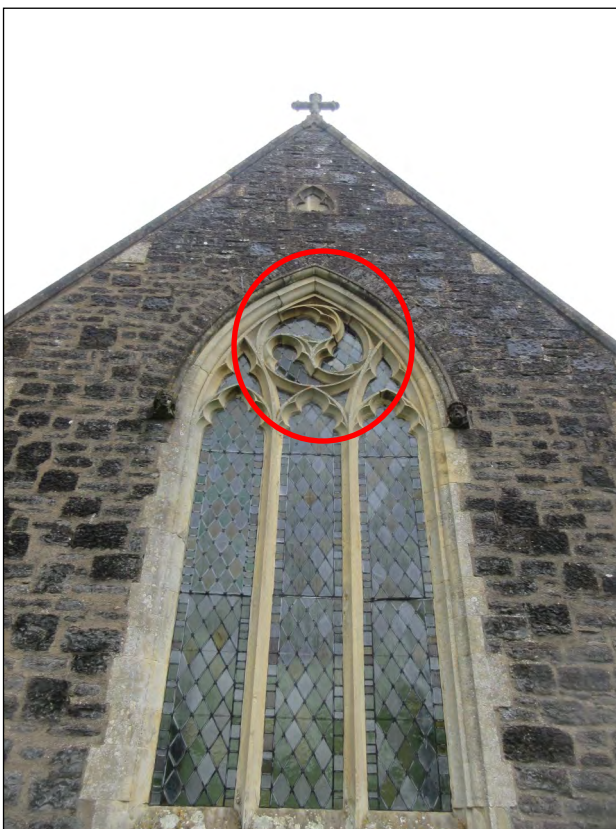
022 The disturbed tracery stonework and glass of the South Chapel window.

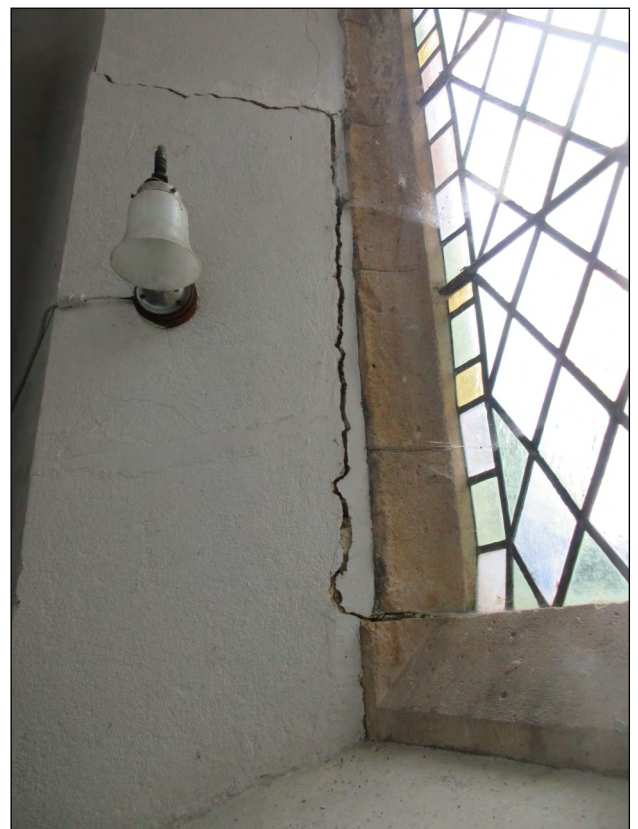
023 Cracking to the South Chapel window east reveal.

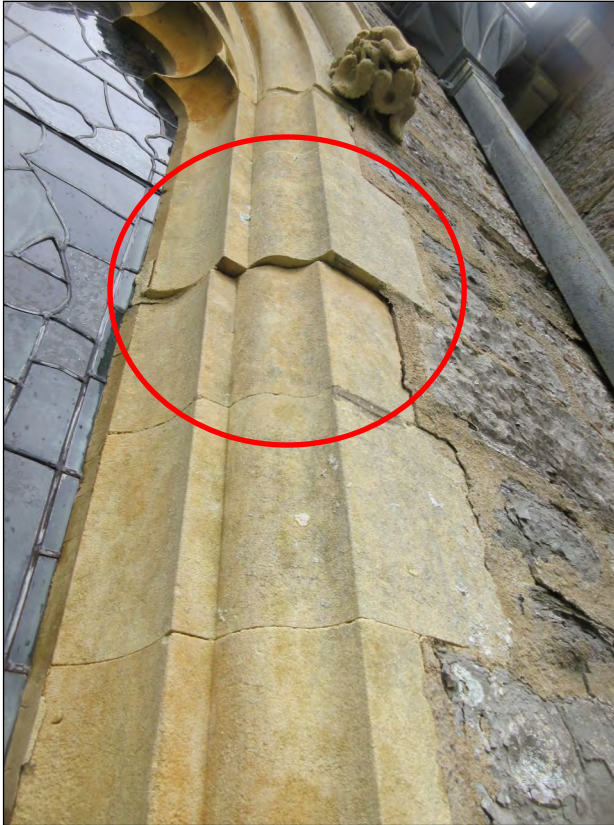
024 Disturbed masonry to Window sIV.

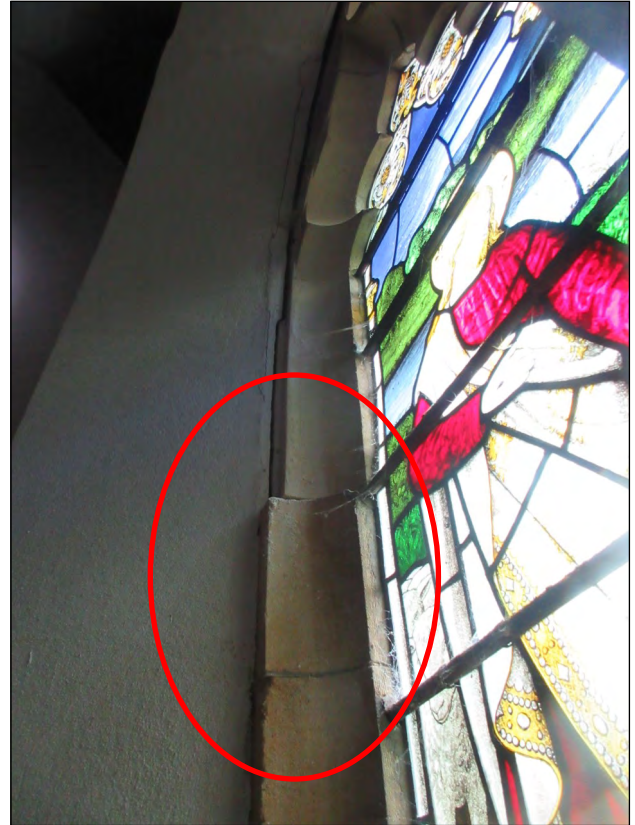
025 Disturbed masonry to Window sIV.

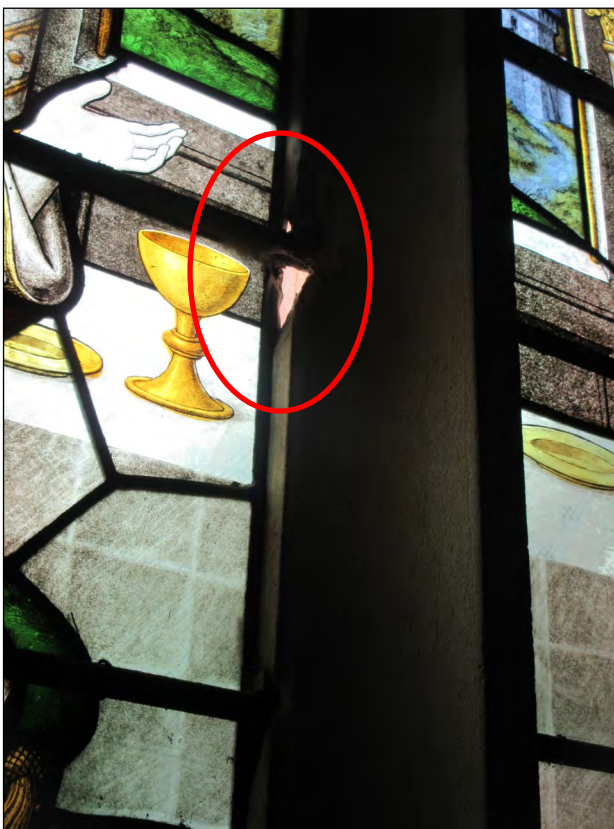
026 Damage to stonework caused by the decay of a tie bar — Window sV.

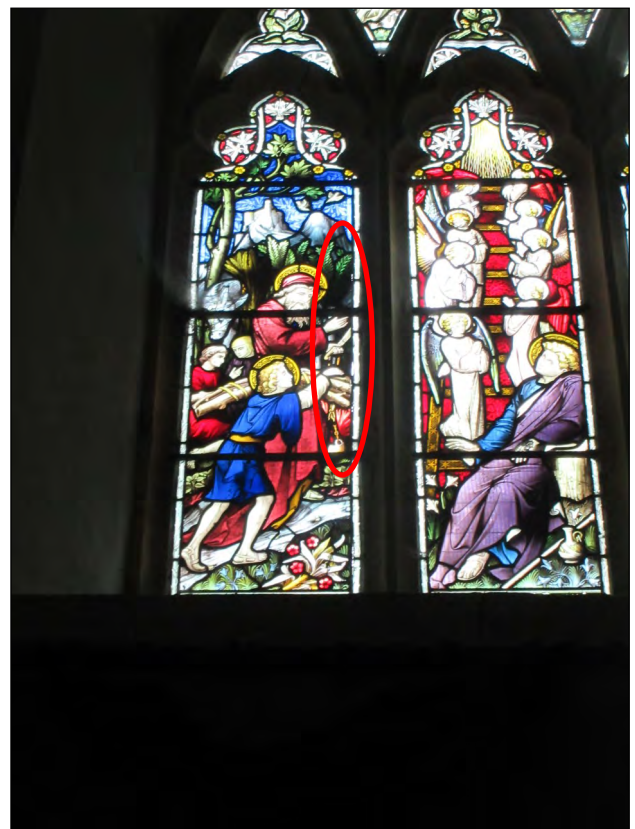
027 There are multiple gaps in the leading to the west window.

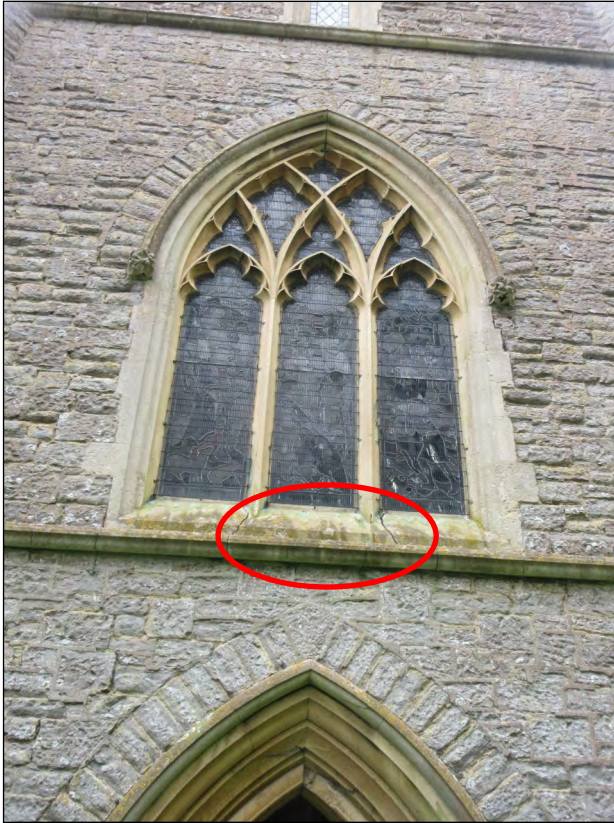
028 Open joints in the cill of the west window.

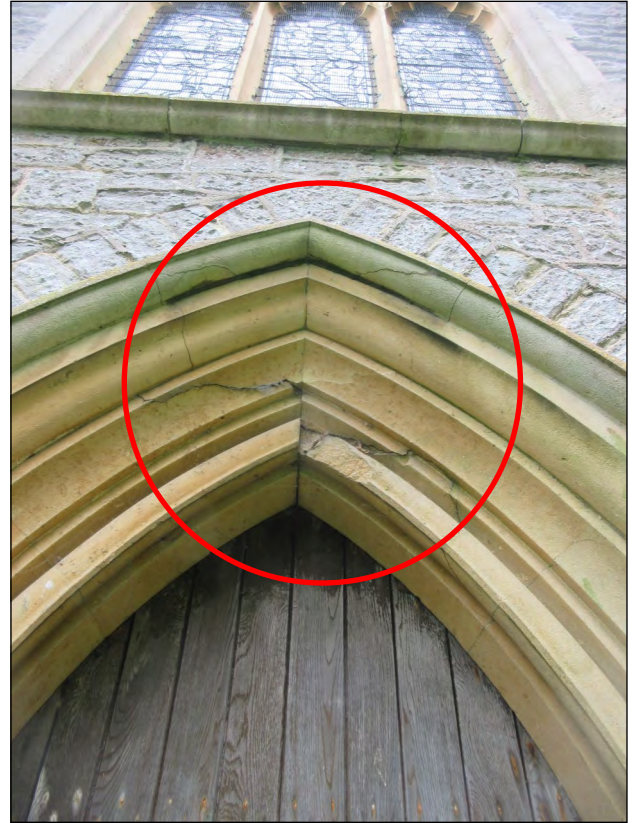
029 Masonry damage to the head of the west door.

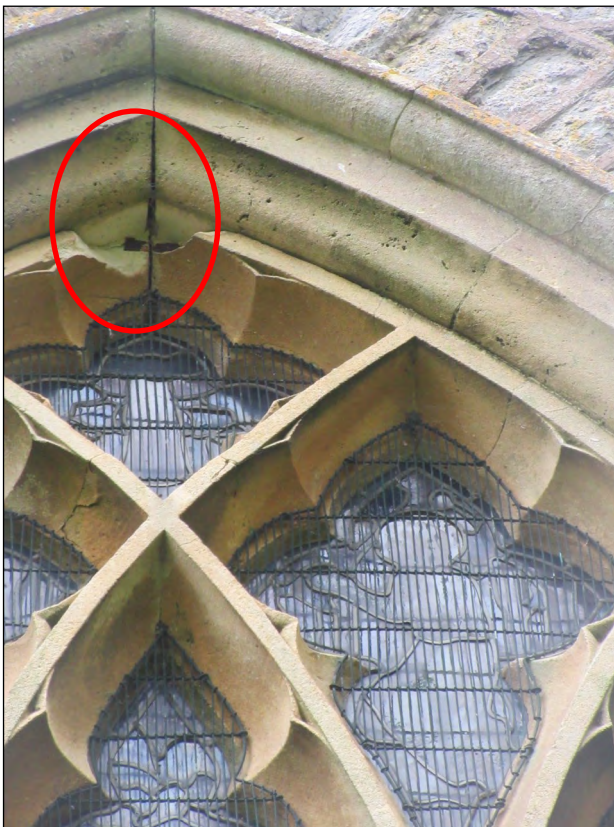
030 Iron cramp damage to the head of the west window.

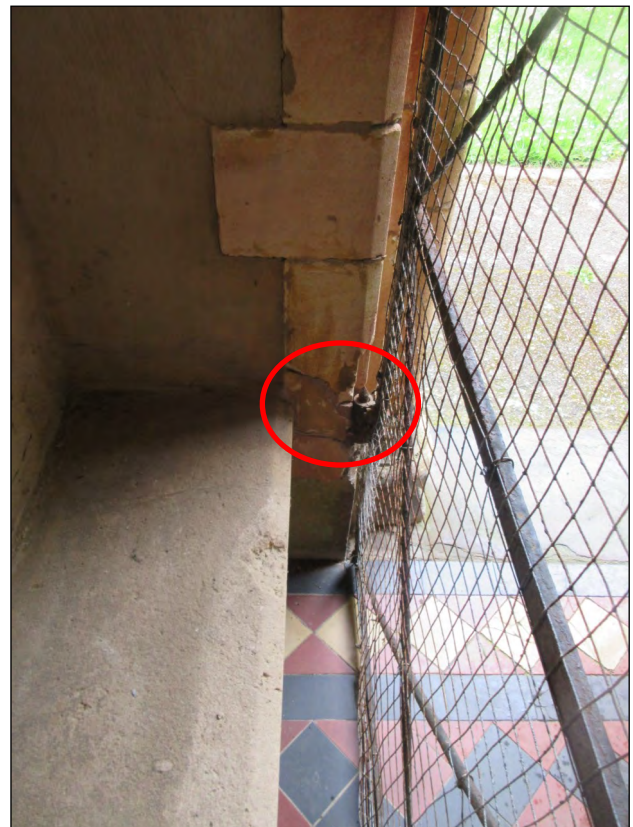
031 Pintel damage to the stonework of the South Porch gates.

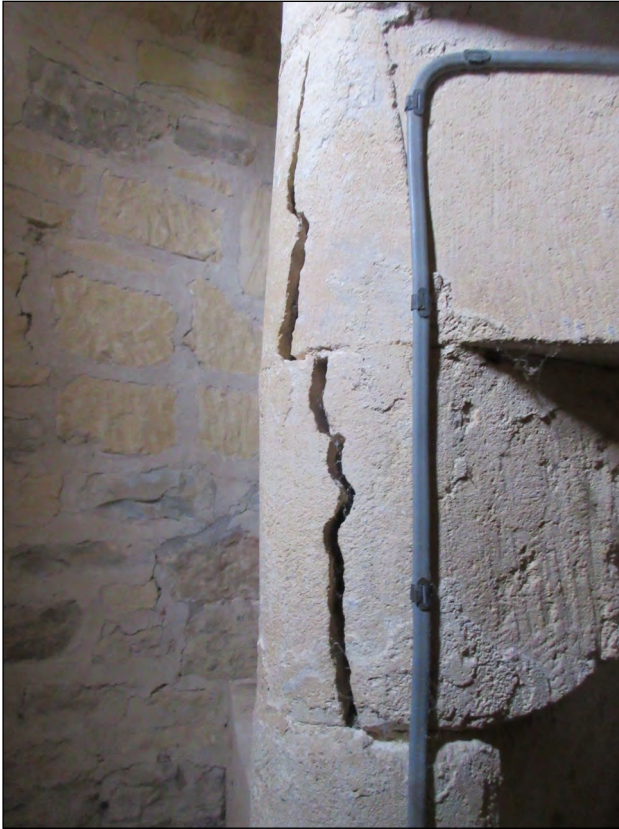
032 The cracking to the vice turret stair newel.

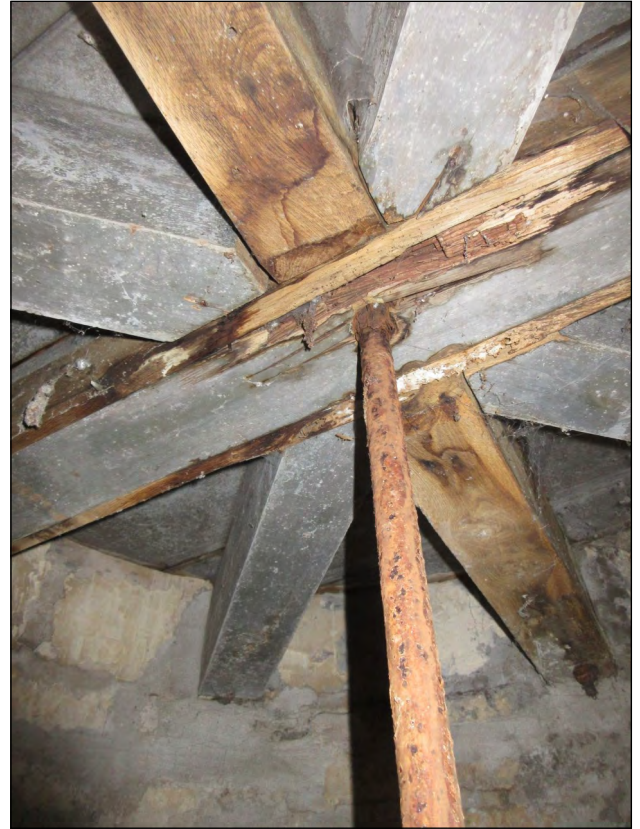
033 Timber decay to the underside of the vice turret roof.

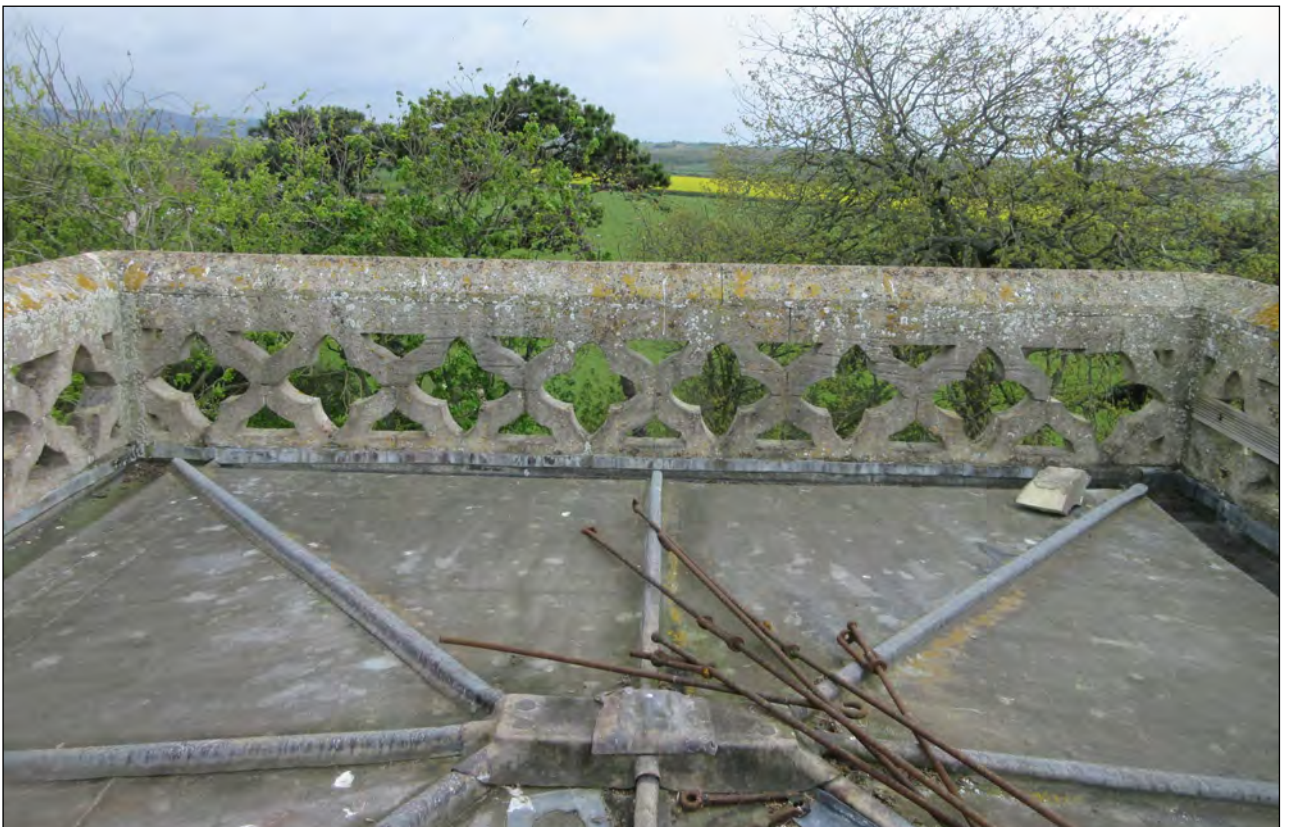
034 The tower roof.

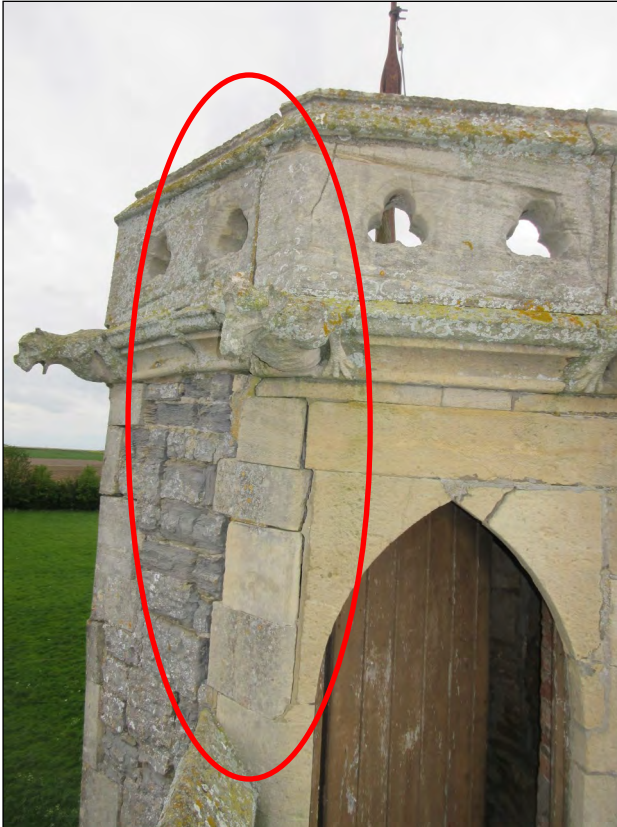
035 Very disturbed stonework at the top of the vice turret.

| 12.21. | The lias masonry to the upper section of this vice turret is in poor condition with washed out joints and severe erosion in some places. A broad open joint between the north face of the vice turret and the north-east face is a very serious defect. The cause of this opening up is not known but ironwork, or even a lightning strike, may have been the cause. A circular iron bar can also be seen running around the top of the upper string course and this is the cause of other stone damage. The rebuilding of the stonework to the upper part of the vice turret is recommended. (Photos 035 & 038) | 4 |

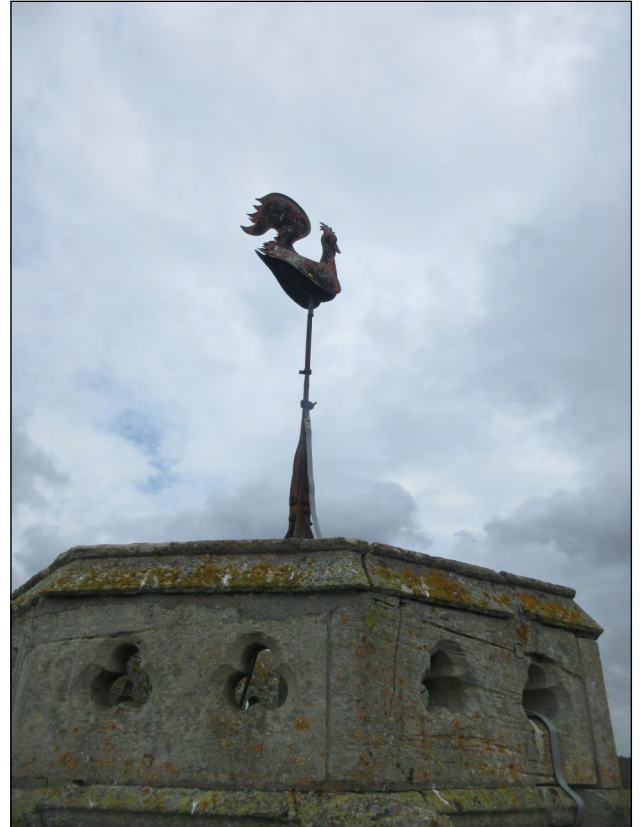
036 The weathercock in need of regilding and re-decoration.

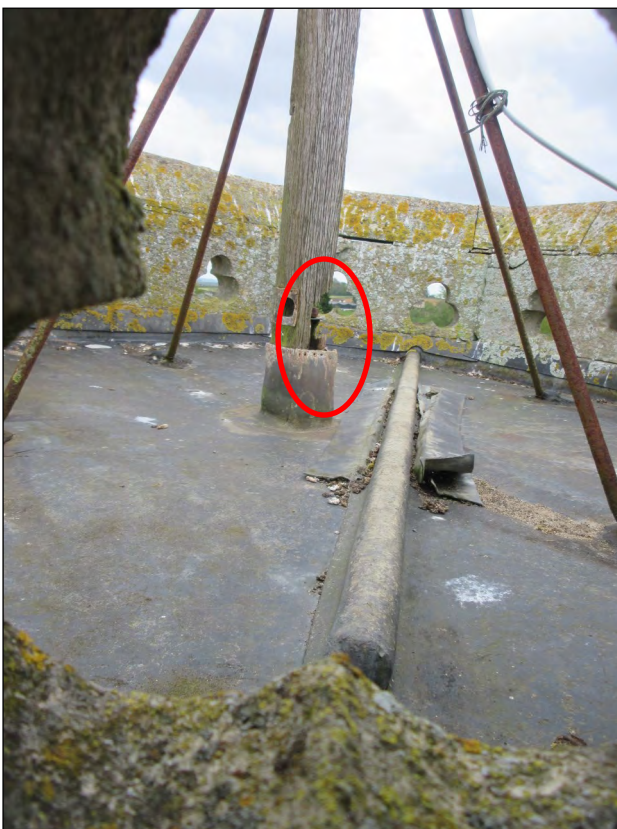
037 Decay to the base of the vice turret weathercock post.

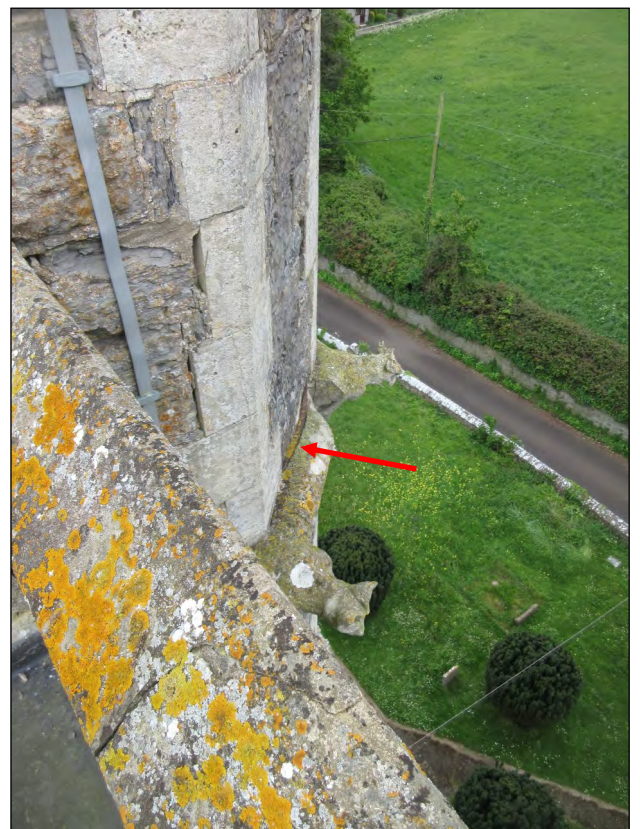
038 The iron band around the top of the vice turret.

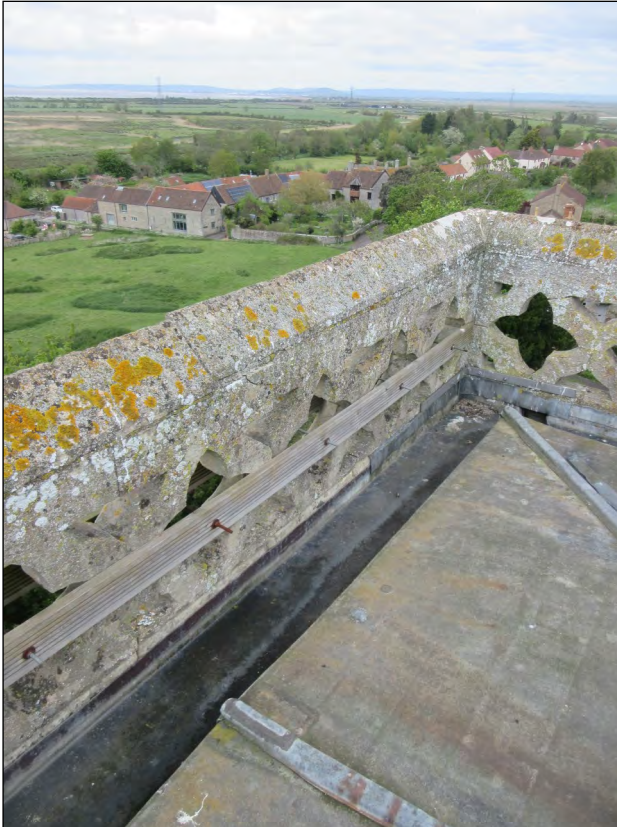
039 The north parapet of the tower roof,

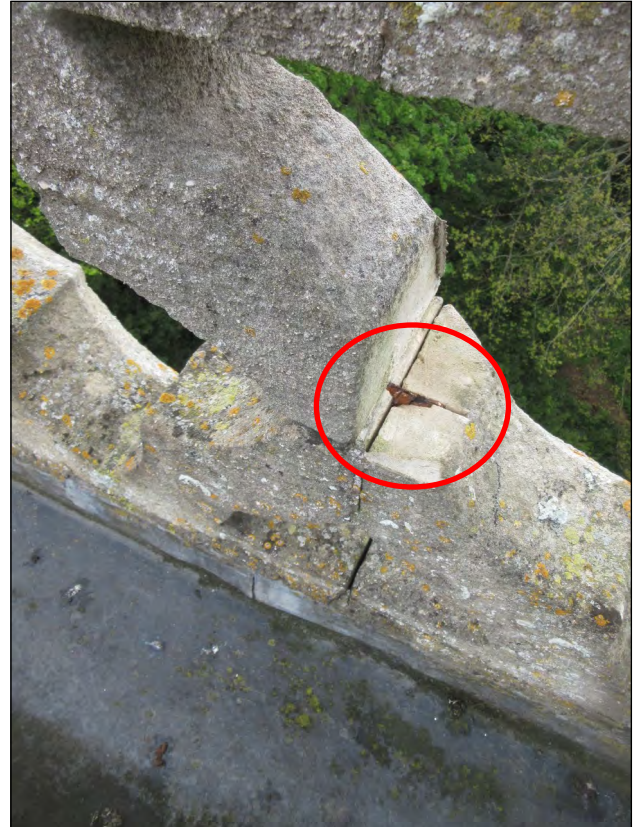
040 Decaying cramps in the tower parapet stonework.
