## **Job No 0281 – STOCKLAND BRISTOL St Mary Magdalene**

QQ Inspection 2024

Date of this survey: 30 April 2024.

Survey and report prepared by Marcus Chantrey, RIBA, AABC, SCA

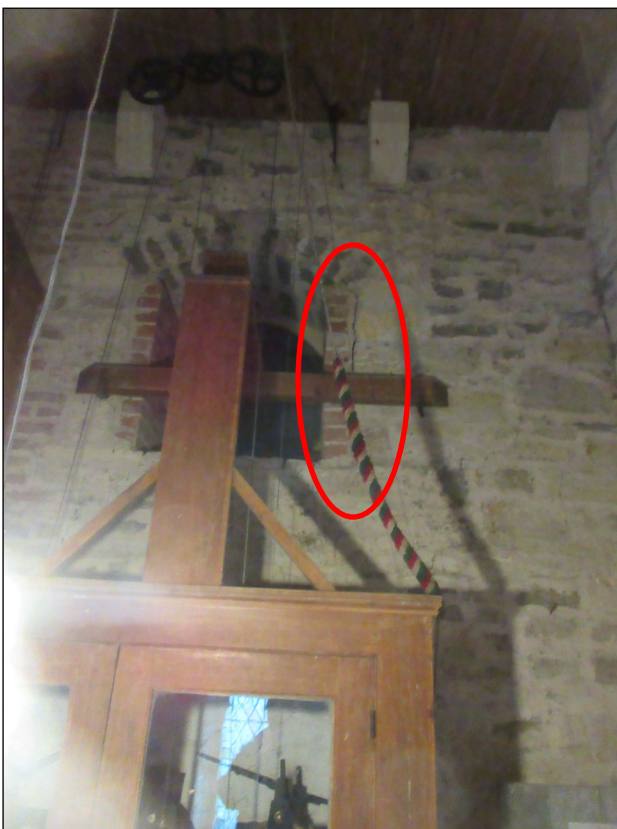
041 The detaching brick lining to the reveal of the east window in the tower.

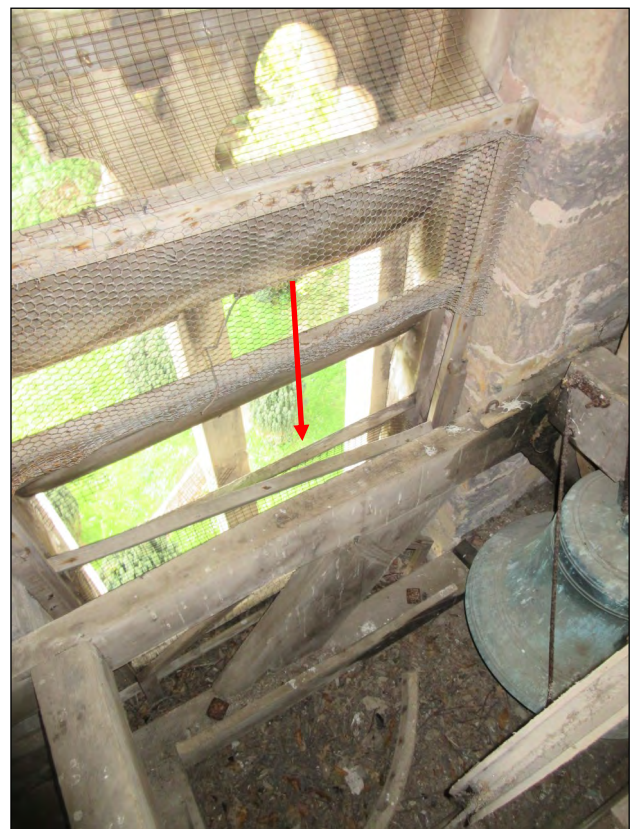
042 Tower louvre decay and open access for jack-daws.

| 12.32. | There are openings in each of the four walls with trefoil openings at high level and large timber louvres below. One of the timber louvres on the south elevation has split and now needs repair (Photo 042)/ | <b>4</b> |

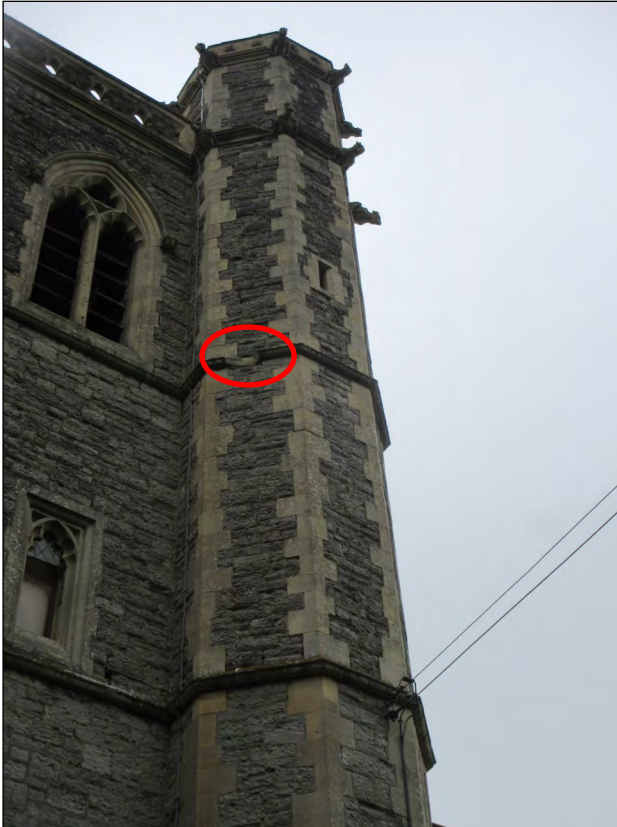
043 A missing section of string course from the vice turret.

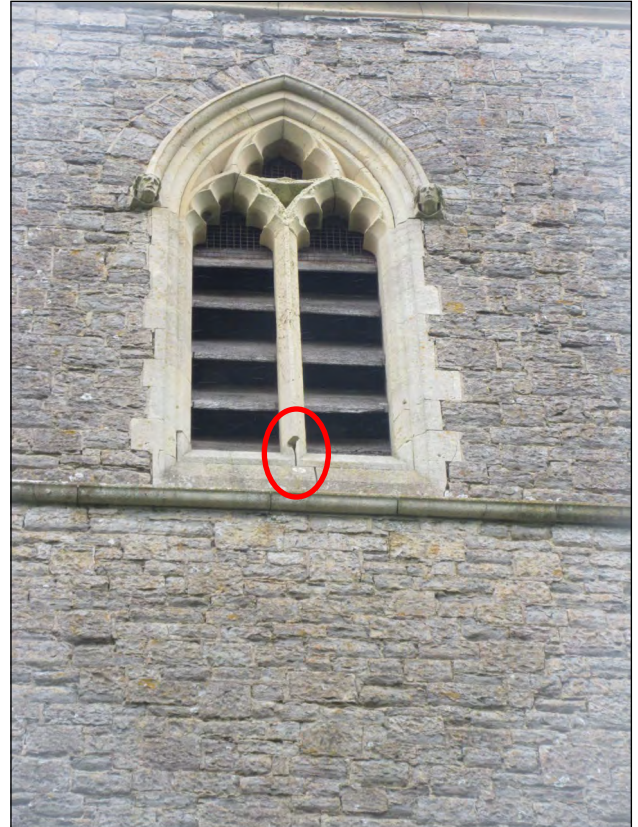
044 Possible iron cramp damage to the west window.

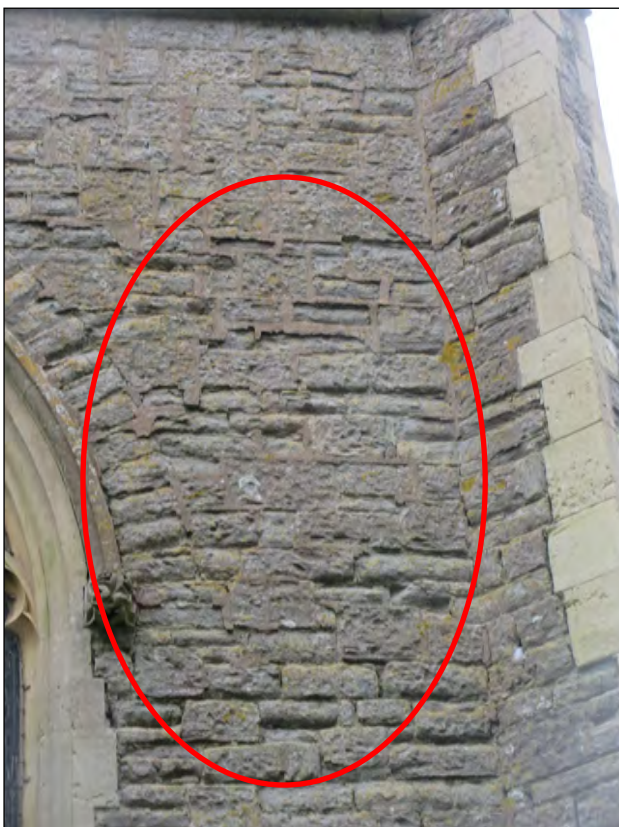
045 Cement pointing to the tower is causing accelerated decay of the stonework.

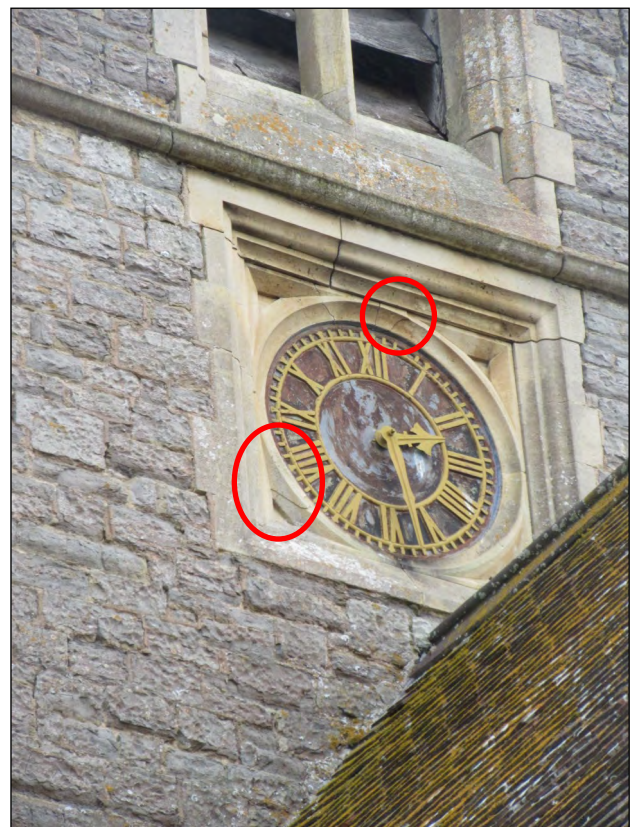
046 Damage to the clock dial surround probably as a result of iron cramps.

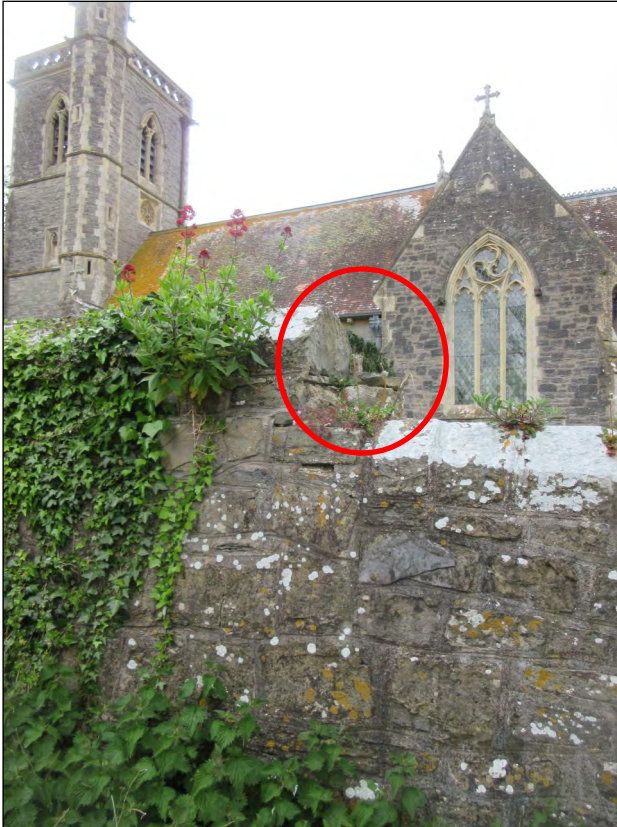
047 A missing section of churchyard wall capping.

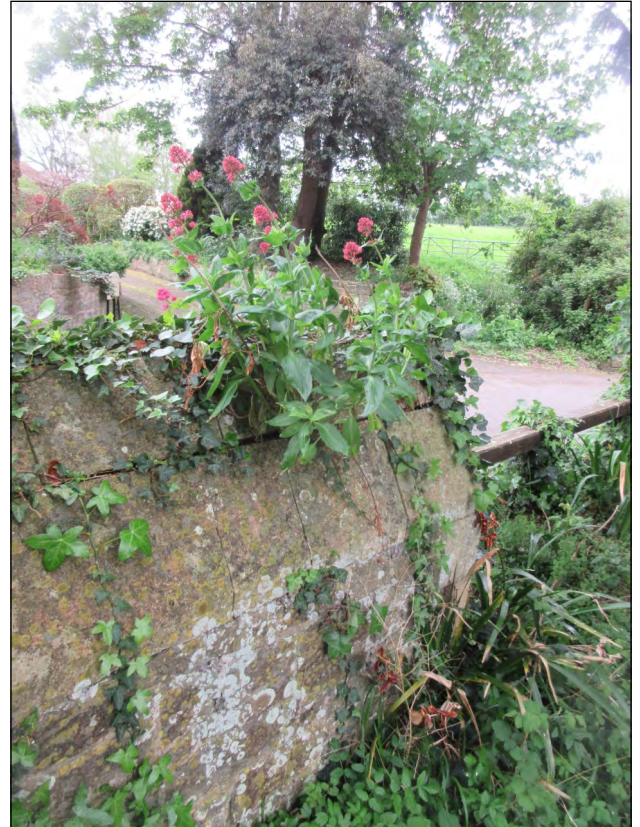
048 Valerian growth needs to be discouraged.

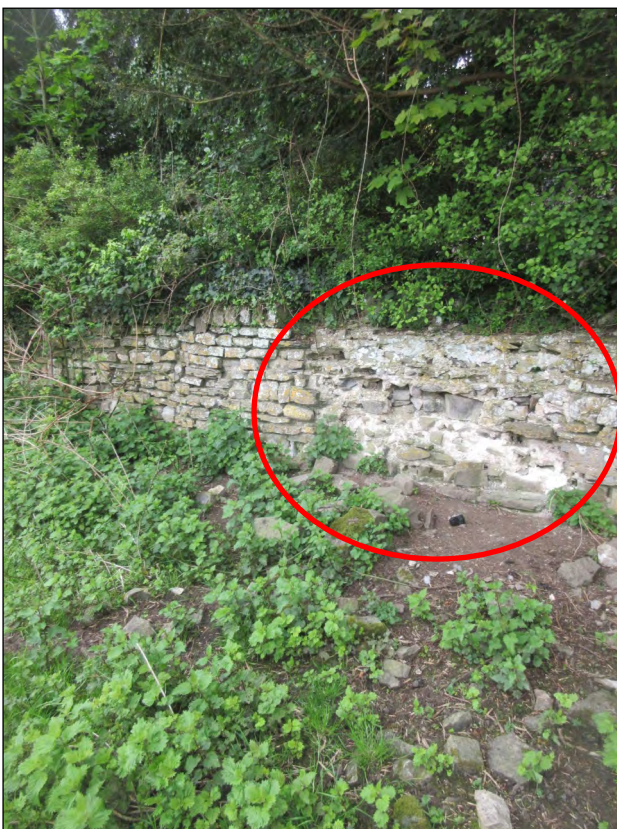
049 The loss of wall face to the north facing churchyard wall.

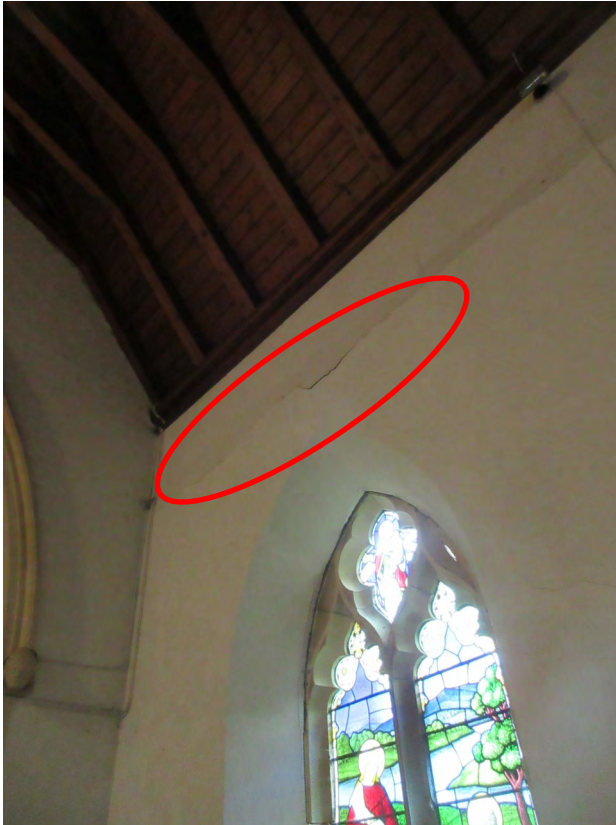
051 The horizontal cracking to the nave plaster.

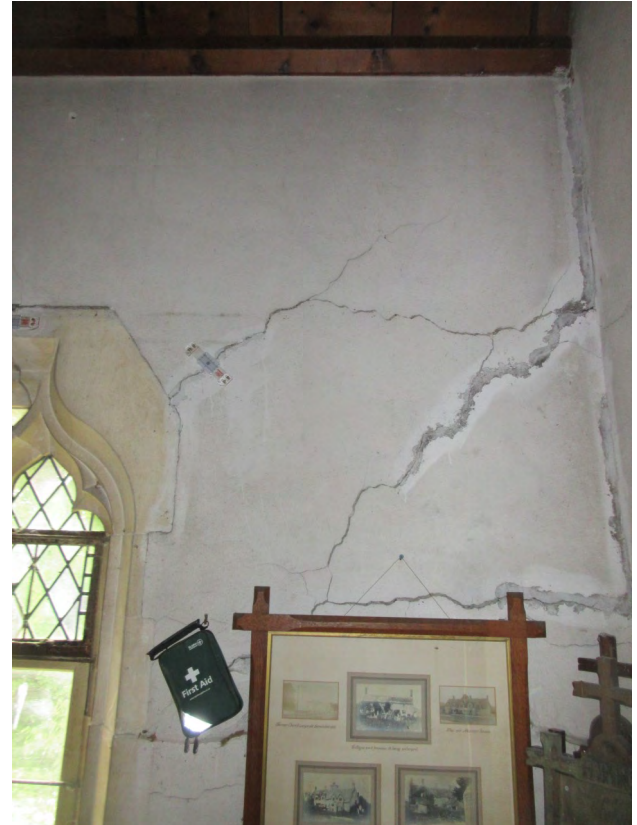
052 Plaster cracking in the vestry.

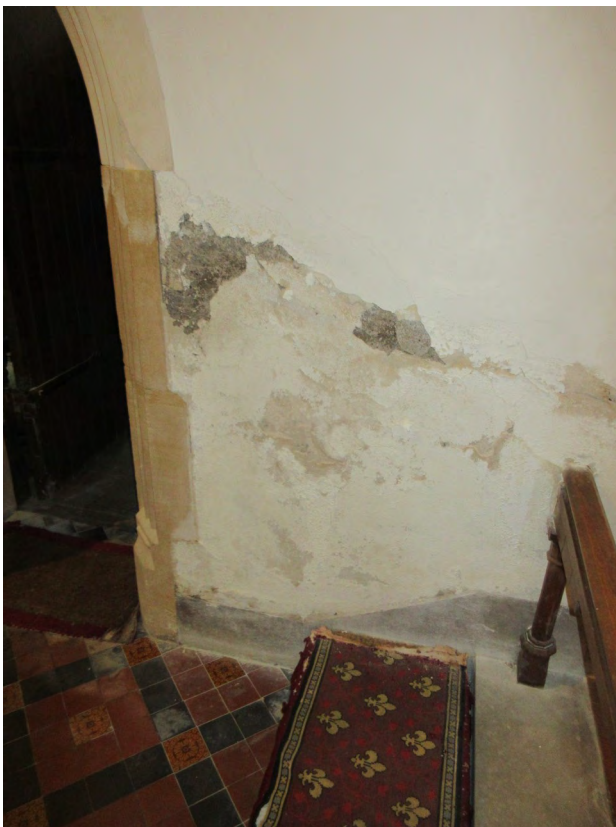
053 Decaying plasterwork at low level on the north wall of the chancel.

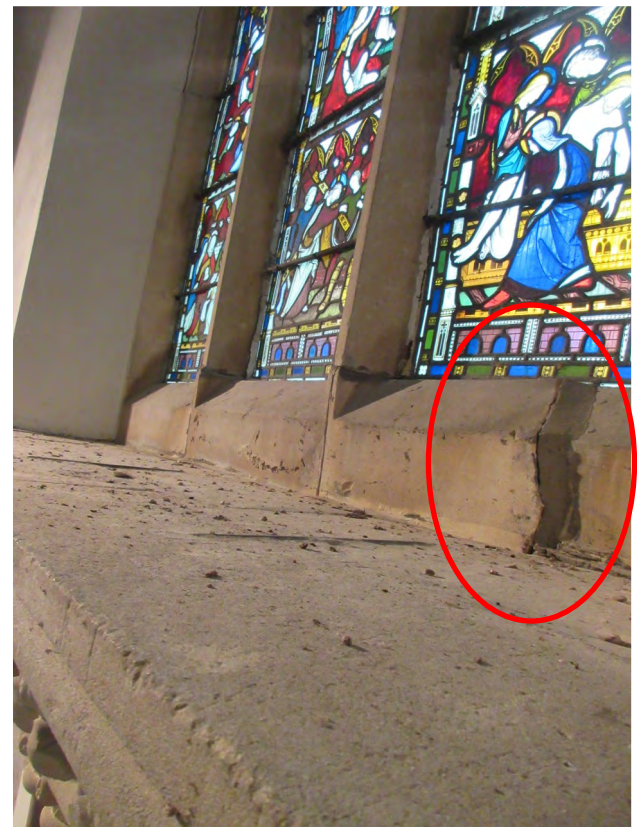
054 Displaced and misaligned stonework to east window is longstanding and appears to be stable.
