**STOCKLAND BRISTOL**  
**St Mary Magdalene**  
**0281**

BELL REHANGING & BELL FRAME REPAIRS

**The Church of St Mary Magdalen, Stockland Bristol. 21<sup>st</sup> January 2025.**  
**A report on the bell installation with proposals and recommendations for restoration.**

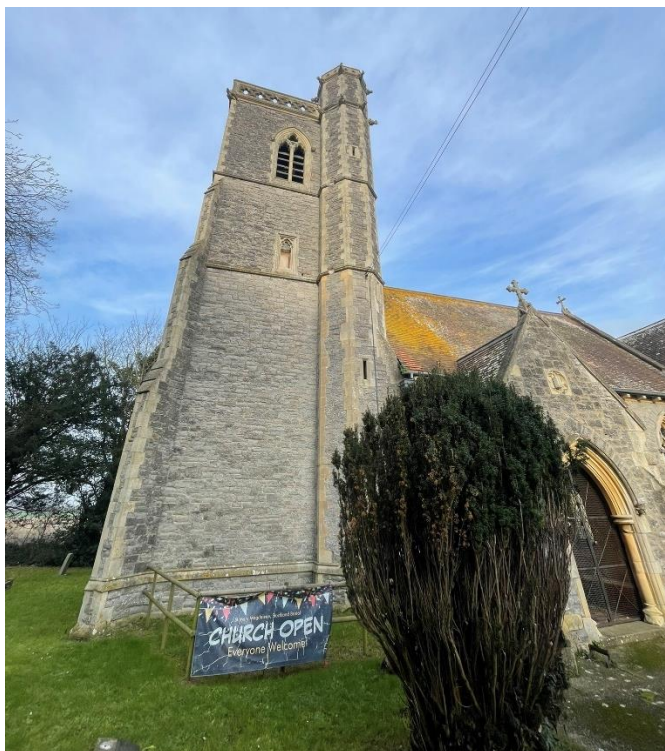
**The tower from the south.**

This attractive western tower, rebuilt in 1865, is built of coursed and squared blue lias with rubble infill and dressings of Bath Stone.

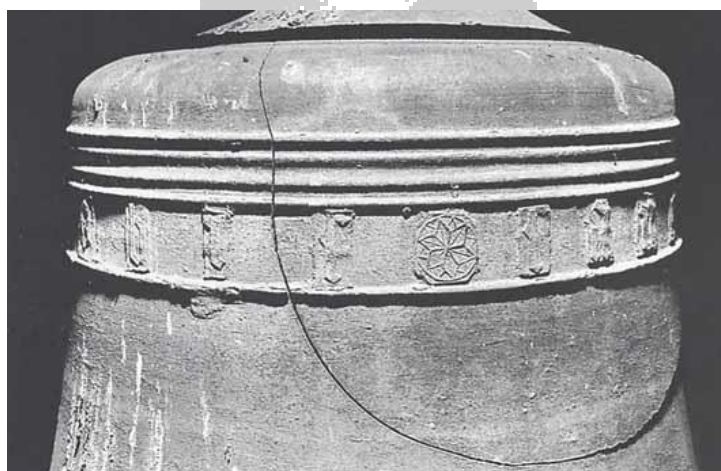
Bells 1,3 and 6 have independent crown staples bolted through central holes. The remaining bells have cast-in crown staples which are visibly corroding.

A typical crack caused by corroded cast-in crown staple.  
(Sparkford, Somerset – Photo Christopher J N Dalton).

- Bells 2, 4 and 5 should be conserved, by having their cast in crown staples carefully extracted.
- I recommend that the bells are tuned together to enhance their individual tone, together with their musicality as a peal.

Carefully extract all remains of the cast-in crown staples. Clean the bells and inspect them for cracks. Liaise with the PCC if any unforeseen repairs are found to be required.

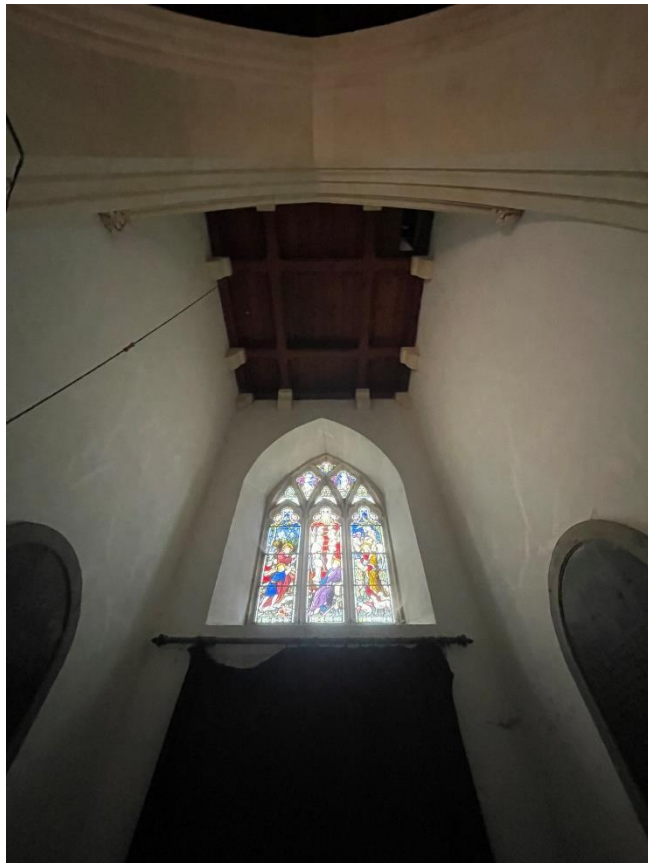
The ground floor chamber is open to the church on the east side, and has a large west door with stained glass window above. This chamber measures 3m x 3.125m in plan, and 7.3 meters in height.

The ground floor chamber.

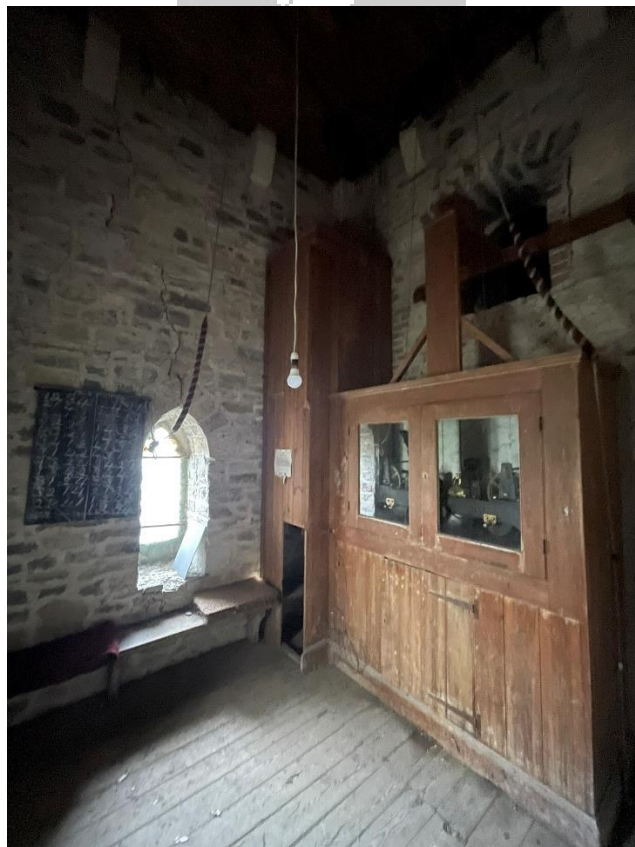
The first-floor ringing chamber measures just over 3.5 meters square in plan and 4.8 meters in height. There are windows to the north, south and west. A large mechanical clock is located against the east wall of this chamber, with a weight chute in the north/east corner.

The first-floor ringing chamber showing the clock case and weight chute.

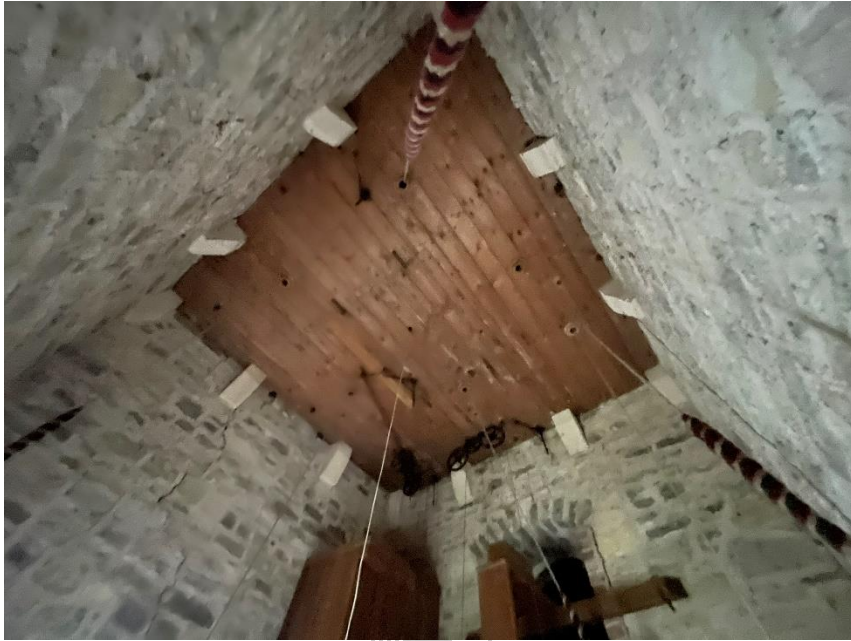
Looking up at the second-floor.

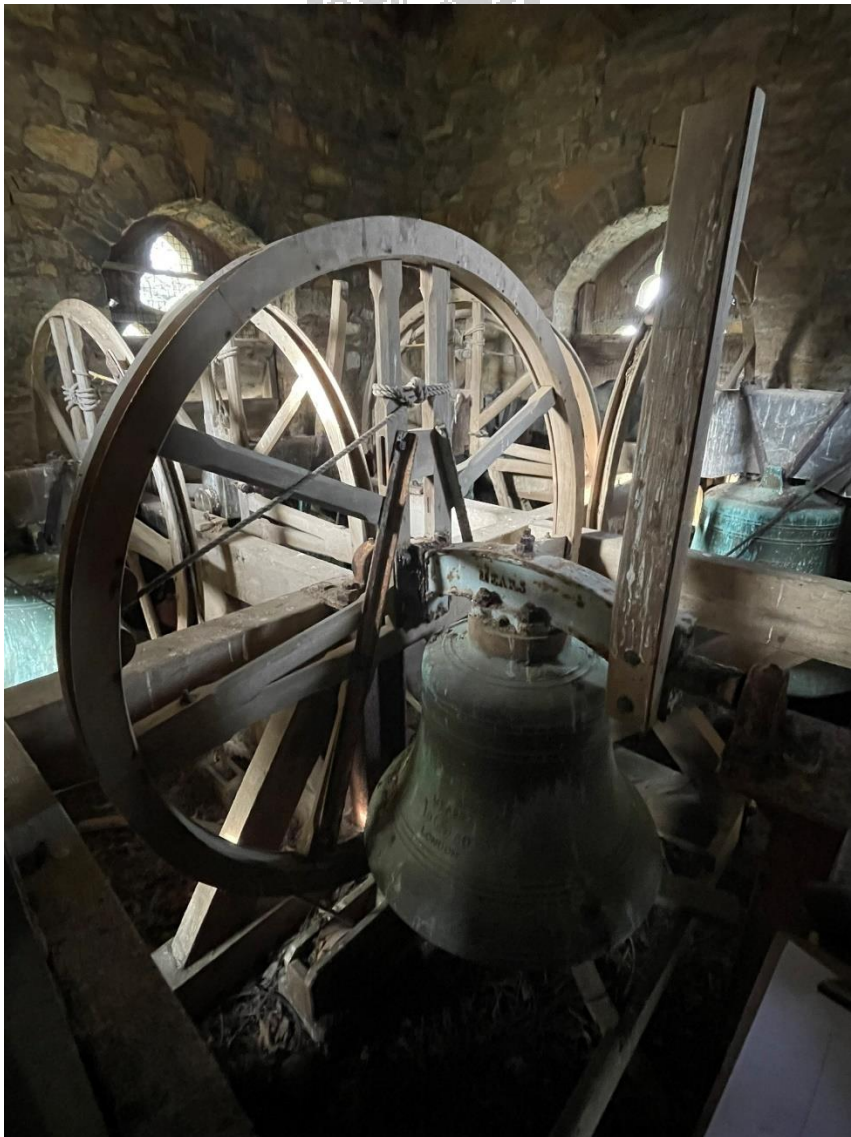
The headstock of bell 1 is of cast iron, and appears to be in good condition, apart from shown signs of surface corrosion. The remaining bells are hung on hardwood headstocks, which appear to date from around 1865. Those fitted to bells 2,3 and 5 have strap type gudgeons secured with stock hoops. The headstocks of bells 4 and 6 have been fitted with more modern plate gudgeons.

Bell 1 and its fittings.

- I suggest that the fittings of bell 1 are overhauled and/or replaced as required.
- The remaining bells should be rehung with all new fittings, to include steel hollow-box section headstocks and modern ball bearings.

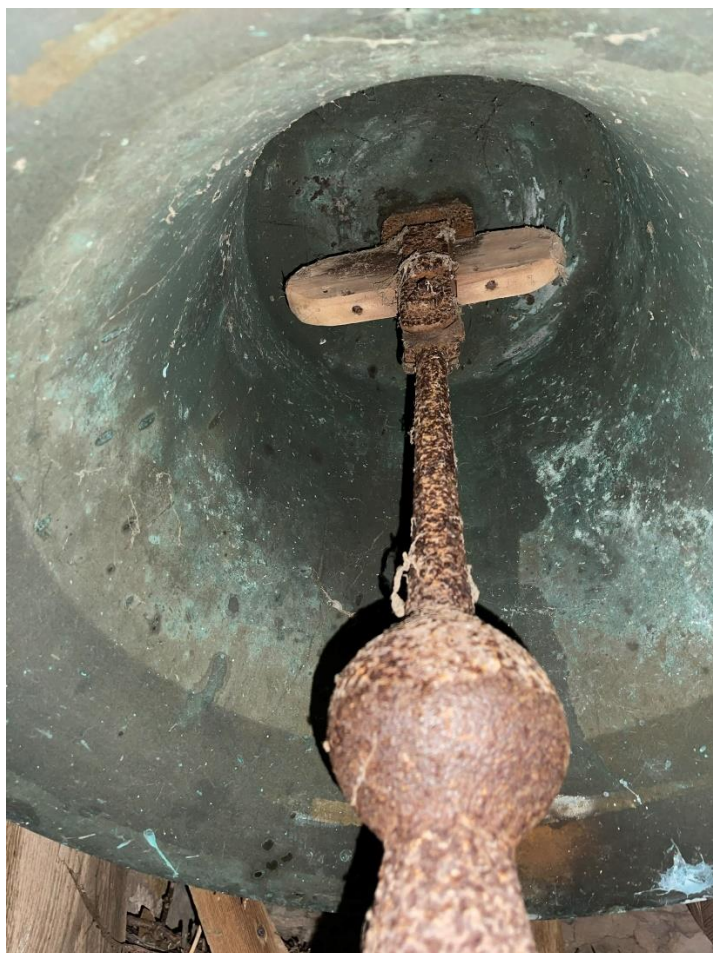
The clappers are made of traditional wrought iron. That of bell 1 has an eye type top end and hangs from an independent crown staple. The remaining clappers have spatula type top ends and are secured with a U stap and bolts. Those in bells 2,4 and 5 hang from the original cast-in crown staples, the remainder hang from independent crown staples, bolted through central holes. The clappers in the larger bells are worn and the point of strike, and at their pivots.

The clapper of bell 2.

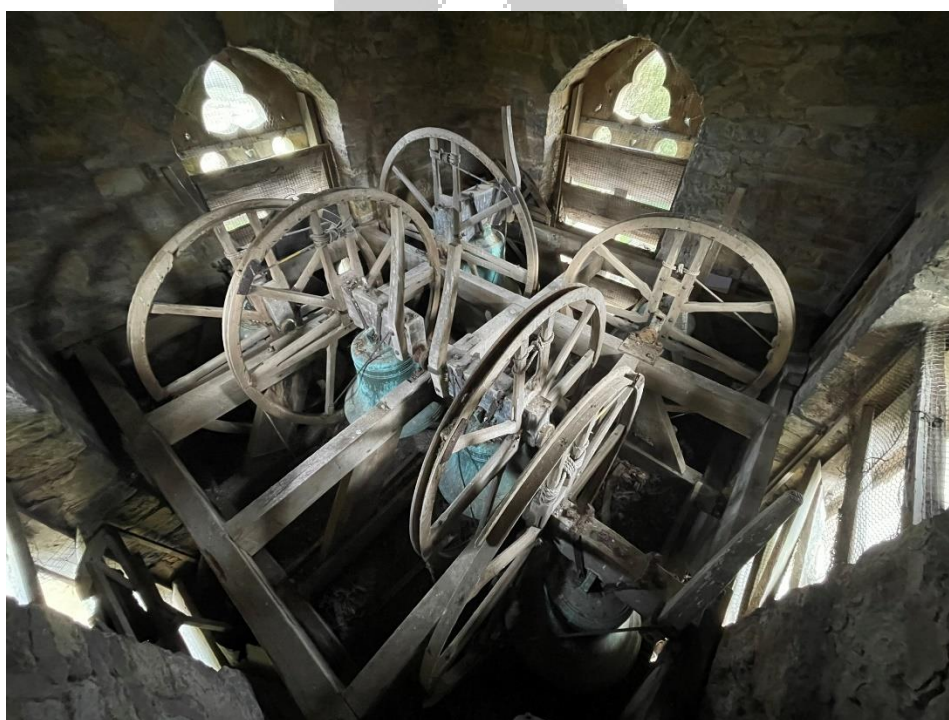
These are made to traditional designs, using hardwood with outer shrouds secured with iron nails or screws. That of bell 1 is in good condition but the larger 5 are in very poor order. The nails which secure the outer shroudings, are heavily corroded and cracking the surrounding timber. Several of the shrouds have fallen off as a result.

Regular ringing stopped in the late 1990's due to fears that cracks in the tower were compromising the safety of the structure as a whole. With no maintenance work being undertaken to the bell fittings in the intervening period, the bell wheels have disintegrated.

A general view of the belfry, showing bellframe and disintegrating bell wheels.

- The timber areas of the bellframe should be cleaned and treated with wood preserver. All ironwork should be cleaned down and treated with rust inhibitor, then primed and then painted with exterior grade machinery enamel.

- Traditional bell wheel of hardwood, with shrouds secured by stainless steel screws. Provide galvanized steel braces (or wheel irons) to strengthen the wheels and keep them straight.
