# Asbestos Survey Report and Register

**St Mary Magdalene Church  
Stockland Bristol  
Bridgwater  
TA5 2PZ**

## Collins Chartered Surveyors

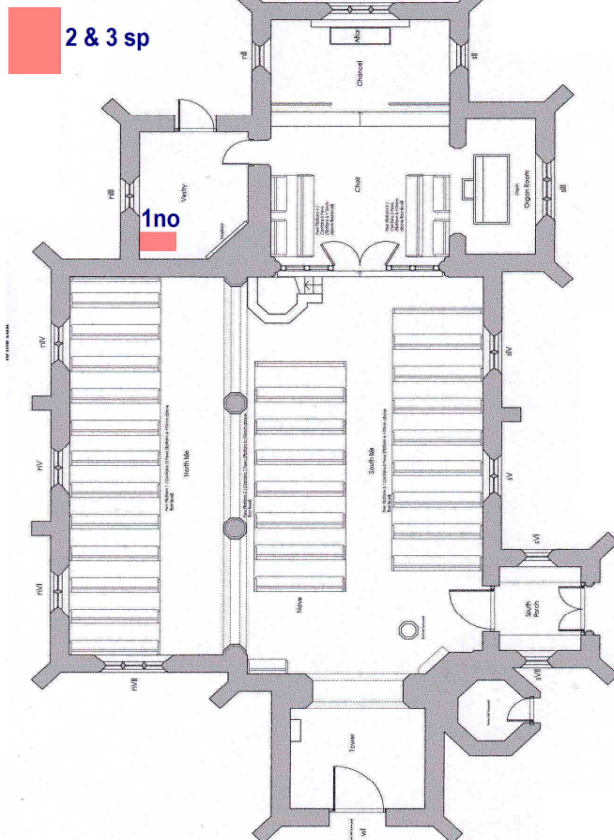
#### Basement Boiler Room

Asbestos Containing Materials (ACM's) have been strongly presumed to be present in a rope seal on the redundant flue and in a boiler gasket on the redundant boiler in the basement. Asbestos Containing Materials may also be present within the safe located in the vestry.

These materials are in good condition and no remedial work is required.

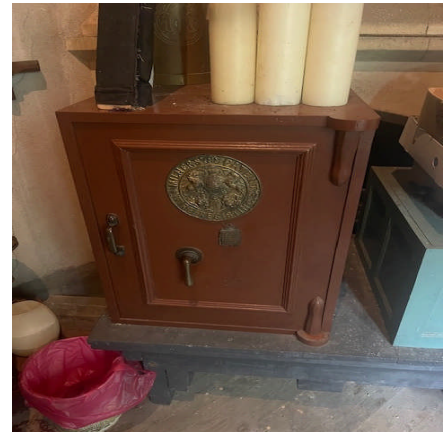
1 No

**Description:** No access

**Location:** Vestry. Safe.

**Level of Identification:** This material has been presumed to contain asbestos since access was not possible.

| Risk assessment of the Asbestos Containing Material only | | Score |
|---|---|---|
| The material risk assessment indicates an asbestos containing material that has a potential high risk of fibre release. | | |
| There is a low risk to health from this material in its location. | | |

Before an area/object is disturbed an inspection should be undertaken by a competent person to determine the presence of asbestos.
