## St. Mary Magdalene, Stockland

### Condition Survey with recommendations for a conservation/restoration approach

08/11/24

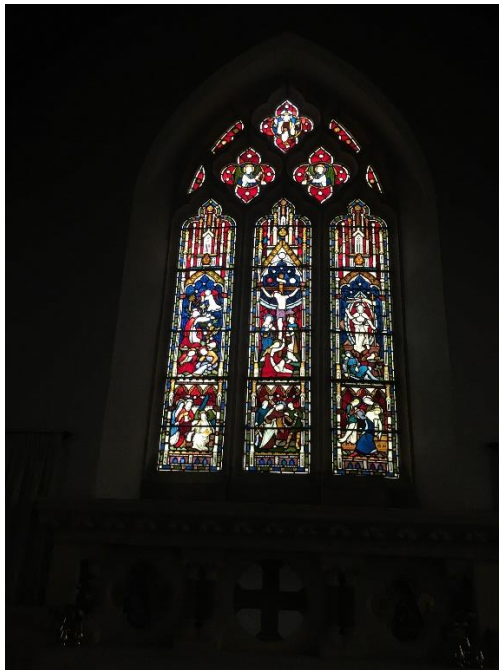
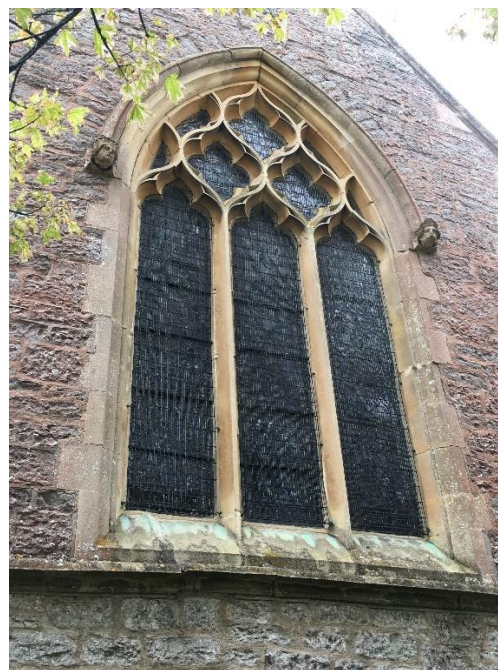
## East window I

A three-light window by Clayton & Bell circa 1860, with trefoil heads, three large quatrefoil traceries, and four subsidiary tracery elements. (Main lights 18 x 89 inches). The subject has scenes from the life of Christ in traceried niches, with censing angels in the traceries.

The glass is good quality, with no signs of deterioration.

The painted detail is well fired. Structurally, the window is sound, although the sill block to the lower right is misaligned. It is not anticipated that any works should be carried out to this window, other than careful in-situ cleaning by a glass specialist.

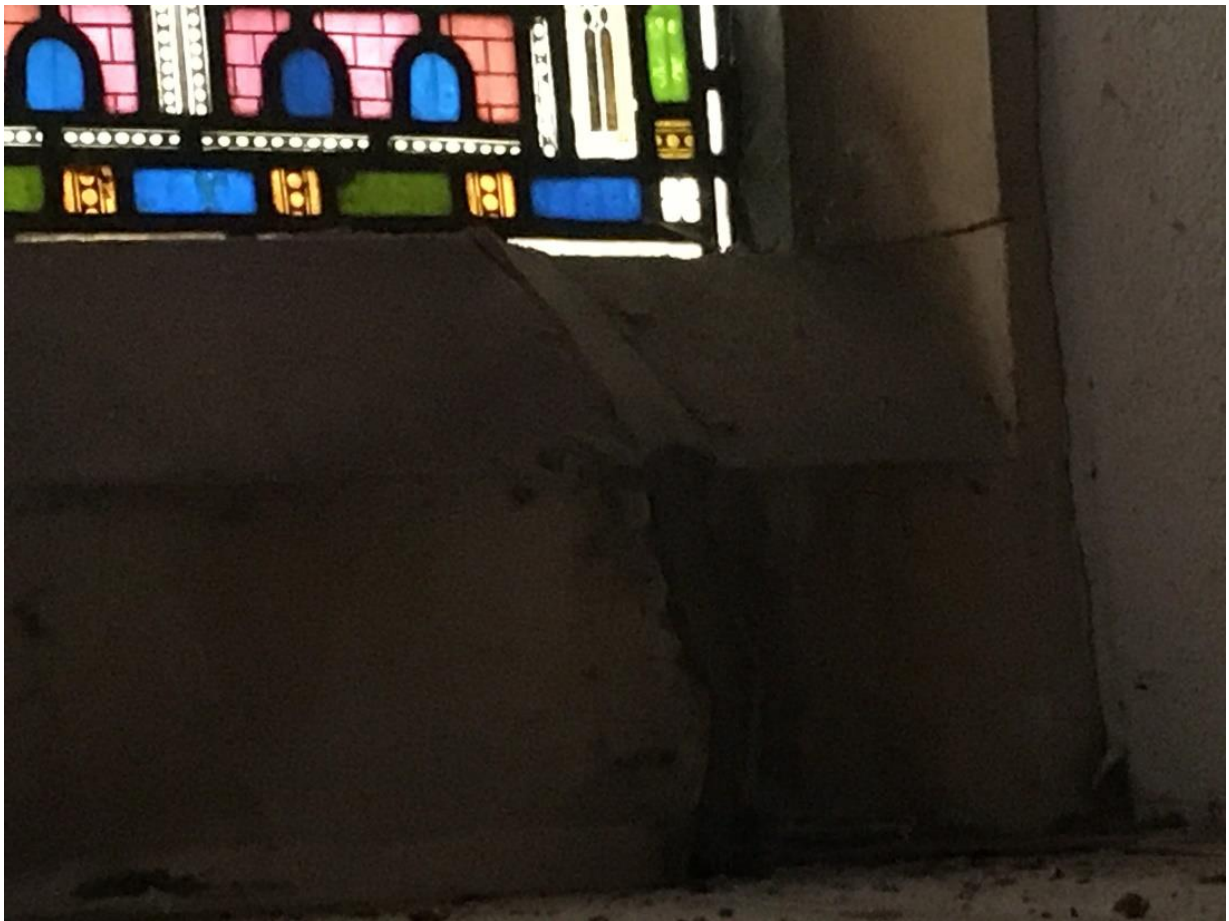
Misaligned sill block

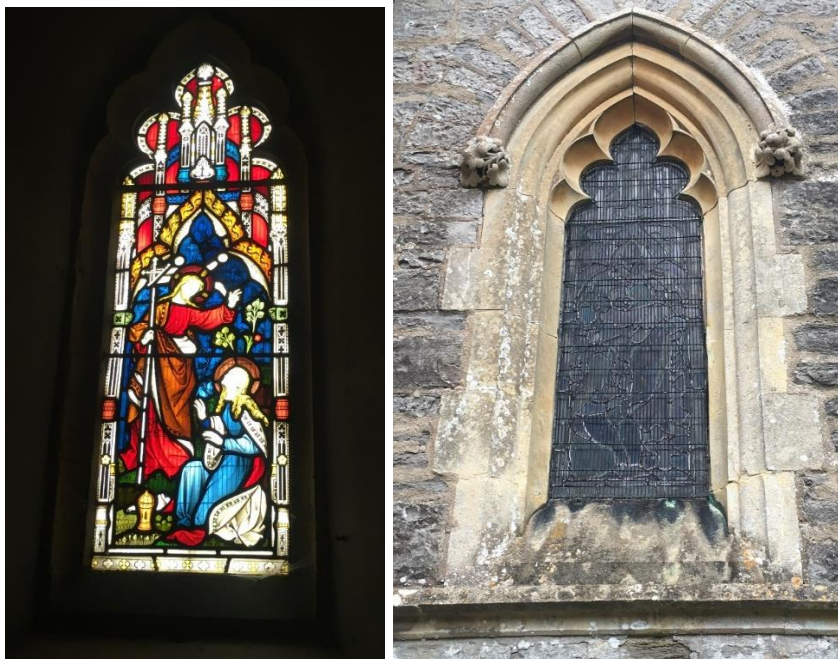
## Window sll

The glass is good quality, with no deterioration. The painted detail is well fired, apart from the floral border at the base, which has some paint loss, probably due to under firing. The lead work (1/4 inch round section) is in good order. There are two ferrous tie bars (1/2 inch round section) which are rusting and spalling the stone work.

Careful in situ cleaning by a glass specialist, and in-situ replacement of tie bars with non-ferrous metal of a similar section.

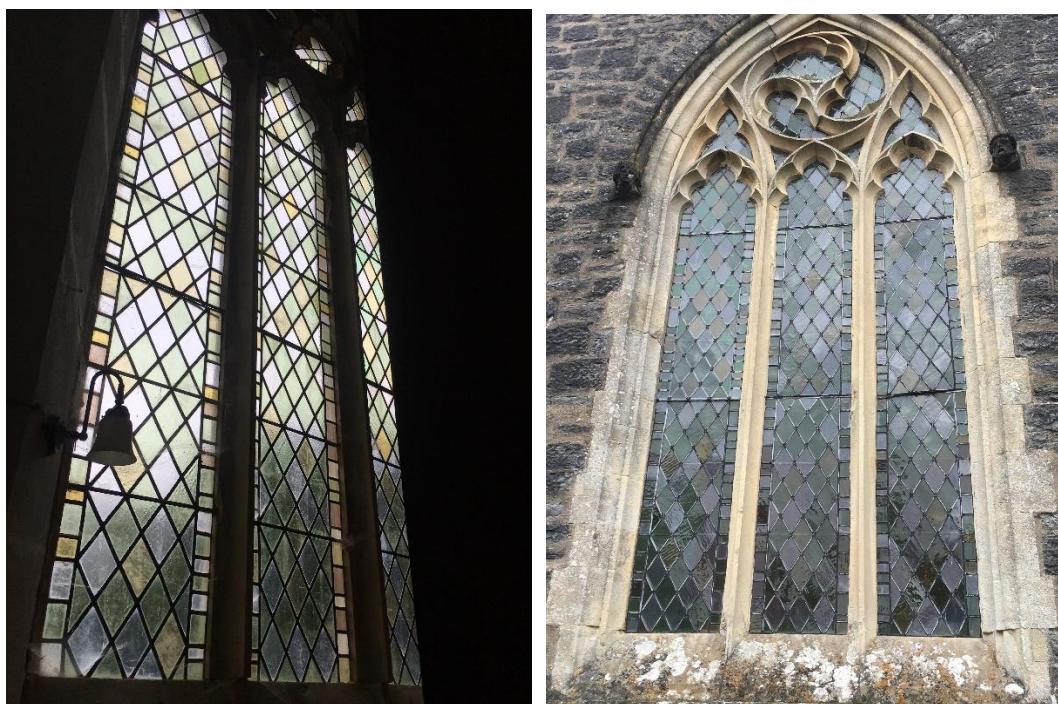
## Window sIII

This large window is dilapidated, with bowed and extremely fragile lead work. (5/16-inch flat section). The ferrous tie bars (five per light ½ inch round section) have spalled the stone work, and several bars are unattached due to their pockets in the stonework having fallen away. Temporary repairs were carried out on the day of the survey to stabilise two bars, however removal of the window at earliest opportunity prior to the main project is advised. These works must be carried out in collaboration with a mason, as propping of the mullions, jambs and particularly traceries will certainly be required. The tracery elements

Remove main lights and traceries, clean, re-lead and fit with new non-ferrous bars in to lime mortar.

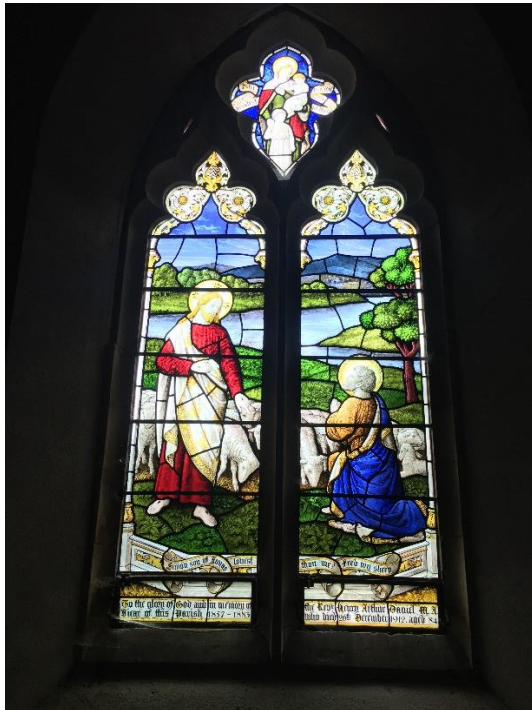
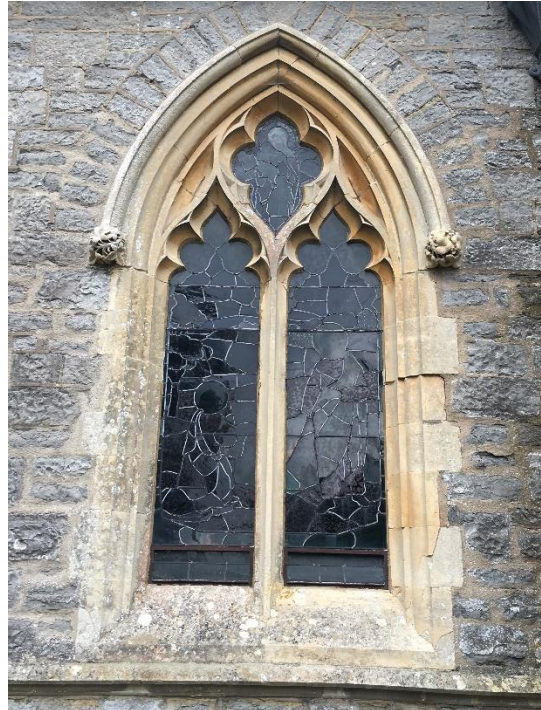
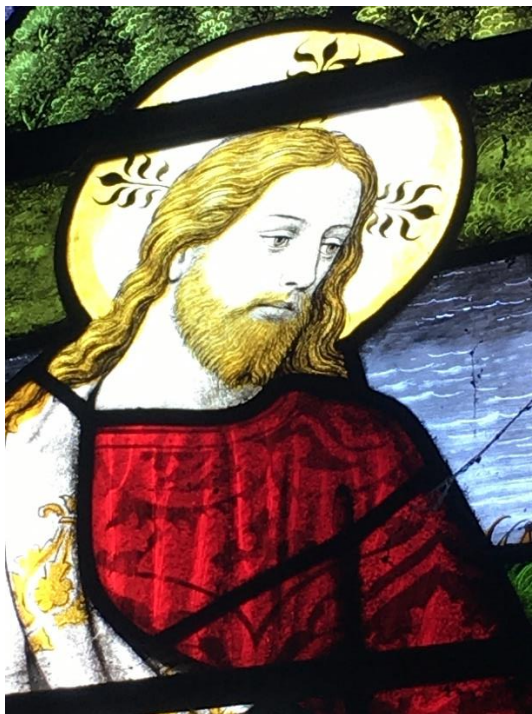
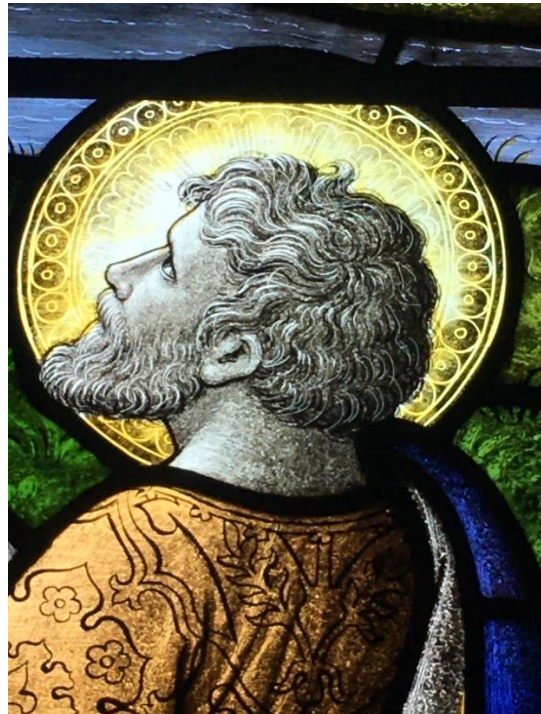
## Window sIV

The glass body, and painted detail in excellent condition. Lead work (1/4 and 5/16 inch round section) in good condition. However, there is serious movement of the stonework, which has bent the leadwork significantly locally- remarkably the glass has not yet cracked as a result.

The ferrous tie bars are rusted, and have caused significant damage to the stonework.

This window will need to be removed to allow stone conservation/restoration. Re-leading will not be necessary. Clean glass with de ionised water ethanol 50:50 solution. Flatten bowed areas, apply new copper ties. Refurbish and decorate casements. Replace in position with new non-ferrous tie bars to similar section, and point perimeters with lime mortar.

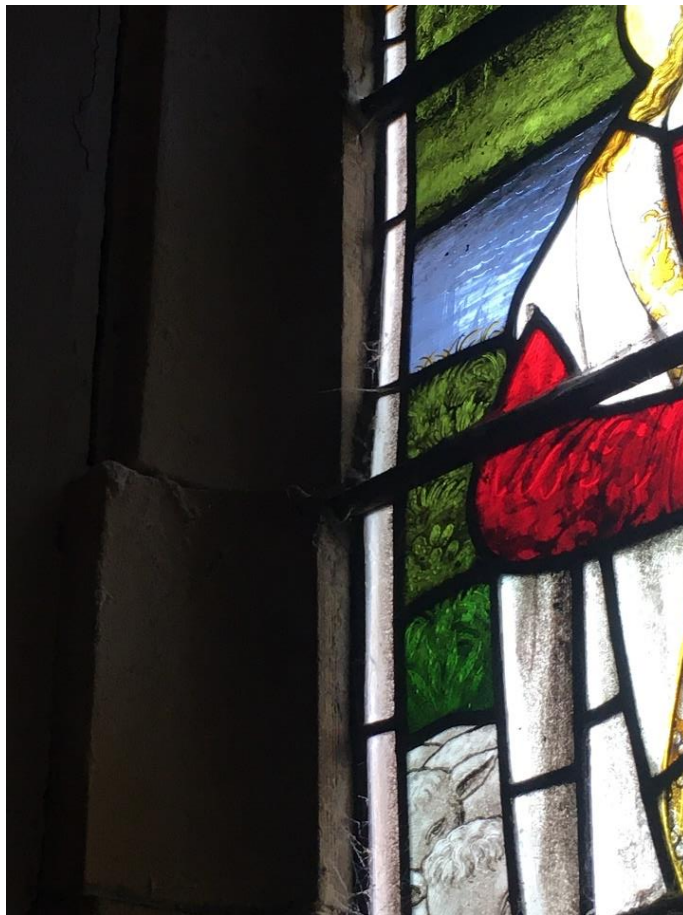
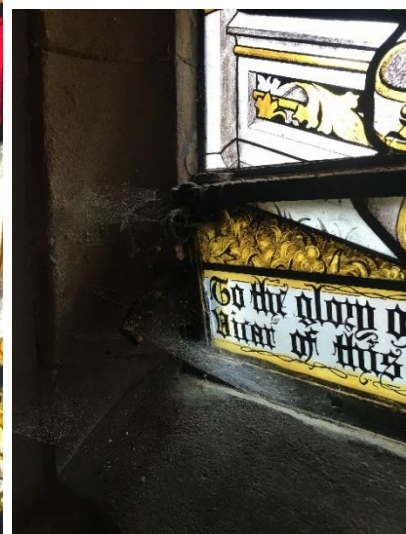
Bowing of lead work caused by movement of jamb stones- detail of seized sill casement

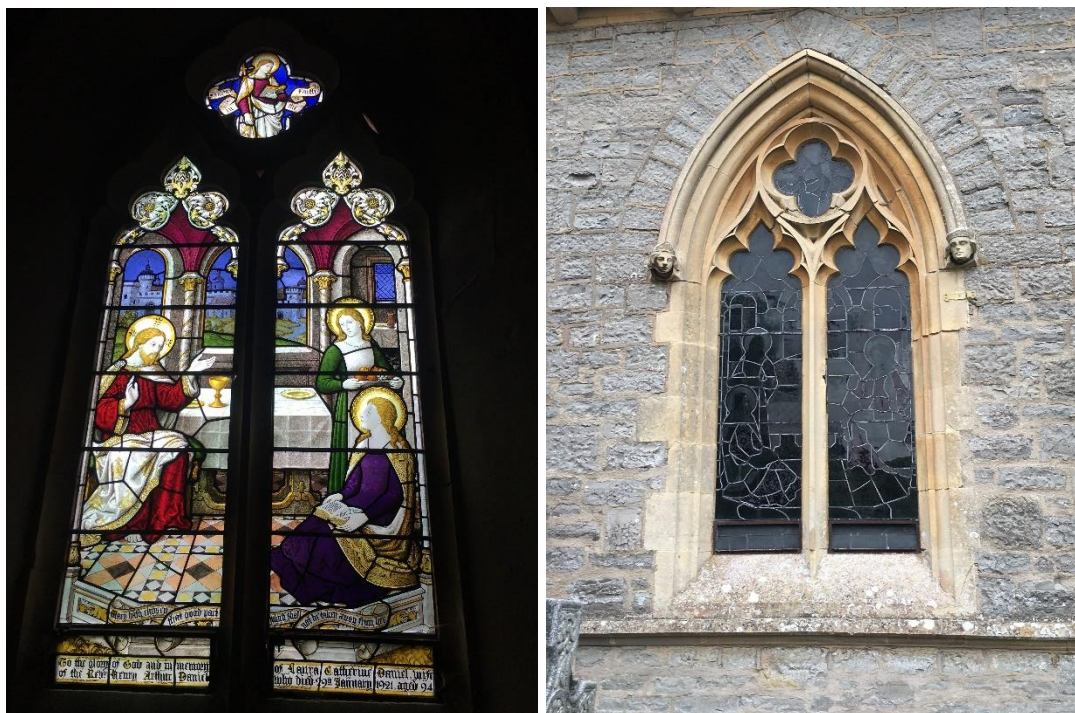
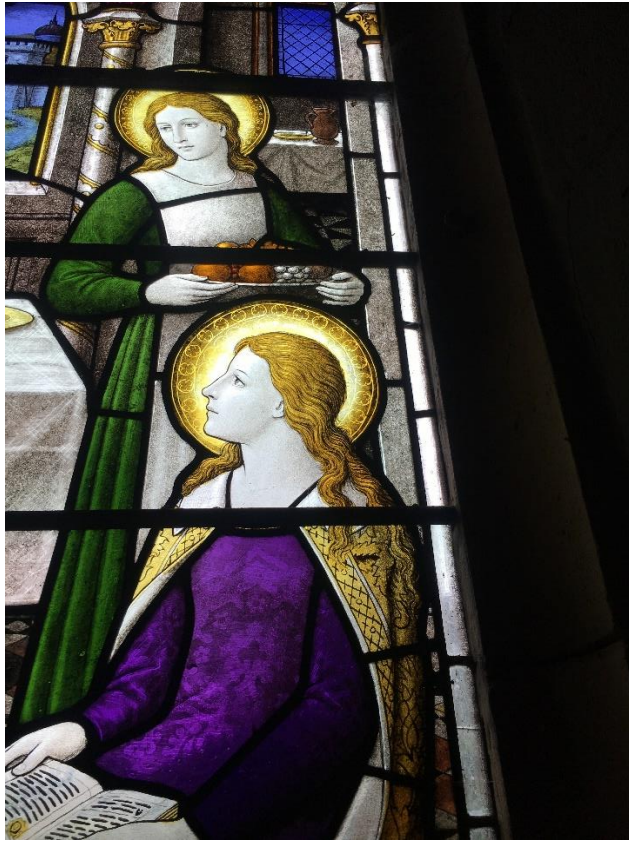
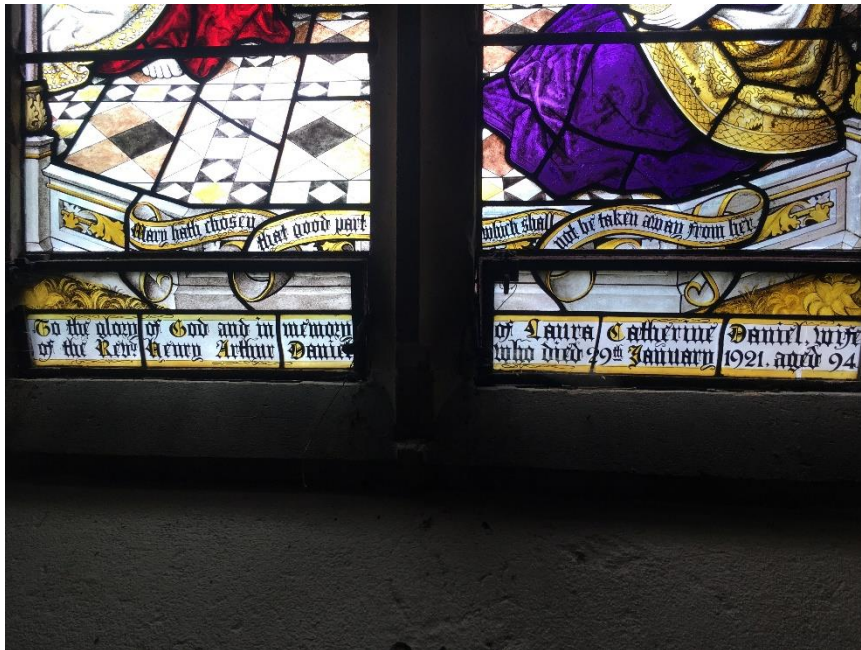
## Window sV

The glass body, and painted detail in excellent condition. Lead work (1/4- and 5/16-inch round section) in good condition. However, there is serious movement of the stonework, which will require extensive remedial work.

The ferrous tie bars are rusted, and have caused significant damage to the stonework.

This window will need to be removed to allow stone conservation/restoration. Re-leading will not be necessary. Clean glass with de ionised water ethanol 50:50 solution. Flatten bowed areas, apply new copper ties. Refurbish and decorate casements. Replace in position with new non-ferrous tie bars to similar section, and point perimeters with lime mortar.

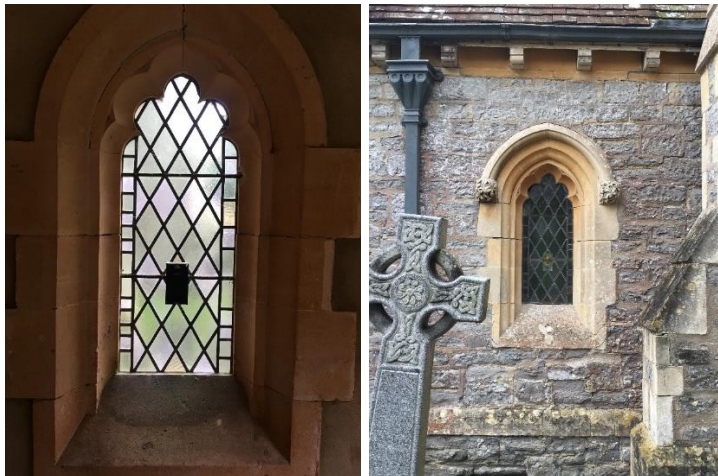
Window sVI

These two small windows are glazed in diamond quarries in double rolled textured glass. (Lights each 15 x 38 inches). 3/8-inch flat section lead in reasonable order.

There is one small in situ repair to carry out in window to sVI upper right. The pointing to both windows is in poor order, it should be carefully raked out, the stonework saturated and re-pointing carried out in lime mortar.

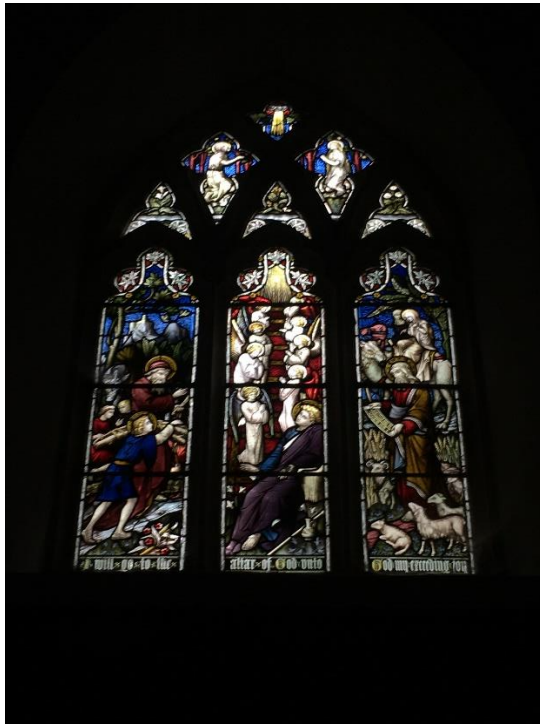
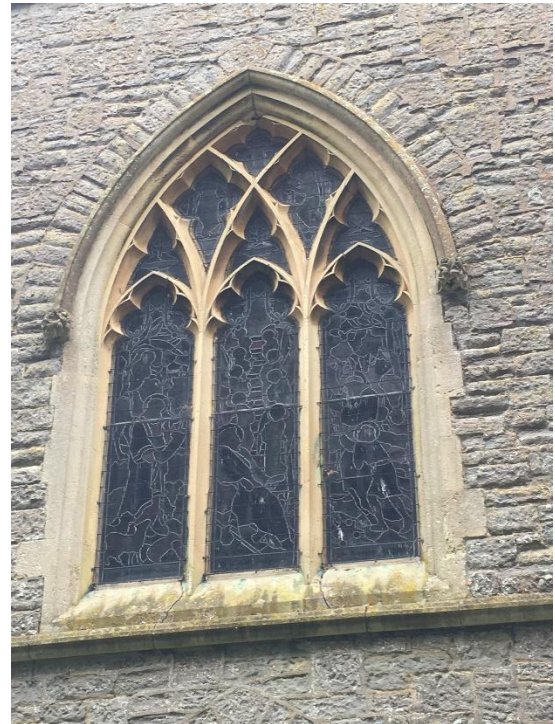
## Window WI (West)

The glass and painted detail appear to be in good order. The tie bars are rusting and spalling the stone work. There is significant movement in the stone work. Which has both compressed some areas, but stretched others, where lead has clearly pulled away from the glass. The condition is poor, but the extent of necessary works is impossible to detail until access is provided, and to some extent when the glass is removed.

The window will need to be removed to allow necessary work to stone work. New non ferrous tie bars will be required. There will need to be some re-leading. The architect has suggested that the scale of this be reflected in alternative costings for total re-leading, and 50%, and 30% re-leading.

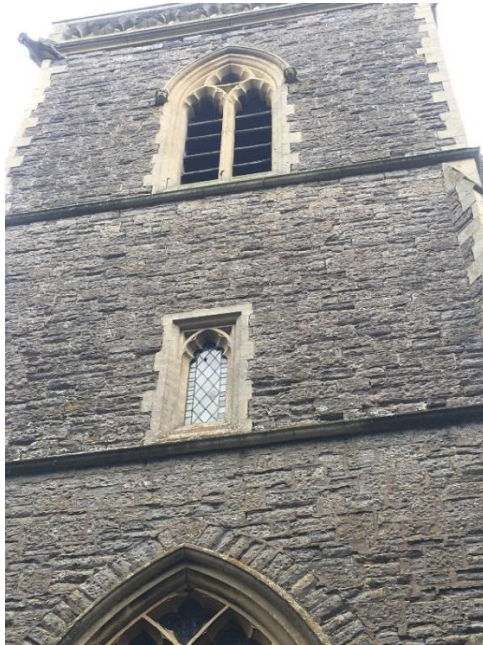
### Tower West

A dilapidated leaded light, which will require removal for re-leading as access becomes available.

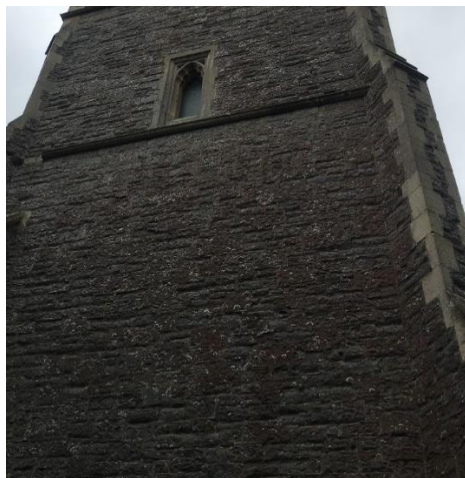
### Tower North

The diamond quarry glazing to this window has fallen out, and is stored at the church in collapsed condition. It will require templating, re cutting of 80% of glass in similar tints of cylinder glass, re-leading and re fitting in to the church with two new non-ferrous tie bars, set into lime mortar.

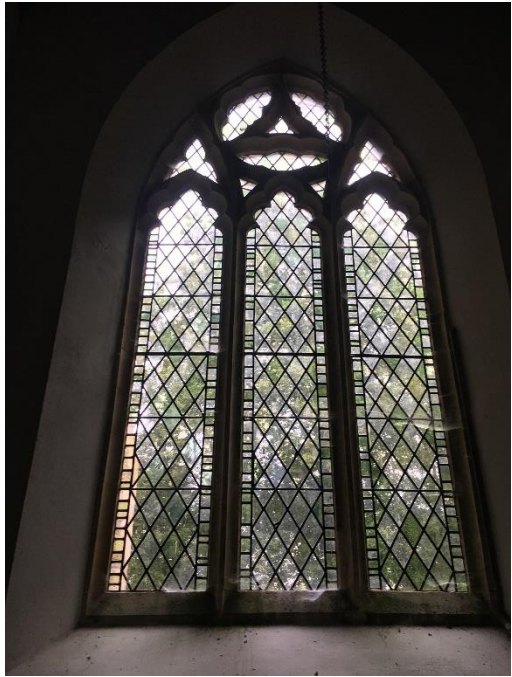
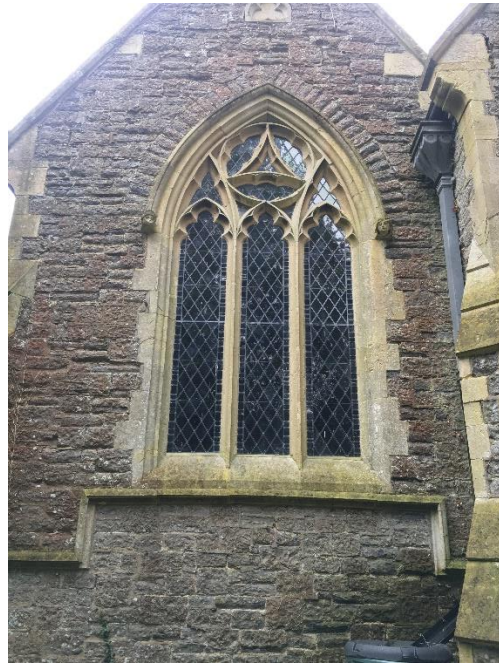
The north aisle glazing is all similar, with diamond quarry pattern in cylinder glass of several greenish tints. The glass appears to be very thin, and is of the type often called 'Nailsea Glass'. Window nVII has been re-leaded in recent years, and has new non-ferrous tie bars. The window is dirty and has heavy algal growth on the internal face, but is essentially in good order and requires only in-situ cleaning.

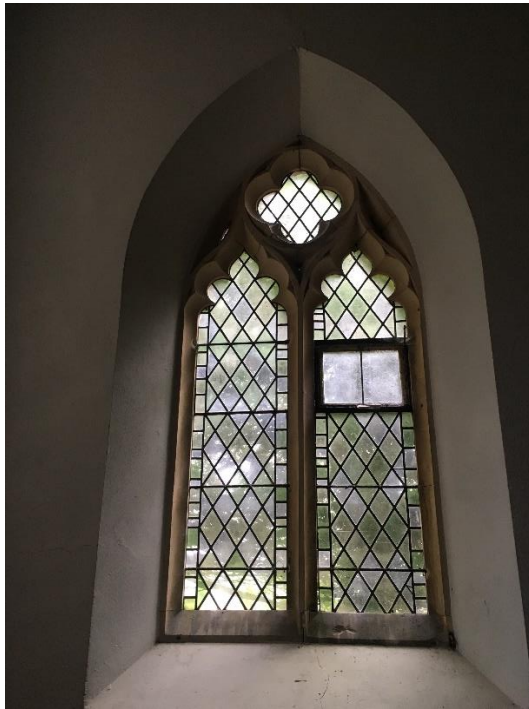
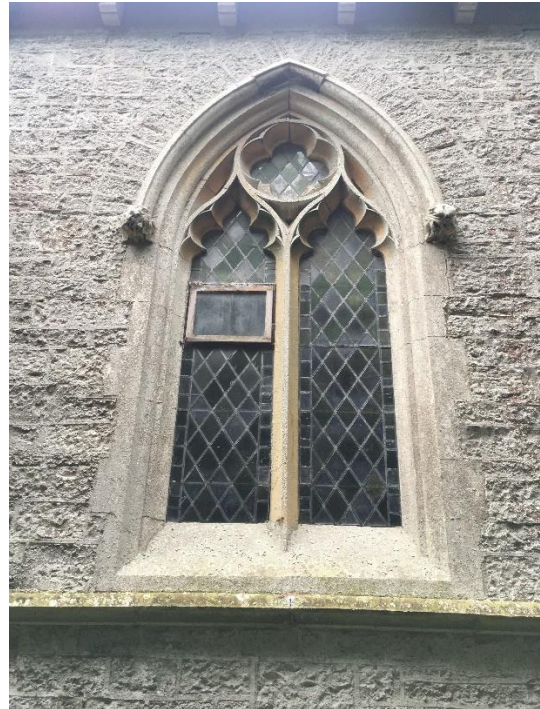
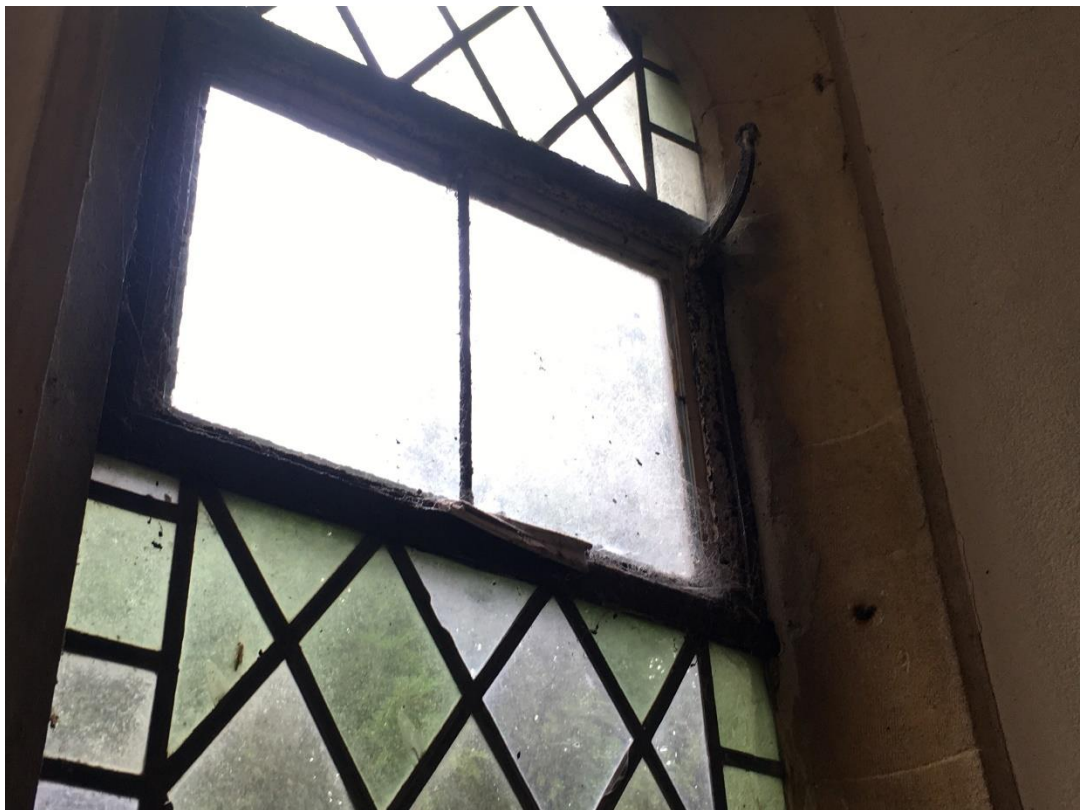
Window nVI

Windows nVI, nV, and nIV have a similar layout, with two lights and a single quatrefoil tracery. There is one cord operated opening casement below the springing line in each window. The casement panel to window nVI is missing and boarded up. These windows are in dilapidated condition, the tie bars are rusting, expanding and damaging the stonework throughout, the lead work is bowed and weakened, with obvious signs of water ingress. All of the casements are defunct- heavily rusted and missing catches.

Remove all glazing. Dismantle, clean, retain all original glass, re-lead in profile matching original section. Provide new non-ferrous tie bars.

Design and manufacture new non-ferrous opening casements. Re fix into lime mortar.

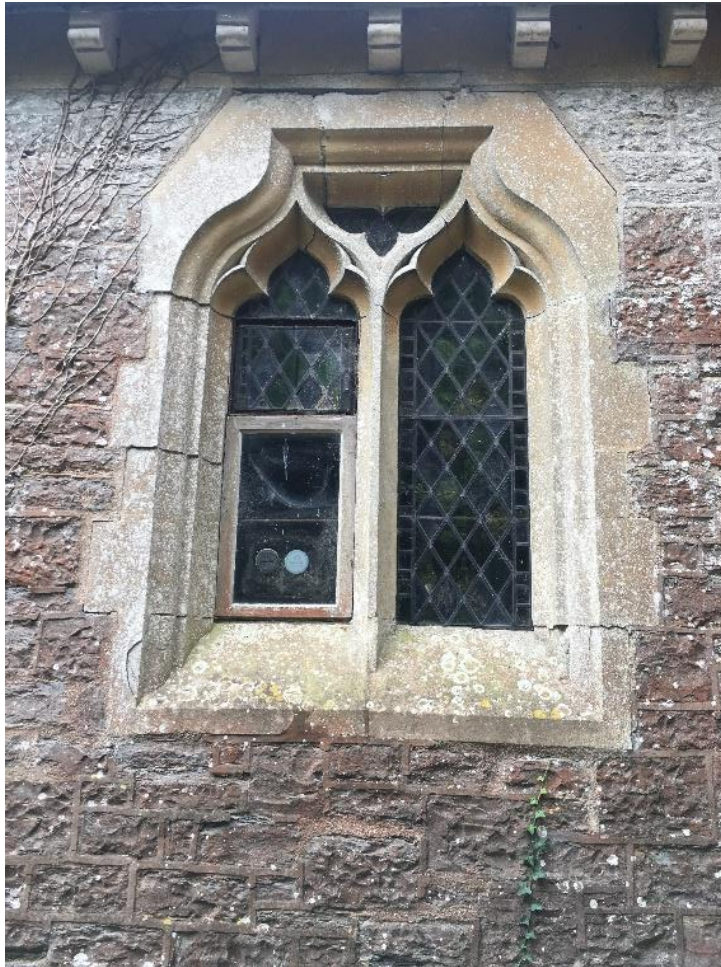
### Window nIII

Vestry window. A wooden casement frame has been installed to the right-hand light in recent years. The remainder of the window is in similar condition to the north aisle windows, dirty and dilapidated, with tie bars spalling stone work. Removal, cleaning and re-leading is necessary.

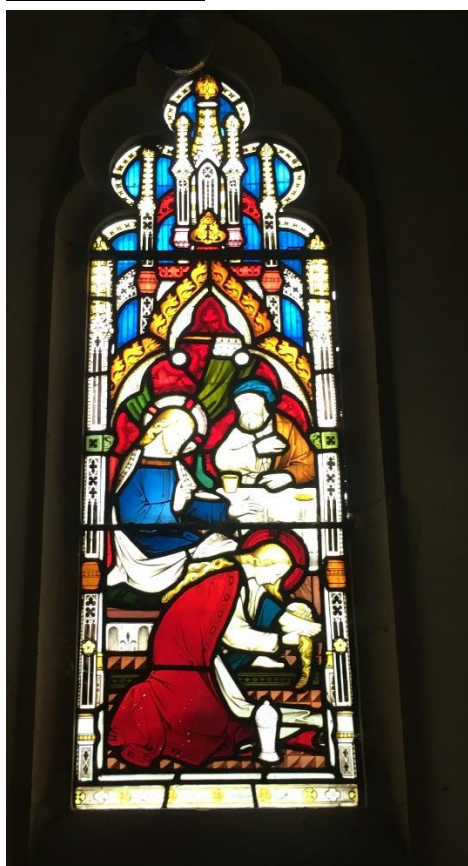
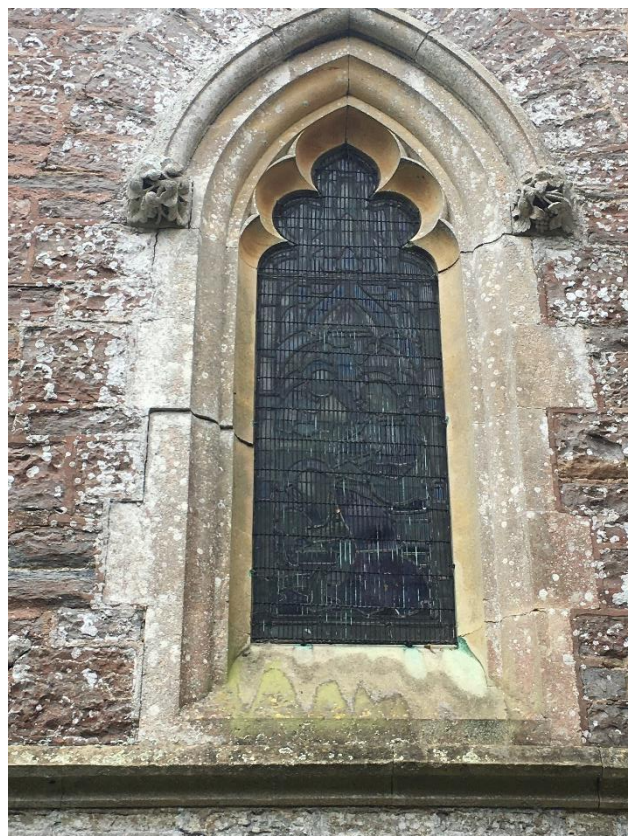
## Window n11

The glass is good quality, with no deterioration. The painted detail is well fired, apart from the floral border at the base, which has some paint loss, probably due to under firing. The lead work (1/4-inch round section) is in good order. There are two ferrous tie bars (1/2 inch round section) which are rusting and spalling the stone work. The perimeter pointing upper right is falling away showing daylight. There is pronounced movement of the stone work which may require removal of the window, but this is not projected at the moment.

Careful in situ cleaning by a glass specialist, and in-situ replacement of tie bars with non-ferrous metal of a similar section. Carefully rake away perimeter pointing locally, saturate stone work and re point in lime mortar.

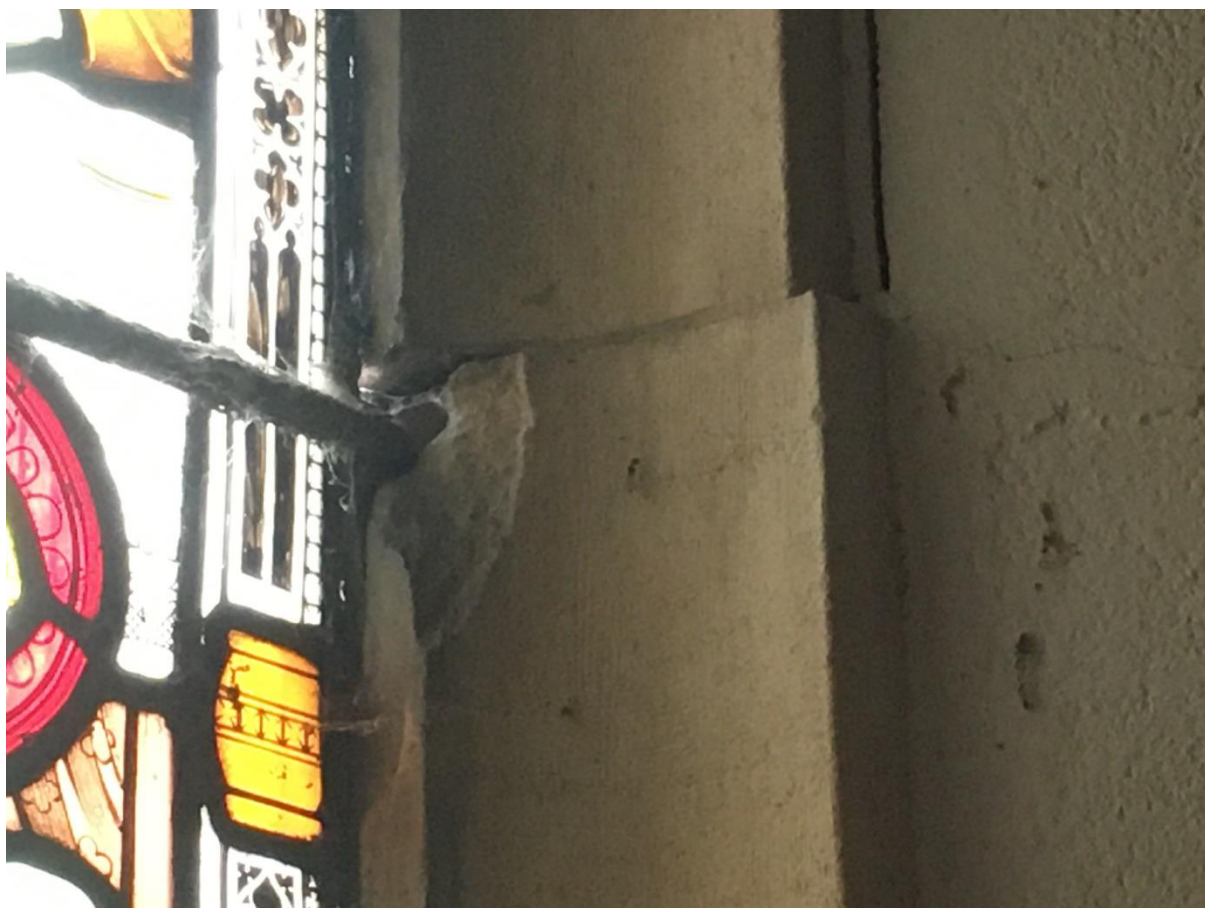
Expanding tie bar spalling stone work. It is likely that the misalignment of the jamb is due to other factors.
