# **CHURCH OF ST MARY MAGDALENE, STOCKLAND BRISTOL, BRIDGWATER, SOMERSET TA5 2PZ**

## **Report on the Archaeological Monitoring & Recording of Structural Engineering, Trial Hole Excavations**

**OASIS Ref No: 2-531467**

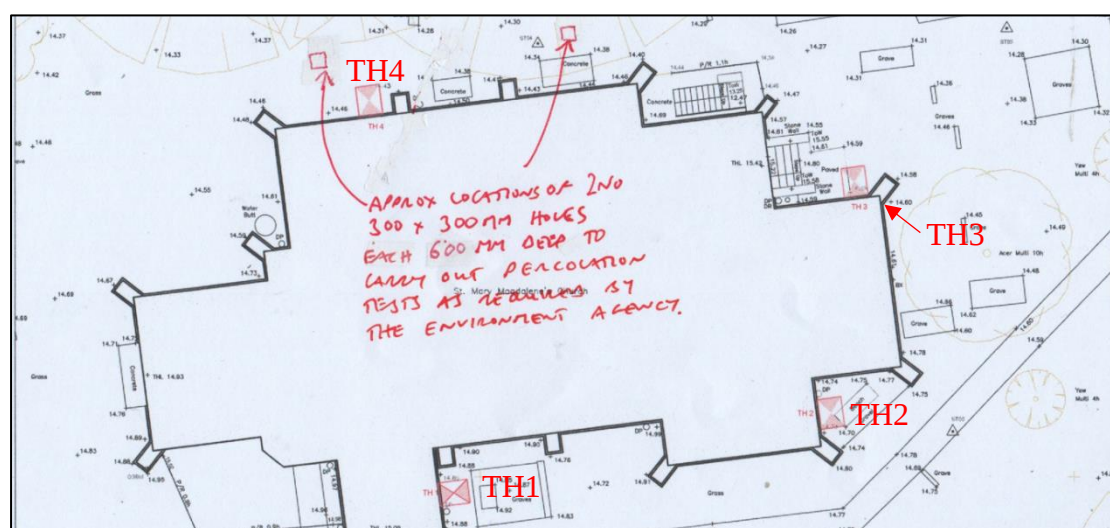
**Figure 1.** Trial Hole Locations (after Mann Williams Structural Engineers).

The trial holes were prefixed with the code TH for ease of recording. TH1 was located on the east side of the south porch, TH2 at the east end of the church, south side, TH3 had to be relocated to the south side of the buttress on the northeast corner of the church due to a Ledger/Memorial stone being in the location envisaged for this hole and TH4 was located on the west side of a buttress on the north side of the church. The two percolation test holes were both located in the churchyard on the north side of the church

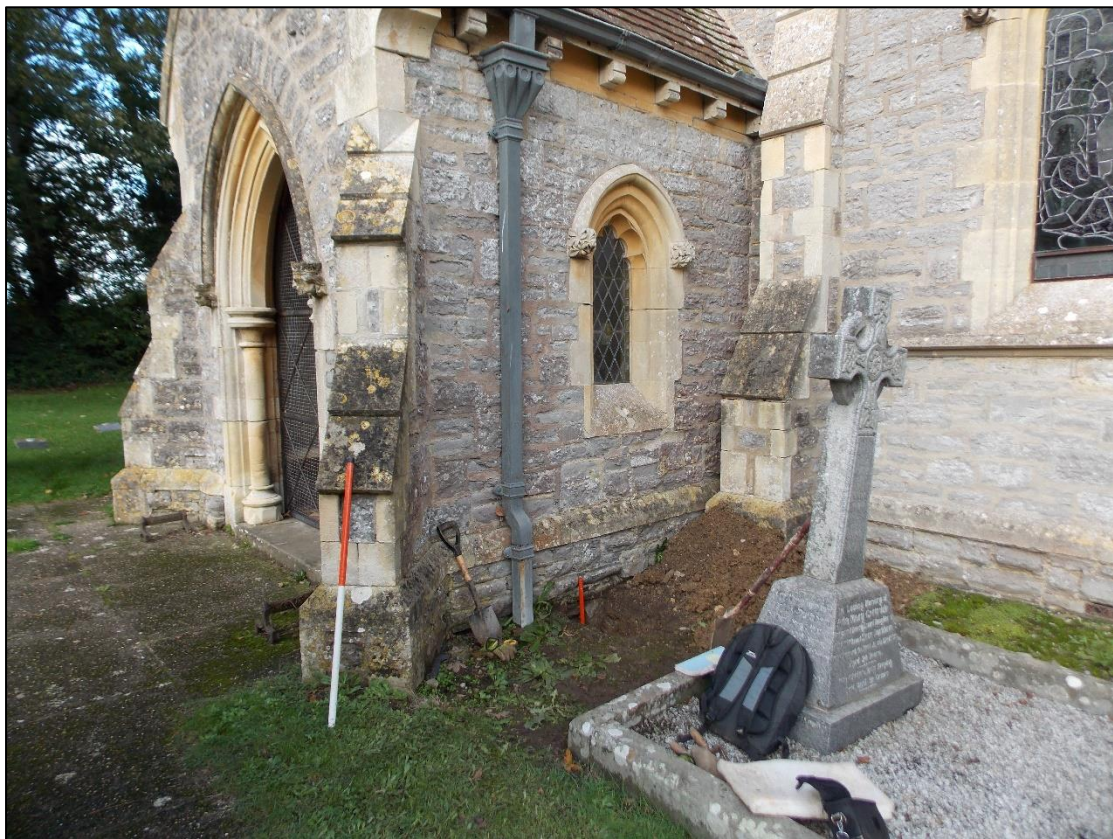
**Figure 2.** TH1 Location: facing NW.

TH1 was 400mm long N-S x 550mm wide E-W and up to 850mm deep and located on the east side of the south porch (Fig. 2). The general stratigraphy comprised 100mm of dark brown garden soil on top of mid brown silty clay containing frequent roof slate fragments, lumps and flecks of lime mortar, charcoal flecks and lumps, occasional small lumps of angular Lias Stone and human bone fragments.

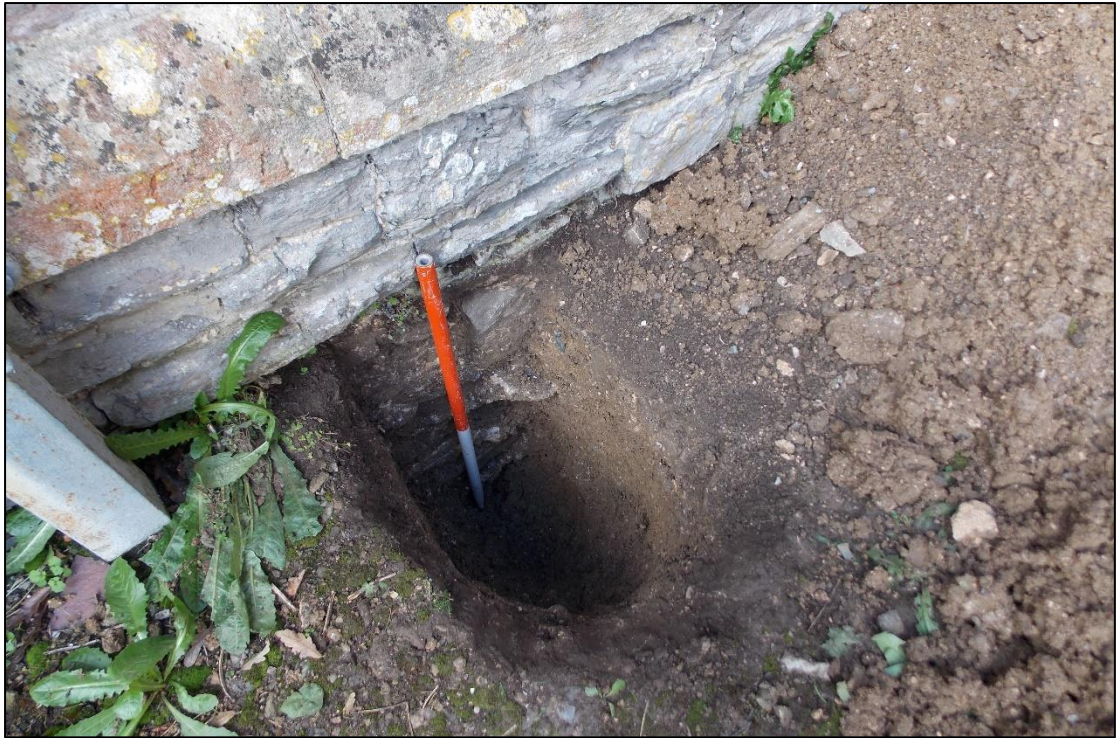
**Figure 3.** TH1: facing NW, 1m scale.

Vertical Lias Stone foundations were observed to the base of the excavation, generally bonded with clay with occasional joints of hard ashy cement/concrete and lime mortar (Fig. 3).

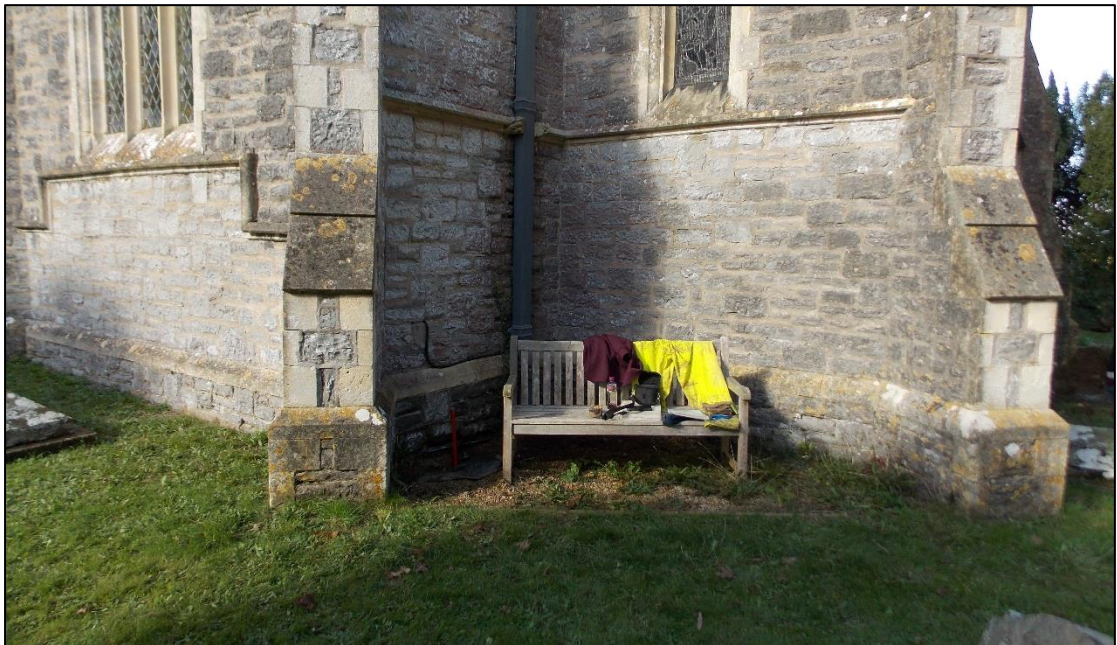
**Figure 4.** TH2 Location: facing NW.

TH2 was 400m long E-W x 500mm wide N-S and up to 750mm deep, south side of east end of church (Fig. 4). This hole comprised of 50mm of modern gravels and membrane on top of similar mid brown silty clay deposit as recorded in TH1. Occasional human bone fragments and a single sherd of 18<sup>th</sup> or 19<sup>th</sup> Century pottery was also recovered from this clay deposit.

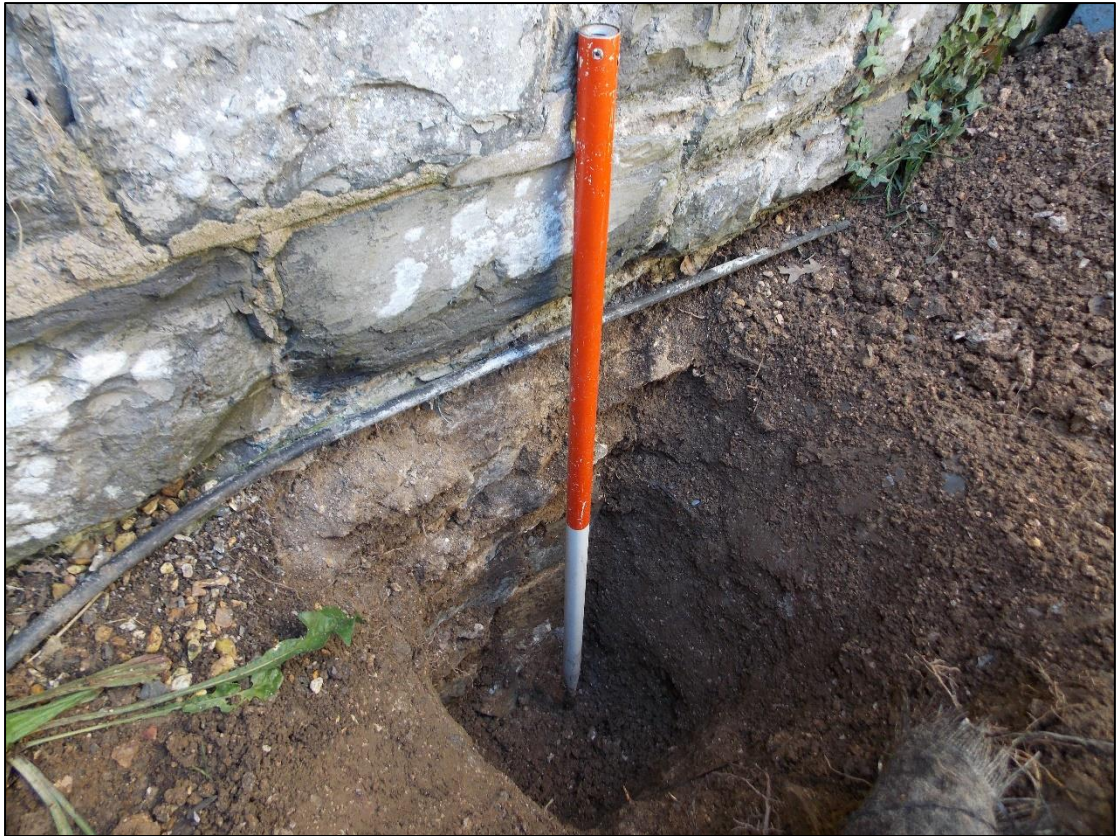
**Figure 5.** TH2: facing NW, 1m scale.

Similar Lias Stone foundations were also revealed in this hole and again bonded with clay and the hard ashy cement/concrete and lime mortar (Fig. 5).

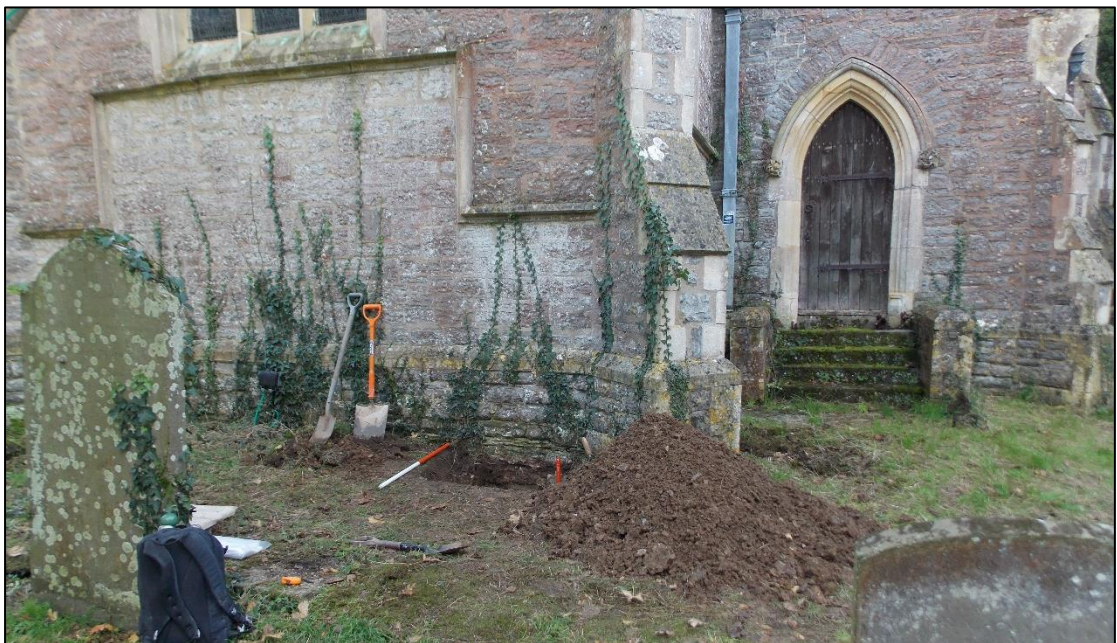
**Figure 6.** TH3 Location: facing W.

TH3 was located on the northeast corner of the church (Fig. 6) and was 900mm long N-S x 600mm wide E-W and up to 1m deep. The stratigraphy comprised of 150mm of topsoil above similar brown silty clay as observed in TH1 and TH2 but contained frequent human bone fragments, occasional brick fragments and sherds of 18<sup>th</sup>/19<sup>th</sup> Century glazed earthenware's. A possible in-situ burial was also revealed at the north end of this hole at a depth of 1m.

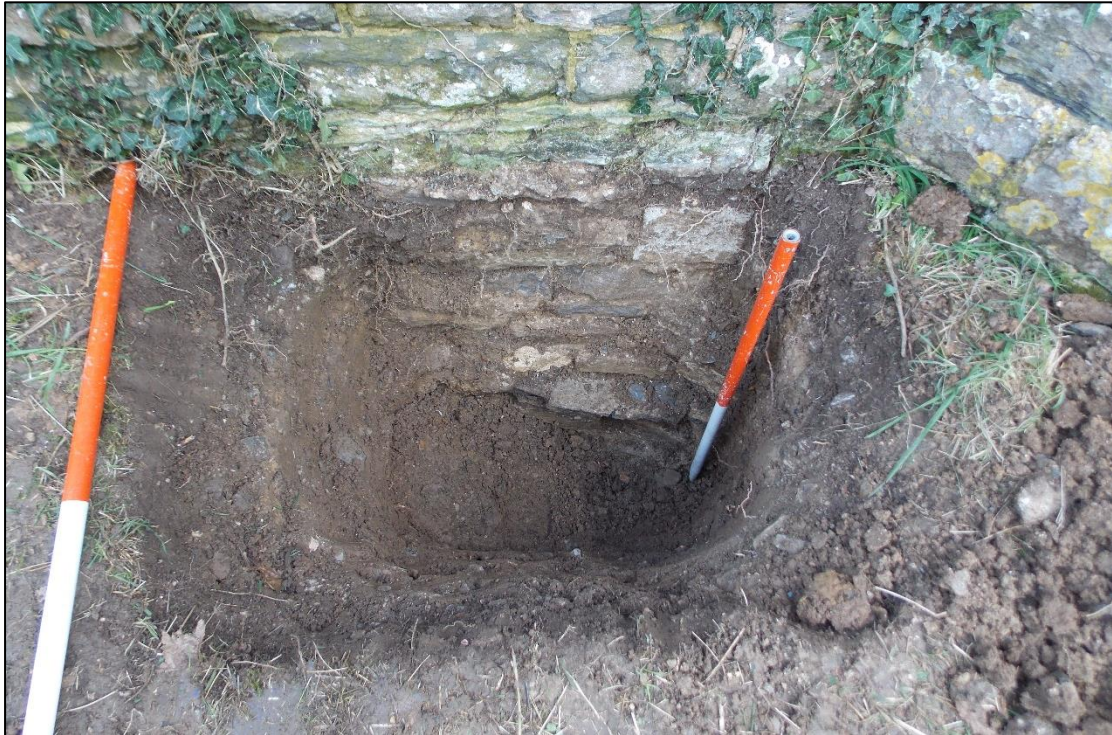
**Figure 7.** TH3: facing W, 1m scales.

Vertical Lias Stone foundations were revealed again in this hole, but they were then offset up to 100mm at a depth of 650mm to form the buttress foundation at the north end of this area (Fig. 7). Only clay bonding was observed within these foundations.

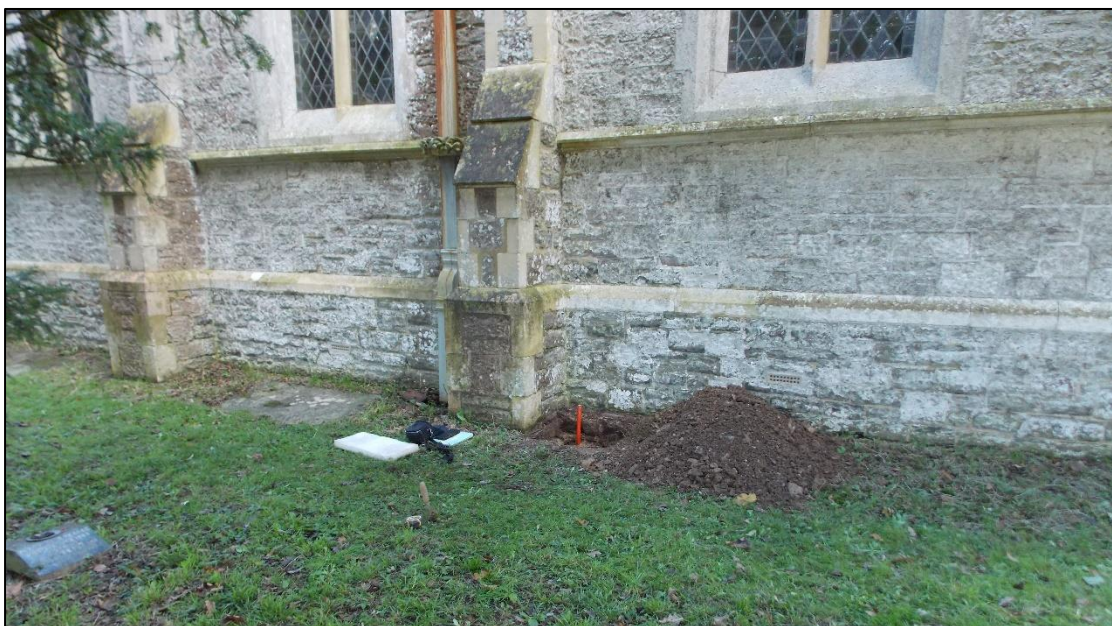
**Figure 8.** TH4 Location: facing SE.

TH4 was located on the north side of the church, west end (Fig. 8) and was 600mm long E-W x 500mm wide N-S and up to 900mm deep. Again a similar clay deposit as seen in TH1, TH2 and TH3 was revealed, containing occasional human bone fragments, a single 18<sup>th</sup>/19<sup>th</sup> Century glazed earthenware sherd and clay tile/drainage pipe fragments.

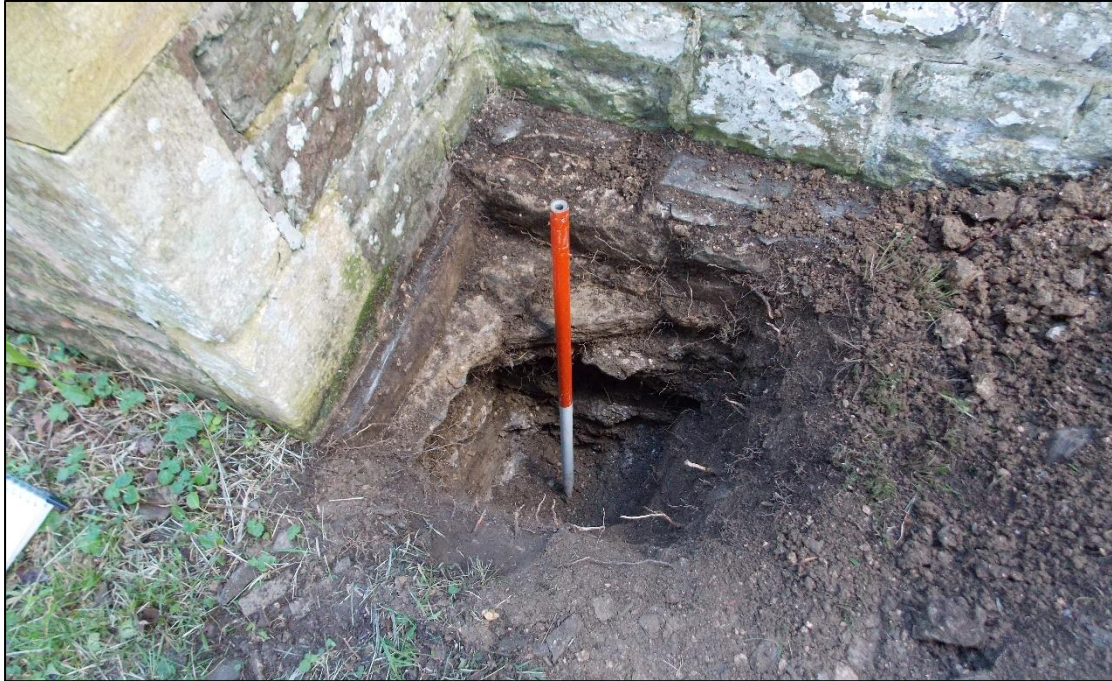
**Figure 9.** TH4: facing S, 1m scale.

The foundations were offset up to 140mm northwards at ground level and the exposed below ground foundations were again vertical as were the buttress foundations. At a depth of 160mm a single 60mm thick Lias Stone block and a bed of lime mortar and slate had been placed on an angle to tie in the church wall and the buttress? (Fig. 9). Clay and hard ashy cement mortar were again observed within these foundations.

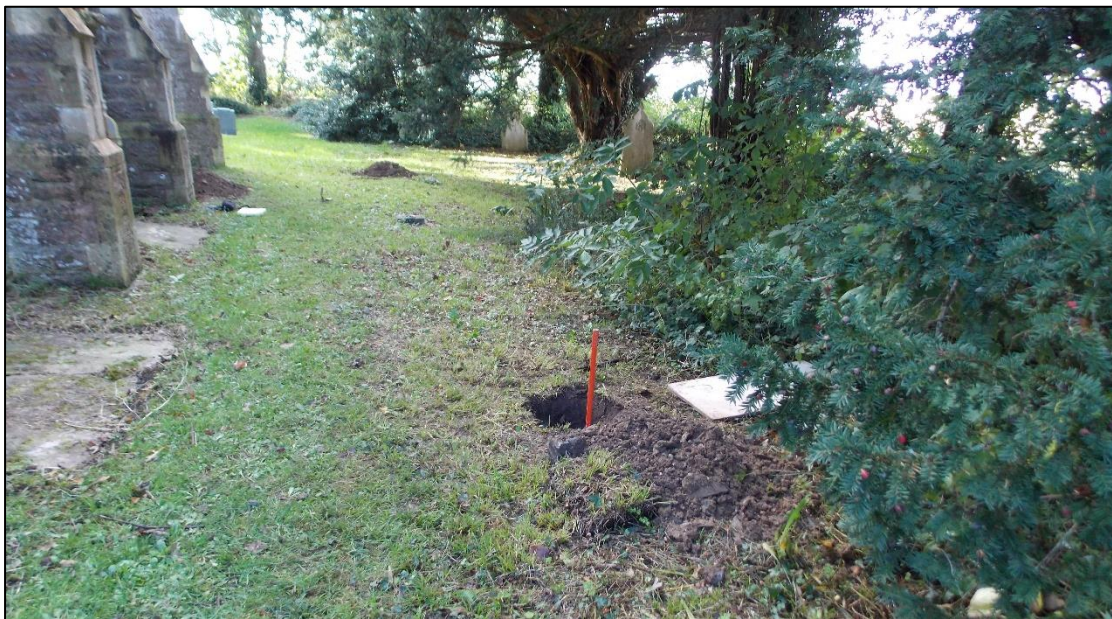
**Figure 10.** Percolation test holes location: facing W.

The two percolation holes were 400mm square x 600mm deep and were located 9.3m apart and 2.6m north of the church (Fig. 10). Both comprised of 200mm of topsoil on top of mid brown silty clay with occasional Lias Stone rubble (Figs. 11 & 12) no human bone was found within these holes.
