# St Mary Magdalene Stockland Bristol

## Preliminary Report on Structural Condition

Project Number: 10166

Date: Feb 2020

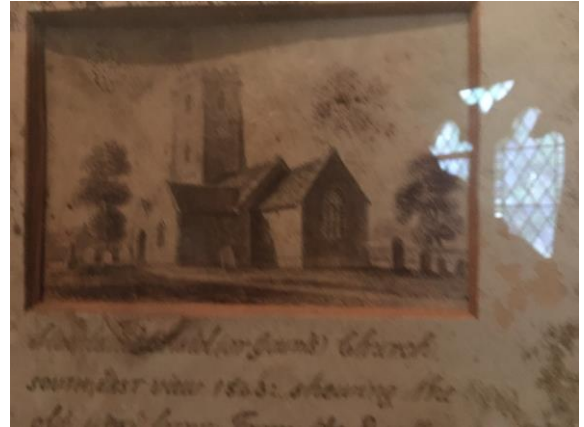
2.3 The church was built in 1865 and replaced a medieval church which stood on the same site, it is understood. An image in the vestry shows the form of the medieval church. It can be seen that

- The vice turret was originally on the NE corner of the tower
- The porch was larger and integrated with the south transept
- The chancel appears to have extended less to the east than the present form.

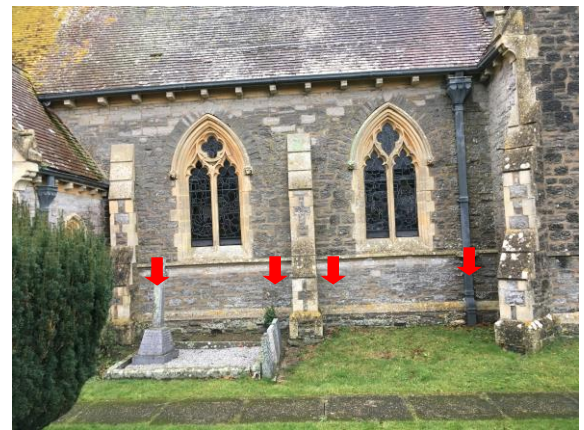
2.4 From an engineering point of view, it is quite striking how the Bath stone string course running around the elevations appears to dip around the window openings. This effect is generally seen on old buildings where there has been some degree of foundation movement, allowing the more heavily loaded panels of masonry to settle relative to the lightly loaded windows.

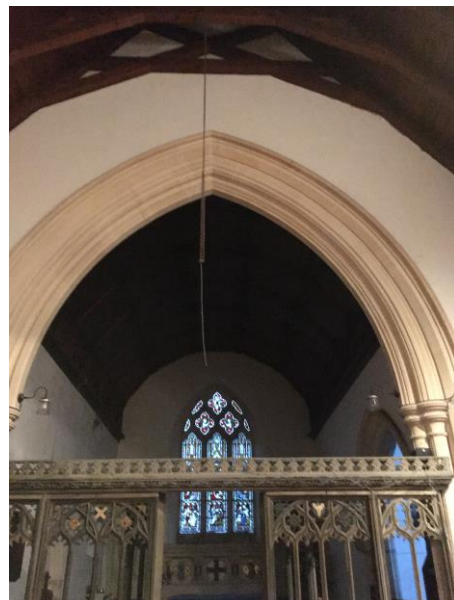
2.5 However, the church does not appear to have suffered from subsidence of the foundations to any significant degree.

For instance, the chancel arch, often in churches showing signs of distress due to movement in the walls on either side, is in excellent condition with no evidence of subsidence related distortion.

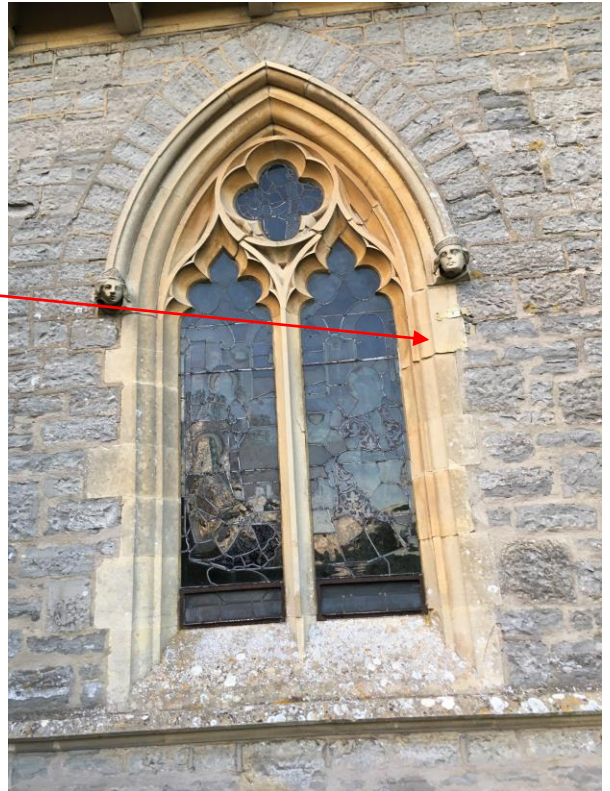
- 2.6 Apart from the wavy lines of the string course noted in para 2.4, significant dislocations of the Bath stone relative to the rubble lias can be seen in many areas.

This image is of the nave south window nearest the porch. Here the tracery has cracked and been displaced, and a jamb stone has been pushed outwards out of position.

A Perspex tell tale has been affixed by others in the past to record ongoing movement here.

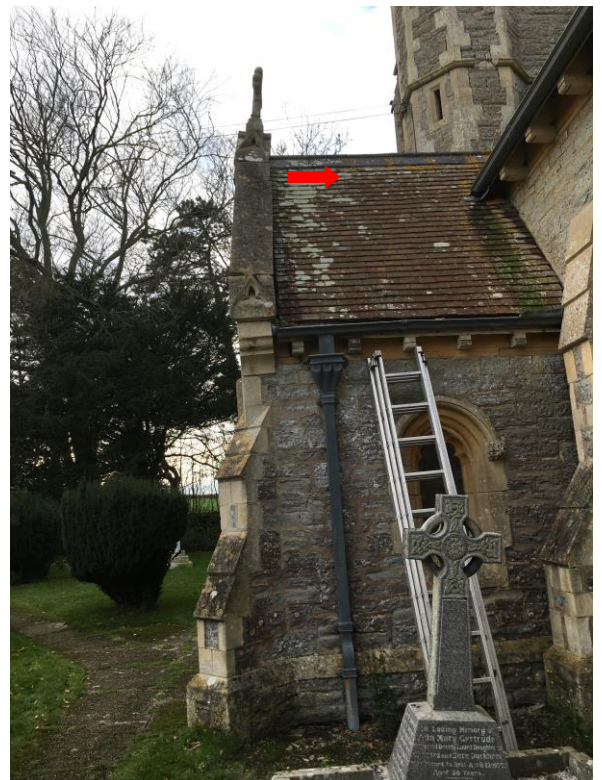
- 2.7 In the adjacent porch, movement in the front wall has caused the gable to lean inwards quite substantially.

- Heaving of the external face of exposed gables, causing the gable to lean inwards, destabilising the copings and finials
  - The “stretch marks” and associated cracks in the nave south wall, and in the vestry.

- Cintec tying of bulging outer faces of lias on the porch and vestry gables

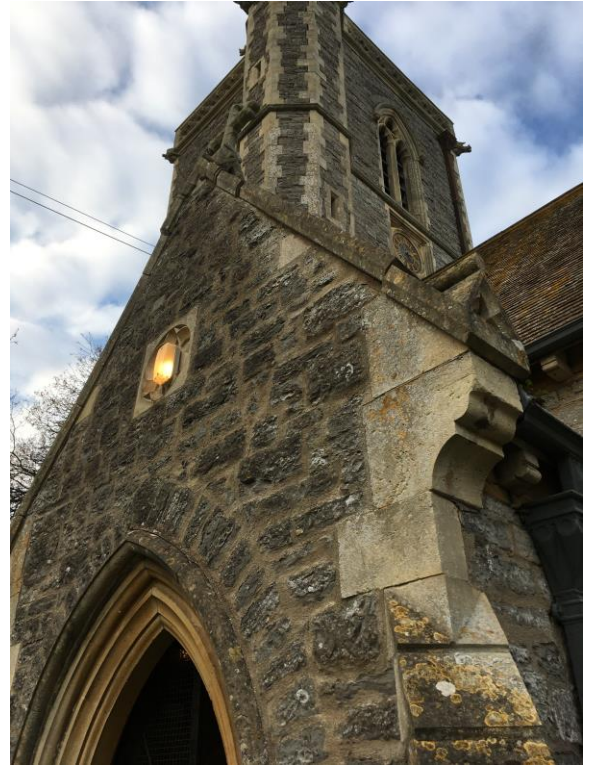
- 2.8 The structural movement has dislodged and displaced the stone copings.

- Repointing and localised stone repairs to the tower
  - Taking off and repositioning all copings on the gables
  - Repointing of all cracks internally and externally, using helifix bars as appropriate

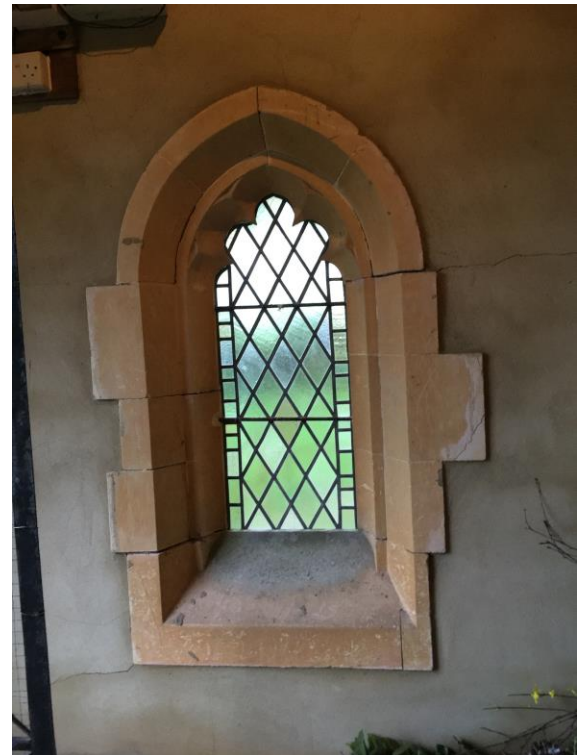
- 2.9 In the Bath stone surrounds to the porch windows, and in the stone doorway surround, significant dislocations are evident.

A metal detector was used to seek for signs of embedded ironwork in these areas. These were often used in the 19C to pin back freestone to the backing rubble.

In the porch and other readily accessible areas, no evidence of the general use of iron cramps or ties was found.

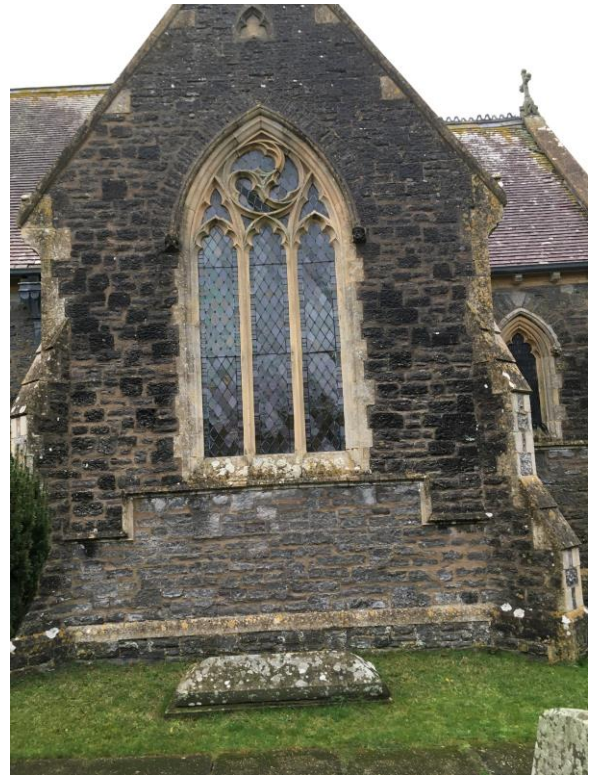
- 2.10 Lower areas of lias have been repointed in recent years. Some areas appear to be very clean and unweathered.

It would be useful to search the church record to see if any areas of lias have been replaced.

This image is of the south wall of the south transept. Again, the dip in the string course away from the window can be seen.

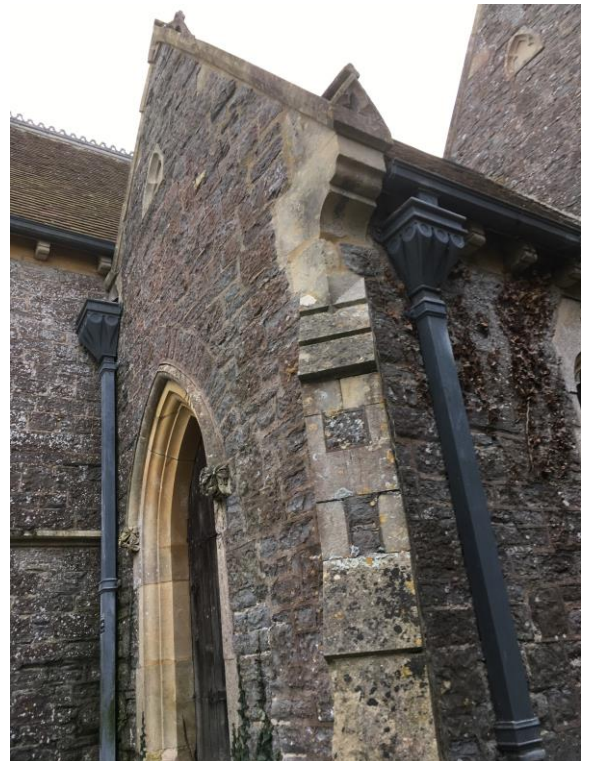
- 2.11 Another area of significant movement is in the vestry on the north side. Here can be seen the outer leaf of the gable bulging outwards and the top of the gable leaning inwards.

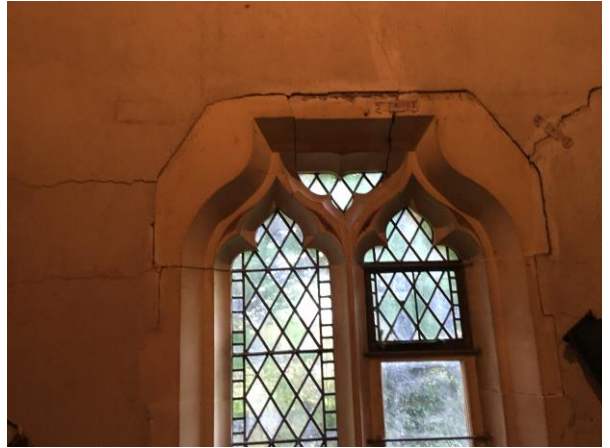
- 2.12 Within the vestry, the structural cracking is even more pronounced. There is much disruption around the window head, with Perspex tell tales affixed in the past to the worst cracks. These suggest a modest degree of movement since they were installed.

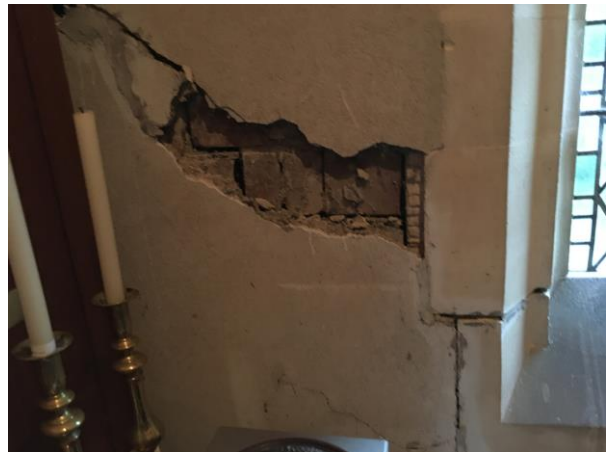
- 2.13 A small section of loose plaster on one of the cracks was removed to allow the wall construction to be seen. The vestry is apparently built of brickwork with an outer leaf of lias.

The boiler room is positioned beneath the vestry and accessed via an external set of steps. The vaulted ceiling of the boiler room is in good structural condition

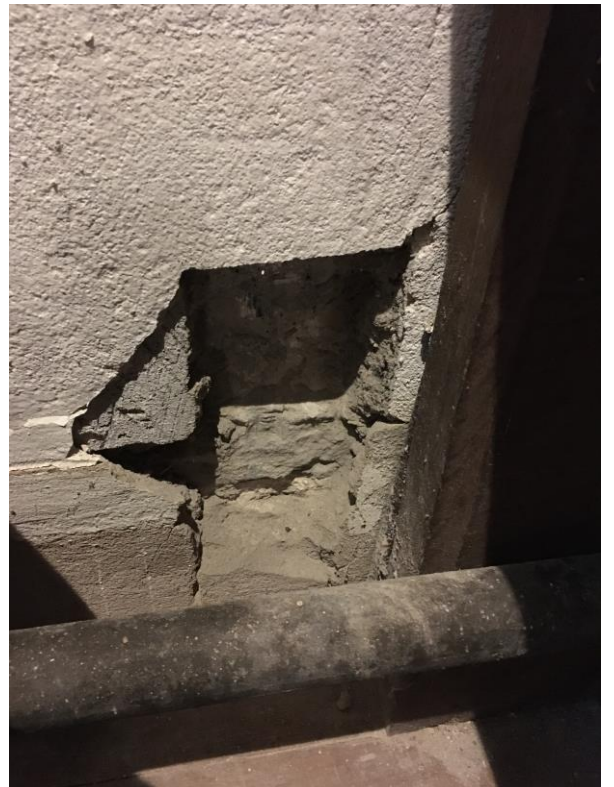
- 2.14 It was decided to remove a small section of plaster 100mm square from the north aisle wall to check the constructional form here. The walling was of lias internally in this instance.

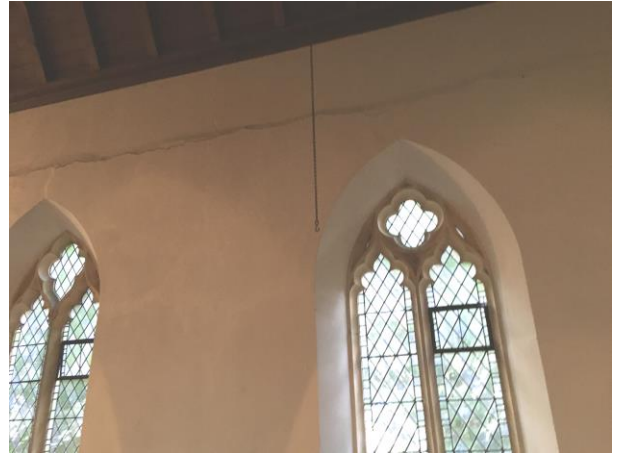
- 2.15 A ladder was used to check the constructional form at high level of the north aisle at the location of the longitudinal crack. The crack was found to mark the junction between masonry walling and a timber stud make up at the eaves. Although disfiguring the crack is not of structural significance.

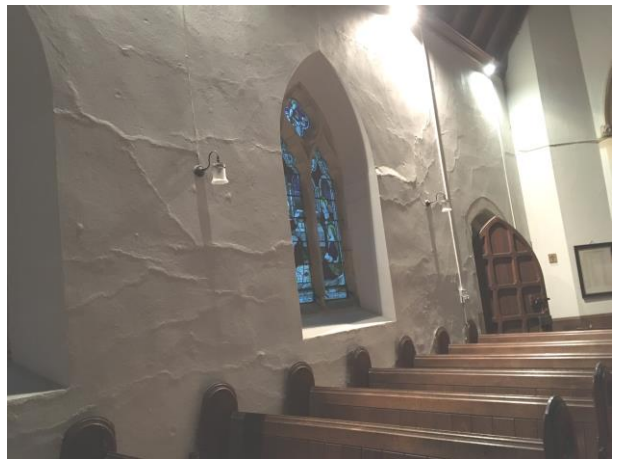
- 2.16 The south wall of the nave has “stretch marks” in the plaster in all locations. The nature and alignment of the cracks is not particularly suggestive of foundation movement but is likely to indicate an increase in height of the wall over time, with the cracks being periodically filled in and decorated.

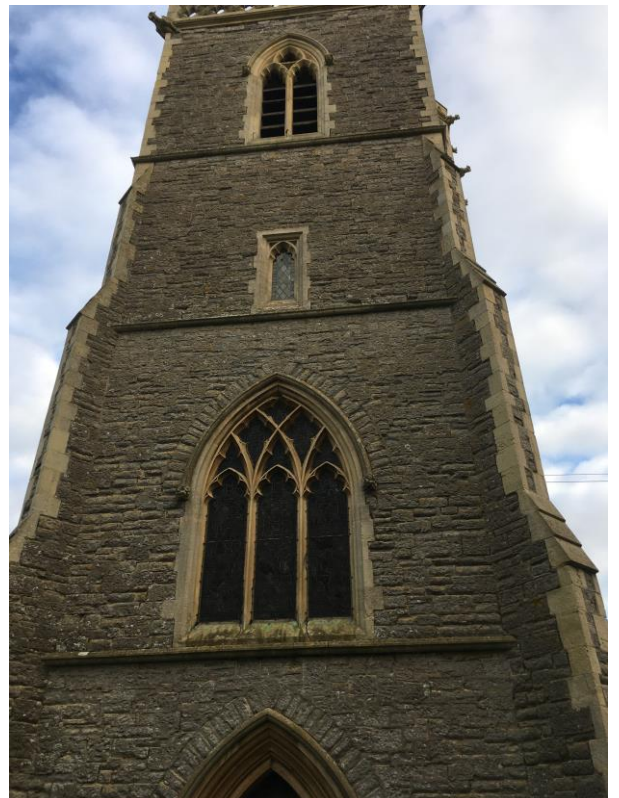
- 2.17 The tower is in a good condition from a global structural perspective i.e. it does not exhibit major distortions or bulges. Much of the Bath stone is in a good state with little in the way of major fractures. The lias has weathered in some areas and the whole tower would benefit from repointing in a lime mortar.

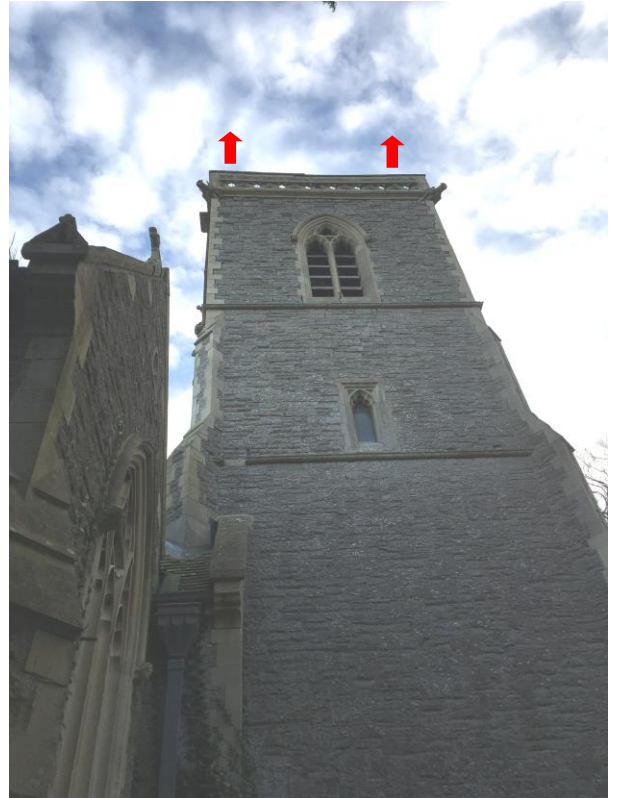
- 2.18 At high level on the north face of the tower, the parapet can be seen to project further outwards at the corners than the central section of this face.

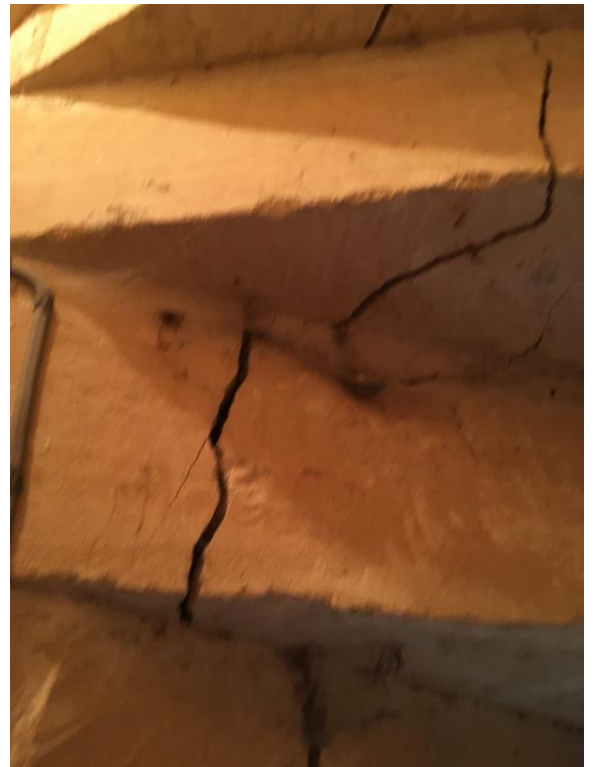
- 2.19 As the spiral stairs in the vice are ascended, there are some serious cracks in the Bath stone treads. These are up to 7/8mm wide.

It appears that the south part of the vice turret, which may bear on 1880's foundations rather than the original medieval ones, has settled relative to the main body of the church, causing this dislocation at the junction.

- Dismantle and repair say 25% of tower parapet
  - Pinning and structural repairs to say 6no treads at the lower levels in the vice
  - Pinning and structural repairs to doorway arch at the ringing chamber and the vertical cracks here and in the belfry

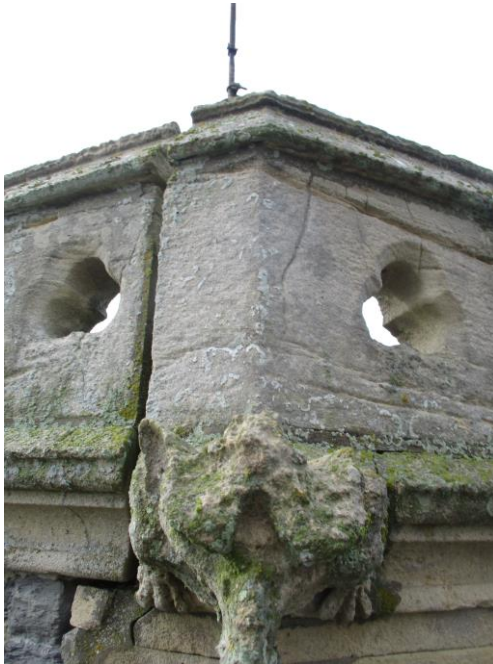
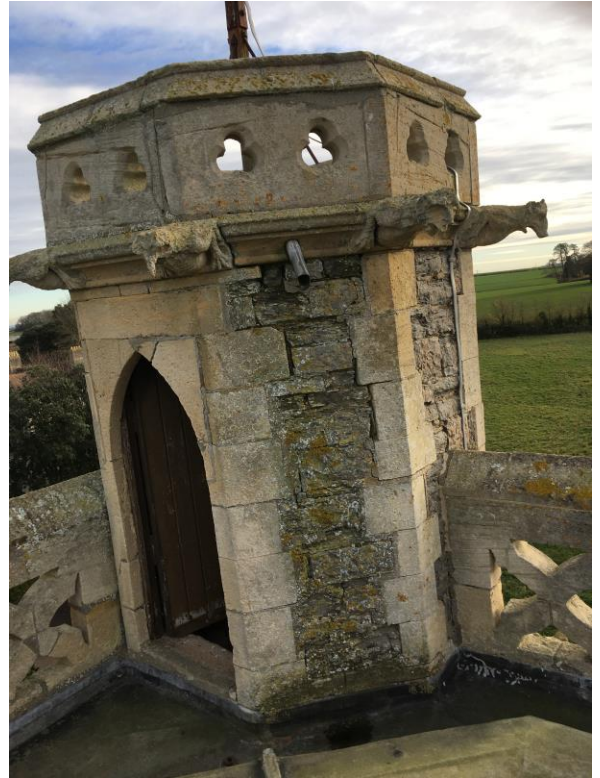
- 2.20 Exiting the small turret at the top of the vice, one is aware of movement throughout this little structure.

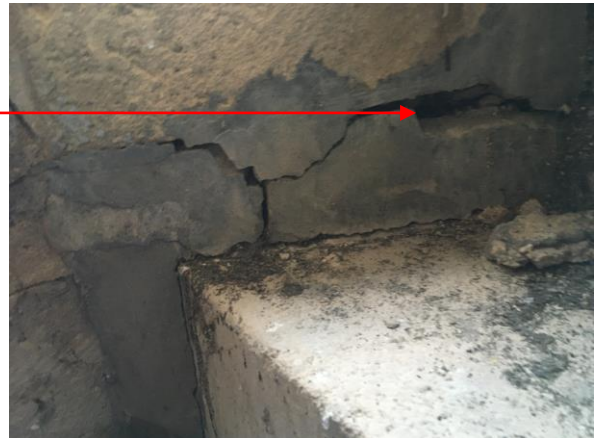
- 2.21 Removal of a piece of harsh cement repair mortar on the top step revealed an iron or early steel ring member running around the circumference of the tower.

This ferrous ring member has corroded badly and is jacking up the turret, causing much of the structural damage.

- Fully scaffold the church to gain access to high levels of all gables and the tower for repairs.
  - Take down and rebuild the top section of the vice turret above tower roof level and extract the iron ring beam. Replace/repair major damage to upper landing stone

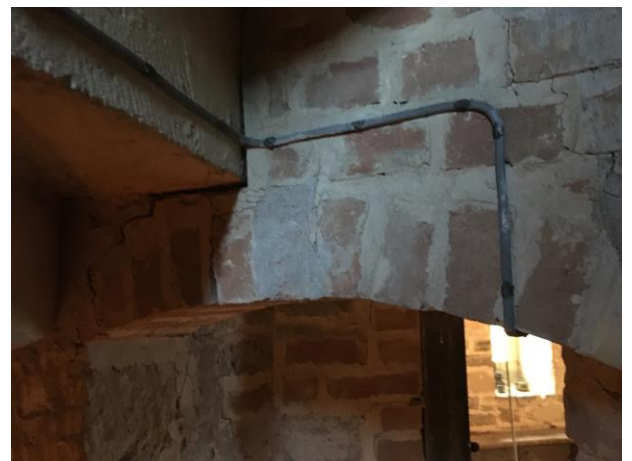
- 2.22 At the door entrance to the ringing chamber, movement in the vice has created a dislocation of the shallow brick arch over the door. This is potentially unsafe and needs pinning to avoid collapse of the arch.

The ringing chamber floor is covered in softwood boards. The condition of the supporting timber structure cannot be assessed without lifting of a number of these boards.

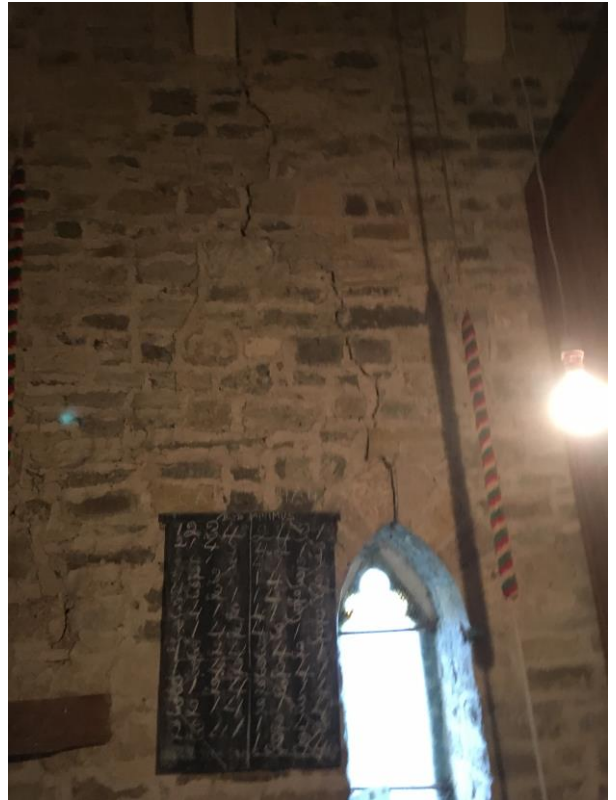
- 2.23 Other cracks in the tower appear to more in the way of ringing cracks caused most probably by swaying of the tower during bell ringing.

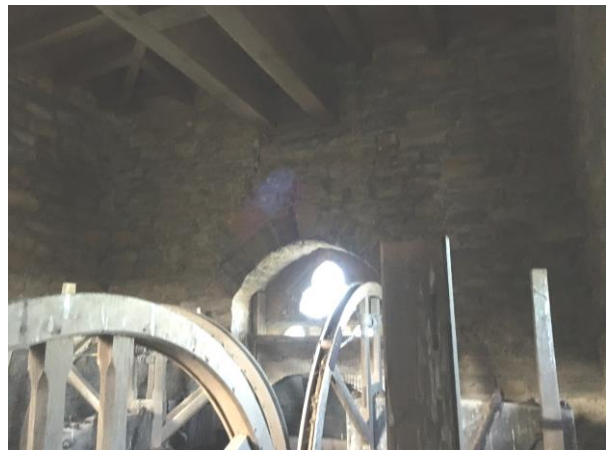
- 2.24 These cracks can be followed up though the belfry. They are not considered to warrant significant repairs such as the introduction of tie bars.

The roof support timbers are visible from the belfry. They appear in good condition visually, although a close inspection is not possible. The bell frames and supporting structure have not been examined at this stage.

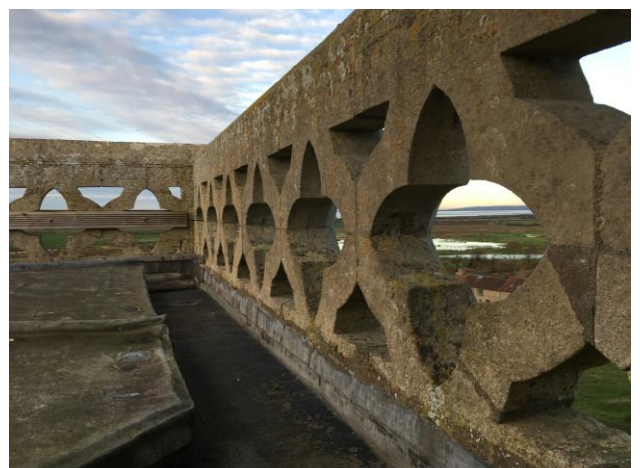
- 2.25 The pierced parapet has a chunky look to it and appears to be in a reasonable structural condition. Some of the sections of the quatrefoil piercings near the vice have broken into smaller fragments – possibly due to movement in the vice.

The north elevation of the parapet has been secured with stainless steel straps and longitudinal timber members -- presumably because of the distortion mentioned in para 2.18. It may have corroding ferrous fixings into the supporting stonework below.
