# St Mary Magdalene, Stockland Bristol

Addendum Report on the  
Condition of the  
Structural Fabric

Job Number: 10166

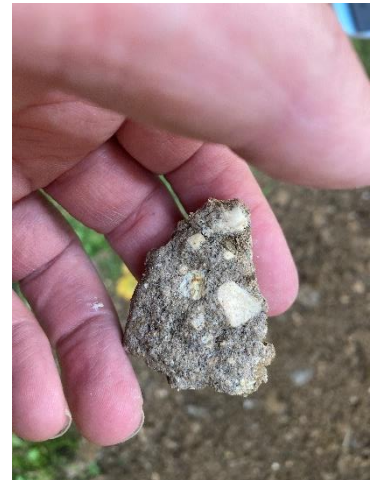
2.1.7 In all holes, the foundations comprised rubble lias stone in a hard lime mortar matrix which appeared to be of C19 origin. Keith Foxton confirmed in his opinion all exposed foundation walling in the holes were C19. All footings were in good condition, but in each hole, it was not possible to dig down to the underside because of the restricted hole size.

2.1.8 Tree roots were not in evidence in any of the holes near the foot of the holes. Shallow roots were visible in TH4.

2.1.9 All stonework in the walling below ground level was found to be in good condition, with no evidence of deterioration of the mortar or degradation by deleterious materials in the soil.

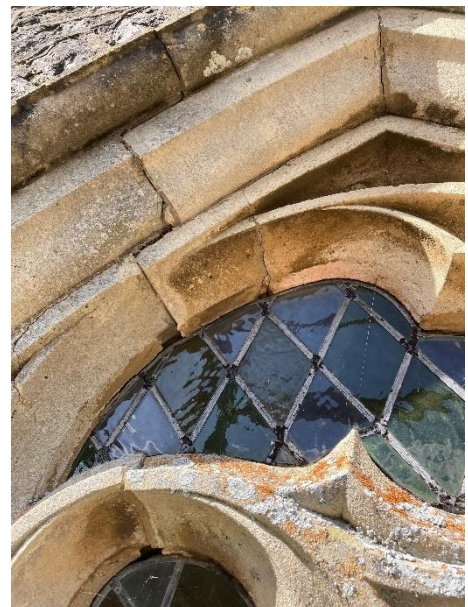
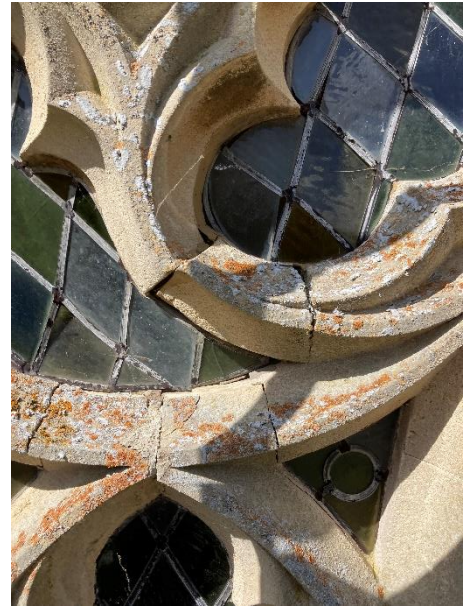
3.1.2 The Bath stone of the tracery and the voussoirs of the main pointed arches have been displaced – by up to 20 - 25mm.

- 3.1.3 The structural integrity of the tracery is not critical as regards the stability of the main window surrounds, the walling over and roof support, but it does figure significantly in restraining the glass from blowing out under strong winds.
- 3.1.4 It would be possible, if the glass was removed locally, to take out the slipped tracery stones and reset them, potentially using small diameter stainless pins. The risk involved with pinning is that should long term movement continue, then the pins could cause the tracery stones to fracture rather than become simply displaced.

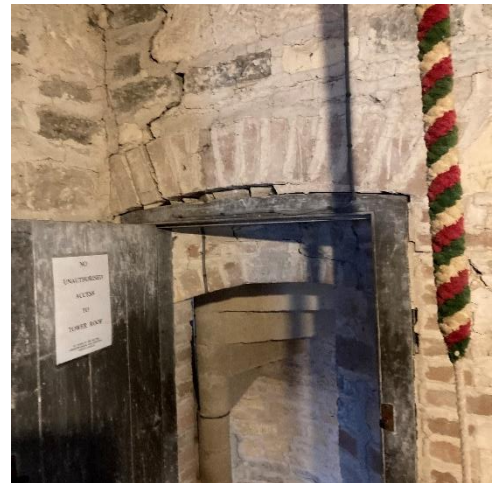
- 4.1.1 Marcus Chantrey has obtained 3 quotations and proposals for restoring the bell frames and bells to a condition where they could be rung again.
- 4.1.2 Two of the three tenderers have noted that in their opinion it was the structural condition of the tower that has prevented the bells from being rung since 1990, and not the bells or frames themselves.
- 4.1.3 Certainly, the long vertical crack on the north elevation emanating from the ringing chamber window looks like a crack caused by ringing, where the tower sways from side to side. Smaller cracks can be seen in the other elevations.
- 4.1.4 In the ringing chamber the south tower wall has become structurally detached from the east wall, causing the brick arched lintel over the door to drop.

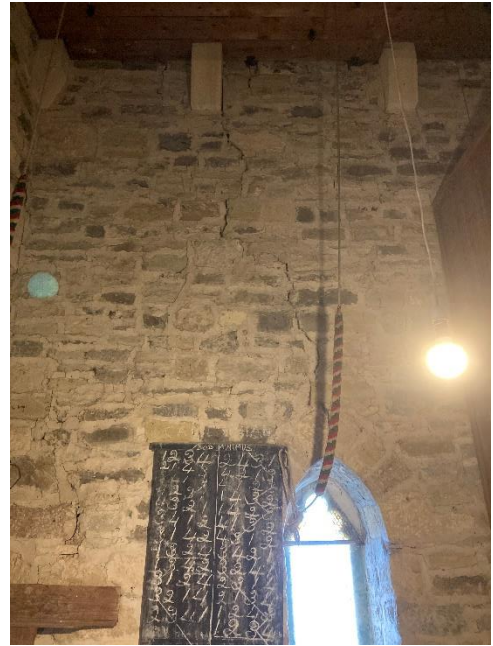
- 4.1.5 The bearings of the bell frames cannot be inspected because of the presence of the softwood boarded ceiling. It seems that the corbels visible under the ceiling are concrete ones, and a retrofit repair to improve the bearing of the frames in the external walls. Allowance should be made in the main contact tender documents for repairs to decayed frame bearings.

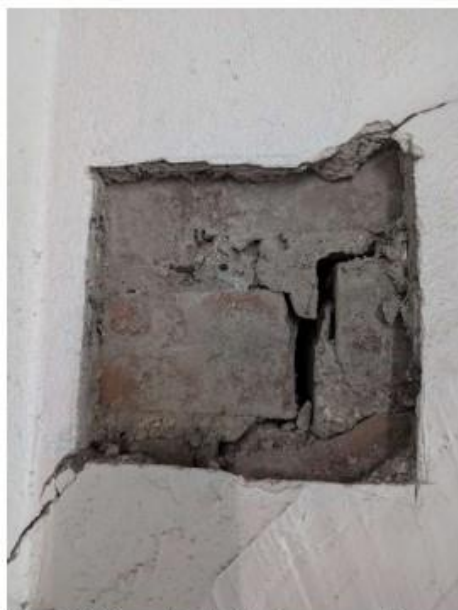
- 5.1.10 If the south transept is also examined, the SSHC opening up revealed opening up of the brick lining skin of wall, running in a diagonal fashion, typical of foundation movement.

Figure 18 Second coat of plaster removed to reveal the brick inner skin of the wall

5.1.17 The situation in the south transept is not so severe. In this instance we recommend that the inner leaf be tied back to the lias with resin bonded ties to ensure that the brickwork does not become detached as it has in the vestry.

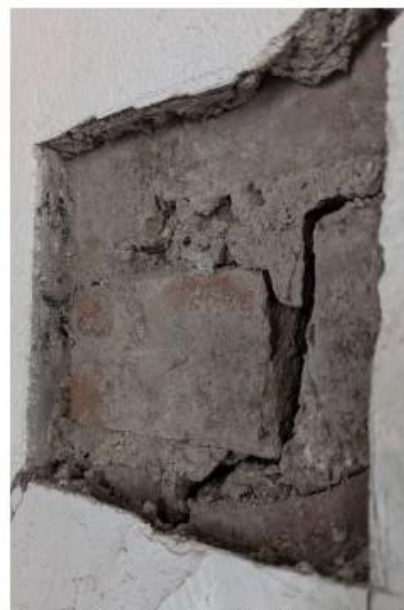
Figure 19 Detail of cracking through the joints of the brickwork

5.1.11 However, there is no matching crack on the external skin of lias, proving that foundation movement is not a significant factor, and that it is an interplay between the relatively dimensionally stable brickwork and the expanding lias that is creating the movement.

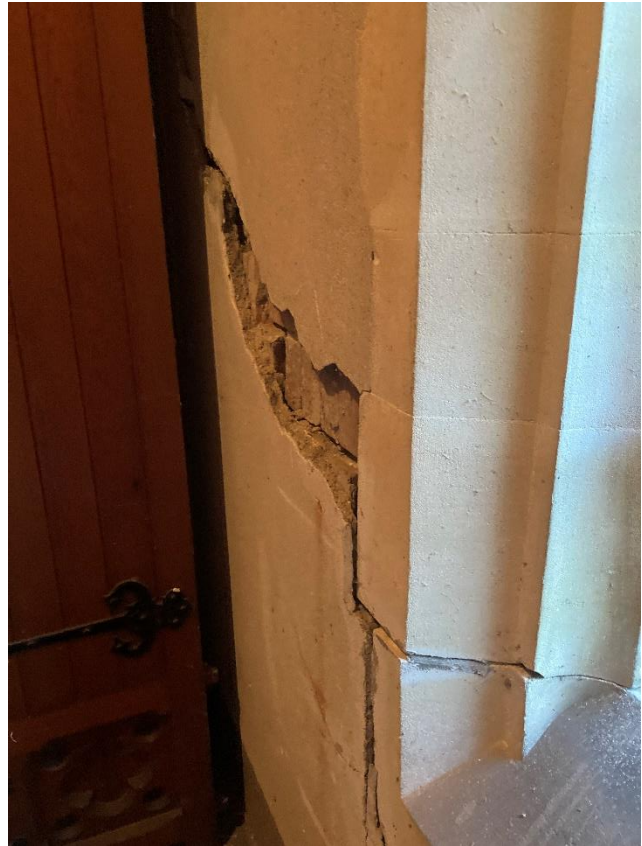
5.1.13 It can be safely concluded that foundation movement is not a significant factor in the extreme movements evident in the external fabric. It is breakdown and subsequent expansion of the blue lias which is causing the damage.

5.1.14 Where the two external stones were removed for inspection by SSHC, the core could be seen to be well compacted and with a reasonable quality of C19 mortar. It seems that there is a mechanism by which the external leaf of lias can expand without causing too much of a problem with the inner skin, where it is also lias. Some degree of relative movement can be seen via the “stretch marks” in the plaster of the nave and north aisle.

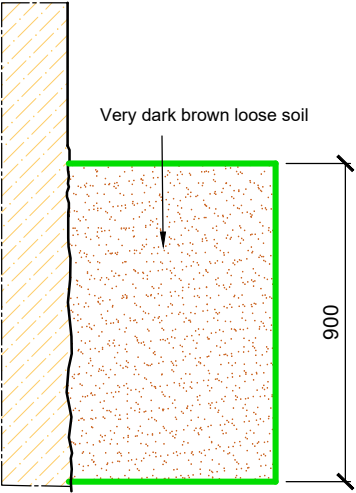
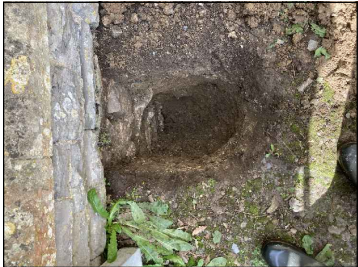
TH 1

IN ALL HOLES THE EXPOSED WALLING BELOW GROUND LEVEL WAS  
RANDOM RUBBLE LIAS IN A LIME MORTAR MATRIX. ALL WERE IN GOOD  
CONDITION WITH NO EVIDENCE OF CRACKING OR DECAY OF THE  
MORTAR.
