# ST MARY MAGDALENE, STOCKLAND BRISTOL

CONDITION REPORT  
Selected Masonry, Windows and Tower Parapet  
St Mary Magdalene Church, Stockland Bristol TA5 2PZ

Client: PCC of St Mary Magdalene Church, Stockland Bristol  
Job No. 3401  
August 2024

Masonry Survey and Mortar Analysis  
St Mary Magdalene Church, Stockland Bristol  
CONDITION REPORT

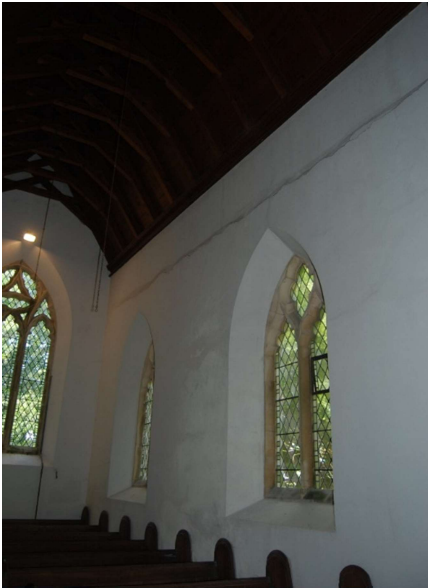
There is a significant lateral crack at upper level along both the south nave and the north aisle walls. The north aisle wall is discussed in the structural report on p.9 and is linked with movement at the interface between the masonry walling and timber stud makeup at the eaves; it is not considered to be of structural significance. The south wall of the nave has a similar lateral crack that causes the upper section of wall to step outwards to the south.

*Figure 6 Lateral crack along the north nave wall at upper level.*

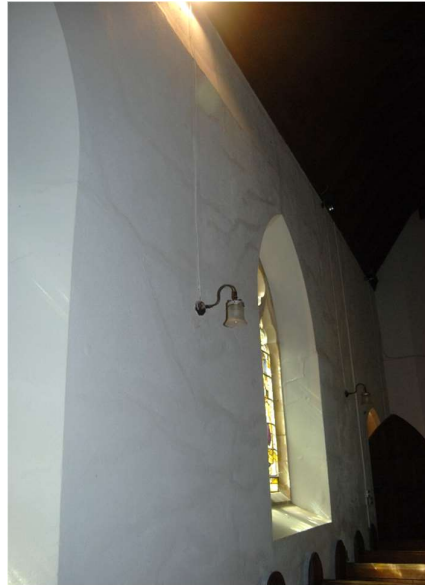
As noted in the Mann Williams February 2020 structural report, there are 'stretch marks' visible on the internal south nave wall which indicate horizontal cracking that has been patch-repaired in plaster historically. The horizontal cracking may be linked with settlement of the building over time, causing opening up along the joints of the internal face of the wall.

*Figure 7 Lateral crack along the south nave wall at upper level. Stretch marks and historic plaster patching visible.*

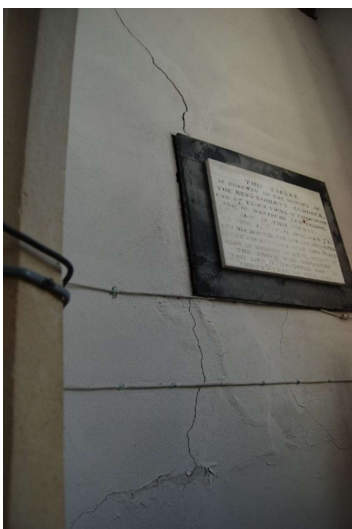
Vertical cracking was noted on the east and west walls of the south chapel/organ chamber. There appears to have been outward/downward subsidence, with the south wall pulling in a southerly direction.

*Figure 8 Vertical cracking to the east wall of the south chapel/organ chamber*

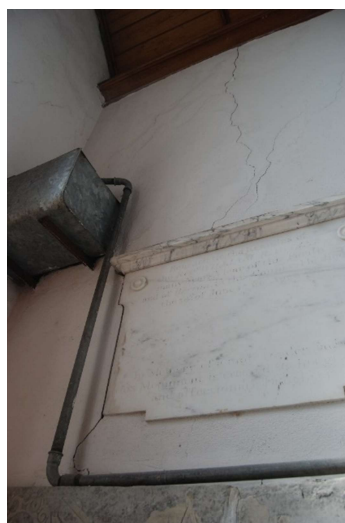
*Figure 9 Vertical cracking to the west wall of the south chapel/organ chamber*

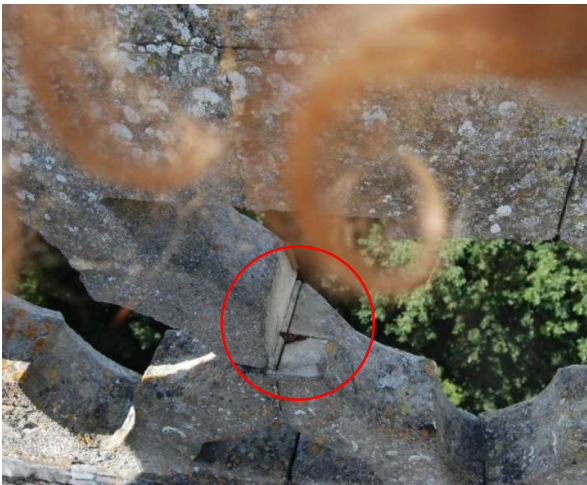
The cover meter survey revealed iron pins through the centre of each of the coping stones along the top of the west elevation only. On closer inspection, these were also visible on the surface of the stone. A corroded iron fixing was visible in the lower bed of the broken section of masonry at the north west corner of the parapet. However, detecting this iron fixing using the cover meter was unreliable, possibly

Figure 17 Corroded iron fixing visible in the lower bed at the centre of the broken panel to the north west corner (west elevation).

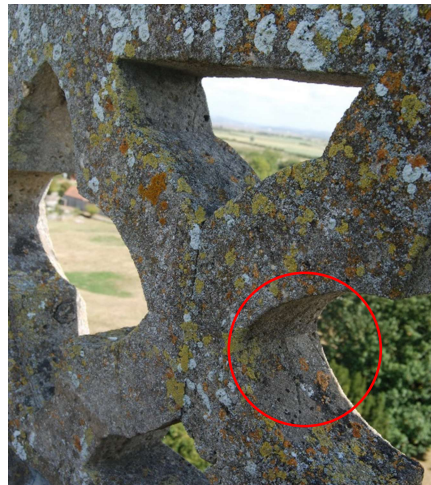
Figure 18 Sealed slot on the inside of a panel at the north east corner (east elevation). It is assumed that the iron fixings have been installed this way throughout the parapet.

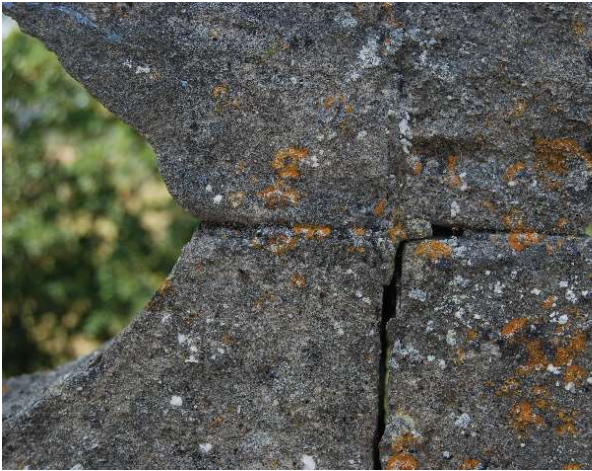
Figure 19 Example of displacement caused by embedded metal fixing at the central joints of a panel.

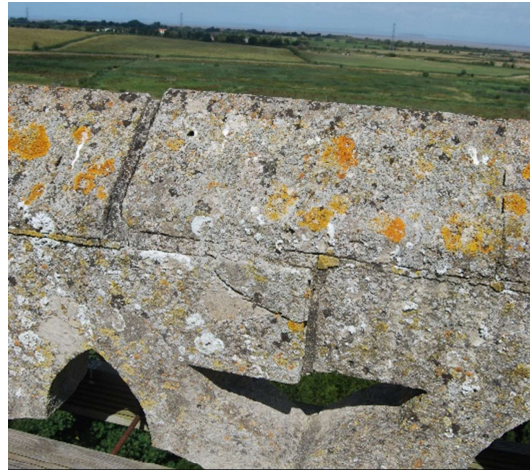
Figure 20 Fractured corner and displacement to the central panel on the north elevation.

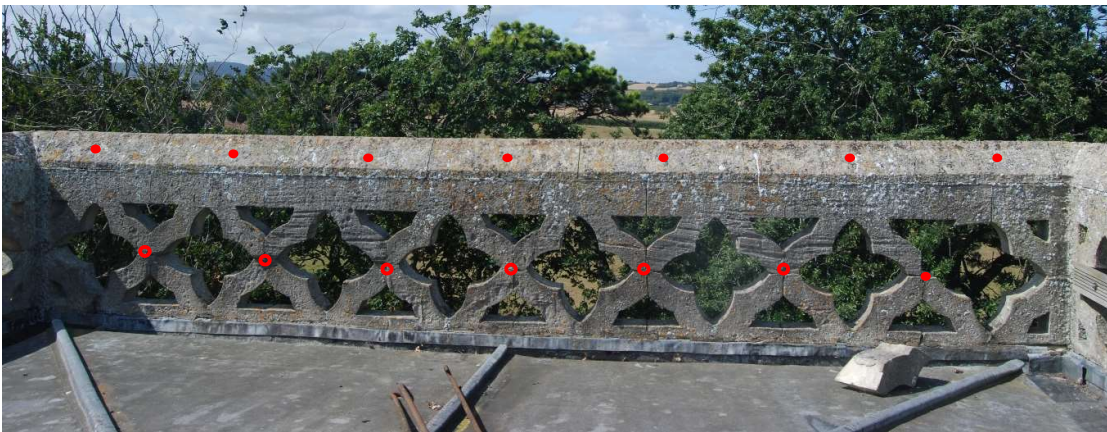
Figure 21 Locations of iron fixings on the west parapet. A solid red circle denotes an actual fixing, a hollow red circle denotes an assumed location of a fixing.

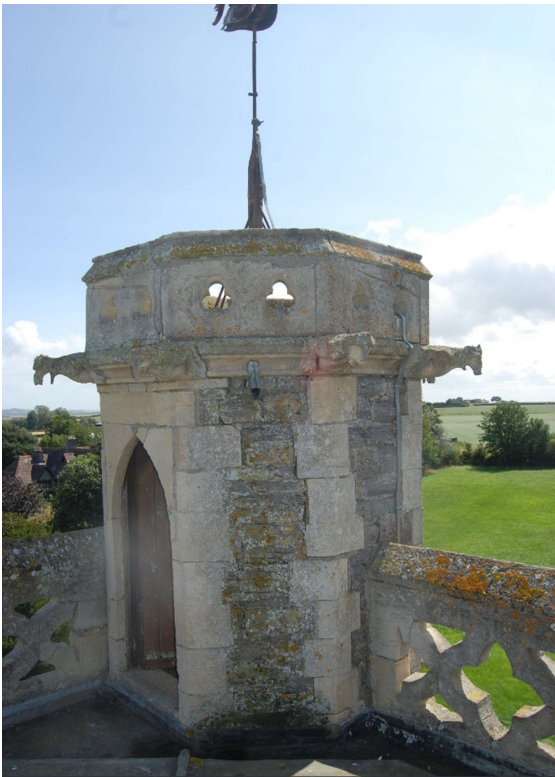
The visible upper section of the vice turret is in very poor condition, both in terms of the structure and the surface of the stone. The structural stability is of concern given the level of movement and lack of overall integrity. The blue lias is heavily delaminated and decayed, with large open joints and displacement throughout. The Bath Stone quoins/dressings appear loose, are displaced and are repointed in cement mortar. There is a large, notable crack to the door head, within which a large ferrous pin is visible. The iron ring that is noted in the structural survey is just visible on the south west side of the turret below parapet level.

Figure 22 The vice turret viewed from the north west.

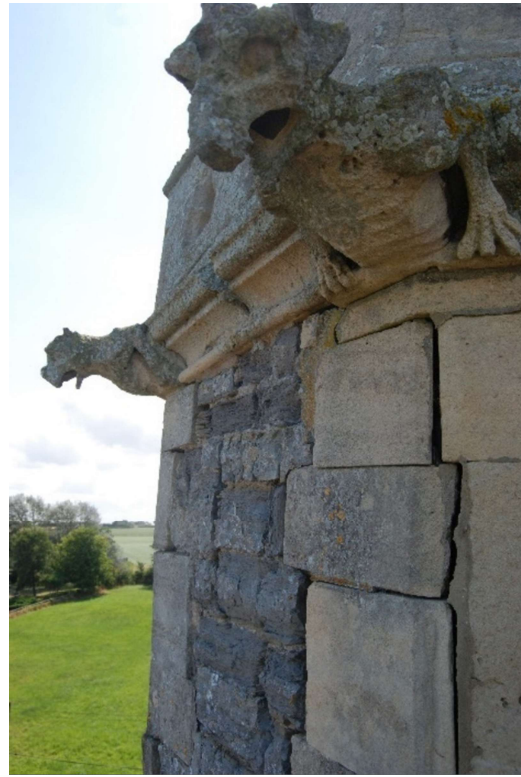
Figure 23 Detail of open joints and movement through the north west side of the vice turret.

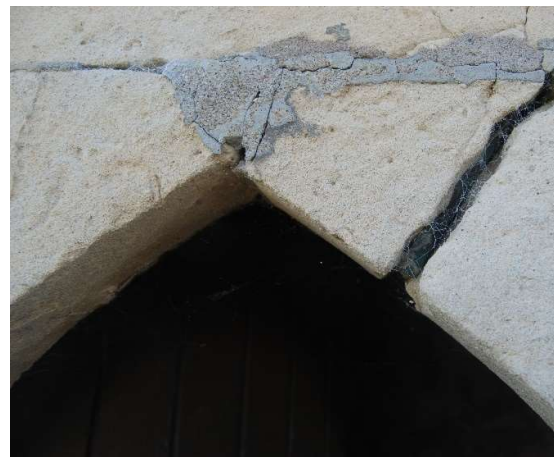
Figure 25 Large crack, visible pin and cement pointing to the vice turret door head.

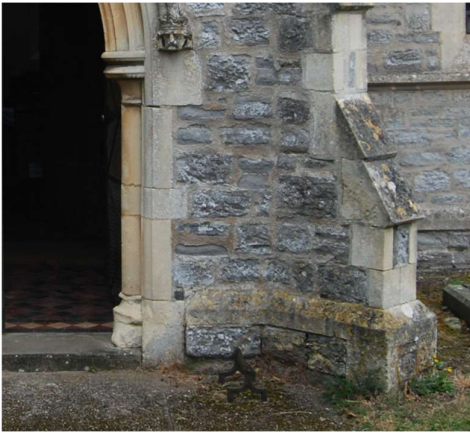
The condition of the Lias and Bath stone is generally reasonable on the external south porch, with some weathering to the faces of the Lias at the lower level either side of the south door. There has been at least one programme of repointing to the south porch, much of which is cement and some of which is failing. There are open joints to Bath stone dressings of the east buttress

Figure 30 Lower east side of south porch door with cement pointing, weathered faces of blue lias and open joints to the buttress visible.

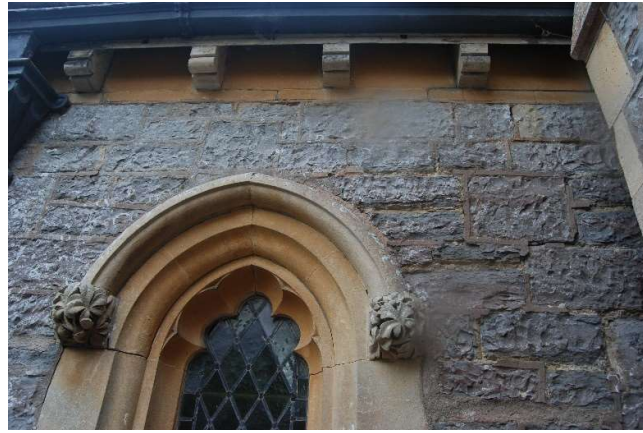
Figure 31 Failing cement pointing above the south porch east window.

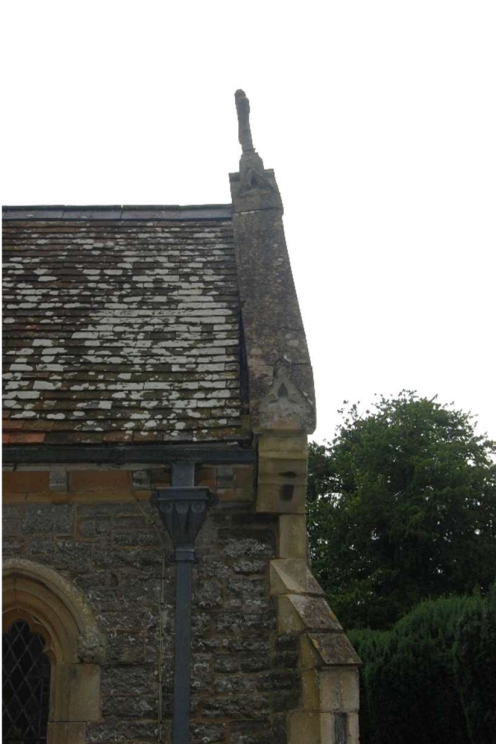
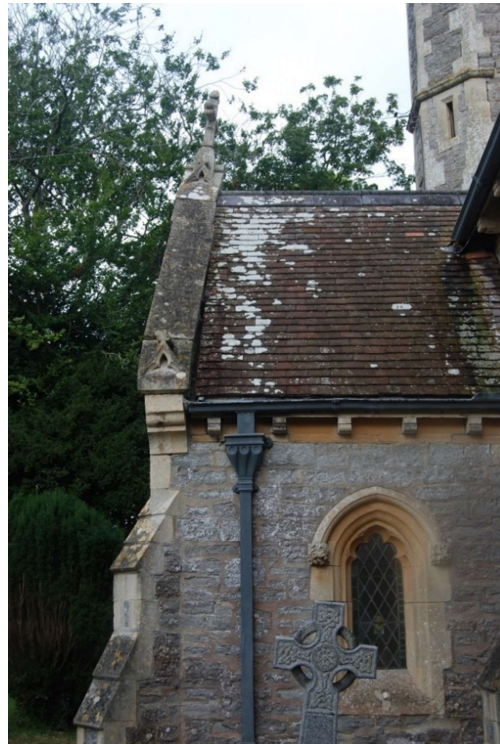
There is a notable issue with the lifting and backward leaning of the upper elements of the south porch gable. The apex cross is leaning precariously, and copings are loose and misaligned, allowing for water ingress, which is likely to be contributing to the swelling and lifting of the blue lias gable wall.

Figure 32 South porch gable from the west

Figure 33 South porch gable from the east

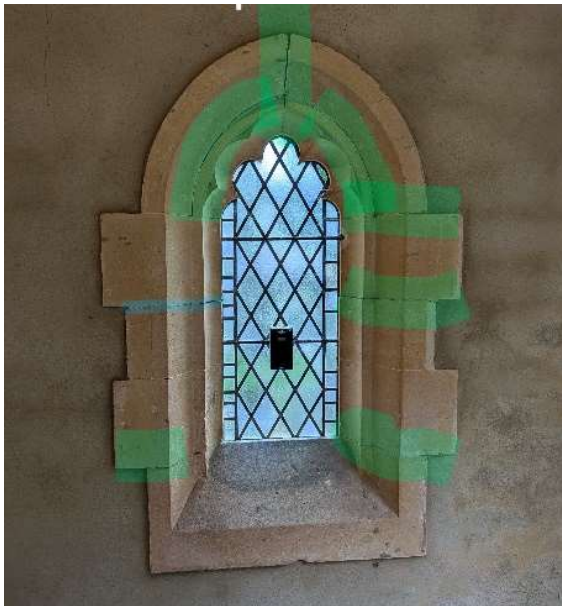
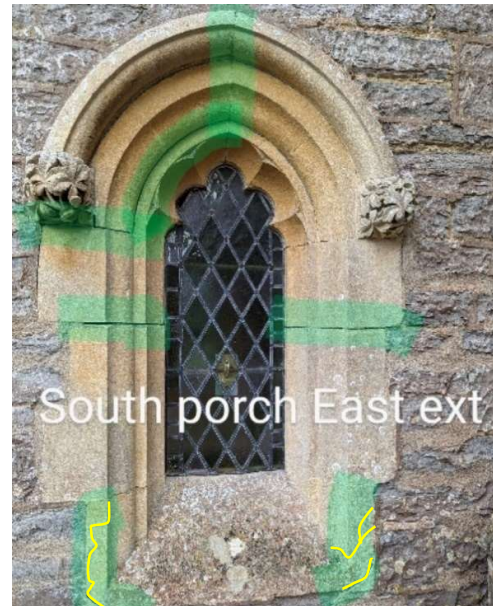
The interior and exterior faces of the south porch east window were inspected. The window is in poor structural condition with open joints and displacement of stones. The lower corners of the external Bath stone cill have stress cracks which appear to have been caused at pinch points where structural movement is occurring; this situation is exacerbated by the adjacent comparatively hard cement pointing. No embedded iron was detected either externally or internally.

Figure 34 South porch east window internal face

Figure 35 South porch east window external face

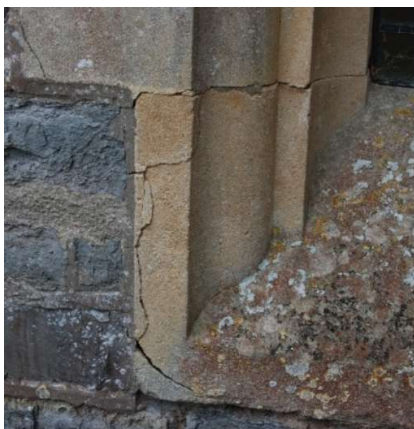
Figure 36 Detail of cracking to the external lower south jamb/cill. Cement pointing visible.

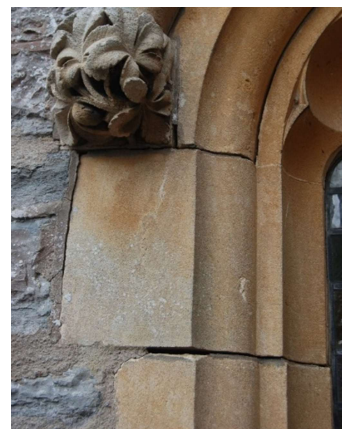
Figure 37 Opening of joints and displacement of stones to the external south jamb.

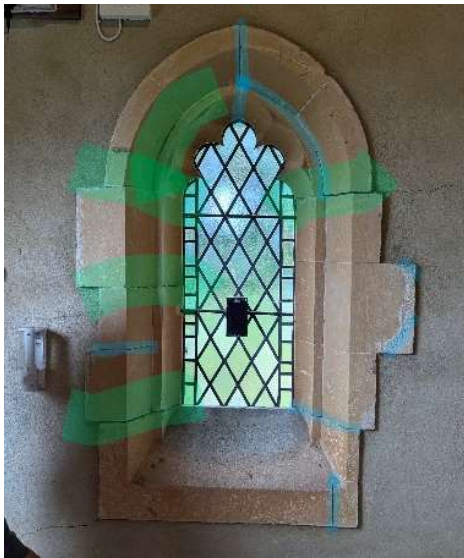
Figure 38 South porch west window internal face

Similarly to the south porch east window, the west window has open joints and displacement in multiple locations. There is some cracking to south jamb. No iron was detected internally or externally.

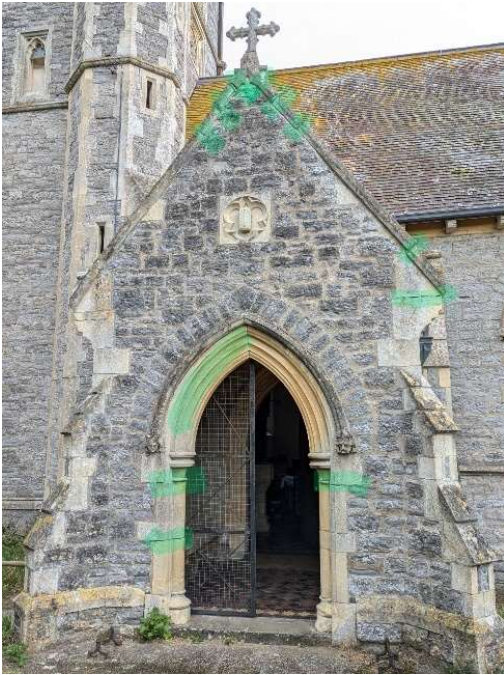
Figure 40 South porch door and gable

There is an opening-up of the joint between the blue lias and the hood mould above the door arch, and again attempts have been made to repoint this in cement mortar; this sizeable open joint appears to be linked with the upward and backward movement of the gable above and is exacerbated by both cement pointing and loose copings and subsequent water ingress. The west voussoirs of the arch are separating from the hood mould on the upper west side of the door.

Open joints and movement to the gable copings are also indicated in the image below.

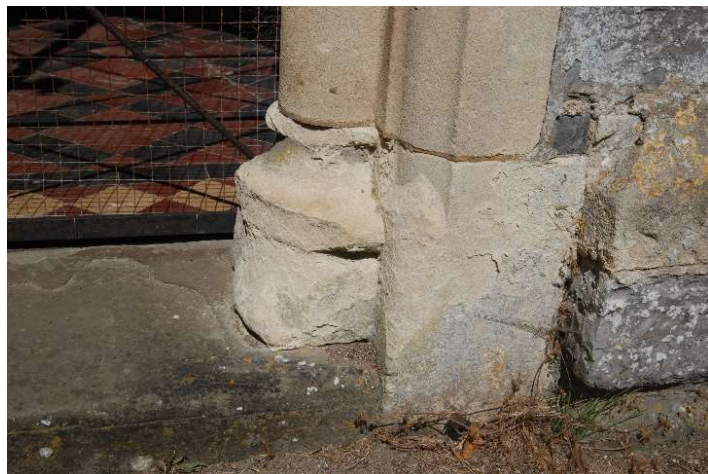
There is surface weathering to the Bath stone of the door surround at low level. Powdering and blistering can be seen here, which is indicative of damage caused by salt crystallisation through wetting and drying cycles.

Figure 42 Surface blistering and loss to the lower east jamb

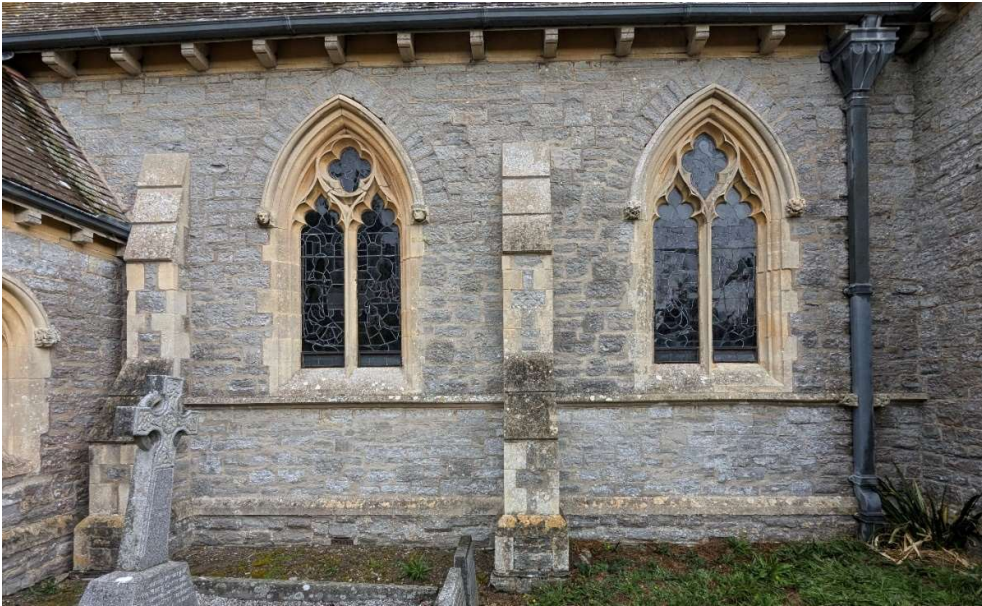
As noted in the structural report, the plinth appears to be true, but the string course drops slightly to either side of South Windows 1, 2 and 3. This could reflect the reduced load passing down through the tracery windows in relation to the full weight of the masonry wall to either side of them.

Figure 43 South nave wall showing dipping of the string course to either side of south windows 1 and 2.

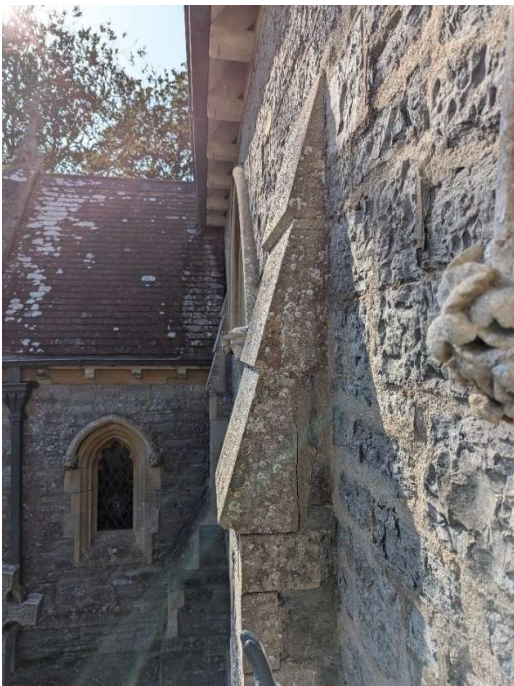
Figure 44 Movement to the buttress between south windows 1 and 2

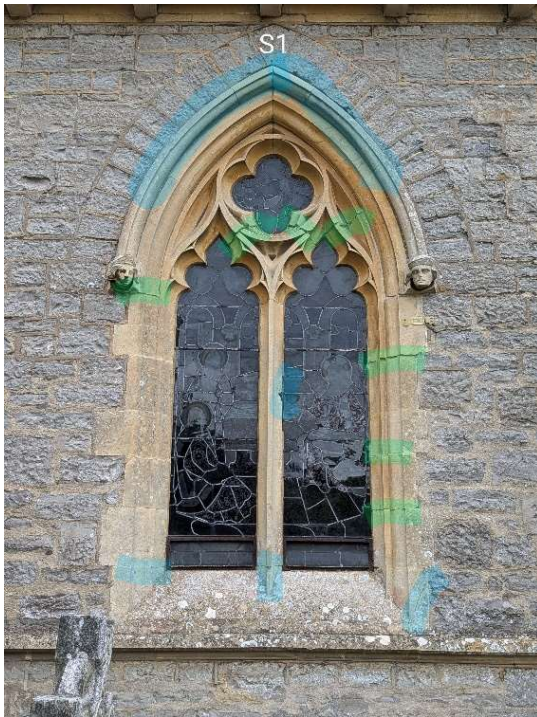
Figure 45 South window 1

The first window to the east of the south porch has a sizable open joint above the hoodmould, and movement through the tracery and jambs. Historically a crack monitoring device has been installed between the upper east jamb and wall, an indication of a long-standing issue with movement. There is fracturing and loss to the central mullion and to the jambs at cill level. The 'rise' of the string course is notable beneath the window. No embedded ironwork was detected during the survey.

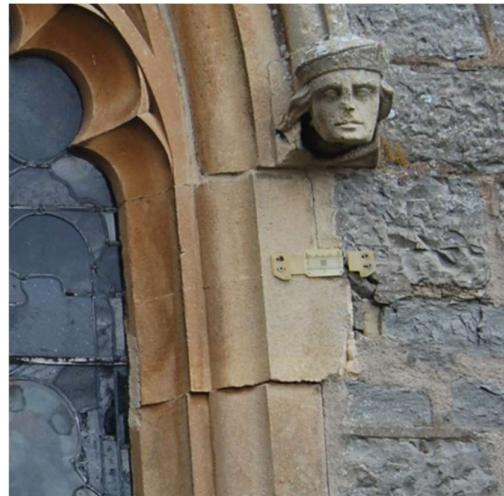
Figure 46 Displaced upper east jamb and historic crack monitoring device

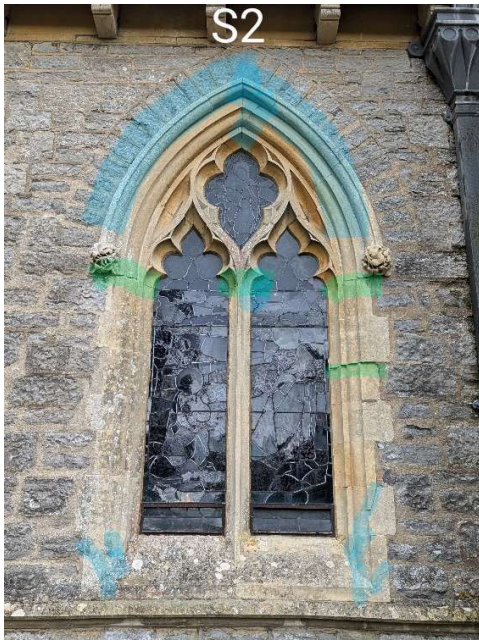
Figure 47 South window 2

The second window to the east of the south porch has a sizable open joint above the hood mould, and movement through the tracery and jambs. Cracks through the Bath stone are visible at pinch points, such as at cill level on the jambs. The undulation of the string course is visible beneath this window. The internal east jamb of the window shows corresponding displacement.

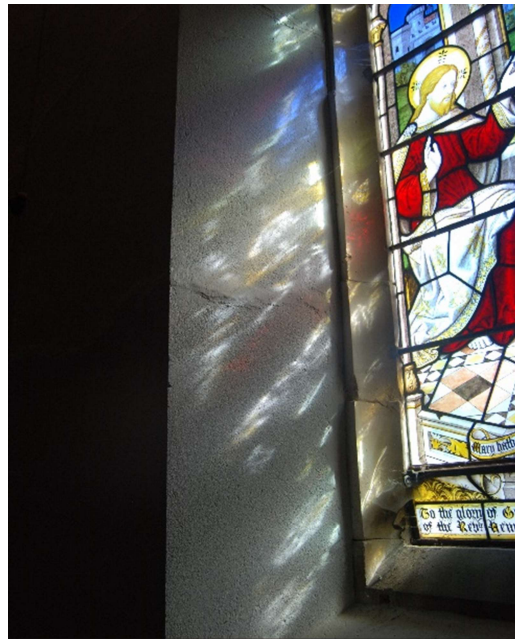
Figure 48 Displacement to internal east jamb

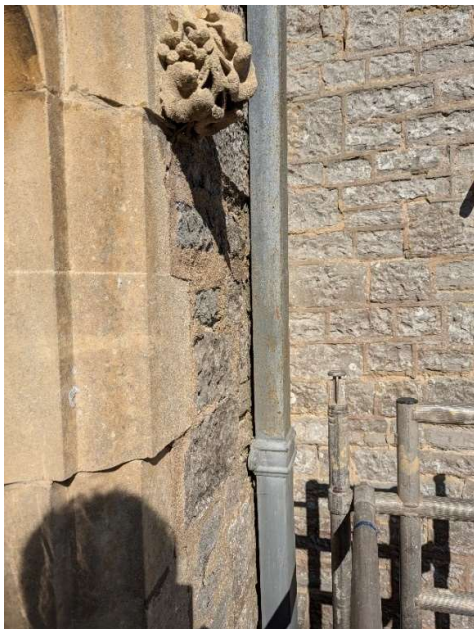
Figure 49 Displacement of east jamb at mid height

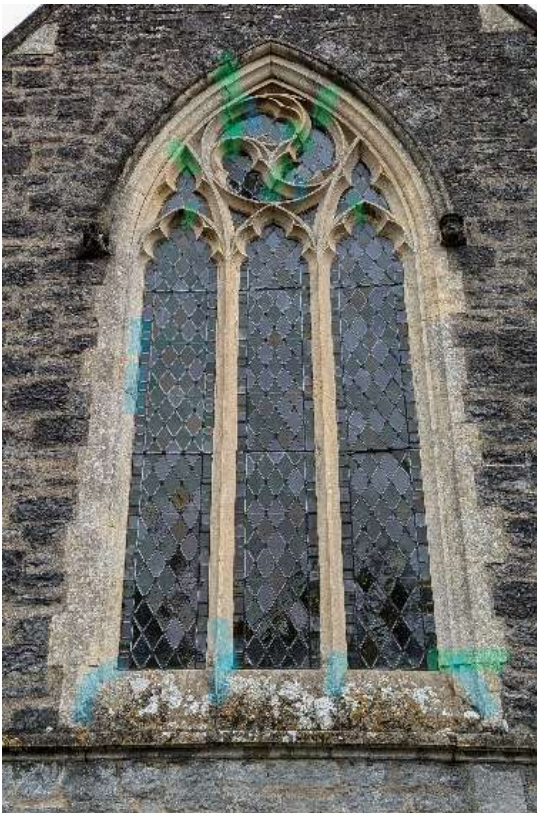
Figure 50 South chapel window 3

The large tracery window to the south chapel on the south elevation is opening-up above the hood mould and has significant movement through the tracery head, voussoirs, mullions and jambs. The Bath stone tracery is generally out of alignment, with open joints, fracturing and distortion of the stained glass. The gable above has misaligned copings with open joints, suggesting that water ingress, combined with cement pointing, is contributing to the overall movement in this chapel. It is also important to note that the cracks on the internal chapel wall also suggest subsidence, which may be reflected in the undulating string course. No ironwork was found in the structure of the window during the survey.

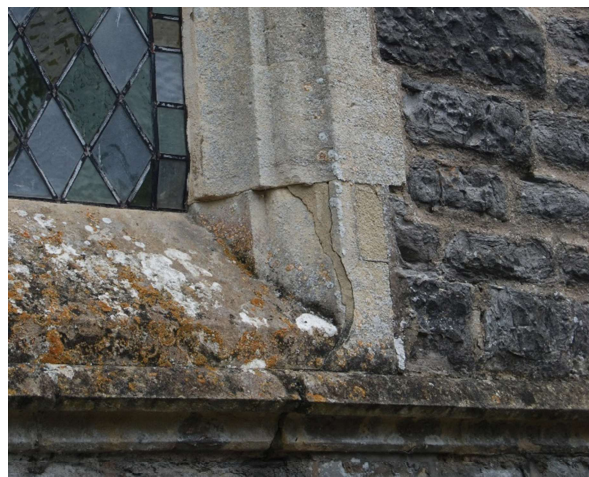
Figure 52 Cracking to the lower east corner at cill level

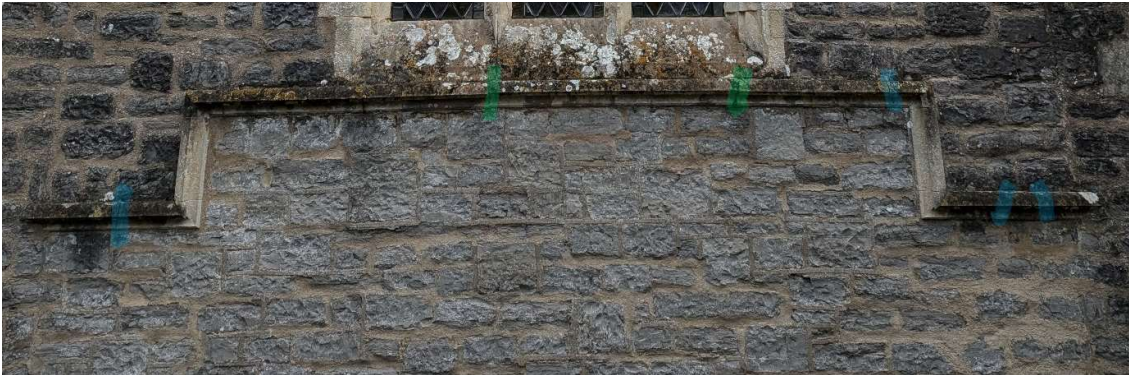
Figure 53 Rising and falling of the string course beneath the window

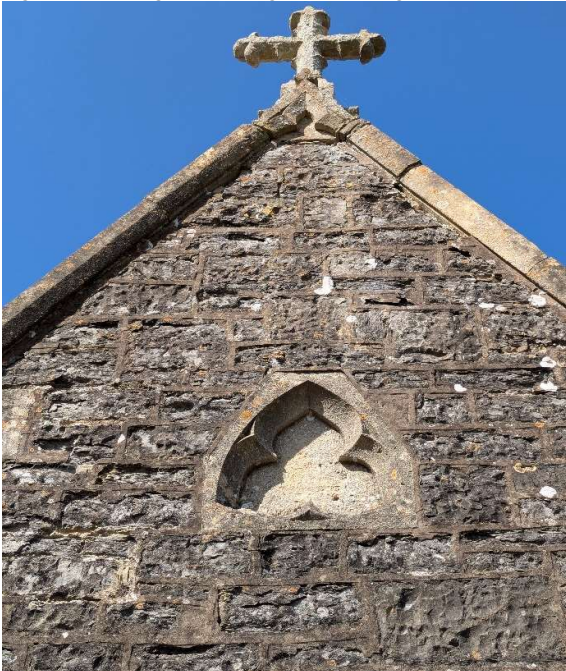
Figure 54 Open joints and movement to the gable copings

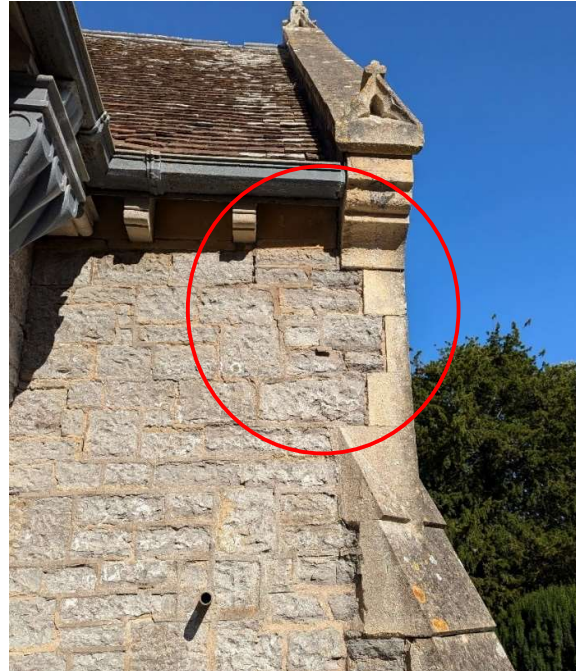
Figure 55 Stress crack to the gable on the west elevation

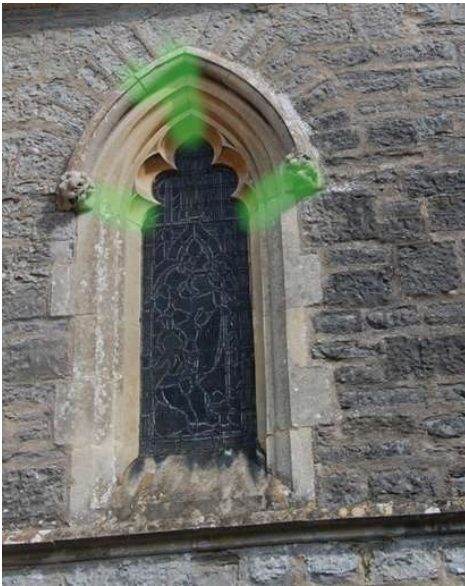
*Figure 56 Chancel south window*

The small south window of the chancel has displacement and open joints visible to the hood mould, at the apex and at the springing point of the arch.

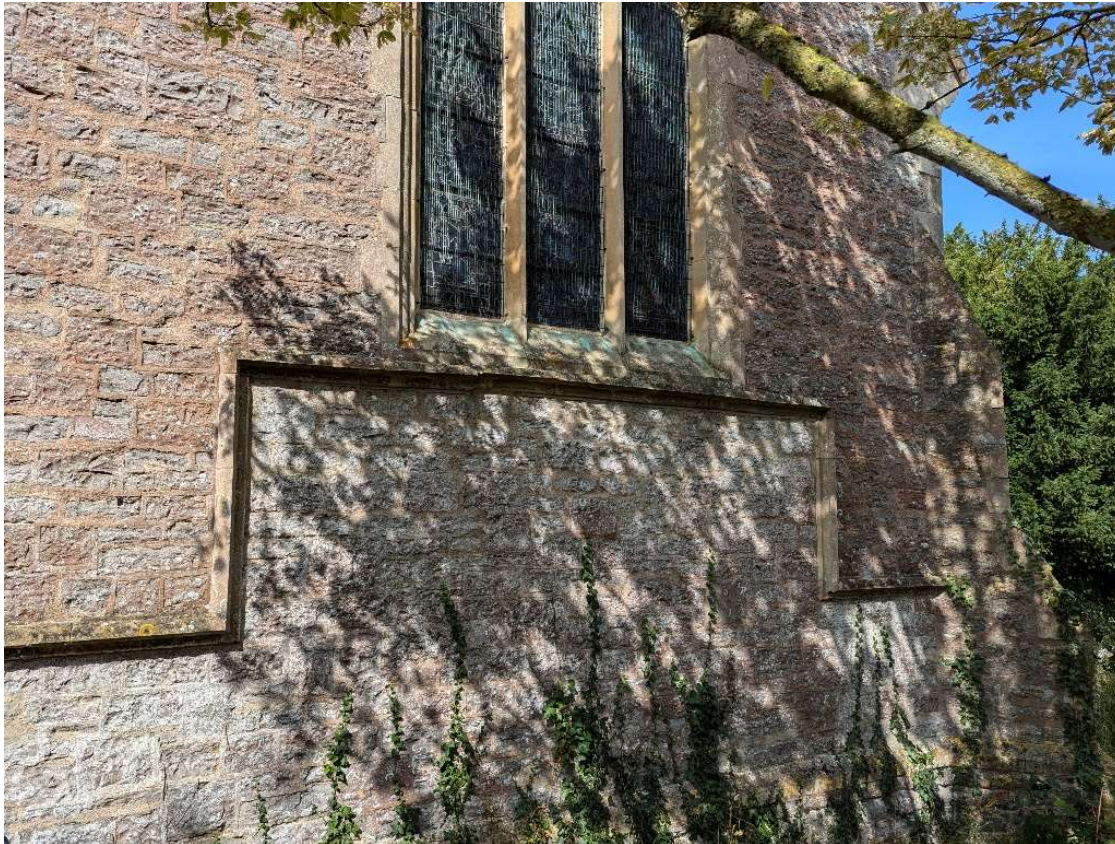
The pointing to the east elevation of the chancel is generally cement, with what appears to be original lime mortar at lower plinth level. The variation in the colour and condition of the blue lias beneath the string course suggests that stone replacement may have been undertaken historically. The string course rises beneath the window and drops to either side, as seen on the south elevation. The condition of the east gable is difficult to assess from ground level, but loose copings, misalignment and open joints were observed, as well as cracking down through the blue lias beneath the kneeler on the north side.

Figure 57 Chancel east end showing variation in stone colour beneath the undulating string course. Cement pointing throughout.

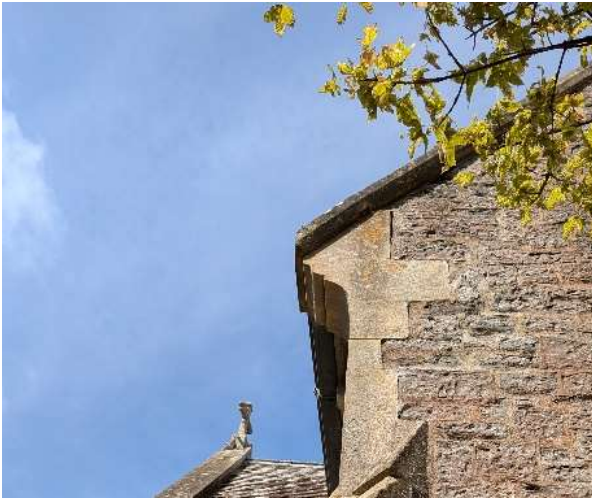
The chancel east gable has open joints visible from ground level, as well as opening up of the cement pointing to the upper corners beneath the kneelers.

*Figure 58 Opening of upper south corner of the chancel east gable*

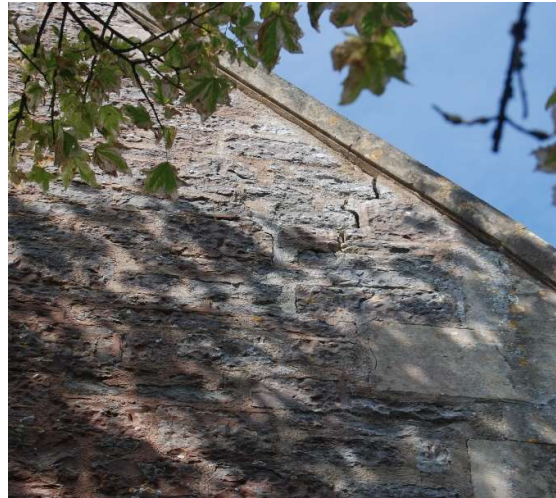
*Figure 59 Cracking through upper north corner of the chancel east gable*

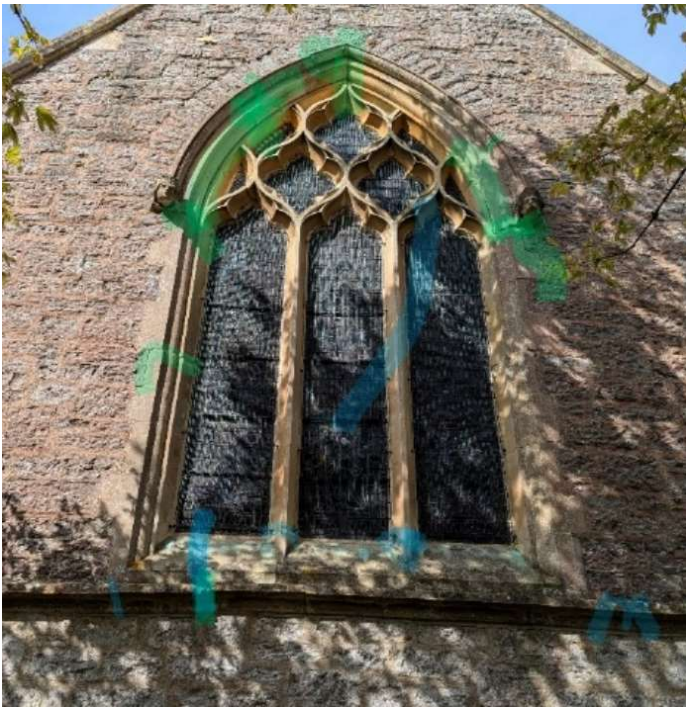
*Figure 60 Chancel east window*

Although not as pronounced as the south chapel window, the chancel east window has movement and open joints above and beneath the voussoirs and to tracery at the head, as well as some displacement to the jambs and mullions. There is cracking to the south jamb at mid-height and at the cill. The cill to the south has lifted and moved out of alignment, shifting the string course with it. Inspection of the window was at ground level only, so a cover meter survey was not conducted, but it is assumed that there is no embedded ironwork.

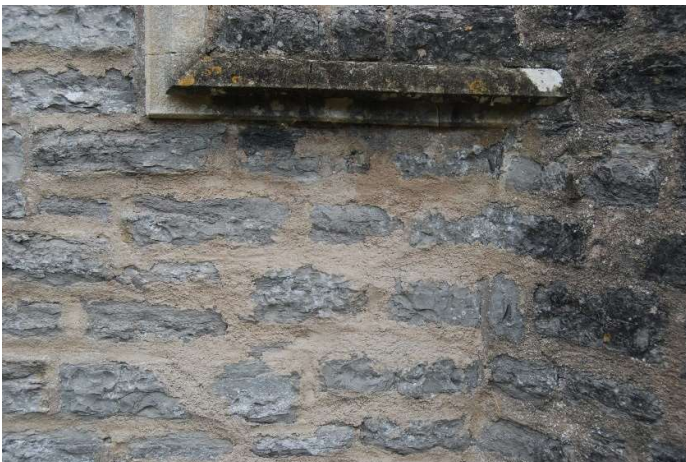
*Figure 61 Detail of smeared cement pointing to the blue lias beneath the string course of the east chancel*

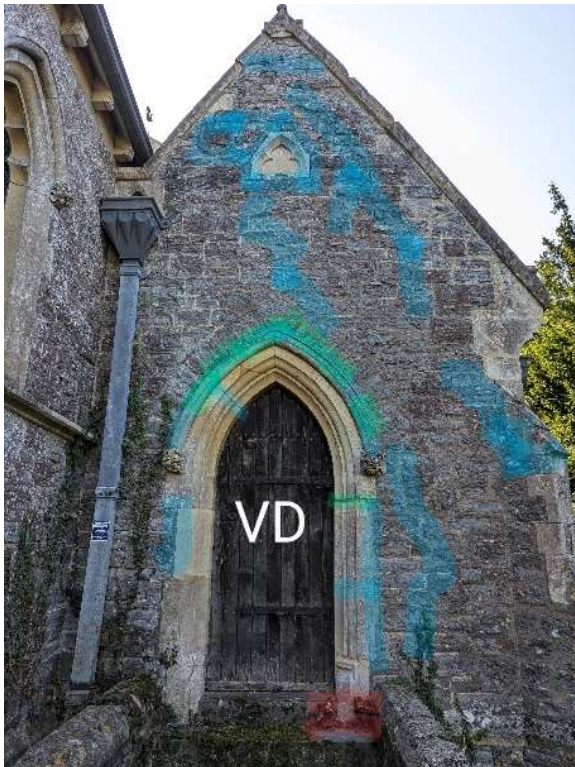
Figure 62 Vestry east door

There is significant cracking and bulging of the wall above the vestry east door. This situation is reflected in the cracking and moisture ingress seen on the vestry internal east wall. The gable has open joints along the copings and directly behind the gable, where the lead flashing is loose and water ingress will be ongoing. The apex cross is leaning precariously backwards, contributing to the misalignment and open joints at coping level.

The hood mould is opening up over the door, and displacement and cracking can be seen through the voussoirs of the arch and down through the door jambs. There is tree root growth through the masonry joints at the base of the north jamb. A downpipe runs close to the door on the south side, and drainage arrangements here are unclear. This appears to be a very damp corner of the building, with heavy moss coverage to the steps to the vestry door.

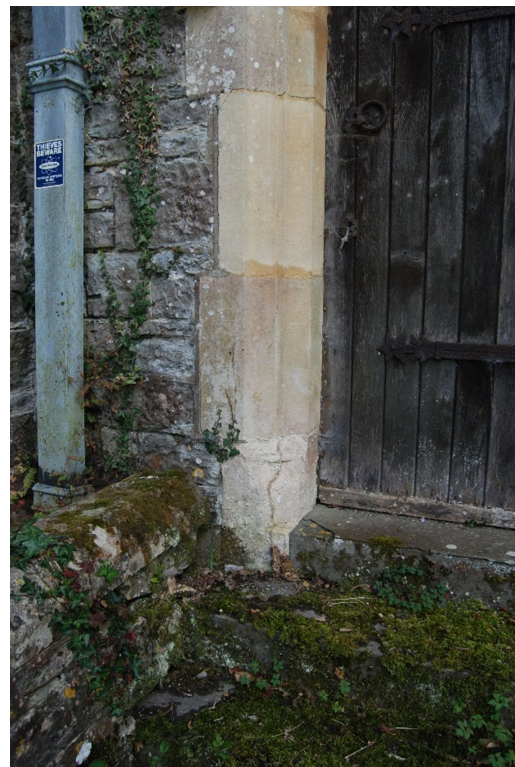
Figure 63 Evidence of damp at the base of the vestry east door and around the base of the downpipe

- Removal of internal plaster to the damp areas of the vestry and north chancel to allow for drying out.

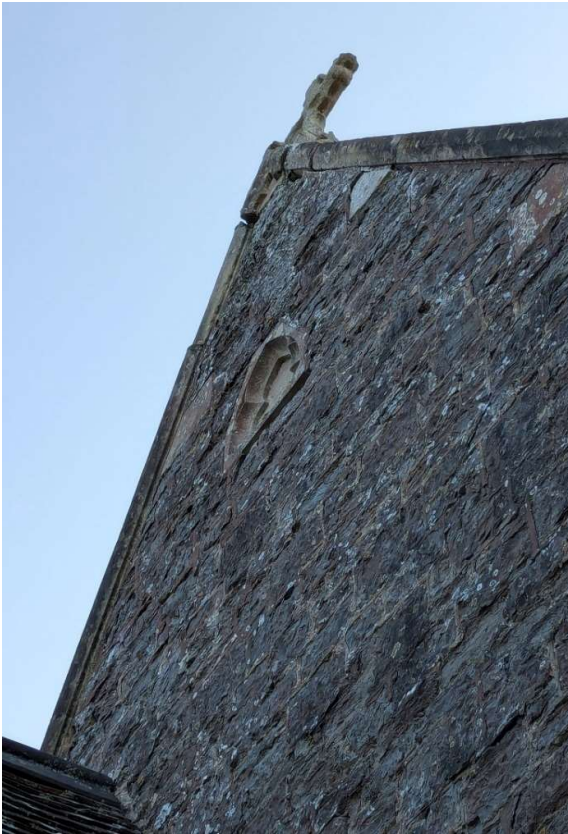
*Figure 64 Bulging of the vestry gable, open joints and leaning apex cross.*

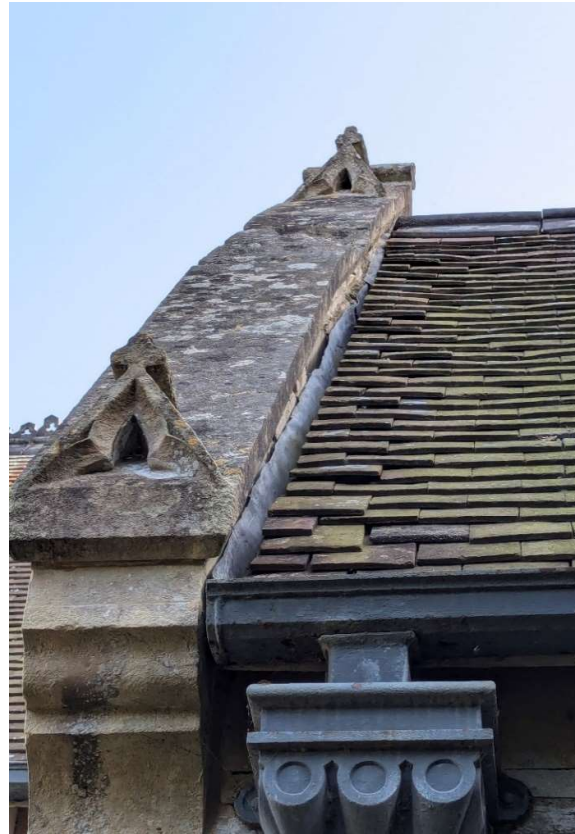
*Figure 65 Point of water ingress where lead flashing is open behind the vestry gable*

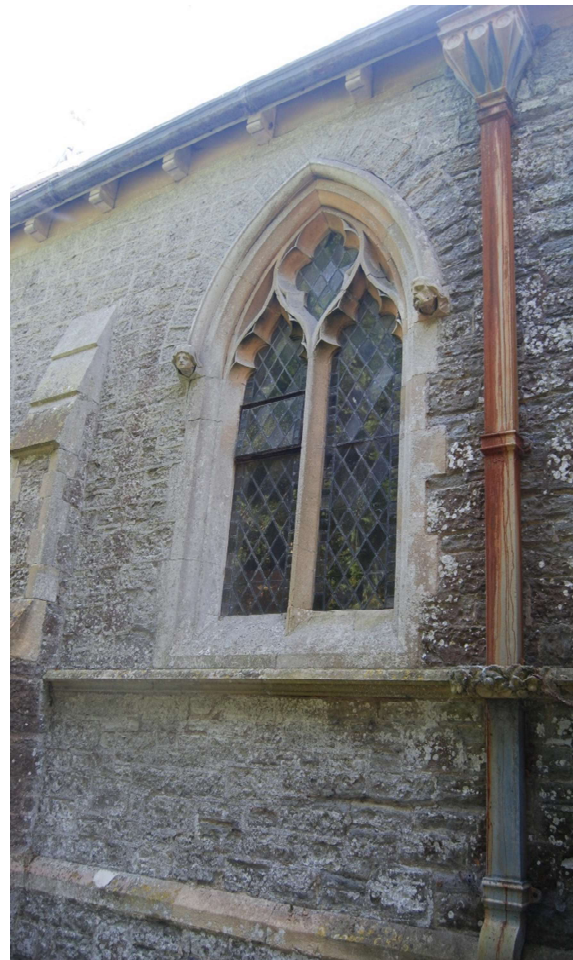
Figure 67 Corrosion to the south aisle downpipe

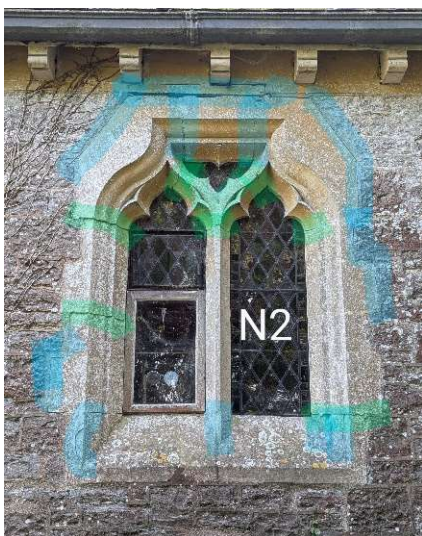
Figure 69 Vestry north window 2

The vestry north window is opening up along a horizontal line at its head, with the wider joint at the east side of the window, where there is also evidence of failed cement pointing. The east jamb is also moving out of alignment. There is cracking to the Bath stone at cill level, where structural movement and the unforgiving cement mortar have created points of stress. This window is located over the steps to the boiler room beneath the vestry.

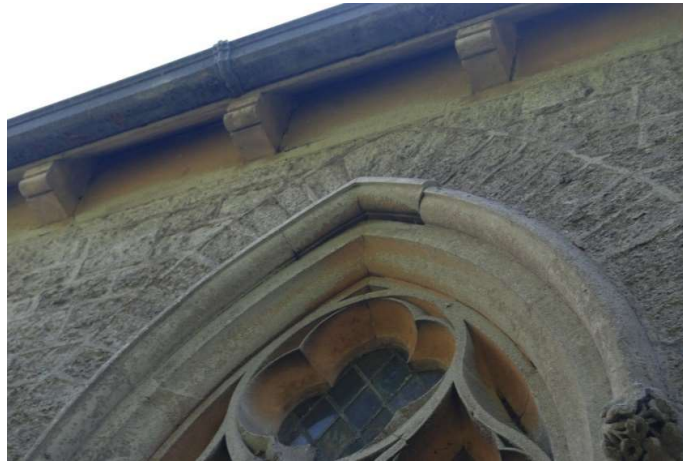
Figure 71 Displacement of the key stone

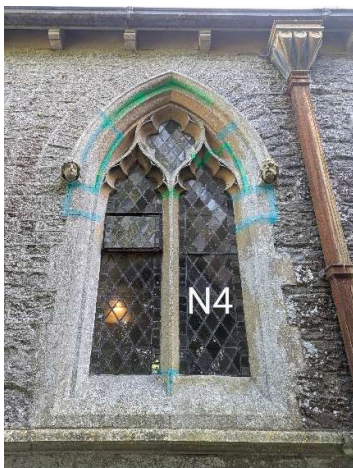
Figure 72 North aisle window 4

The north aisle window 4 is in reasonable condition structurally but with a level of opening up of joints at the head and upper jambs, and at the base of the mullion. This window is in close proximity to the corroding downpipe and so water ingress (historic or ongoing) in the masonry may be expected here.

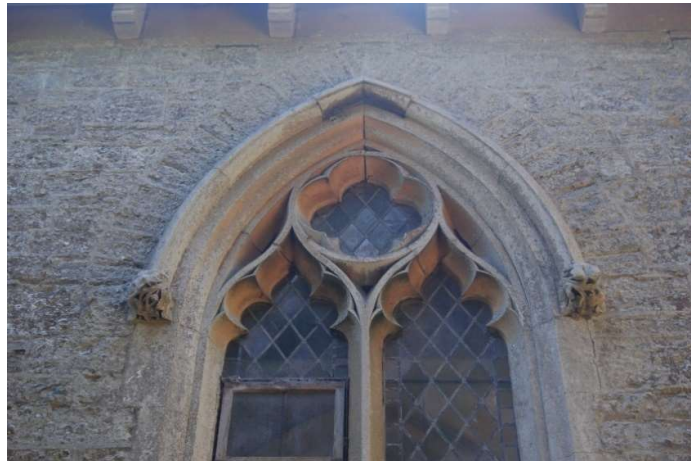
Figure 74 Displaced keystone

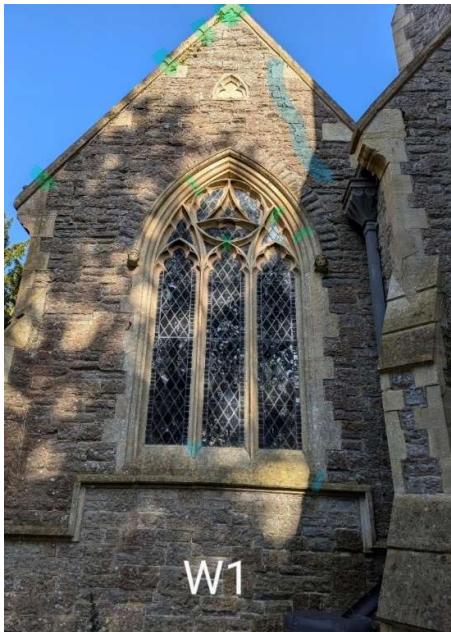
Figure 75 South aisle west window

There are significantly fewer areas of visible movement or open joints to the south aisle west window than seen on other elevations of the building. The tracery does not appear to be opening up or moving out of alignment. The string course, however, does appear to rise and fall beneath the window, as seen on the south and east.

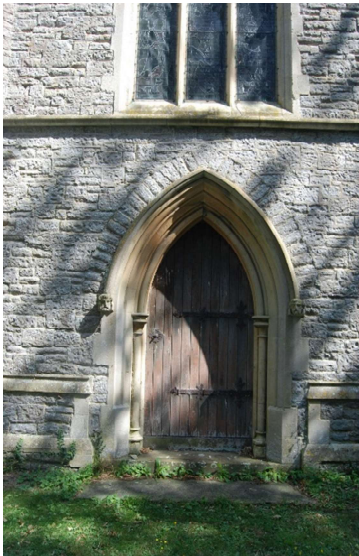
Figure 76 Tower west door

The voussoirs of the tower west door are both displaced and cracked at the apex. Previous attempts have been made at repair using a colour-matched mortar, but these repairs have failed at some of the joints.

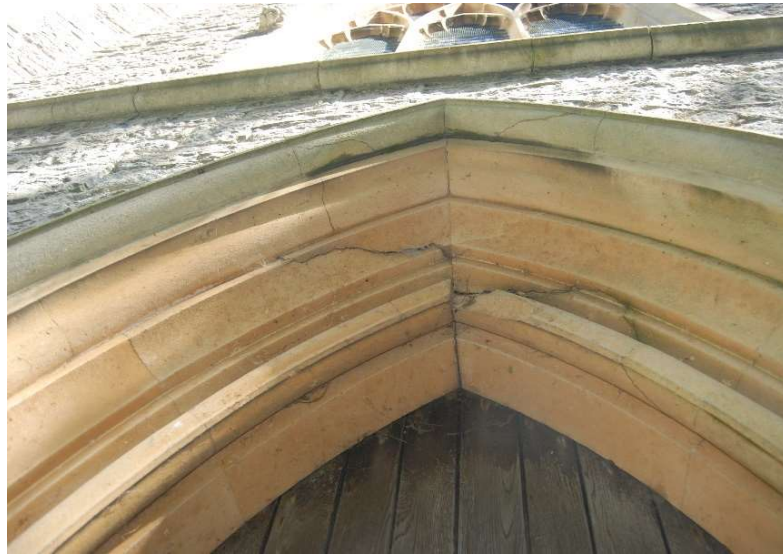
Figure 77 Cracking over the tower west door
