Masonry Investigations  
St Mary Magdalene Church, Stockland Bristol  
ADDENDUM TO CONDITION REPORT  
November 2024

## Addendum to the August 2024 Masonry Condition Survey St Mary Magdalene Church, Stockland Bristol

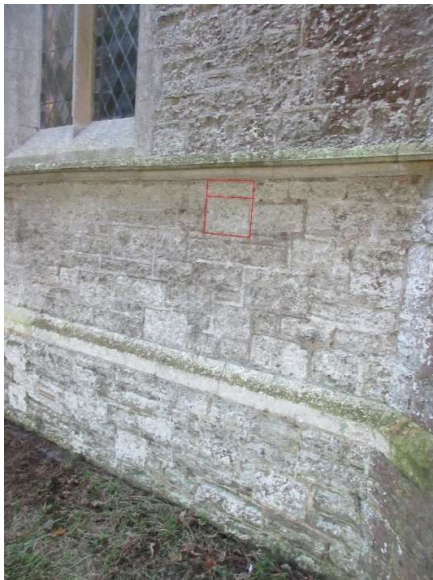
Figure 1 Location for external stone removal at the west end of the north aisle (1.1)

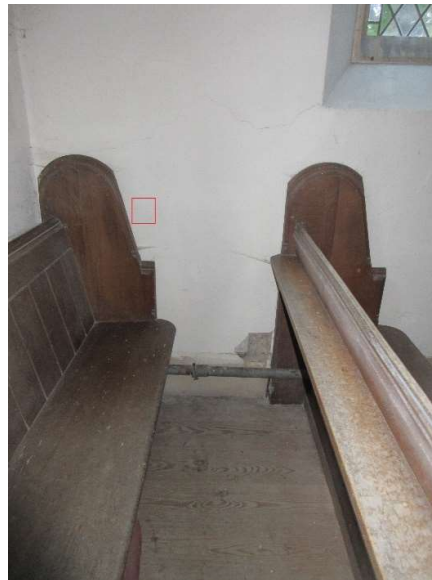
Figure 2 Location for internal plaster removal at the west end of the north aisle wall (1.2.1)

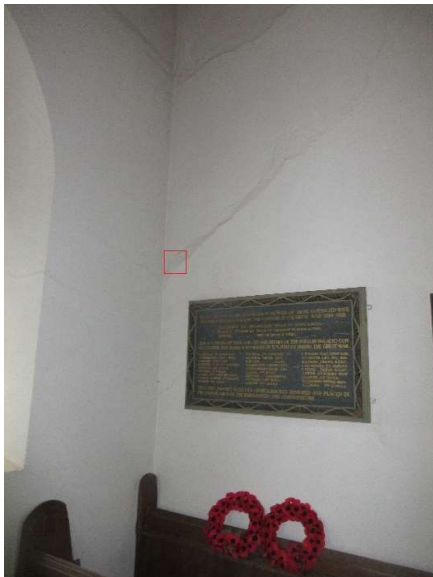
Figure 3 Location for internal plaster removal at the east end of the north aisle (1.2.2)

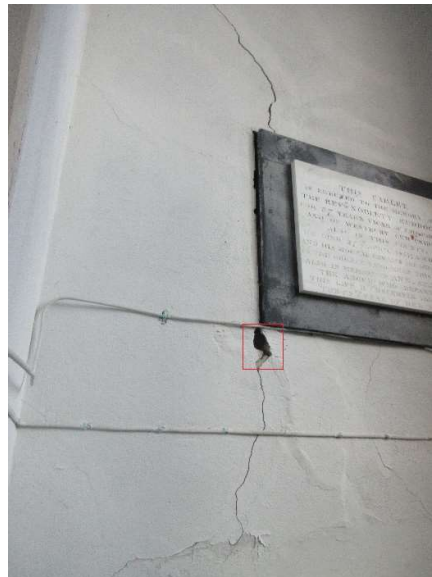
Figure 4 Location for plaster removal on the east wall of the organ chamber beneath the wall monument (1.2.3)

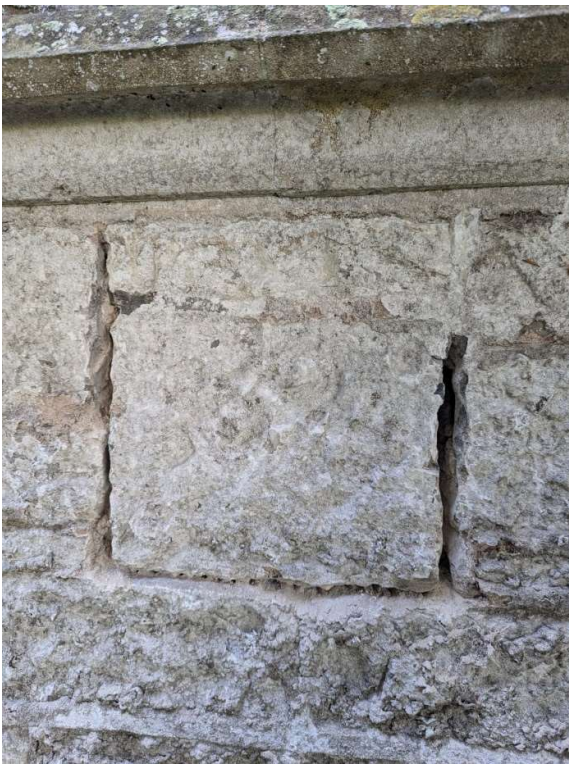
The two stones identified by the architect were carefully removed by hand using a sharp chisel and avoiding damage to the adjacent masonry. When lifted from position, the void revealed a grey bedding and pointing mortar which had been faced in the joints with a more modern pinkish mortar, which was fine in consistency and appeared to have a lime binder. The original grey bedding and pointing mortar appears to contain some medium to large aggregates, a charcoal/ash-type inclusion, and some fragments of chalk and unslaked lime; the sample that was removed from the wall has been submitted for laboratory analysis in order to gain a better understanding of its composition.

Figure 5 The stones with joints raked-out, prior to removal

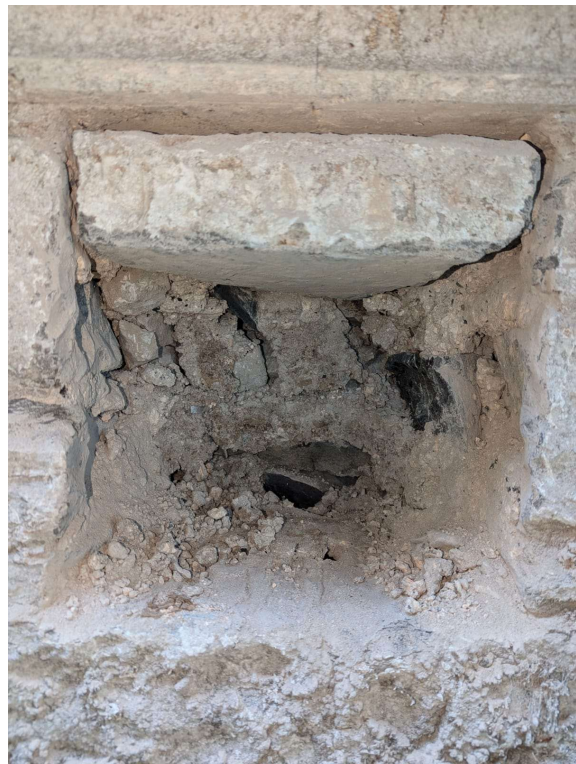
Figure 6 The void left by the lower of the two stones

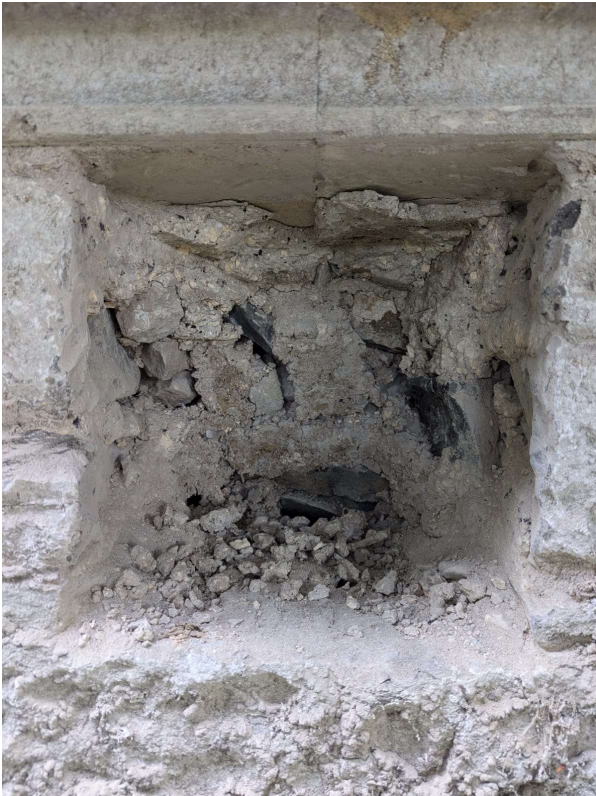
Figure 7 The void with both stones removed and original bedding and pointing mortar visible

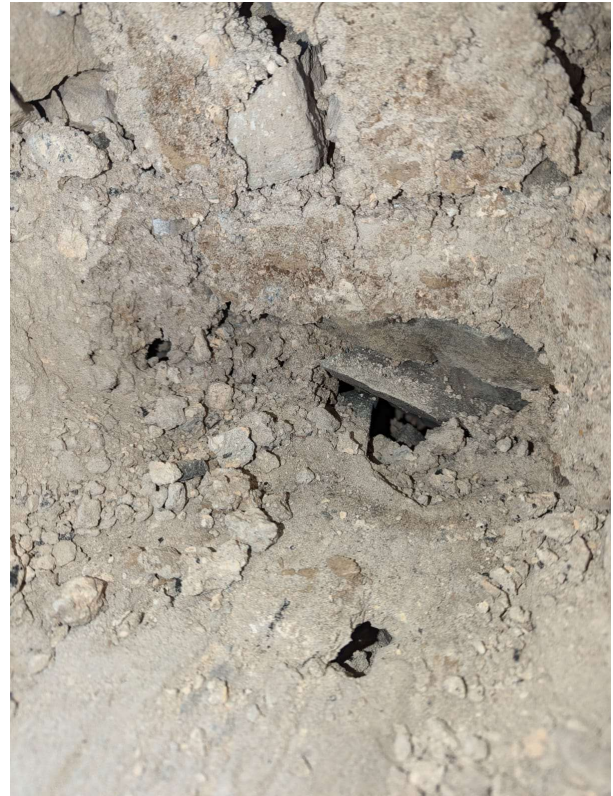
Figure 8 Detail of the wall core within the void

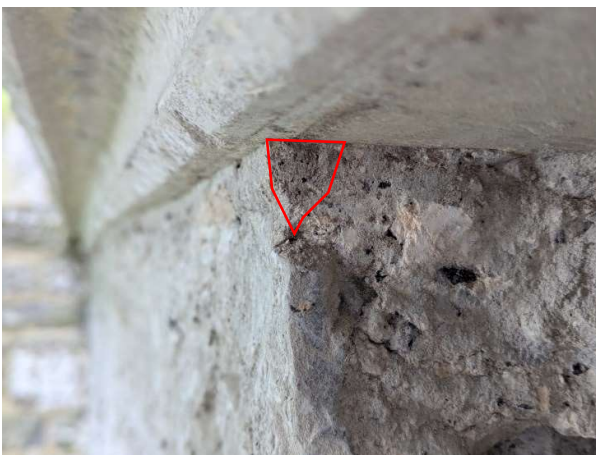
Figure 9 The pinkish mortar found on the face of the joints is indicated in red

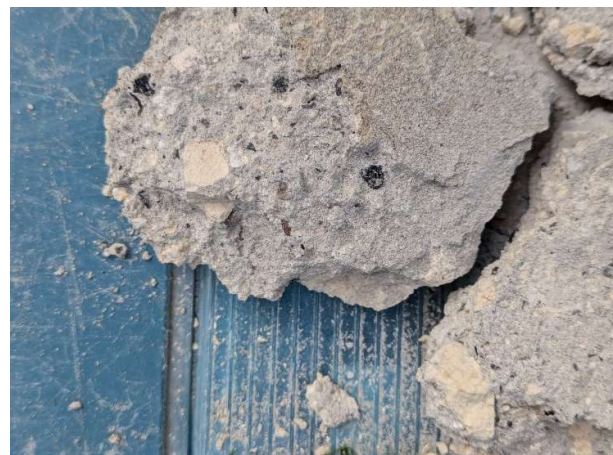
Figure 10 Detail of sample of original bedding and pointing mortar submitted for laboratory analysis

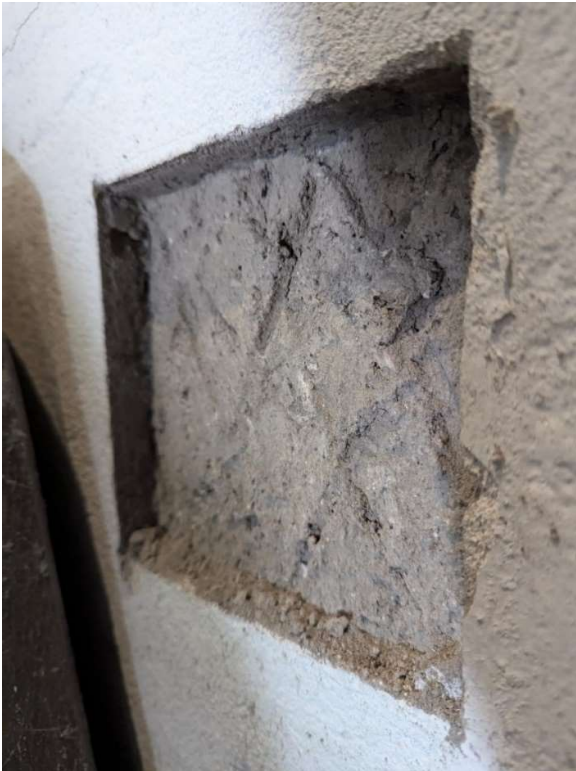
A small window was carefully cut into the north aisle north wall at low level at the west end, as instructed. This window corresponds with the external stones specified for removal. There was found to be a fine, buff plaster top coat, and a second, coarser coat in grey. The plaster scratch coat that has been applied directly to the rubble stone wall beneath is also coarse and grey in colour. There was not found to be a brick internal skin to the wall in this location.

*Figure 12 Upper two coats of plaster removed to reveal the grey plaster scratch-coat*

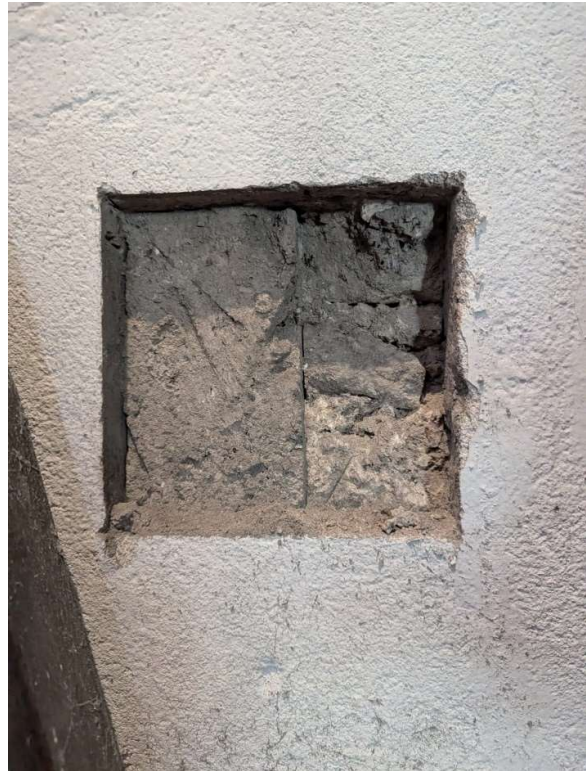
*Figure 13 Further partial removal of the plaster scratch coat to reveal the stone core of the wall*

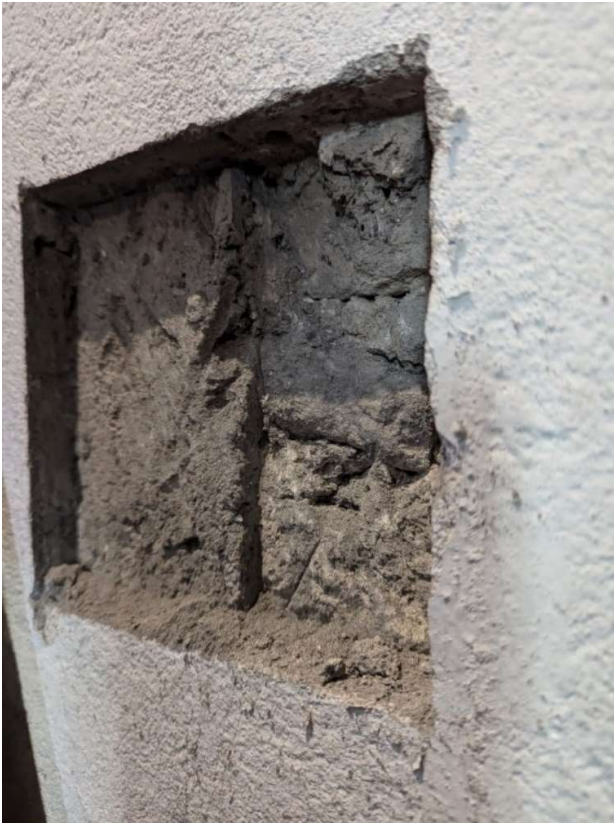
*Figure 14 Detail of the partially removed scratch coat and rubble stone core*

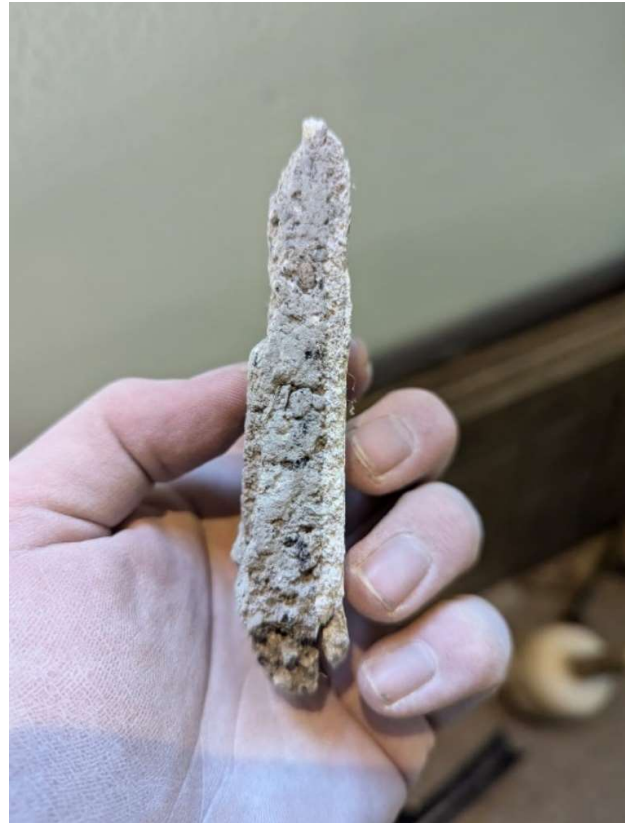
*Figure 15 Fragment of two-coat plaster removed*

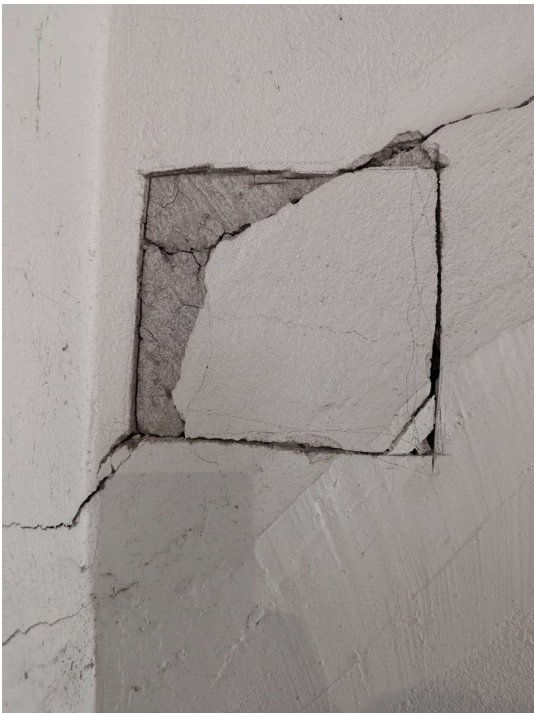
A small window was cut into an area of cracking at the upper level on the east wall of the north aisle. The plaster here consists of a fine, buff topcoat and a fragmented coarse, grey second coat applied to the brick inner skin of the wall beneath. The cracking to the plasterwork was found to be reflected in movement of the brickwork skin itself in this corner. The brickwork appears to have been bedded and pointed in a similar coarse grey mix.

*Figure 16 The window with an area of topcoat plaster removed*

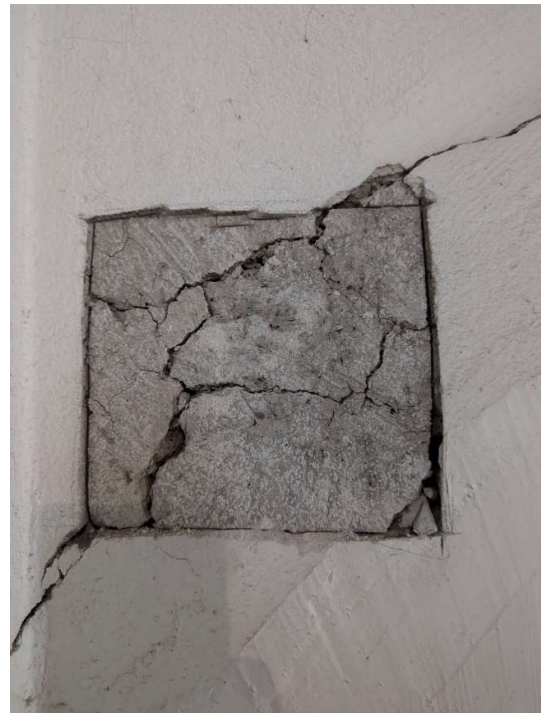
*Figure 17 The window with topcoat plaster removed, revealing the second coat beneath*

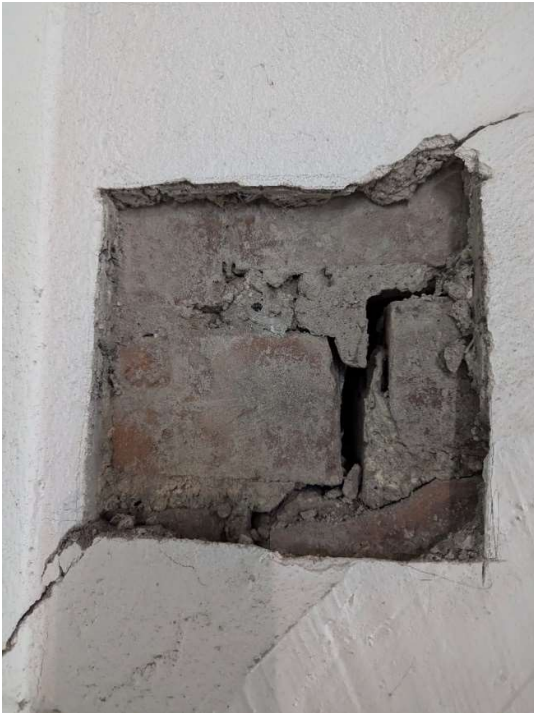
*Figure 18 Second coat of plaster removed to reveal the brick inner skin of the wall*

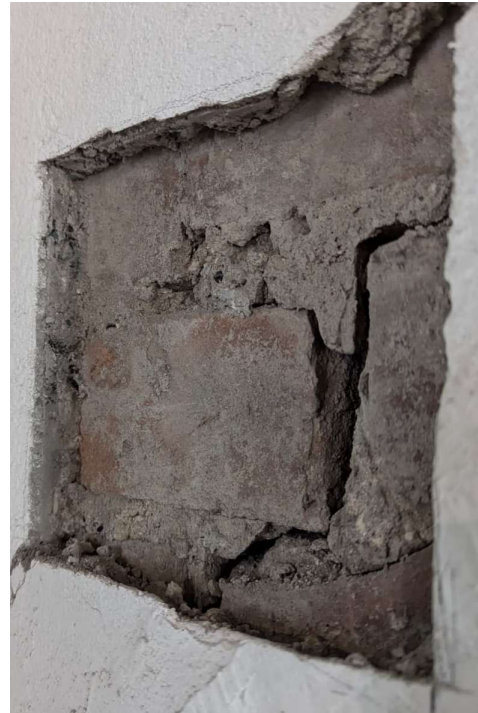
*Figure 19 Detail of cracking through the joints of the brickwork*

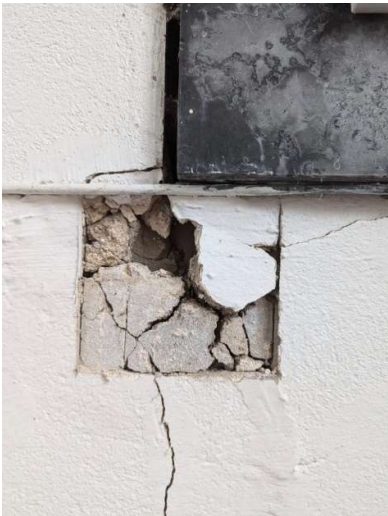
The existing crack and hole beneath the monument on the east wall of the organ chamber were carefully expanded to allow a better understanding of the wall and potential stability of the monument. The plaster was found to consist of a fine, buff top coat and a coarser grey second coat applied to the brick inner skin of the wall. The joint in the brickwork has opened-up, and the plaster has peeled away from the substrate in this area. Due to this movement, there is insufficient support at the base of the monument, and its stability is severely compromised.

Figure 20 Partial removal of the topcoat plaster beneath the monument, revealing the fragmented second coat of plaster beneath

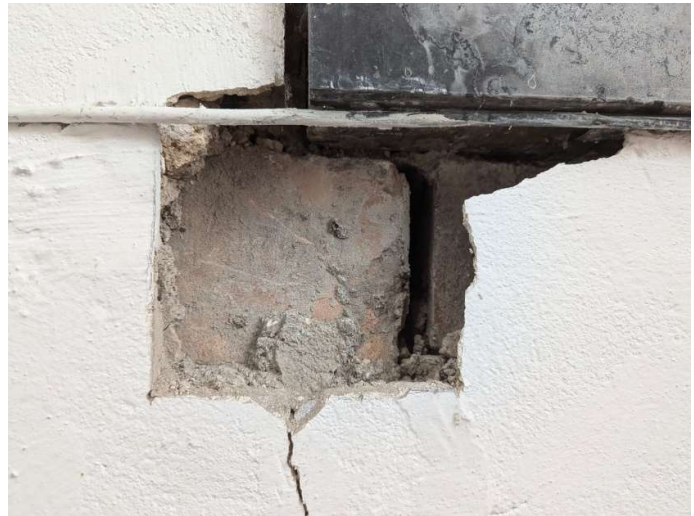
Figure 21 Second coat of plaster removed to reveal the brickwork inner skin of the wall

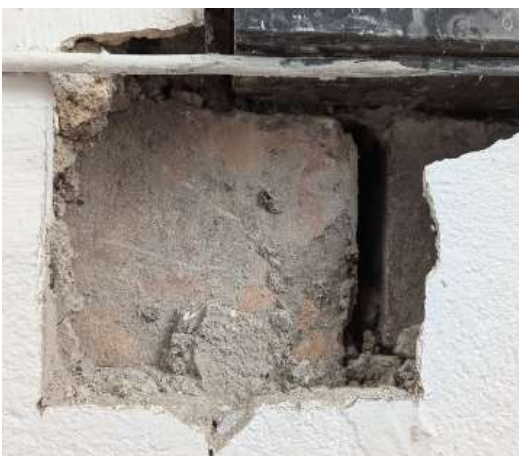
Figure 22 Detail of the brickwork and open joint

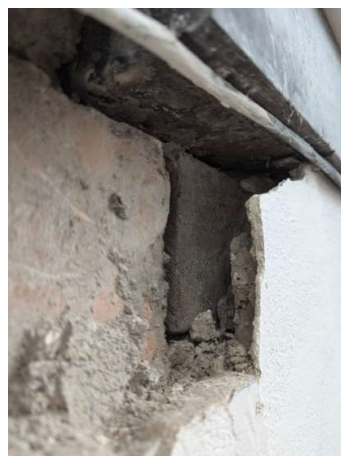
Figure 23 The plaster appears to have detached from the brickwork
