# Rope Access Condition & Recommendation Report

**Rope Access Condition &  
Recommendation Report for  
St Mary Magdalene Church,  
Stockland Bristol –  
September 2024**

**Job number: 3535**

**Client: Marcus Chantrey**

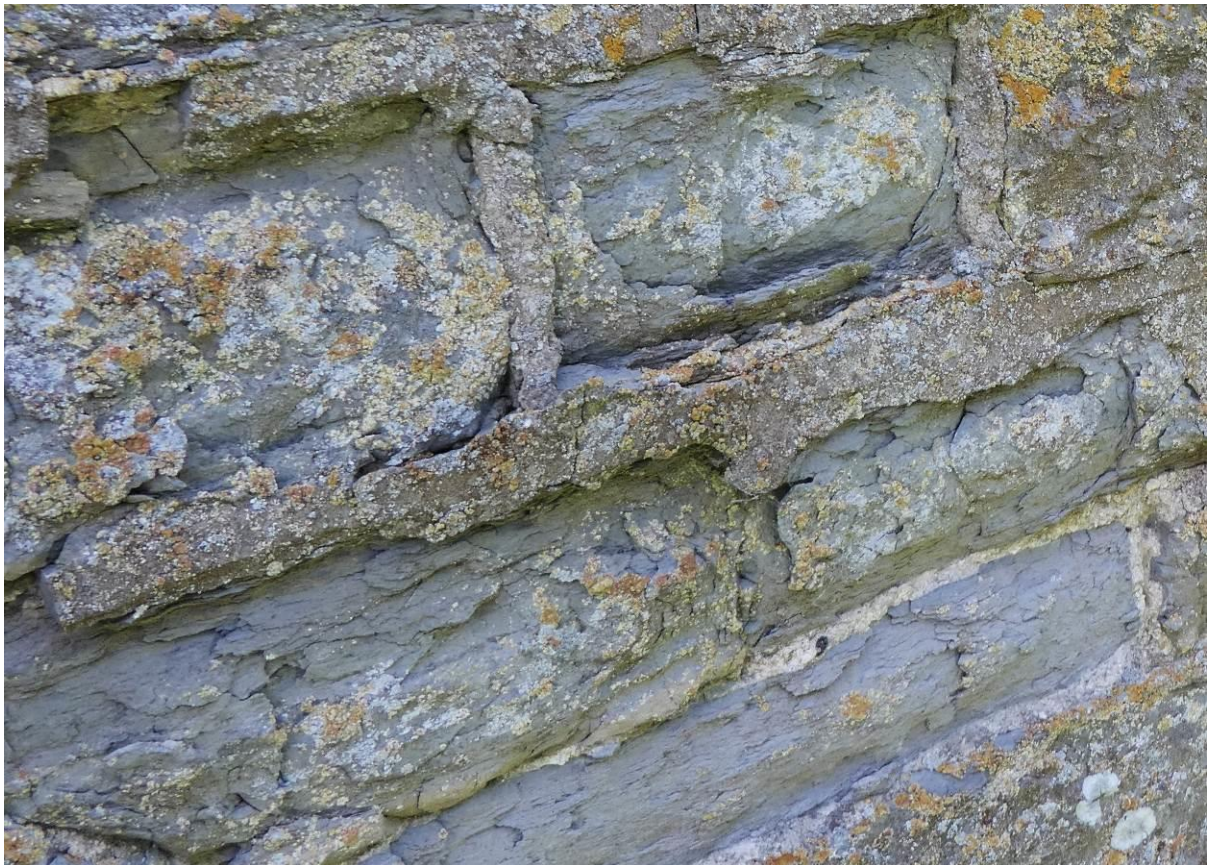
With regards to the effects of the weather on the structure and stonework, the lower stages of the tower are quite well-protected from the elements by nearby trees, but the upper levels are however very exposed. The lias stonework is however in very poor condition and instances of swelling and contracting have already been noted in the structural report. The proximity to the sea and the marine environment has exacerbated the issues of stone decay, with airborne sodium chloride causing powdering of the stone surfaces and fragmentation of the stone pieces through repeated wetting and drying cycles.

The result of this decay in isolation results in, at least, a great loss of surface material and the associated increase in rate of decay due to vulnerable softer internal matrices being exposed. In combination with widespread forces exerted through structural movement however, it presents a perfect storm of issues that puts the structure at great risk of partial collapse, especially in the upper section of the stair turret down to around the top of the 2<sup>nd</sup> stage, and in the tower elevations around the windows.

**Figure 5 - P1000458 Example Area of Decaying Masonry Exacerbated by the Marine Environment and Cement Pointing in Tower West Elevation above West Window**

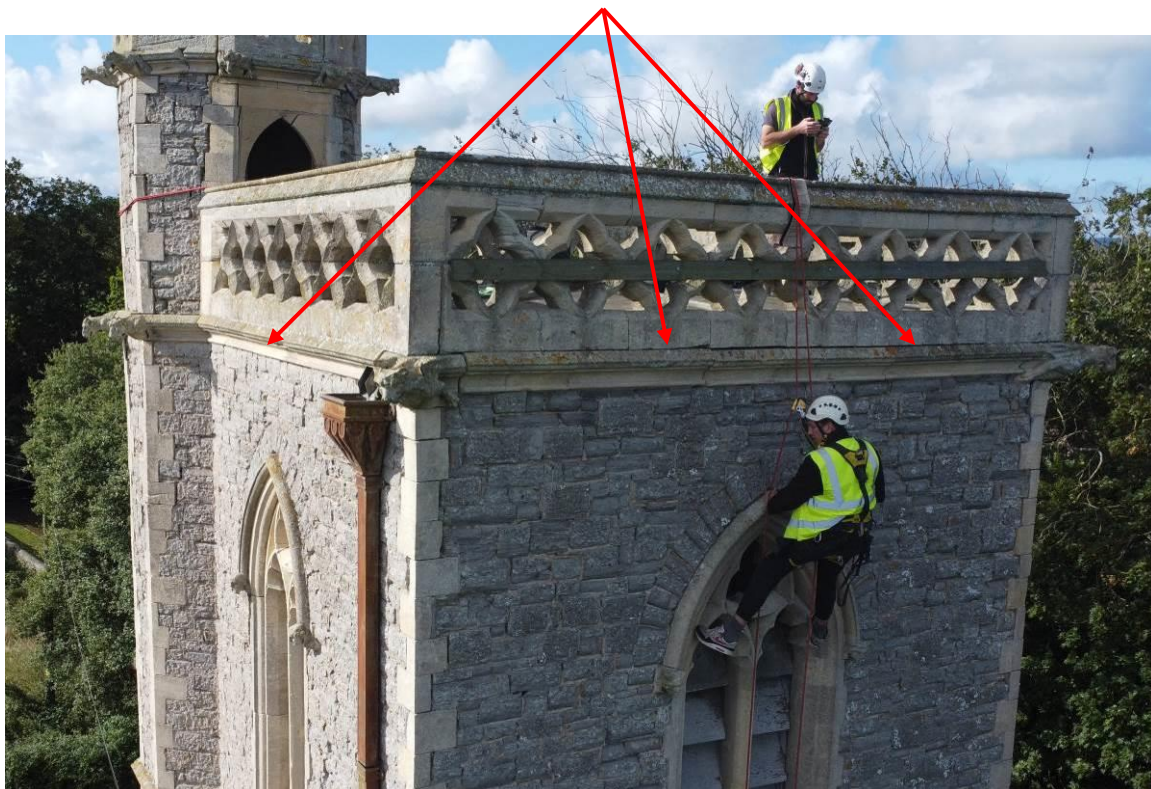
Figure 10 - DJI\_0202 Masonry 'Jacking' & Displacement Visible in All Four Elevations of the Tower Parapet

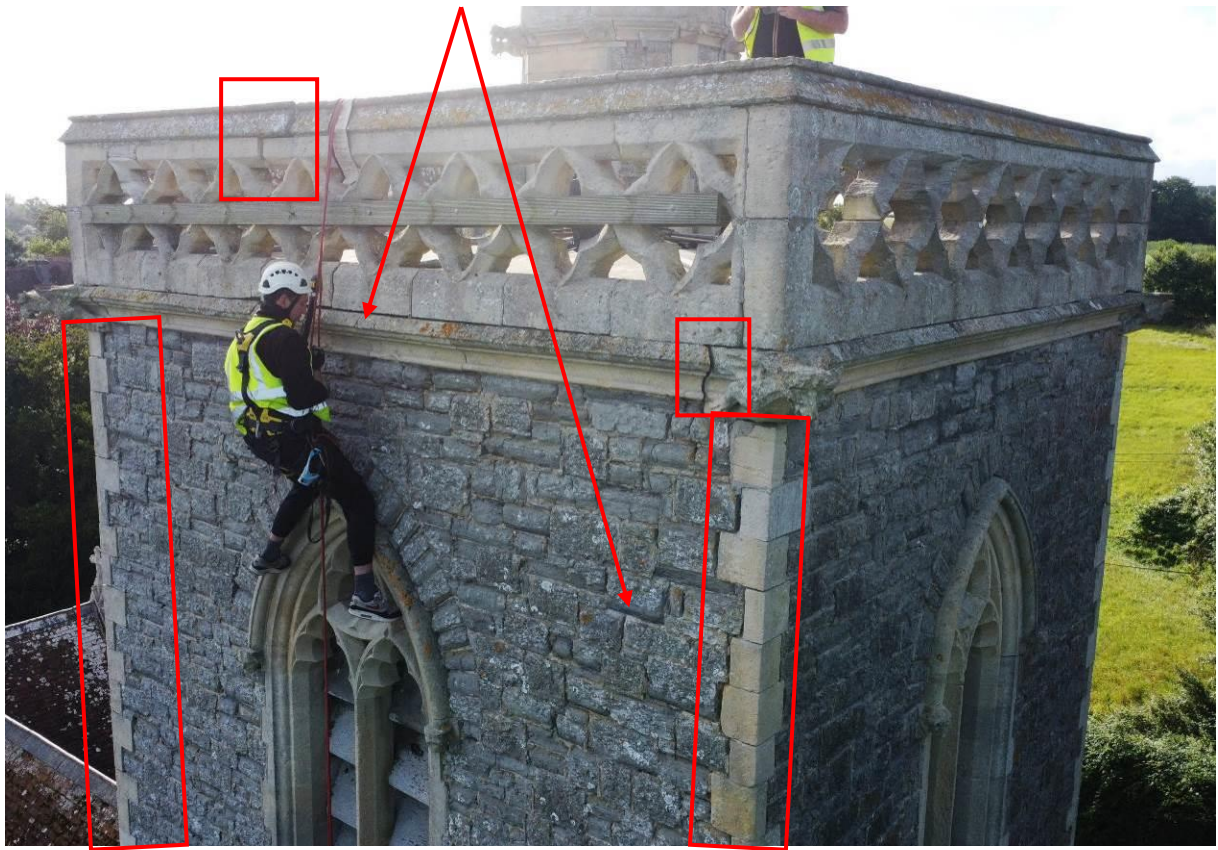
The parapet in the north elevation is in very poor condition, exacerbated by what is believed to be a rusting ring beam lifting or 'jacking' the masonry. This is combined with the upward force of the lias masonry swelling and/or the non-window vertical lines of the building effectively subsiding into the ground. The parapet is currently braced with a temporary timber structure, but it still leaves the parapet in a very precarious state and so requires completely rebuilding. If a rusting ring beam is present, it requires removing and re-fixing with a stainless-steel replacement specified by a structural engineer. Considering the ongoing deterioration of the lias masonry and the ground conditions, the structural engineer might wish to specify additional fixings to reinforce the parapet and make it more able to withstand further movement in the future. Numerous masonry fractures require pinning repairs and rusting iron fixings require removing and replacing with stainless steel replacements before reassembling the parapet. At least one section of the parapet panels will require a piecing-in repair.

Figure 12 - DJI\_0200a Severe Displacement of Parapet & Open Joints in Walls & Along Quoins

- If a rusting ring beam is present in the parapet, it requires removing and re-fixing with a stainless-steel replacement specified by a structural engineer.

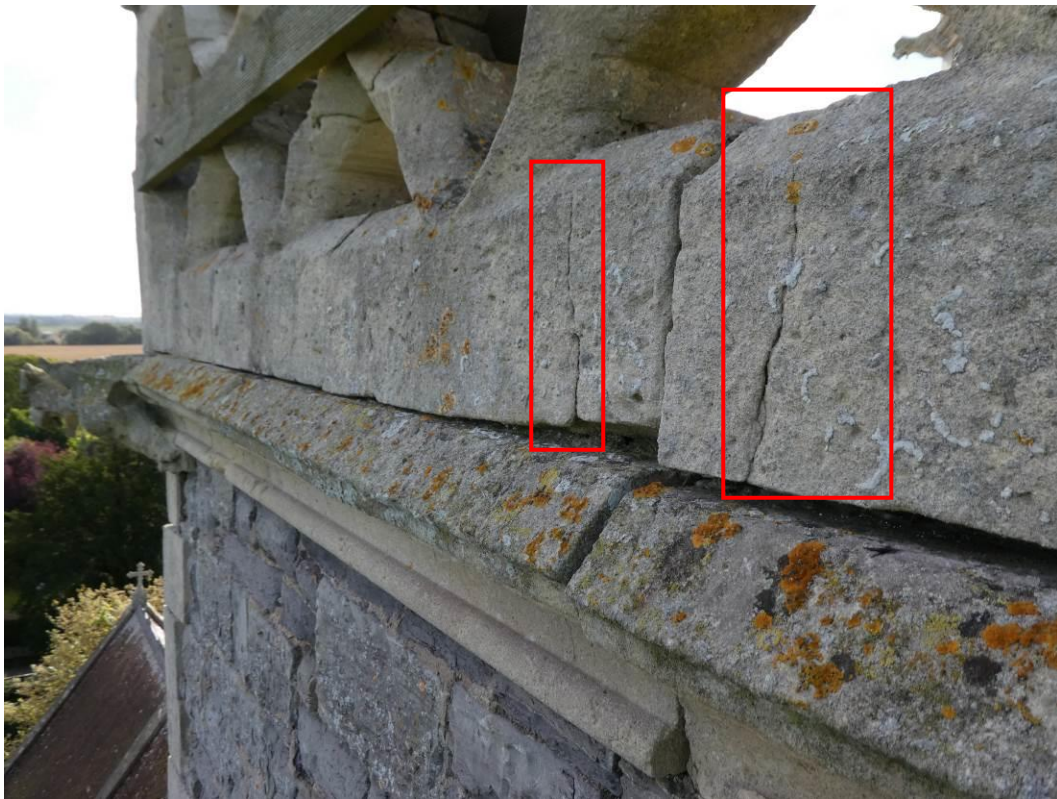
Figure 13 - P1000237 Example Masonry Fractures in North Elevation Parapet

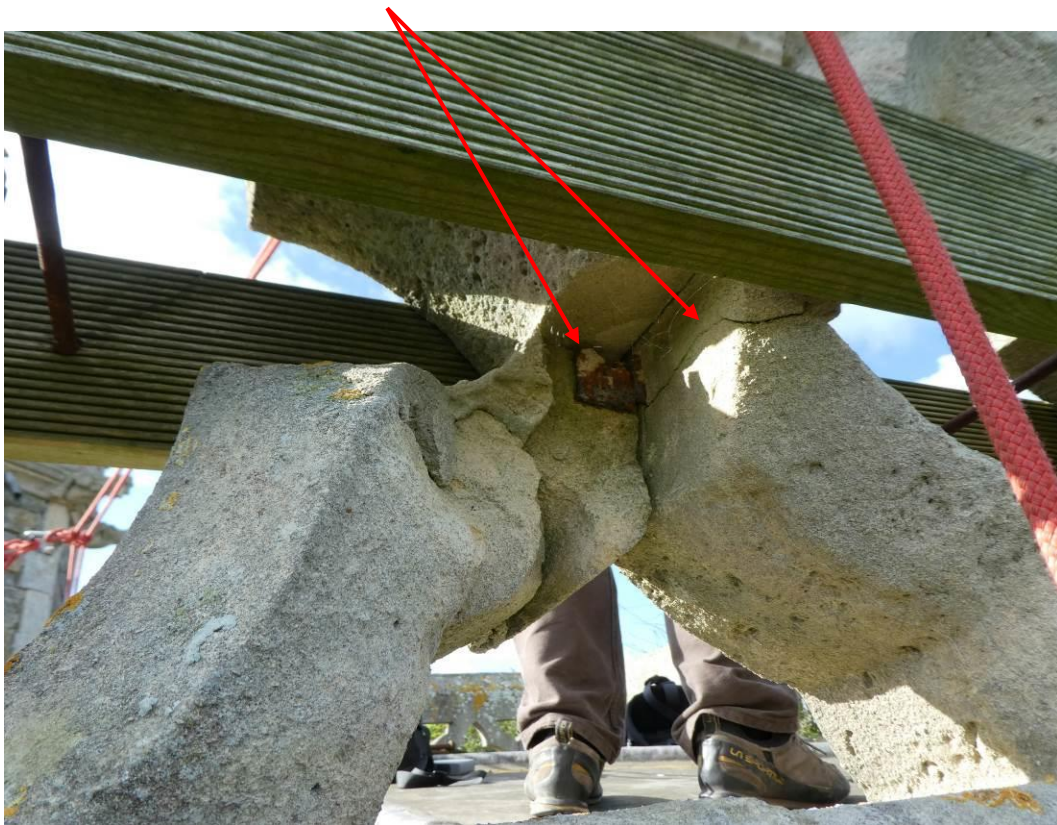
Figure 14 - P1000239 Example Rusting Fixing & Associated Masonry Fractures in North Elevation Parapet

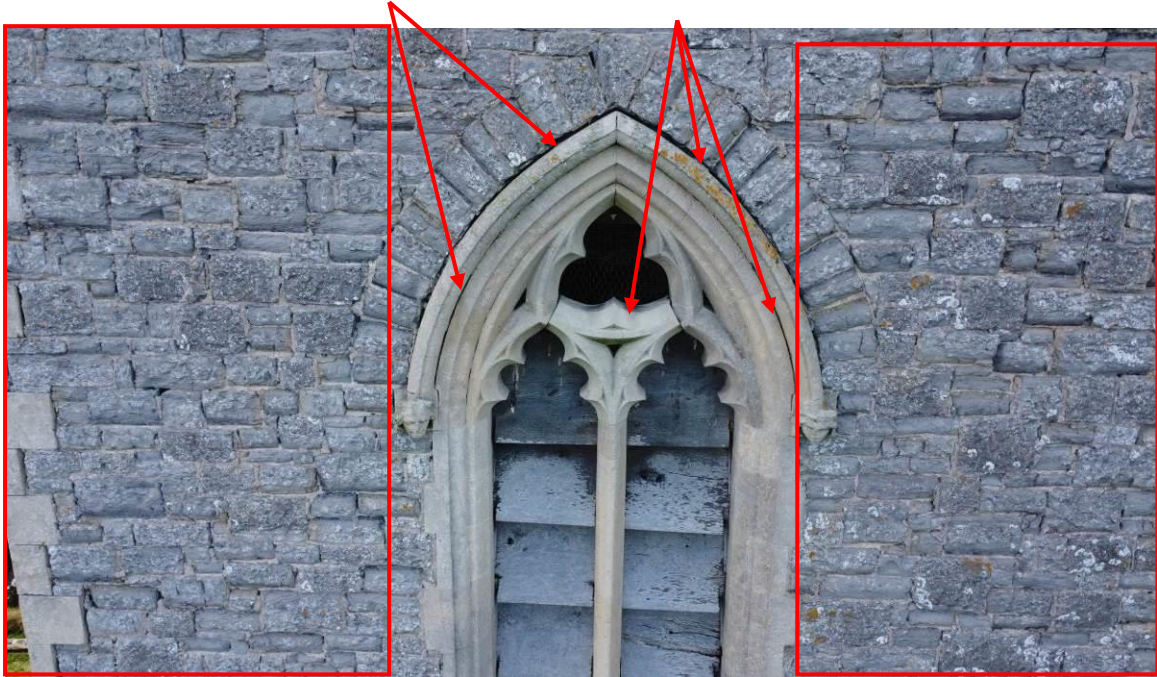
Figure 15 - DJI\_0245 Widespread Open Joints & Voids Throughout North Elevation Belfry Level

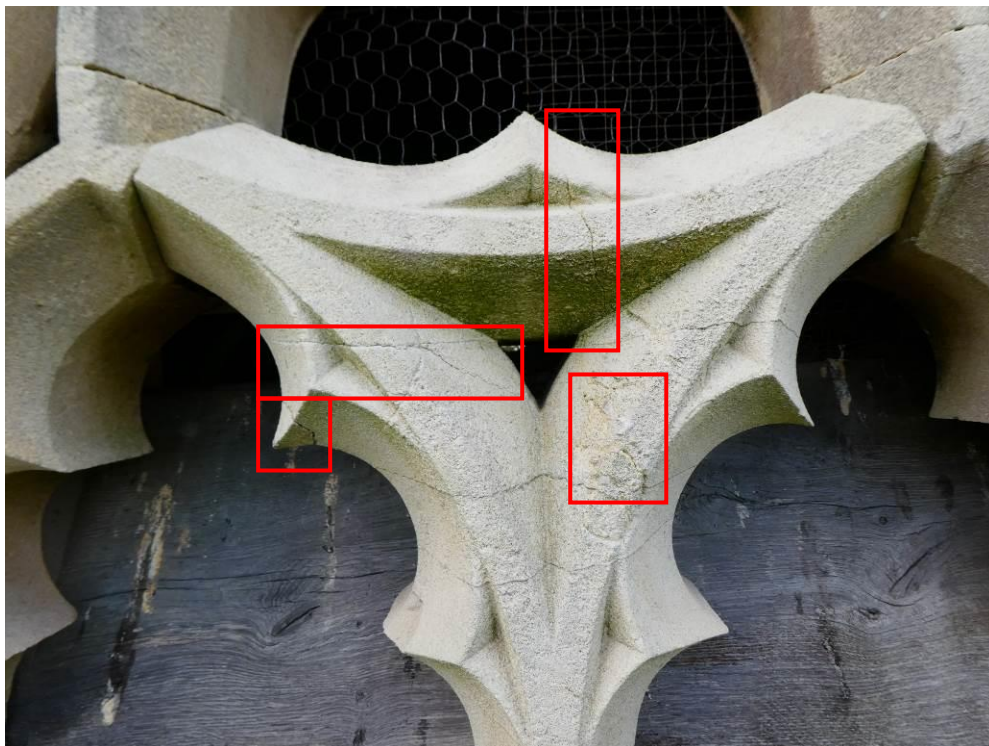
Evidence of a combination of swelling lias masonry and potentially subsiding wall sections is visible in the belfry, where the centre of the belfry window mullion and tracery are either jacked or have stayed correct, while voussoir and hood have dropped. The joints above the window header and in the voussoir are open and the tracery masonry severely displaced in relationship to them. Fractures resulting from the forces exerted on it are visible throughout the central tracery masonry piece.

Figure 16 - P1000250 Numerous Fractures in North Belfry Window Central Tracery Piece (Note Displacement)

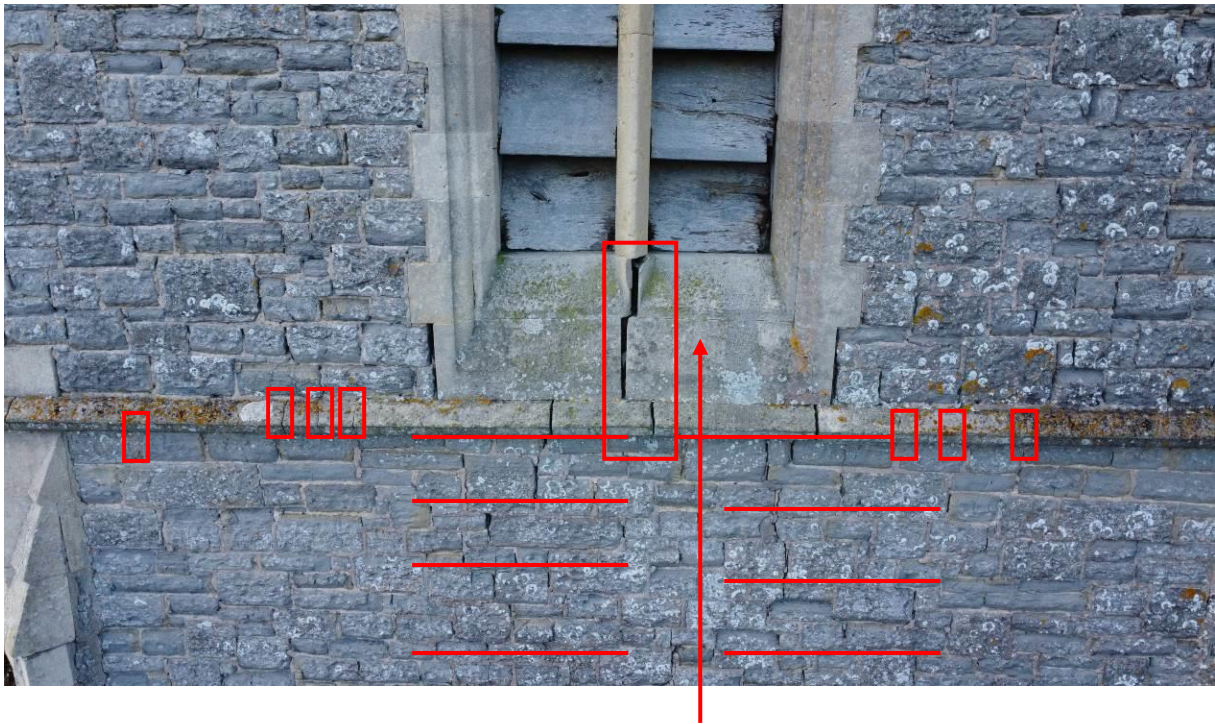
The open joint system that extends through the belfry window sill and all the way down through the 3<sup>rd</sup> stage window, is more open in the top of the upper joint than the bottom, suggesting that the masonry is being pushed upwards. This evidence is supported by the slight upward curve in the string course underneath as it passes below the window sill, and the associated open joints and masonry fractures in the string course either side of the window sill. Mitigation would involve dismantling the tracery, mullion and sill, reinstating the string course horizontally and then rebuilding upwards.

Figure 17 - DJI\_0246 Open Joint Systems Extending Through Belfry Window North Elevation

The two vertical open joint systems require stabilisation so consider fixing 10mm diameter x 1 metre length helifix or stainless-steel threaded pins set into masonry resin horizontally across the vertical open joints down to the 3<sup>rd</sup> stage window header.

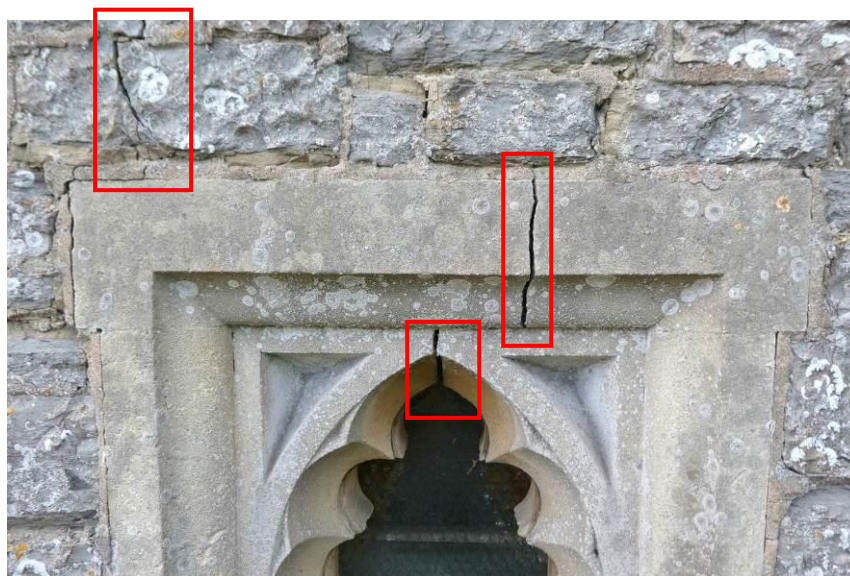
Figure 18 - P1000269 Masonry Fracture & Open Joint in 2nd Stage Window Header North Elevation

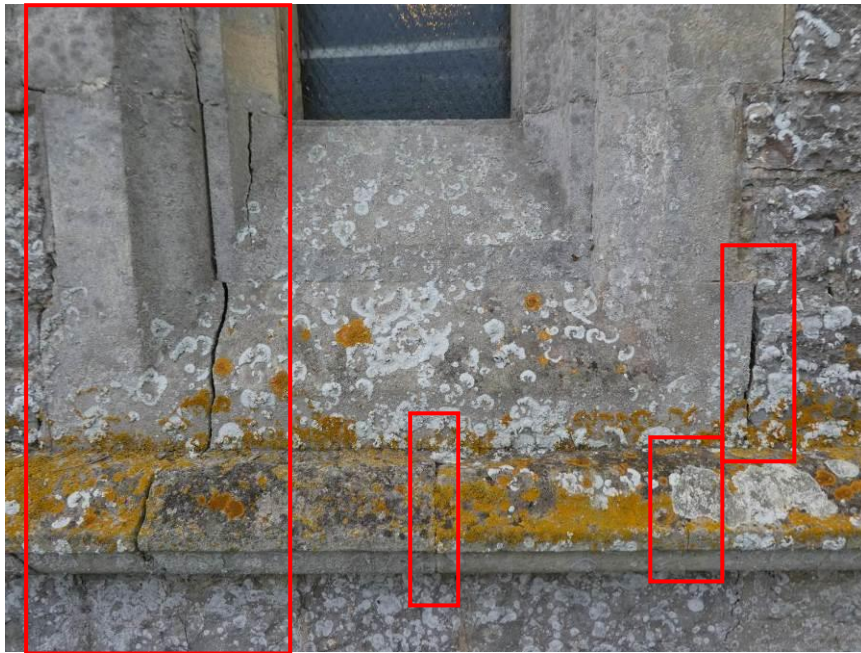
**Figure 19 - P1000275 Masonry Fractures & Open Joints in 3rd Stage Window Sill & String Course North Elevation**

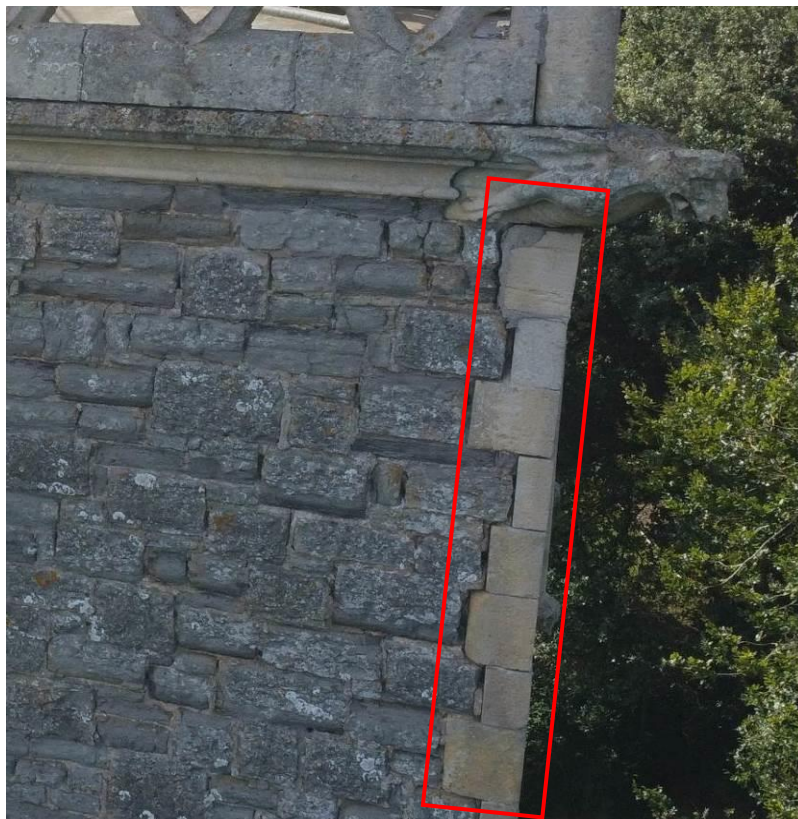
The same combined issues are causing the belfry level tower edge quoins and a kneeler stone in the 2<sup>nd</sup> level north east buttress to become precariously loose and in danger of falling to ground level. These should be stabilised with holding repairs by deep-pack re-pointing with lime mortar as a priority and then revisited for thorough re-pointing once the scaffold is erected. Some unstable quoins will inevitably require removing and re-bedding in lime mortar.

**Figure 20 - DJI\_0201 Displaced & Loose Quoins in North Elevation Belfry Level**

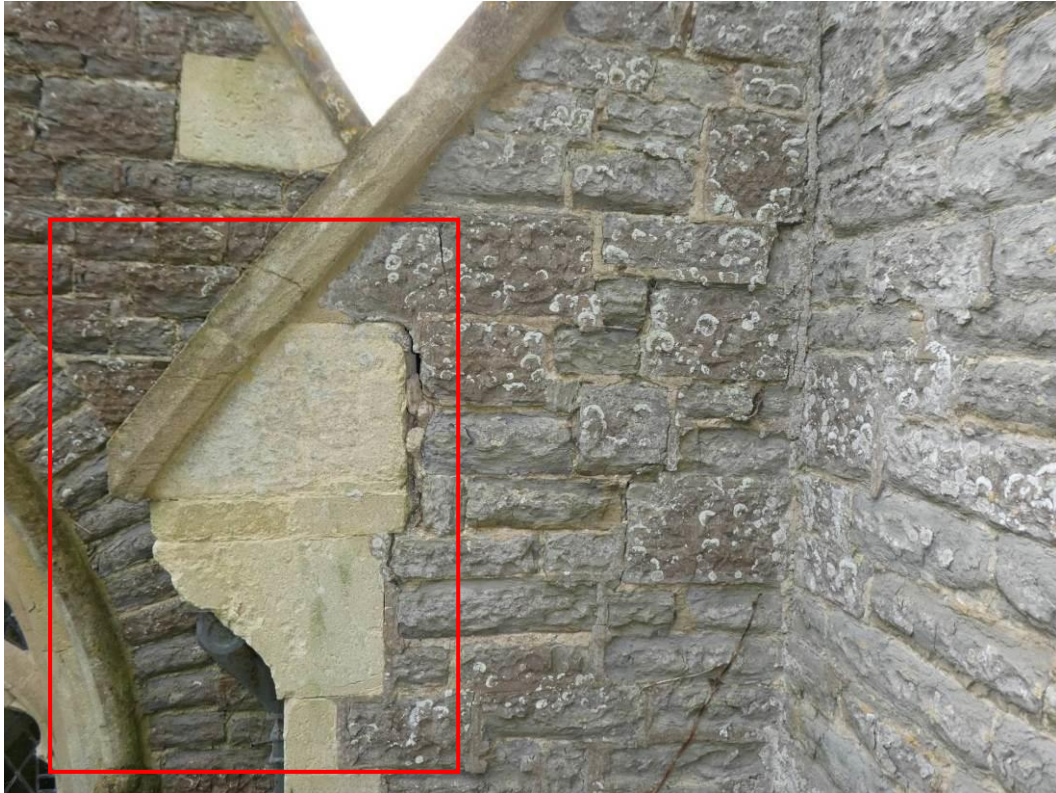
**Figure 21 - Precarious Kneeler Stone in North East Buttress 2nd Level**

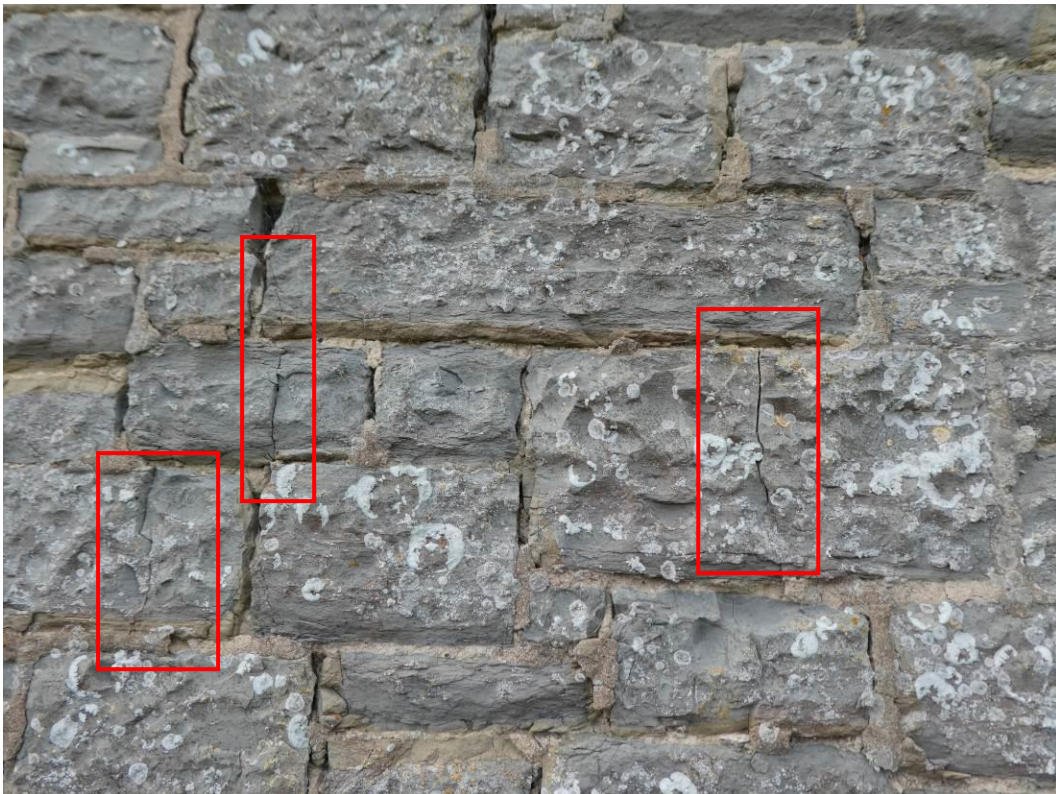
In some places the lias masonry has fractured where associated with open joint systems.

**Figure 22 - P1000264 Masonry Fractures Associated with Structural Movement Open Joints in North Elevation 3rd Stage**

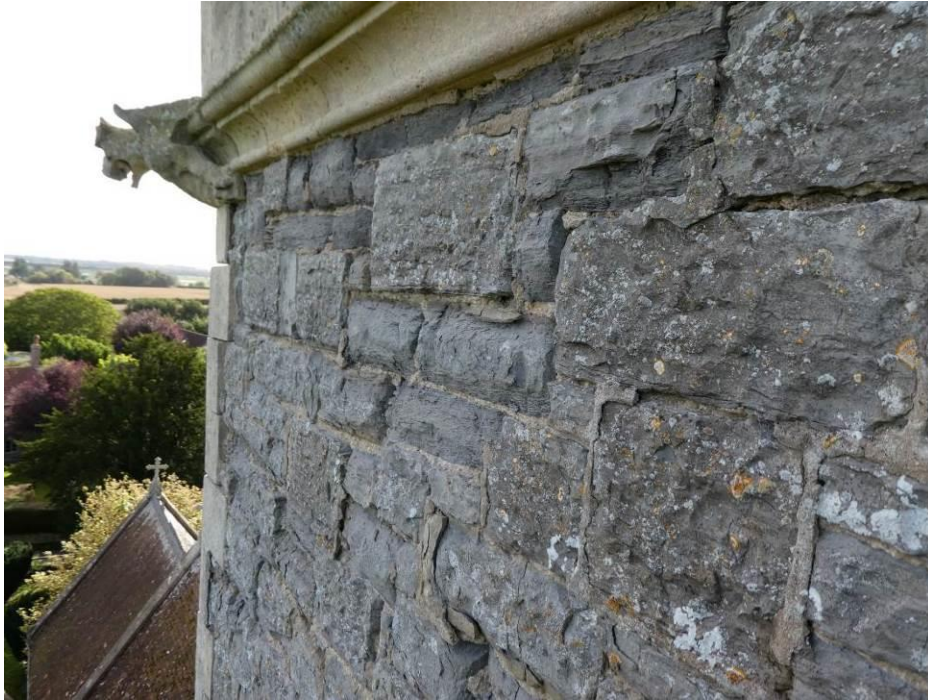
**Figure 23 - P1000241 Example Area of Deteriorating Lias Masonry & Cement Pointing in North Elevation Belfry Wall**

The pointing is in very poor condition, exacerbated by the lias swelling and incompatibility of the cement mortar with the lias stone. All cement mortar should be removed and the whole elevation re-pointed with lime mortar. Where lias decay has left water traps, lime mortar repairs will aid in water runoff and help avoid the saturation of the stone.

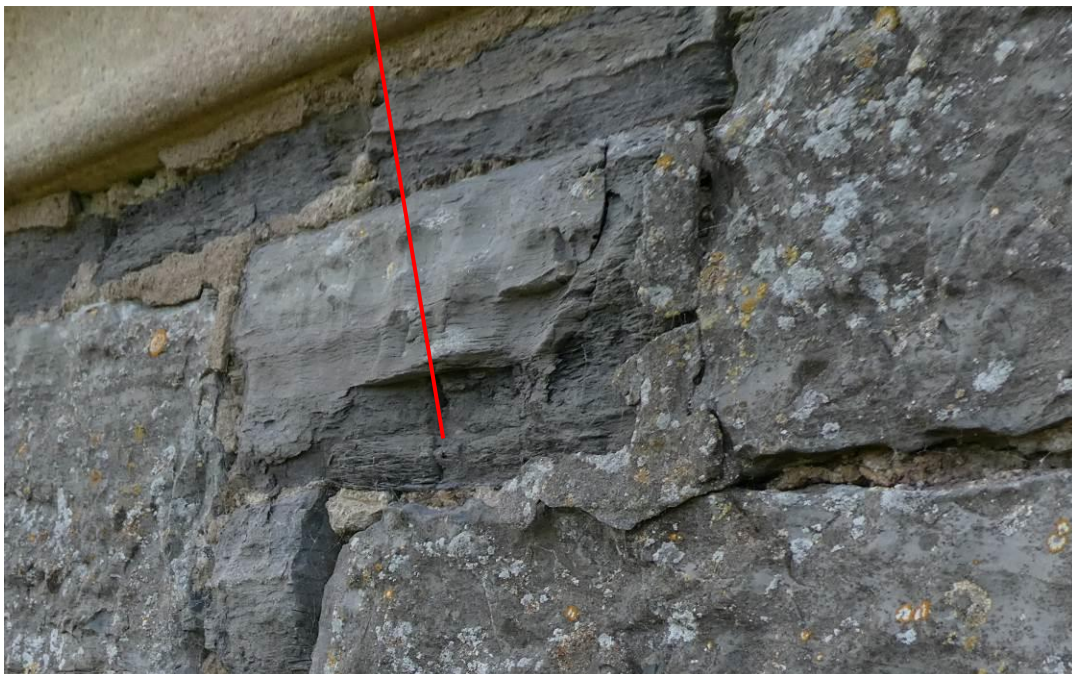
**Figure 24 - P1000241 Example Lias Decay Where Mortar Repair Would Aid in Water Runoff**

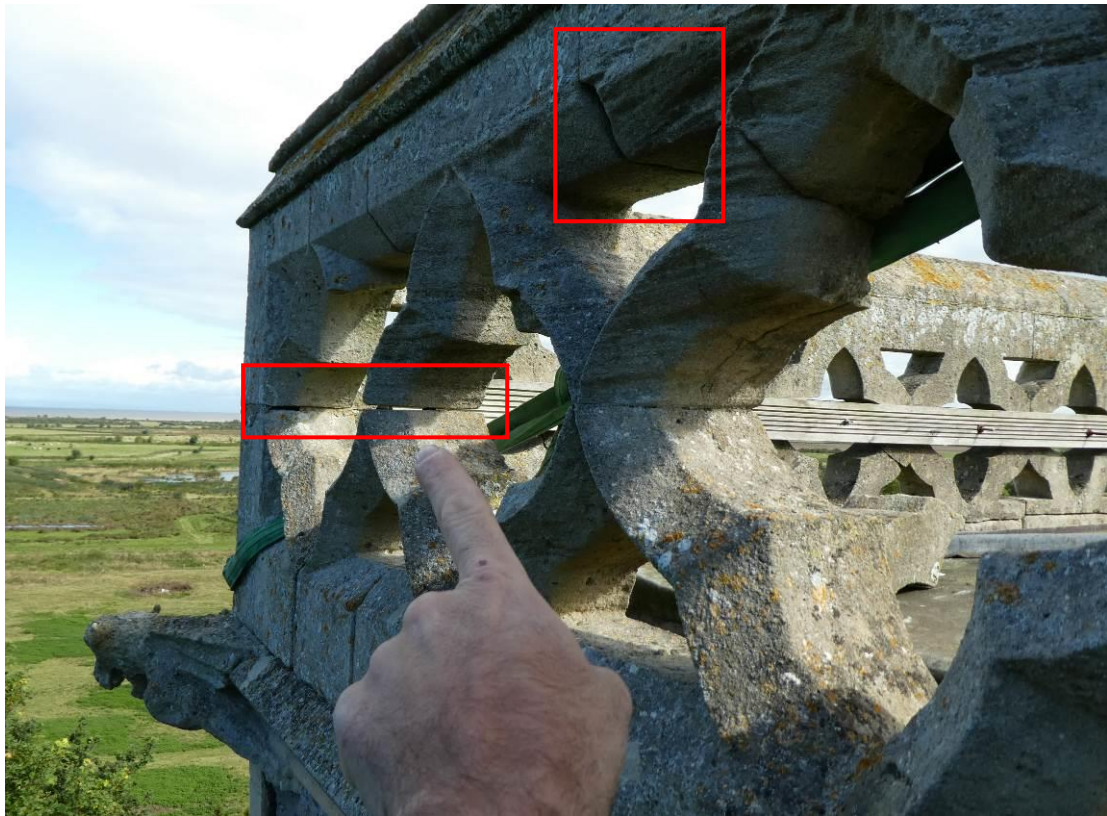
Figure 26 - P10004263 Open Joints Illustrating West Elevation Parapet Bowing Out to West

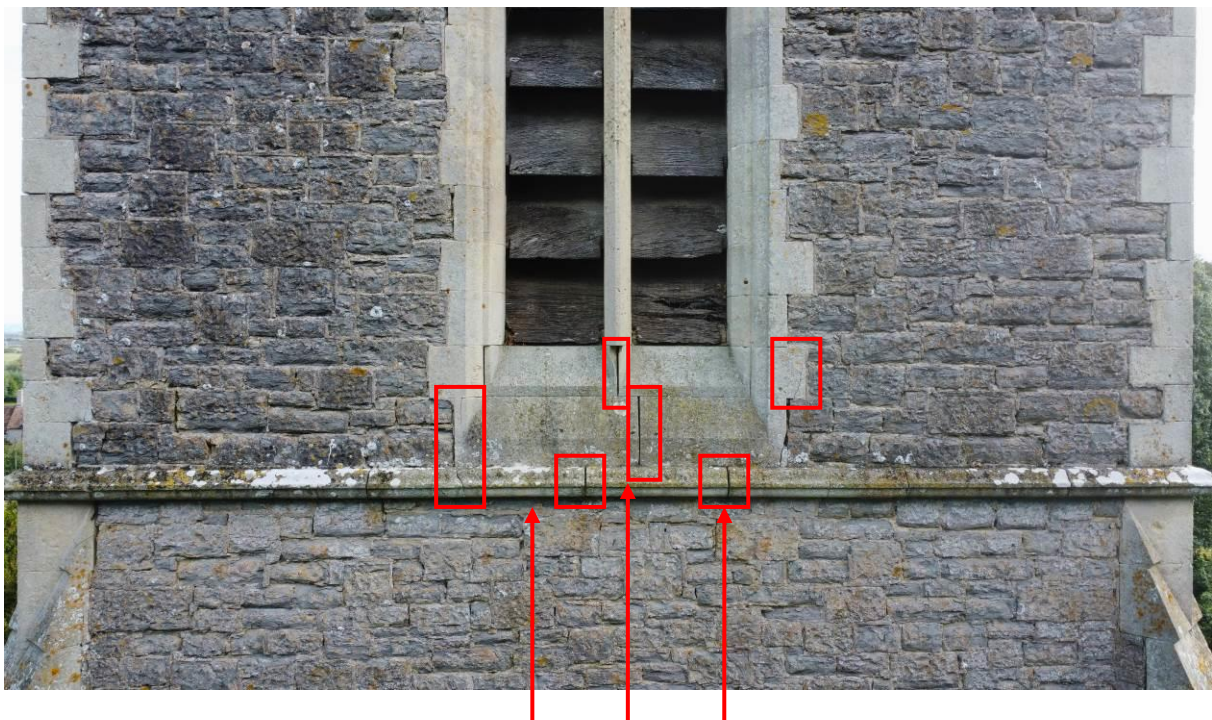
Figure 27 - DJI\_0250 Vertically Displaced Belfry String Course, Fractures & Open Joints in West Elevation Belfry Window

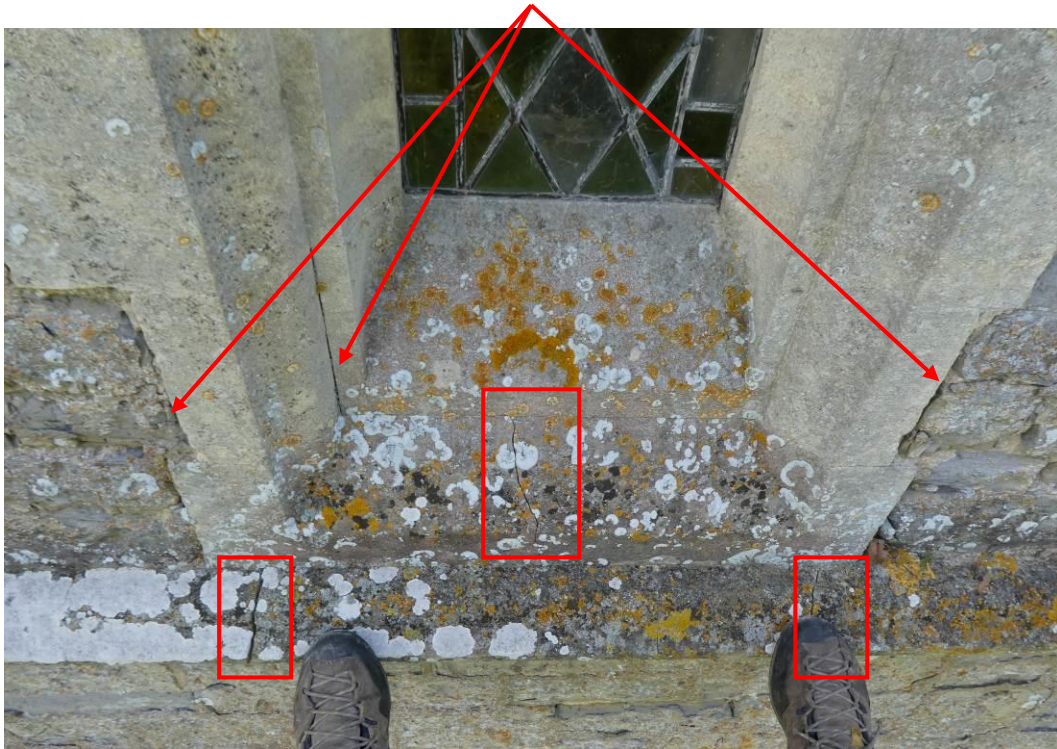
**Figure 28 - P1000450 Masonry Fractures & Open Joints in 3rd Stage Window Sill & Reveals West Elevation**

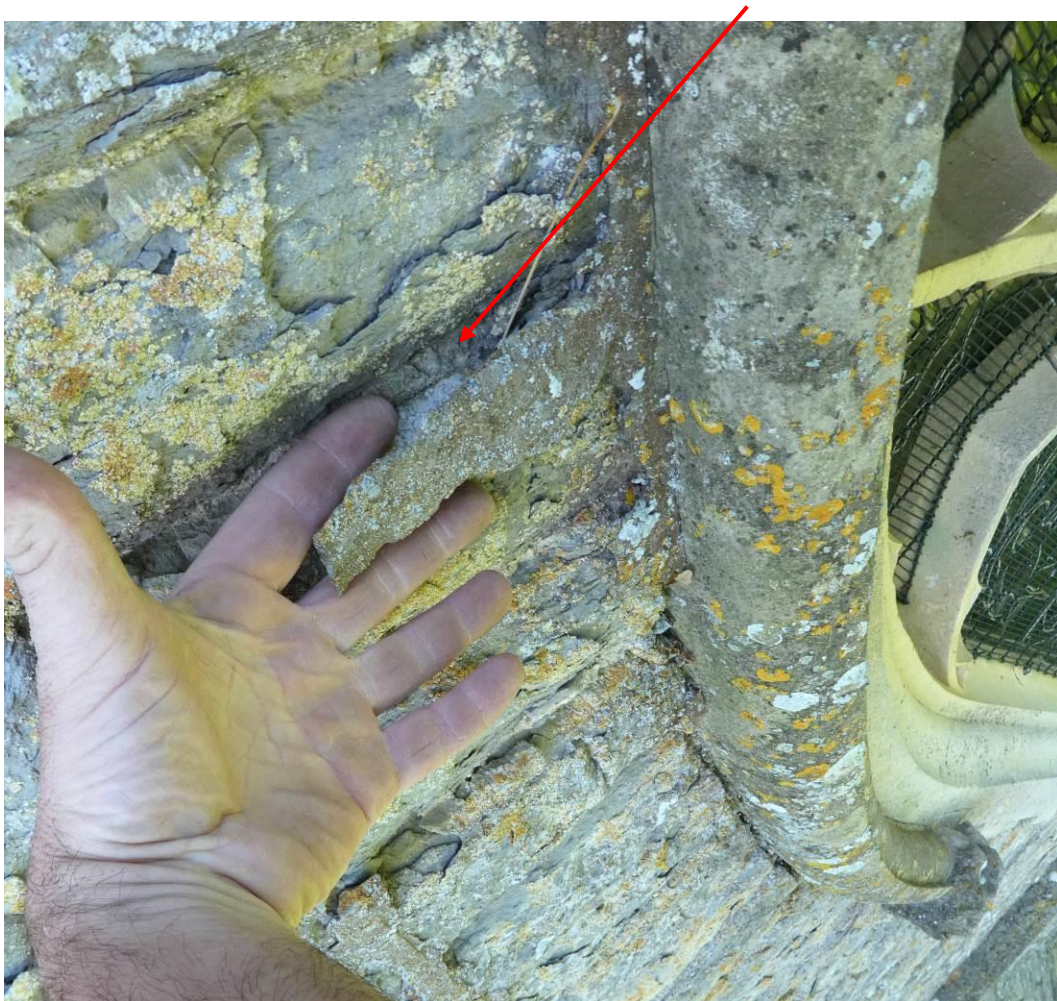
The cement pointing and associated masonry decay is in very poor condition, especially in the 2<sup>nd</sup> stage around the west window.

**Figure 29 - P1000455 Example Badly Decayed Masonry Around West Window Cement Pointing in 2nd Stage**

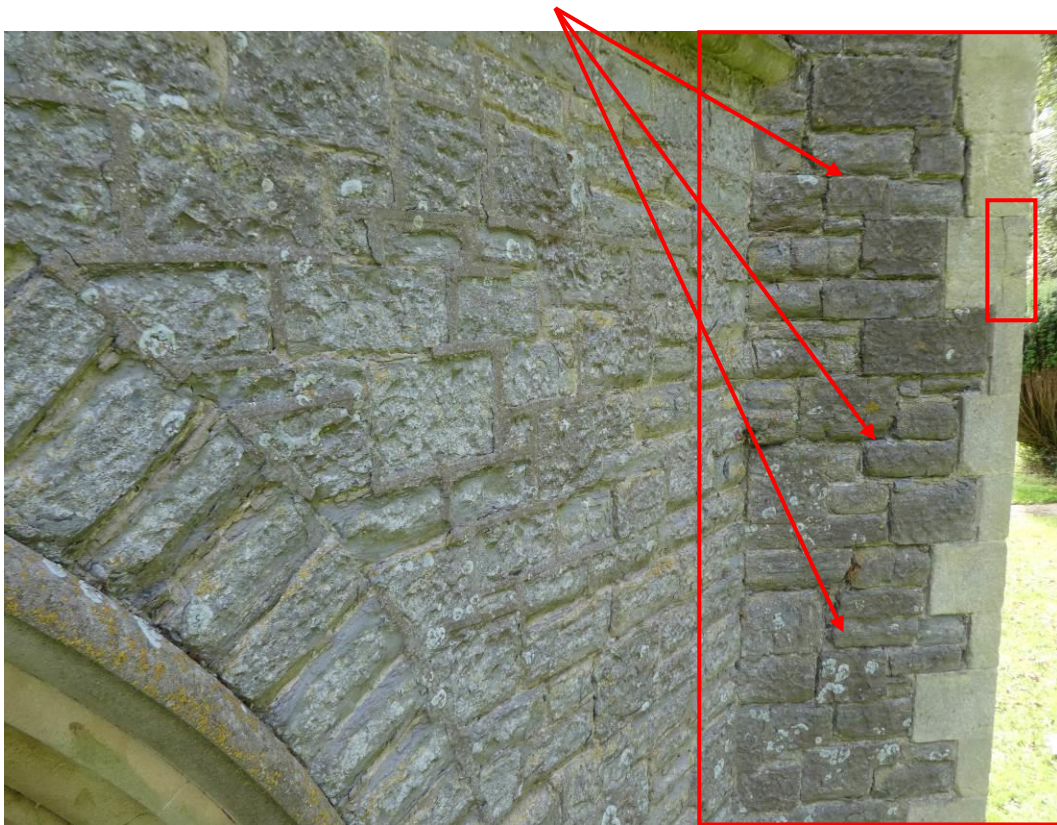
**Figure 32 - P1000476 South West Buttress Appears to be Under Great Structural Stress**

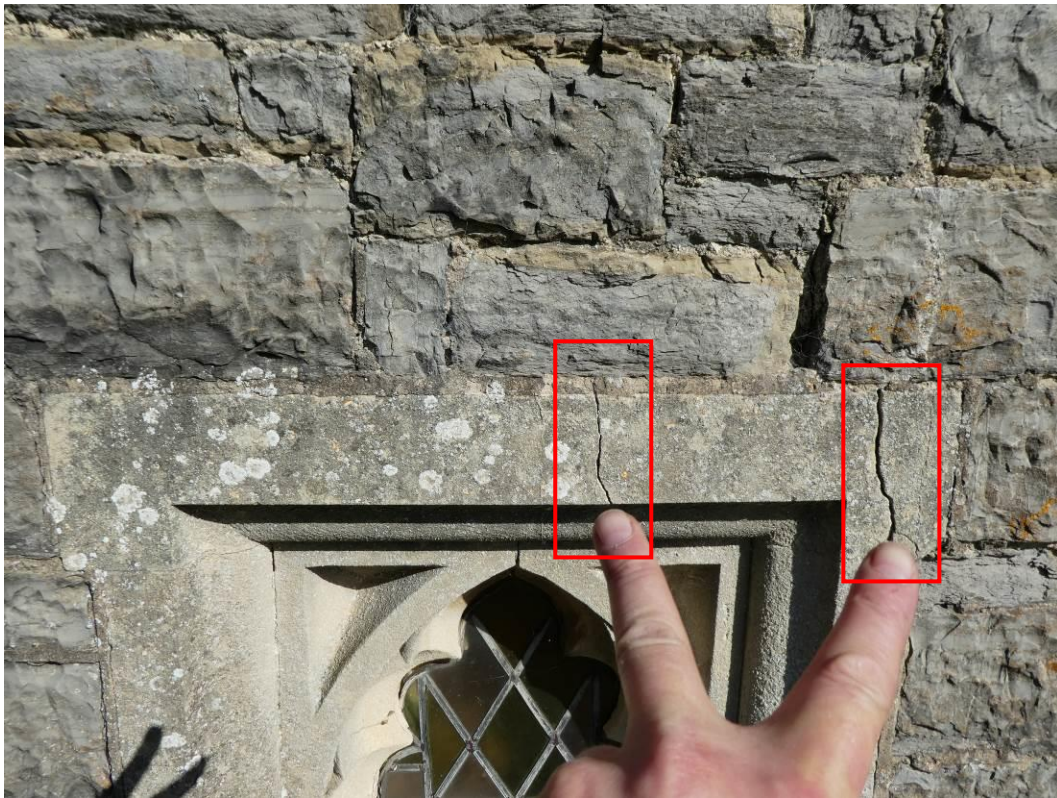
**Figure 34 - P1000364 Masonry Fractures in 3rd Stage Window Header South Elevation**

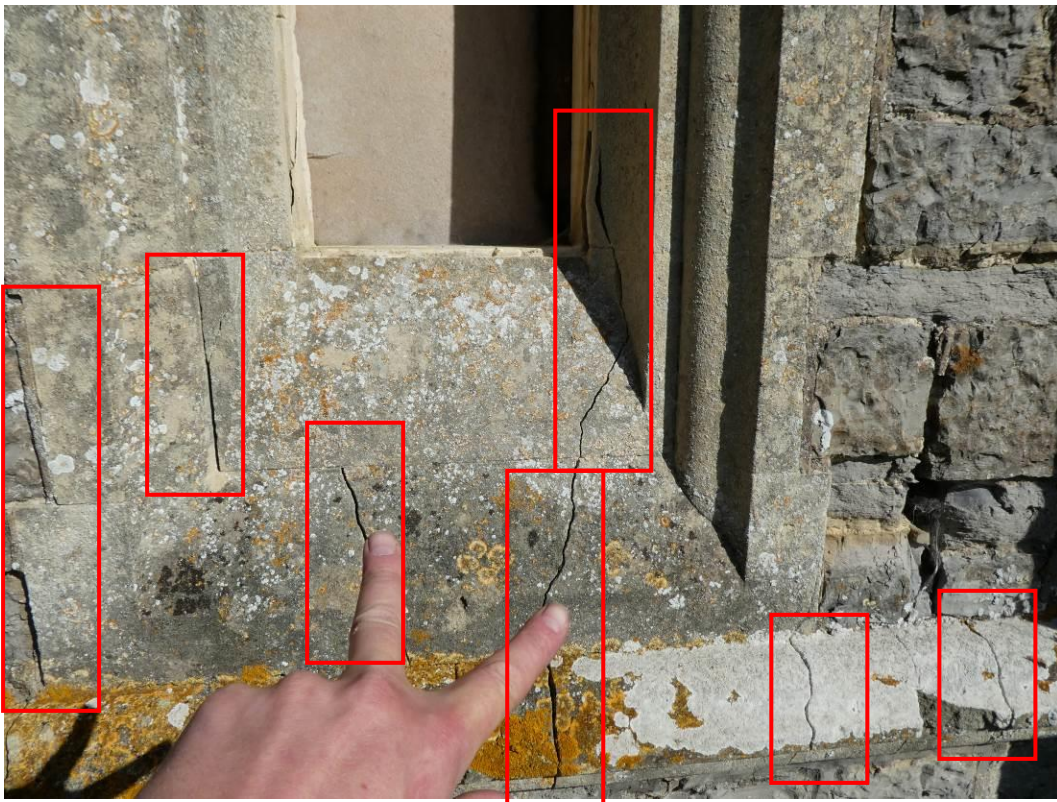
**Figure 35 - P1000368 Masonry Fractures & Open Joints in 3rd Stage Window Sill South Elevation**

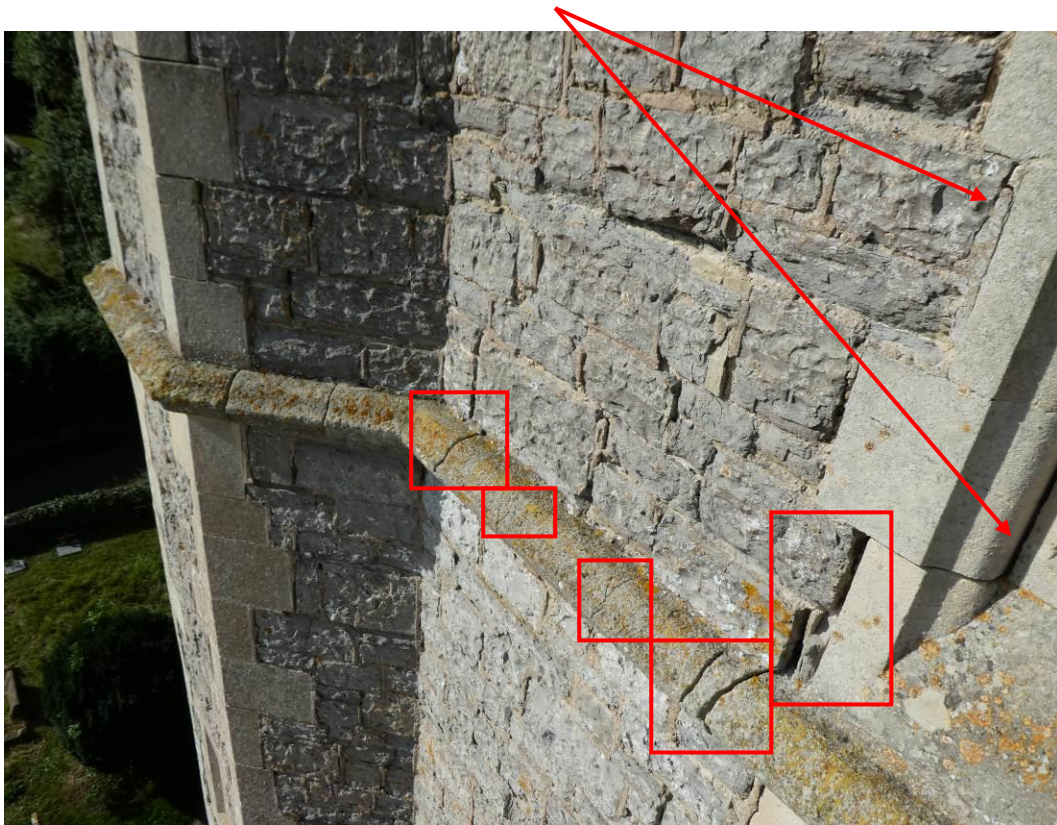
Figure 37 - P1000319 Masonry Fractures & Open Joints Below & Around Belfry Window East Elevation

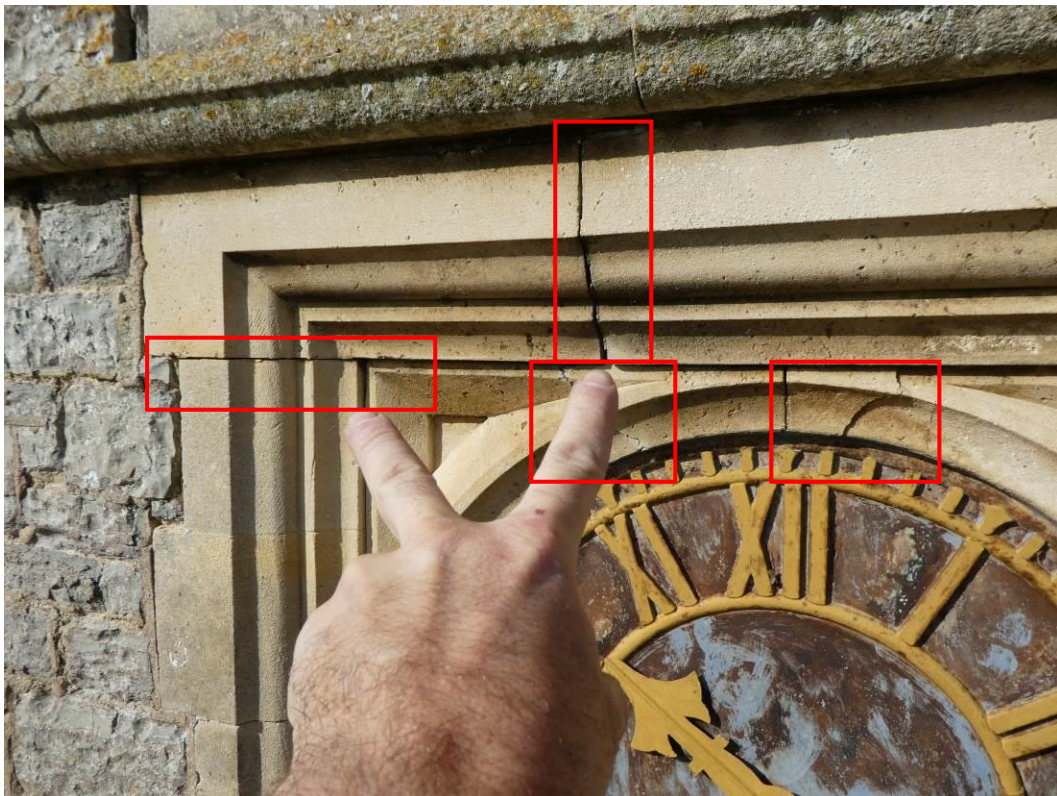
Figure 38 - P1000325 Fractures & Open Joints in East Elevation Clock Surround

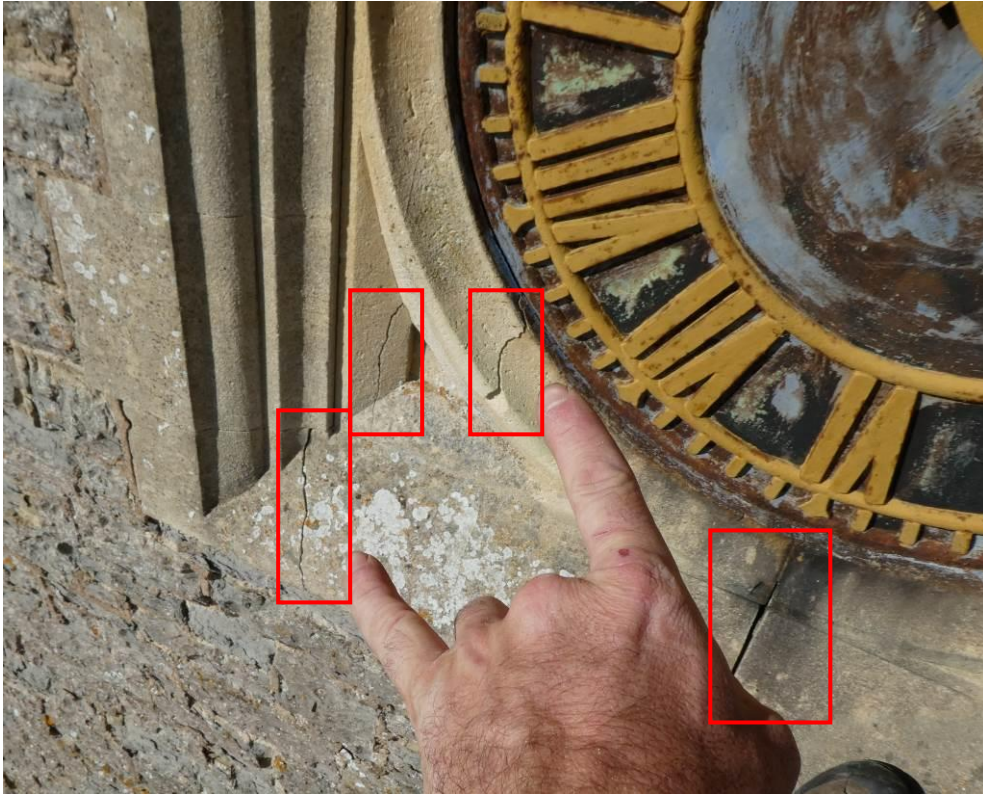
**Figure 39 - P1000329 Fractures & Open Joints in East Elevation Clock Surround**
