# Rope Access Condition & Recommendation Report

**Rope Access Condition &  
Recommendation Report for  
St Mary Magdalene Church,  
Stockland Bristol –  
September 2024**

**Job number: 3535**

**Client: Marcus Chantrey**

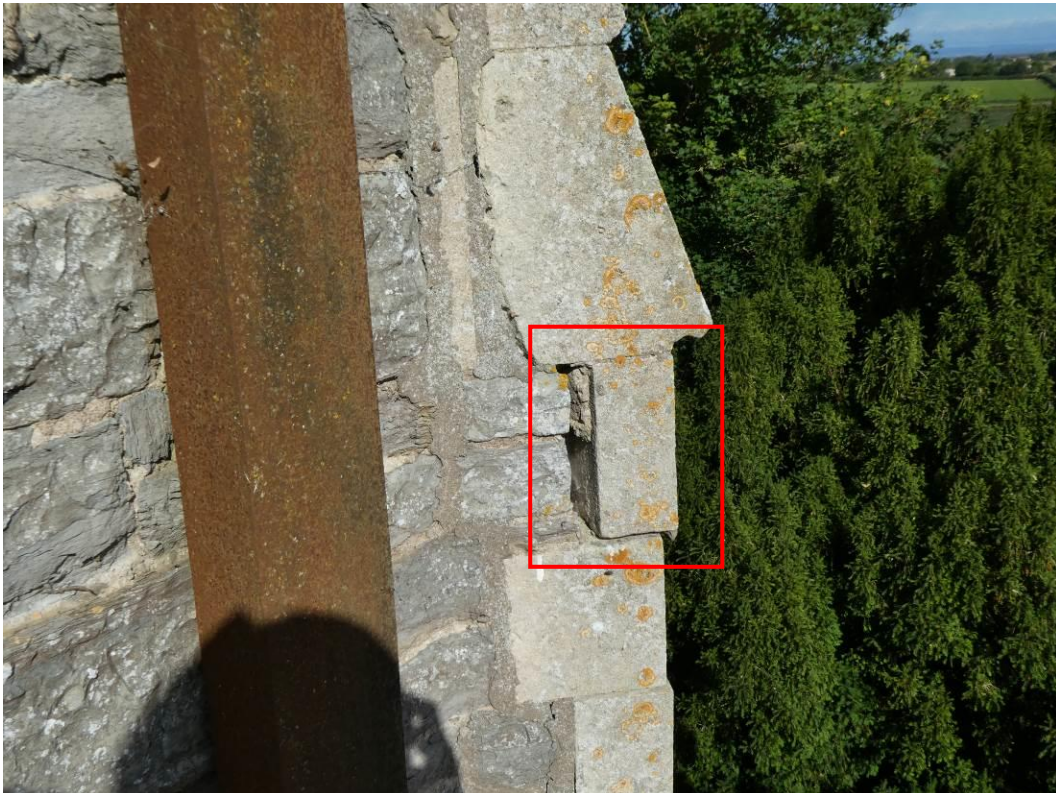
**Figure 40 - P1000327 Unstable Quoin in East Elevation North East Buttress**

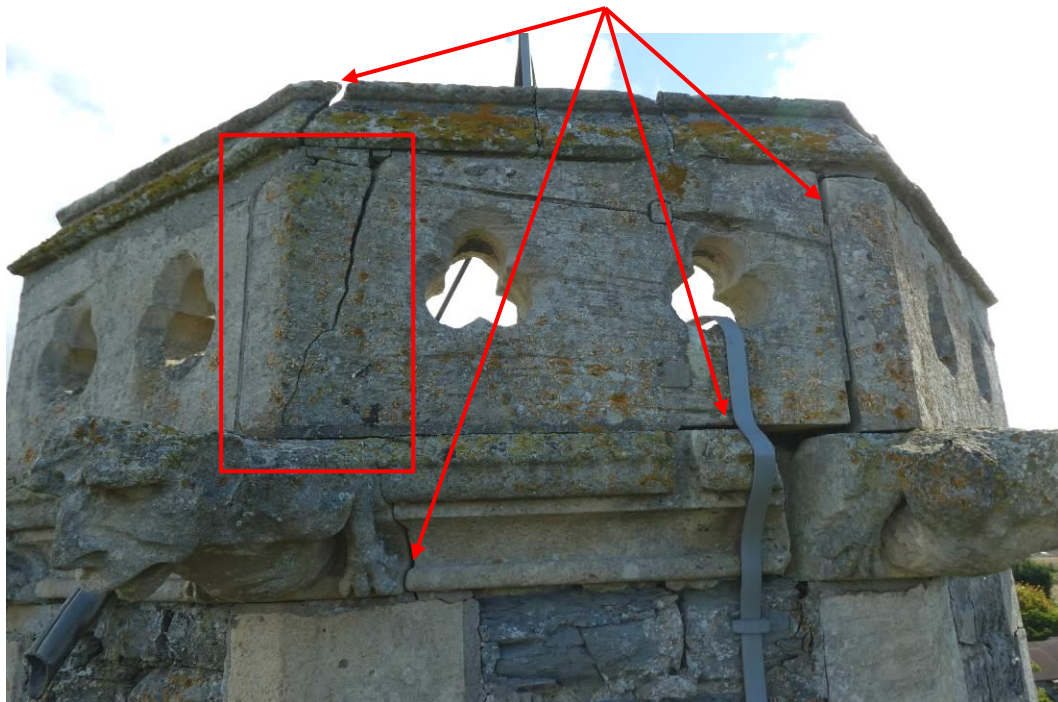
Figure 41 - P1000396 Masonry Fracture & Open Joints in Stair Turret Parapet Panel West Elevation

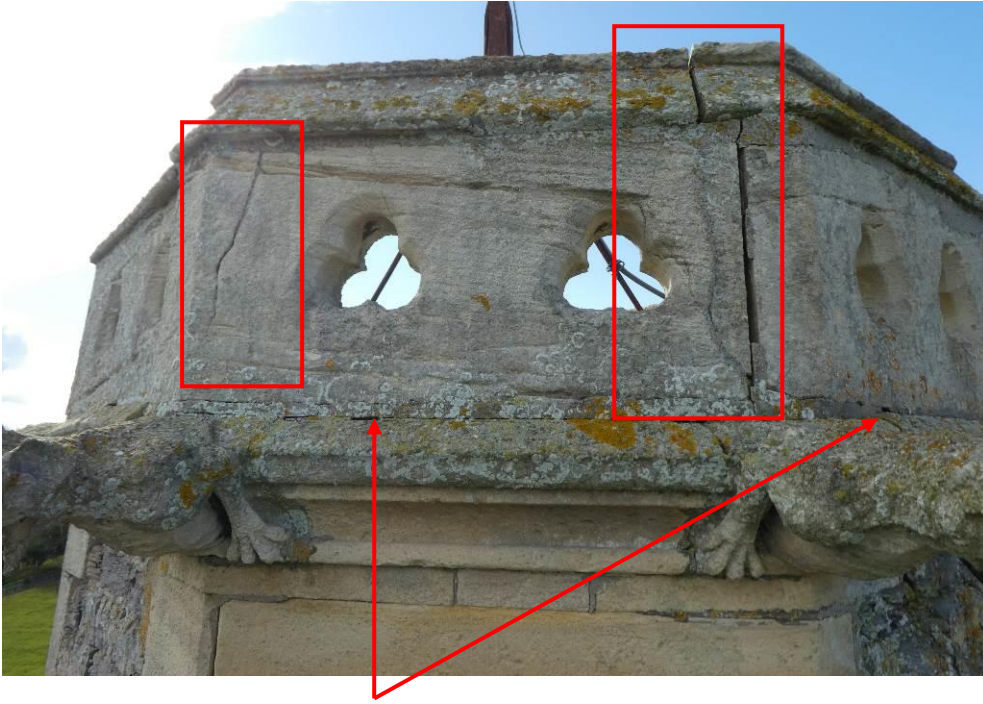
**Figure 42 - P1000401 Masonry Fracture & Open Joints in Stair Turret Parapet Panel North Elevation**

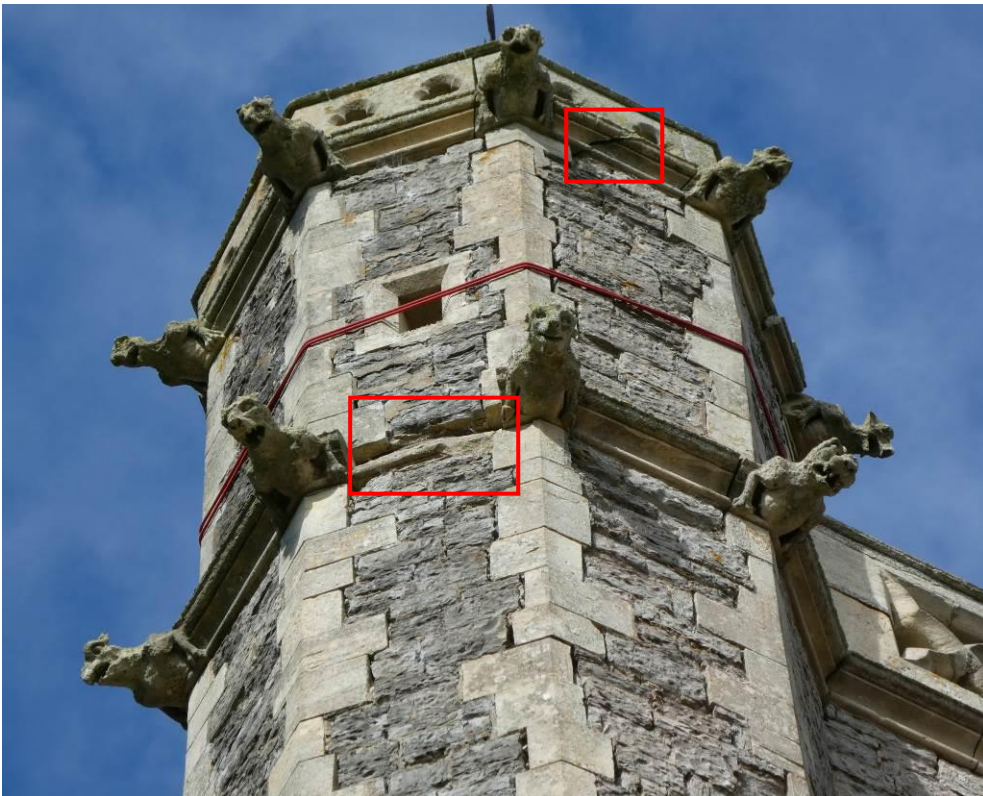
**Figure 43 - P1000481 Masonry Fracture & Missing String Course Section in Stair Turret Tower East & South East Elevations**

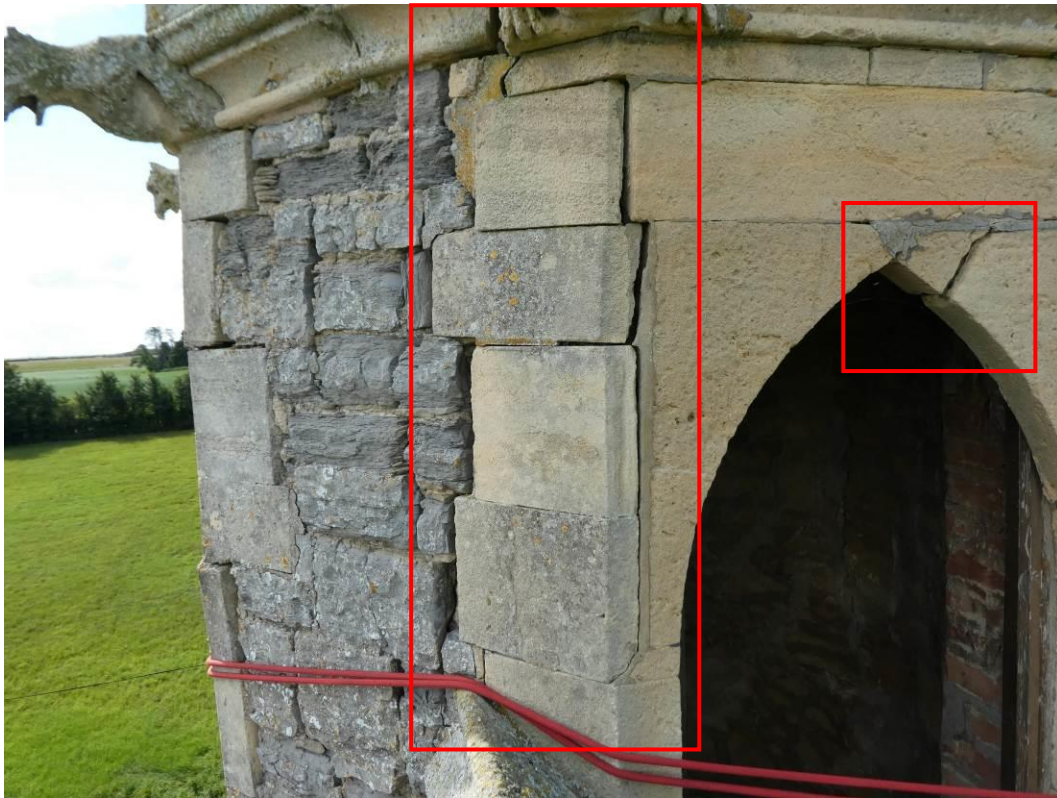
**Figure 44 - P1000403 Advanced Open Joints & Masonry Fracturing in Stair Turret Doorway**

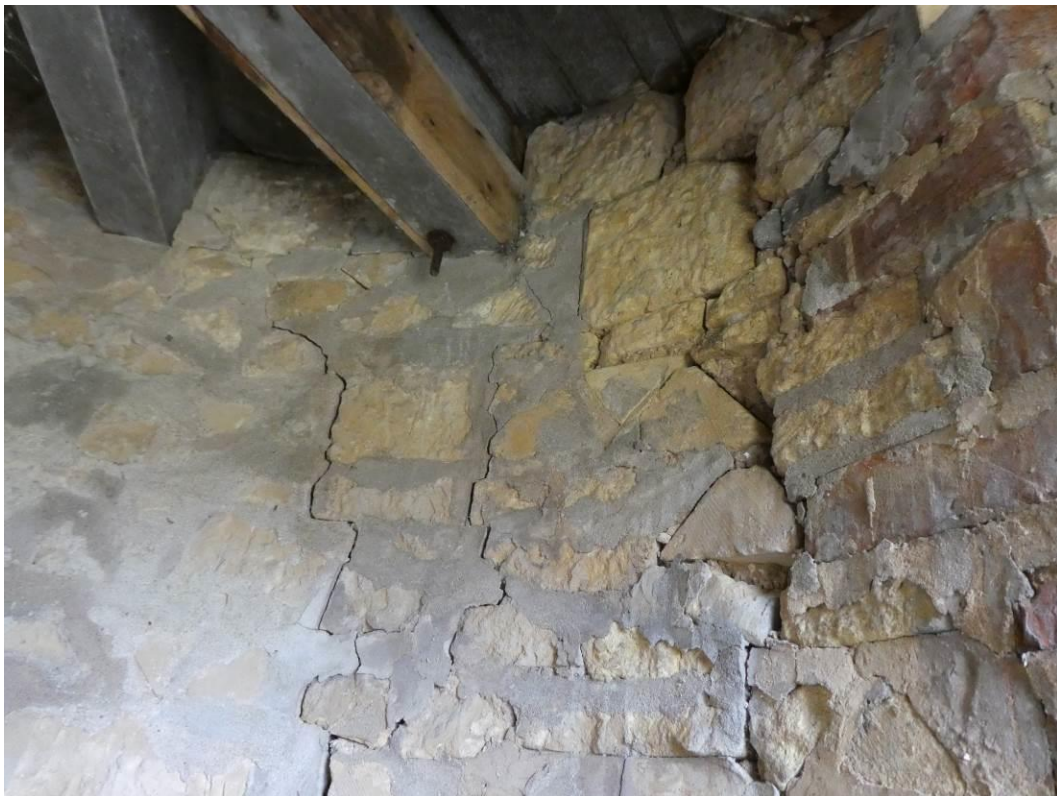
**Figure 45 - P1000416 Example Open Joint Systems Inside Stair Turret Tower**

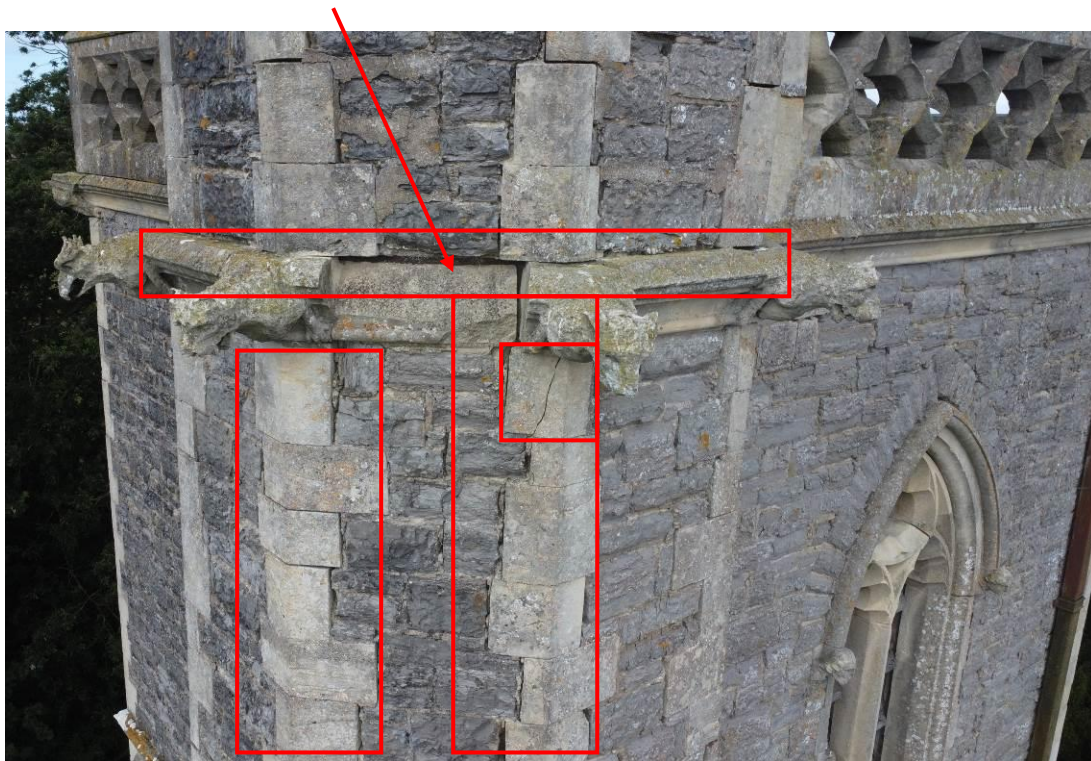
Figure 46 - DJI\_0236 Rusting Ring Beam, Fracture & Open Joints in Stair Turret South East Elevation

- The same type of replacements will be required for the circular ring beams visible in the parapet-level, 3<sup>rd</sup> and 2<sup>nd</sup> stage string courses.

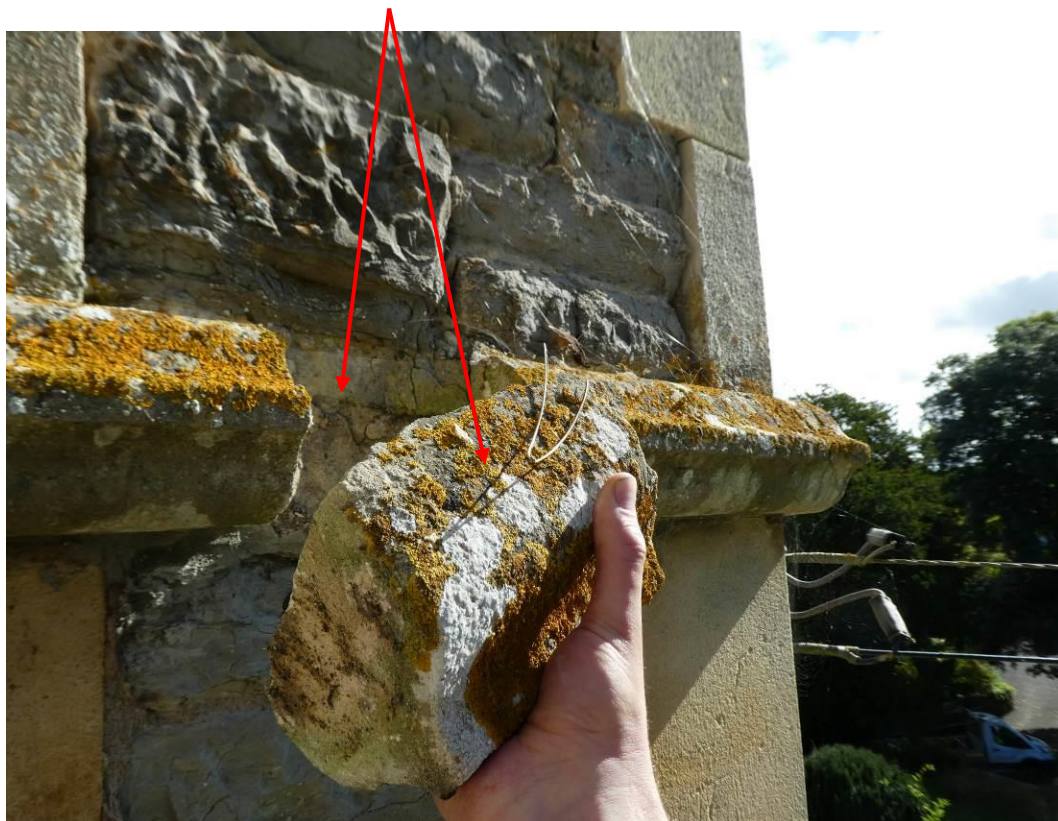
- The loose fractured string course section removed from the former during the survey and the missing fractured string course masonry in the latter, are further evidence of these.

Figure 47 - P1000376SW Fractured Masonry Removed from Stair Turret South West Elevation 3<sup>rd</sup> Stage String Course During Survey

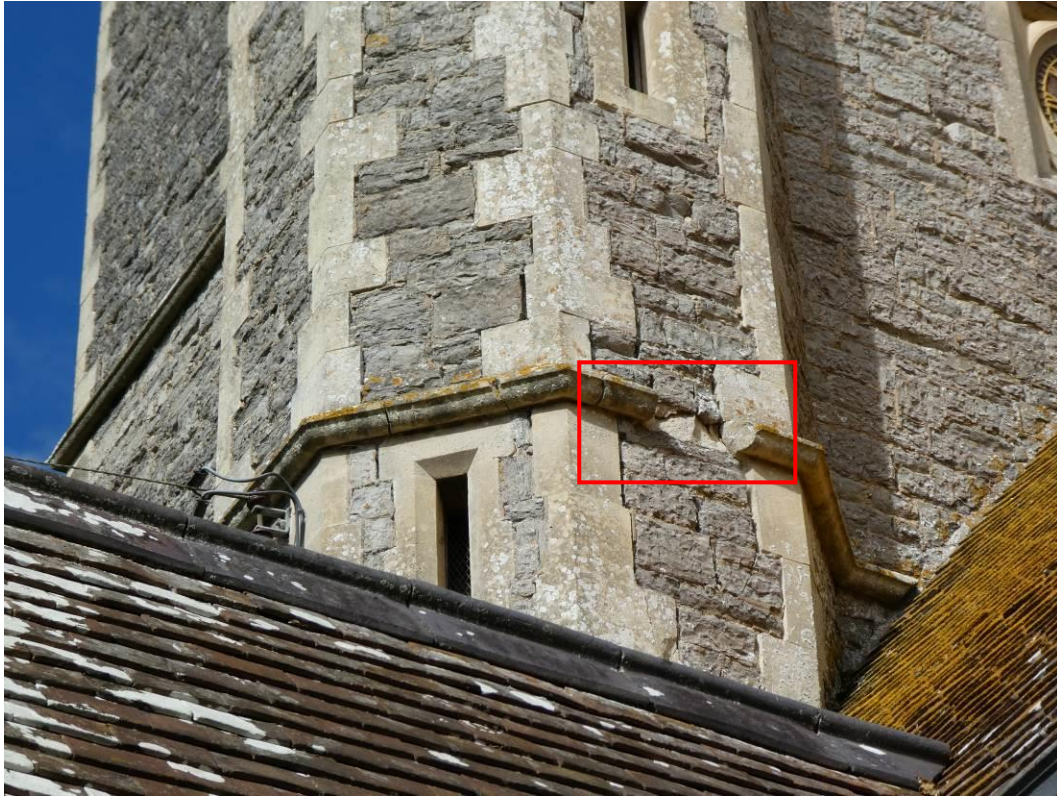
**Figure 48 - P10000205 Missing 2nd Stage String Course Likely Resulting from Rusting Ring Beam in Stair Turret East Elevation**

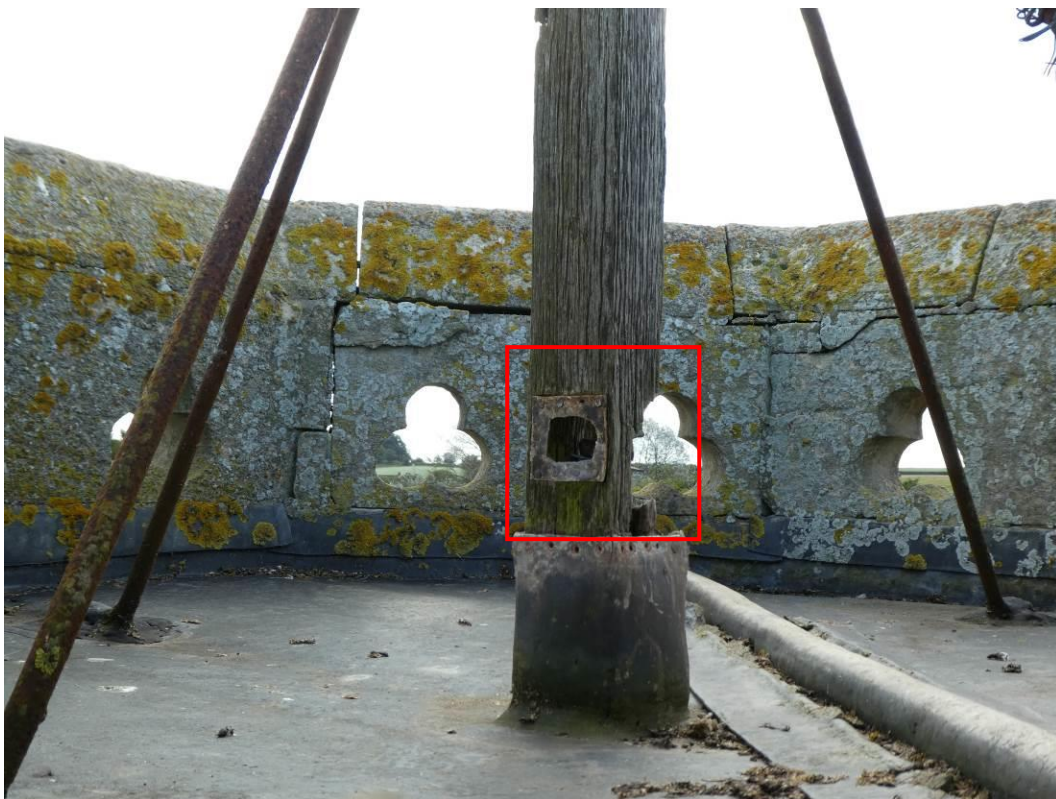
**Figure 52 - P1000489 Rusting Weather Vane Stays & Severely Compromised Wooden Central Pole**

While the stair turret is dismantled and rebuilt, the weather vane can also be dismantled and repaired. The weather cock requires cleaning and regilding or re-painting while the iron fixings require cleaning, treating and re-painting. Although the metal frame stays appear structurally reusable, the central wooden pole is very rotten, severely compromised and requires replacing.
