CONDITION AND RECOMMENDATION REPORT  
Internal War Memorials and Commandment Boards  
St Mary Magdalene Church, Stockland Bristol TA5 2PZ

Client: PCC of St Mary Magdalene Church, Stockland Bristol  
Job No. 3417  
November 2024

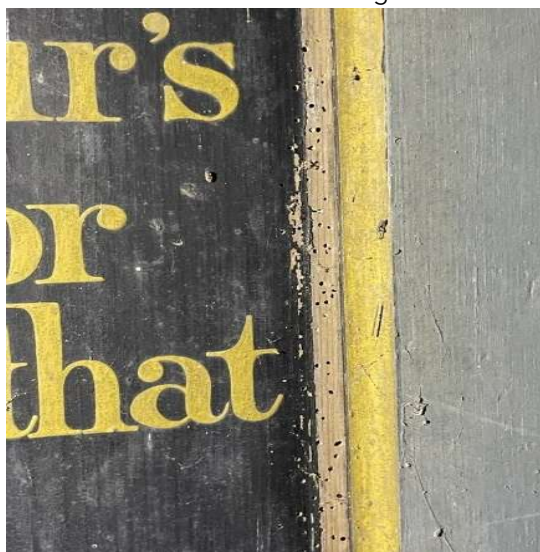
The plaque is structurally sound, and the joints of the frame are tight, however the paint surface on the commemoration board is deteriorating.

Figure 16 The frame is made up of several components, including the moulds and the hollow carved frieze. This construction is sturdier than the commemoration board (the black inner board), which may explain why the frame is in better condition than the inner -pai

- The frame around the black-painted memorial board is layered with dust, cobwebs, and splatters of white paint. Cleaning the surface would be advantageous to prevent dirt from embedding itself deeply.
- The black commemorative paint surface is quite delicate, with the black paint layer peeling away and the gold lettering suffering significant damage. It is advisable to secure the paint layers to the wood and restore any missing sections of paint and lettering.

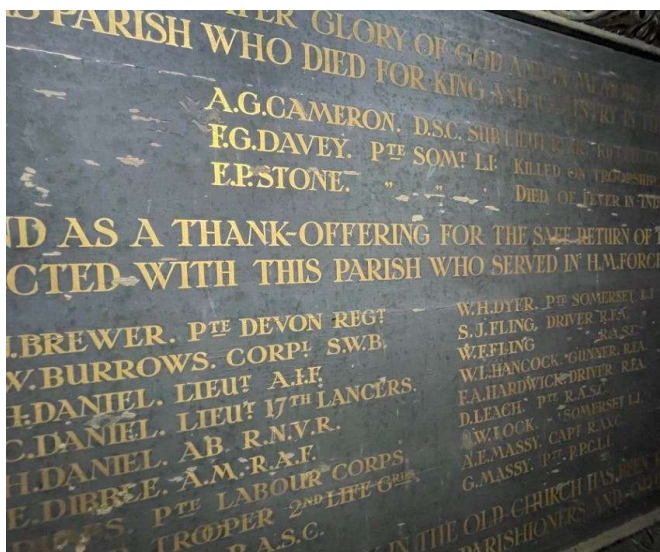
Figure 17 The black commemoration board is likely more vulnerable to moisture damage due to its closer placement to the wall and its thin construction. Significant cracks on the wall surrounding the plaque may be contributing to the extensive deterioration of the

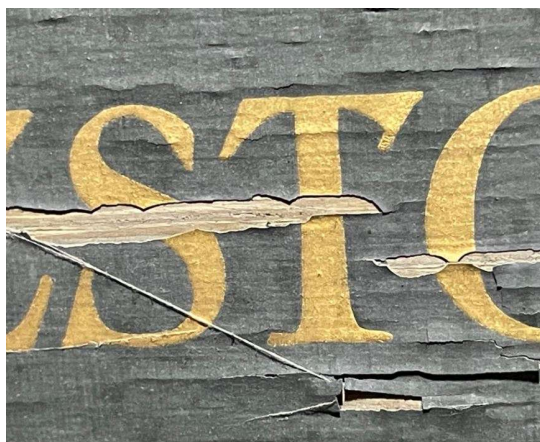
Figure 18 The commemoration black board is closer to the wall and it may be the reason for the paint lifting

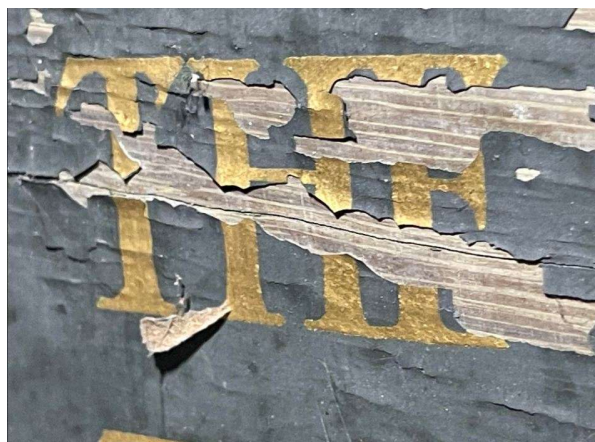
Figure 19 A closer look at the surface is showing cracks in the wood which may be the cause for the lifting of the paint layers.

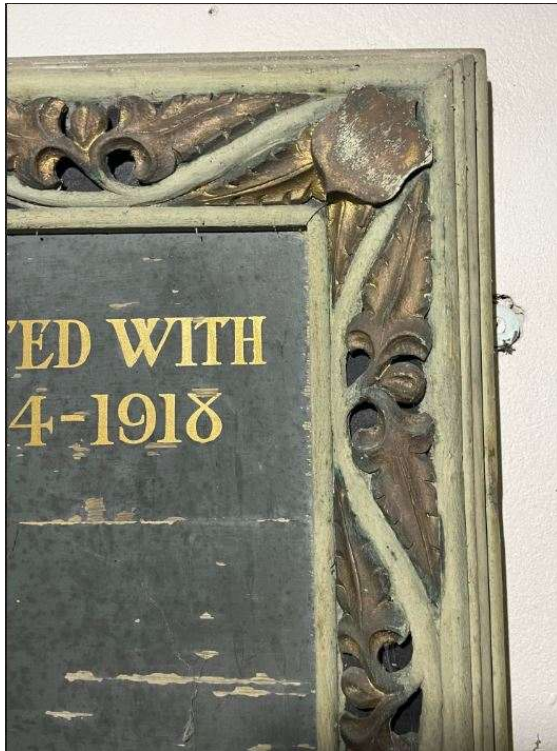
*Figure 20 The carved frame is in solid condition, with all joints remaining intact. Some remnants of gold paint can be seen on the intricately carved leaf sections, and both inner and outer mouldings appear to have been repainted multiple times.*

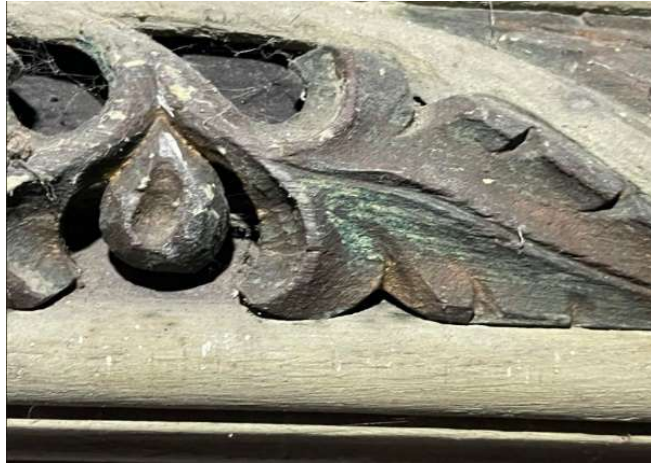
*Figure 21 Green oxidation is visible on the carved sections, which may indicate that the substrate was coated with a gold-like paint, such as bronze or copper alloys. This type of paint tends to oxidize in the presence of moisture.*

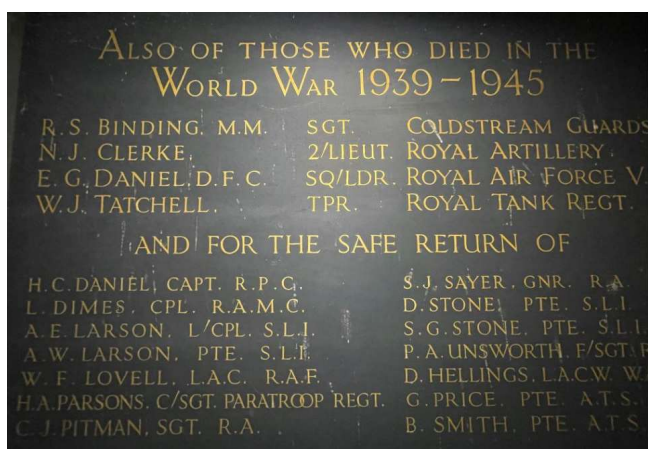
Figure 22 The black background and lettering remain intact, with only a few white marks visible. The absence of cracks on the surrounding the plaque, along with the likelihood that it was created decades after the World War I plaque, could explain why its condition is superior to that of the earlier plaque.

- While the memorial plaque is generally in good condition, a gentle surface cleaning could enhance its appearance. If not cleaned or dusted regularly, dirt, dust, paint stains, and mould layers can penetrate the wood surface, leading to a dull look and making future cleaning more challenging. Mould can cause permanent damage to wood and may require removal.

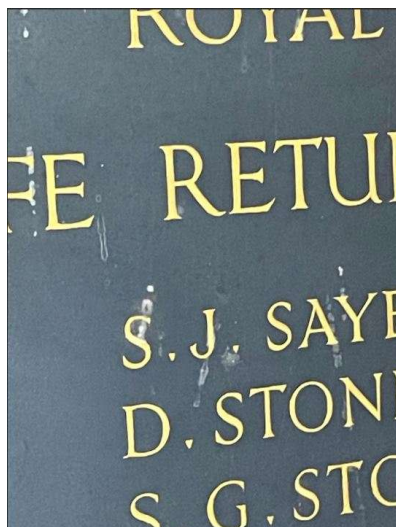
Figure 23 A close-up image reveals a smooth paint layer on the surface, although some white residue is present.

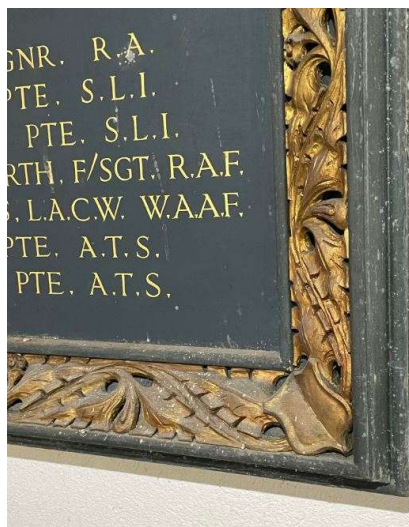
Figure 24 A heavy layer of dust is settled on the moulded and carved sections of the frame. On the exterior of the frame there is a dusty white coating that could indicate the initial stages of mould, likely due to elevated moisture levels in the wall.

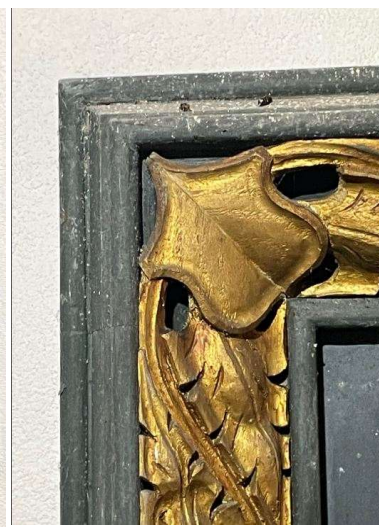
Figure 25 Signs of woodworm holes can be seen at the top of the frame, indicating potential early woodworm activity.

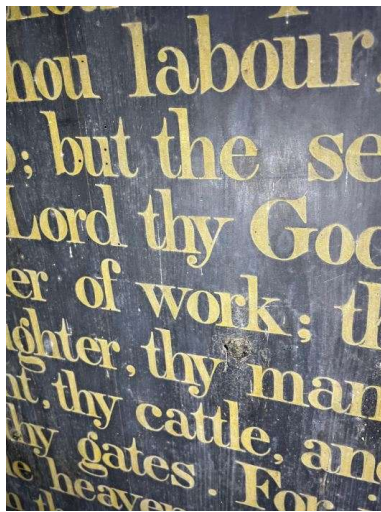
Figure 26 There are knots with sap pockets all over the surface, they all have a large ring of dry sap around them. The dry sap shrunk over the years which caused damage to the paint layer. This type of damage is not due to environmental factors but is related to

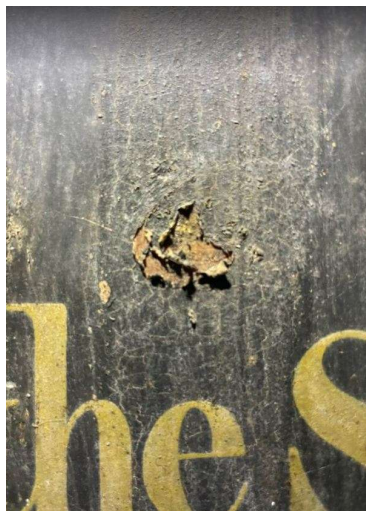
Figure 27 A knot showing the damage made by a sap pocket.

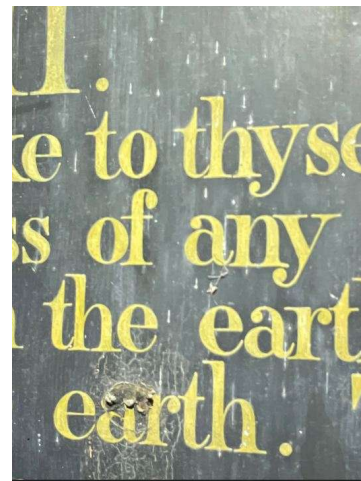
Figure 28 White paint drops and dust layer appear all over the surface.

- The primary issue with the board is woodworm damage. The woodworm may still be active, so it's important to keep an eye on their activity. (Refer to Commandment Board 2 treatment proposal for details.)
- A gentle cleaning of the board may be beneficial. There are different types of dirt on the surface such as loose dust layers, cobwebs and white paint residue.
- The woodworm affected areas can be powdery, consolidate the woodworm affected areas can prevent further damage.

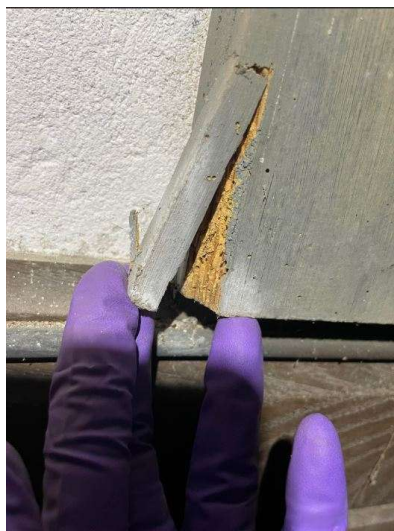
*Figure 29 There are woodworm signs all over the surface of the boards but for some reason the bottom sides of the frame are the most damaged.*

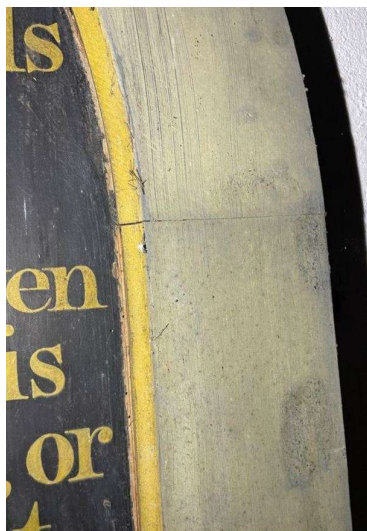
*Figure 30 Woodworm exit holes are dotted around the surface of the board.*

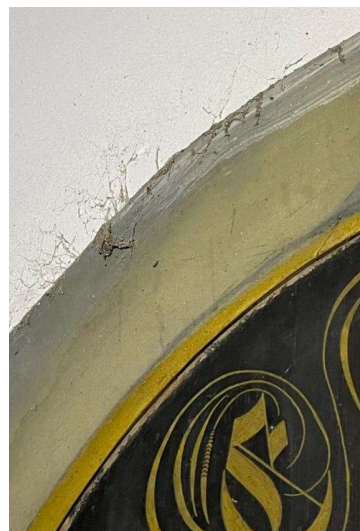
*Figure 31 The top frame is covered by a thick layer of dust, cobwebs and paint layers.*

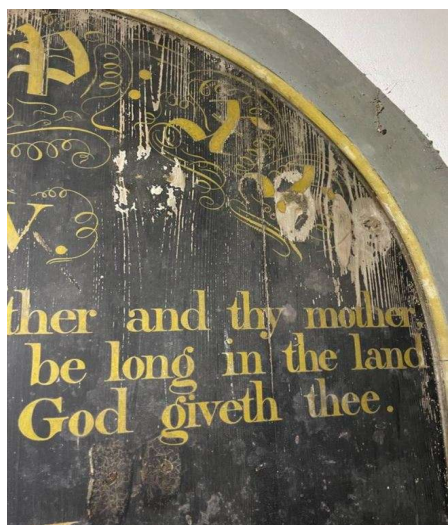
Figure 32 Loss of mainly the black surface paint on the top part of the board.

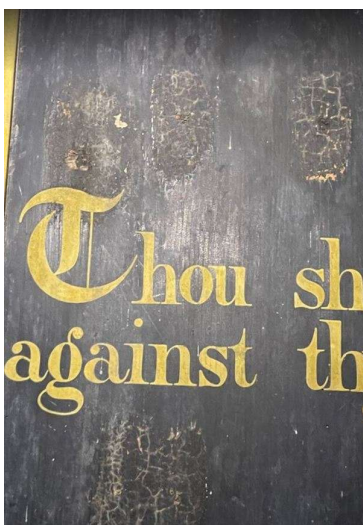
Figure 33 Natural wood knots are located all over the surface, they appear like a large crusty lumps.

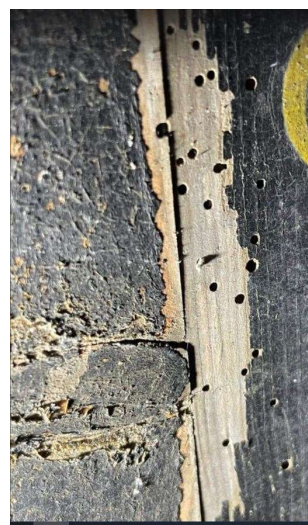
The board is structurally stable, but there are cracks extending from the top to the bottom, which may indicate that its structure is compromised. The surface shows more wear than board number 1, possibly due to its location on the church's outer wall.

Figure 34 Shrinkage of the wood is causing gaps to the board from top to bottom. There is also a shrinkage of mainly the black paint layer area.

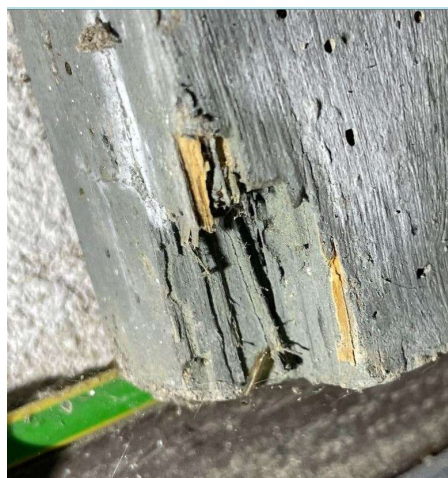
Figure 35 Woodworm damage on the proper bottom left of the frame. This area seems to have been over painted in the past. Woodworm damage is irreversible.

- The board has been infested with woodworm, the infestation could still be ongoing, potentially harming other wooden items and furniture in the church. It's advisable to keep an eye on woodworm activity. A simple method to monitor this is by removing any frass from the surface and checking periodically every few weeks for its return. If the woodworm remains active, consider fumigating the affected items.
- Cleaning of the surface should be done as it is important for the upkeep of the commandments board.
- Consolidation of areas damaged by woodworm is necessary to prevent further damage.

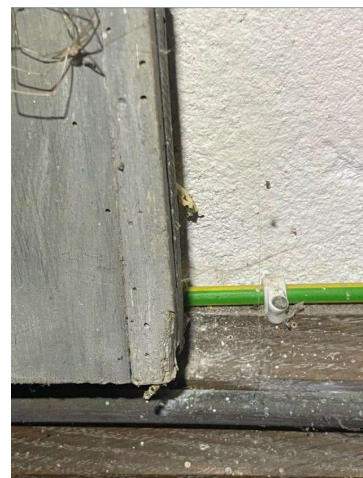
Figure 36 Woodworm exit holes on the proper right bottom side of the frame.

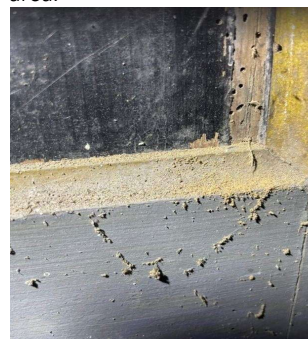
Figure 37 Woodworm residue called frass, it appears on the surface as fine sawdust. It may suggest that woodworm may still be active.
