Drawn Checked Rev Notes
JW MC B For List B / Faculty and Tender STOCKLAND BRISTOL St Mary Magdalene's Scale

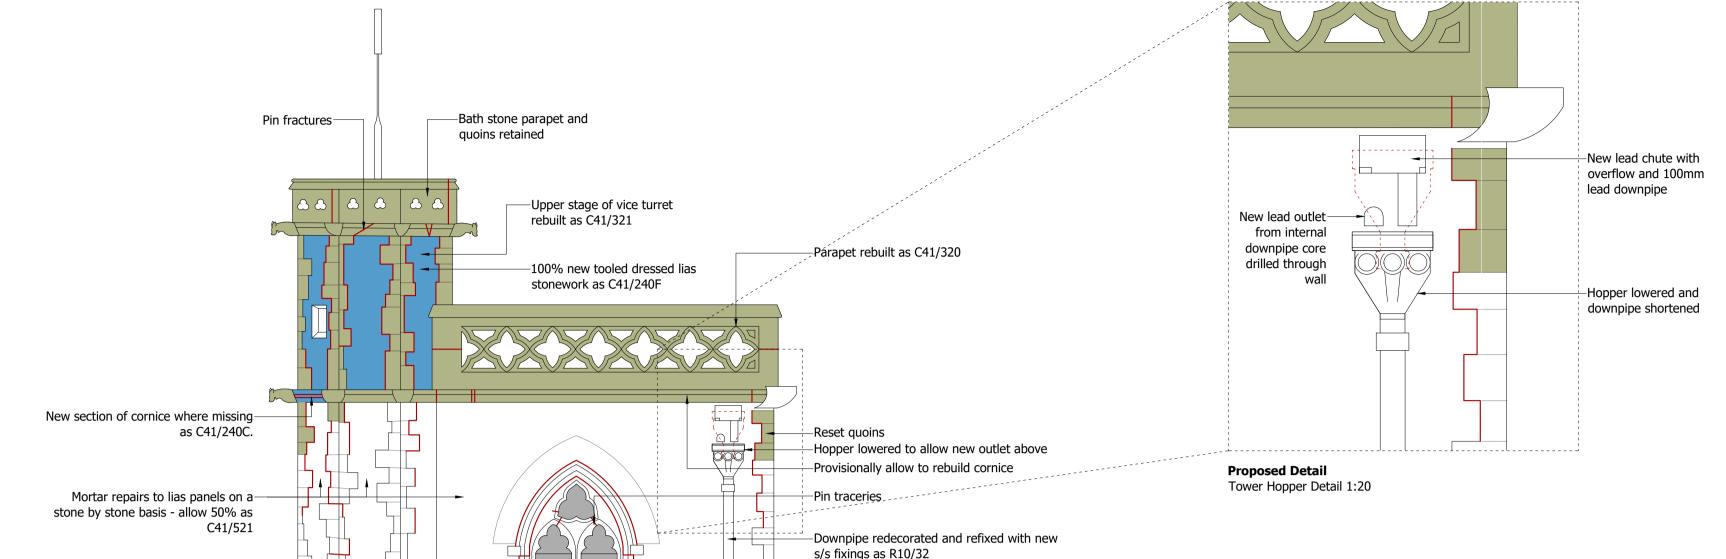
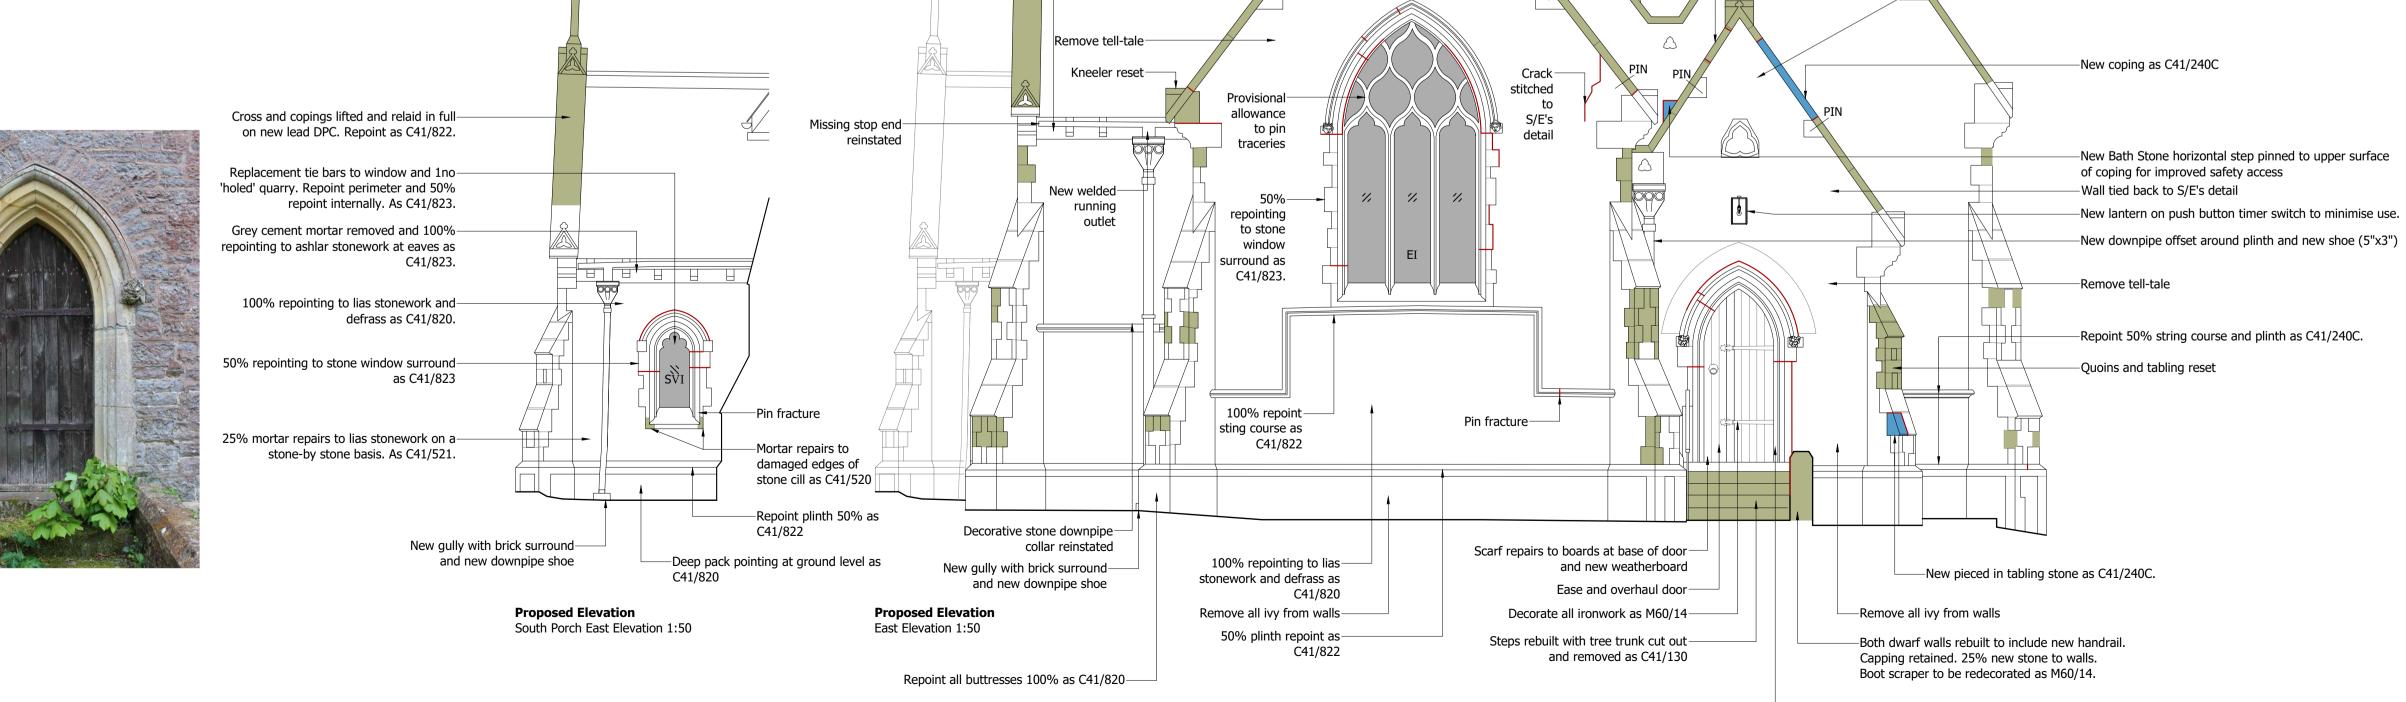
Cracking/Open Joints ——

Windows s/s fixings as R10/32 -Minor mortar repairs to stonework as C41/520 as C40/230A. Existing louvres repaired and refixed 100% repoint as C41/820—

> -100% repointing to lias stonework and defrass as C41/820

—New s/s bird protection behind —50% repointing to window as C41/823

-Clock dial repainted and regilded. Mortar repairs to stone surround as C41/520.

-100% repoint to coursed lias stonework as C41/820

Lift and coping on lead DPC Cross and copings lifted and relaid-

End of soffit board reinstated where decayed (400mm)

Mortar repairs to individual stones (10%)-

New powder coated stainless steelguards to vice turret windows

To the squared blue lias walling, brush down to remove all loose stone (defrass), remove all cement pointing and then repoint as clause C41/820 (allow also for 10% deep pack pointing of any voids). Additionally where indicated include for by non-hydraulic mortar repairs on a stone-by-stone basis to the percentages described and as Clause C41/521

Allow for 100% repointing of all buttresses as C 41/820 Advise where quoins are loose. All highlighted quoins to be reset during repointing with new cramps introduced to secure masonry as S/E's detail. All cramps Grade 316 Stainless Steel.

To the plinth and string courses skyward facing surfaces repoint as clause C 41/822 (NHL 5.0)

All copings to be numbered, lifted and then reset on a new bitumen painted Code 6 lead DPC dressed down 20 mm over the face of the stonework as H71/43. Copings to be twice pinned in the locations indicated on drawings. Repoint as C41/822.

Window stonework to be repointed internally and externally 50% as clause C 41/823 Allow also for 50% replacement of perimeter pointing. All glass protected during the works. All ferrous tie bars to be replaced with painted stainless steel new tie bars as L40/18 and painted as M60/14 . Tracery stonework to be pinned or rebuilt to the extent indicated on the drawings with leaded lights temporarily removed as required to facilitate the work. Mortar repairs to window stonework as C 41/520. All stonework water-washed and brushed
