# Site Visit Report

Project: **St George’s Church, Wembdon**

Report No: **12555-551**

Mann Williams have been engaged by the Parochial Church Council of St George’s, Wembdon to provide structural advice following recent storm damage to the church.

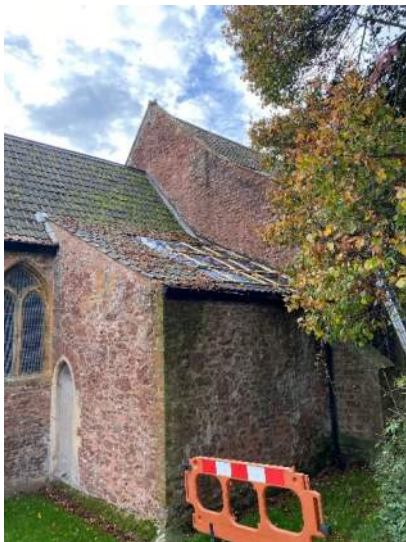
At the time of our visit, the organ had been removed along with the damaged roof finishes. Temporary sheeting had been installed where roof tiles had been lost and tiles over the Chancel reset to temporarily address weather tightness and stem the risk of further damage from water ingress (refer to Photos 1 & 2 below).

Photo 1 – Roof temporarily sheeted above organ room

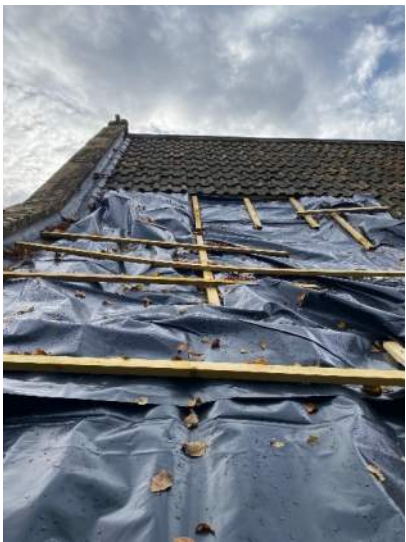
Photo 2 - Roof temporarily sheeted above east end of north aisle

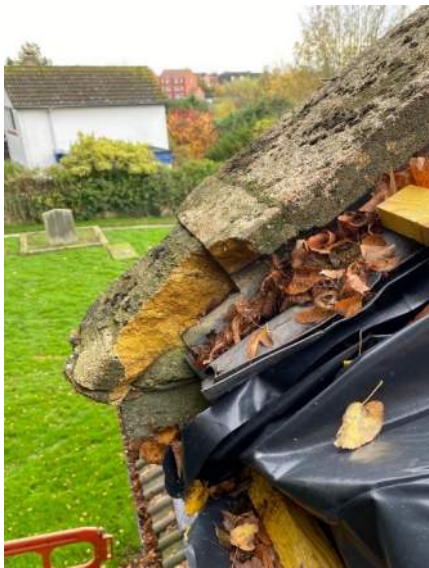
Externally the areas impacted by falling tree limbs were inspected at close quarters from ladder access. Note, that in order to maintain weather tightness, the roof sheeting was not disturbed. Aside from the impact on the north aisle roof, the copings at the east end of the north aisle have been impacted with the fractured kneeler stone (Photo 3) requiring an indented repair or replacement; the bedding of the copings has also fractured. It is envisaged that the copings will need to be lifted and re-secured as part of the repair work to the roof finishes. The easternmost window of the north aisle shows signs of movement both internally and externally. Whilst some of the movement to this window will be longstanding, movements appear to have been exacerbated by the shock loading from the falling tree limb which also fractured and caused the localised loss of gutter ironwork. The keystone to on the external face of the window is delaminating (Photo 4) and will require an indented repair or replacement depending on the depth of fracturing. Internally there is also further evidence of recent movement to the window tracery. All open joints in the window tracery should be cleaned out and repointed in a suitable lime mortar. Similarly, fractured joints above the head of the window need to be raked out and fully filled with lime mortar (both internally and externally).

Photo 3 – Fractured kneeler stone to east end of north aisle

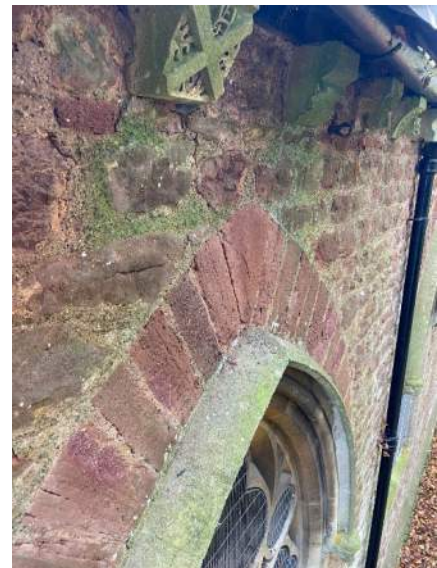
Photo 4 – Failing keystone and fracturing of masonry above (north aisle, east end)

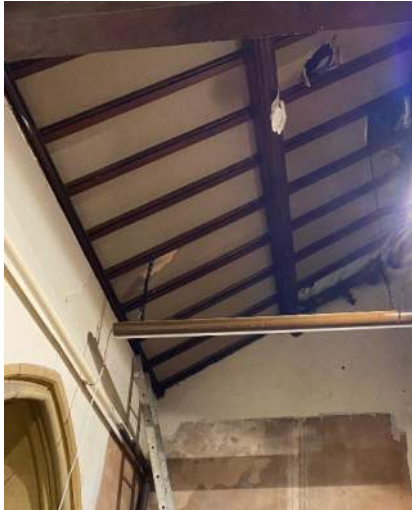
At the east end of the north aisle, failure of the insulated plasterboard ceiling panels are evident where the tree limbs have pushed through (Photo 5). Fracturing is evident in the roof purlin, indicating this has been weakened by the impact of the tree limb (Photo 6). We advise the fractured purlin be partnered full length with a new timber. This timber should bear into the east wall to account for the loss of shear strength in the fractured purlin. The full cross sections of the north aisle common rafters is not visible (with the insulated plasterboard supported on battens fixed to the sides of the common rafters) and their condition will need to be reviewed externally ahead of recovering.

Photo 5 – Damage to ceiling panels of north aisle. Fracturing of masonry above east window.

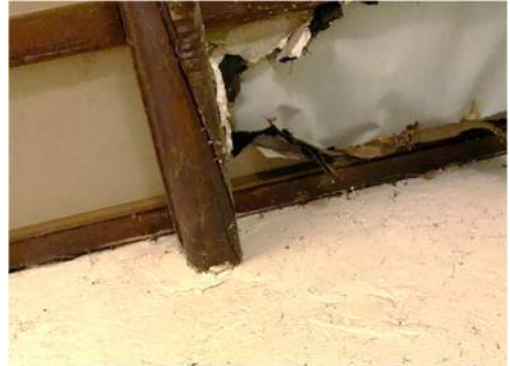
Photo 6 – Fracturing of roof purlin and damage to ceiling panel.

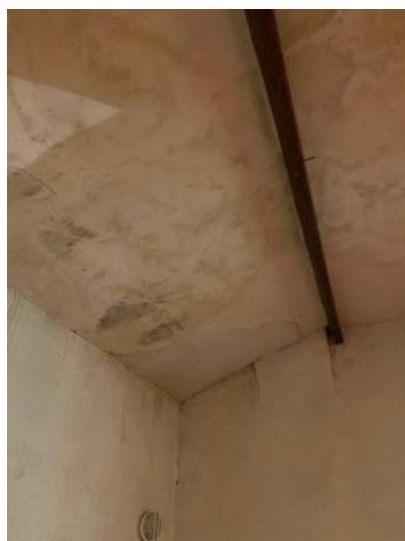
The ceiling structure over the organ was found to be badly fractured below the level of the intermediate roof purlin (Photos 7 and 8). It is also clear that there has been significant water ingress where the roof tiles were lost. It appears that the ceiling is of lath and plaster construction. The ceiling finish will need to be stripped to the lower half of the ceiling (i.e. beyond the northern edge of the purlin). Over this area of roof, only the down stand of the purlin was visible for inspection and this appears undamaged. However, it may be that there is damage to the common rafters above the ceiling line. The roof structure will need to be fully appraised when the lath and plaster is stripped. At this stage, we suggest an allowance is set against partnering the common rafters to the lower half of the roof in treated structural softwood timber in case these elements have fractured.

Photo 7 – Damaged ceiling structure over organ. Down stand purlin appear sound

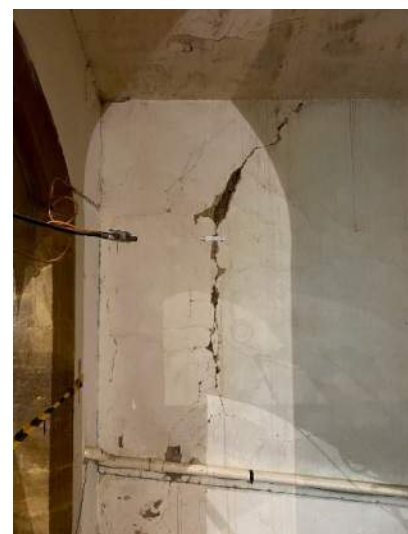
Photo 8 – Area of severe ceiling fracturing within the organ room. Fracturing to the north wall.

The north wall of the organ room has a longstanding fracture. An Avongard tell-tale has been set across the fracture in the past (the date of fitting is not known) but this is not indicating any structural movement since fitted. We would recommend that the delaminated plaster be removed and stainless steel spiro ties set across the fracture, within the bed joints. With the plaster removed, the fractures can also be raked out and fully pointed. Lime mortar can be utilised for bedding the spiro ties as well as pointing the fractures. An allowance should be made for 800mm long spiro ties set centrally across the fracture at approximately 300mm vertical centres. Plaster will need to be reinstated to match existing. Whilst this fracture is considered to be longstanding, it is likely that degradation of the wall plaster has been exacerbated by the recent water ingress.

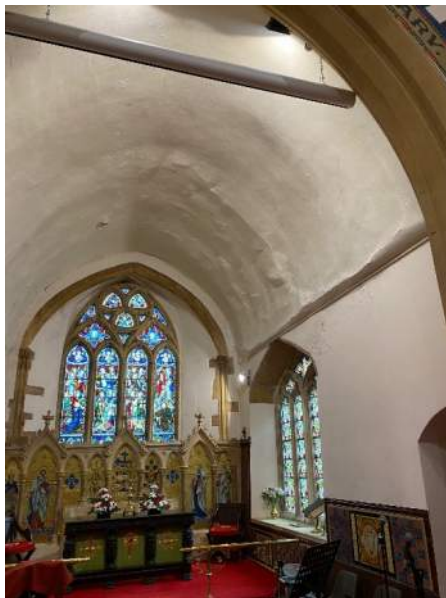
Whilst tiles were lost on the north slope of the Chancel roof, at the time of our visit these had been reinstated. The ceiling to the Chancel appears to follow the line of an early barrel-vaulted roof structure. The ceiling would appear to be lath and plaster and is in particularly poor condition beneath the southern roof slope (Photo 9). From ground level, the condition of the ceiling appears poor and as such we consider there is potential for plaster falls (in particular of plaster which has become detached from lath or even where lath fixings have degraded). The church should take appropriate steps to safeguard against plaster falls and plan for investigation and repair of the Chancel ceiling structure. It is considered possible that the roof frames which form the barrel vault may also require repair and again we advise the church should plan for this. We cannot rule out the possibility that there has been some limited damage to the plaster under the north roof slope as a consequence of water ingress, following the storm damage, but currently it is the plaster under the southern roof slope which is in poorest condition.

Photo 9 – Degraded plaster work to barrel-vaulted ceiling of Chancel.
