ENVIRONMENTAL CLAIM INVESTIGATION

INITIAL REPORT

OHES Ref:	FJ_395931
Adjuster:	Woodgate & Clark
Adjuster Ref:	12440
Insurer:	Ecclesiastical
Insurer Ref:	16651541
Insured:	The Vicar and Churchwardens FTTB and The PCC of West Harptree St Mary in the Diocese of Bath & Wells
Site:	St Mary's Church, West Harptree, Bristol, BS40 6HF
Report Author:	William Dorey Environmental Consultant
Report Approver:	Alison Haynes Regional Manager
Issue Date:	25 th February 2025

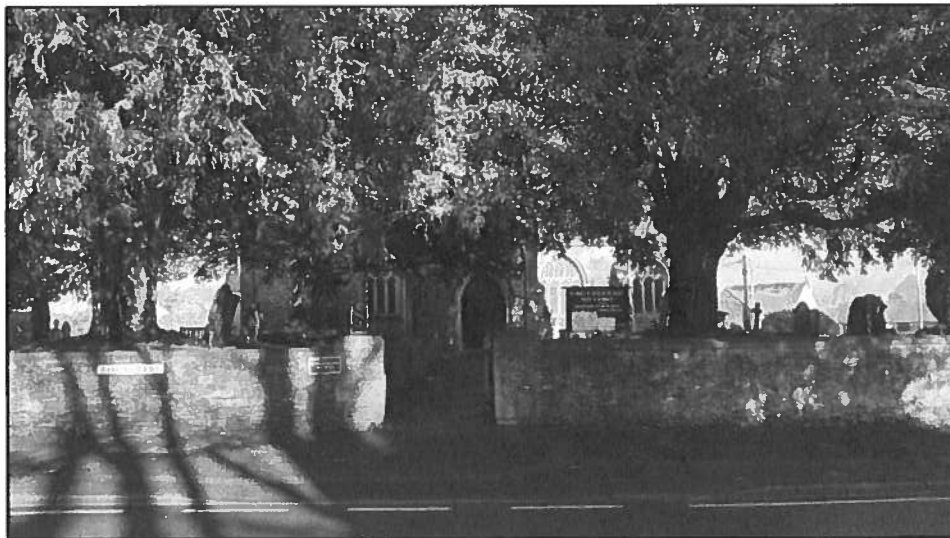
Photograph 1 – Entrance to St Marys Church on The St A 368 (31/01/2025)

On 31st January 2025, OHES Environmental Ltd (OHES) were instructed by Woodgate & Clark to investigate potential impact to soils and controlled waters following a loss of kerosene from the oil storage tank (OST) at St Mary's Church in West Harptree (**Photograph 1**).

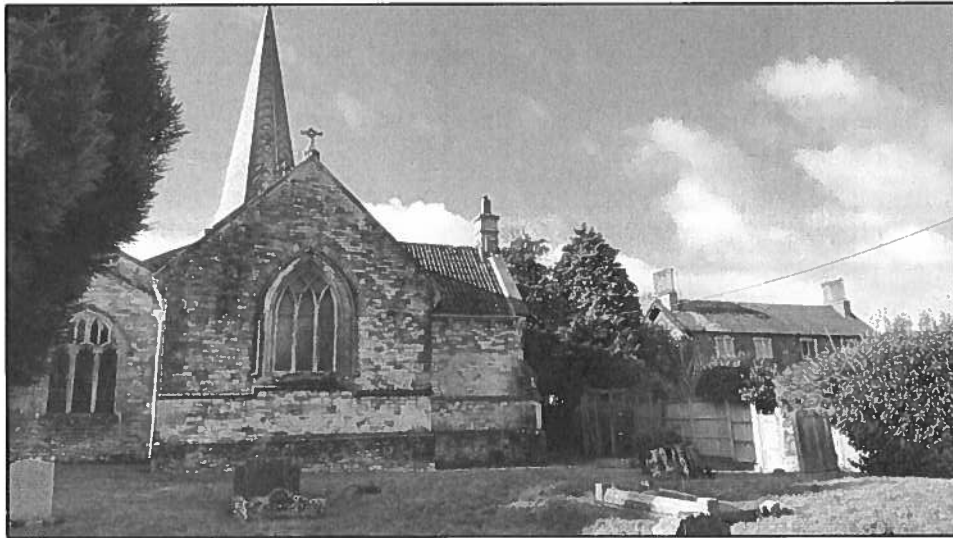
It has been reported on 15th January 2025, an oil leak at the church was noticed and reported by a neighbour. A church volunteer visited site, the same day to check the OST at the site (**Photograph 2 and 3**), identified the leak and secured the loss. The church volunteer then notified the Environment Agency (EA) of the incident and made arrangements for Chew Valley Tanks to visit site and repair the leak.

Photograph 2 – The churchyard and OST on the northern boundary (31/01/2025)

2.4 Heating Oil Tank and System	
Location, type, capacity and condition:	The OST tank, located within the churchyard on the northern boundary of site, is a plastic, double skinned 2,500L tank that sits on a raised concrete base and has a wire mesh enclosure covering the front end of the tank.
Sight gauge and fittings:	At the time of the inspection the filter bowl had been fixed, and all fittings were deemed to be in good working condition.
Fuel transfer line:	The fuel transfer line, which is buried and not visible beyond the OST, is estimated to trend directly south towards the boiler.
Heating appliance:	The boiler is located within the vestry (Photograph 7).
Compliance with regulations:	The current site set up is considered compliant with current OFTEC regulations.

1. The OST, tank base and tank enclosure is to be moved to another area of the churchyard to allow further soils investigation of the underlying ground conditions.
2. The tank will not be reconnected to the boiler at this stage of the works, as the church have confirmed that heating is not required at present.

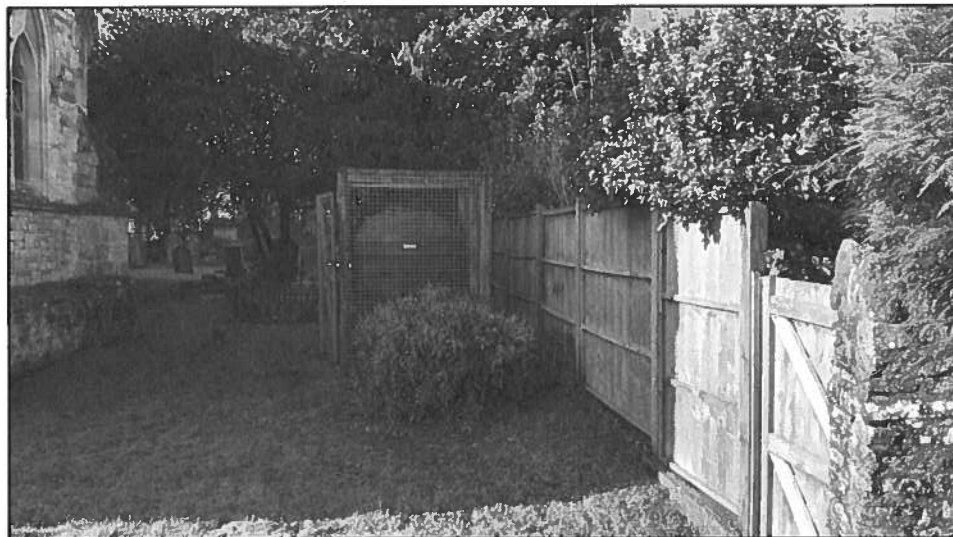
Photograph 3 – The OST (31/01/2025)

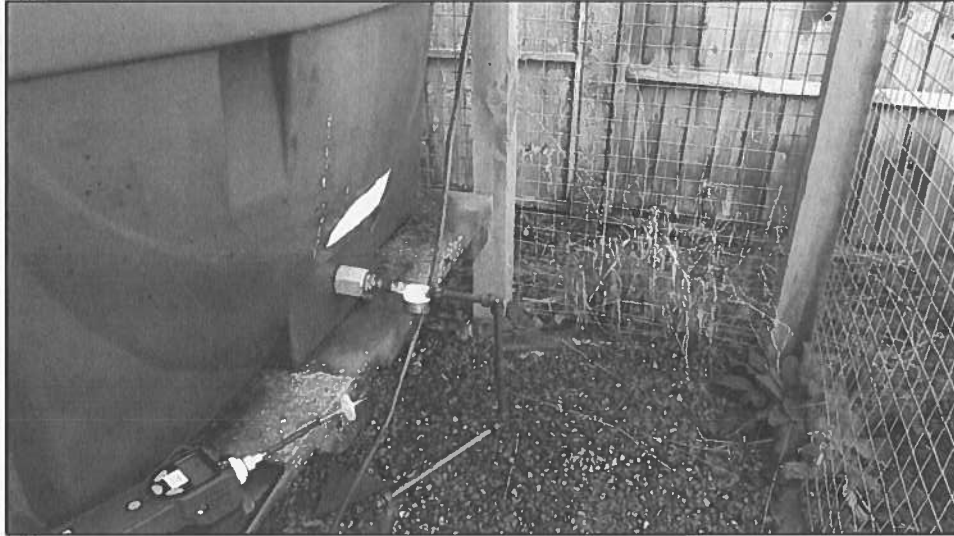
Chew Valley Tanks undertook the repair works on 16th January 2025 and identified the O ring within the filter bowl on the OST was loose (**Photograph 4**). It is suspected this may have been a result of water condensation freezing in periods of cold weather, resulting in loosening the O ring, and then thawing allowing oil to escape. Church volunteers have estimated that 350 L may have been lost to ground based on the current oil volume within the tank to the volume in August 2024, when it was last inspected. It is understood heating had not been used within the church during this period.

Photograph 4 – The Oil Feedline and Filter Bowl (31/01/2025)

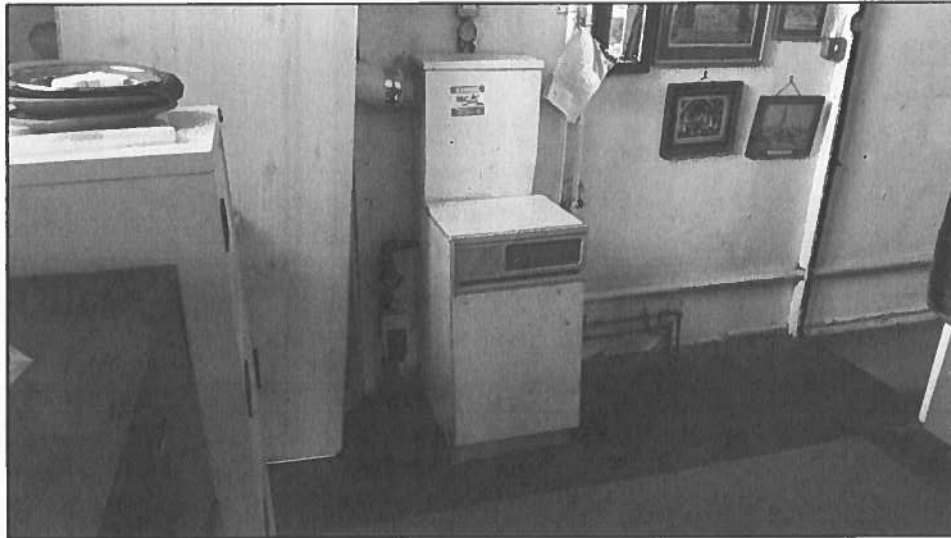
Photograph 7 – The boiler (31/01/2025)

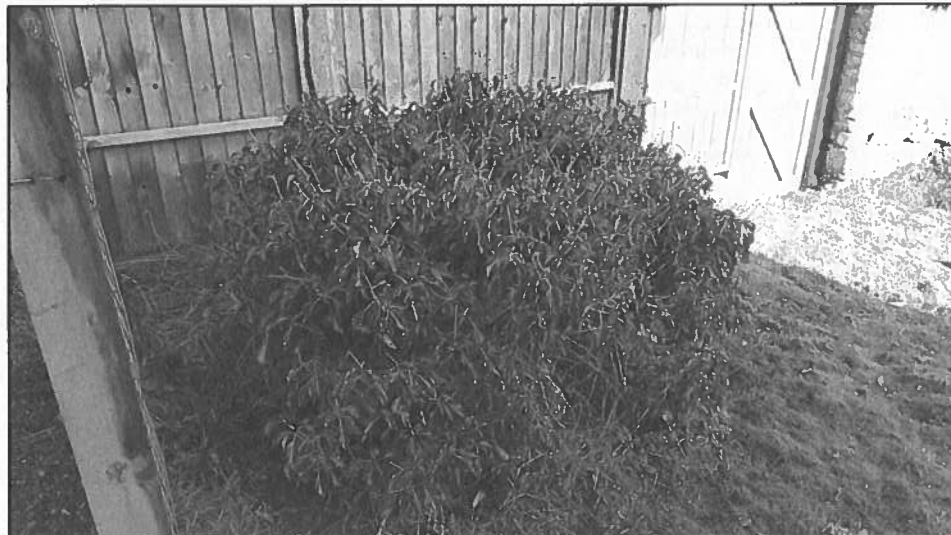
Previous reports of both vapours within Tilly Manor, the neighbouring residential property, and minor sheens observed on nearby surface waters indicate contamination to the surrounding area has occurred. However, no visual (**Photograph 8**) or olfactory evidence of contamination was identified on site during the site investigation by OHES on 31st January 2025.

Photograph 8 – Bush directly downslope of the loss (31/01/2025)

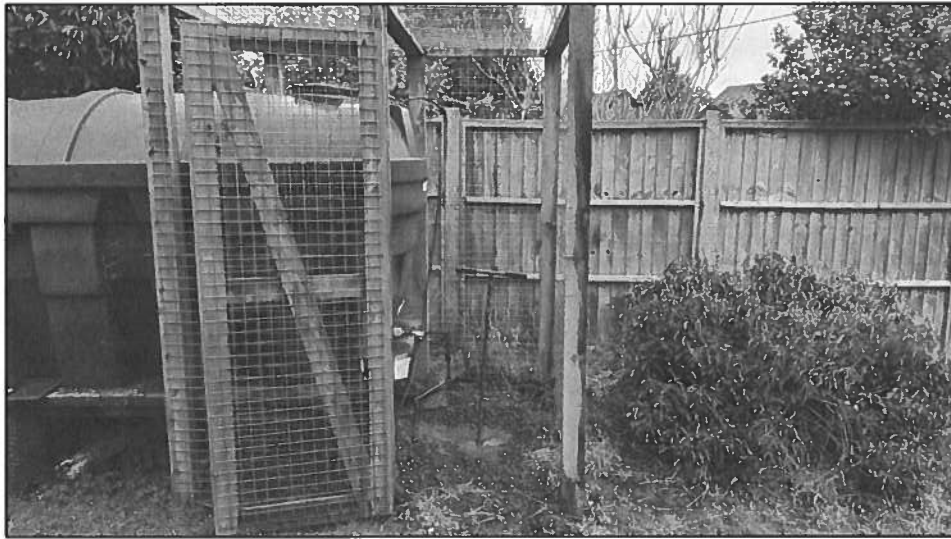
Analysis of samples **S1** and **S3** have identified minor concentrations of petroleum hydrocarbon, interpreted as naturally occurring compounds and a trace of possible kerosene, and polycyclic aromatic hydrocarbons (PAHs) & trace of kerosene respectively.

Photograph 8 – Soil sample S1 (31/01/2025)

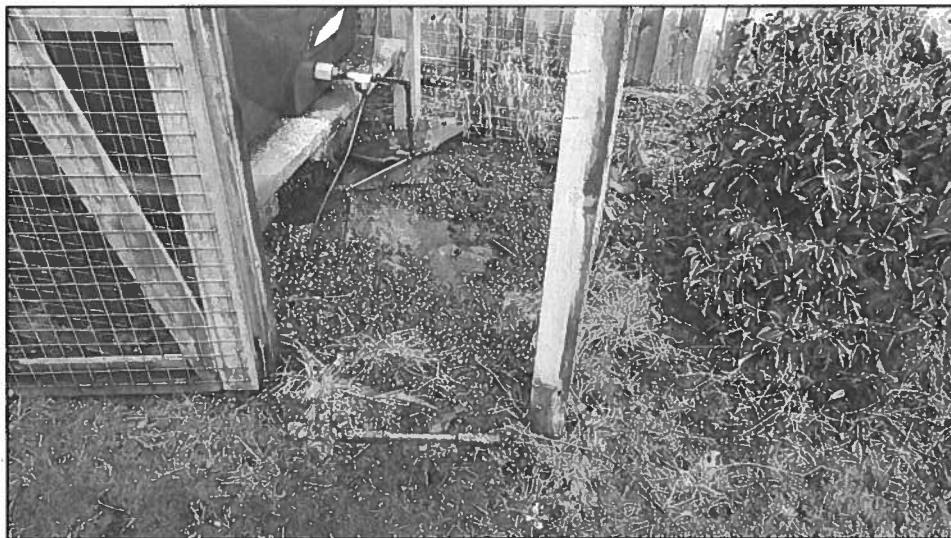
Analysis of samples **S2** (0.3m), **S2** (1.0m) and **S8** (0.0m) have identified elevated petroleum hydrocarbon concentrations within the carbon range of C₈ – C₁₆. The carbon distribution has

been associated as deriving from kerosene and exceed the GAC when compared to a residential without plant uptake land use scenario, based on a conservative approach.

Following the review of field screening and laboratory analytical data, gross kerosene contamination has been identified within surface level soils directly beneath the OST. Gross kerosene contaminated soils have also been identified, within a localised area outside of the OST enclosure door, down to the depth of 1.0m bgl.

Photograph 9 – Soil sample S2 (31/01/2025)

3. OHES will mobilise to site for 1 day with drilling contractors to undertake windowless sampling of the impacted area.
4. Track matting will be placed in the churchyard to limit any superficial damage to the churchyard.
5. Several boreholes will be drilled and installed to 3 – 5 m bgl to investigate the presence of contamination at depths greater than 1 m bgl. This will help evaluate the risk to the groundwater and the installed pipework could be utilised at a later date for remediation if necessary.

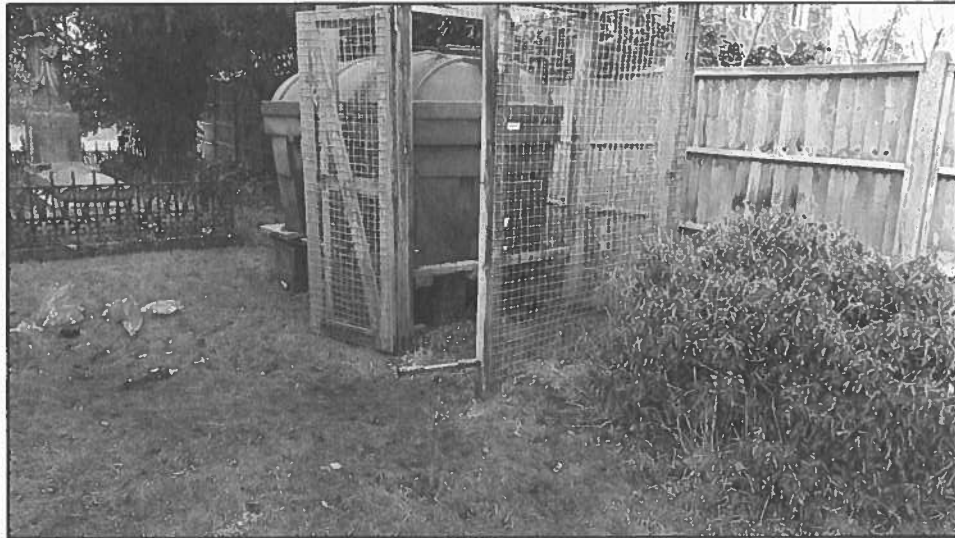
Photograph 10 – Soil sample S3 (31/01/2025)

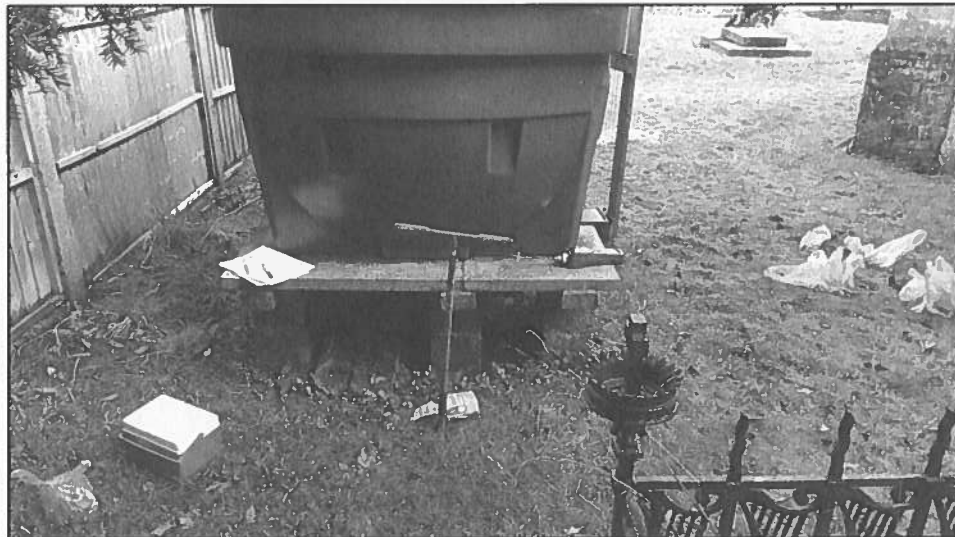
No petroleum hydrocarbons were identified above the laboratory's limit of detection (LOD) In samples **S5**, **S6** or **S7**.

Photograph 11 – Soil sample S5 (31/01/2025)
