ST LAURENCE CHURCH, EAST HARPTREE, SOMERSET

SURVEY OF THE PAINT AND PLASTER
AT THE WEST END OF THE NORTH AISLE

FEBRUARY 2024

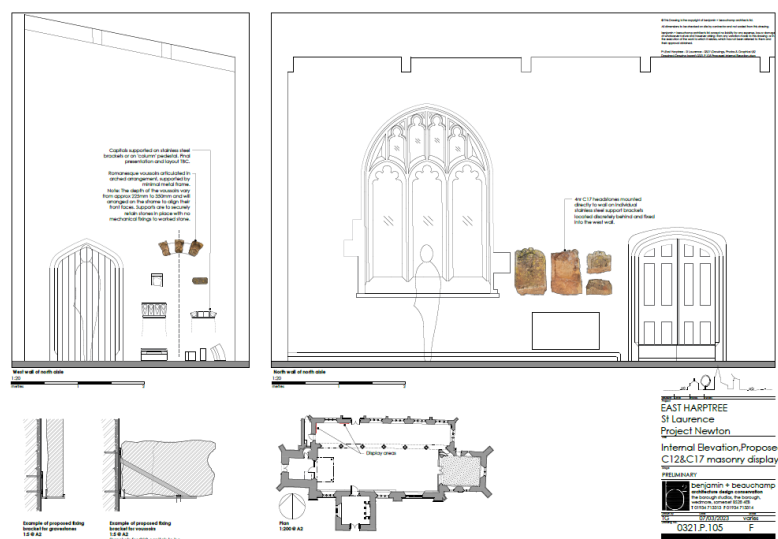
Plan provided by B2 architects showing areas where fixings are to be made in the plaster.

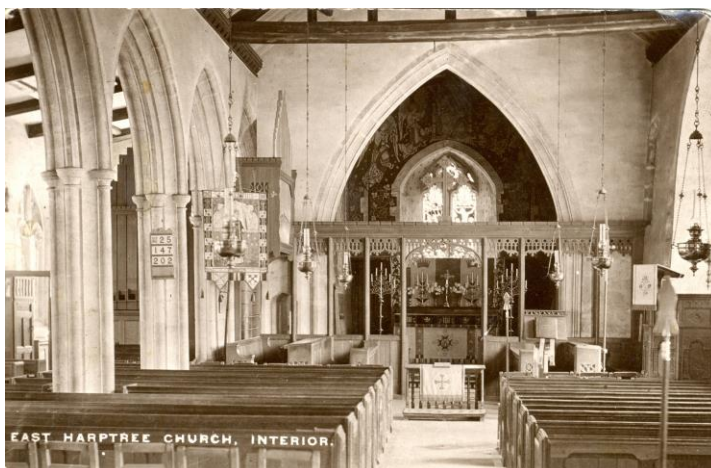
Plate 1

Early photograph showing the nave with the original scheme in the chancel.

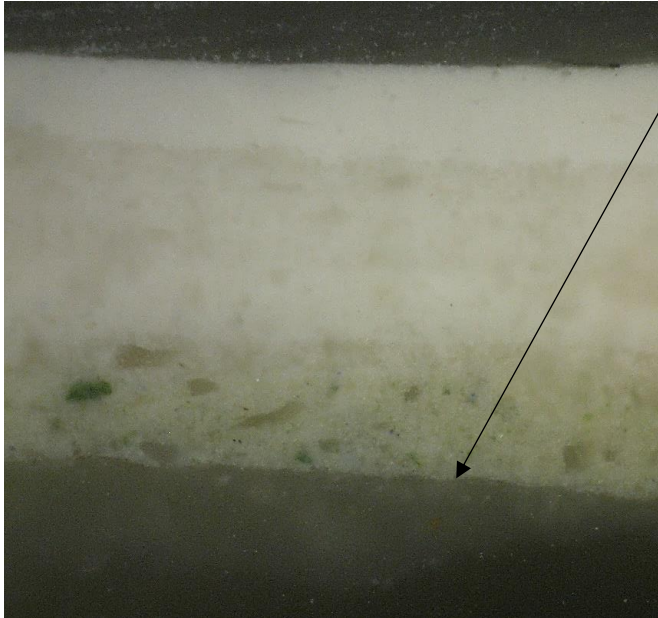
Plate 2

In 2019 paint samples taken from the south walls of the nave revealed that only twentieth century paints that contained zinc white existed on the surface.

Photograph showing the paint layers revealed in the nave in 2019. The paint layers are the same as those found in the north aisle. A dirt layer was found beneath the earliest 20th century paint layer indicating that the 19th century plaster had been left unpainted.

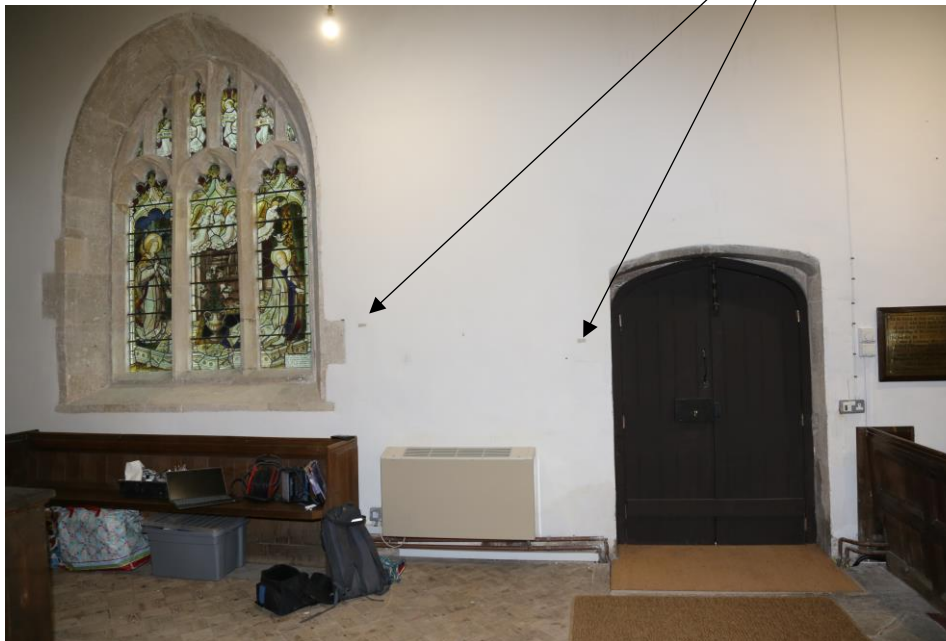
Plate 3

The recent uncovering trials undertaken on the north and west wall revealed that the north wall in the north aisle had clearly been replastered in the 20th century with a soft grey plaster. In many areas the wall sounded hollow when tapped, indicating that this plaster had lost adhesion. In one area where there was a small depression the removal of the most recent emulsion layer revealed that the grey paint was powdering behind the surface.

View showing the area on the north wall where the wall was examined.

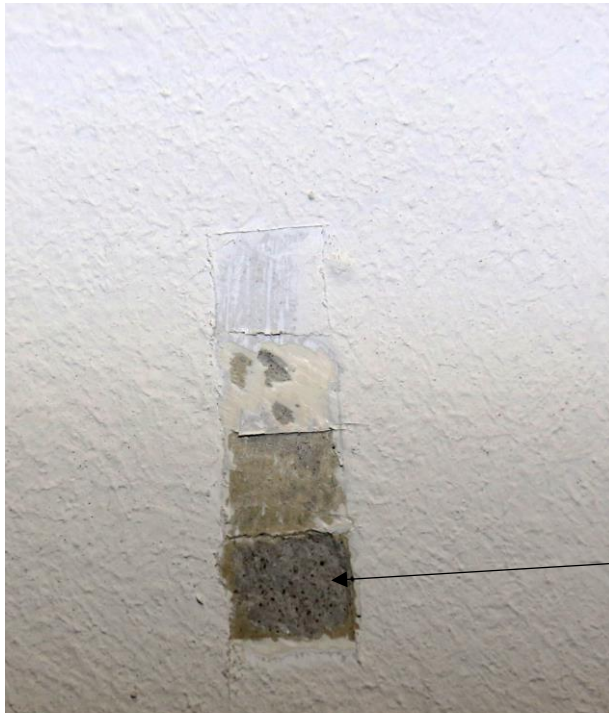
Plate 4

Detail of the paint uncovering trials.

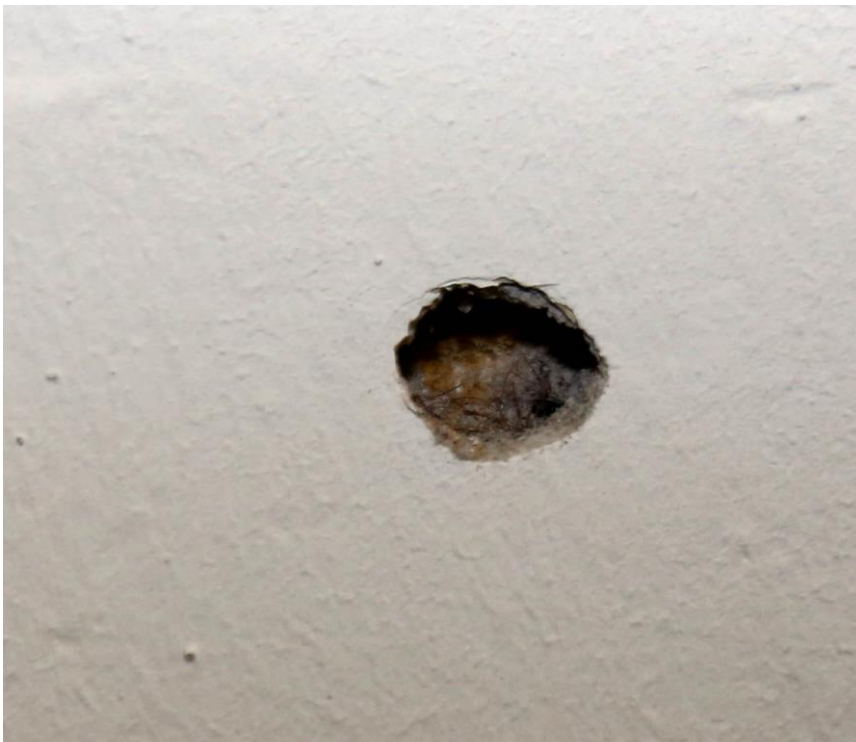
Plate 5

Grey plaster

Detail showing a lacuna in the grey plaster that is crumbling, exposing an earlier buff coloured plaster beneath.

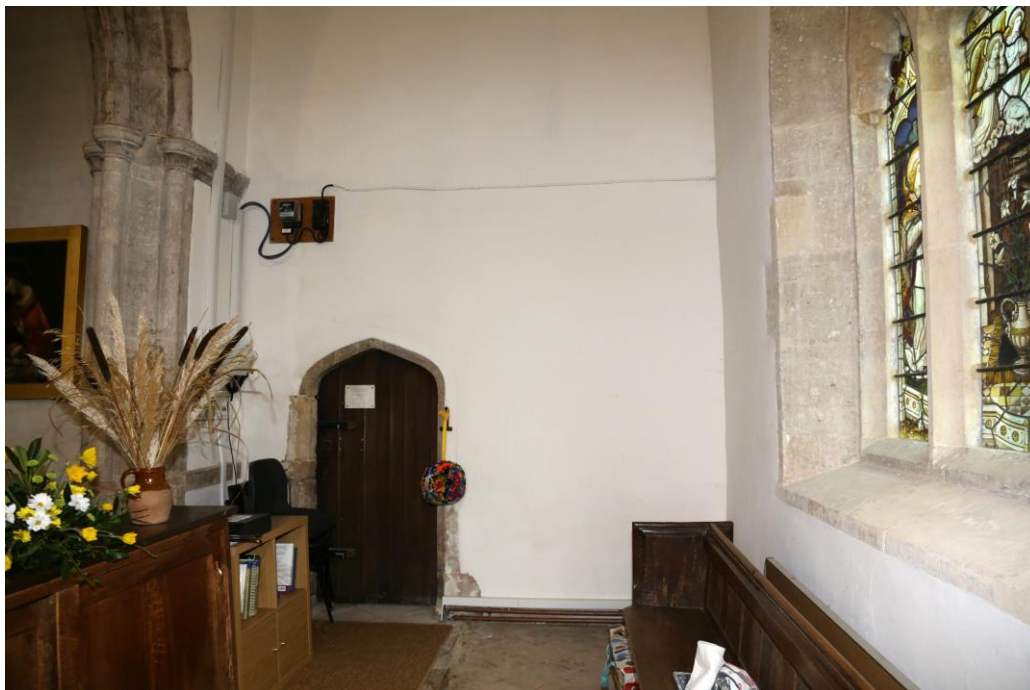
Plate 6.

View showing area of west wall that was examined.

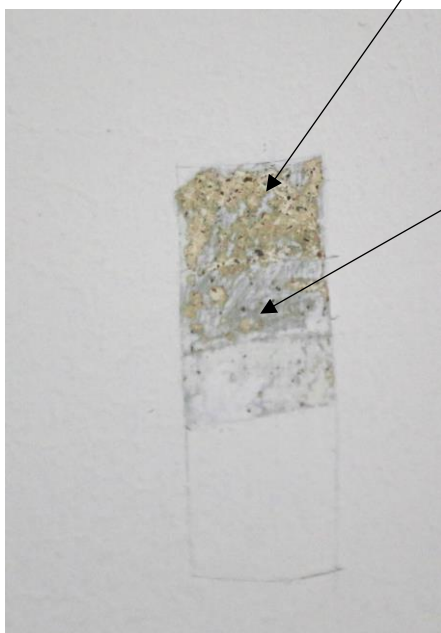
Plate 7

Detail showing the results of the uncovering trials on the west wall. This wall was not replastered with the grey plaster in the 20th century. The plaster beneath the grey paint is the same as that found in the nave.

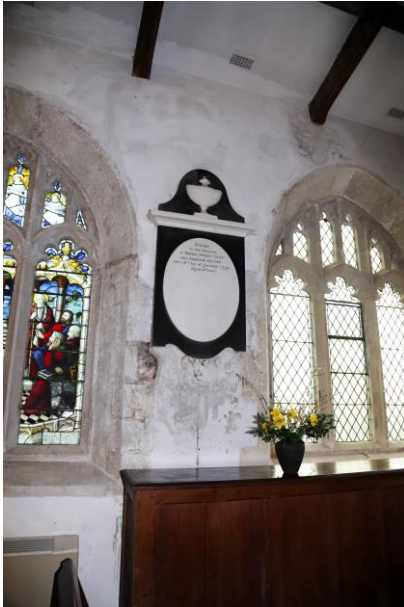
Plate 8

Green layer beneath the white emulsion.

Area at east end of north wall where the later grey plaster has been exposed by historic water ingress.

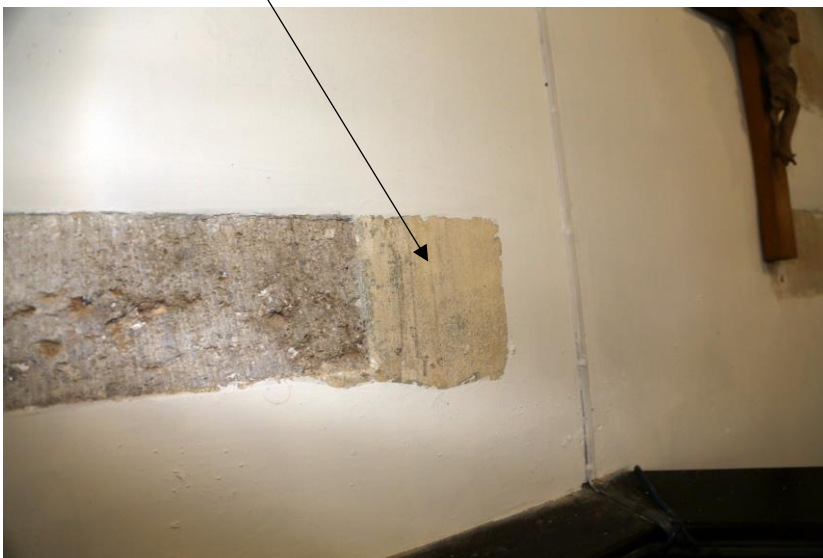
Plate 9.

19th century smooth finish plaster exposed on the south wall of the nave.
