# **CHURCH OF SAINT LAURENCE, EAST HARPTREE, PROJECT NEWTON**

## **Summary Report on the Archaeological Monitoring & Recording of Access Improvements to Churchyard, South Porch & Rebuilding of South Entrance Pathway Wall**

**OASIS Ref No: 2-507963**

**The PCC of the Church of Saint Laurence, East Harptree**

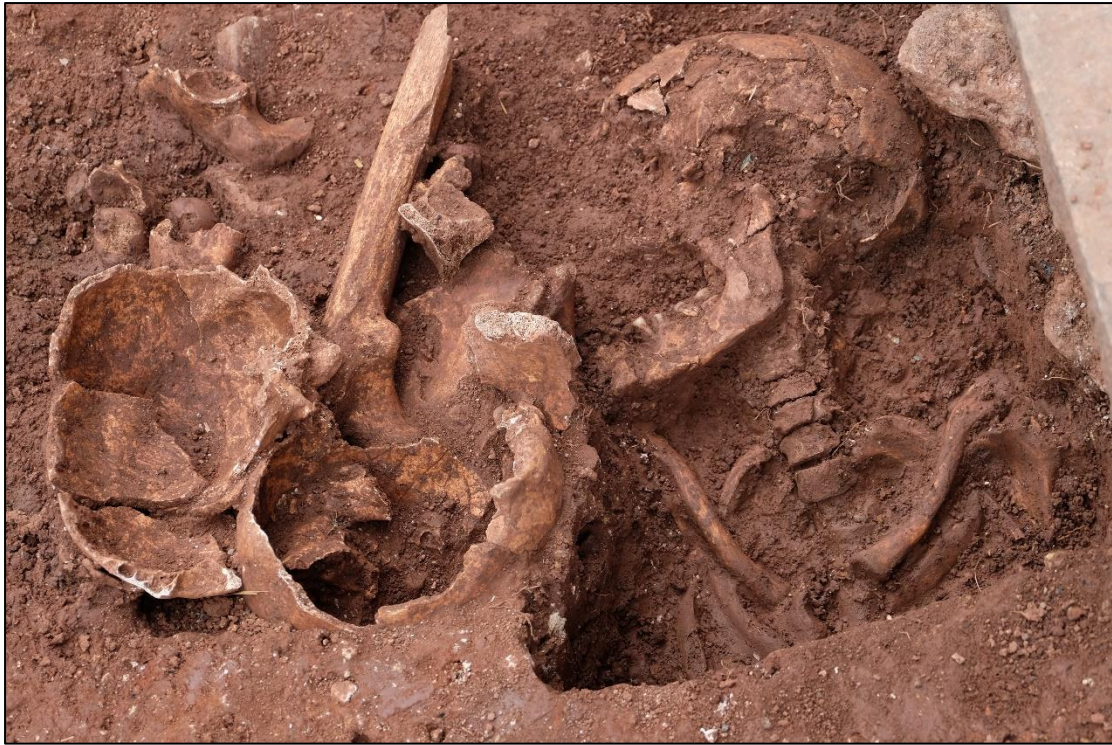
Three charnel deposits were uncovered outside the entrance (Fig. 1) and the complete skeleton of what appeared to be an adult female was revealed just east of the entrance (Fig. 2). Excavation and removal of the charnel deposits uncovered a further burial on the north side of the most easterly charnel deposits (Fig. 3). No clear grave cuts were observed but the female skeleton appeared to have cut through an earlier burial (Fig. 4). A few small sherds of medieval coarseware pottery were found within the deposits surrounding the burials.

**Figure 3.** Burial on N side of charnel deposits: facing W.

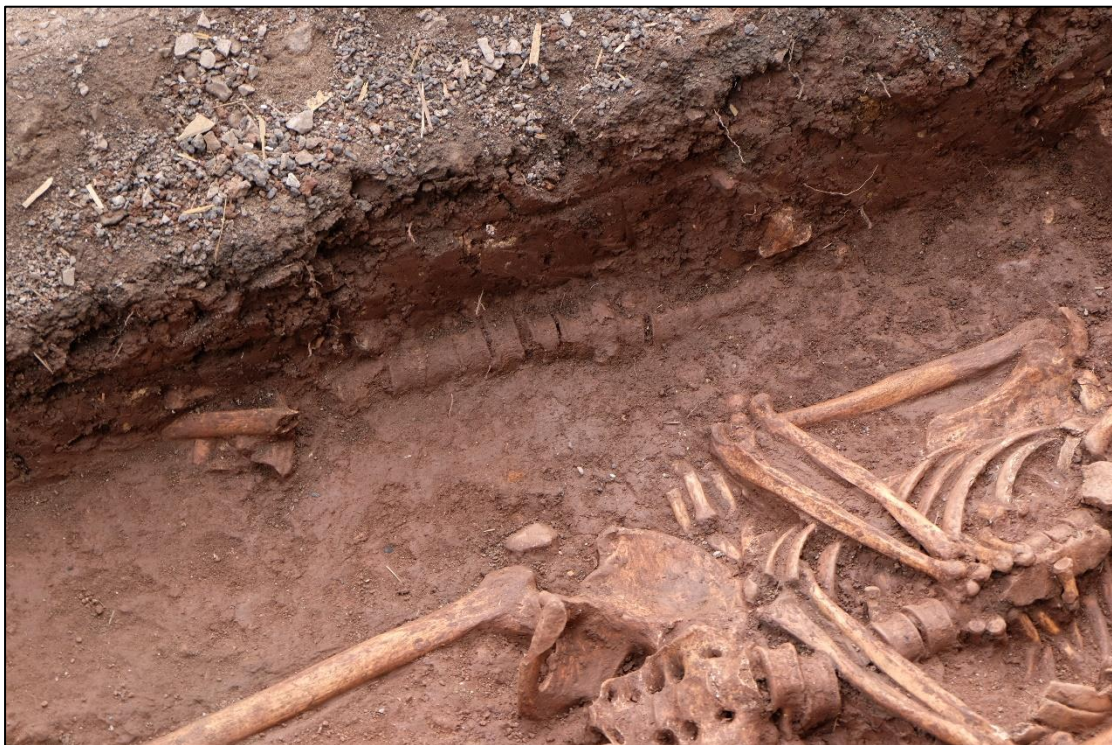
**Figure 4.** Remains of burial in S side of trench, cut through by female skeleton: facing SW.

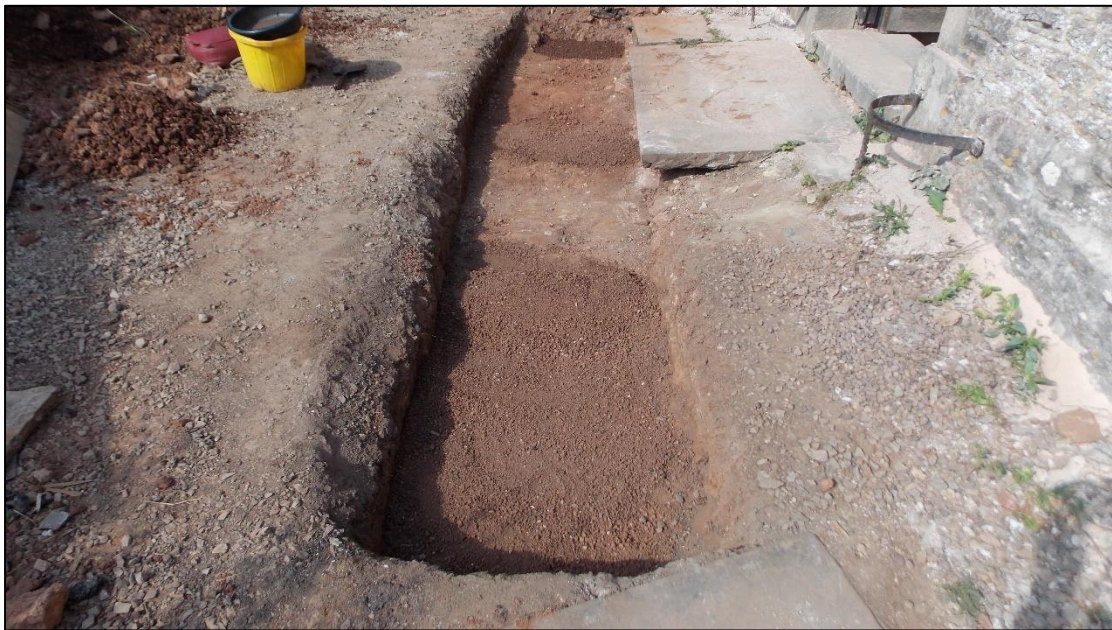
**Figure 6.** Burials covered with sieved soil: facing W.

The charnel deposits were recorded and removed to enable the level access into the church but the complete skeleton was left in-situ as it was possible to obtain the required levels without causing further disturbance. The charnel deposits were reburied within the east end of the original trial trench, but the widening of this area revealed a further burial (Fig. 5). After recording the exposed burials were covered with sieved soil (Fig. 6) before being further protected using a breathable membrane.

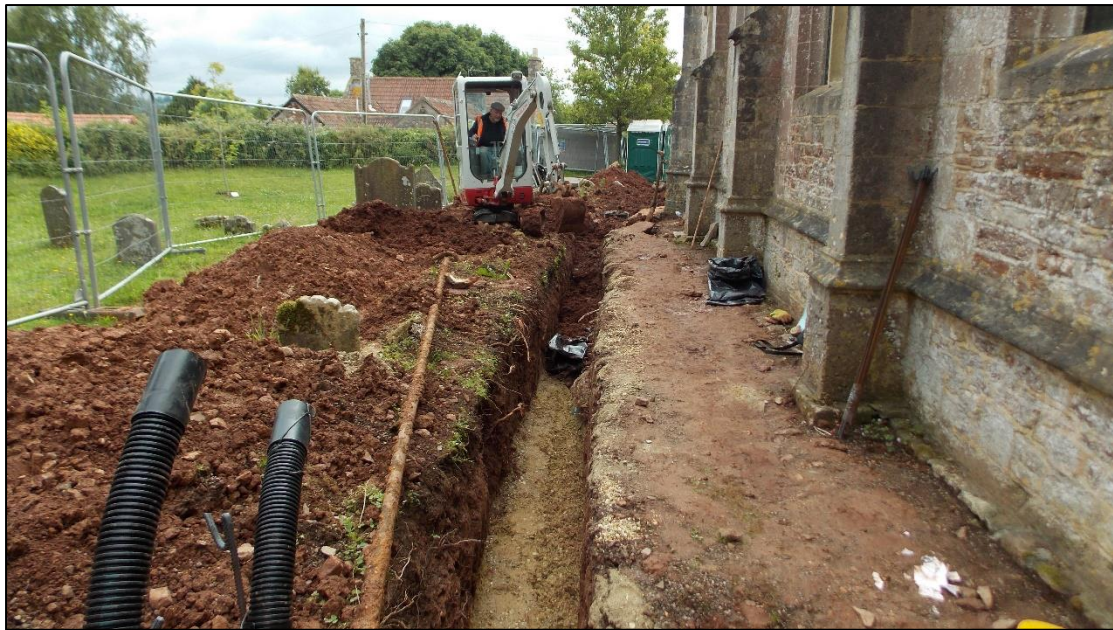
The removal of the existing pathways along the north side of the church out to the east gateway (Figs. 7 & 8) only revealed modern landscaping deposits, modern service pipes, mixed red silty clays, and previously disturbed burials. The red clay appeared to be the usual mixed deposits containing frequent human bone fragments that you would expect to observe in churchyards.

**Figure 7.** General view of removed path and service trench: facing E.

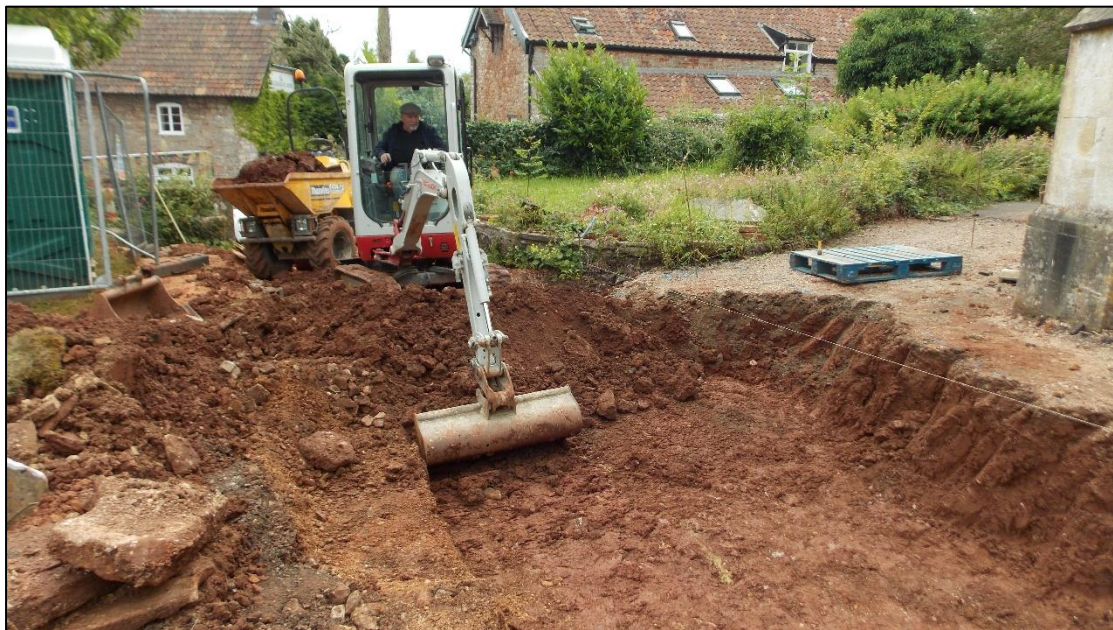
**Figure 8.** Pathway reduction in progress at east end of site: facing E.

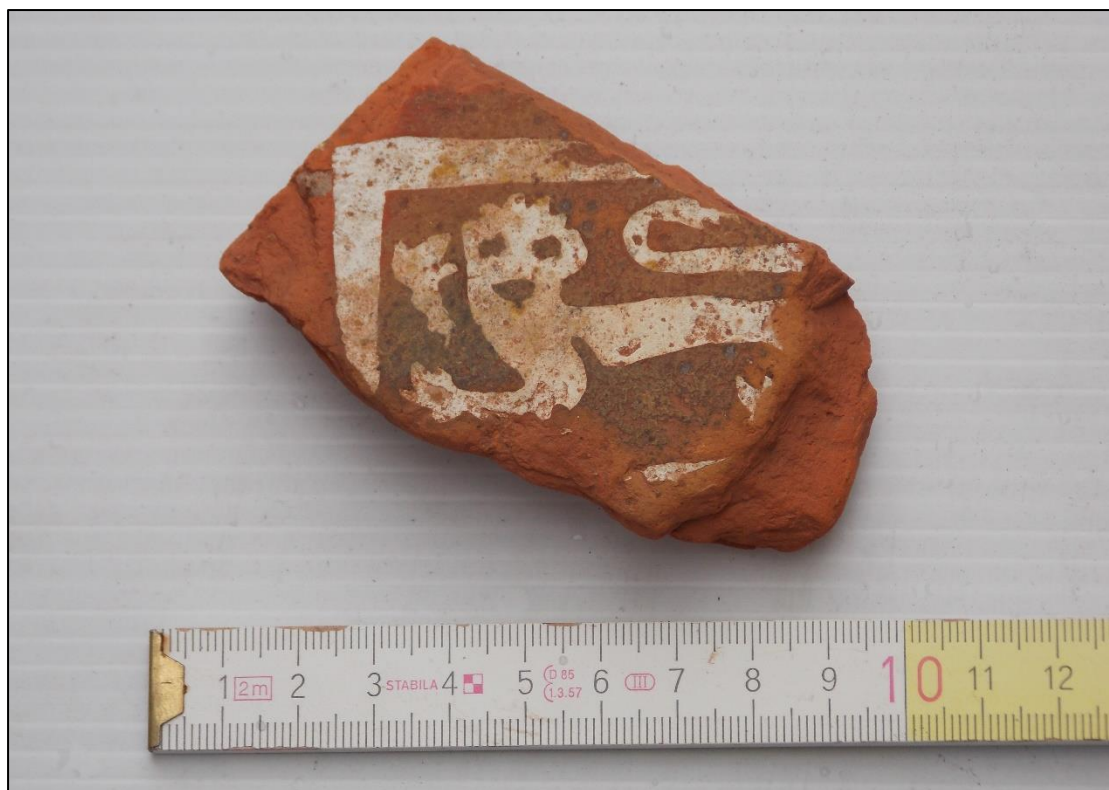
Fragments of decorated and plain medieval floor tiles were found within the red clay at the east end and north side of the Chancel and at the west end of the North Aisle. One of the tiles recovered from the west end of the North Aisle shows the top lion within a shield set diagonally (Fig. 9), representing ‘England’, and dating from the late 13<sup>th</sup> early 14<sup>th</sup> Century.

**Figure 9.** Medieval tile with lion decoration.

The deposit containing the medieval tile fragments appeared to be the usual disturbed grave soil containing fragments of human bone which you would expect to find in churchyards. There was no visible distinct layer within this deposit containing the tiles, but it is assumed that these tiles were once located within the church and formed part of a fairly high-status floor covering. The internal floors of the church were obscured with a protective covering during these works so it was not possible to see if similar tiles survive elsewhere within the church. The tiles will be retained by the church for their own heritage interpretation display.

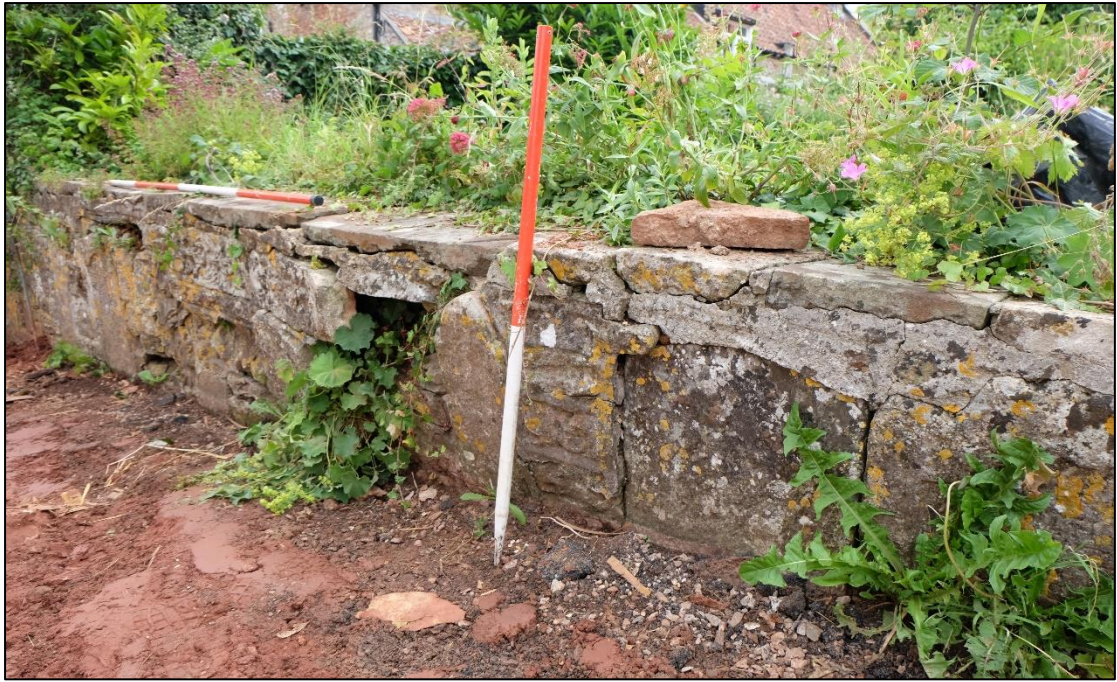
The existing wall was in a very poor state of repair (Fig. 10) and part of the new works required it to be dismantled and rebuilt. Prior to the commencement of the works the exposed face of the wall was known to contain 17<sup>th</sup> Century gravestones and various architectural fragments including Romanesque style voussoirs.

**Figure 10.** East gateway to South entrance wall: facing SE, 1m scale.

The dismantled wall appeared to be of a 19<sup>th</sup> Century construction and was roughly built from local limestone faced with various architectural fragments that must have become redundant and had been kept within the churchyard.

It was originally envisaged that most of these items would be built back into the new wall, but once removed it became apparent that some of the stones were significant enough to be moved into the church to stop any further deterioration. A catalogue of stones for potential display has been produced for the PCC (Faxon 2022).

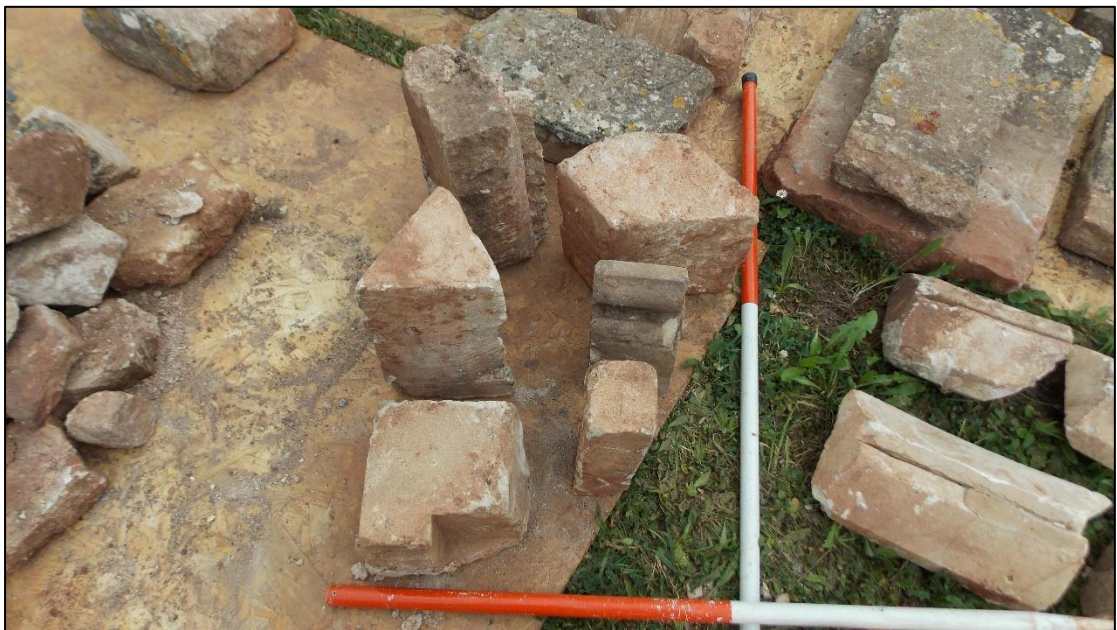
During the dismantling of the wall numerous, previously unseen architectural fragments were recovered from the wall foundations and these included window mullions, window tracery, hood mouldings, jambs, a corbel, and 18<sup>th</sup> Century chest tomb fragments (Fig. 11). All these items were removed and put into storage as they potentially represent earlier construction and modification phases of the church's fabric.

**Figure 11.** Selection of architectural fragments from wall foundations.
