# Bath Abbey

## The Tower Roof: Re-covering etc.

## Project summary

## BATH ABBEY, BATH: TOWER ROOF PROJECT

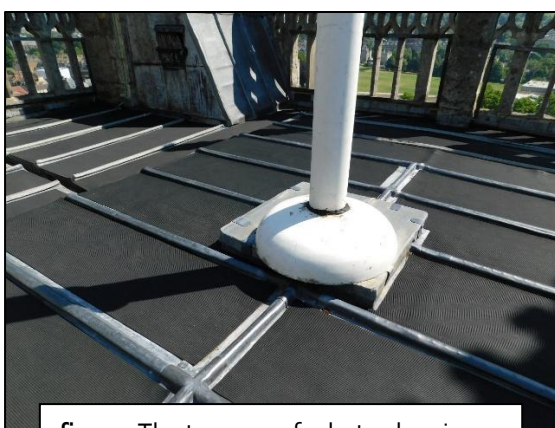
**fig.02:** The tower roof, photo showing flagpole connection and rubber matting laid over lead roof covering

- a The lead roof covering dates from the last major campaign of work to the tower, in 1947. The lead covering was replaced, laid onto new (or possibly C19th) sarking boards. The flagpole was replaced in 1999 and some of the 1940s lead bays have been renewed, probably dating from the same period. The lead bays are covered in rubber matting to protect the surface of the lead from footfall, and to provide a non-slip surface, as the tower roof is the highest point on the Abbey's public roof tour itinerary. Water is held against the lead surface under the matting, and cracks in the lead covering are concealed by the matting.

- 3.04 Consequently, in order to provide the Abbey with the most reliable way to keep surface water out of the interior, the option to install a jointless membrane is the preferred choice. Although it is recognised that the guarantees associated with such membranes usually extend to a maximum of thirty years, as opposed to the expected life-span of a properly laid lead roof of one hundred years, the primary need to reliably keep water out of the building is considered to trump the lifespan consideration.

- 3.05 Further, the new membrane will be protected from mechanical damage by means of a walkway grid (see 3.08 below) which will be a further asset in assuring longevity by protecting it from mechanical damage. If and when the membrane needs repair, this can be done locally with patch repairs. When the membrane reaches the end of its service life, it can be replaced with a new version, one half at a time, with the central 'ridge' as a break-point.

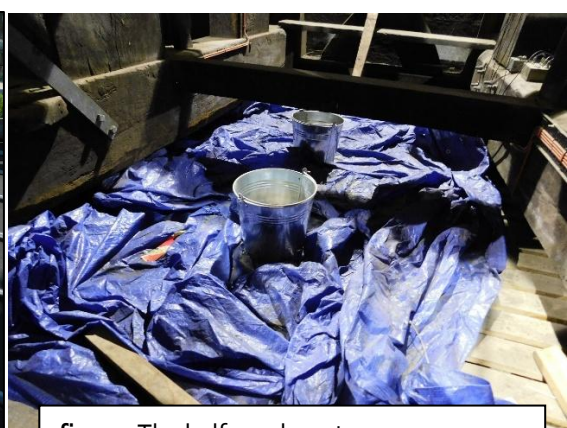
- 2.01 The quinquennial inspection of the Abbey church building 2023 by the current architect identified the present lead roof covering of the tower one of the most urgent fabric items to address. The lead covering is leaking, allowing water to penetrate into the belfry below. This puts the tower's timber roof structure, the bell frame, and the belfry floor structure at long term risk as a result of rot and decay. Holding repairs and temporary coverings in the belfry are not long-term solutions.

**fig.03:** The belfry, where temporary protections are in place to contain water ingress

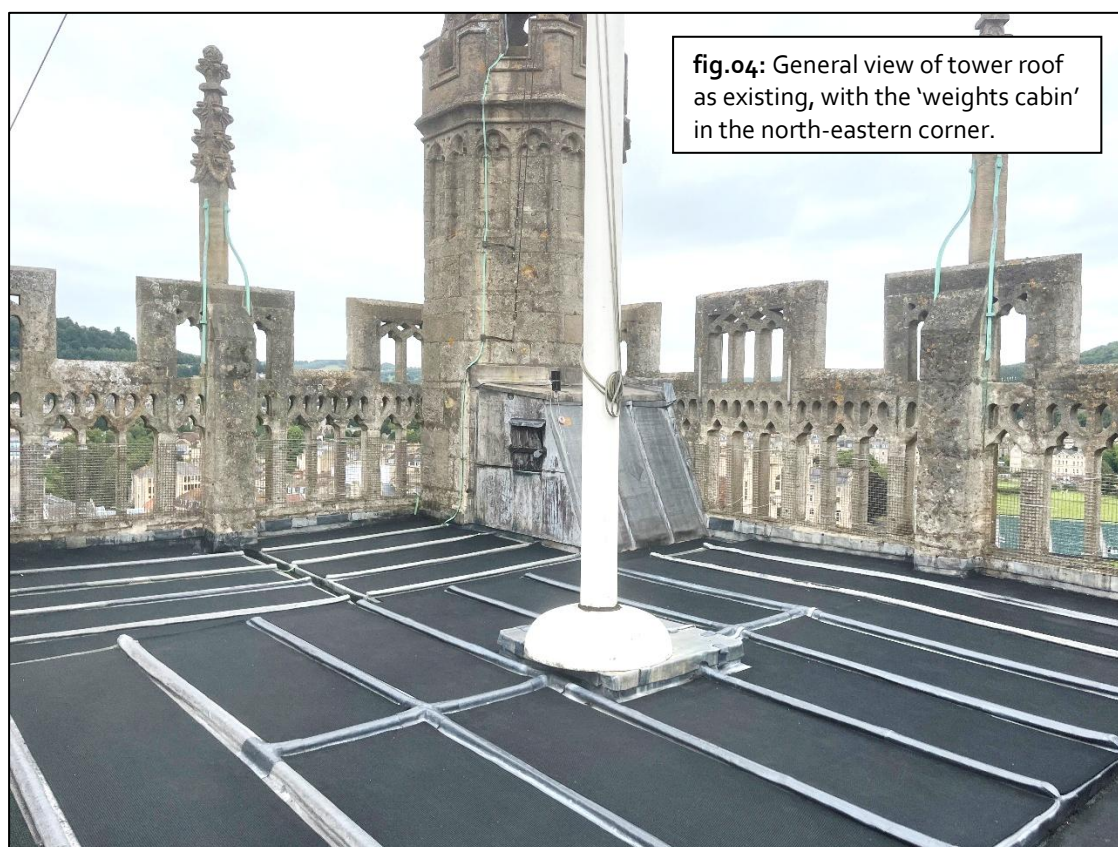
**fig.04:** General view of tower roof as existing, with the 'weights cabin' in the north-eastern corner.

- b The layout of the roof deck is such that surface water can only escape the roof to north and south, and a central 'ridge' means that there is only one outer per side. The traditional leadwork layout, running to these single point outlets, dictates that there are many lead-drip details, all of which are potential points of water ingress if the outlets block. Further, the lead covering itself is coming towards the end of its service life.

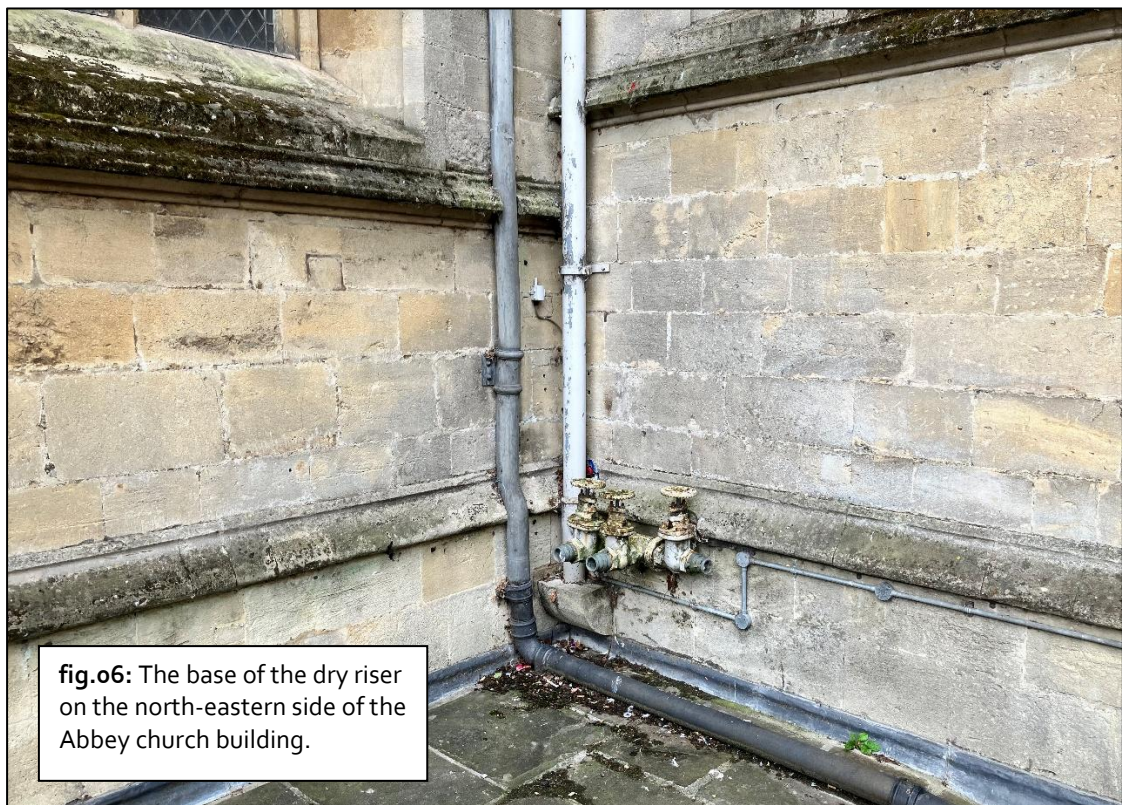
- 3.18 The large bore pipework which snakes up the external face of the building in the north eastern and south-western returns is the dry riser system, installed to assist in firefighting many years ago (see fig.o6 below). The Abbey, its insurers and the Avon Fire & Rescue Service have noted the poor condition of the pipework, and have concluded that it is no longer required for effective firefighting, should the eventuality arise. Rather than perpetuate its existence and continue to maintain it, the pipework is to be removed in a phased programme of work as access allows. In this instance, the pipework on the north-eastern return is to be accessed via the scaffolding to be erected from pavement level to the tower roof. The metalwork will be carefully removed, and any resulting apertures in the stonework made good using matching masonry repairs.

**fig.o6:** The base of the dry riser on the north-eastern side of the Abbey church building.
