## **BELFRY ROOF STRUCTURE BATH ABBEY, SOMERSET**

### **Historic Buildings Assessment**

ASE Project No: 240405  
ASE Report No: 2024181

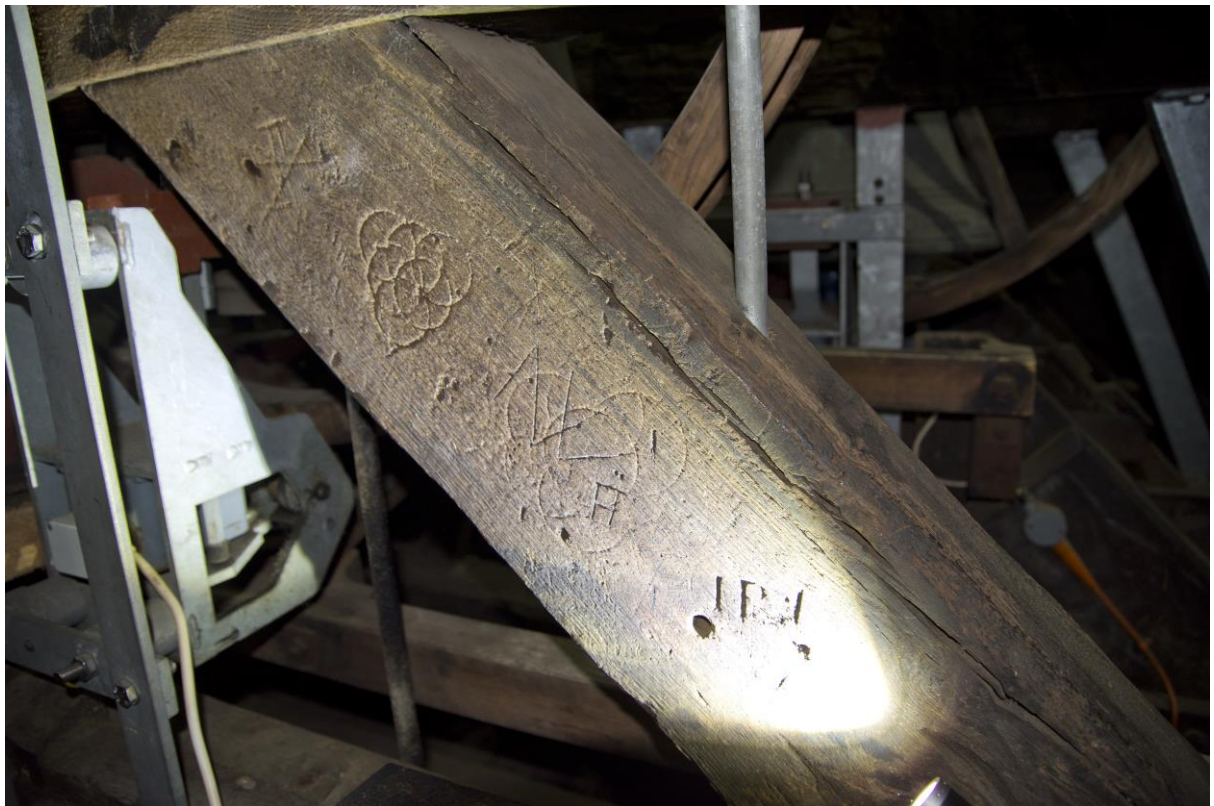
**Plate 8** – Detail of the bell frame, showing apotropaic markings

6.1 The belfry is of ashlar stone construction, pierced by pairs of louvred openings in each of its four walls (now partially infilled with modern concrete blocks; Plates 1-6). Large square putlog holes are present around the wall, at the level of the springing of each of these openings. The space is almost entirely occupied by the great bulk of the bell frame, with its ten bells. This is dateable to at least the late 17<sup>th</sup> century on the basis of a graffiti date of 1674 on a straight brace, and bears repeated episodes of apotropaic markings to deter malign spirits, including overlapping circles and Marian marks (Plate 7; Easton 2016). The core of the frame is probably of earlier date, however, conceivably original to the early 16<sup>th</sup> century tower, since here the braces are curved rather than straight (Plate 8).

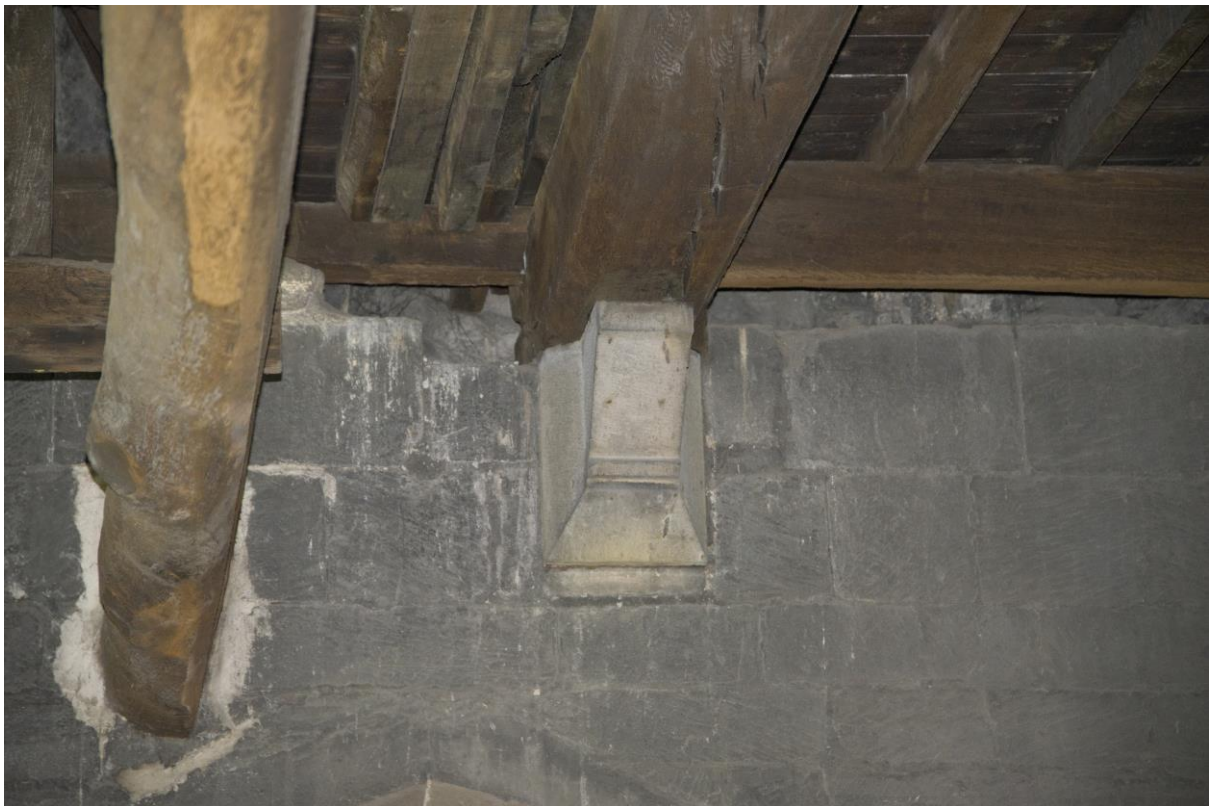
**Plate 10** – Detail of an upper cross-beam corbel, looking east

6.3 The two cross beams belonging to the roof itself are supported on the tower's side walls by faceted stone corbels, which appear quite fresh and recently replaced (Plate 10). The southern cross beam is of oak, and has a chamfer decorated with step-and-runout stops to its ends, as well as where it articulates with the central axial beam (Plates 11-12). Stops of this type are known from the late medieval period, and remained in common use until the early 17<sup>th</sup> century (Hall 2005, 158-160). The date and coherency of these stops makes it highly likely this principal timber is original to the roof, or at least to its mid-16<sup>th</sup> century restoration.

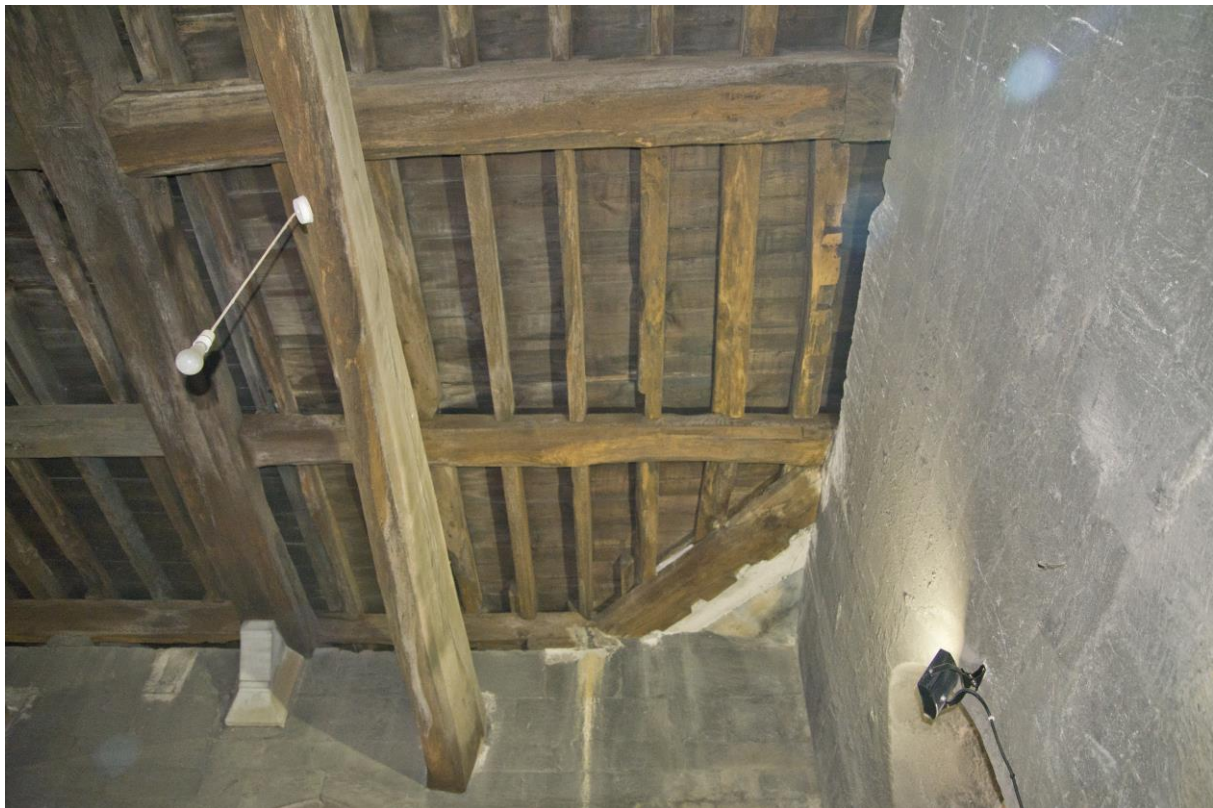
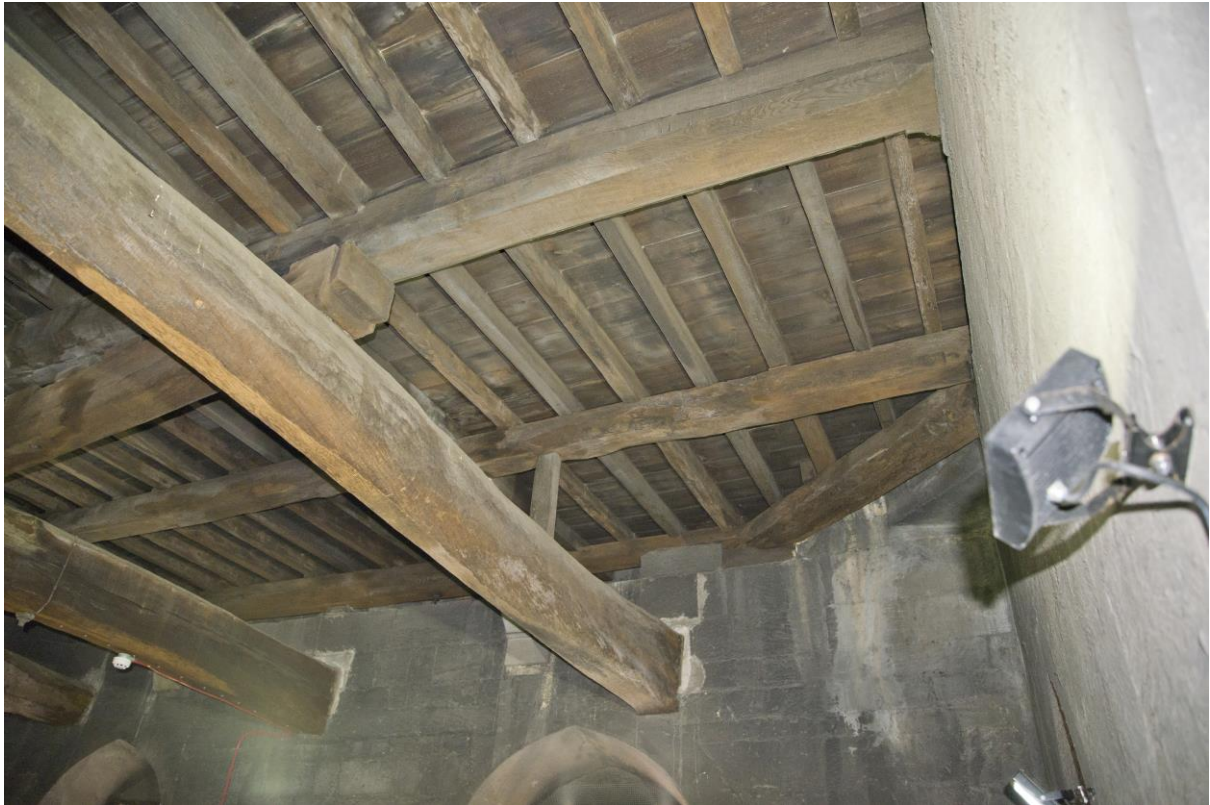
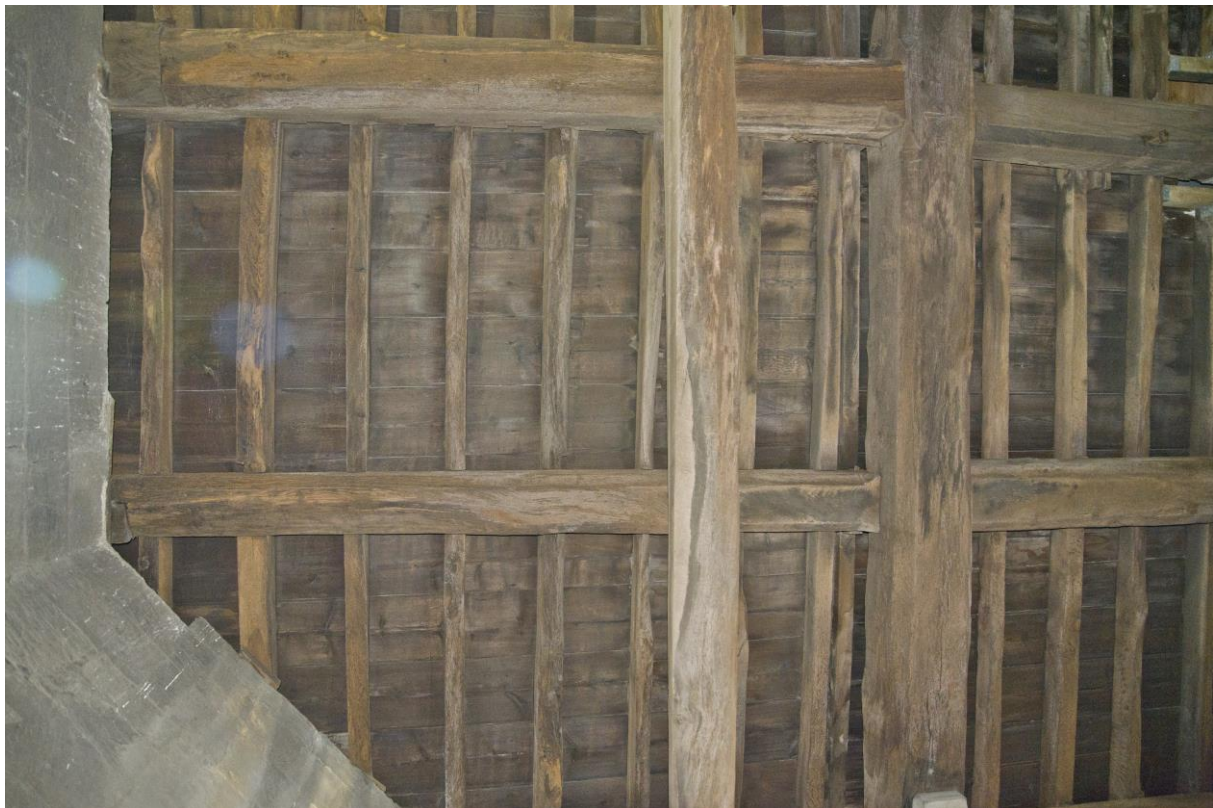
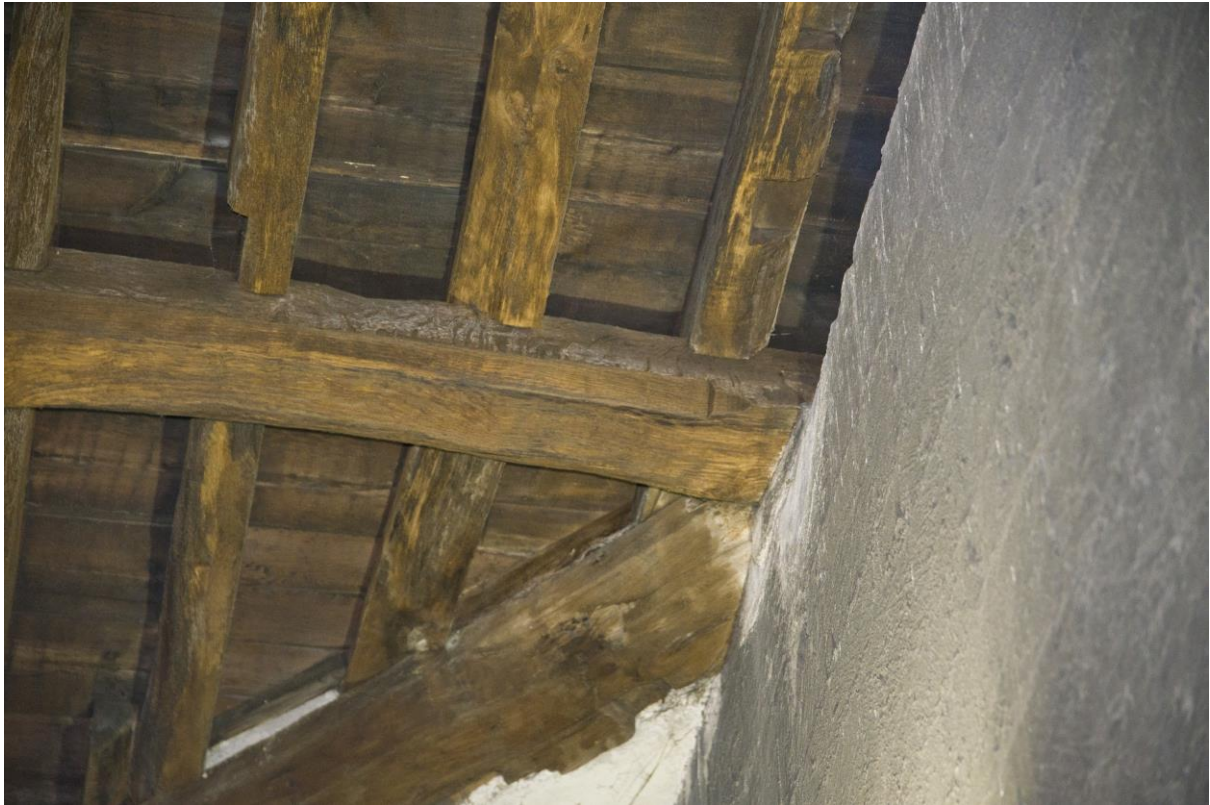
- 6.5 The roof has three axial beams to each of its three bays, which are either jointed into the cross beams or rest atop the masonry of the belfry's end walls (Plates 14-17). All three axial beams to the belfry's southern bay appear to be original: they have the same step-and-runout stops as the southern cross beam, they are oak, and they have a consistently aged patina and irregular finish (Plates 14, 17 & 18). Interestingly, a row of redundant mortices can be glimpsed to the upper face of the central of these three axial beams, meaning that it has been re-set. This implies that the entire roof was originally jointed together (as would be normal during the 16<sup>th</sup> and 17<sup>th</sup> centuries), and that the present lapped arrangement is a more recent intervention.

- 6.6 Three other axial beams are also probably original: the western beam to the middle bay and the western and eastern beams to the northern bay. The remainder are markedly crisper than the others, and their patina is different. Vertical saw marks can be discerned to the central beam of the northern bay, which is evidence that it has been processed using a mechanical reciprocating saw, rather than the diagonal markings diagnostic of a traditional pit saw. Reciprocating saws became widespread in the mid-/late 19<sup>th</sup> century, which would fit with the period of Gilbert Scott's restoration.

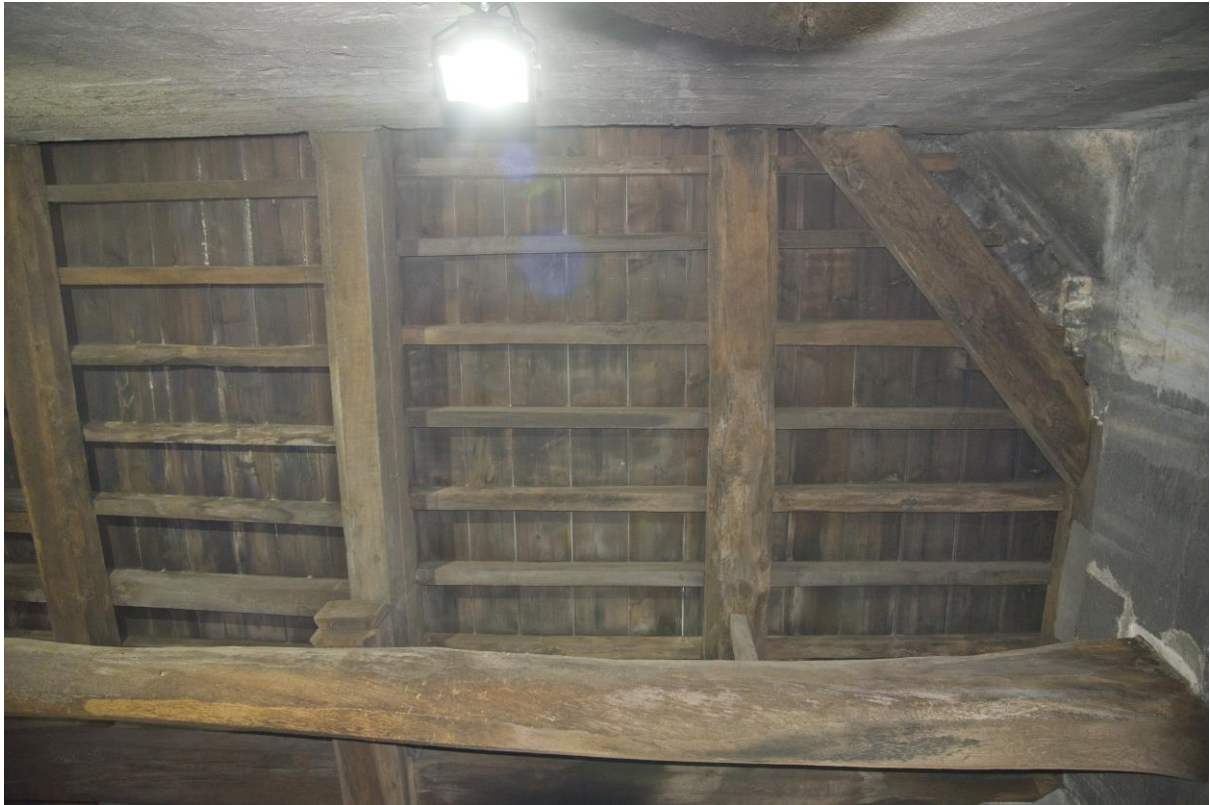
**Plate 19** – Axial beams, joists and dragon ties, looking up

- 6.8 The majority of the joists are markedly deeper in proportion to their breadth, and are likely to date to the mid-/late 19<sup>th</sup> century restoration of the roof (e.g. Plate 19). Most are machine sawn to a consistent size, and lack chamfers. A handful are of much rougher timber, implying they have been cut-down from earlier timbers on the site. The re-use of timber was particularly common in England during the 18<sup>th</sup> century, due to shortages caused by the demands of the Royal Navy, but before the height of the later 19<sup>th</sup> century Imperial project meant that plentiful good quality timber could be extracted from the Empire. It is therefore plausible that these joists

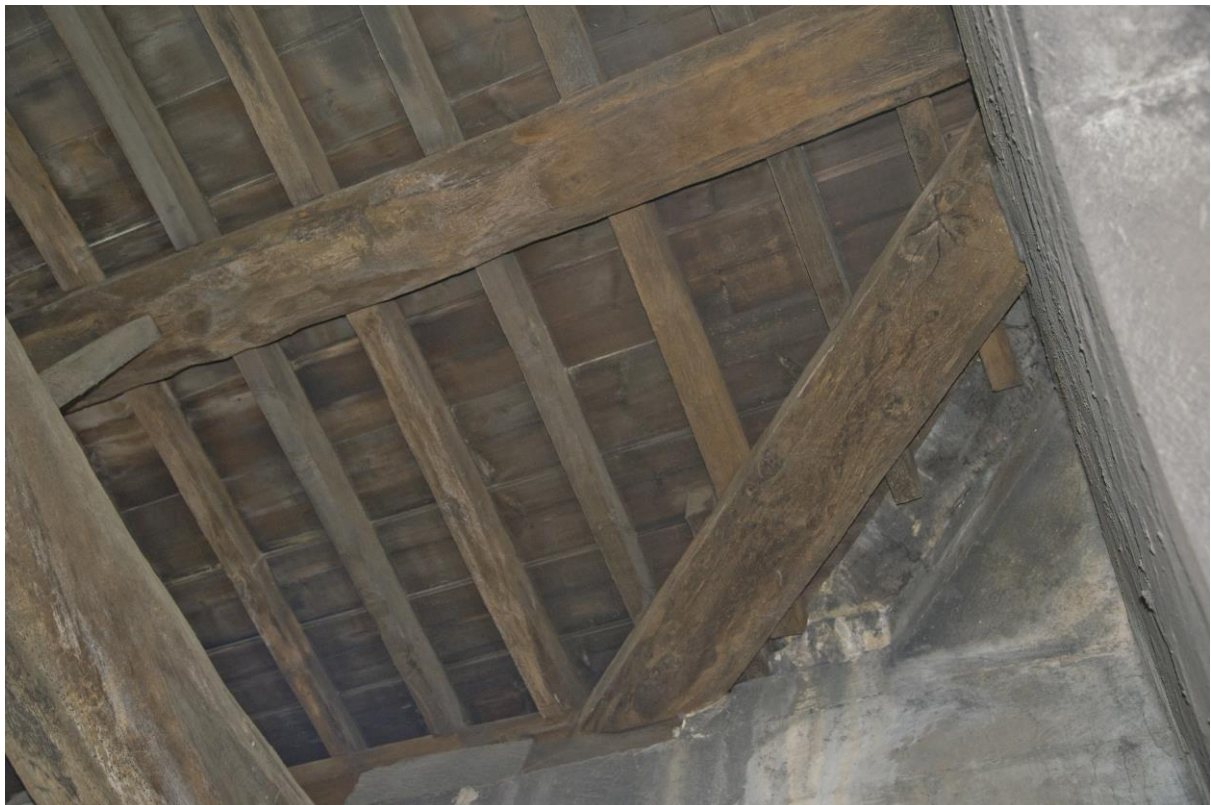
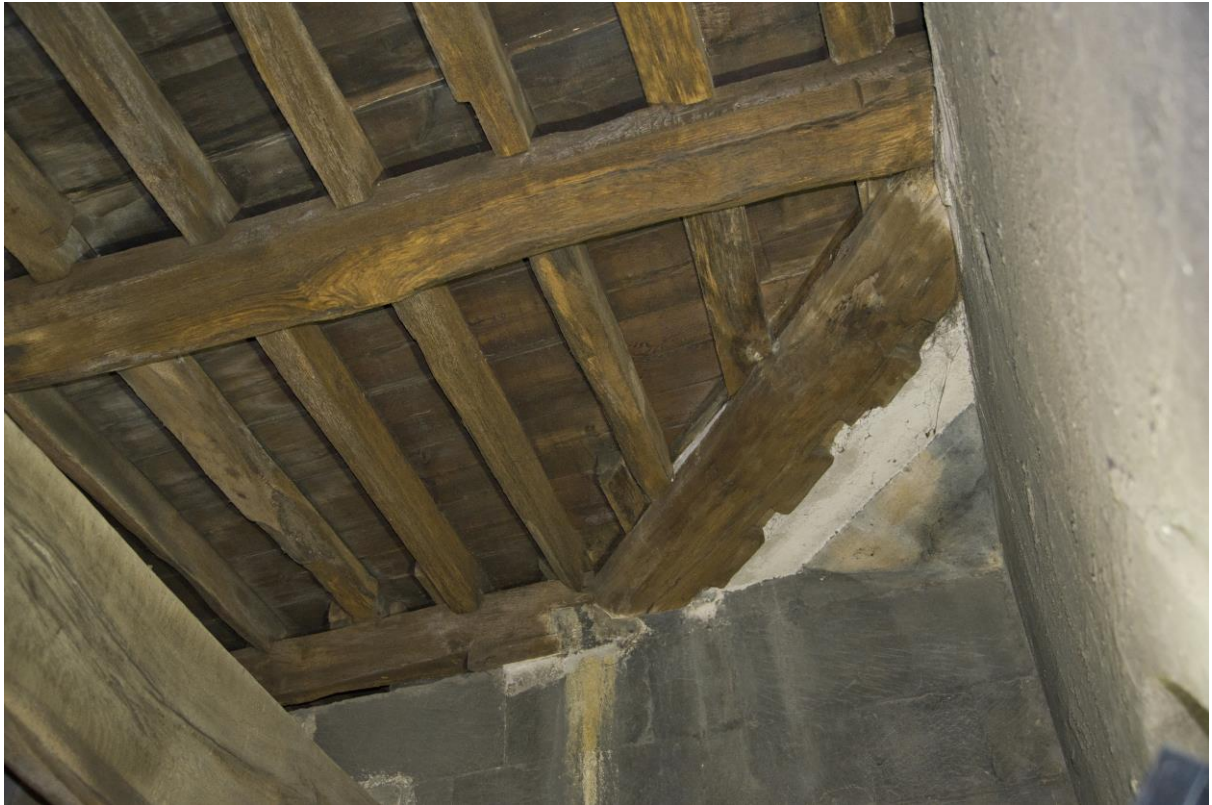
- 6.11 Two diagonal dragon ties are extant within the roof, designed to carry the joists where they met the corners of the towers (Plates 22-23). That to the north-west corner is nicely chamfered oak, and may well be an original timber, although it has clearly been re-set. That to the south-east corner is formed from a piece of re-used timber, so can be tentatively dated to the repairs of 1814. The dragon tie to the north-east corner appears to have been removed when the clock mechanism was installed; the presence of the newel stair in the south-west corner made a diagonal tie here unnecessary.

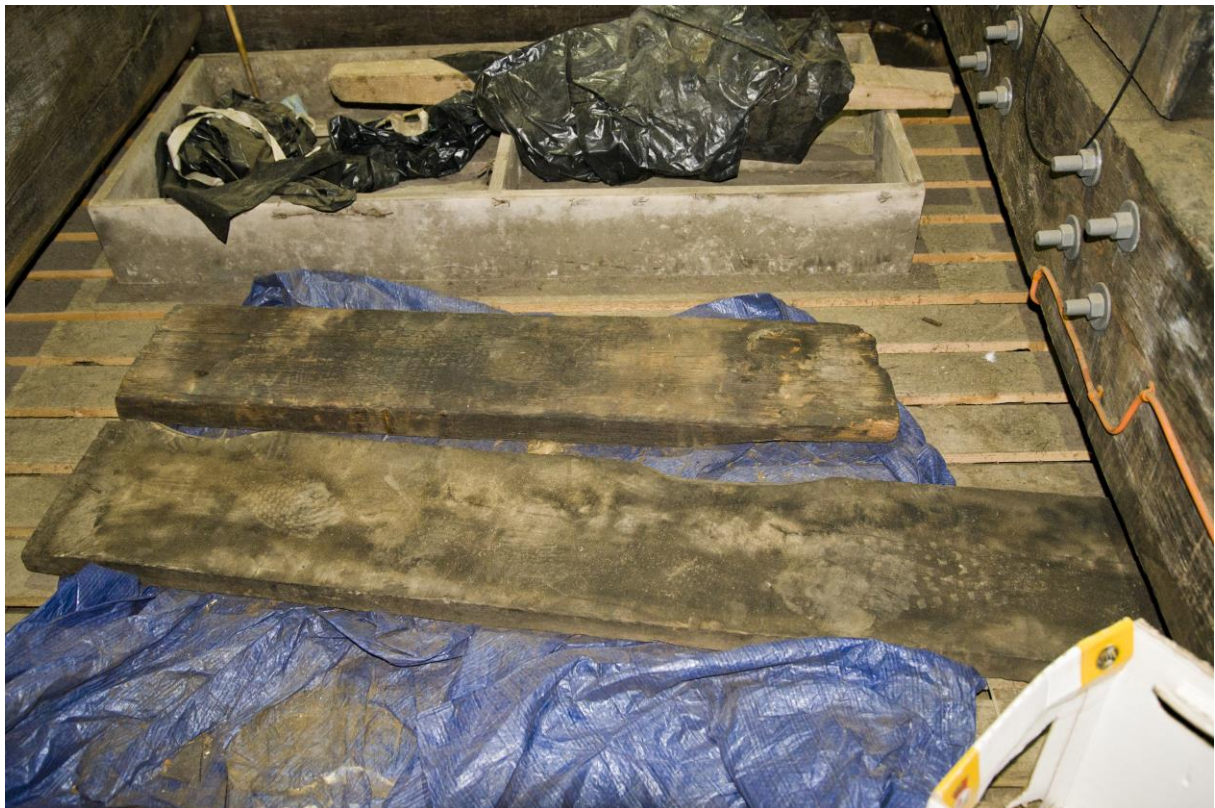
**Plate 24** – Suspected historic sarking board retained within belfry level.

- 6.12 The plank-like sarking boards which are laid across the joists are of a crispness, narrowness and consistency to indicate they all date to the late 19<sup>th</sup> century repairs to the roof, or perhaps the 1947 repairs to the leadwork. It is difficult to be confident from a distance, but their relatively wide grain is suggestive of softwood rather than oak.
- 6.13 Several loose planks are present within the belfry. One is of oak, and may be an original (or at least early) sarking board that is indicative of those which were formerly present (Plate 24).

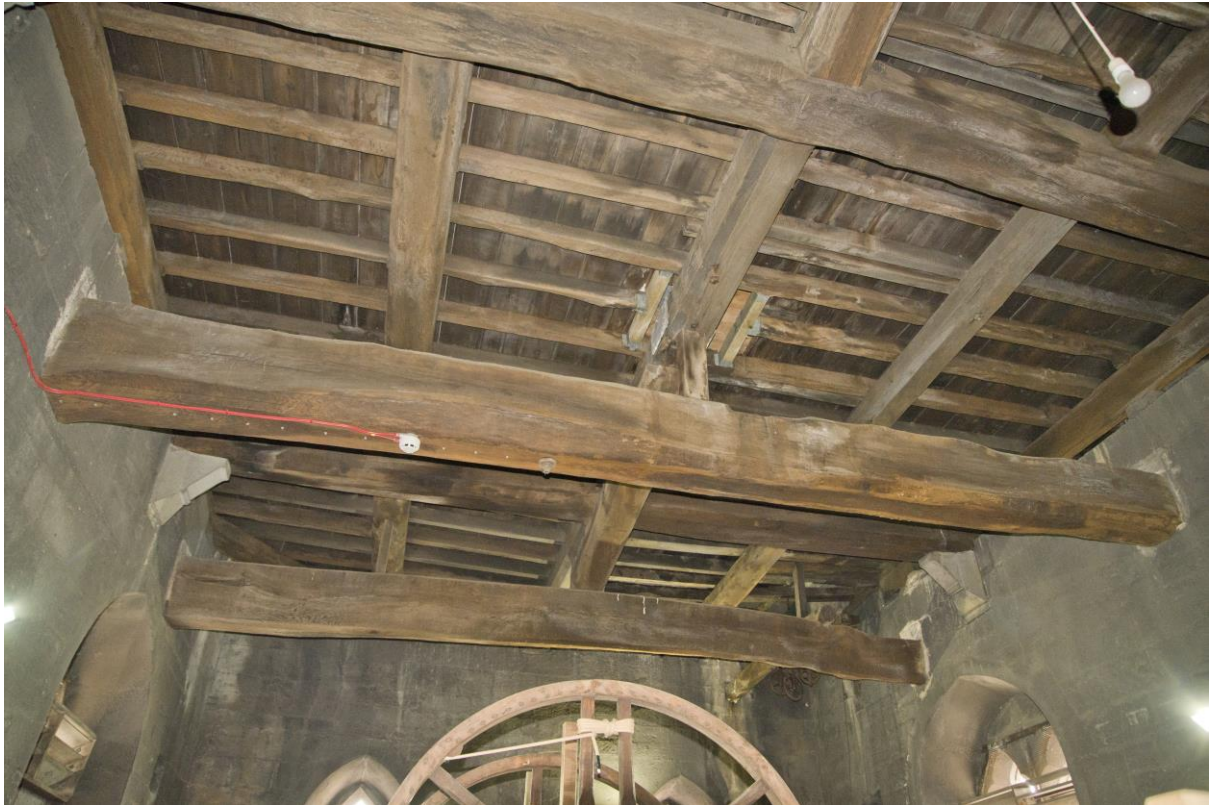
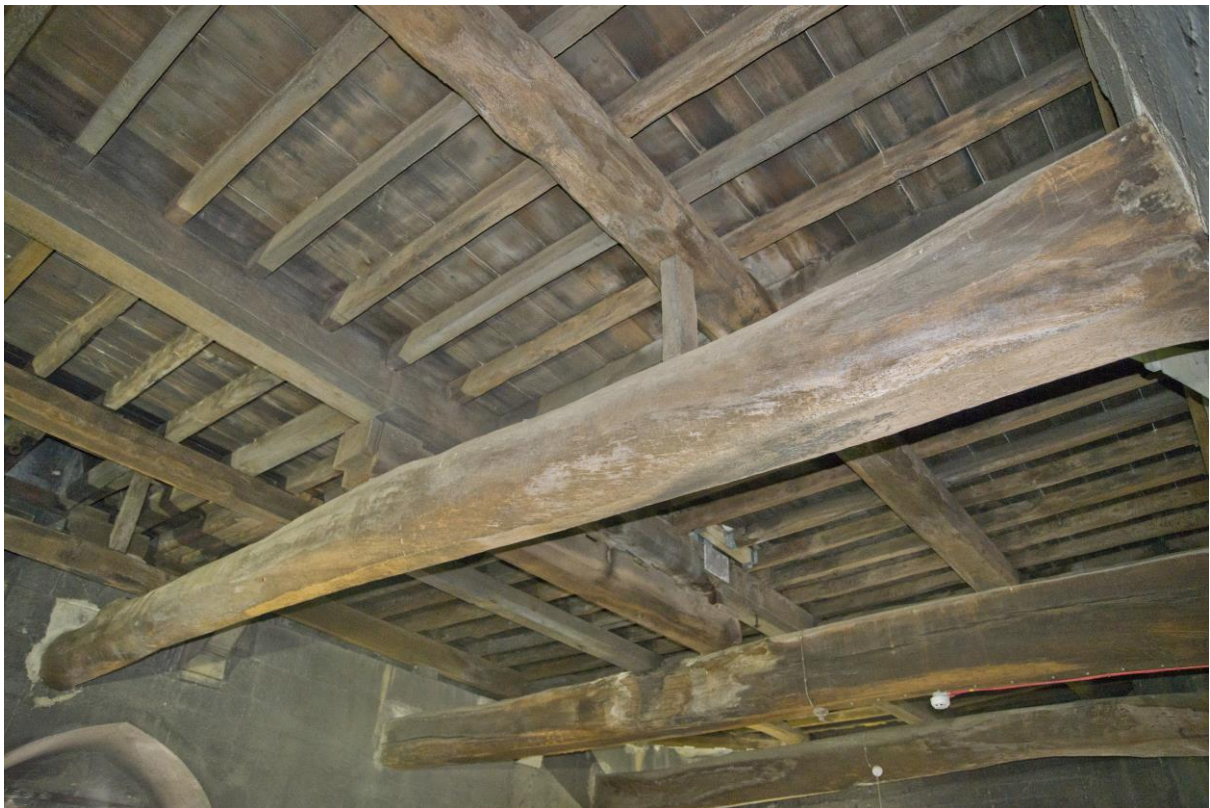
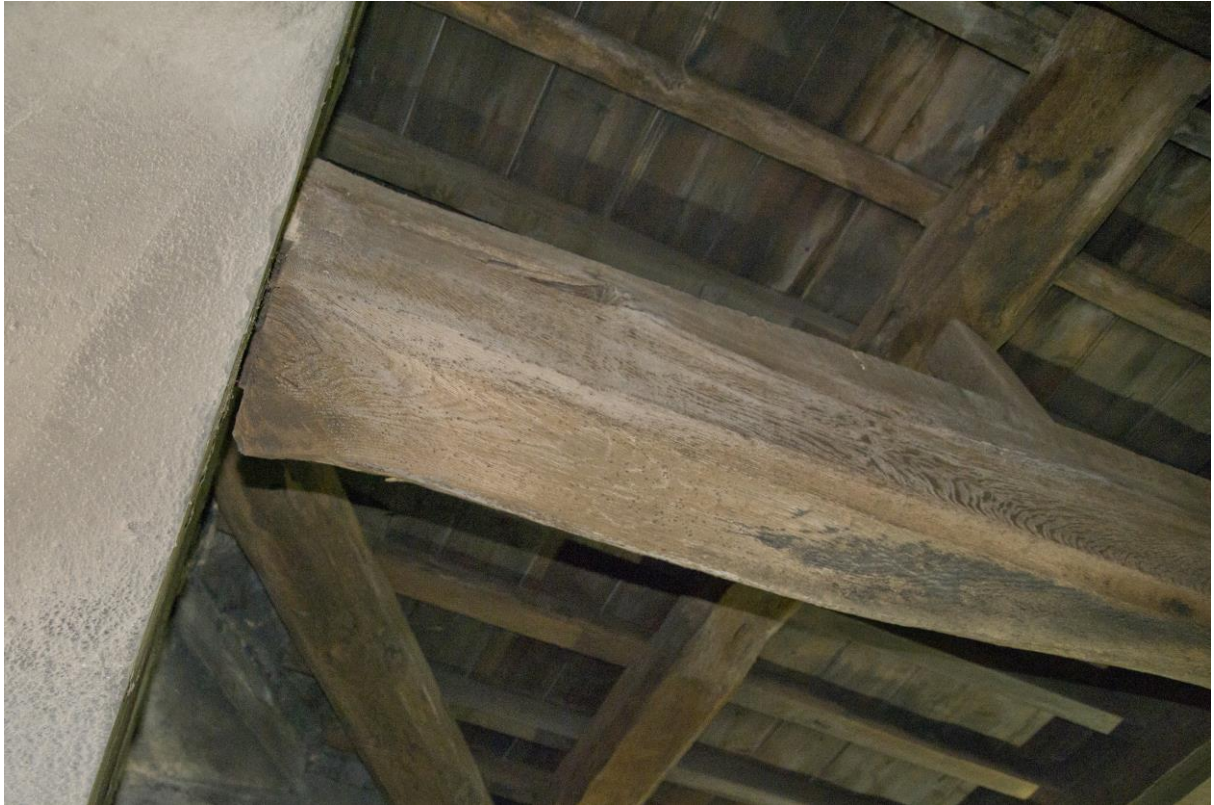
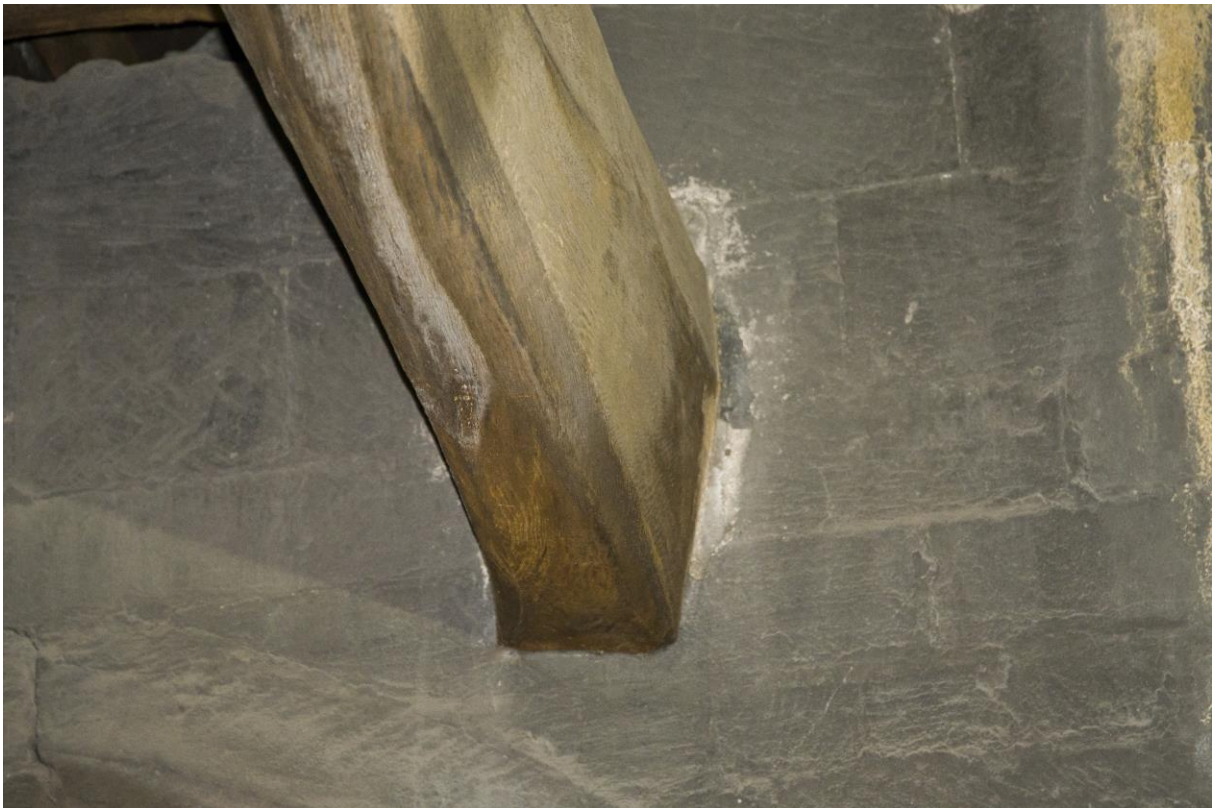
- 6.14 Three cross-beams are present c.0.8m below those of the primary roof (Plates 25-28). They have been cut into the walls of the tower rather than resting on corbels, indicating that they belong to a later phase. They bear simple runout stops to their chamfers, which are more typical of the 18<sup>th</sup> century than the earlier period. They are also formed of relatively poor quality wood, which is indicative of the timber shortages during this period: one cross-beam is essentially a half-sawn tree trunk, and the others have extensive sapwood and waney edges.

- 6.15 The lower cross-beams are structurally independent of the roof. It is possible they were installed to tie the side walls of the tower together, which does have a long history of cracking and subsidence. They are embedded into the masonry of the tower, whereas the upper cross beams belonging to the roof simply rest upon corbels and therefore provide little lateral support.
