# JOHN TAYLOR & CO.,

### **Church of St Peter, West Lydford - The Bells**

In accordance with your request, we inspected the bell installation on Wednesday 26<sup>th</sup> June 2024. We would like to thank you for meeting me at the church, and for accompanying the inspection. We report on our findings as follows.

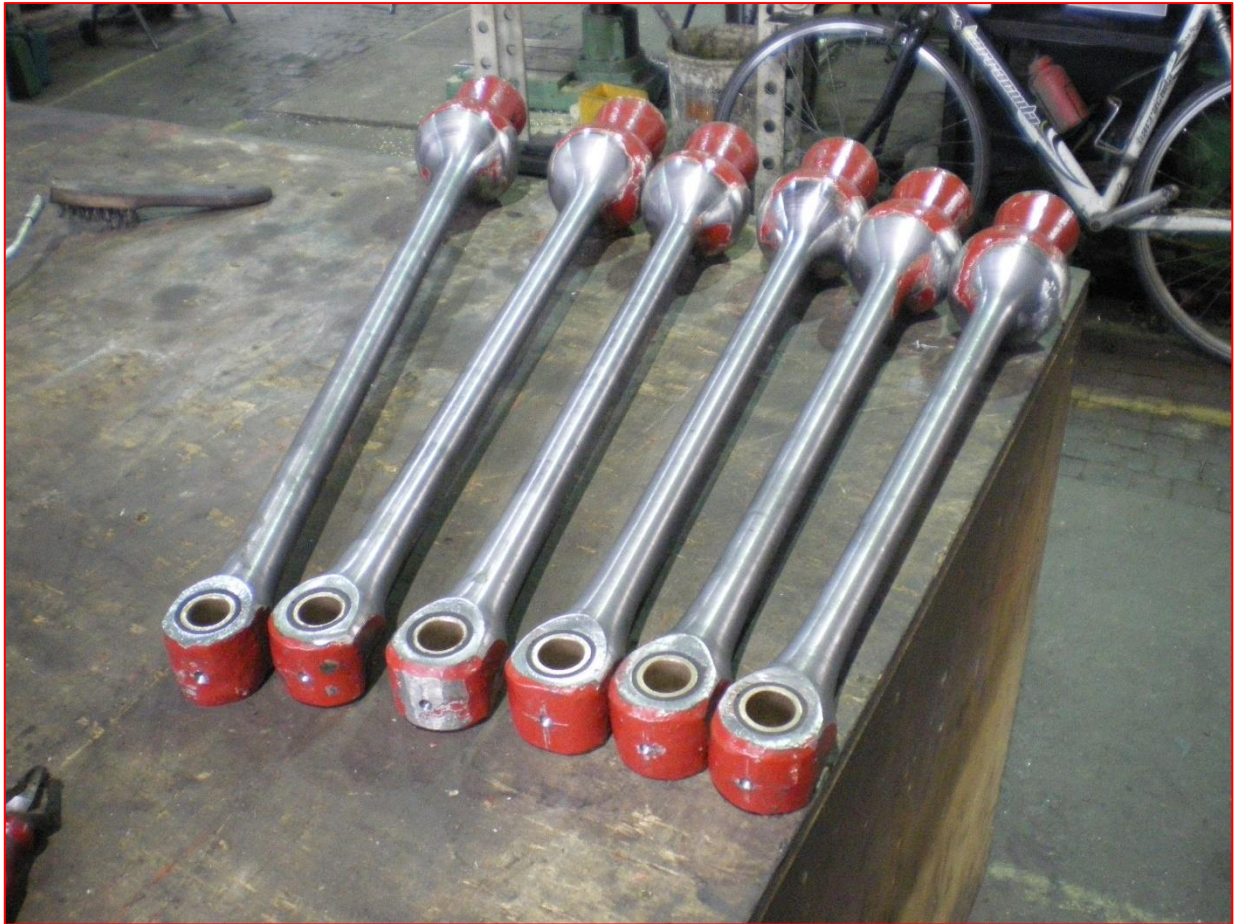
Photo: SG iron clappers with their shafts lathe machined to improve their timing

The clapper shanks to be lathe profiled turned to remove excess material as to improve their swing times. The clappers to be tested on the bench jig and their swing times carefully observed.
