**ST SWITHUN'S CHURCH  
BATHFORD, SOMERSET**

**A REPORT ON THE ORGAN**

**MARCH 2018**

**HARRISON & HARRISON LTD  
ORGAN BUILDERS  
DURHAM**

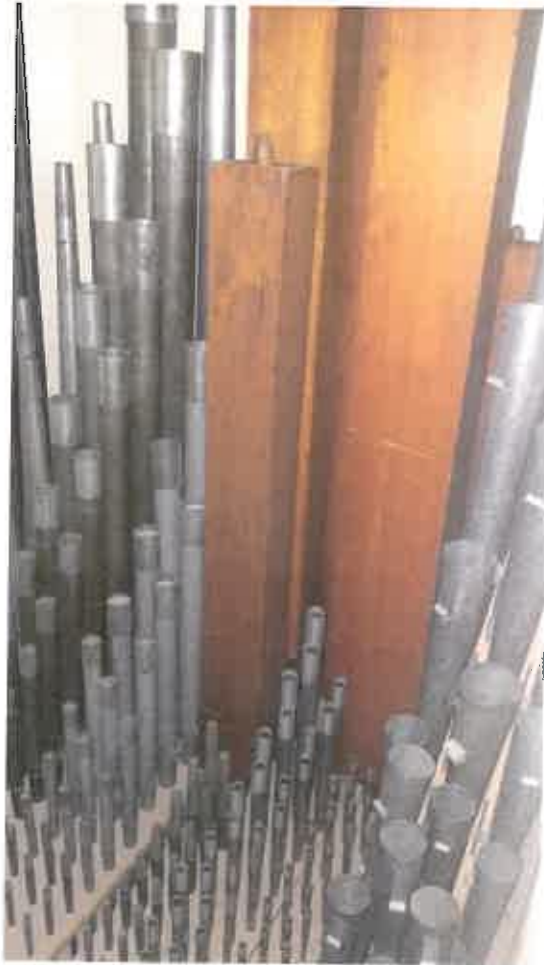
The general condition of the pipework is good. It is a mixture of new and old, the latter either from the old organ or from the builder's stock. Unfortunately, through an idiosyncratic system of 'borrowing', an exceptionally small number of bass pipes is shared between the Pedal Organ and the manual foundation stops, a system which saves space and expense but must inevitably undermine the organ's tonal effectiveness.

*Swell pipework*

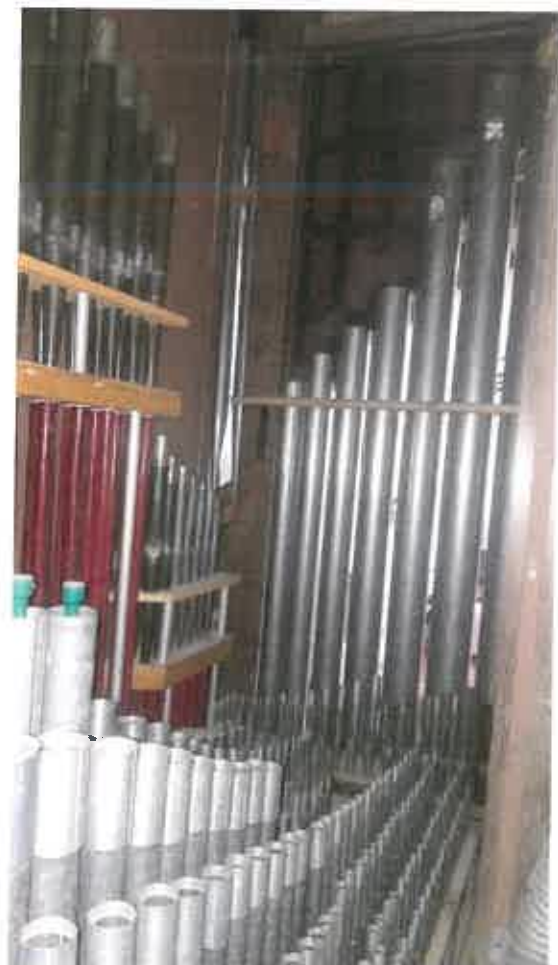
*Great pipework; front pipes in background*

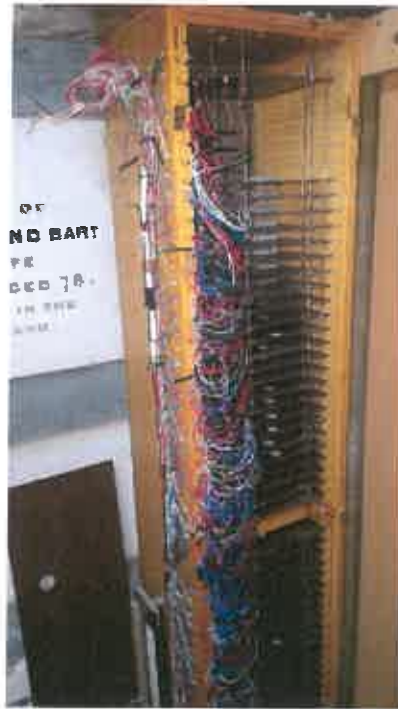
*Electronic coupling system and cabling*

As mentioned above, the electronic control system, never robust, is now obsolete and in a state of terminal decline. The cabling is somewhat chaotic. Piecemeal repairs will not cure the system's woes; total replacement would be the only solution.

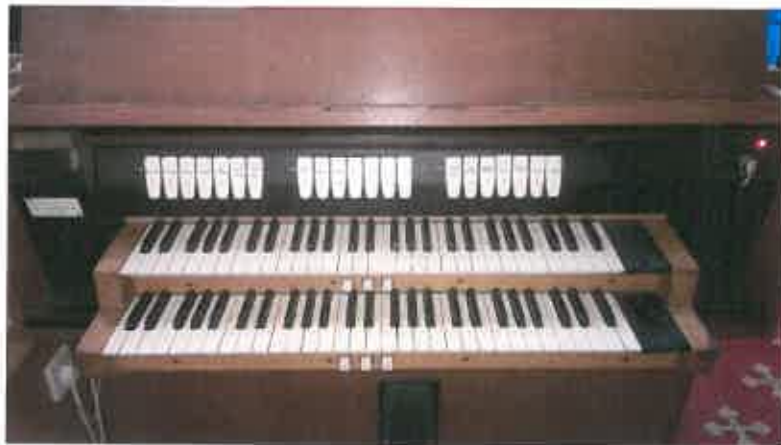
This is a neat, compact piece of work, well constructed and with an ingenious mechanism for retracting the keyboards. With renewal of the electrical components and a general overhaul it would continue to be serviceable and pleasant to use.

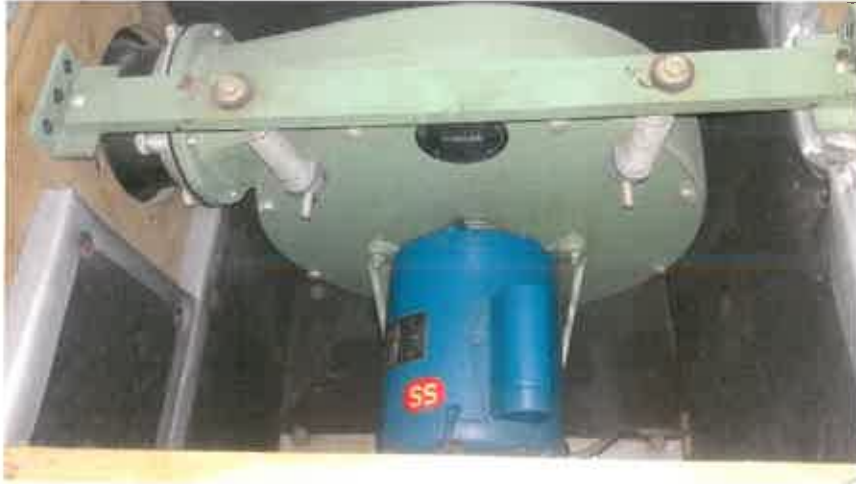
Wind is supplied to the organ by a centrifugal fan, or blower: this was made by a well-known manufacturer, Watkins & Watson, and is of first-class quality. It has a very long life-expectancy if properly maintained.

*Electric blower*

As for the present organ: the console (suitably restored) might be adapted and re-used for the replacement organ, and the excellent blower could be retained if its capacity proves adequate. Some of the pipework would be suitable for use elsewhere and would be worth preserving: it could be offered to an interested organ builder.
