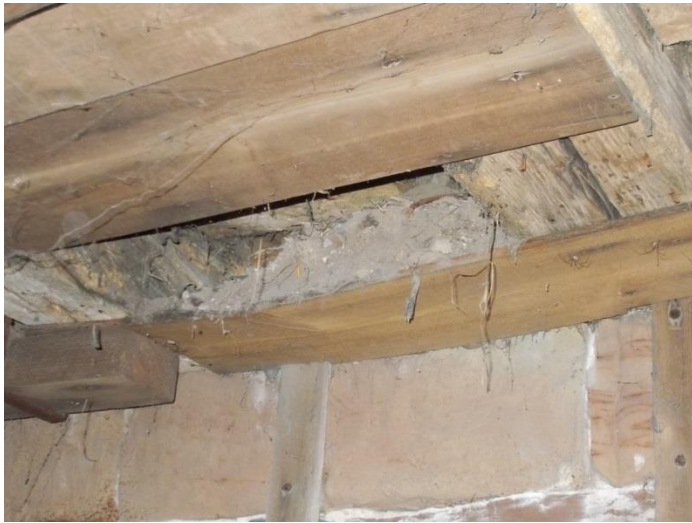
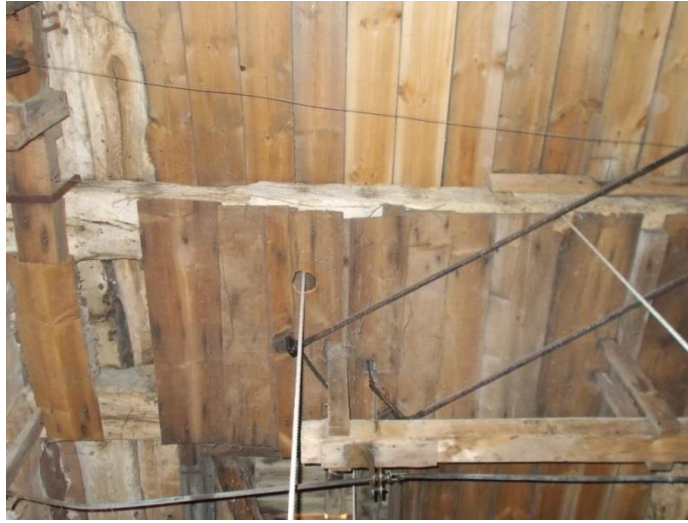
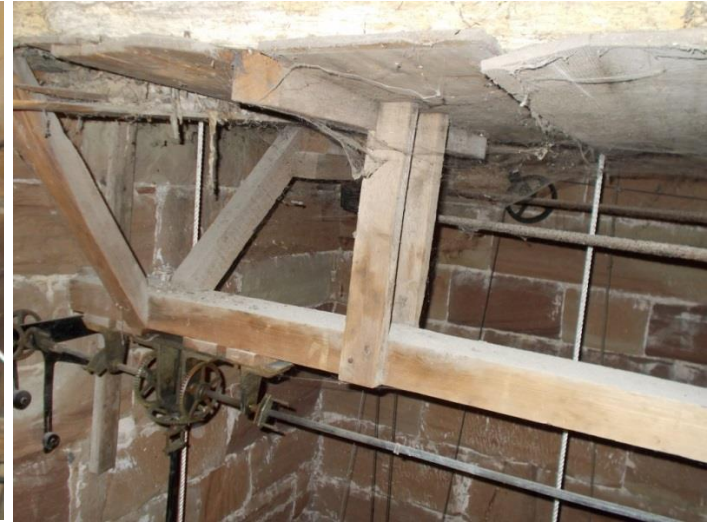
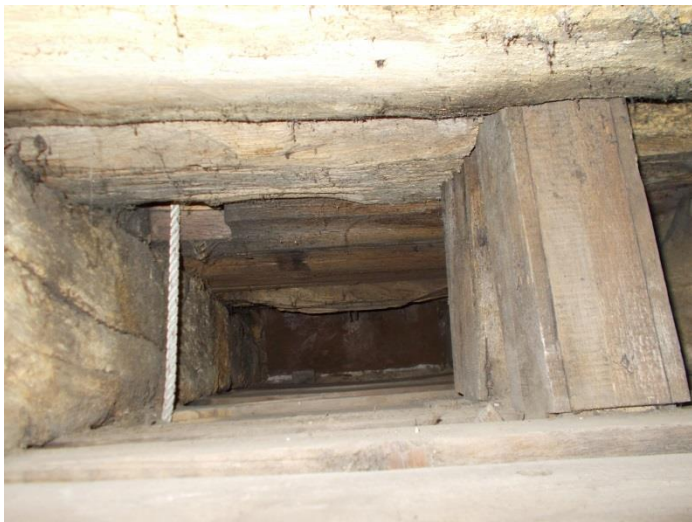
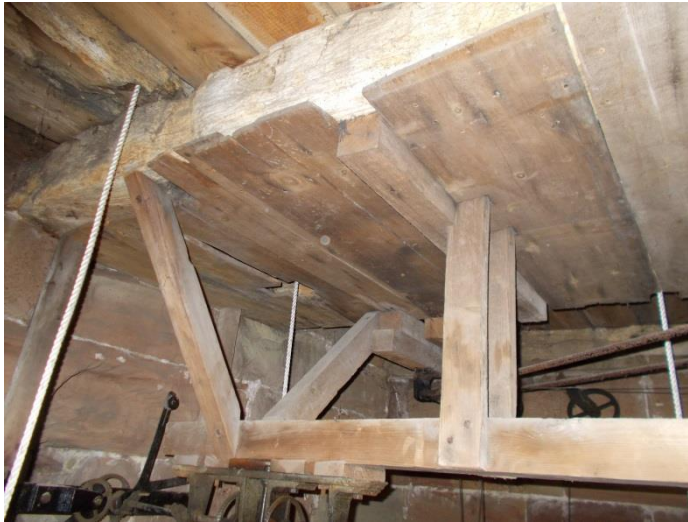
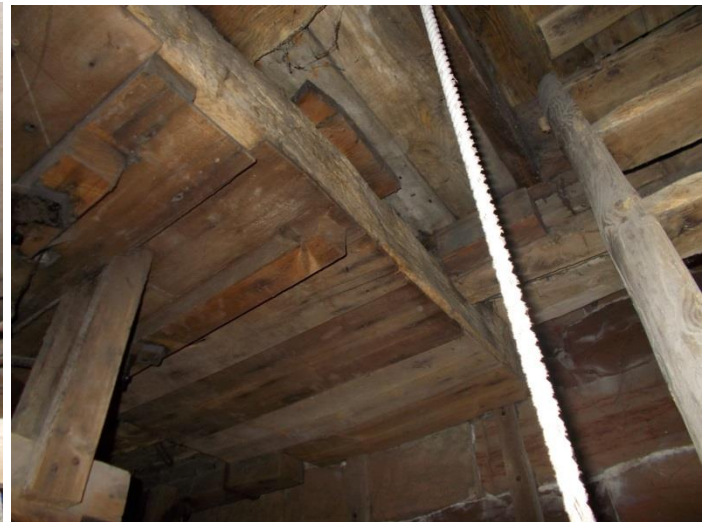
January 2017: Clock chamber: fallen ceiling board (& dislodged dust/debris) and other boards also splitting 2016 - cleared out & boards re-secured 2017

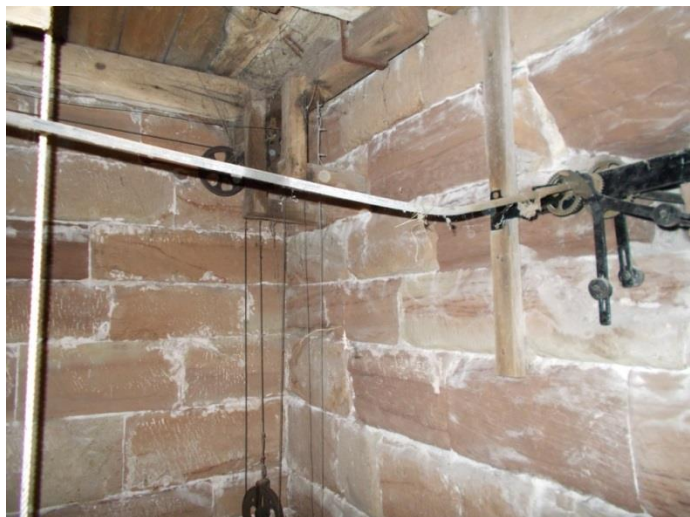
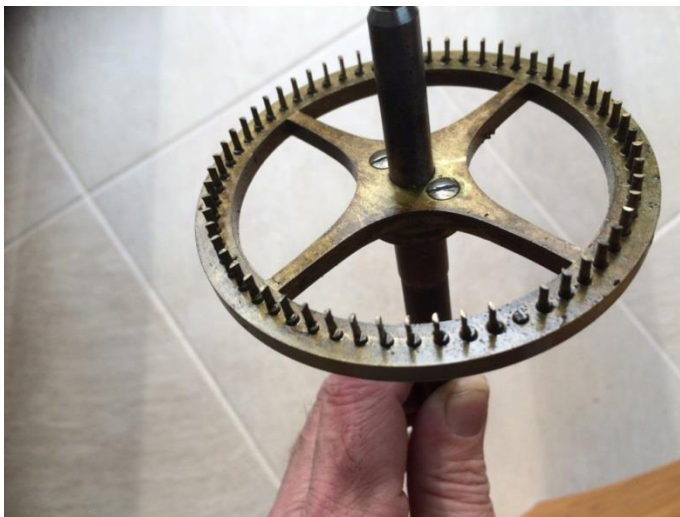
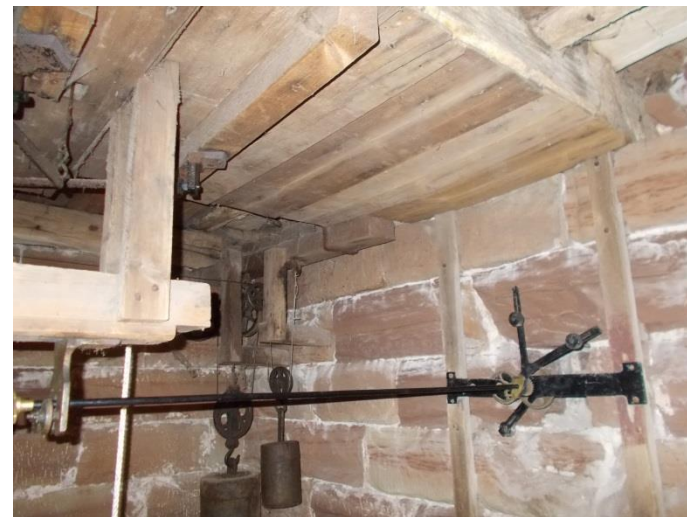
March 2017: clock connecting rod damaged by ceiling board falling on it +broken tooth on pin wheel escapement 2016, repaired & reinstated 2017

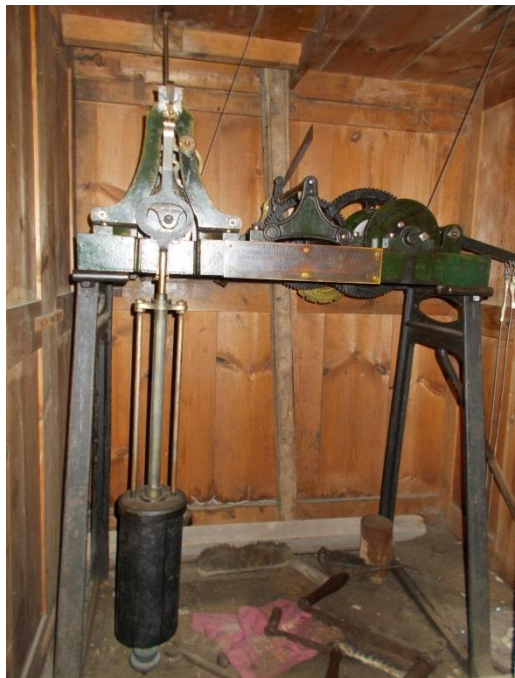
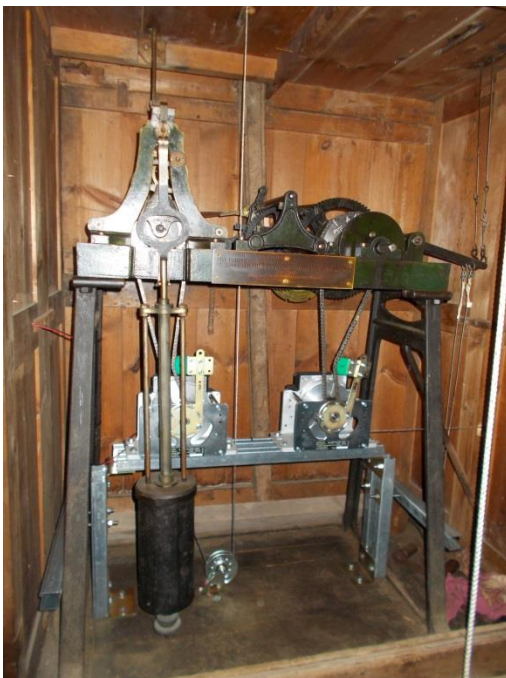
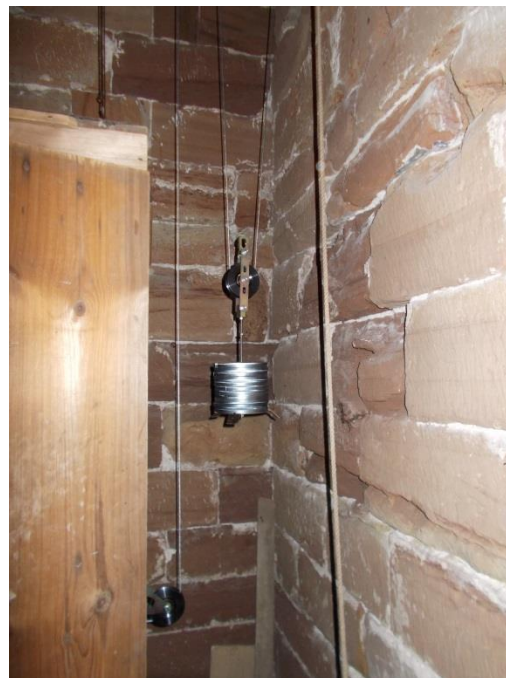
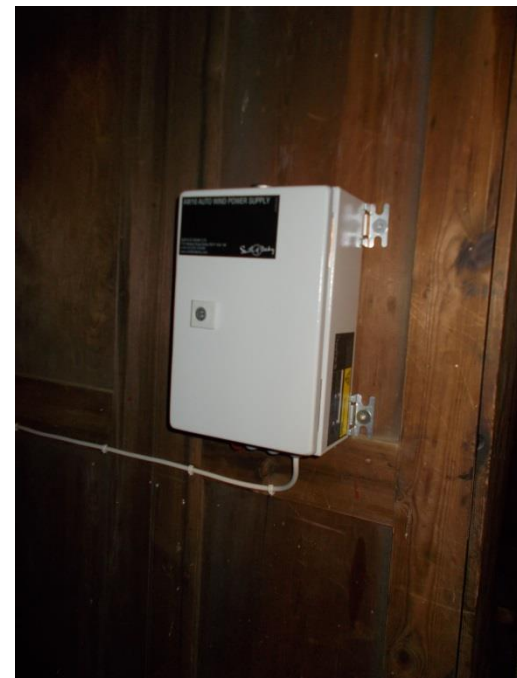
June 2017 automatic winding installed: extra framework clamped (not bolted) to existing frame, new weights & pulleys, battery backup attached to cupboard
