THE CHURCH OF ST. EDWARD THE MARTYR, GOATHURST, SOMERSET.

SINGERS GALLERY PANELS

CONDITION SURVEY

MAY 2025

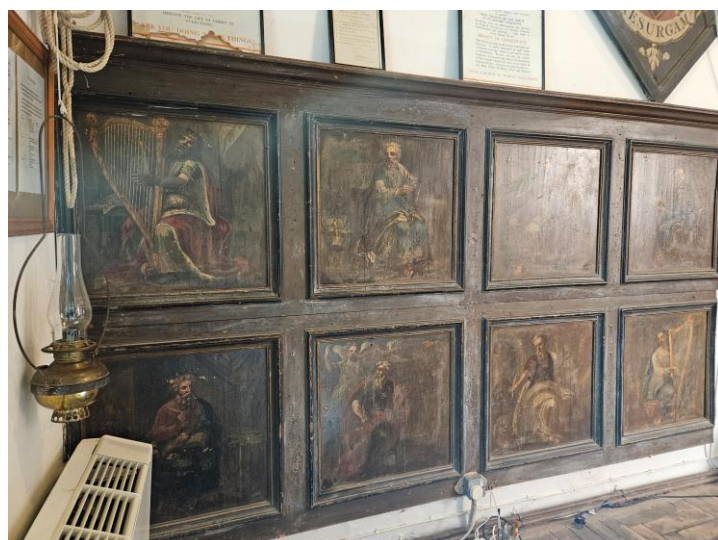
FIG 1

It is unfortunate that an electrical socket has been fixed into the frame at the centre of the lower section of panelling and a radiator has been placed on the west wall immediately adjacent to the lower painted panel at the west end.

Gallery panels viewed from the west.

Note the radiator at the east end and the electrical socket in the central lower rail.

Prior to treating the panelling, it is recommended that the radiator on the north side of the west wall is moved to the south side. The electrical socket should also be removed and refitted in a more appropriate position on the wall, preferable not near the panelling.

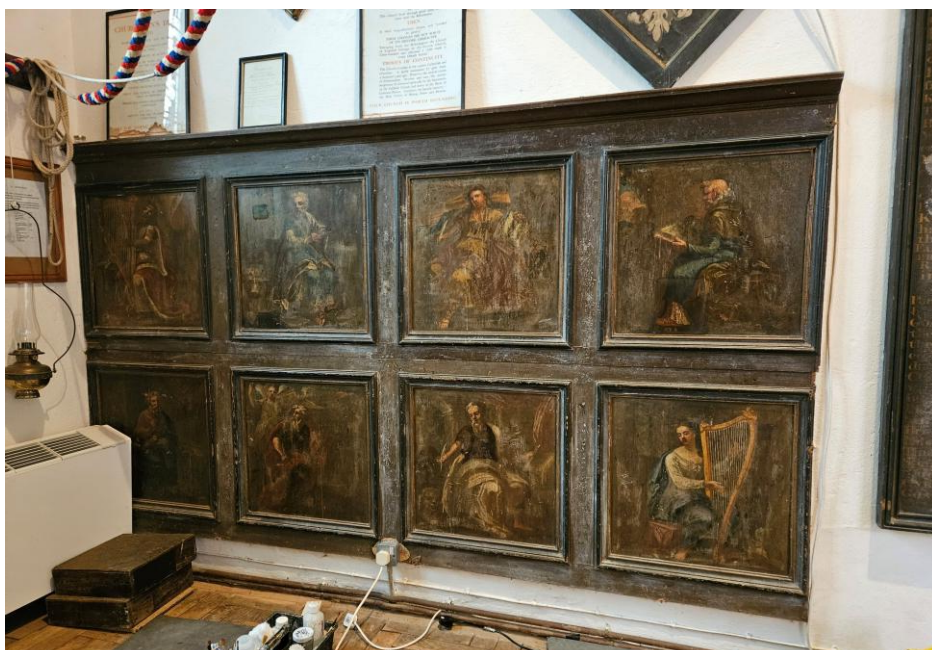
FIG 2

Gallery panels viewed from the east.

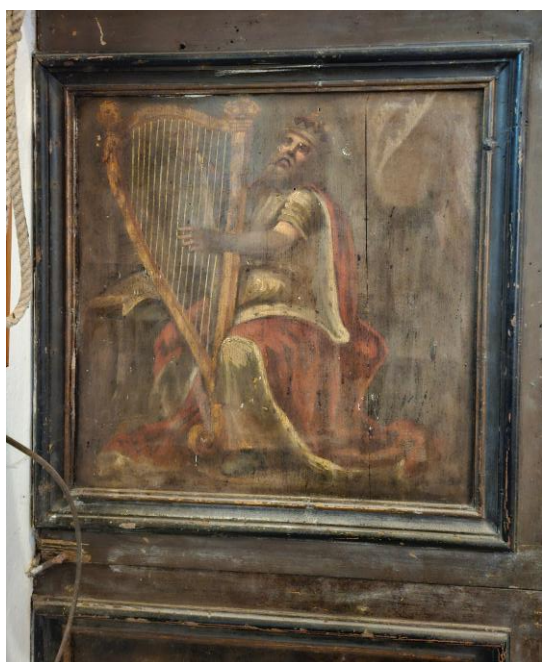
FIG. 3

The paintings have clearly been restored more than once, and several disparate surface coatings were identified. The earliest varnish layer is a fragmentary dark brown layer that appears to have been partially removed. A second layer was applied either to secure flaking paint or to make the images visible. In doing this the lower layers of varnish in contact with the paint film have fractured away from the paint appearing opaque and obscuring the image. To ameliorate this, more recently a layer of PVA varnish / medium has been applied. This film no longer allows the painted image to be seen. It is for this reason that there appear to be streaks of white over the surface.

King David playing his harp. Note the white veil of the deteriorating varnish layers.

The various coatings will be removed using solvents and cleaning agents as appropriate to the situation. The PVA can be softened with ethanol and further removed using dilute ammonia. The earlier varnishes can be removed using alternate applications of Acetone to remove the varnish and Tri-ammonium citrate (5%) to remove dirt layers between the varnish layers. This work would be undertaken using cotton wool swabs with the aid of a magnified head lens.

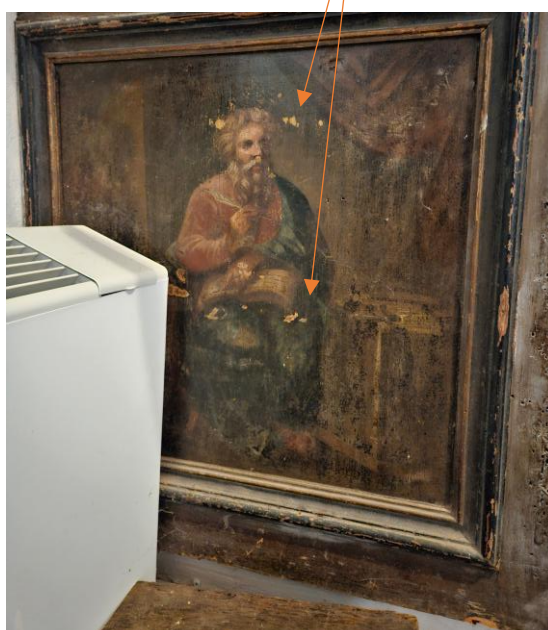
FIG. 4

The painted surface appears to be generally stable apart from localised areas of damage. Paint loss is visible in the area at the west end, partially obscured by the radiator. In other areas there is some evidence of mechanical damage where paint loss has also occurred.

Lower left figure. Some loss of paint from mechanical damage is visible. This may have occurred when the radiator was put in. This figure has yet to be identified.

A limited amount of retouching of areas of loss will be undertaken using Gamblin retouching colours.

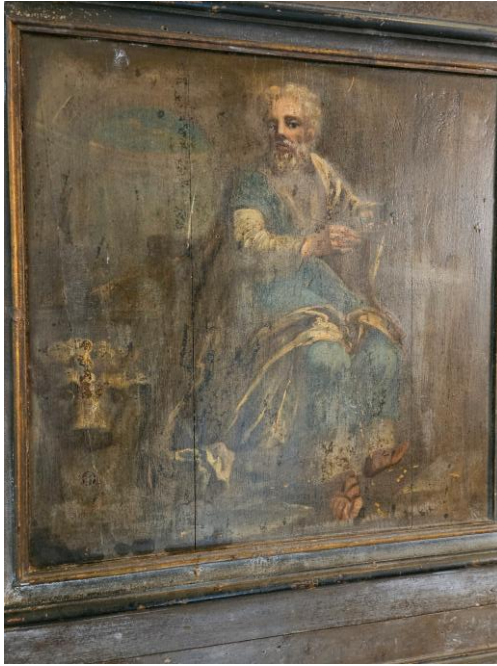
FIG. 5

The Evangelist Luke identified by his symbol the bull in the lower left corner. Much of the image is obscured by the varnish.

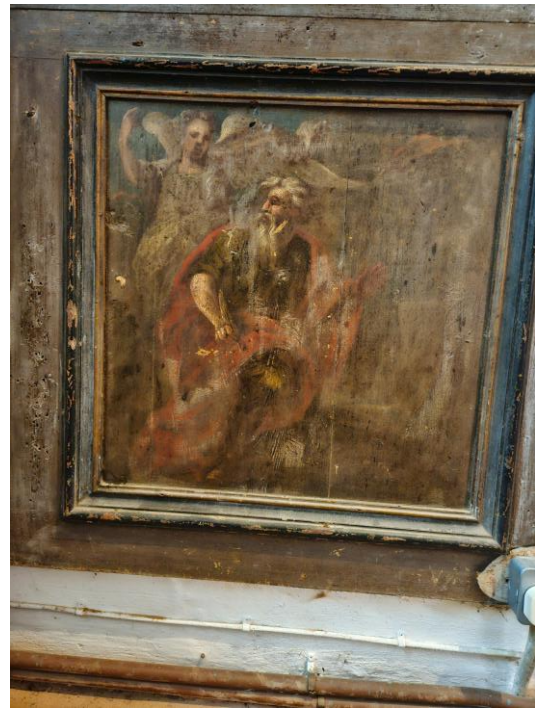
FIG. 6

The evangelist Mark with the symbol of the angel in the upper right corner

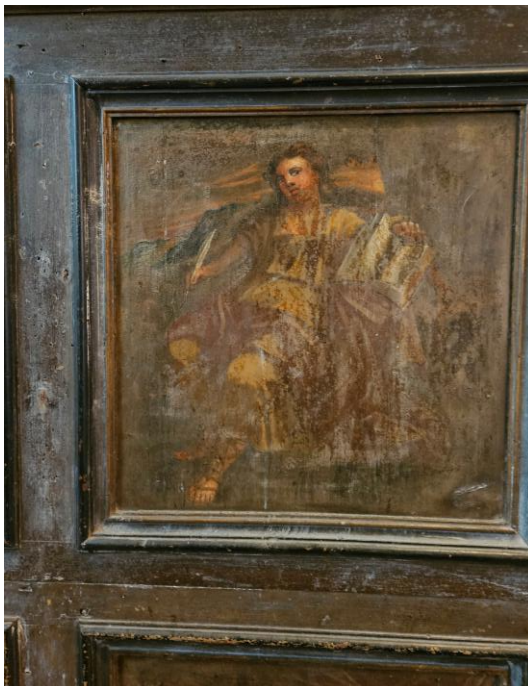
FIG. 8

It is thought that this may be a depiction of a young John the Baptist, although the eagle is not currently visible.

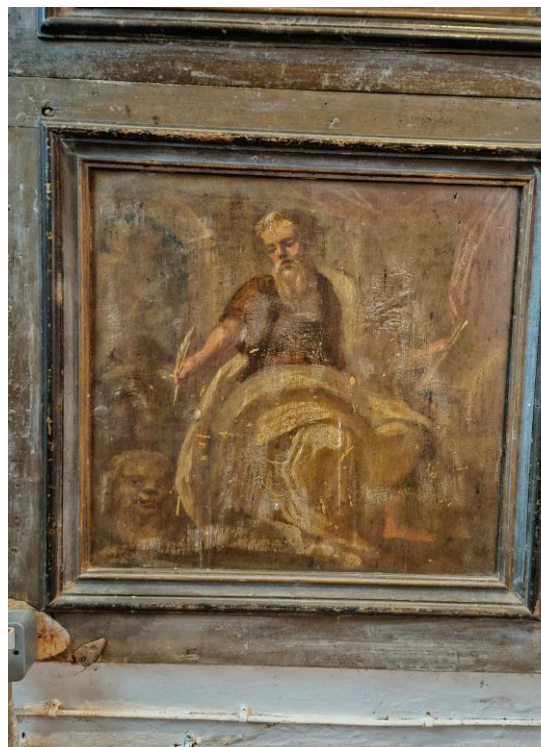
FIG. 9

Mark, the evangelist with the lion in the lower left corner.

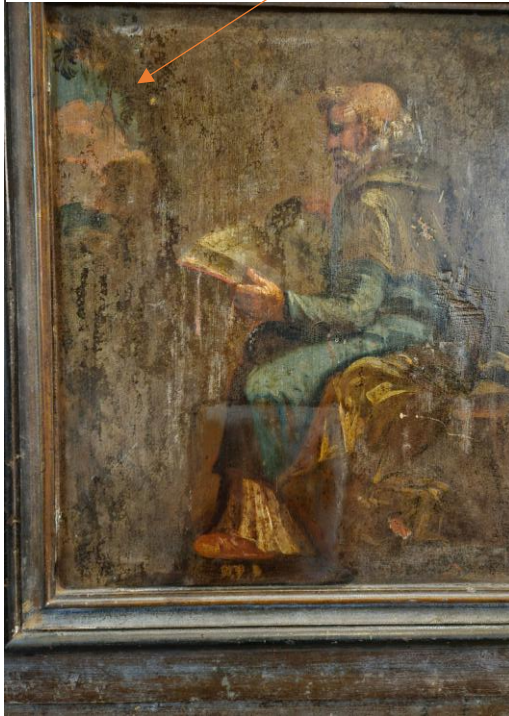
FIG 10

Elderly learned figure thought to be one of the church fathers. Remains of earlier darkened varnish.

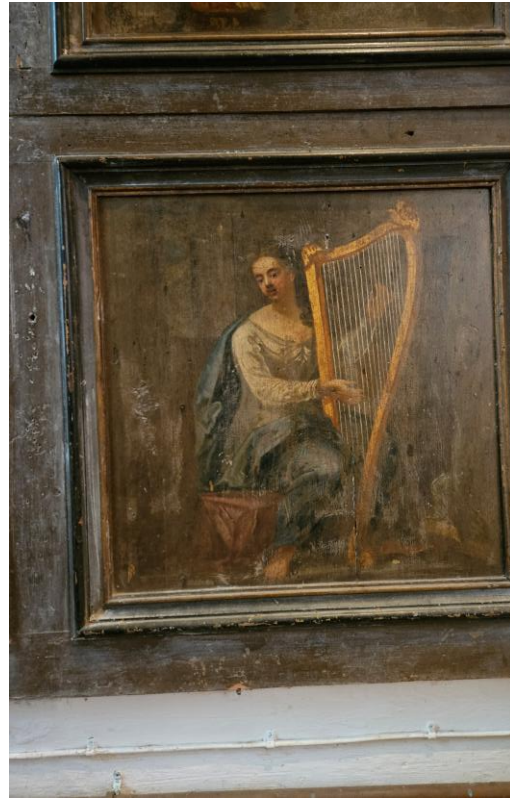
FIG. 11

Female figure playing a harp, dressed in classical costume. This scene maybe allegorical.

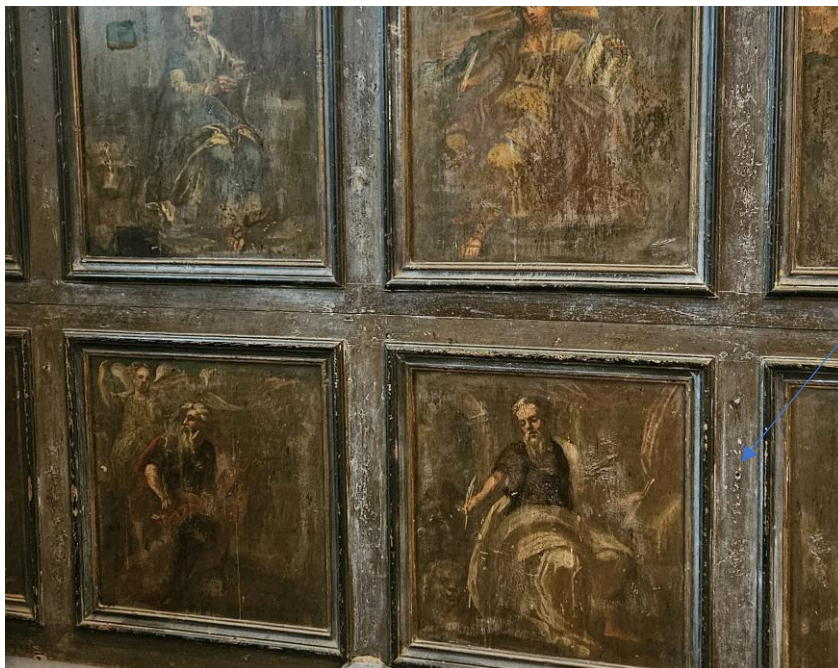
FIG 12

Detail showing the holes and paint loss on the post and rail framework.

The surrounding frame would be surface-cleaned and the losses and holes filled with coloured wax.

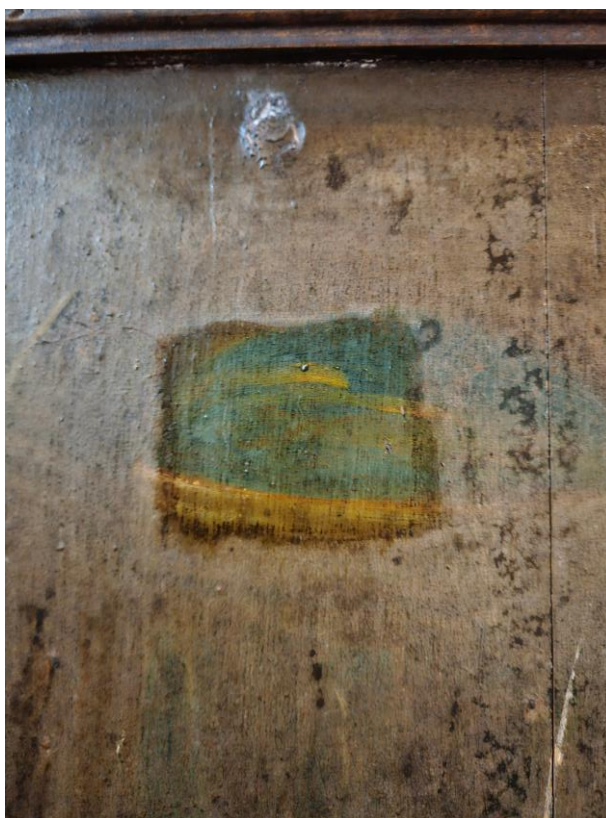
FIG 13

Second upper panel from the left (Luke).

Results of preliminary cleaning trials to remove the layers of varnish that are obscuring the painting of the sky. Note the contrast between the area where the varnish layers have not been removed where the sky is barely

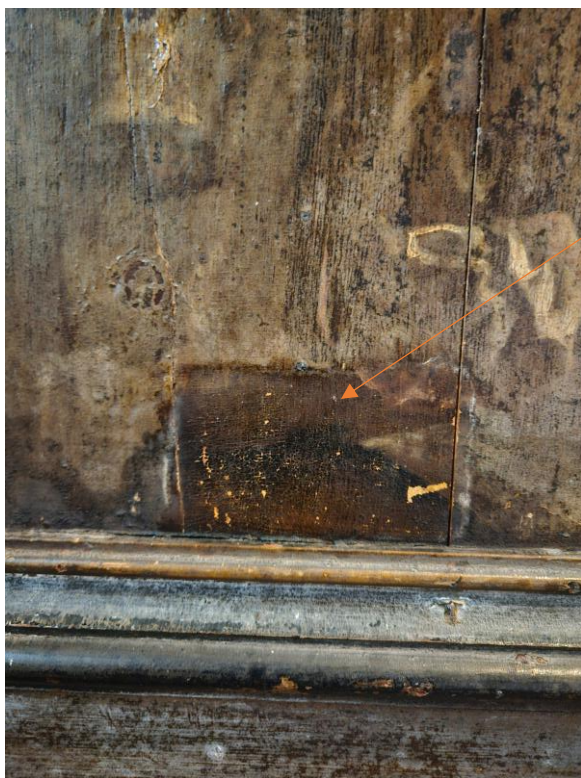
FIG. 14

Second upper panel from the left. Removal of the varnish and some later retouching revealed areas of previous loss.

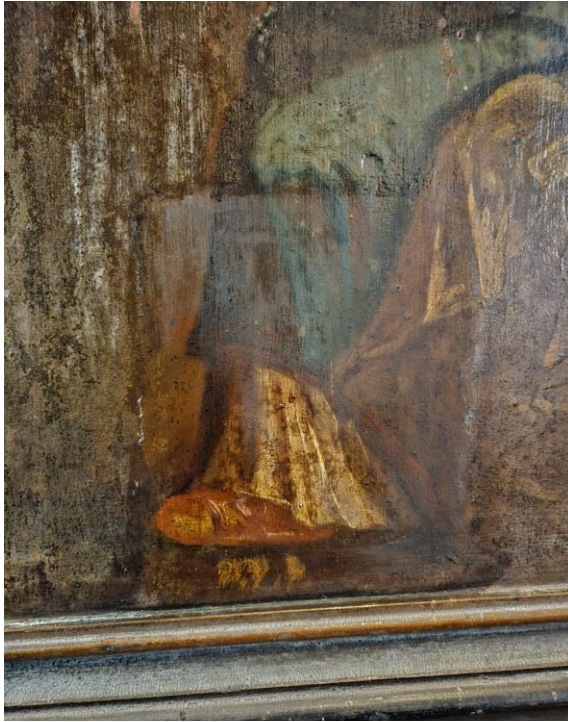
FIG 15

Preliminary removal of varnish layers on the right-side upper panel. In this area there is still some of the darkened varnish remaining to be removed but removal of the upper layers has revealed the colours of the painting.
