THE CATHEDRAL STUDIOS

St Mary the Virgin Church Hastingleigh

nVI

Final Report on the conservation of the historic stained glass

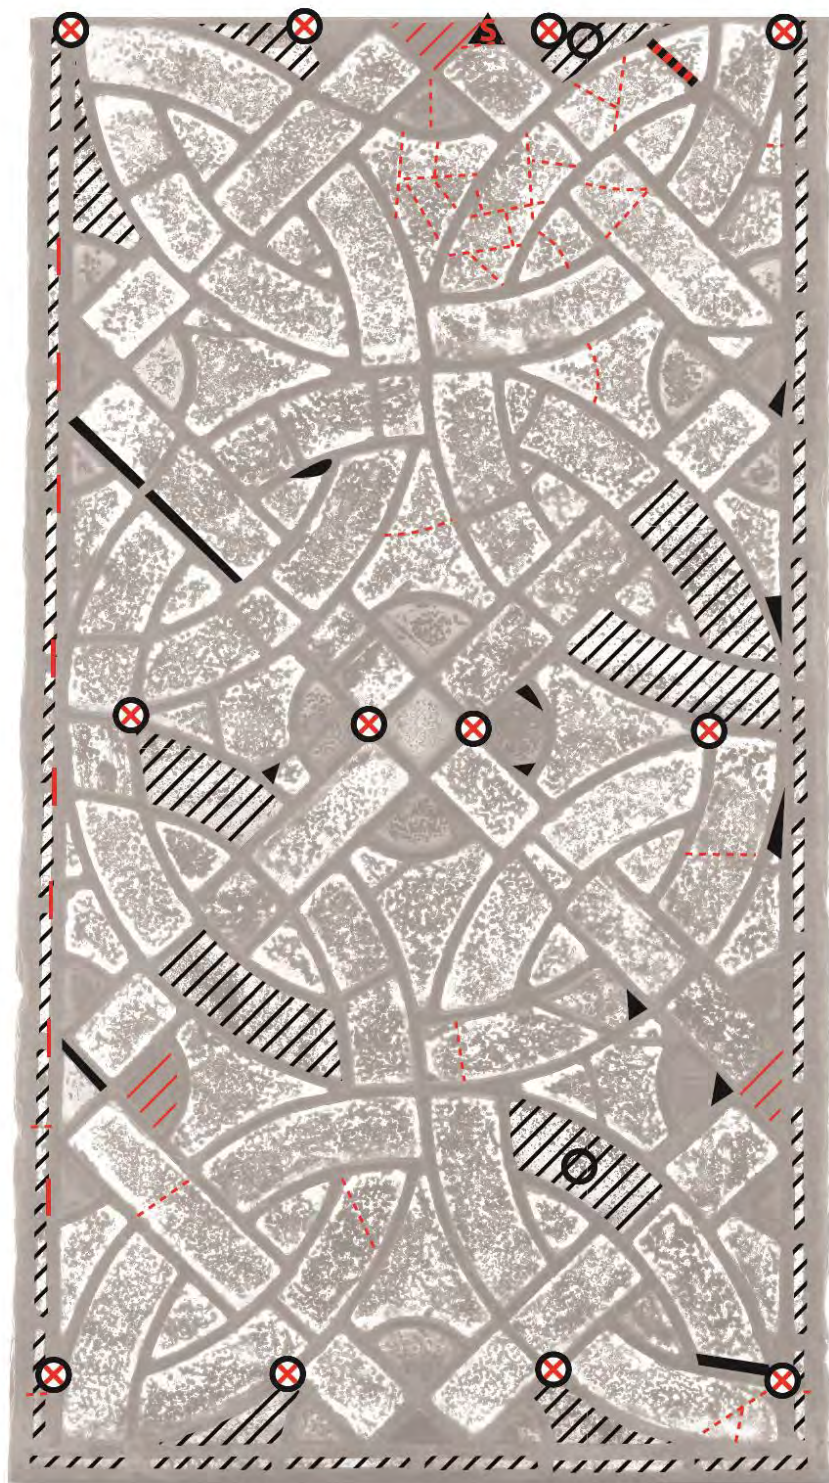
Modern replacement
-

Another modern replacement
-

Glass crack
-

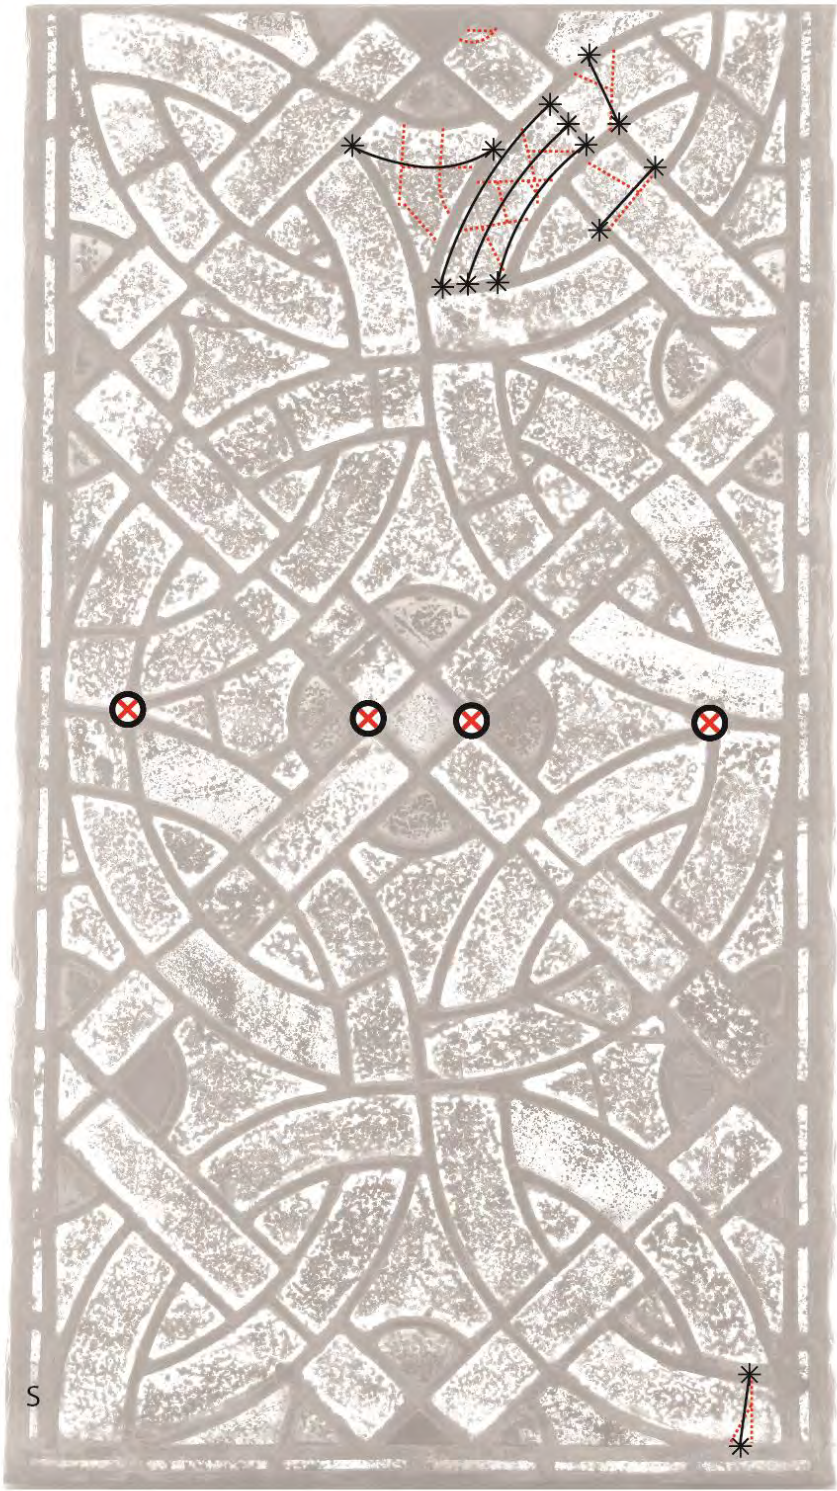
Location: St Mary the Virgin, Hastingsleigh	
Window number: nVI 1a	Dimensions: 765 (left) and 760 (right) x 422 (top) and 425 (bottom) mm
After Conservation Internal	Date: March 2025

Glass crack consolidated with Paraloid B72
-

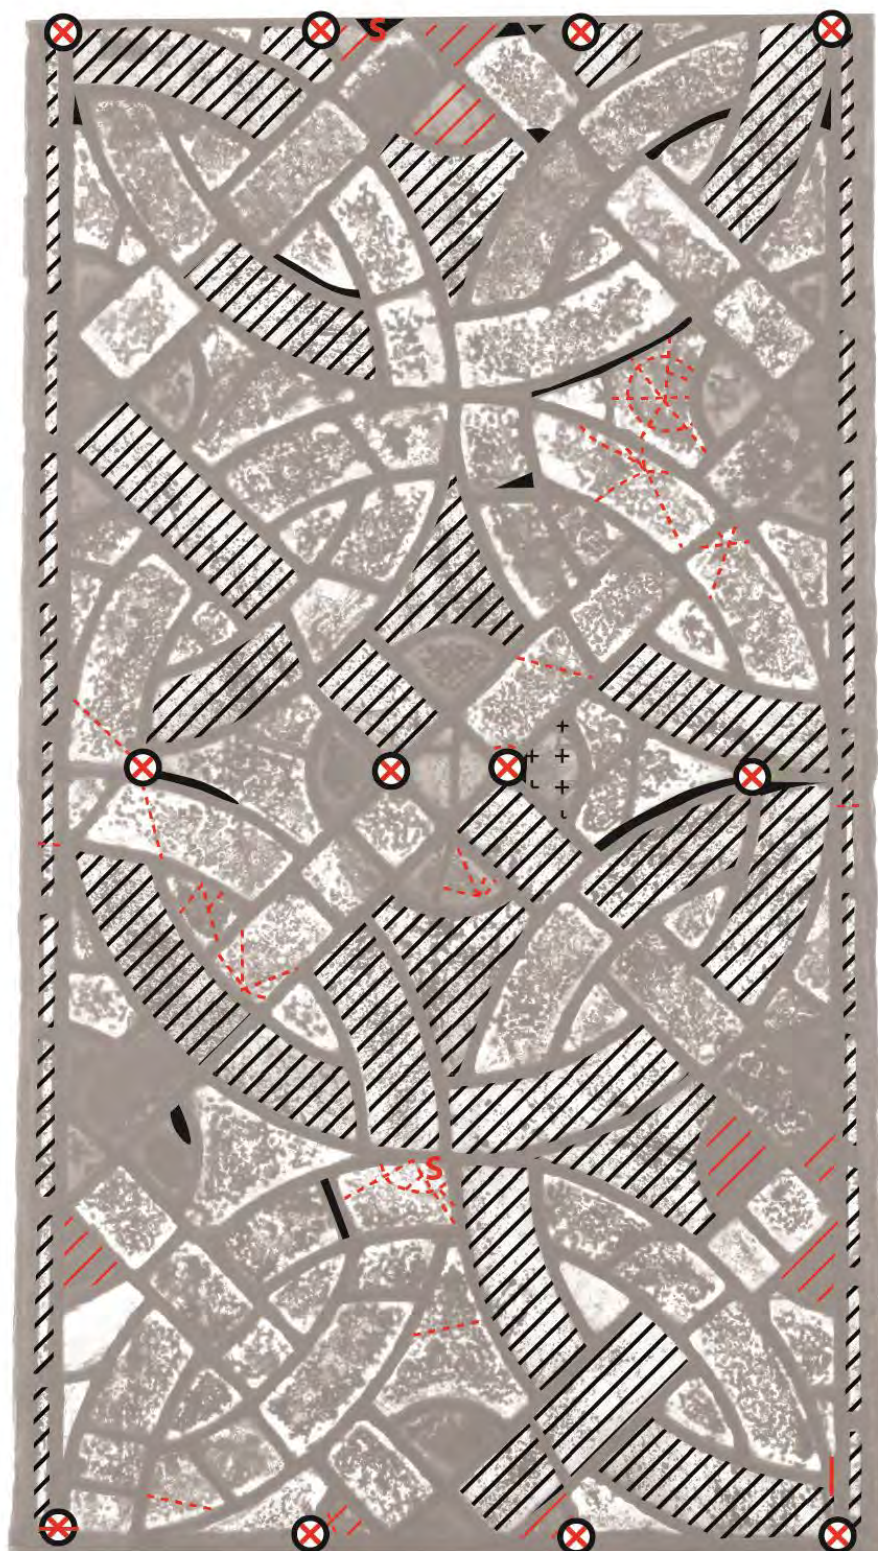
Modern replacement
-

Another modern replacement
-

Glass crack
-

Lead crack or unsoldered joint
-

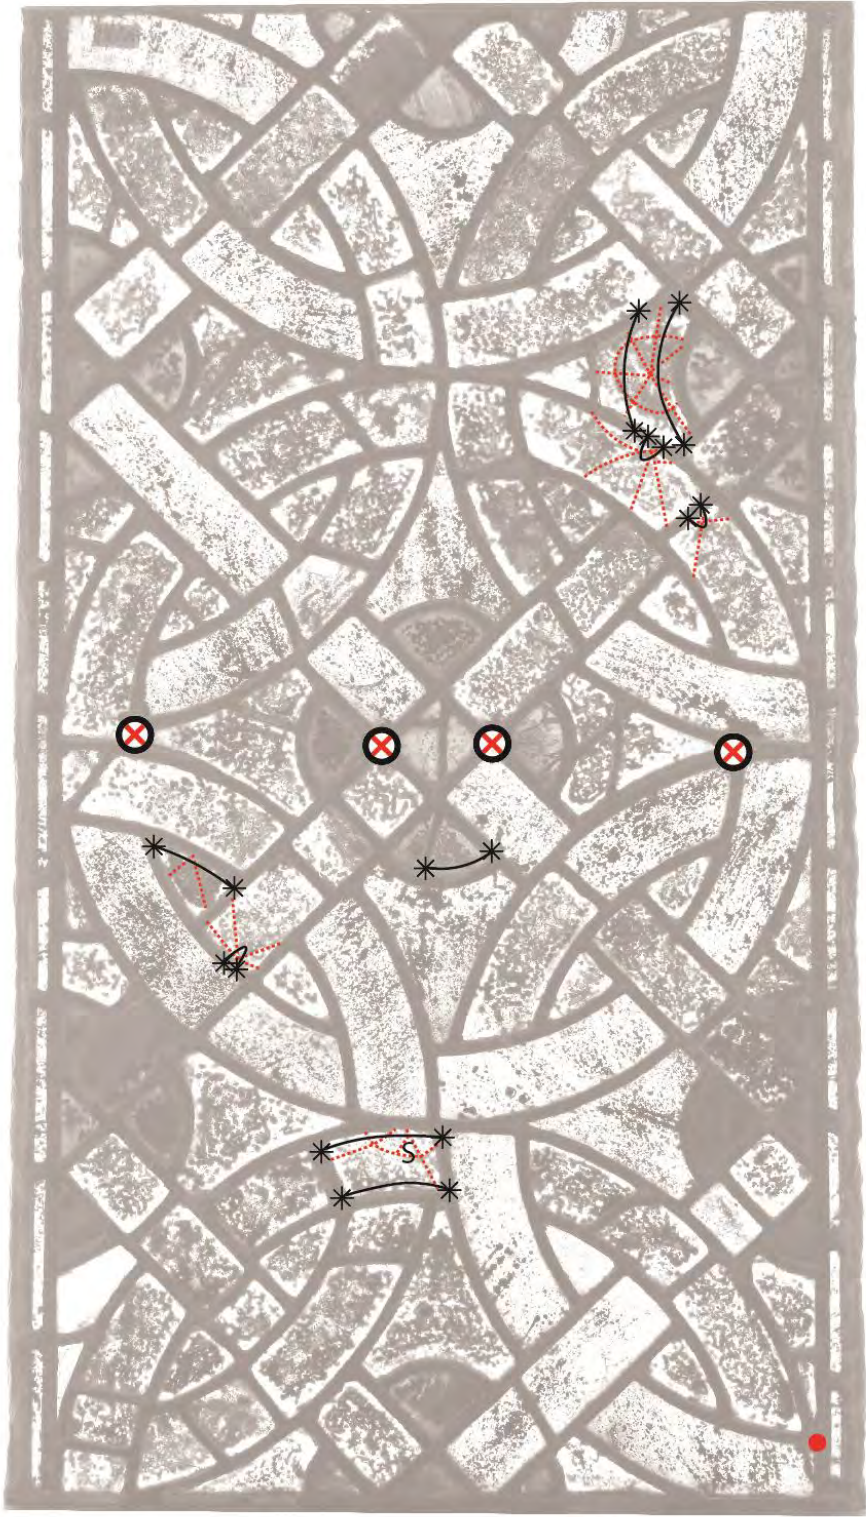
Location: St Mary the Virgin, Hastingsleigh	
Window number: nVI 2a	Dimensions: 748 (left) and 745 (right) x 429 (bottom) and 415 (top) mm
After Conservation Internal	Date: March 2025

Glass crack consolidated with Paraloid B72

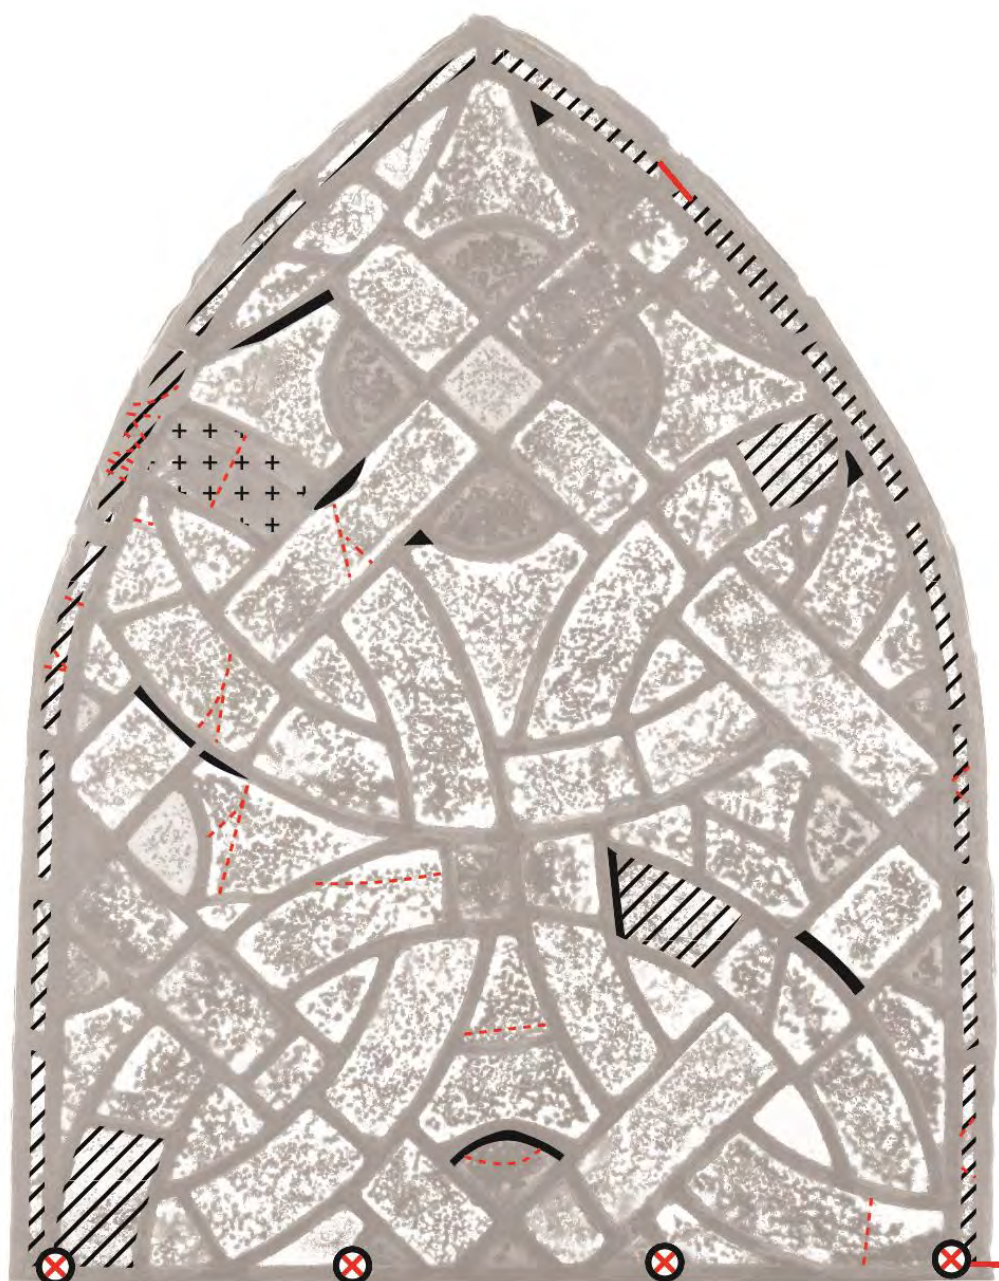
Original glass

Modern replacement

Glass crack

Lead crack or
unsoldered joint

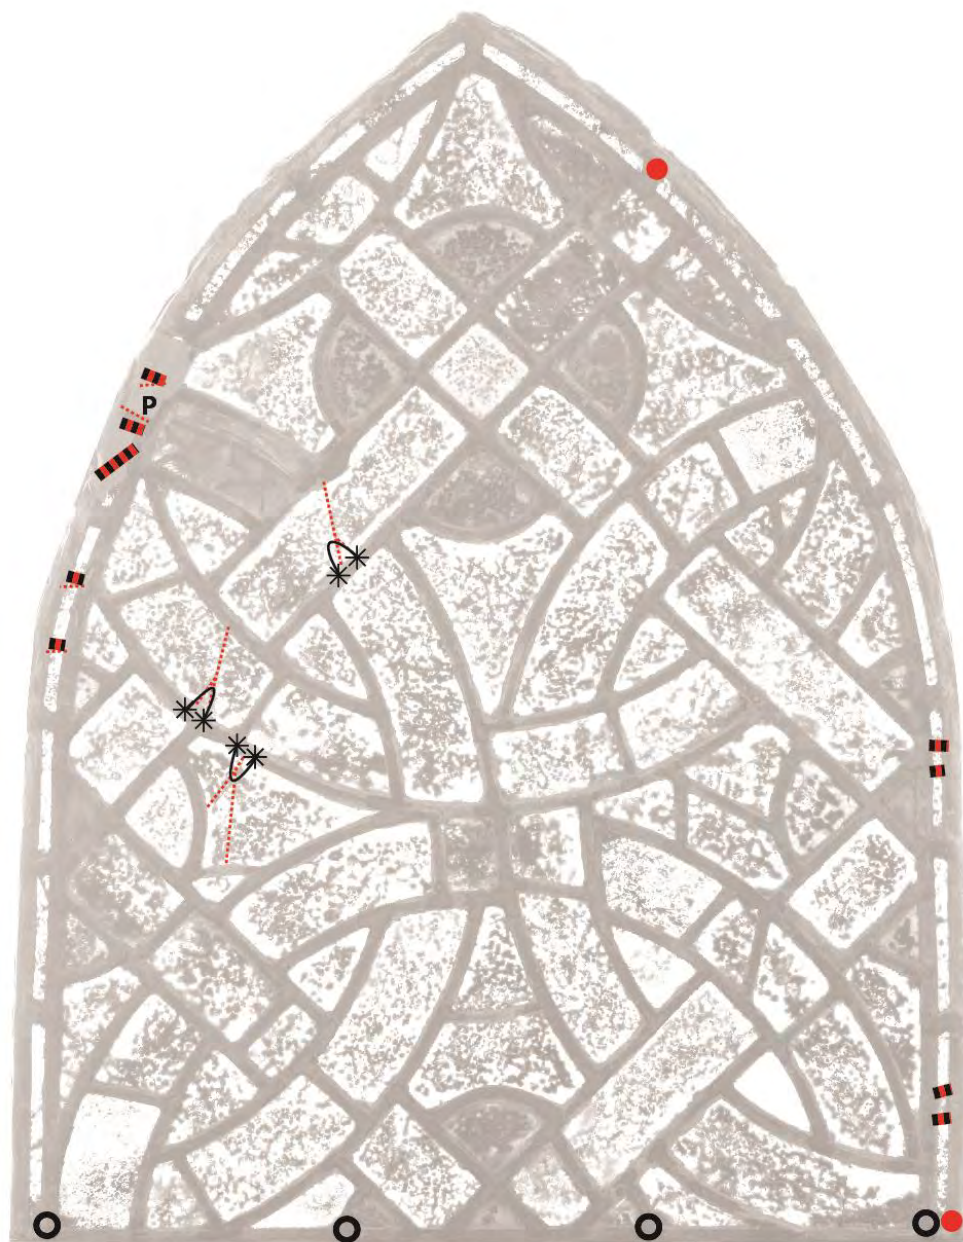
Glass crack
consolidated with
Paraloid B72

Putty repair

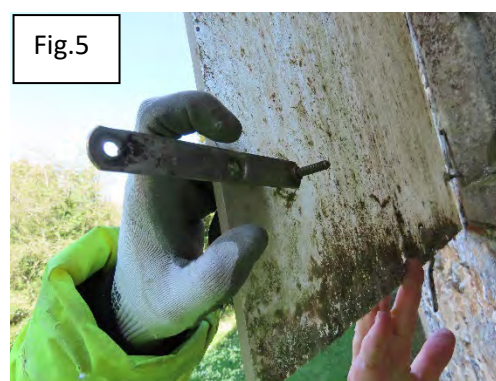
Accumulation of dirt on polycarbonate

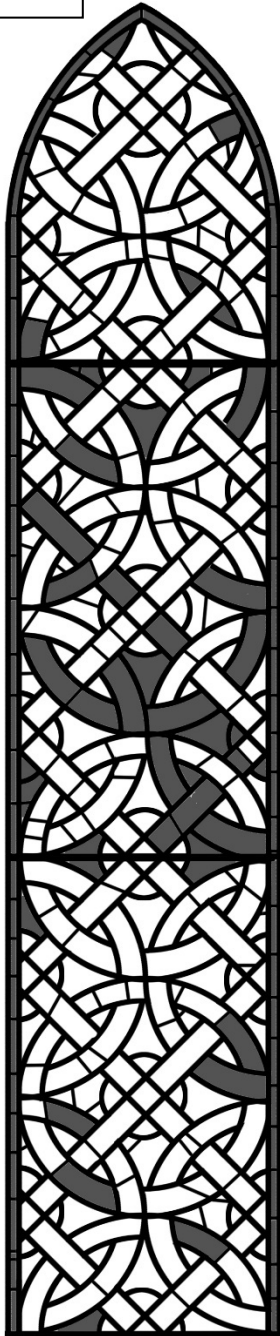
Original glass and later additions (in grey)

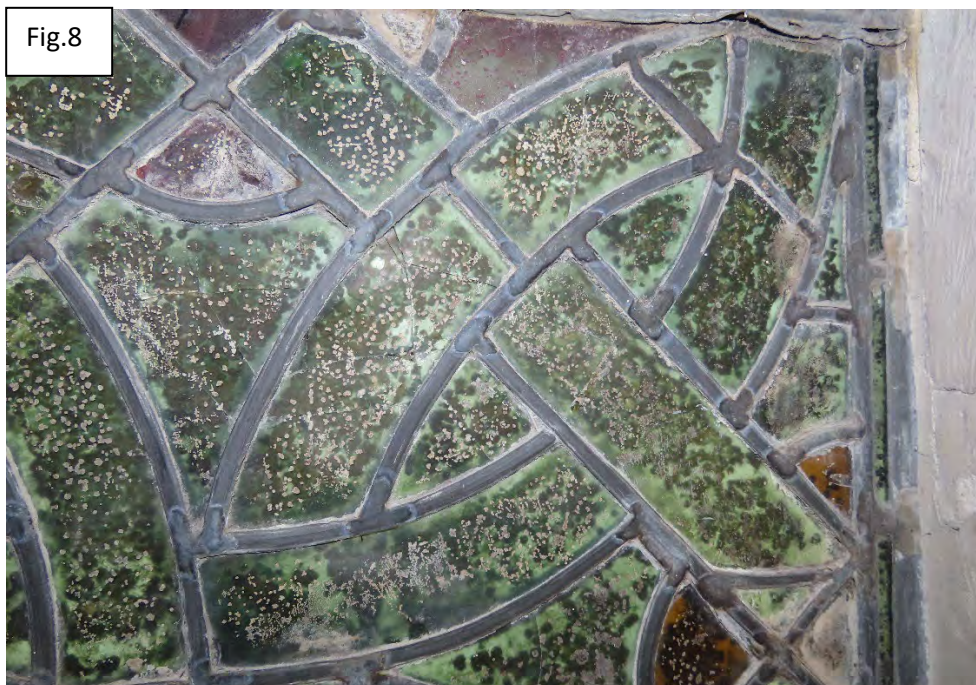
Both internal and external glass surfaces show corrosion damages in the form of pitting (fig.8).

Corrosion pitting on the inside, showing white corrosion products

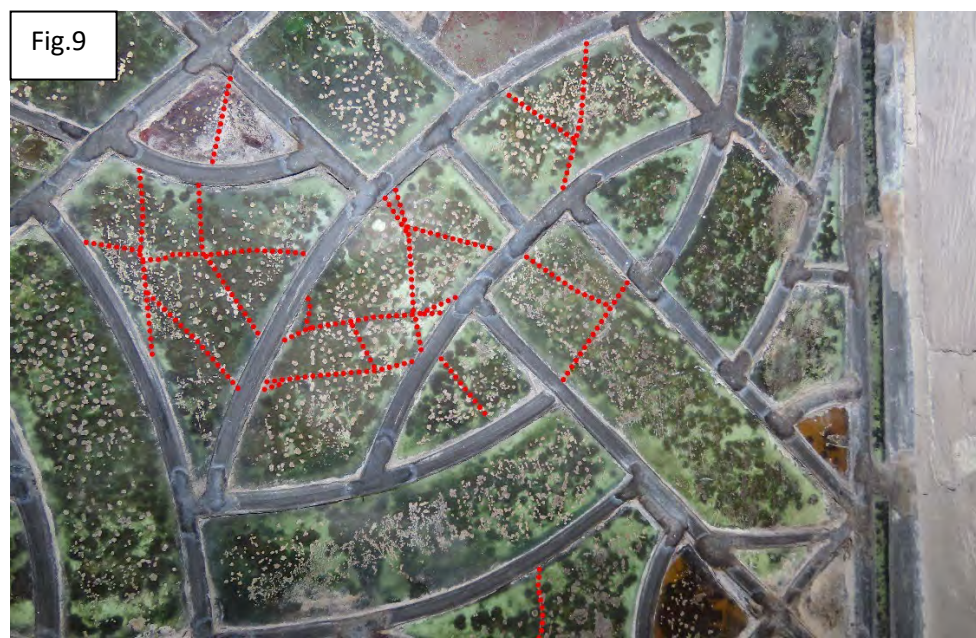
Glass fractures highlighted

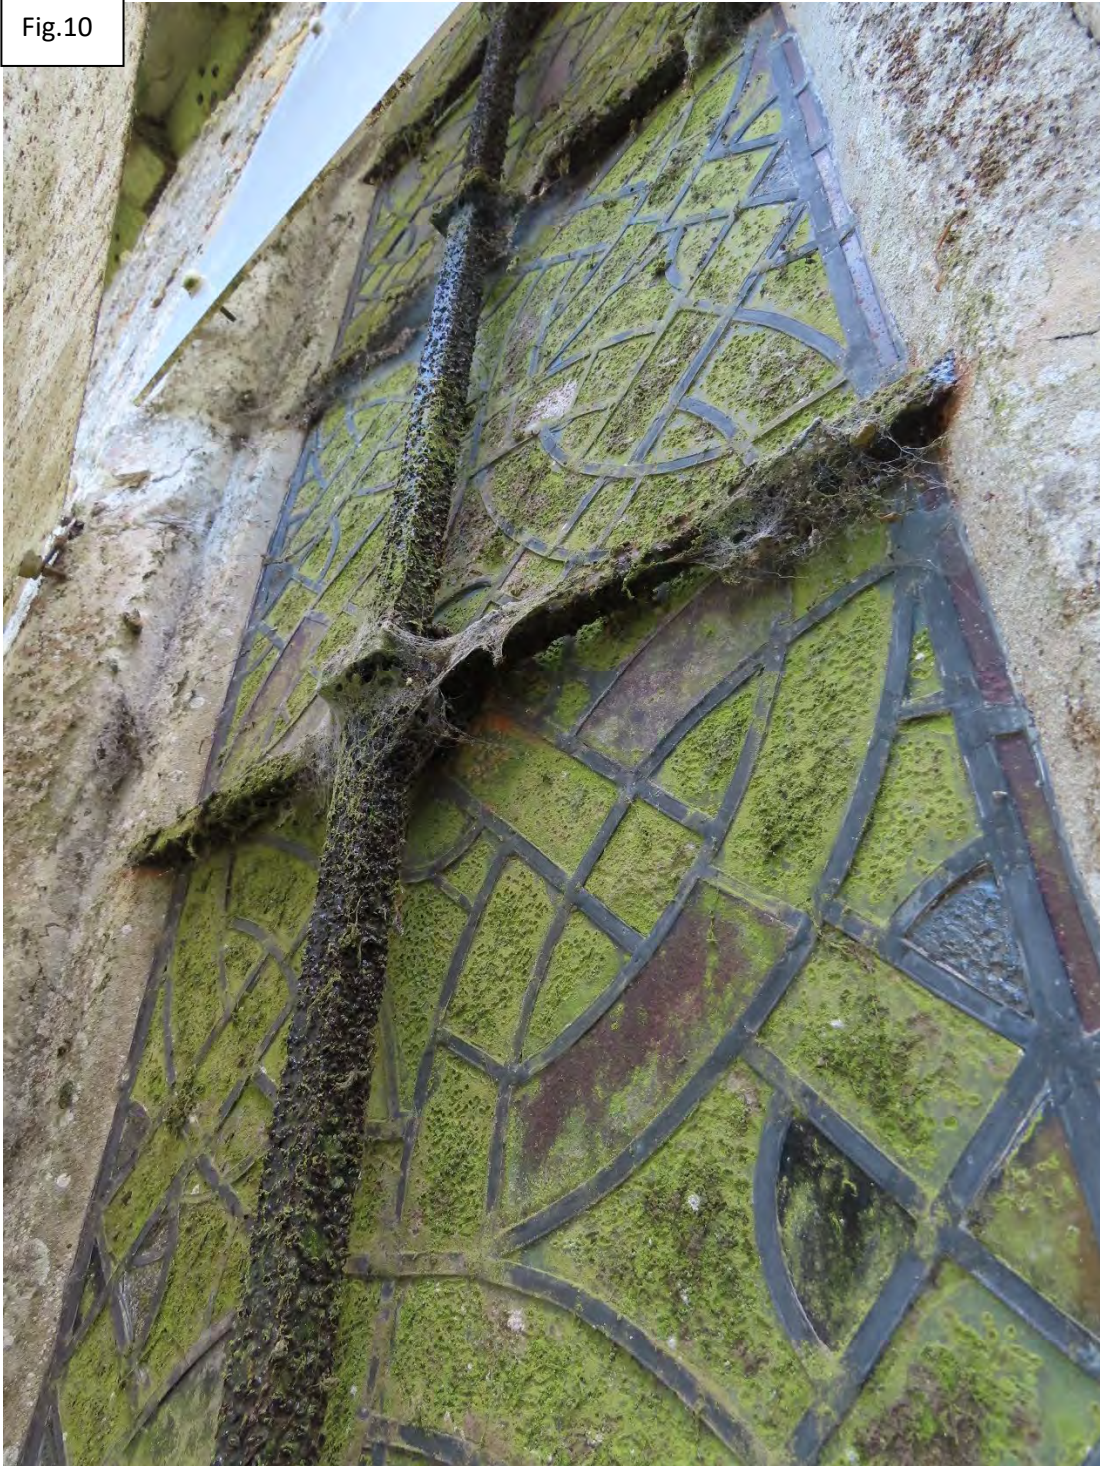
Fig.10

Microbial growths, dirt, cobwebs in interspace, rust staining of mortar at bar ends

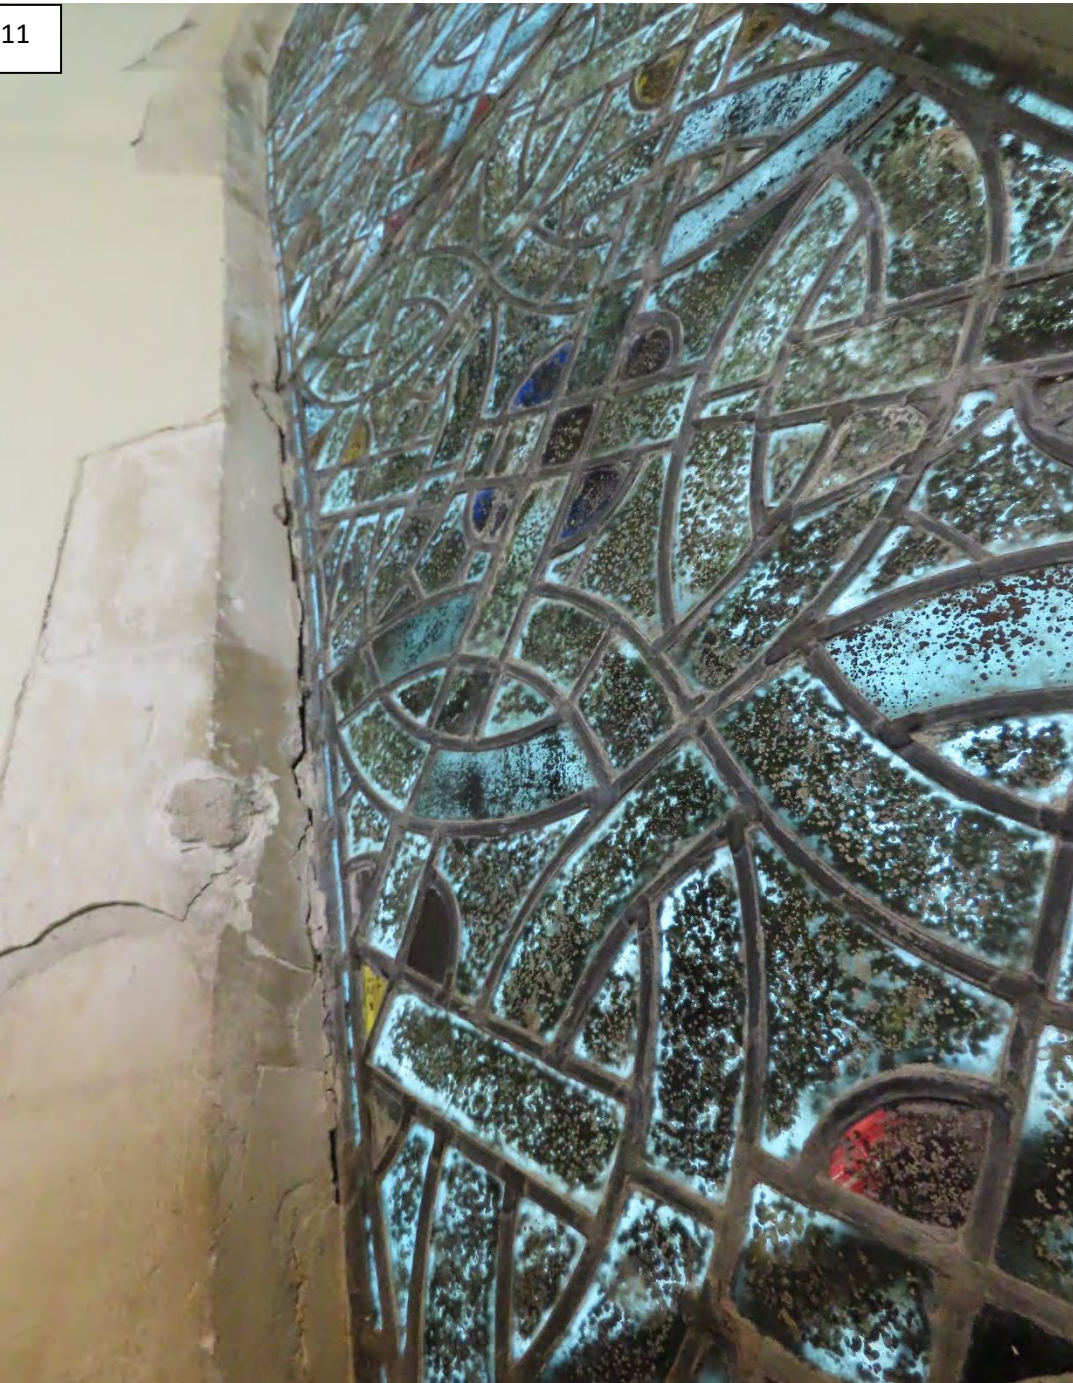
Fig.11

Damage to stonework through rust expansion of embedded ferramenta bar ends

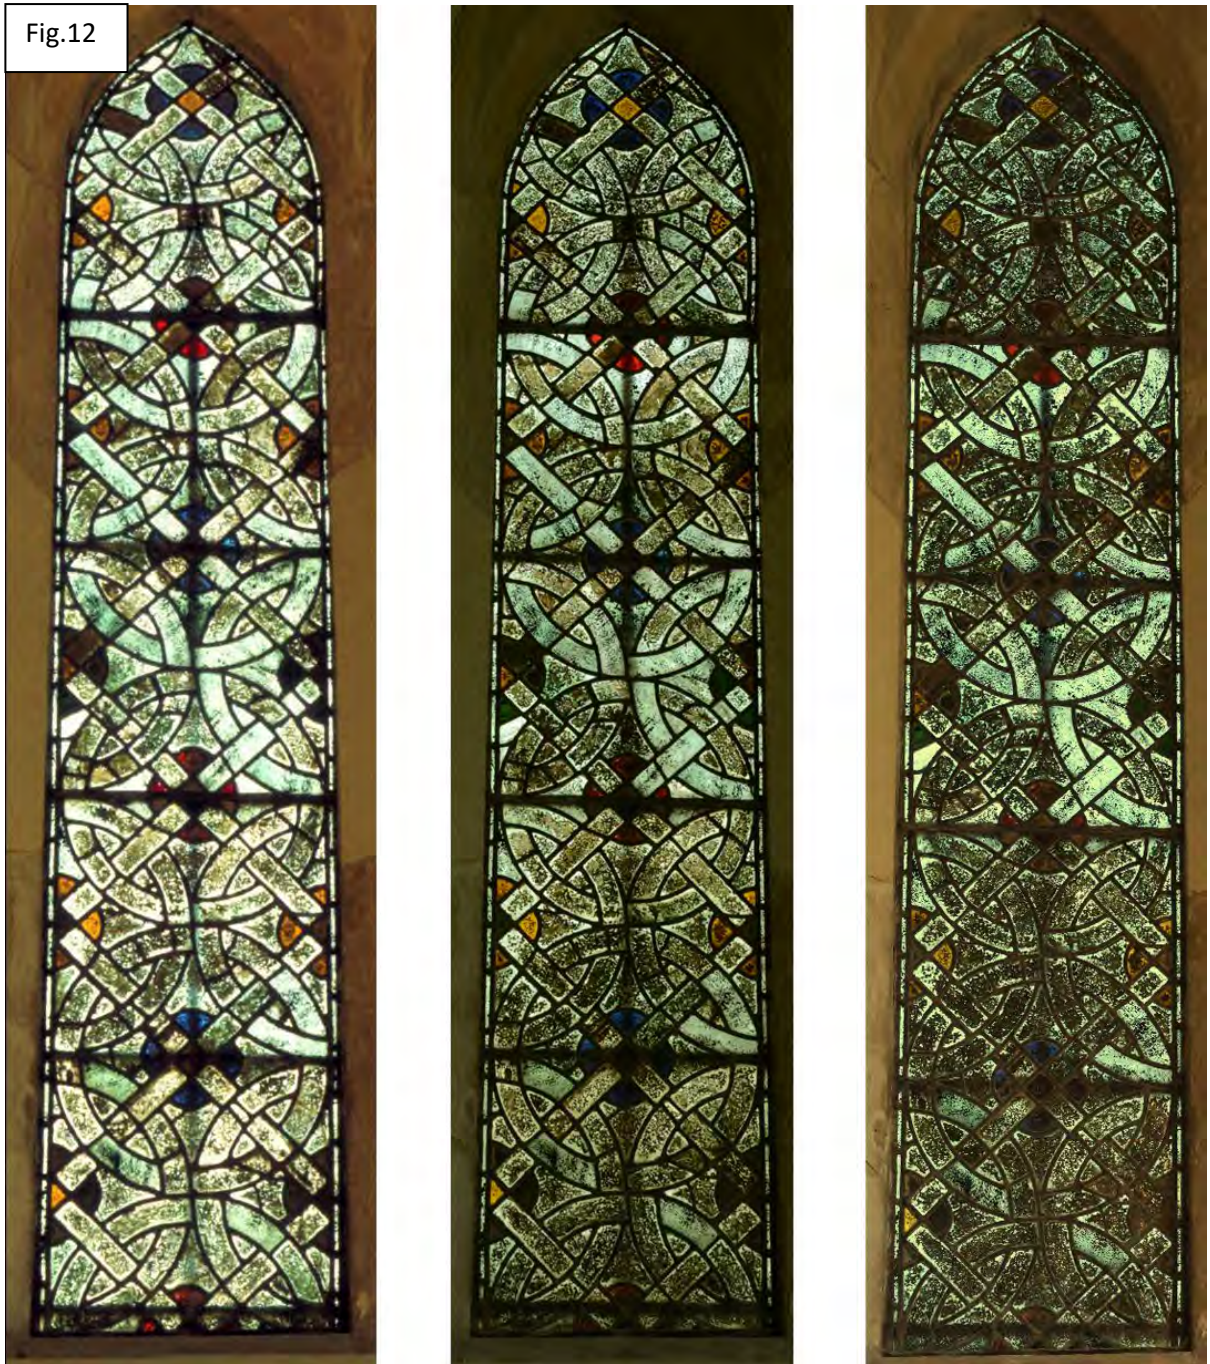
Fig.12

Condition of glazing in the 1970s (Prof Nigel Morgan), 2015 (Hans Fischer), 2023 (author)
