St Laurence's Church Northfield Birmingham

ARCHAEOLOGICAL RECORDING

Archaeology Warwickshire Report No 2110
FEBRUARY 2021

Project: Watching Brief during excavation inside St
Laurence's Church, Northfield, Birmingham

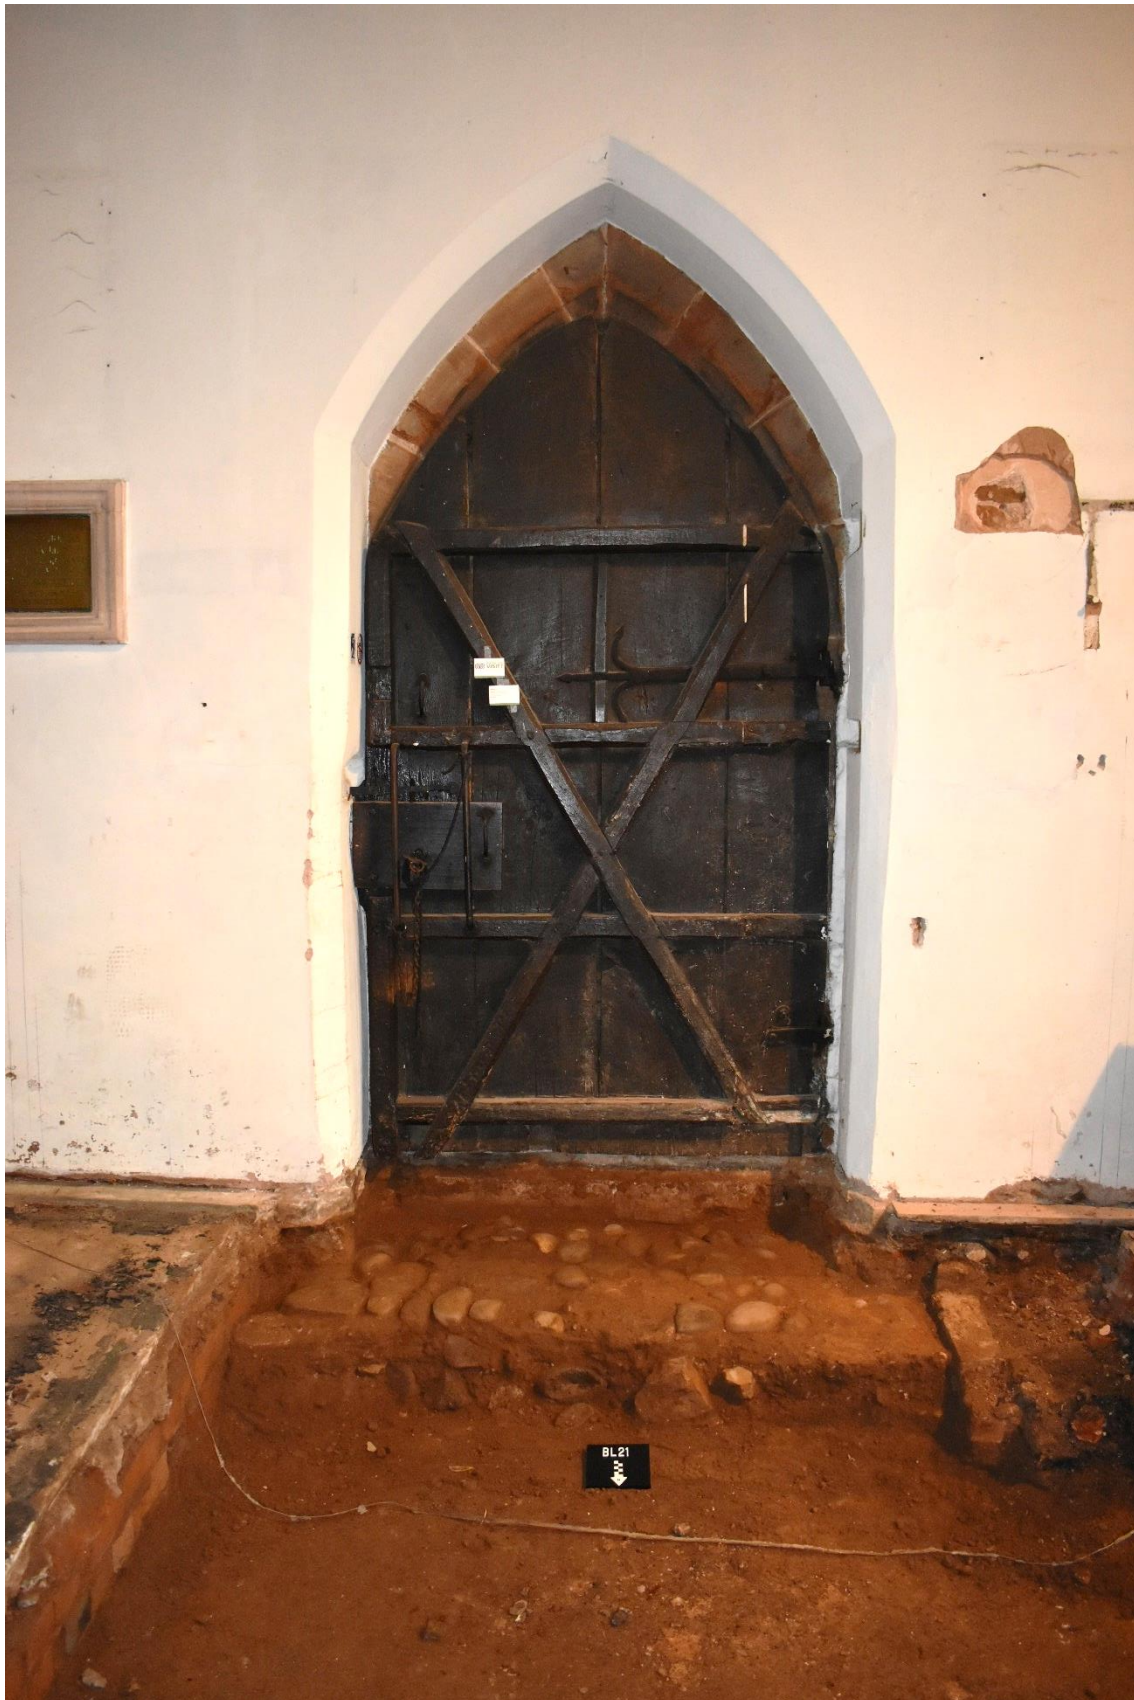
- 5.2 immediately below the line of the standing, late 13th-century, south aisle wall, and projecting 0.30m to its north, was a footing made up of cobbles of various sizes bonded with a mixture of compacted soil and lime mortar (1). The visible width of this footing was 0.70-0.80m and 0.20m height was exposed. The foundation trench for the 13th-century wall (13) appears to have cut through the earlier footing and it is possible that the later footing was constructed slightly further to the south, allowing for a larger south aisle. The cobbles were overlain by a thin layer of soft reddish brown sand (2).

1: South aisle doorway and cobbled footing (1)

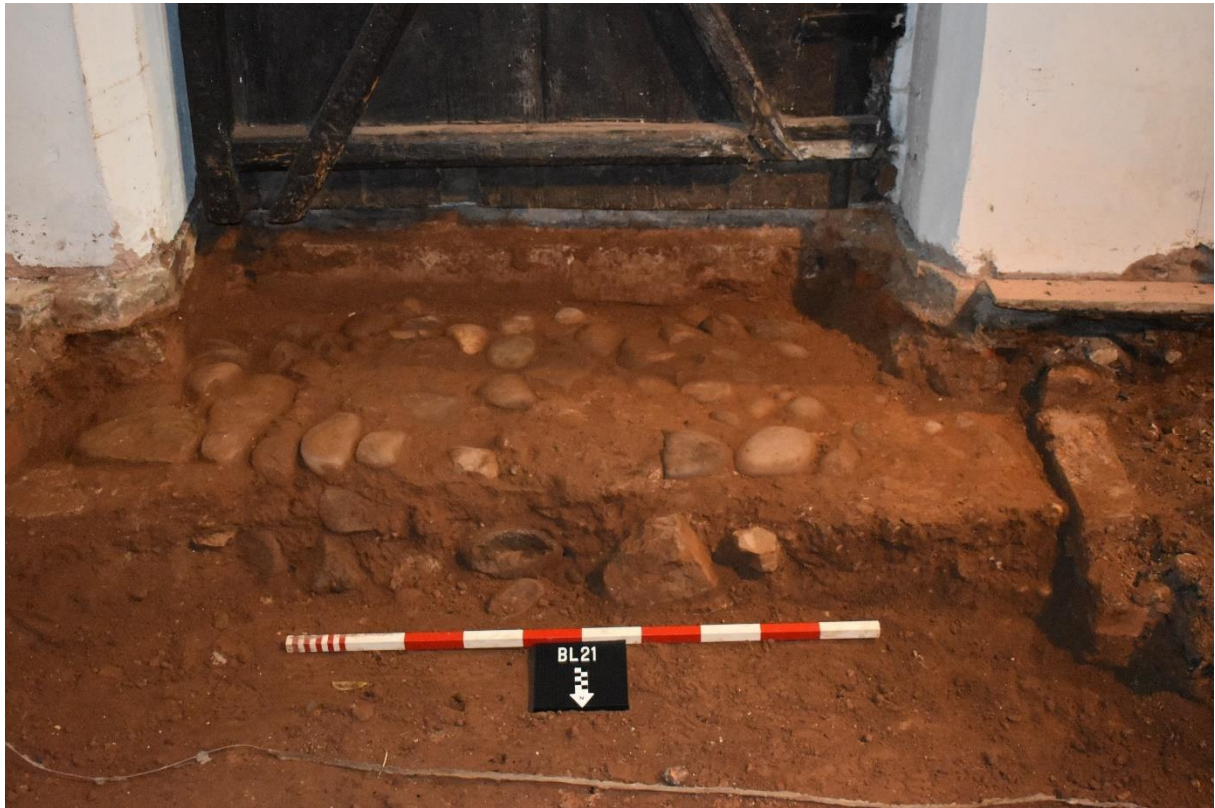
2: Detail of cobbled footing with brick support wall to right

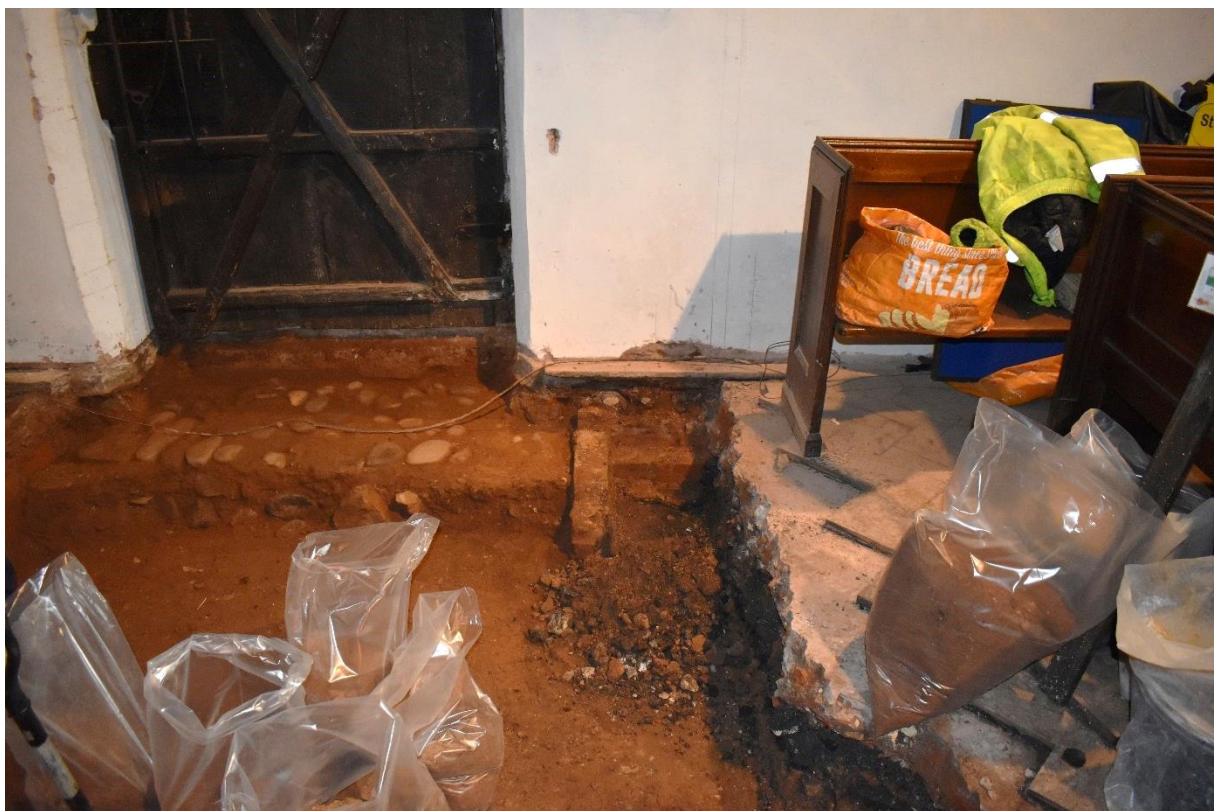
- 5.3 Either side of the door openings were two dwarf brick walls 1.90m apart (3 and 4), both c.0.35m high, to support the weight of the large flags (10) at the entrance to the south aisle. To the west of wall 4 and immediately north of the aisle wall was a double-width brick footing with a stepped base (6). Overlying footing 6, immediately west of brick wall 4 was a 0.20m deep deposit of compact dark grey grit which contained fragments of broken brick and lumps of mortar (5). On the western side of the trench layer 5 was overlain by a thick layer of concrete that contained a large amount of broken brick and mortar lumps (14). Layer 7 and concrete 14 were overlain by 50mm of concrete screed for the wooden floor (9).

3: Brick walling 4 and 6 with fill 5 and thick concrete 14 to west of doorway
