ST DUBRICIUS CHURCH, PORLOCK

CONDITION SURVEY OF THE PAINTED AND GILDED TIMBER REREDOS

MARCH 2025

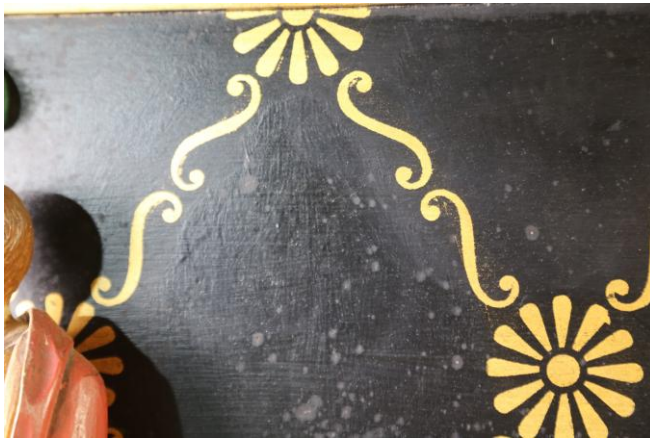
FIG. 6

A detailed examination of the surface in raking light revealed that the decoration on the background to the lower panel has been altered. Decorative leaf motif details within the diaper shaped borders have been overpainted. It is possible that this adjustment was made when the heraldic shields were attached.

Detail of the background to the lower panel in raking light, showing details that have been painted out in black.

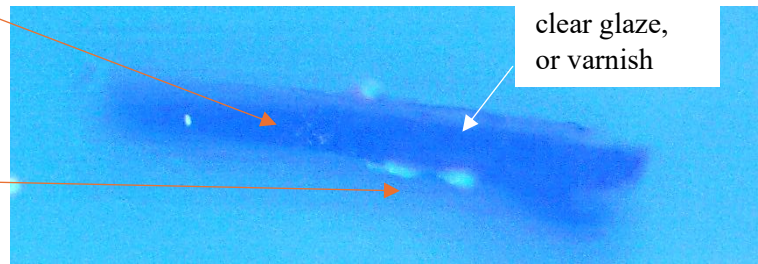
SAMPLE 4

Black background of lower panel

Over the black is a clear glaze or varnish.

Under the black is some white from the ground layer

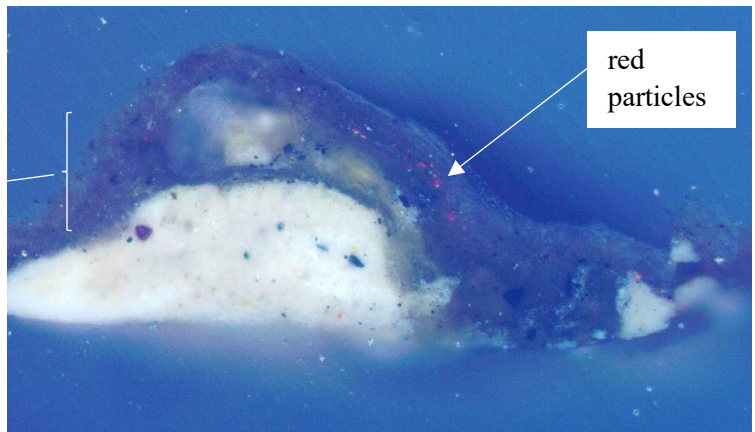
SAMPLE 5

In Sample 5 from the white gown, the coating is much thicker than in Sample 4, and in transmitted light it appears to consist of more than one layer. The coating in Sample 4 is clear, but in Sample 5 it is cloudier, and there appear to be pigment particles caught up in it.

White of Dr Bellenden's gown

glaze or varnish

red particles

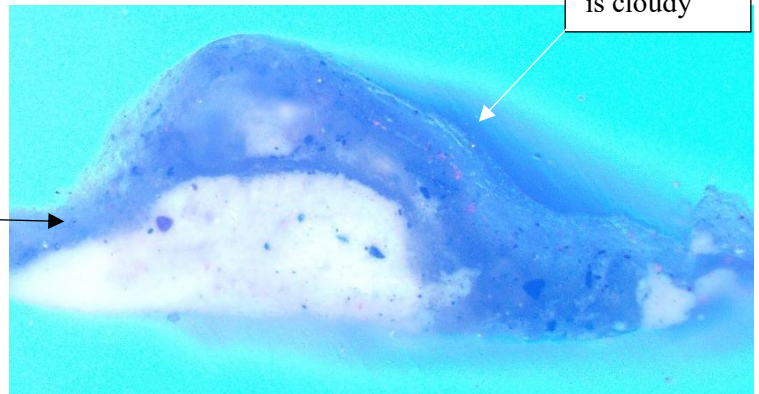
Showing what appear to be two coats of the varnish

lower coat is translucent, but brownish in colour

upper coat is cloudy

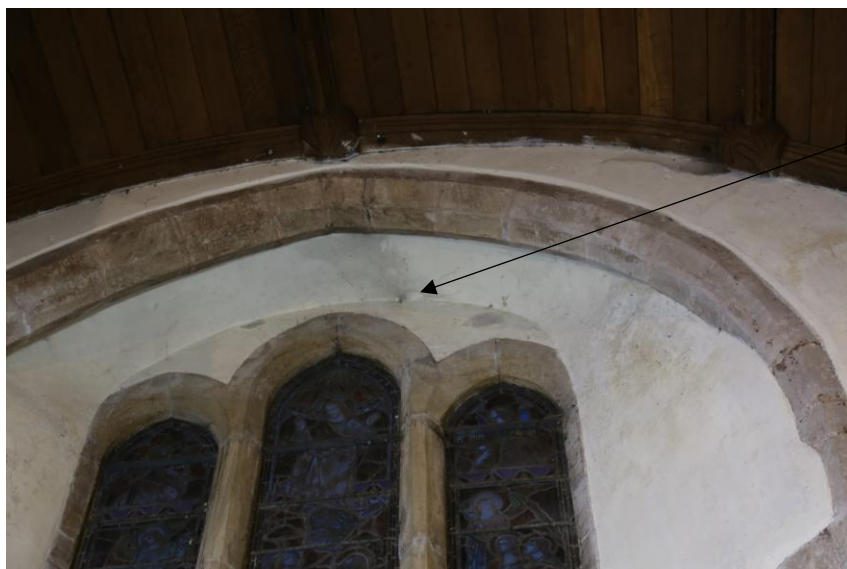
FIG. 7

The upper section of the reredos is positioned in front of the east window at sill level – an area that is bound to be susceptible to moisture ingress and fluctuations in temperature. The window structure and adjacent jambs are both showing some deterioration and in these areas moisture ingress has occurred. The paint on the splay immediately below the window is visibly lifting and blistering, indicating that there has been moisture run-off, probably from the windows.

View showing the upper window reveal where there has clearly been some moisture ingress.

Prior to any work being carried out on these painted surfaces, it is important that the cause of the deterioration is identified and where possible rectified. Initially this will involve the repair and conservation of the east wall and window surround where there are cracks in the plaster and stonework.

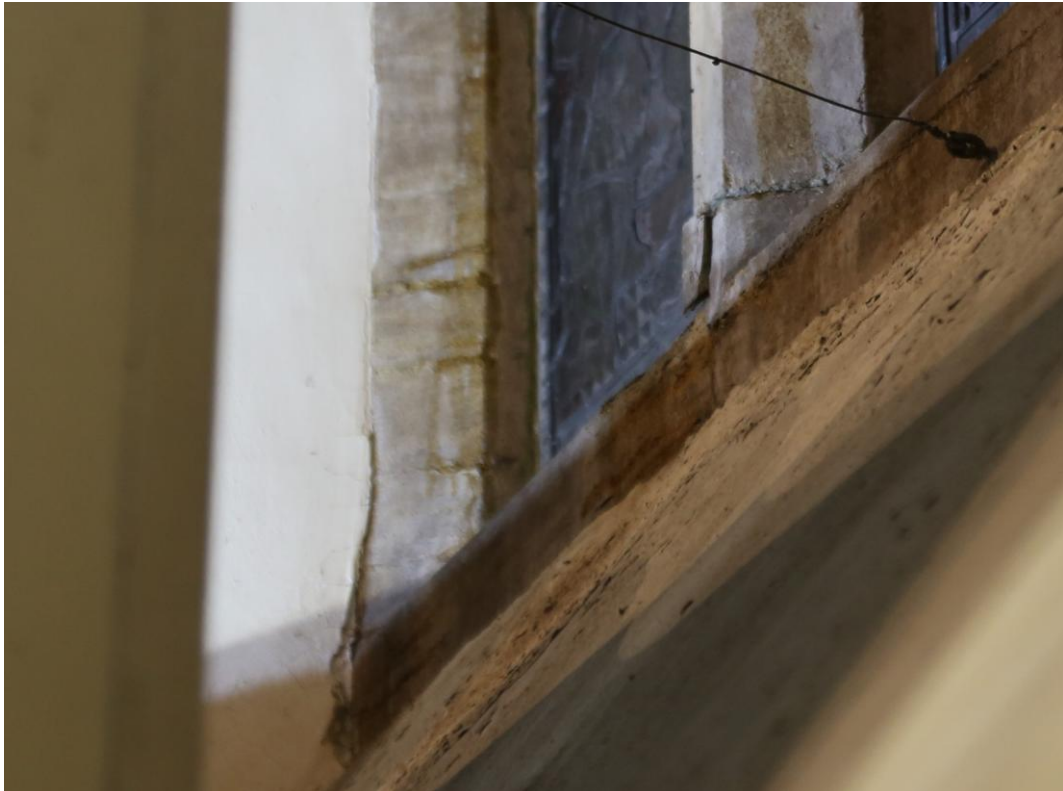
FIG. 8

The plaster on the wall adjacent to the lower north side window jamb is lifting away from the surface and there are cracks in the plaster high up. The base of the north side mullion has cracked, and the stone has moved out of alignment

View taken behind the reredos showing damage to the stone and plasterwork and lifting paint on the window slay where moisture has run off from the window.

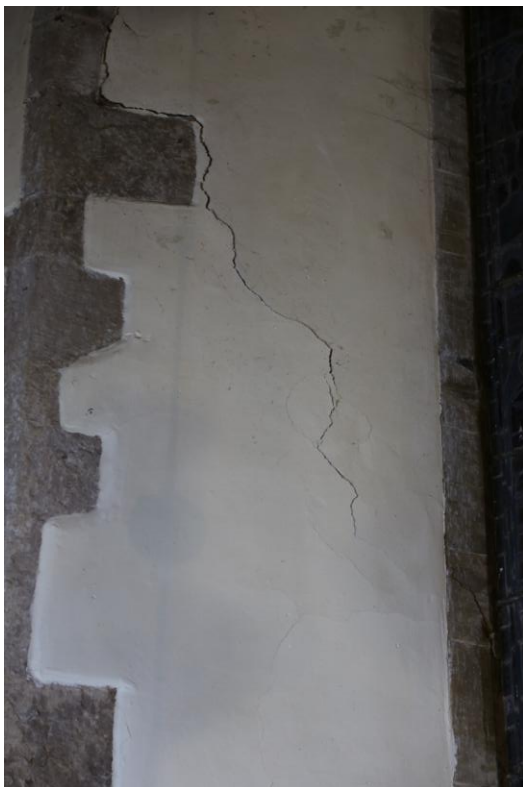
FIG. 9

Detail showing a crack that has formed on the north window reveal.

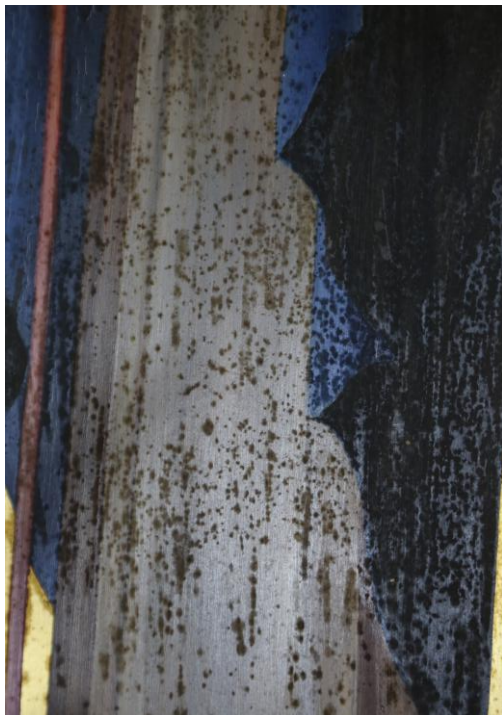
FIG. 10

The main noticeable decay phenomenon on the painted surface is the brown spotting that can be seen in many areas on the surface. Interestingly these are most noticeable on the front face of the painted and gilded panels that form the polyptych. An examination of these spots revealed that they are most probably microbiological growth (MBG). Where they were present on the gilding, the surface beneath the MBG is undamaged. However, where they are present on the paint, it was sometimes found that the surface beneath the MBG had deteriorated. Areas of paint containing lead white were generally found to be less affected. It is not known how long this decay phenomenon has existed and whether it is historic or ongoing.

Detail showing the mould growth that has formed on the figure of St. Brendan

The treatment trials have indicated that the panel surface can be cleaned using saliva carefully applied with cotton wool swabs followed by further cleaning with a 5 % solution of Tri-ammonium citrate (chelating agent that sequesters the dirt layer).

It is recommended that the surface should be protected with a synthetic resin varnish (Regalrez 1094 in Shellsol T) with added UV protection (Tinuvin 292) to prevent any further microbiological attack. The varnish will need the addition of microcrystalline wax to achieve the same matt finish.

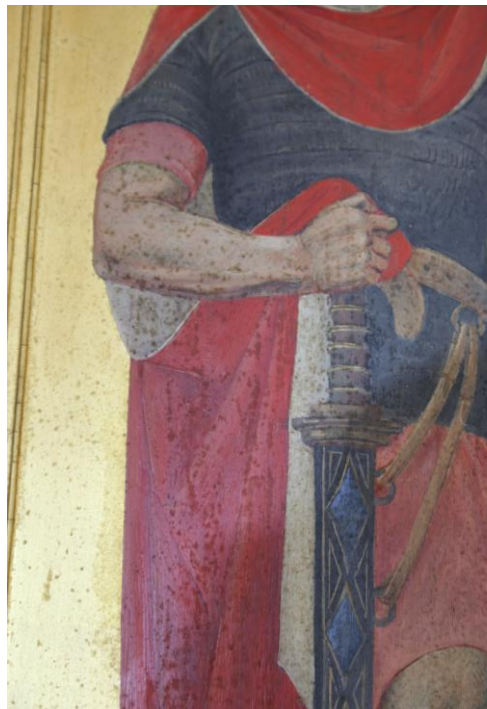
FIG. 11

Detail of St. Olave showing the spotting on the surface.

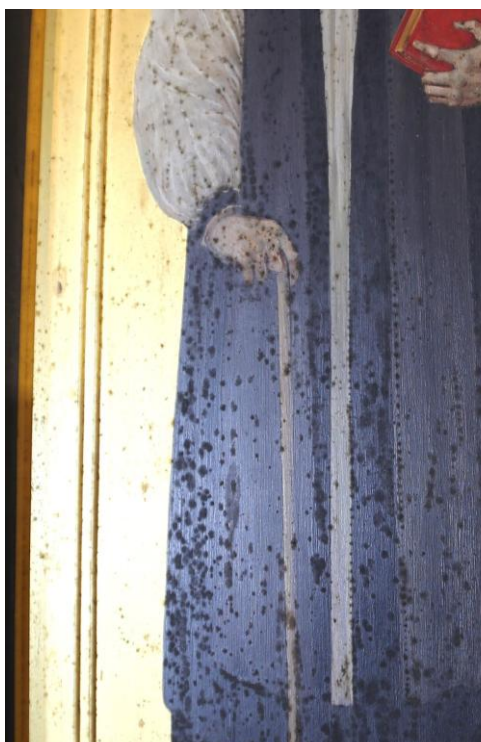
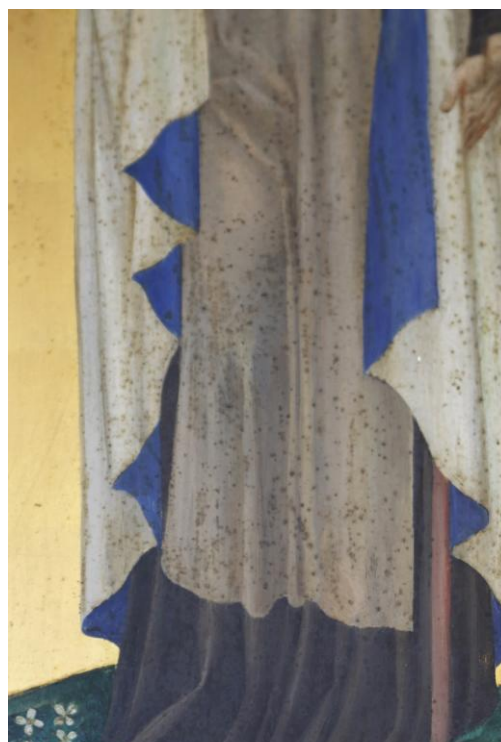
FIGS. 12 & 13

Detail of Dr. Bellenden (below) and St. Bride showing the same pattern of mould growth on the painted surface.

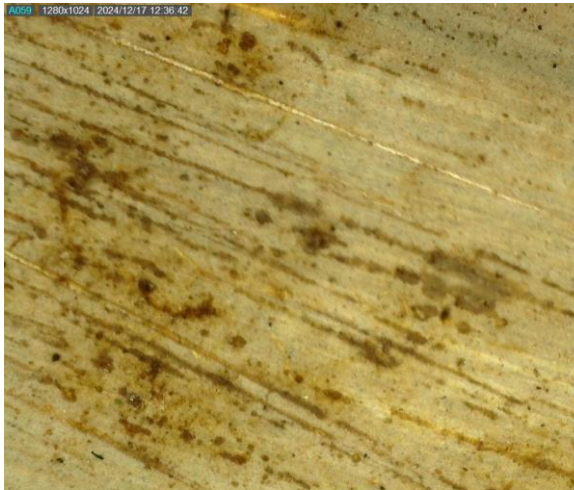
FIG. 14

Photograph taken with the digital microscope showing the microbiological growth on the surface of the white areas.

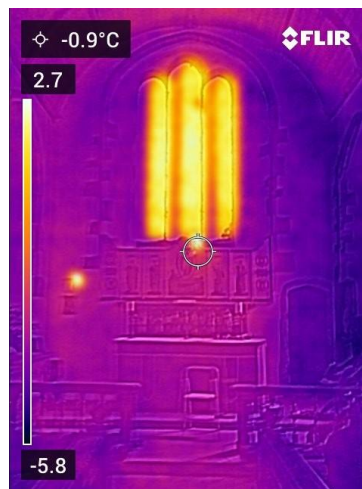
East wall of the chancel

These photographs indicated that as expected the east chancel wall, particularly around the windows and in the corners were the coldest areas in the church.

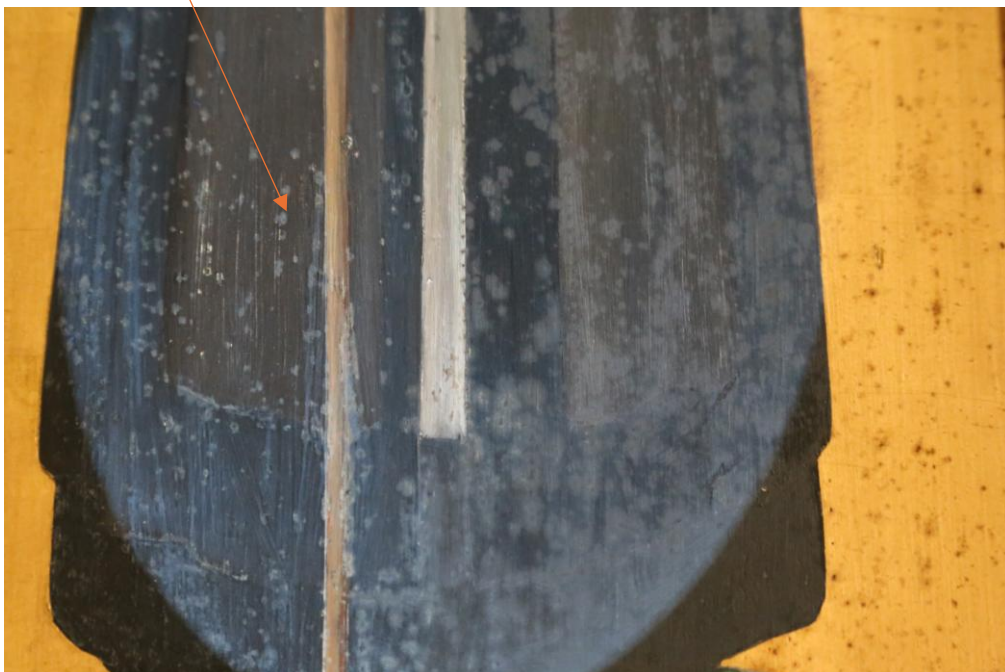
FIG. 15

View showing an area that was cleaned using saliva and TAC. The white dots are areas where the MBG has damaged the painted surface.

Areas that have been damaged will require limited toning in to reduce the impact of the losses using either watercolour or Gamblin retouching colours as appropriate.

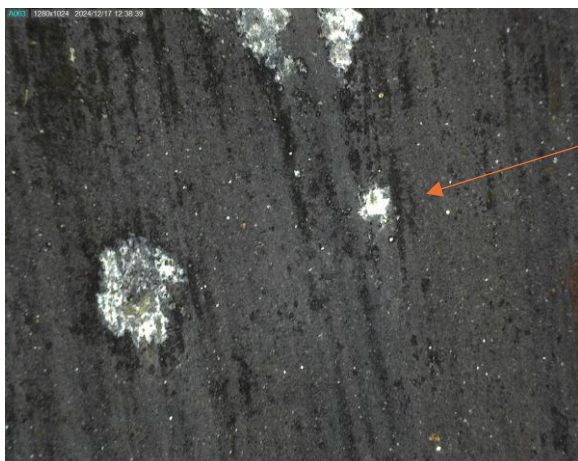
FIG. 17

Detail of the black area after removal of the MBG. Here the exposed white underlayer can be clearly seen.
