23rd April 2025

Re: ST DUBRICIUS CHURCH, PORLOCK, MINEHEAD – NAVE ROOF

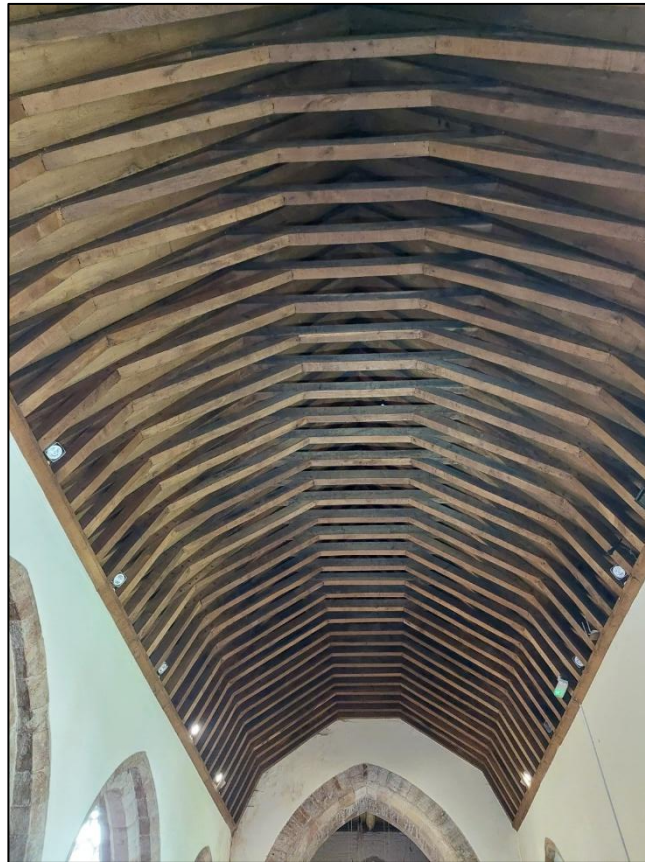
This is made up of a traditional cut roof with common rafters set at approximately 300/350 c/c. and including a high level collar and two supporting struts and braces

on each side forming a faceted barrel vault appearance, with each common rafter effectively forming an arch-braced truss.

Nave roof structure as viewed looking west.

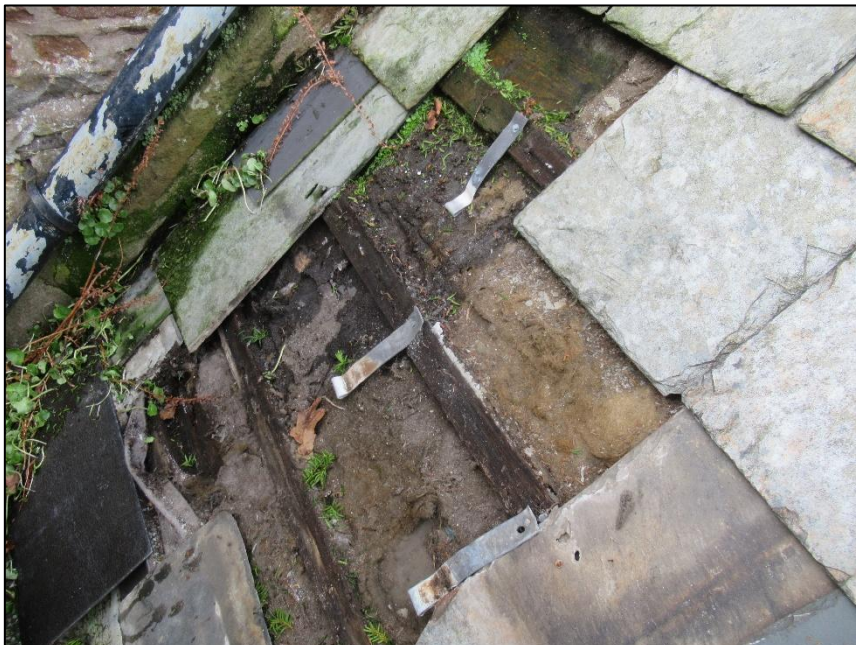
On top of the rafters is softwood boarding with battens fixed direct to the boarding and an early form of horsehair insulation set between the battens under the natural slate roof covering.

Nave roof opened up local to the east side of spire.

The general condition of the structural timbers associated with the nave roof appear to be quite good but, from the limited inspection of opening up an area of slate roof covering, it is evident that deterioration has occurred to the battens, the horsehair insulation and possibly to some of the boarding over the common rafters.

With the current exposed structure and no finishes sensitive to changes in deflection, we confirm that, going forward, the structure supporting the PV panels should work well. There may be some disturbance locally as part of the re-roofing works, but nothing that should cause structural concern. Any defective timber encountered during the works should be repaired or replaced as required.
