Re: ST DUBRICIUS CHURCH, PORLOCK

Further to our limited inspection of the church spire on Wednesday 18th December 2024, and our various liaison with yourselves, we report as follows having made various amendments and additions to our original initial report dated 20th January 2025.

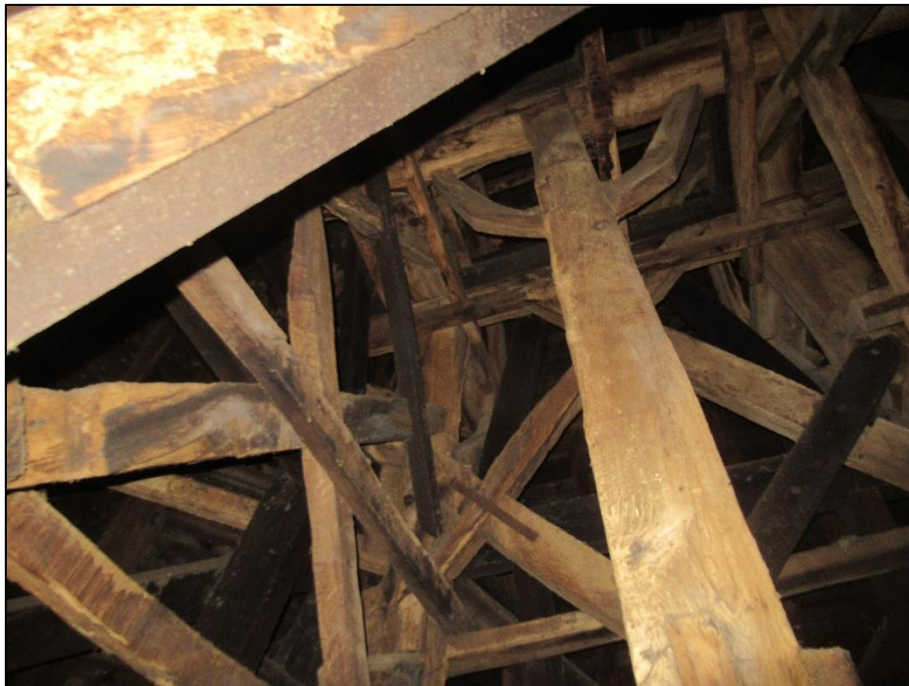
As outlined, the general construction of the spire is timber framed, with the earliest parts of it dating back to C13. This includes the central crown post (nominal 250 square) and the four inclined primary posts (nominal 230 square), together with the foundation bearing beams, which span west to east. Some of the bracing timbers are also original, including wing braces off the central crown post.

Central crown post showing original wing braces.

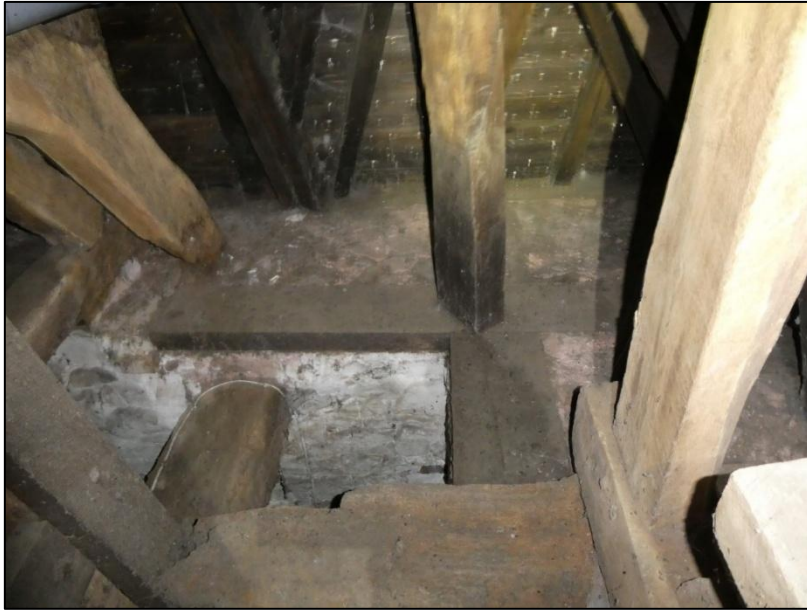
The spire structure is supported off the principal walls of the tower, with an inner and outer wall plate, the outer plate being in the order of 300x150 deep, chamfered at its external edge and jettied slightly over the external wall line, with the internal plate being nominal 275 wide and 100 deep. These inner and outer wall plates are linked, and half lapped at the corners of the tower and are generally embedded in to the tower wall head stonework.

Typical wall plate arrangement on head of tower wall.

It is probable that the external aspect of the substantial external wall plate may have suffered from some rot and deterioration. It may be possible to repair the plate, by scribing in new timber to match, in a traditional way, but allowance should be made for some replacement. Sections should be half lapped or plane scarfed where connecting to retained plate. Allowance should be made where required to mechanically connect the plate to the wall head using M12 stainless steel studding set @ 1.2m c/c staggered, resin fixed allowing for a minimum embedment of 300mm.

As part of the work required to repair wall plates, allowance should be made for wall head consolidation and making good stonework where required.

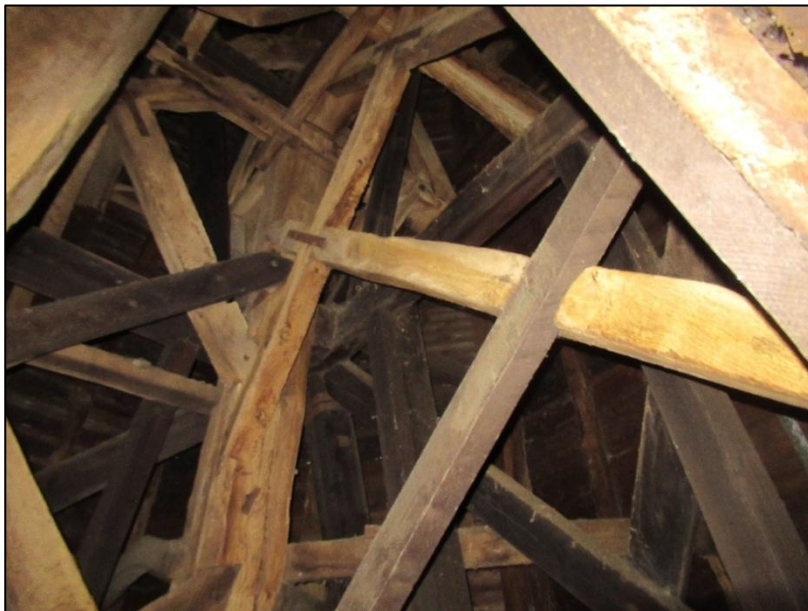
The foundation bearing oak beams span west to east, and it appears that the original centre beam, nominal 300x300, has been strengthened with an additional 200x300 timber on either side. This central beam arrangement primarily supports the central crown post. The raking corner posts of the central braced tower framework bear off further 200x300 timber beams.

Strengthening timbers added in the late C19 and early C20.

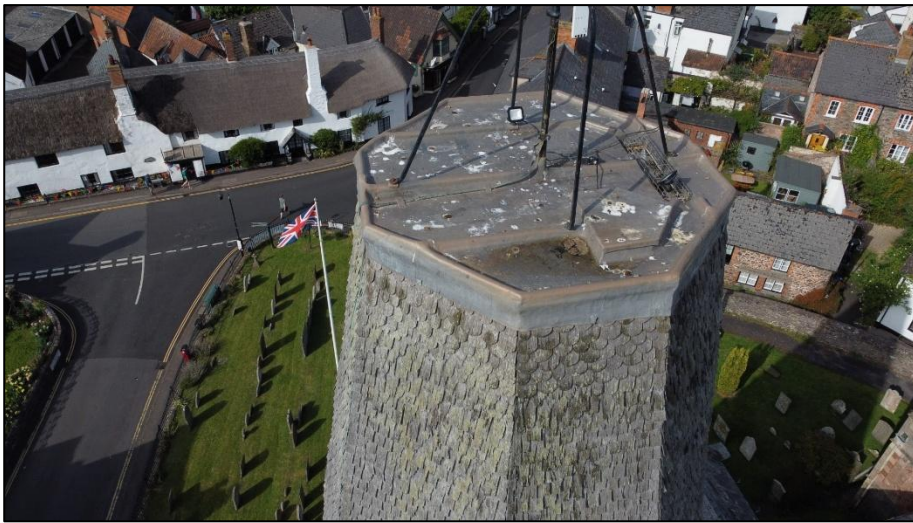
The lead covered small octagonal flat roof to the truncated spire is drained on its eastern side with a 100mm diameter PVC drain pipe extending down the inside of the spire and discharging, via a slightly tortuous route, in to the eastern eaves gutter. The eaves' guttering arrangement is poor and includes a plastic gutter set within the oak/elm timber gutter with no lead lining, all of which needs to be repaired and upgraded.

Octagonal lead flat roof to truncated spire.

As outlined, the spire roof was recovered in 2007, and allowance should be made to renew or repair joists and boarding where required once the existing lead has been taken off, prior to relaying the new Code 8 lead.

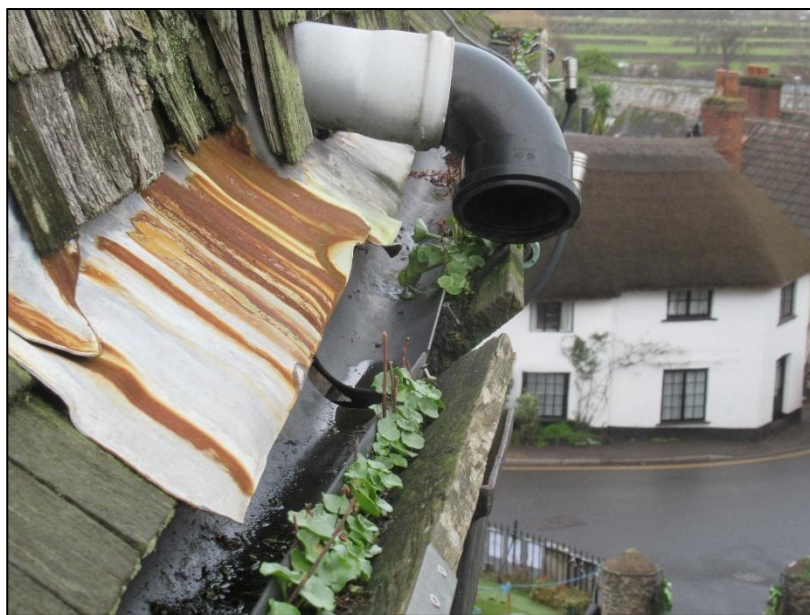
Inadequate guttering and spire roof rainwater collection requiring repair and renewal.

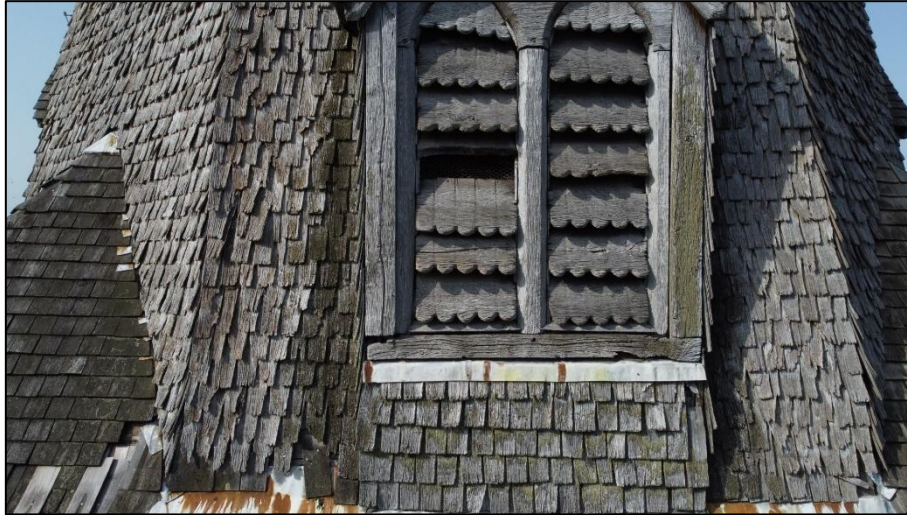
As outlined, it is proposed to re-cover the spire with new oak shingles, as the existing have reached the end of their effective life. Some rot and deterioration has been occurring to sarking boarding, rafter feet, the external wall plate and trimming timbers around the lucarnes, together with the lucarnes themselves, particularly on the exposed elevations. Repairs will be required to these elements, with works undertaken in a considered and traditional manner.

An example of deterioration of timber work around the southern lucarne.

As outlined, repairs will be required around the Lucarnes, particularly on the exposed elevations. Allowance should be made for potential replacement timbers, including rafters and trimmers, as well as traditional scarf repairs where appropriate.

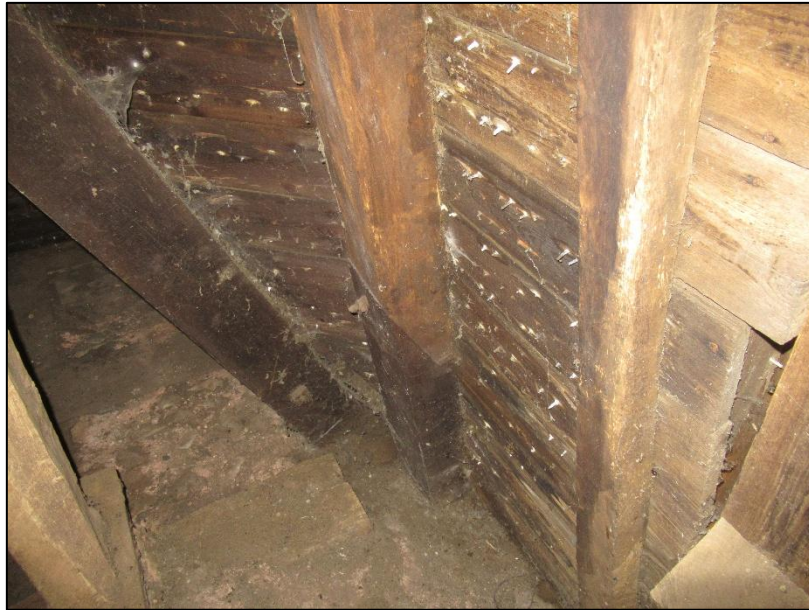
An example of a previous hip 'scarfed foot' repair undertaken in 1933.

Deterioration of the rafter feet may also have occurred requiring repair. Where required, we would recommend a 'scarfed foot' repair is adopted, similar to that used previously.
