Porlock ST DUBRICIUS

BRIEF REPORT ON CONDITION OF SPIRE

as at November 2022

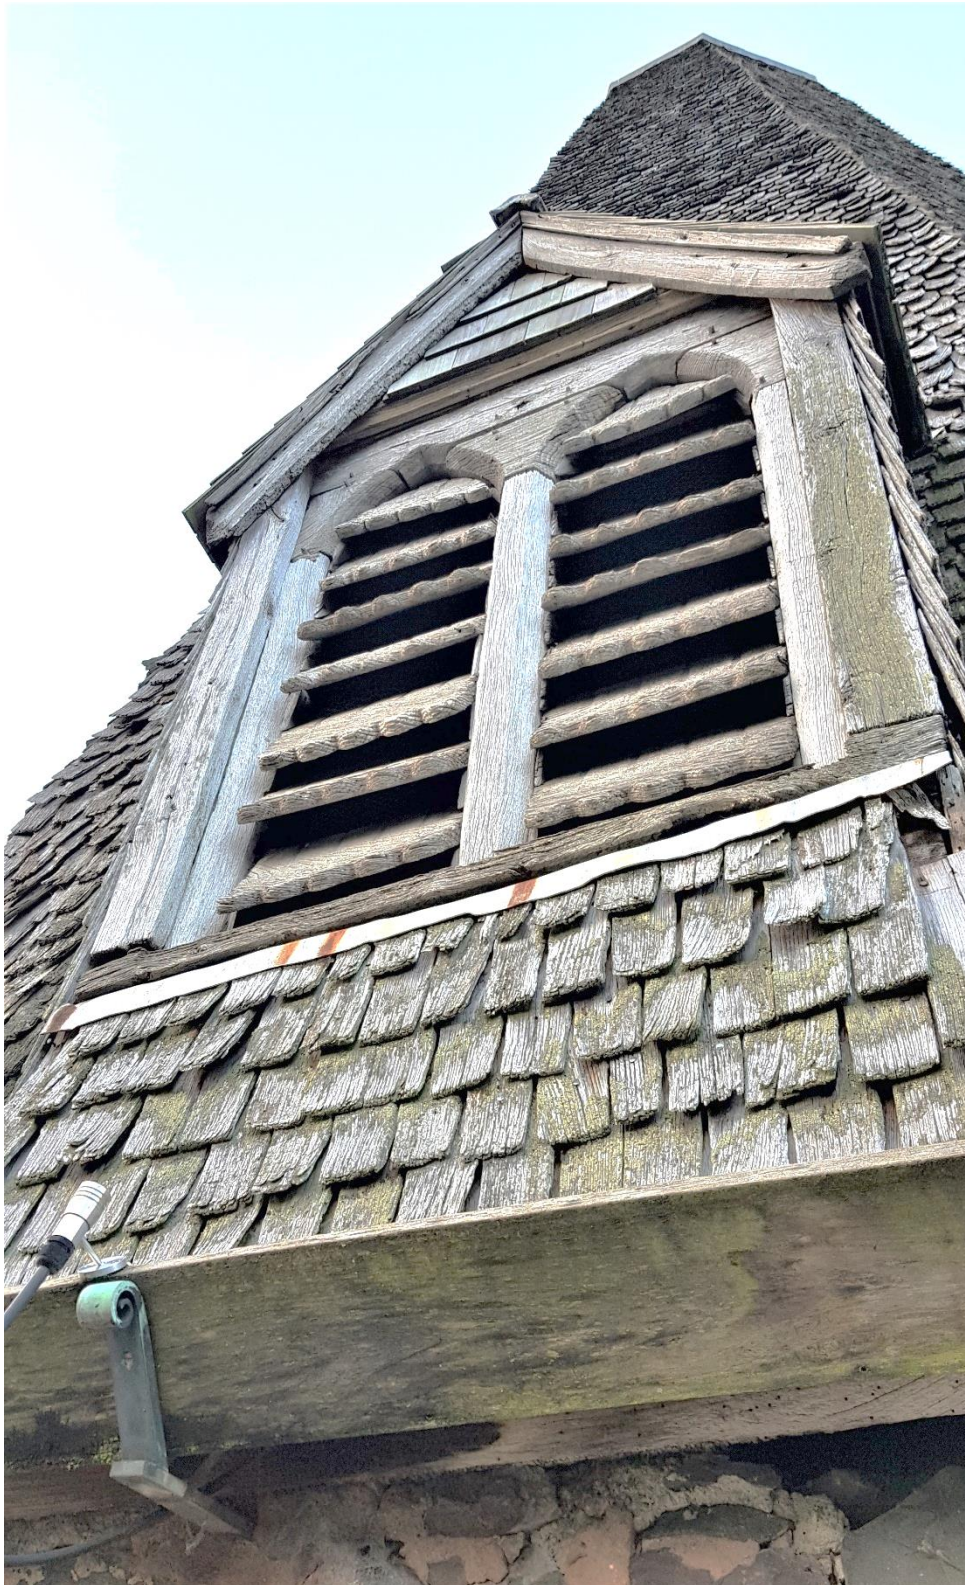
- 4.5. The oak shingles generally are worn thin and curling on all slopes. Numbers are worn so thin that they have either fallen away or no longer provide cover for the boarding below. As noted above, the broach slopes (which are less steep) were renewed in the 180s however they are already extensively decayed, having been repaired with Cedar which has a life expectancy of typically only 40 years. These areas will also need to be re-covered with new oak shingles.

Lunette and gutter, west side note missing and curled shingles and rot in bottom of gutter

- 5.1. Renewal of the shingles using oak is recommended and repairs to rafters hips, lunette windows and extensive wall-plate repairs.
- 5.2. A quantity surveyors estimate has been commissioned and includes all the repair works so far identified and reported in this document.

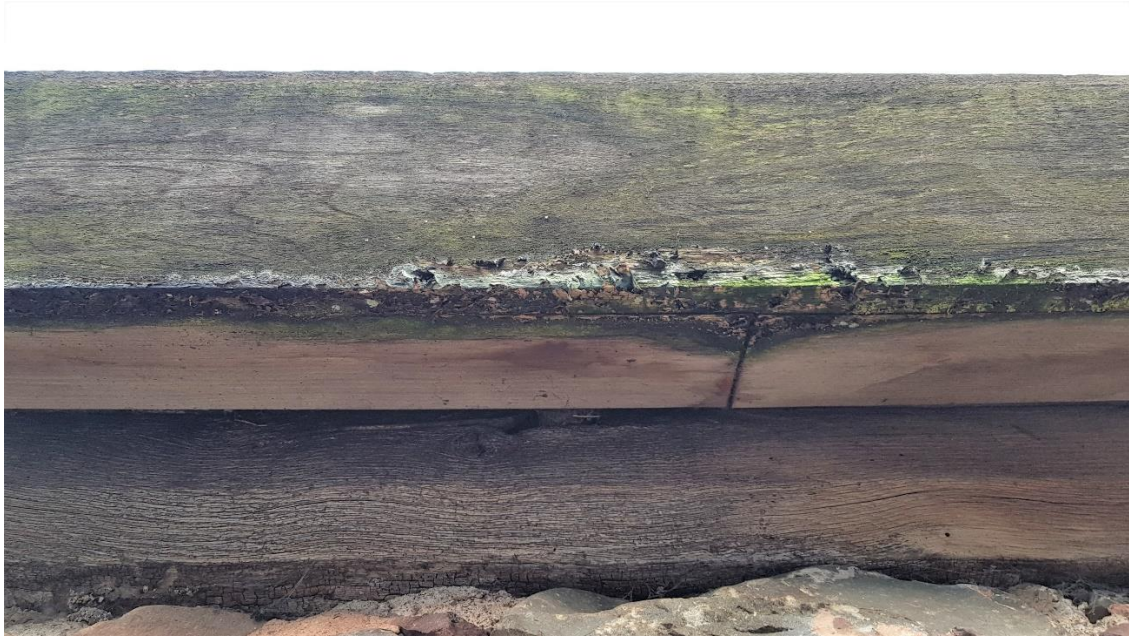
- 4.4. The elm gutters are decayed at the lower edges of the boards in almost all cases. This is not causing a problem because there are plastic gutters set inside these timber gutters; however, the plastic itself will degrade fairly quickly and isn't a long-term solution. In addition, the fitting of the plastic gutters has probably worsened the decay of the elm, as the gap between the elm and plastic is now largely filled with wind blown debris and is constantly wet. The elm gutters do not appear to have been lined with lead or other similar material. These gutters are a feature of the tower and have very fine bronze supports so consideration needs to be given to their repair.

Gutter, west side

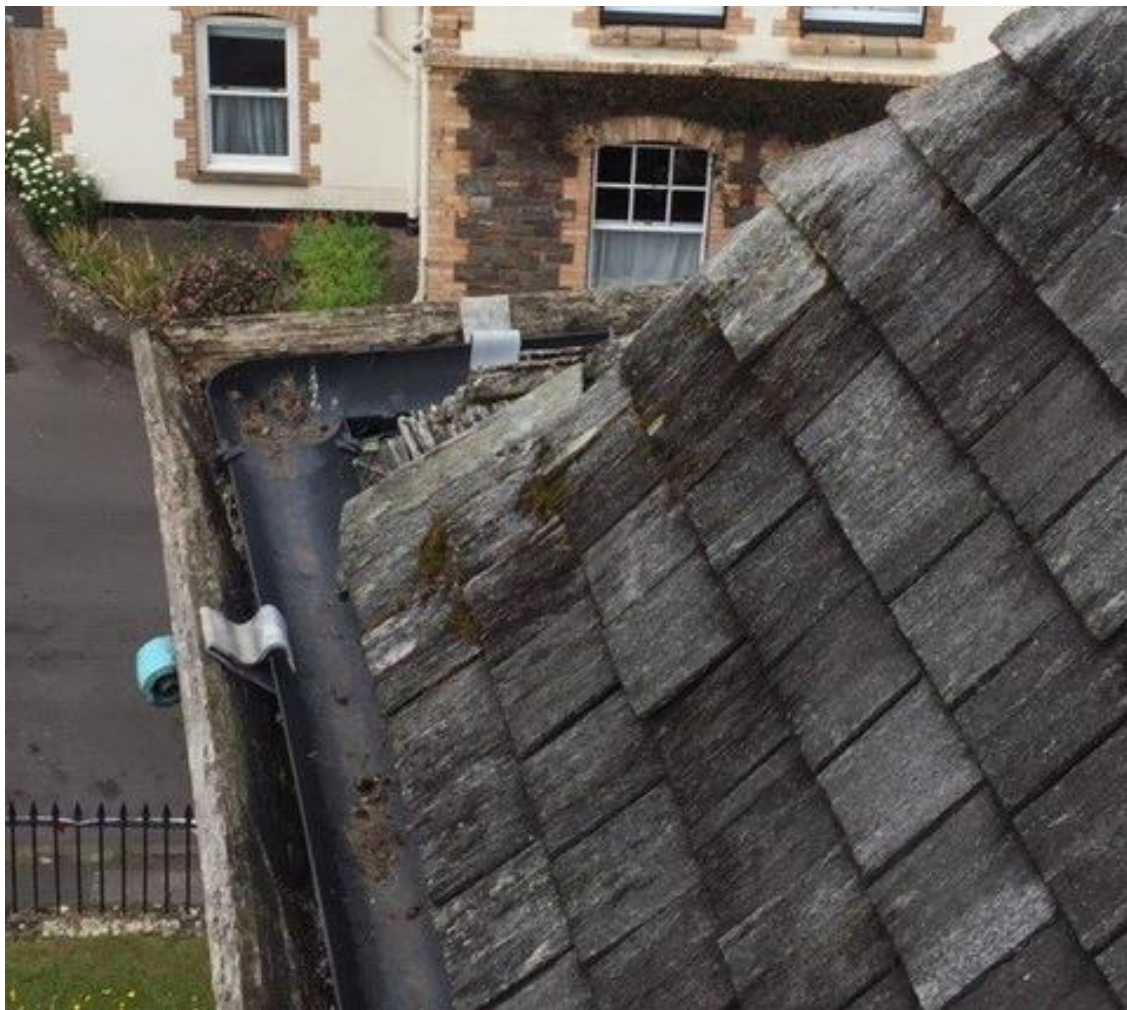
- 4.7.7. At the southwest corner (cedar) shingles were decayed and several missing completely.
- 4.8. The remaining lunettes are in better condition than that on the south but barges and mouldings are poor in all cases, and missing for part of the west lunette. There may be some decay in the joint between the post and head of the western lunette but this is not visible on the interior. The flashing at the eaves' sprocket is also dislodged along part of the west side.

- 4.17. The outer wall plates have been renewed under the broaches in all cases and were in satisfactory condition. However between these, the lengths of plate were rotten in all four sides, with a visible hole on the south side. Daylight is also visible through the southwest corner where the shingles have been lost/rotted away.

Southwest corner, missing shingles and rotten boarding

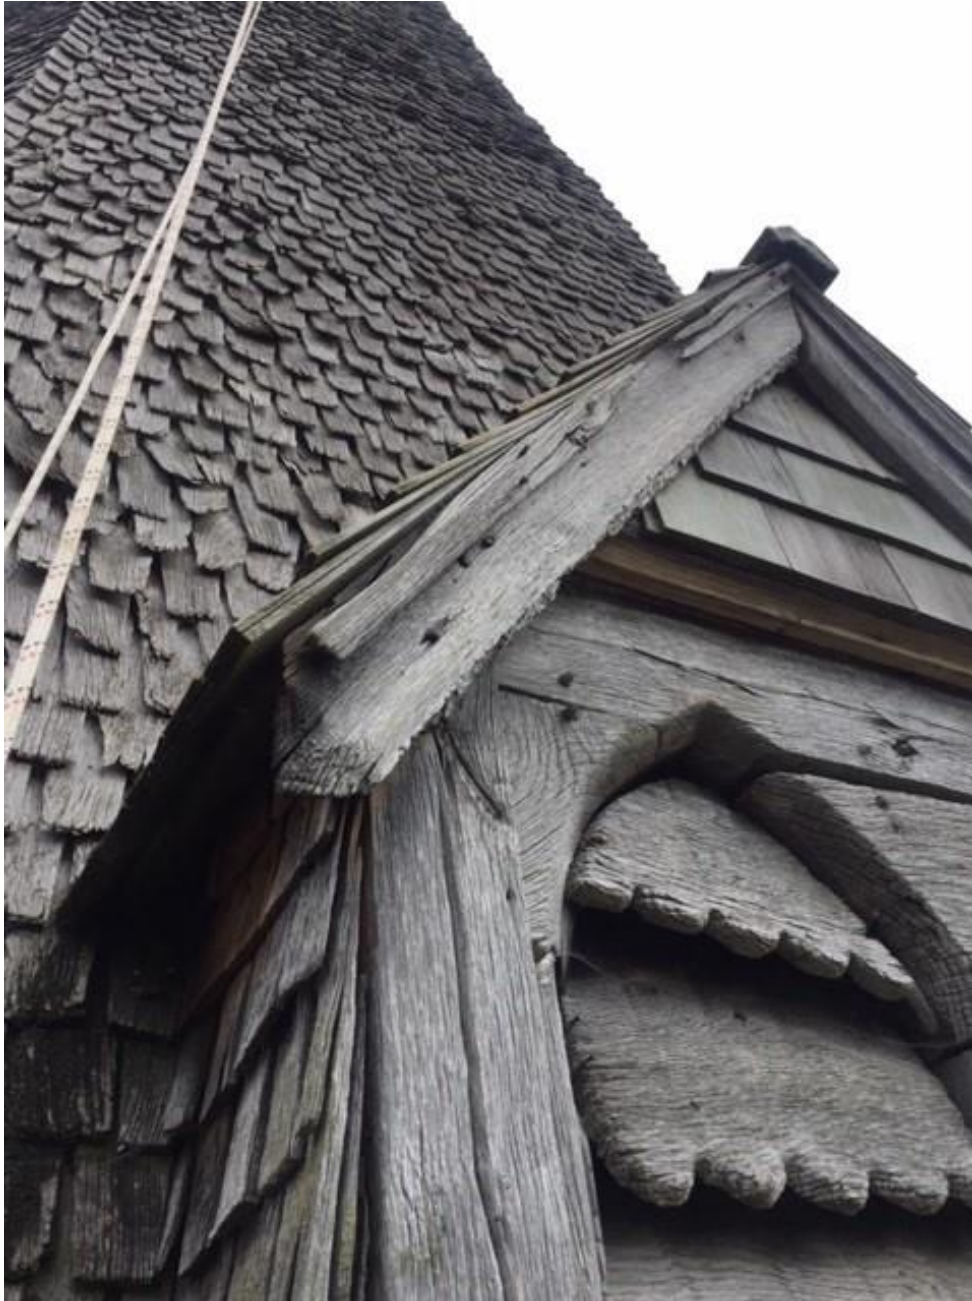
- 4.7.3. The mullion of this window was loose.
 - 4.7.4. Cover timbers to the jambs were both decayed.
 - 4.7.5. Barge boards and the moulded cover strips to the lunette roof were in poor condition.

South lunette showing condition of barge and moulding and jamb

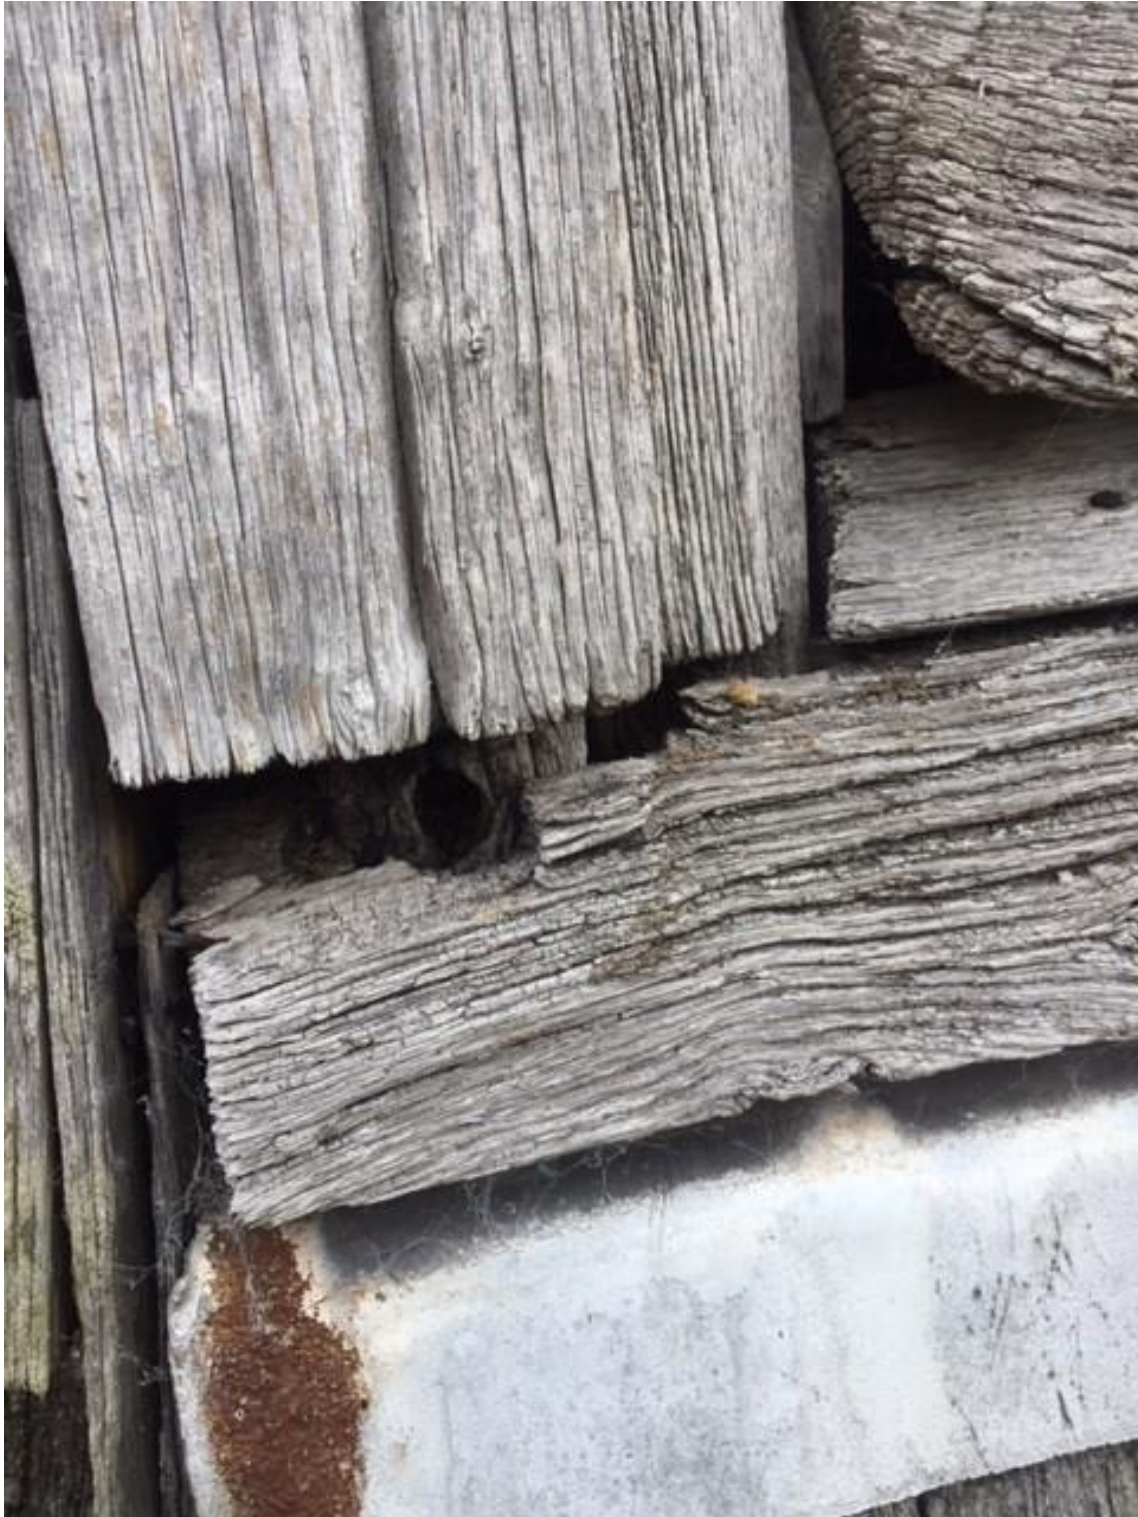
- 4.7.1. One louvre on the south lunette was split with the lower part very loose and this was taken out to avoid it falling.
 - 4.7.2. The cill of the southern lunette has lost part of its section around the peg-hole on the west end .

South lunette window joint at cill

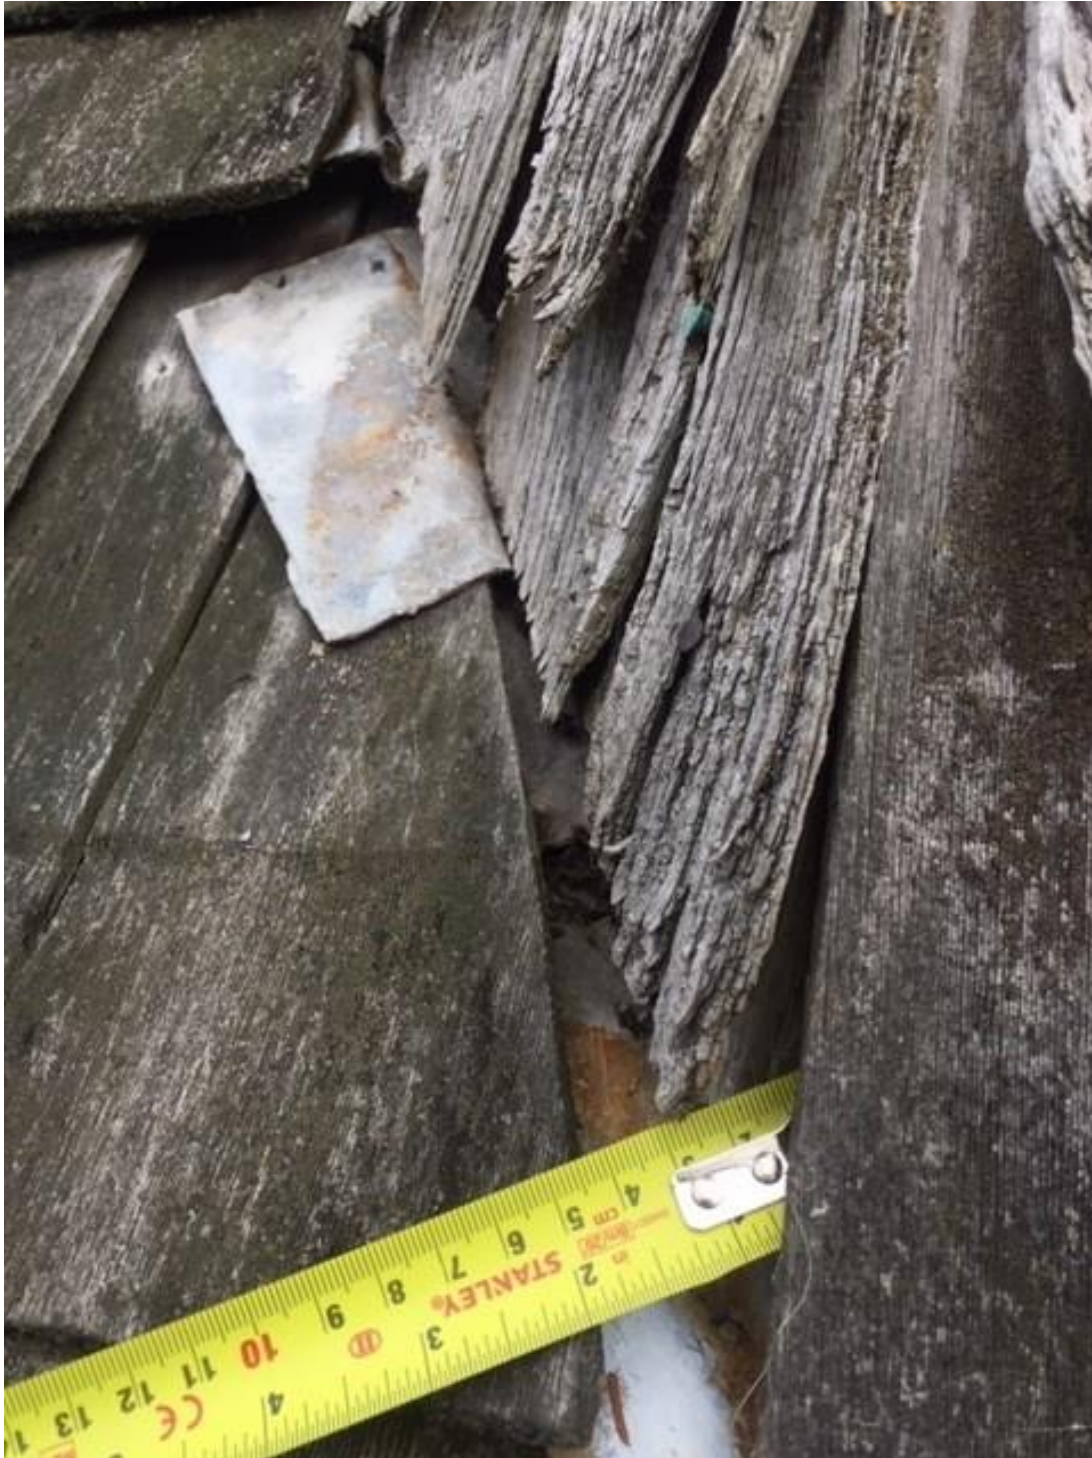
- 4.6. The hips have narrow lead flashings at the foot of each slope where it meets the edges of the broach, but there are no hip flashings. This is not unusual for such a steep slope, but given that the shingles are in very poor condition and the overlap at the edge of the hip has eroded, decay in the ends of the boards in the lower part of the slopes and possibly to joints beneath, is to be expected.

South valley very narrow flashings and note condition of shingles

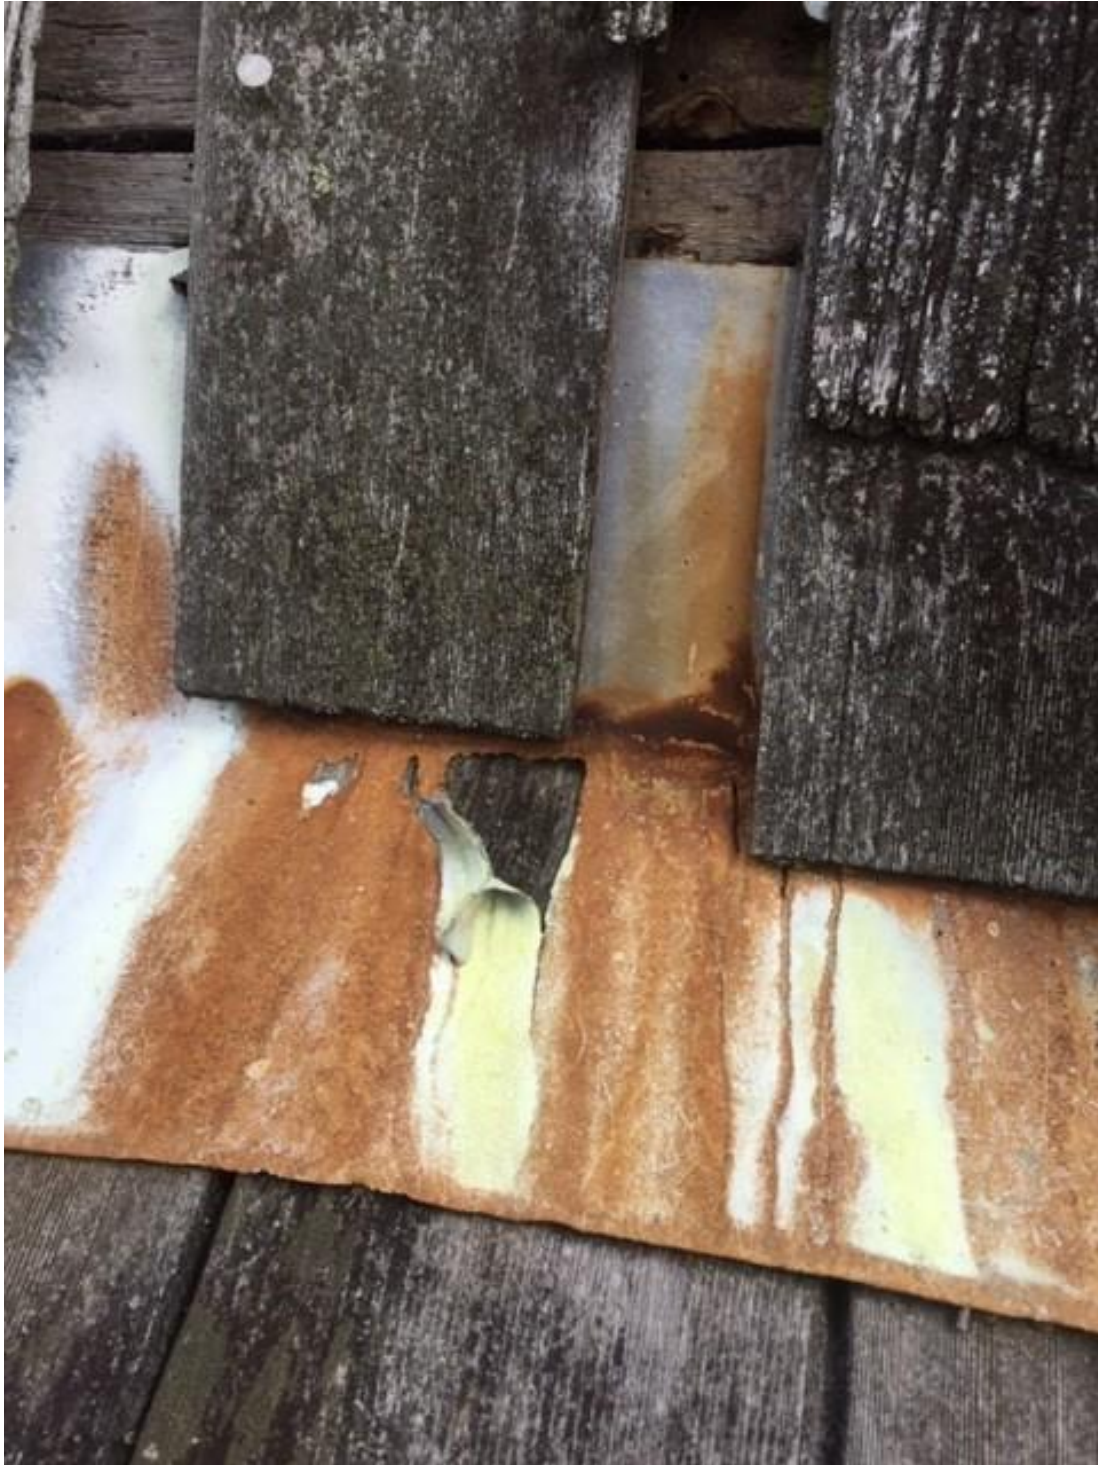
- 4.7.6. Some of the lead flashings at low level on the south face were loose. There was a hole worn through the lead in the change of slope at the eaves.

South side over sprocketed eaves, hole in lead (worn by acid run-off from shingles) and note condition of shingles with boarding below visible

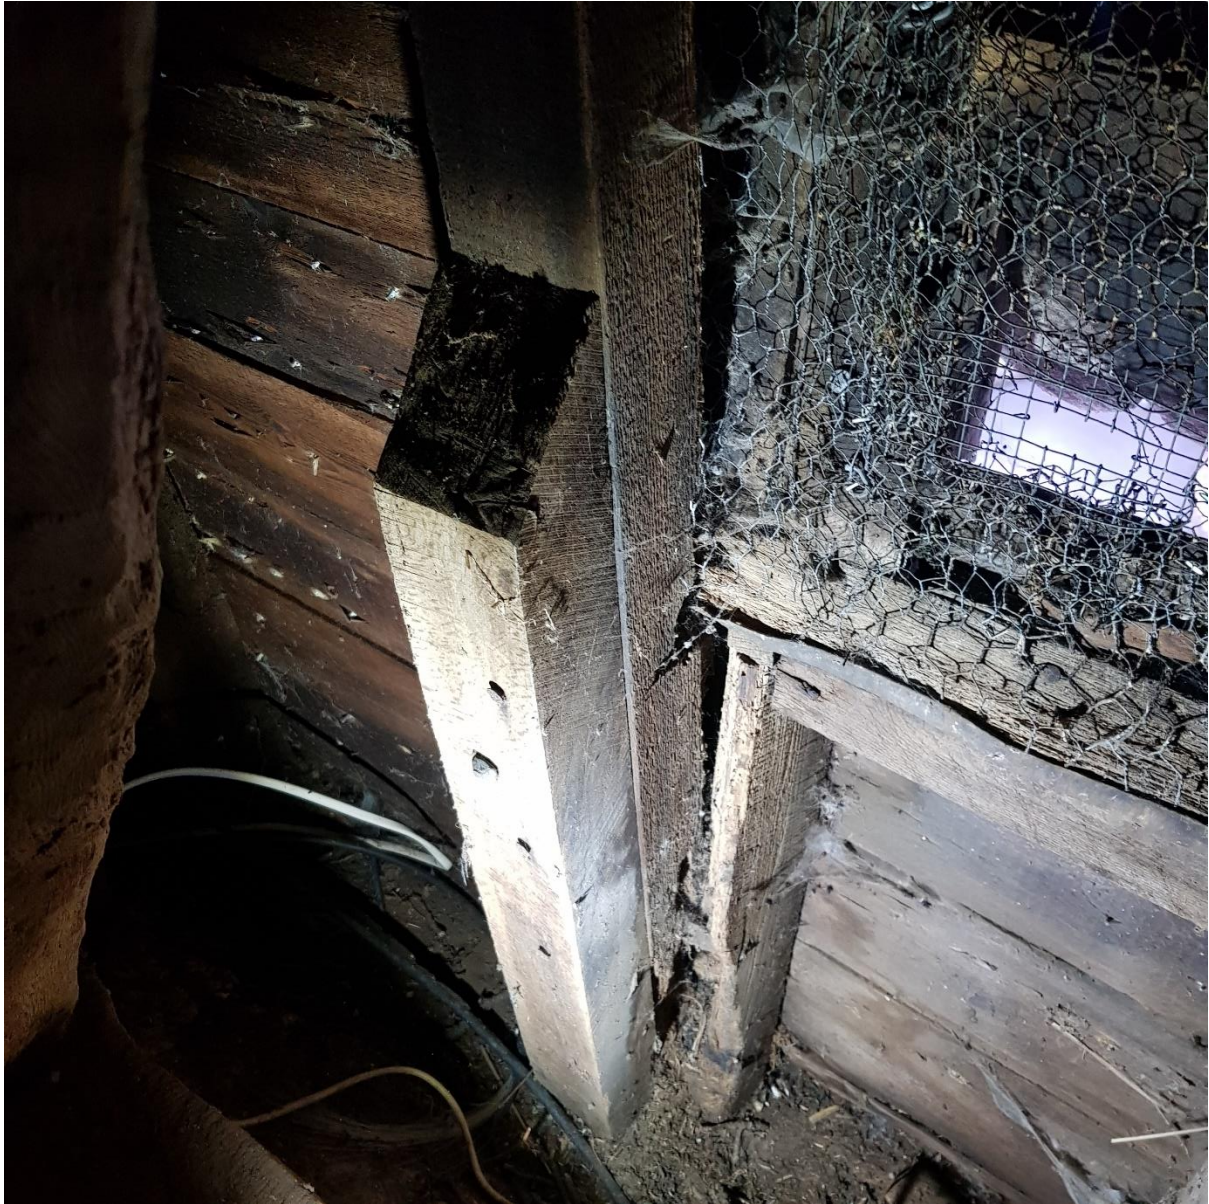
- 4.13. On the west slope one rafter is rotten and has been paired up with several phases of repair.
- 4.14. Rafter feet have been repaired with simple scarfs in the 1933 phase of work. On the west face the upright to the lunette window and three rafters have extensive rot for the lower 12-16"

Lunette upright west side

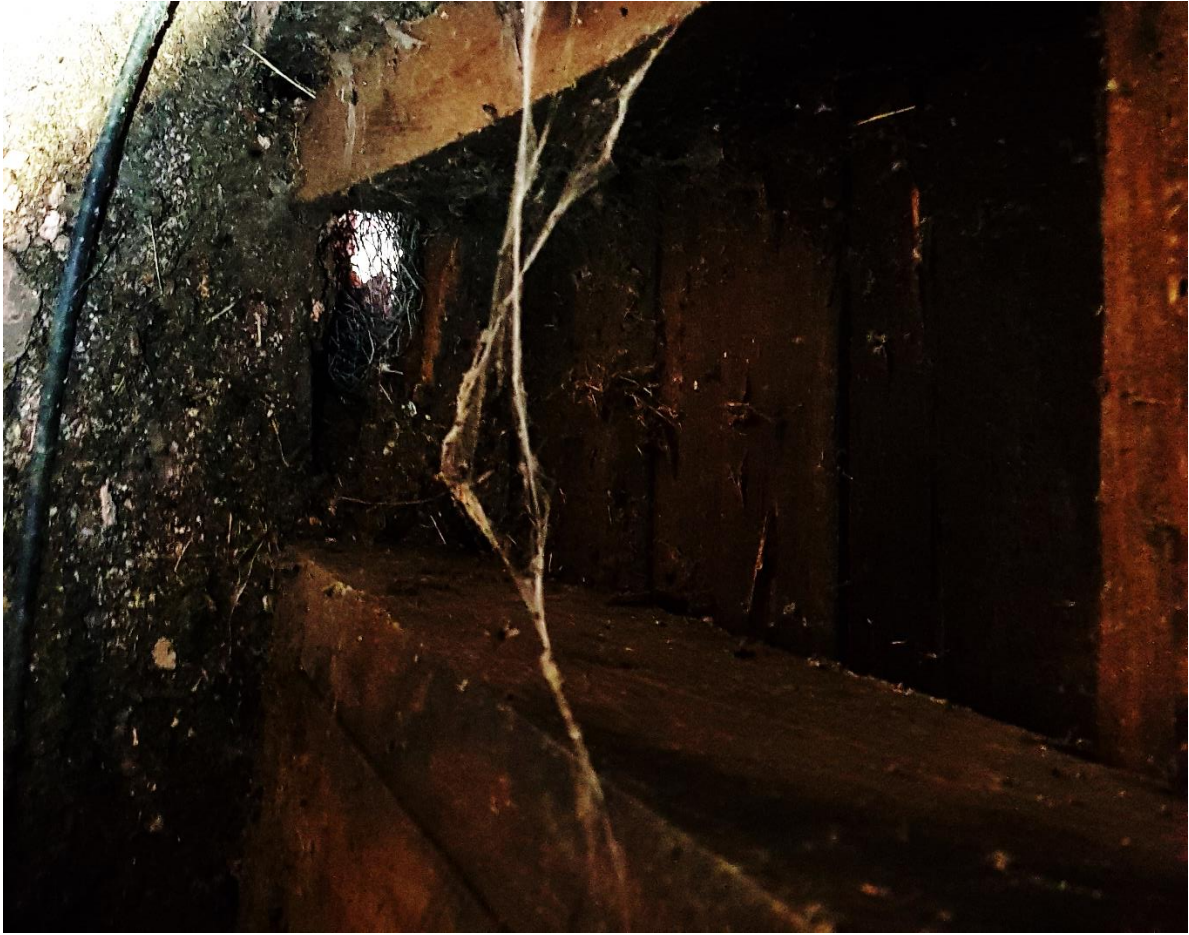
South side hole through wall-plate

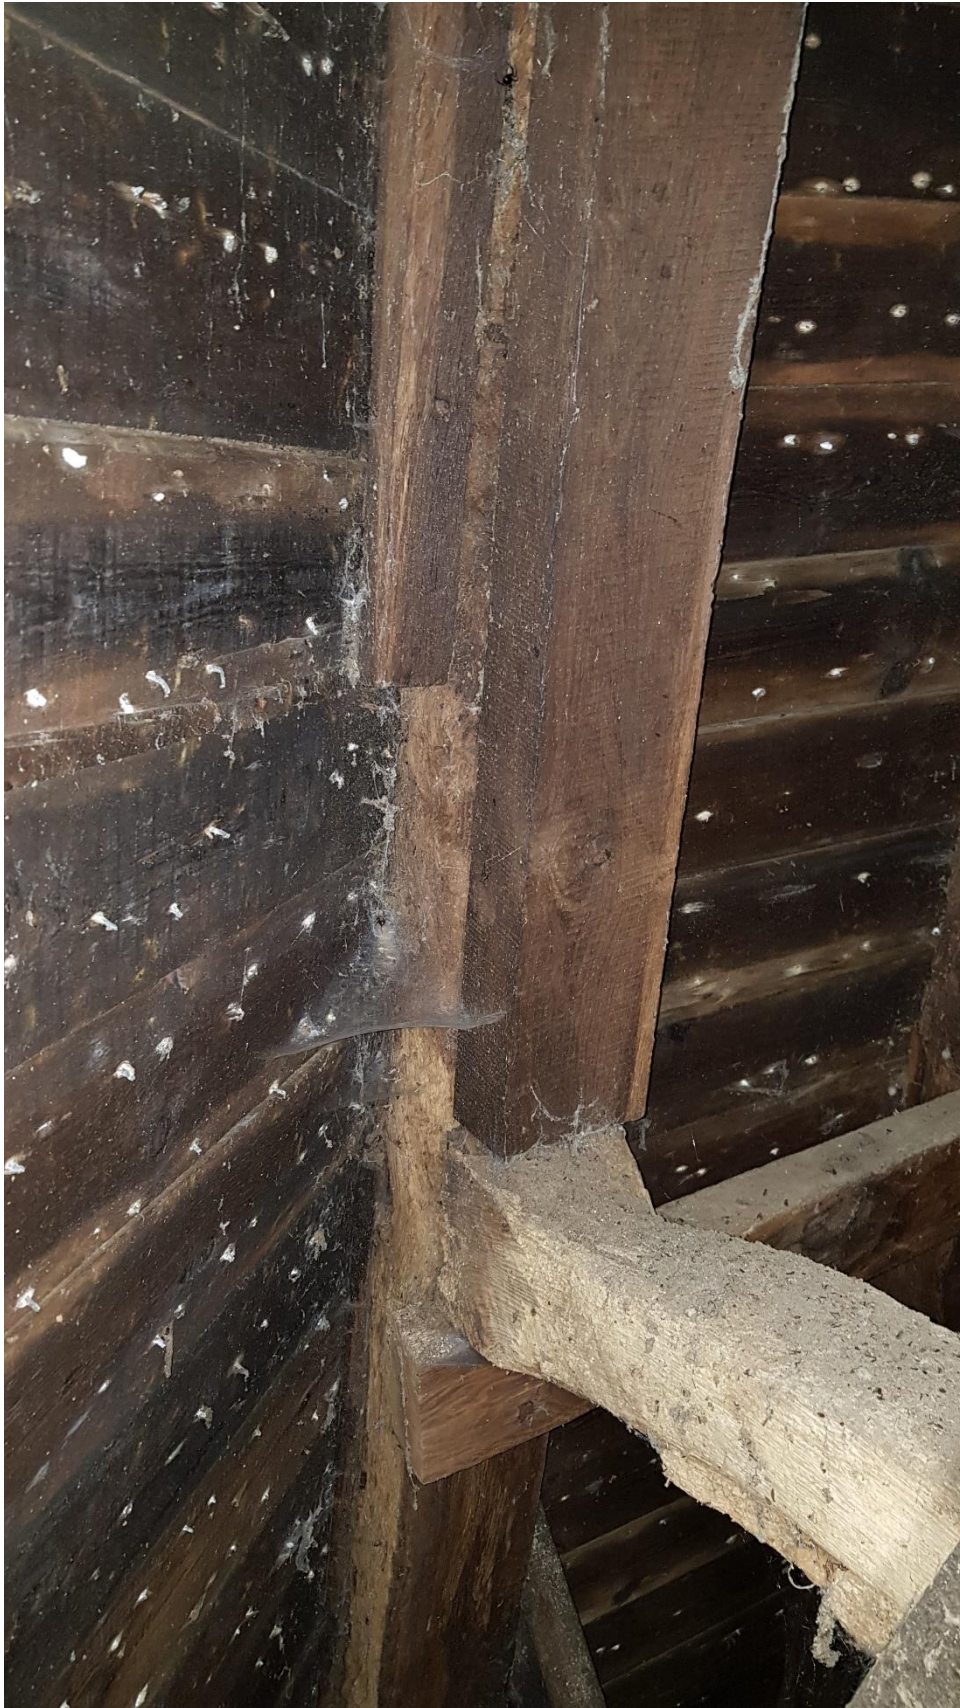
- 4.12. The joint between the horizontal support member and the southwest hip was poor; this is a vulnerable position and was the source of problems on another project (not by this practice) which increased the cost of repairs. The exterior of the joint is covered with boarding in all cases and difficult to inspect unless rot is very extensive. An allowance for repairs at these joints needs to be made.

Joint between southwest hip and support member – multiple additional timbers and continued rot to hip
