# The Bath & Wells Diocesan Association of Change Ringers

9<sup>th</sup> February 2024

## **Kingston Seymour, All Saints, Initial Tower Inspection**

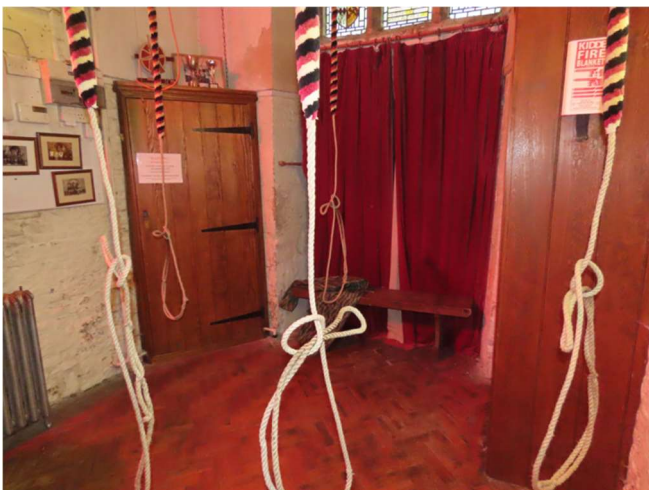
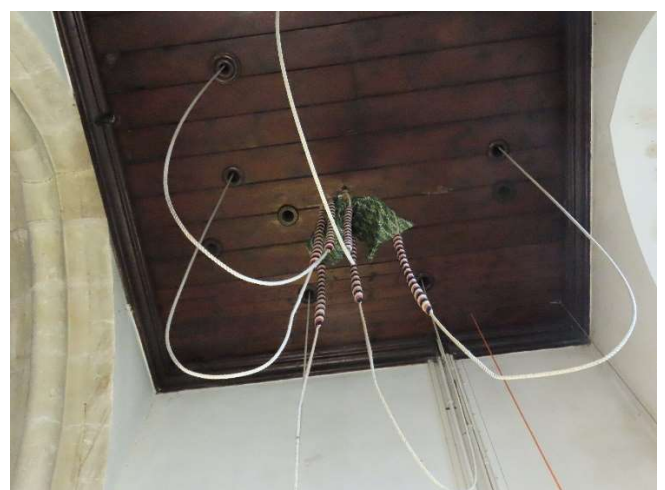
At some stage there appears to have been an Ellacombe apparatus installed as there are hammers on the bells and ropes leading into the intermediate chamber. There was no Ellacombe frame apparent at the time of the inspection.

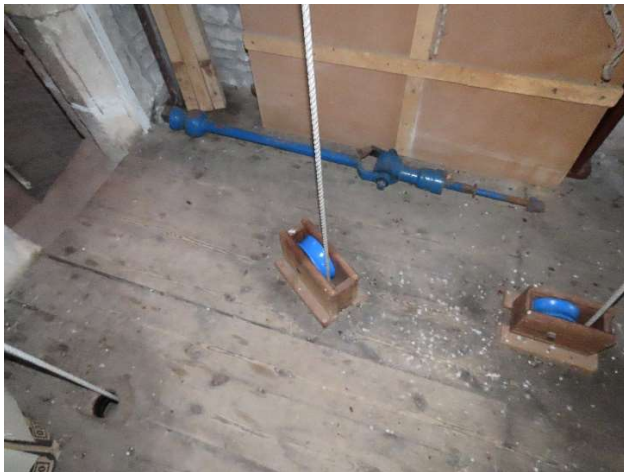
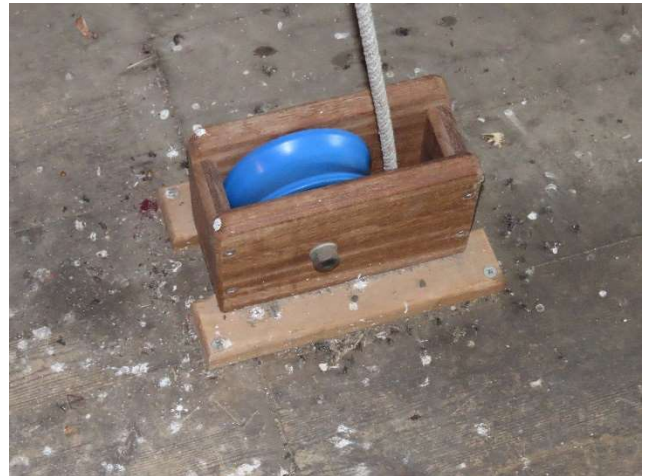
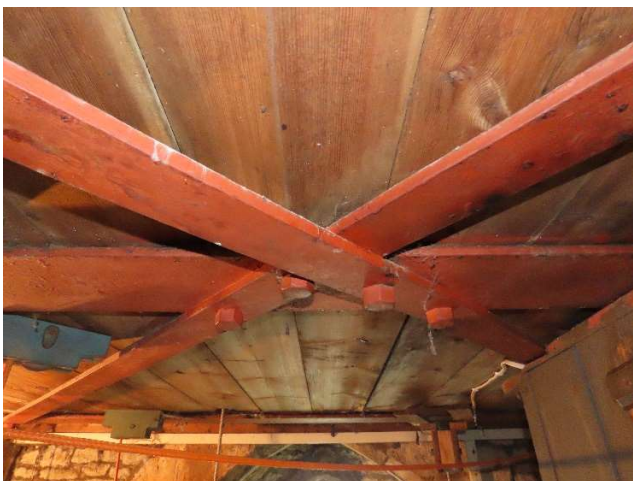
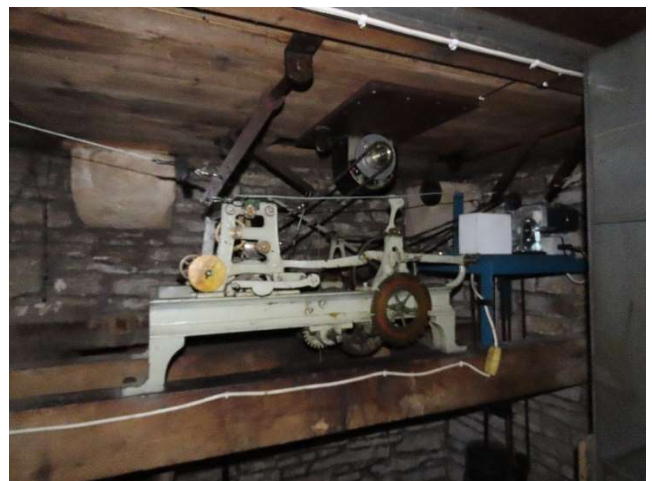
The ropes of the treble and second bells are drawn sideways slightly to form the rope circle below. This possibly contributes to the challenging handling of these two bells. The ropes for the remaining bells fall straight, including the 5<sup>th</sup> rope that falls through the clock case.

Ground pulleys are fitted to the treble, second and fourth bells. There is also a ceiling pulley on the treble and 4<sup>th</sup> bells. All pulleys rotated freely and were fitted with modern plastic style rollers that appeared in good condition. The rope on the 2<sup>nd</sup> bell did not quite align properly with the centre of the pulley.

There is a clock installed in the Intermediate Chamber supplied by Dell of Bristol dating from 1869, striking the hour on the tenor bell. The clock is fully functional and in good condition. It is electric wound from a system provided by Smith of Derby.

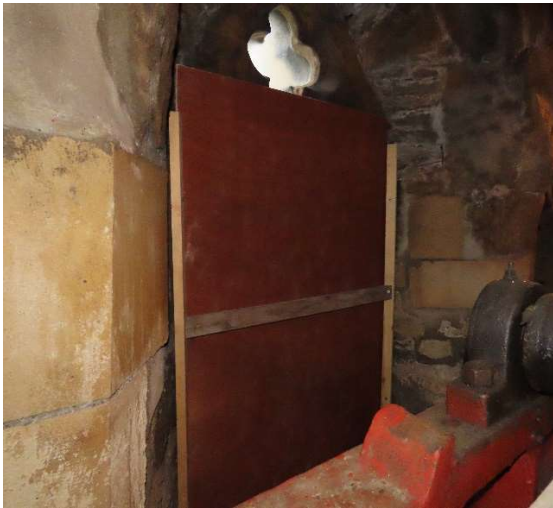
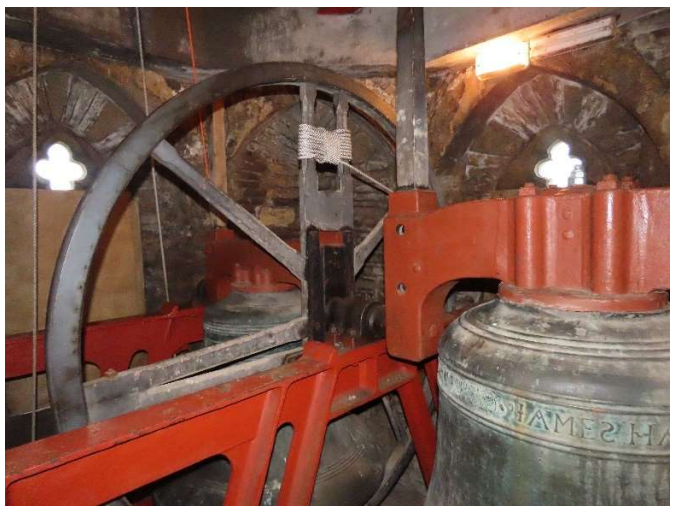
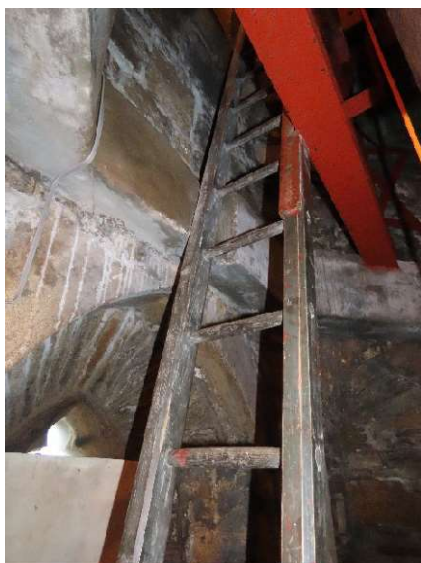
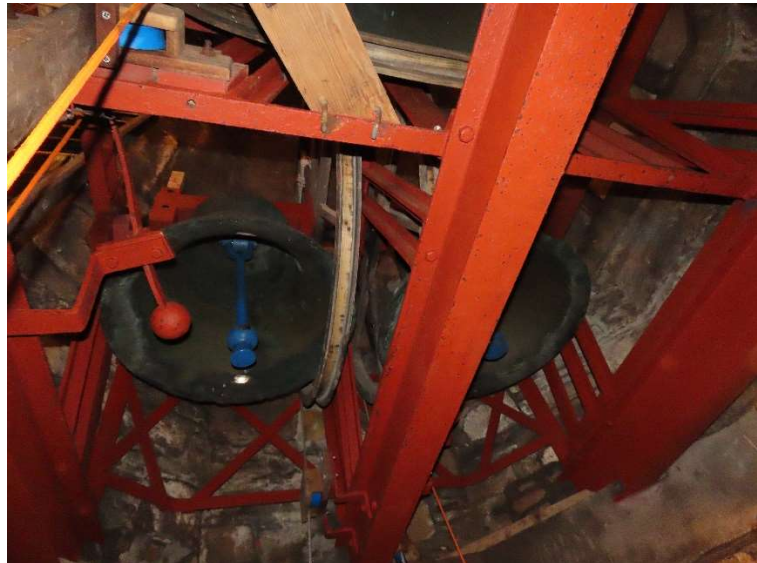
Entry to the bell chamber is through the lower tier. A narrow wooden ladder on 20 rungs is provided, fixed in position across the end of the lower frame to access the upper tier. Access is a tight squeeze.

The general appearance of the bell chamber was satisfactory for a bell installation with no signs of water ingress or significant accumulation of debris.

The sound openings were covered with wooden boarding that provided good protection from the ingress of birds and debris, generally in good condition. It is doubtful if this provides any significant sound control.

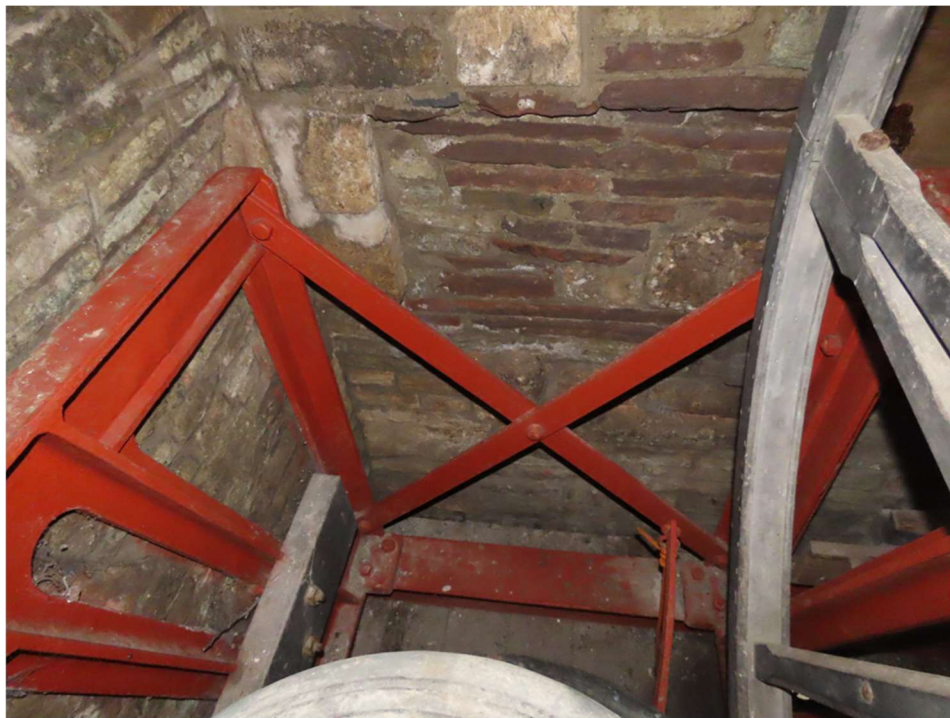
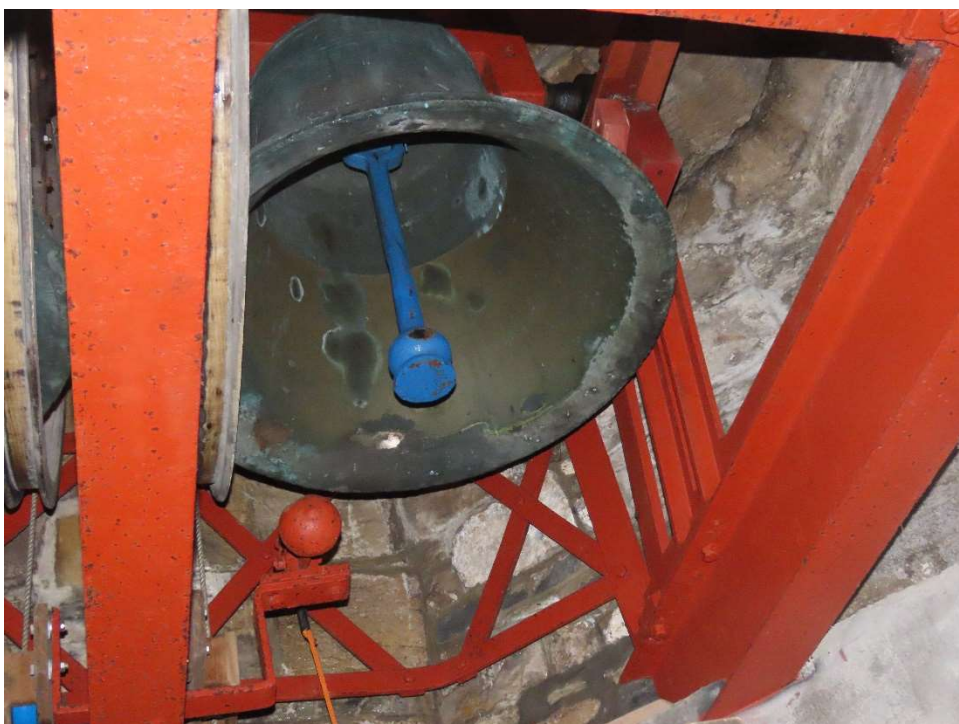
The bells are hung on two tiers in a cast iron frame supplied by Llewellyns and James in 1908, possibly installed as a frame for six bells. The 2<sup>nd</sup>, 5<sup>th</sup> and tenor bells are on the lower tier with treble, 3<sup>rd</sup> and 4<sup>th</sup> bells on the upper tier. The upper frame sits on a concrete ring beam.

The frame was generally in good condition and had been well painted possibly in the 2007 overhaul.

The main supporting structure under the frames were RSJ beams that were well braced with no signs of corrosion. All wall sockets appeared in good condition with no evidence of decay or frame movement.

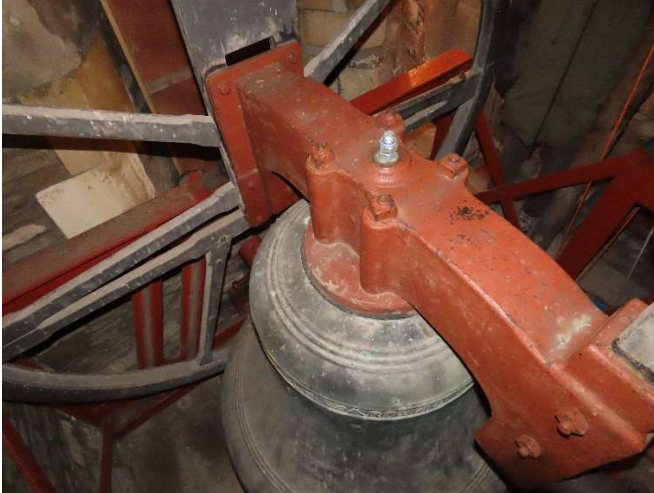
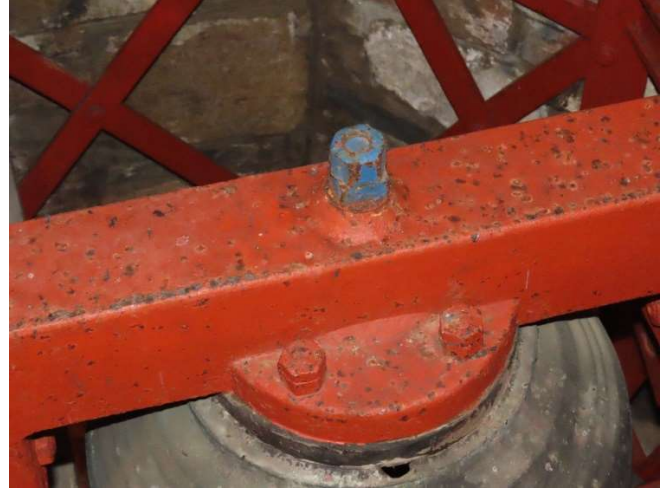
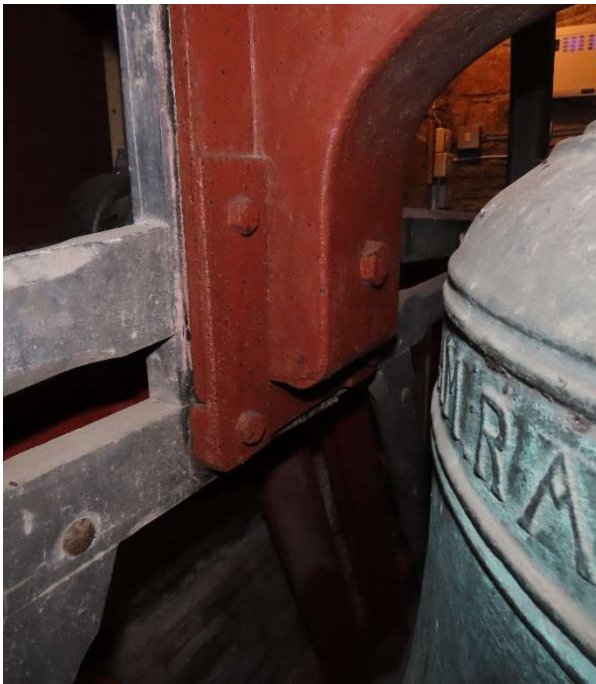
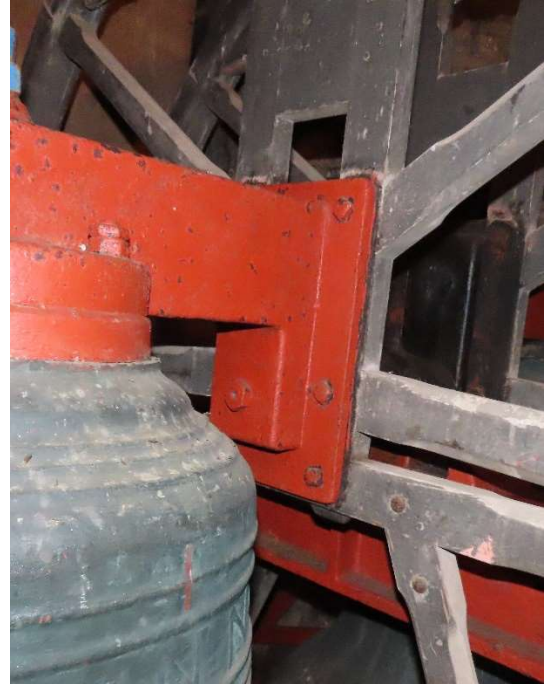
The bells are hung on cast iron headstocks supplied Llewellyns and James during the 1908 rehang. They are generally in good condition some minor spots of corrosion in a few places, particularly in the upper tier. Whilst not significant at this stage, repainting the headstocks in the next two to three years would prevent this becoming more significant.

All gudgeon pins appeared satisfactory from limited visual inspection only.

- a) Attend to minor corrosion spots on headstocks in the medium term before these become more significant. Re-paint headstocks with appropriate paint for metal structures.
- b) Investigate 5<sup>th</sup> slider for cause of occasional jumping out of position. The slider runner hand stoke end stop is slightly damaged and the slider itself is quite worn. Consider replacing the slider and repairing the slider runner to correct this issue.
- c) Consider replacement of the sliders and slider runners throughout the peal to correct excessive wear. Whilst not urgent, attention to this may be required in the medium term.
- d) Consider applying appropriate timber treatment to the wheels, stays and sliders in the next two to three years.
- e) Consider installation of rope guides to improve handling issues caused by the long draught.

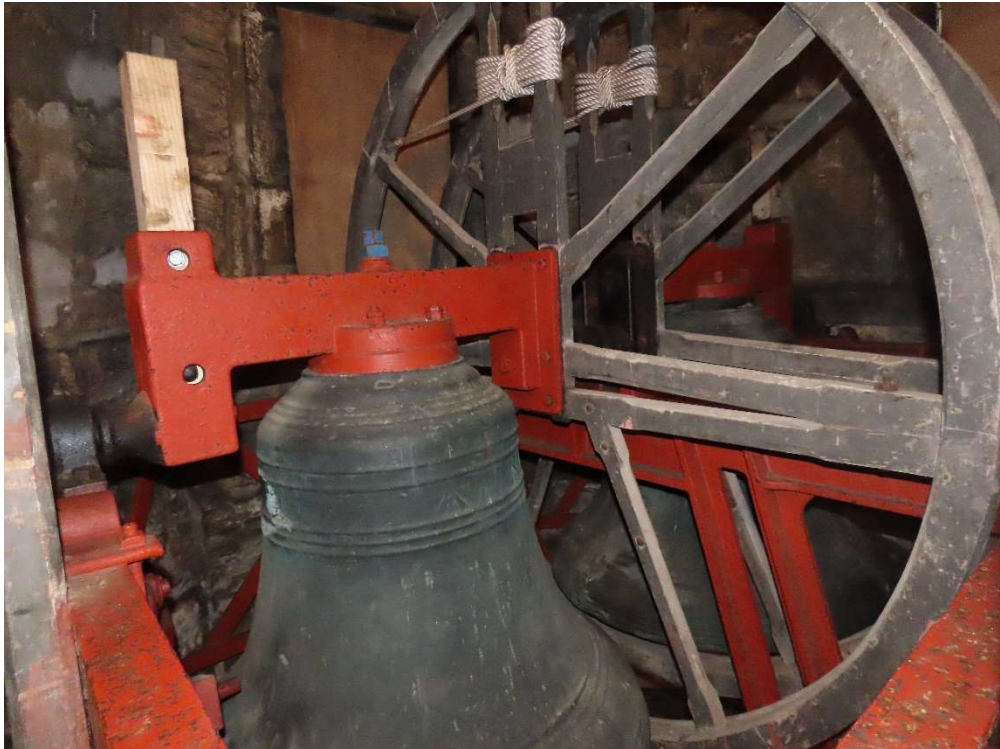
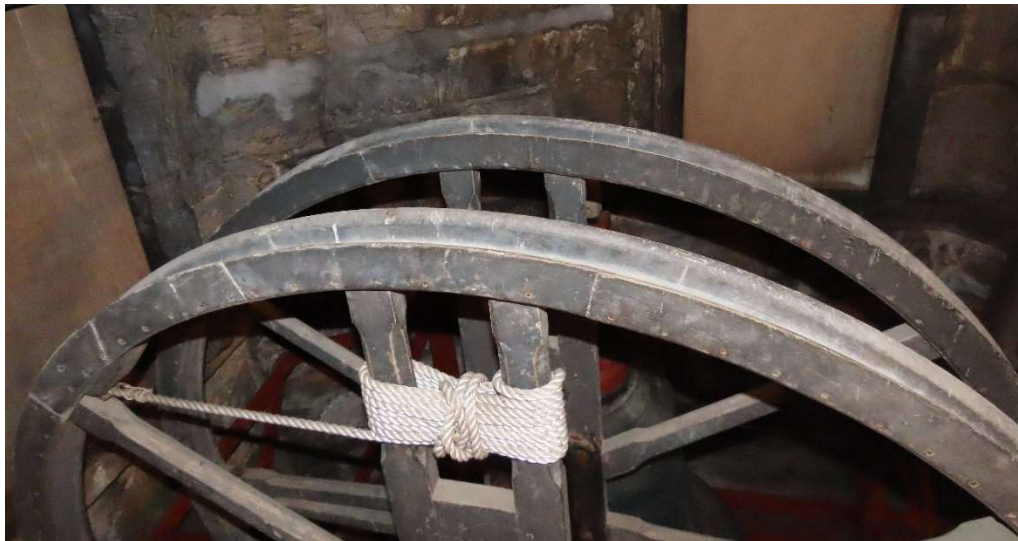
The wheels are generally in good condition throughout the installation. There were no signs of damage or decay on any of the wheels. The wheels possibly date back to the 1952 rehang by Mears and Stainbank. Treatment with a suitable timber preservative whilst not urgent, would be appropriate in the medium term of the next two to three years.

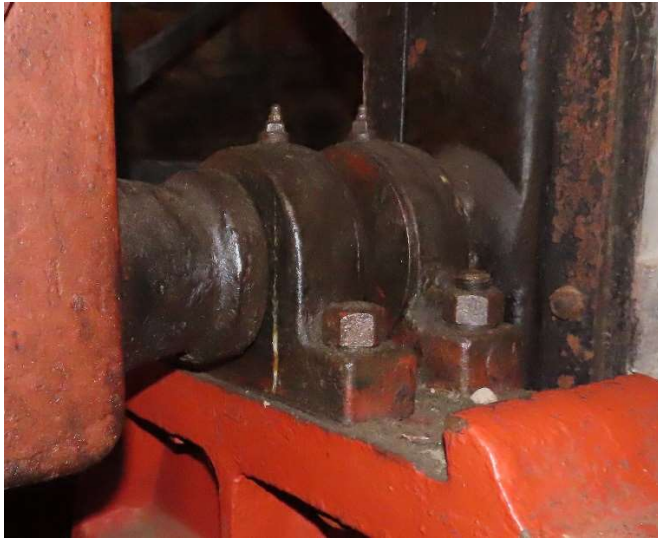
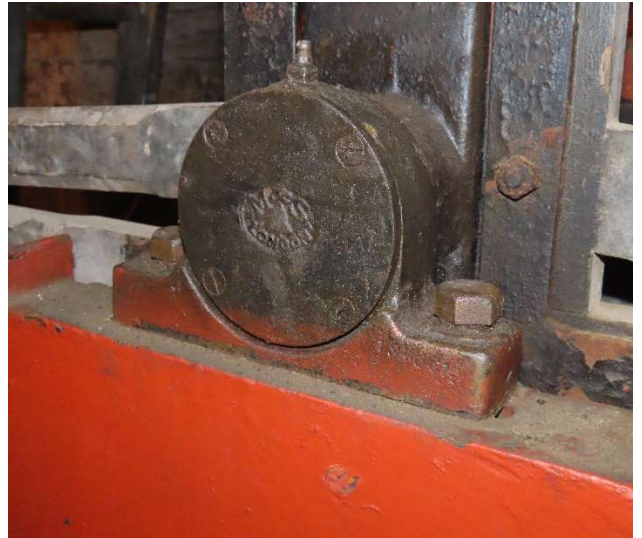
The bells are all hung on modern ball bearings supplied by Mears and Stainbank during the 1952 rehang. These will have been overhauled during the work carried out by Whites in 2007.

The general condition of the bearings visually looked good with no signs of grease leakage.

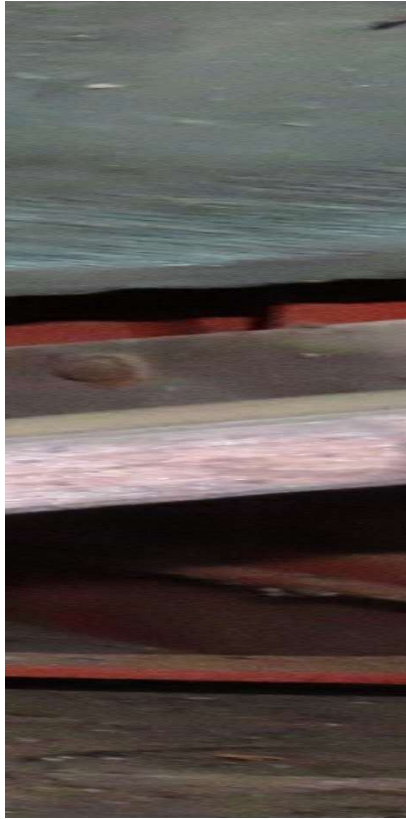
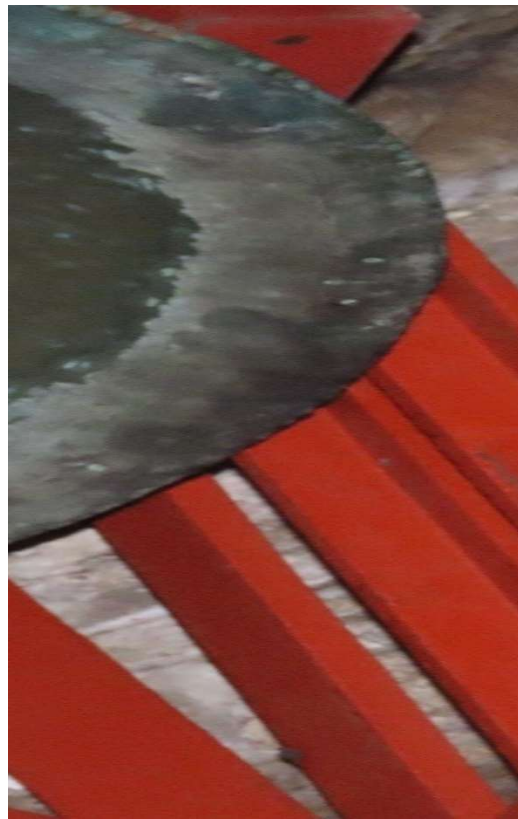
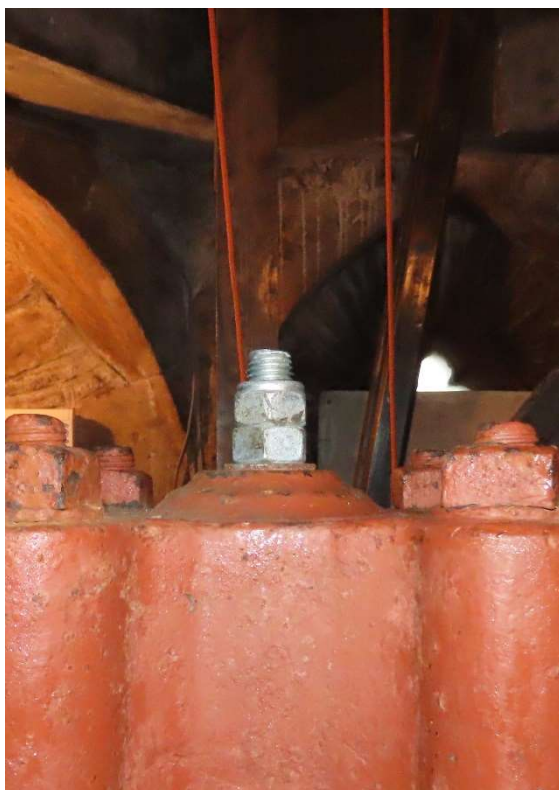
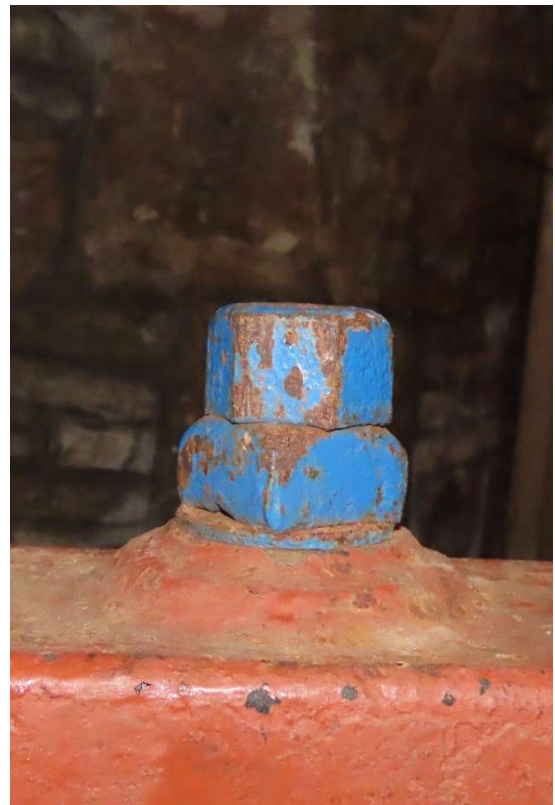
As a peal, all of the bells have a sound ring with no evidence of any cracks or damage. They were retuned by Mears and Stainbank during the 1952 rehang and are of reasonable tone bearing in mind the age of some of the bells.

The clappers are a mixture of wrought iron and SG Iron type possibly dating back to the 1952 rehang. The clappers were refurbished by Whites in 2007 and are still in good condition. There is no excessive wear or movement, and all secondary locking of crown staples was in place.

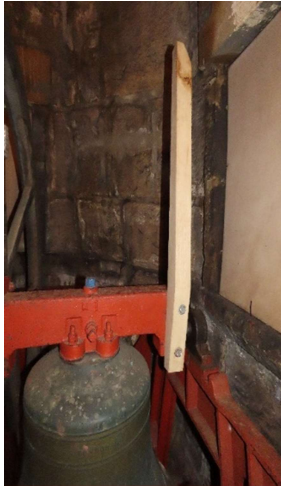
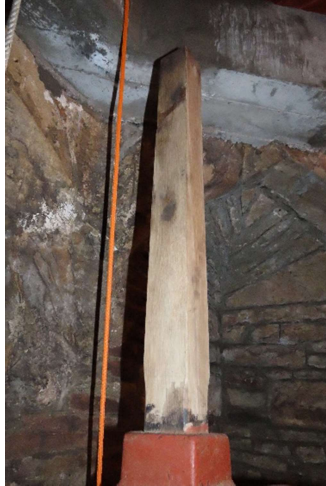
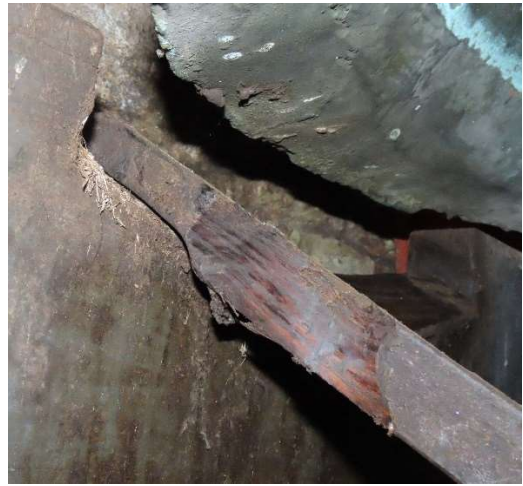
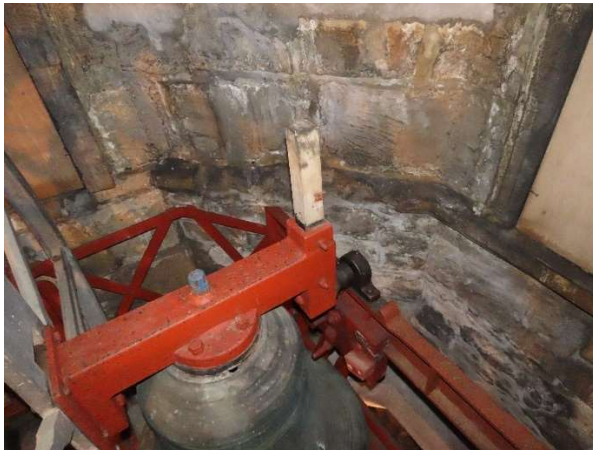
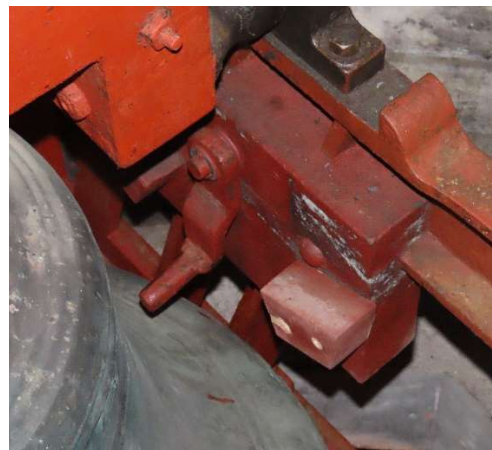
The bells on the lower tier are fitted with conventional stays and sliders. The bells on the upper tier are fitted with short stubby stays and a swinging metal stop arrangement in place of a slider. This is presumably due to limited headroom caused by the proximity of the spire.

The stays and sliders throughout the peal were in generally in satisfactory condition with no signs of significant damage apart from the 5<sup>th</sup> bell (see later). However, the slider runners and the ends of the sliders are showing some wear that will need some attention in the next few years.

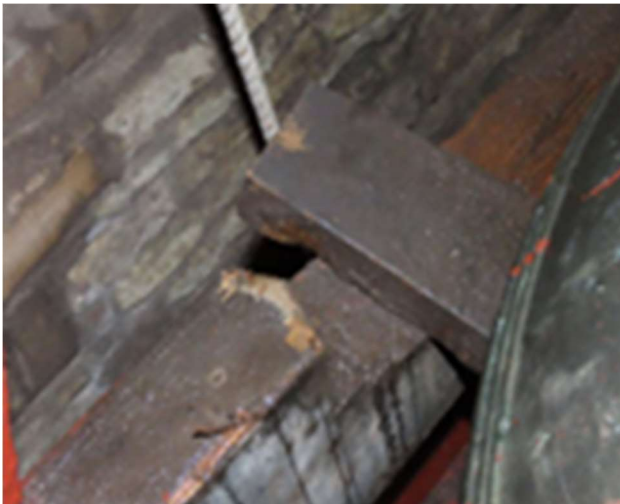
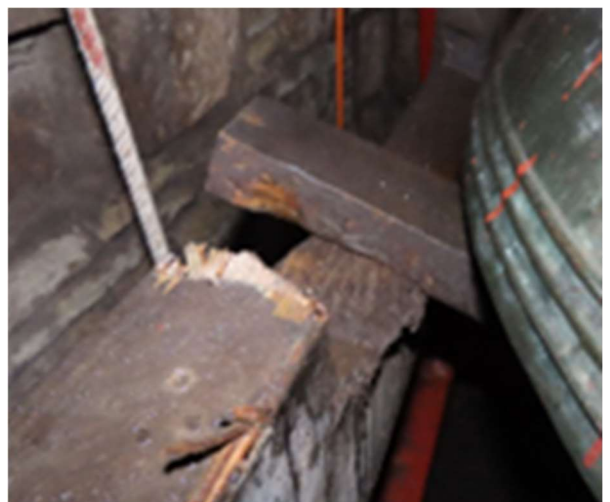
There are reports of occasional problems with the 5<sup>th</sup> slider where it occasionally jumps out of position particularly with rough handling. The hand stroke end stop of the 5<sup>th</sup> slider runner does show some damage which might be the cause of this problem. Replacement or repair of this runner should correct the problem. There is also significant wear at the slider rubbing surface and around the slider pin allowing it to rock slightly. Slider replacement would help resolve this issue.

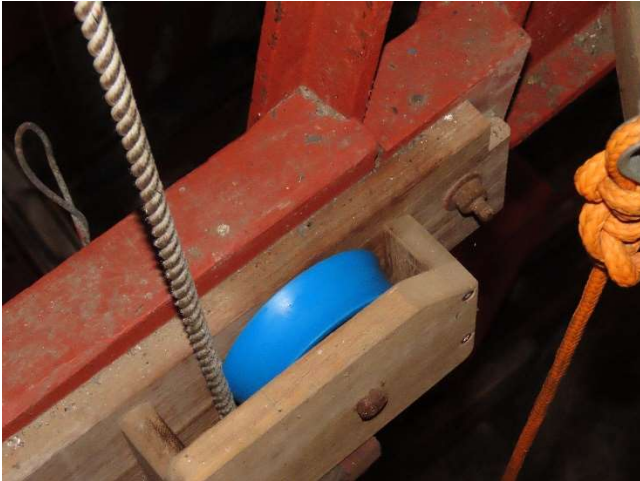
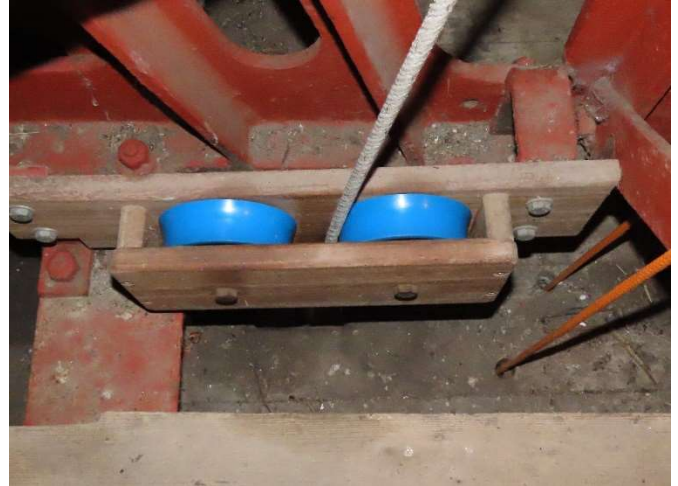
The ground pulleys were generally in satisfactory condition and rotated freely. All were fitted with plastic pulleys replaced possibly in the 2007 refurbishment.

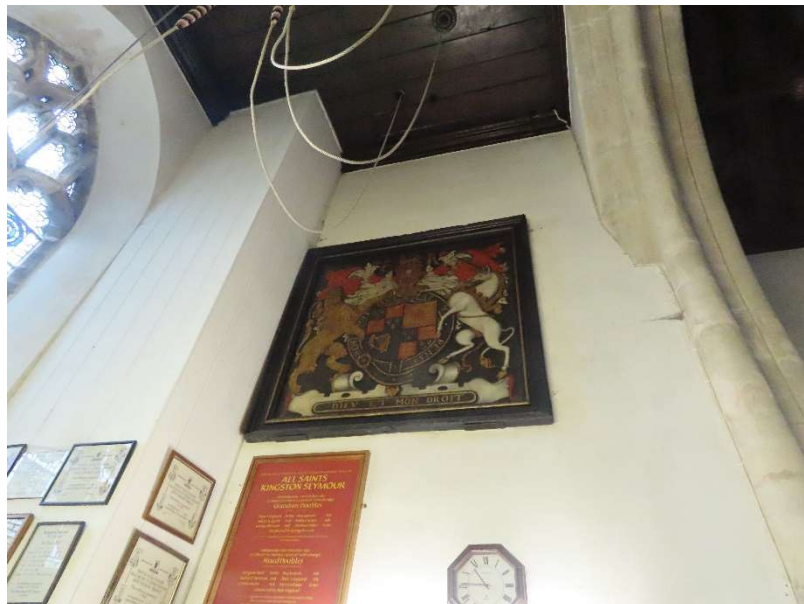
The bells are in regular use by the local band and go reasonably well. The long rope draught does make the handling of the bells challenging for learning and less experienced ringers, particularly the treble and 2<sup>nd</sup> bells of the peal.

There is a proposal to install rope guides which would significantly improve the situation. There is a large wall mounted coat of arms which is quite historic and would limit the distance the rope guides can be installed below the ceiling (approx. 6ft below). However, the height of the sally of the tenor rope when set at back stroke suggests the rope guides can be installed just above the coat of arms without changing its location. Ideally, the sally should not go all of the way through the guide. It is also noted that the treble and 2<sup>nd</sup> bells are quite significantly drawn in the intermediate chamber and the installation of rope guides would improve the fall of the ropes. The installation of the rope guides is therefore fully supported.

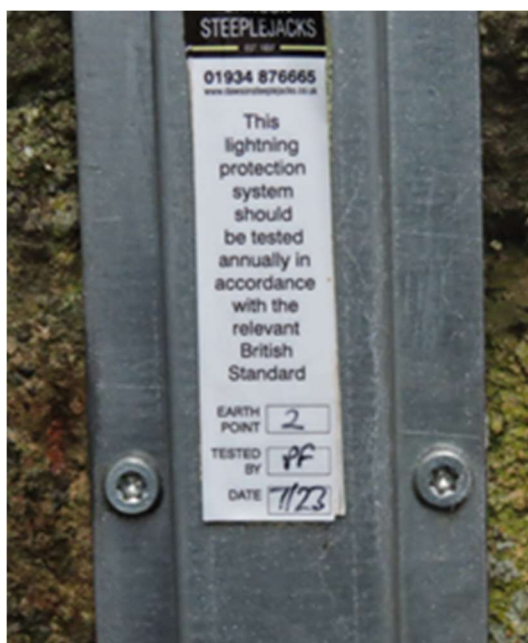
A lightning conductor is fitted to the tower and its regular inspection was in date. There was no evidence of an earthing strap fitted to the bell frame. This should perhaps be checked with the contractor who deals with the lightning conductor and a suitable strap installed if not already fitted.
