# SECTION I - SCHEDULE OF WORK

- 1.01 The works described in this schedule form the main contract for the repairs to the cemetery Chapels at Keynsham. This schedule is written as a description of the method and sequence of repair. This schedule is based on the site survey carried out by use of a cherry picker. Certain elements have been assumed as a full opening up was not possible. Additional provisional items of repair are included at the end of this schedule as provisional sums to be directed or omitted during the course of the contract.

KEYNSHAM
CEMETRY CHAPEL

# Structural Report

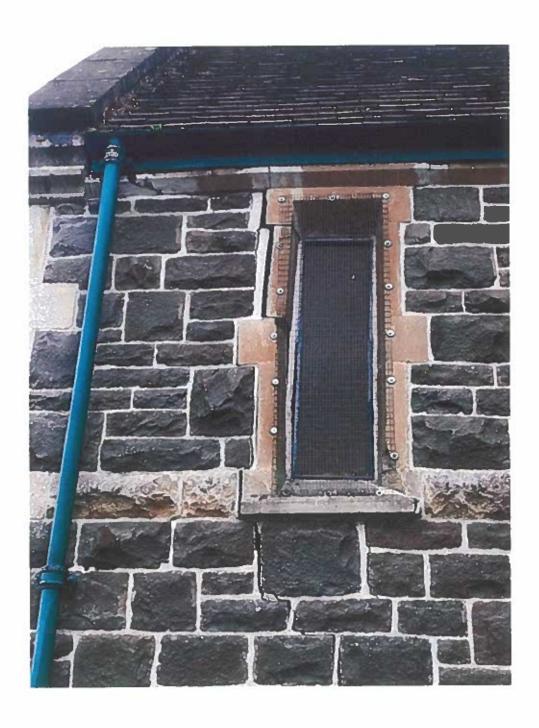
Photo of East Elevation cracking November 2022

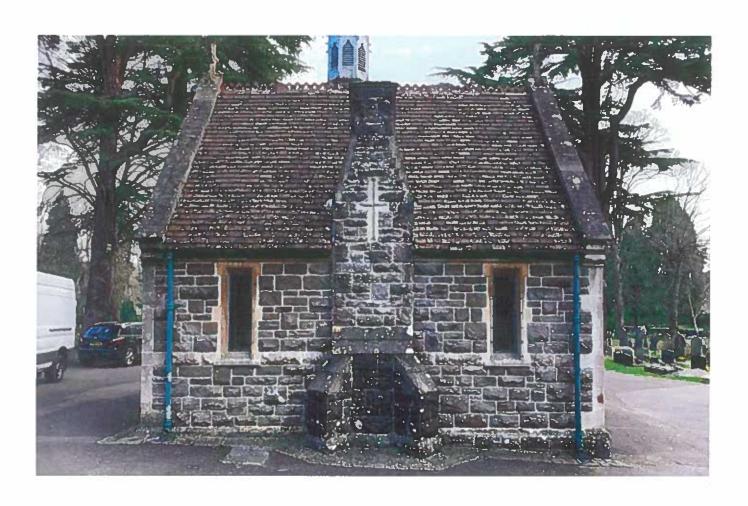
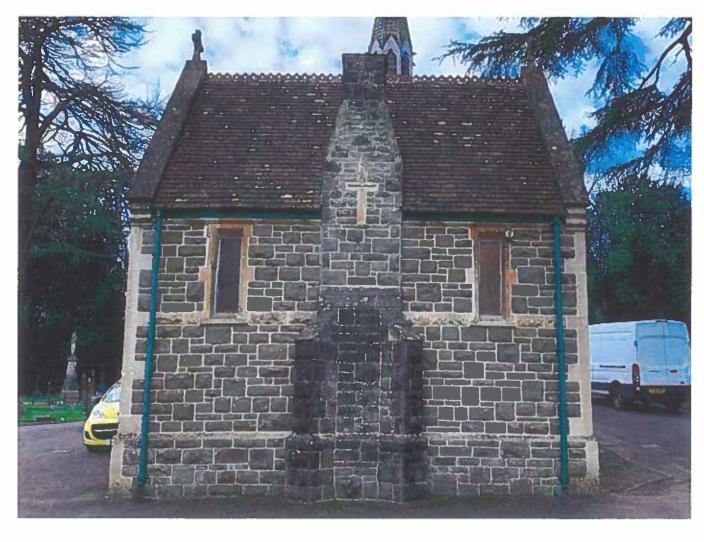
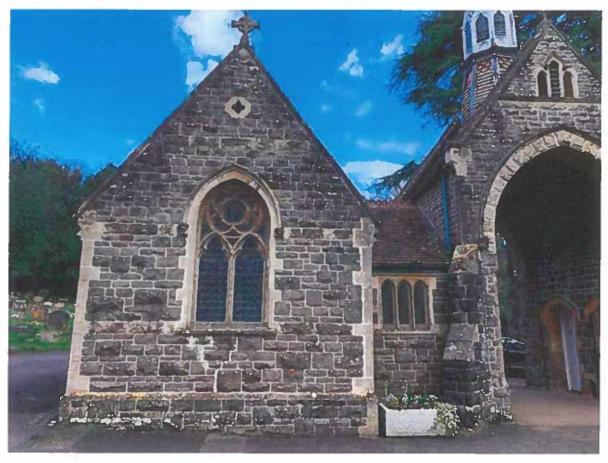
Above : The South East elevation of the South West chapel Below : The South East elevation of the North East chapel

The structural issues relate to the north east chapel. Glass 'tell tales' to the south east corner of the North East Chapel indicate relatively recent movement of 9 to 10mm. This is an ongoing issue made clear by the sequence of repointing works to these structural cracks

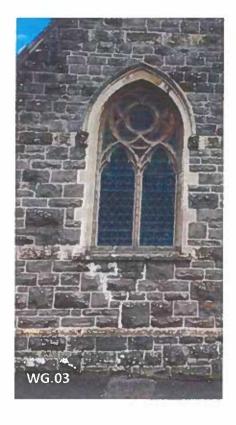
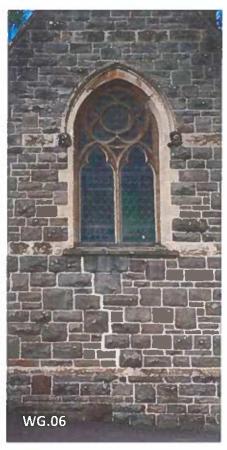
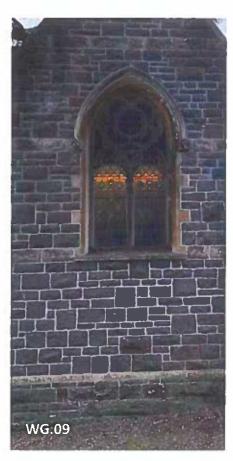
Above: Open joints beneath the principal chapel windows, not noticably beneath wg.06 where this movement is continued out on the return elevation to the left and below wg.07. This corner of the building is live and continuing to move.

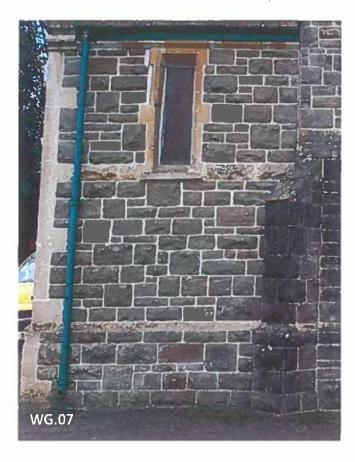
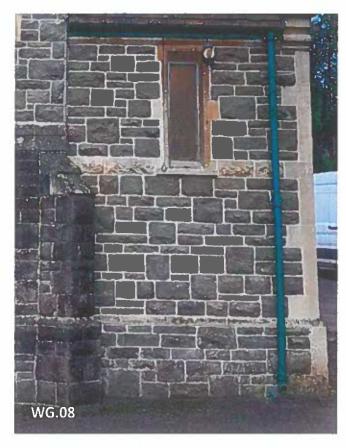
Below: The East elevation of the North East chapelwith movement around each window but more noticably to wg.07

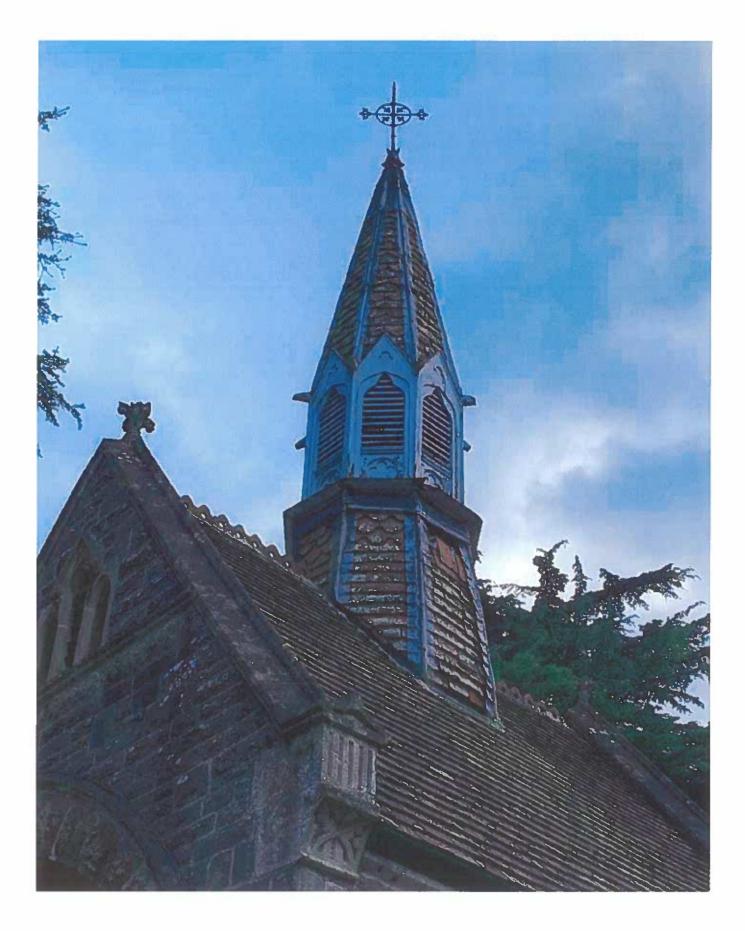
Above: The central timber lead and tile tower and spire showing the slipped tiles and leadwork.

- 8.02 Carefully strip the lower base section of the spire roof of all tiles [ carefully setting aside for reuse]. Strip off all battens and felt, etc, back to the existing rafters and steel frame. Allow for replacing all damaged or decayed rafters. Denail all remaining timbers and inspect junctions with the external walls.
- 8.03 Lay salvaged clay tiles to all roof slopes disturbed on new 25mm marine plywood boarding to replace the decayed softwood roof boards
- 8.04 See section 10.00: Lead work for valley and hip lead work, collar, abutment and apron flashings etc.

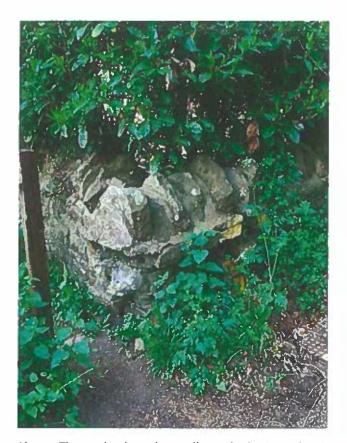
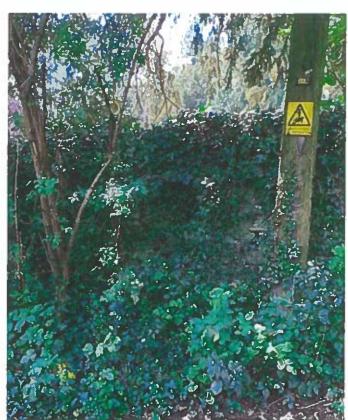
Above: The norther boundary wall onto Durley Lane showing areas of loose and falling stonework Below left: The entrance gate pier and low stone wall showing the open joint between the two Below right: The low wall to the side of the drive showing signs of partial collapse.
