ST MARY'S, WHORLTON

ARCHAEOLOGICAL MONITORING DURING DRAINAGE WORKS

Robin J Taylor BA PhD MBA FSA

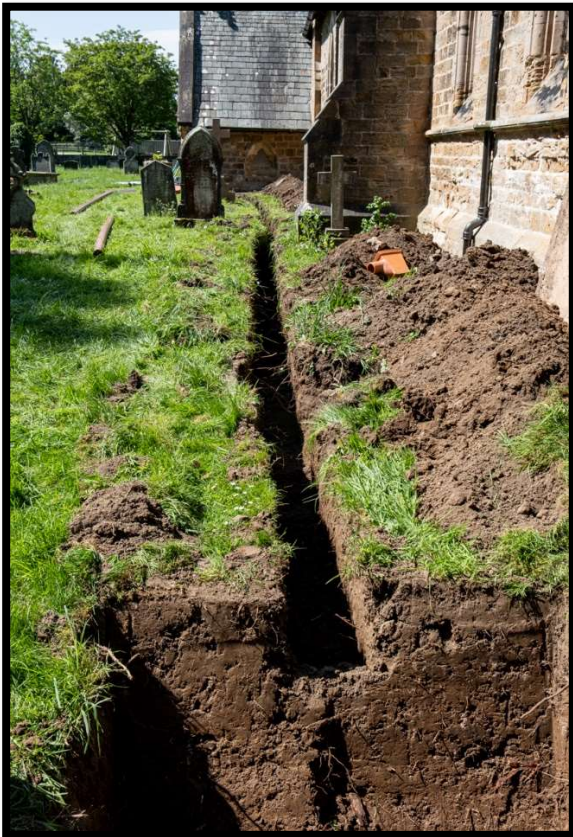
Fig 3 Drainage trench on South side from soakaway (Whorlton May 25-1)

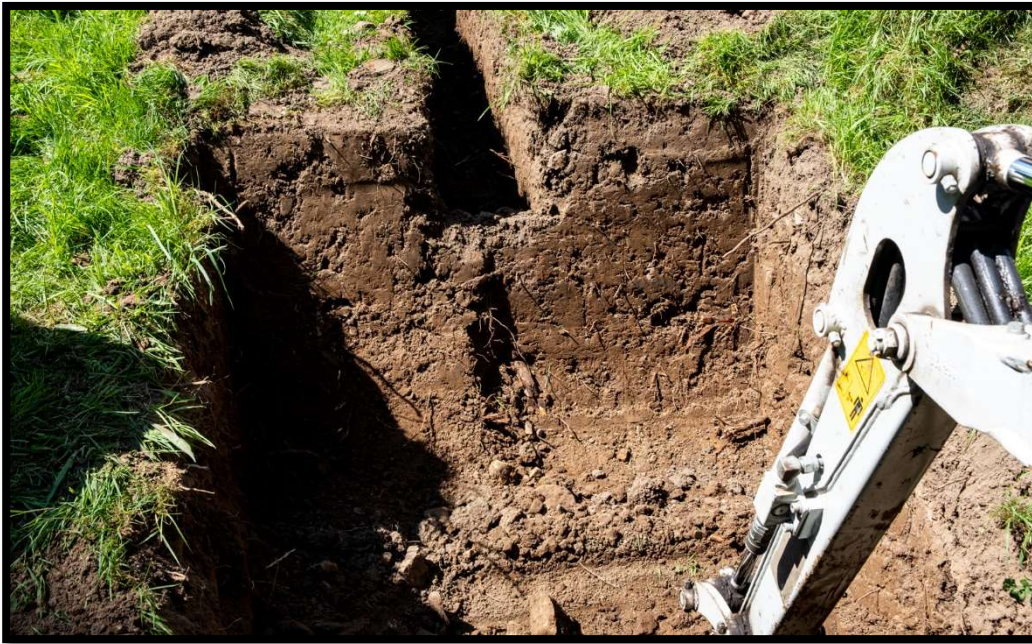
Fig 4 S side soakaway, and depth of soil and rubble infill of disturbed ground (Whorlton May 25-2)

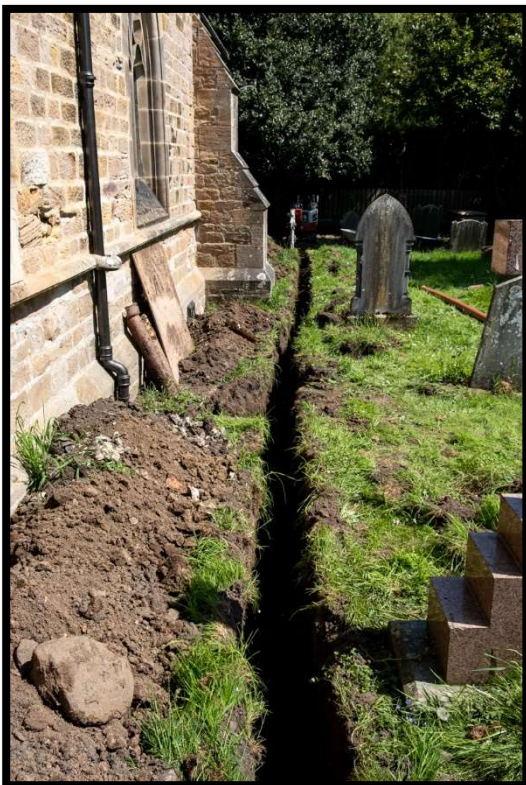
Fig 5 Drain cut S side, avoiding grave slabs (Whorlton May 25-3)

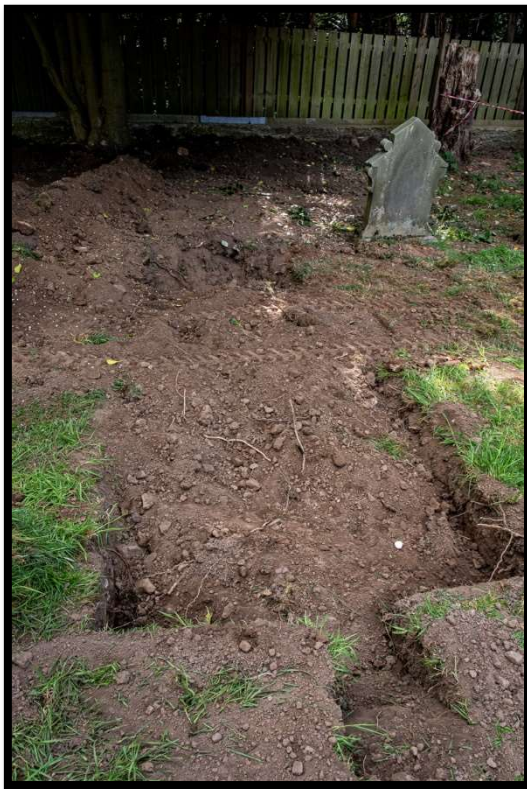
- 6.4 Getting the pipes in and down to the drainage cages was rapid and efficient. Soon the trenches to N and S were filled in and the cages filled over (Fig 6). Work was done carefully, avoiding above ground monuments and closely following the apparent lines of the earlier clay pipework. It was puzzling that the earlier pipes did not seem to lead to clearly defined soakaways in themselves and seemingly just ended in the soil. As the soil was deep and full of disturbed rubble, perhaps this was deemed enough at the time to provide drainage.

Fig 6 S side drain and soakaway cuts backfilled (Whorlton May 25-18)

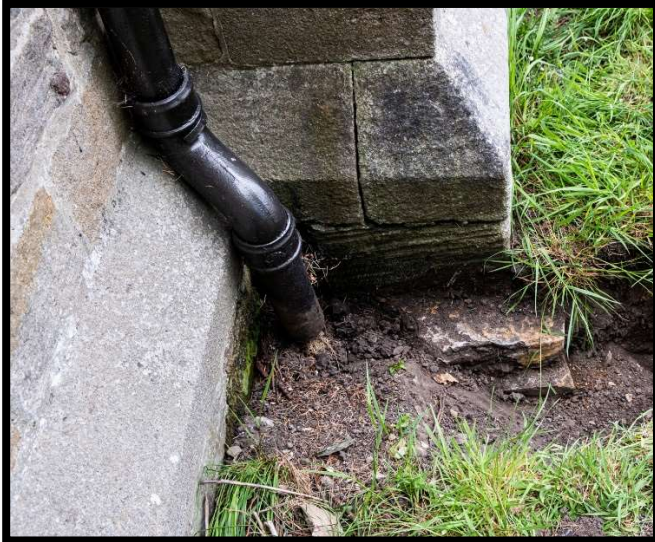
6.5 The porch seemingly did not have anywhere to take the downpipe on its West side, ending just above the ground. The plan was to cut across the tarmac path and lead a pipe to a soakaway on the other side of the path. Digging down near the porch wall showed more of a foundation, than was seen elsewhere round the main church walls. There were also some traces of clay piping which may have lead around the porch to meet up with the drain run on the other side. The trench away from the porch, under the path level and into a blank area of ground between graves, produced little other than dry, sandy soil and rubble. Again, the depth of soil and rubble went down at least 1m with no perceptible layers or feature cuts (Figs 7 and 8).

Fig 7 W side of porch drain cut, showing foundations (Whorlton May 25-21)

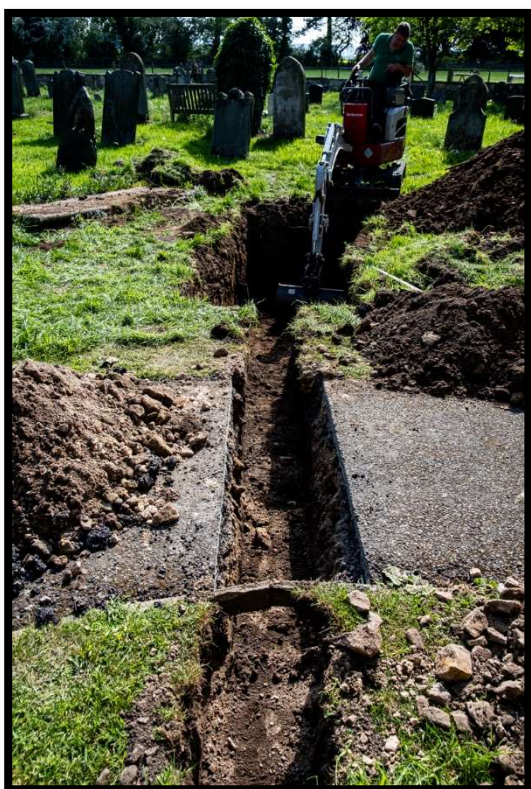
Fig 8 Drain cut from porch, through path, to soakaway (Whorlton May 25-9)

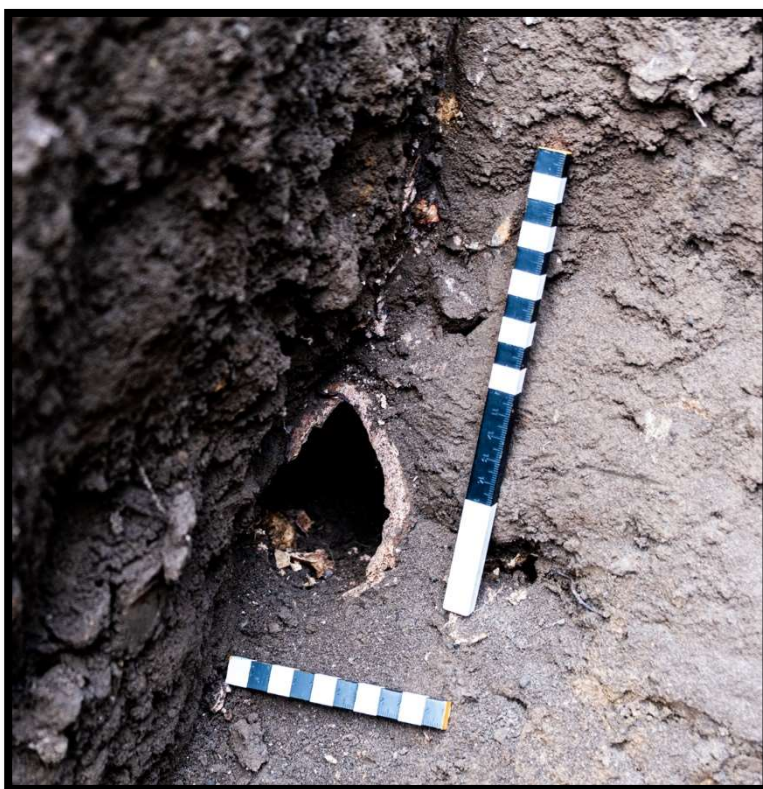
- 6.6 As the machine cut a rectangle for the soakaway cages in this area, fragments of bone appeared towards the base of the trench. The first pieces to come out strongly suggested skull fragments, and there was a small void in the corner of the trench, where a skull had given way. The angle was odd and the skull seemed very narrow, but digging into the side and the creation of any further disturbance were avoided. In the loose soil from the end of the trench, there was a collection of small fragments, some skull, some small vertebrae and the rounded tops of leg joints (where they meet the pelvis). All were very fragmentary and apparently broken in the past. The pieces seemed to be from several individuals. This was all disarticulated material, not laid down in any direction or in any feature that could be seen (Figs 9—11).

Fig 9 Skull fragment in corner of porch soakaway (cm scale; Whorlton May 25-23)

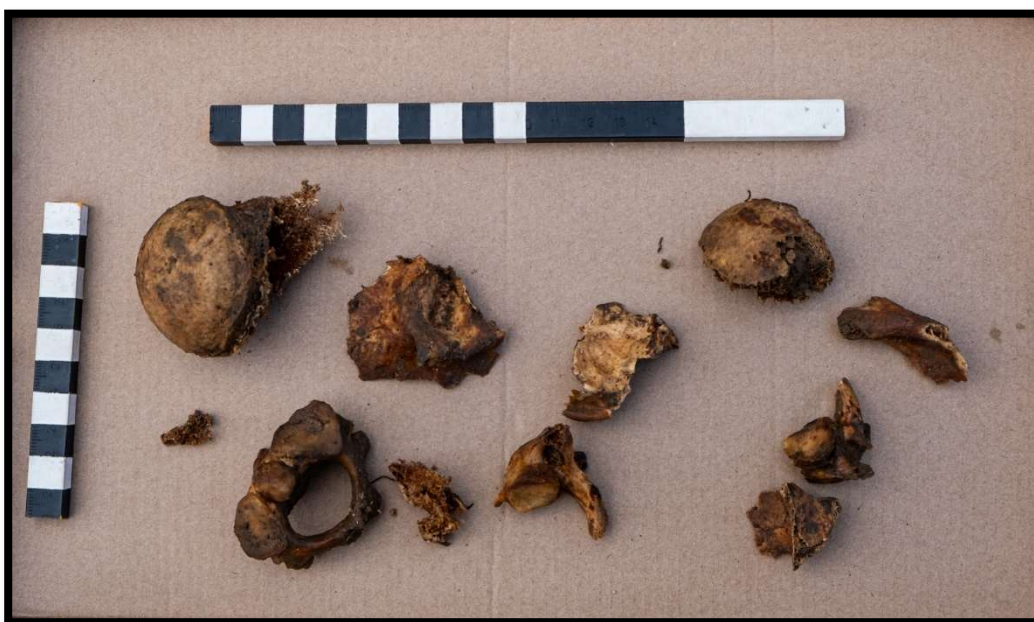
Fig 10 Bone fragments from porch soakaway, showing leg joint articulations and vertebrae (Whorlton May 25-10)

- 6.7 The general principle was to avoid further disturbance if possible, and the loose remains to be reinterred near to where they were found. The pieces were so fragmentary that detailed study would be unlikely to show much more about them, certainly little about any individuals. It was hard to tell whether the fragments were all human, as they were so broken up (and not by recent breakage either). But the skull fragments and the tops of leg bones certainly looked human and from someone of adult age. The fragmentary vertebrae, if human, could only be from a child due to their small size.

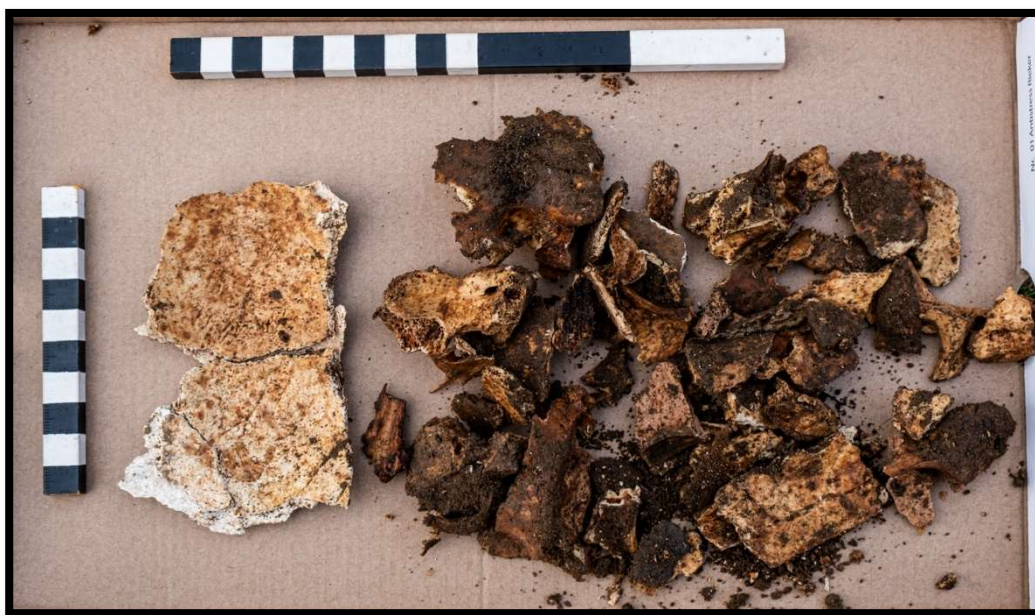
Fig 11 Skull and other disarticulated fragments from porch soakaway (Whorlton May 25-11)

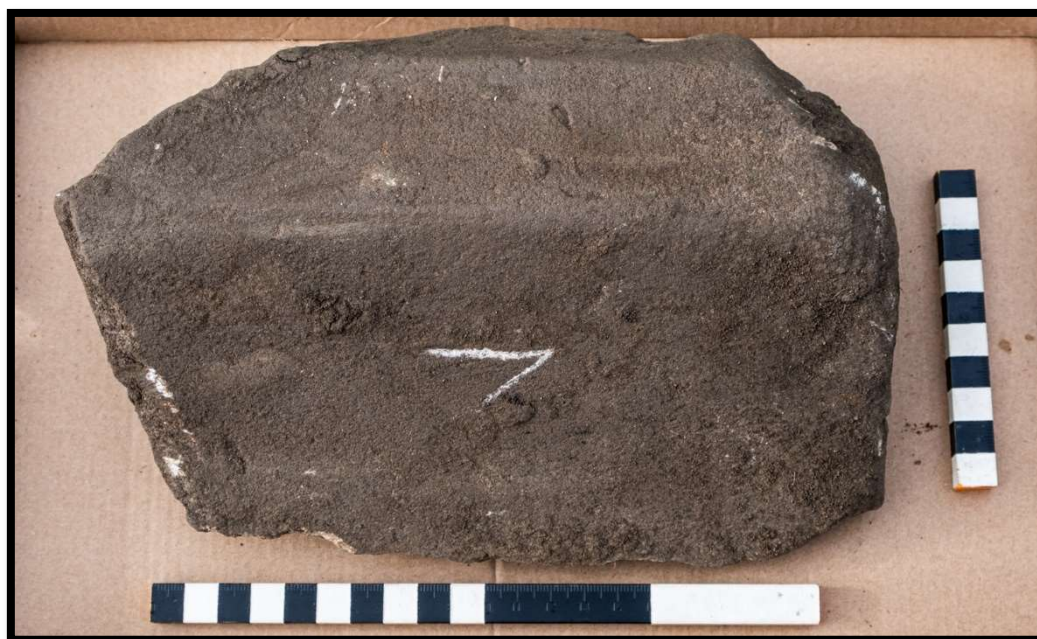
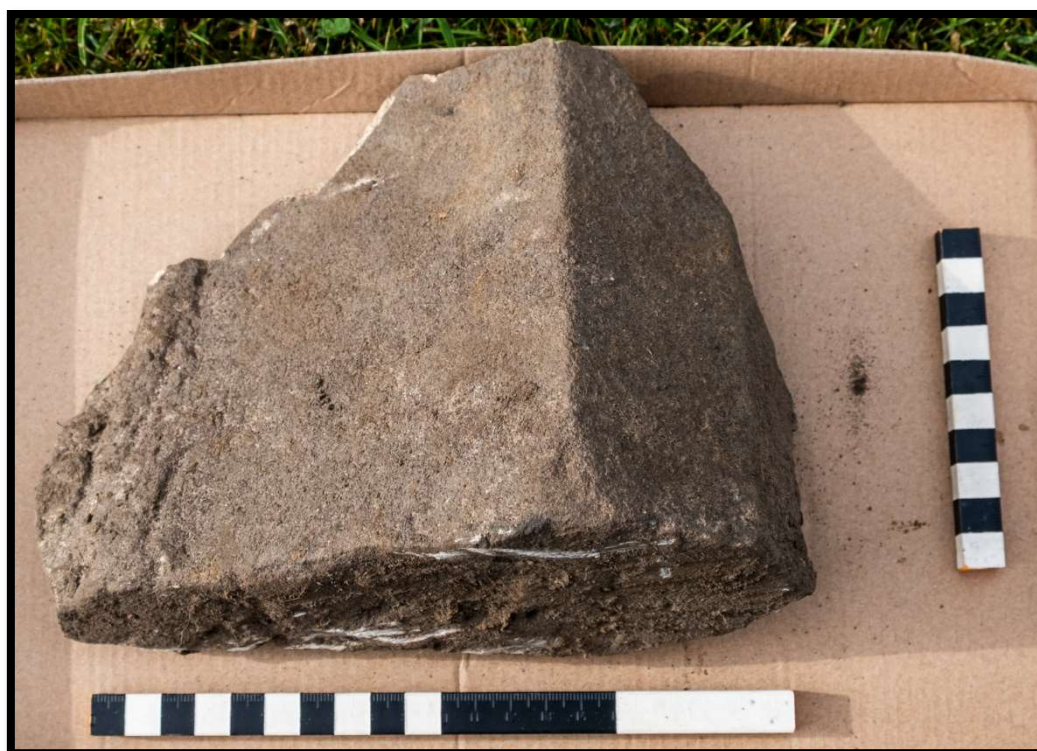
- 6.9 The following day, record photographs were taken of the bone fragments and chamfered pieces of stone (Figs 12 and 13), plus general shots of the filled-in trenches.

Fig 12 and 13 Chamfered stones (Whorlton May 25-12)

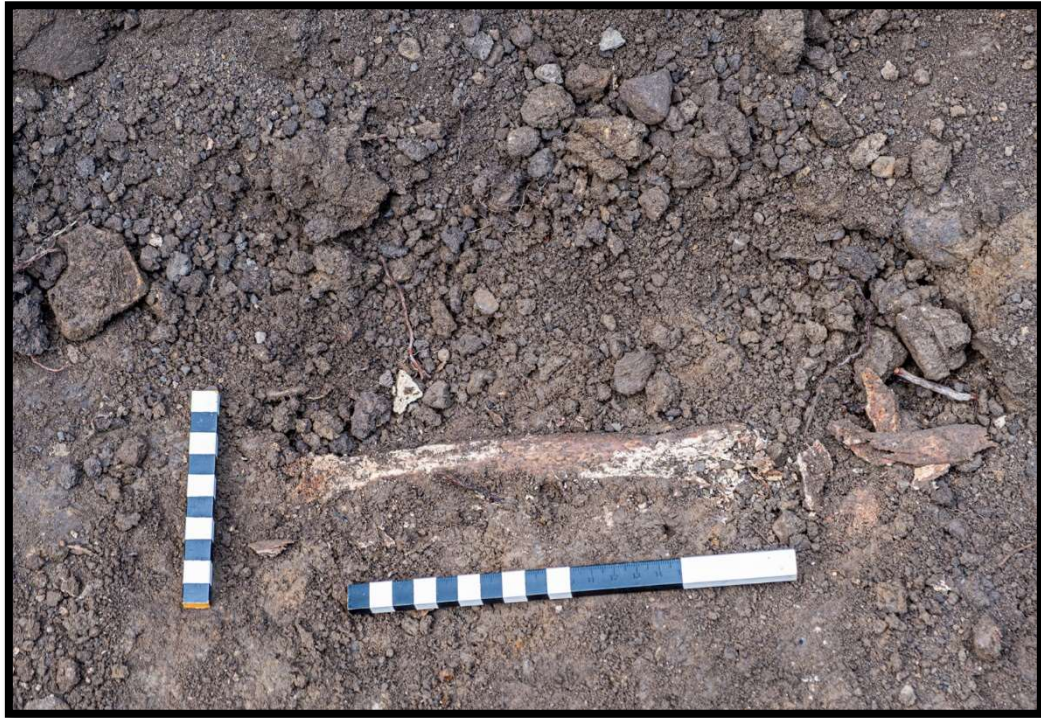
1m 10cm deep. The skull was about 10cm across the oval-shaped opening. The possible leg bone in the base of the trench was also exposed, again in a fragmentary state. This was photographed in situ; it was about 20cm long and 2.5cm across. This would possibly be from a young adult. The bone appeared to be pressed into the clay subsoil at the base of the trench. Everything above this was loose soil and bits of rubble, and very disturbed. There was no apparent grave cut or other features; this bone was left in place, undisturbed (Fig 14).

Fig 14 Leg bone and fragments, base of porch soakaway (Whorlton May 25-25)

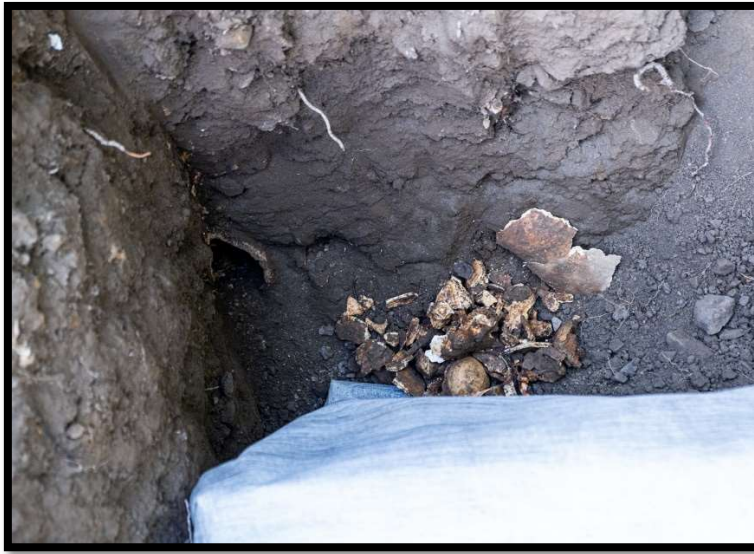
Fig 15 Skull and disarticulated fragments reburied alongside the drainage cage, porch soakaway (Whorlton May 25-27)

- 6.11 After discussion with the Vicar, it was agreed that the disarticulated remains should go back in the hole with the drainage works, as per the rules and specification. This was duly done and subsequently backfilled on top; photographs were taken (Fig 15).

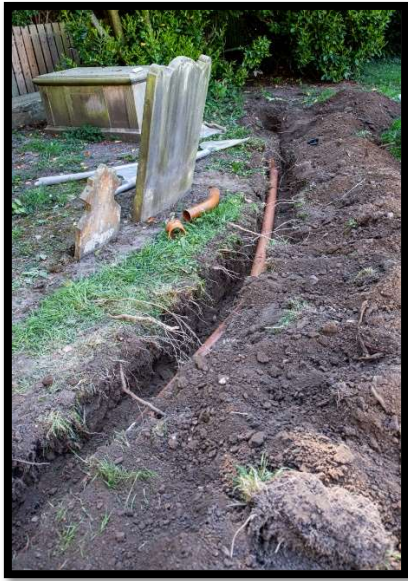
Fig 16 S side overflow pipe in place (Whorlton May 25-35)

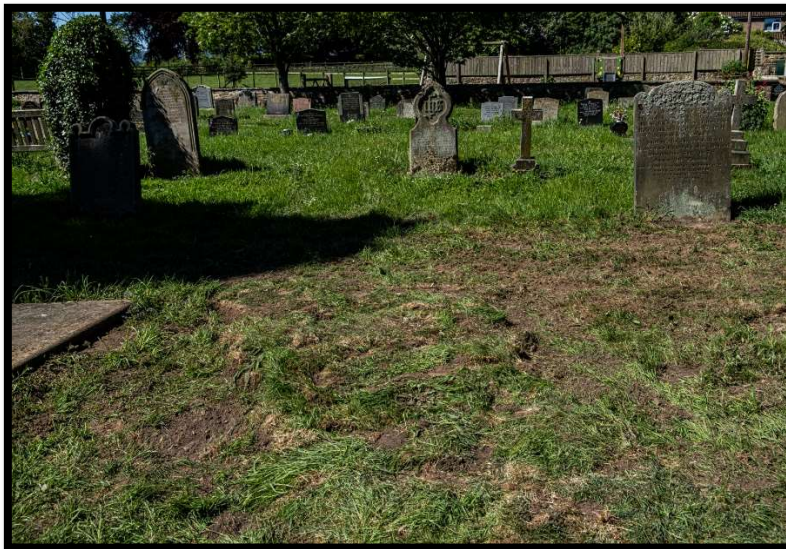
Fig 17 Porch soakaway area backfilled and tidied (Whorlton May 25-47)
