VALENTINE WALSH ACR FIIC FSA

REPORT ON THE CONSERVATION TREATMENT OF  
CULPEPPER TOMB EFFIGIES

ST MARY'S GOUDHURST SEPTEMBER 2025

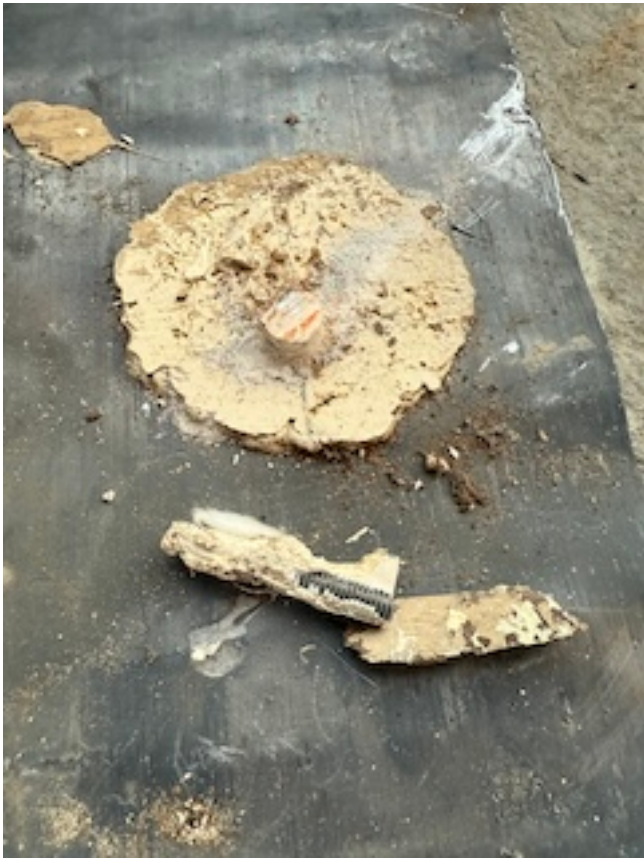
This image shows the lead and plaster which were between the stone base and the figures holding them in place. Note that the screw thread is modern.

The figures were moved from their stone plinth in order to work on them. It was found that they had been secured with two fixings each, comprising a threaded stainless steel bar set in plaster of Paris both in the stone and in the bottom of the effigies, with a lead pad separating the effigies from direct contact with the stone. They had to be cut in order to lift the effigies and the remainder of the threaded fixings were then removed from the bases of the figures.

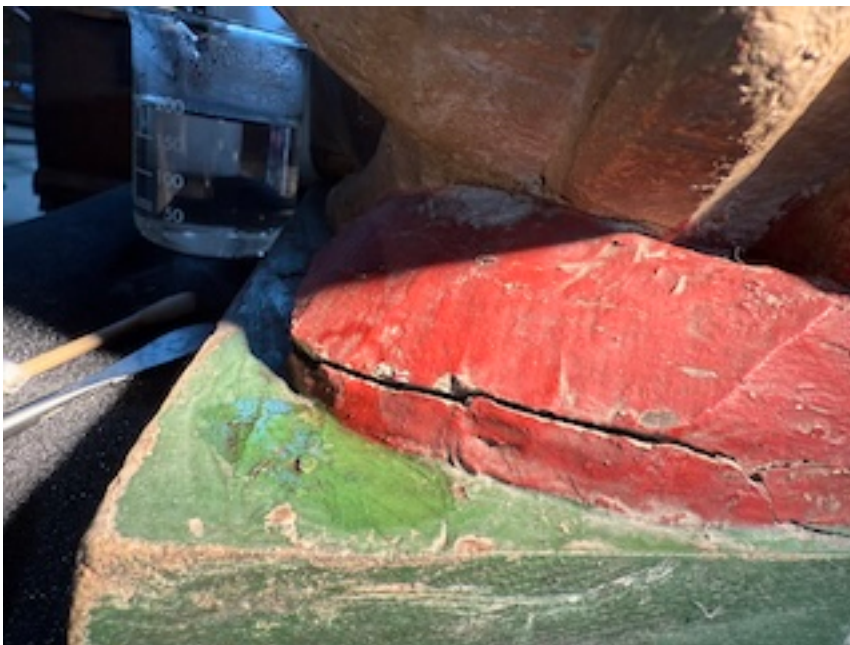
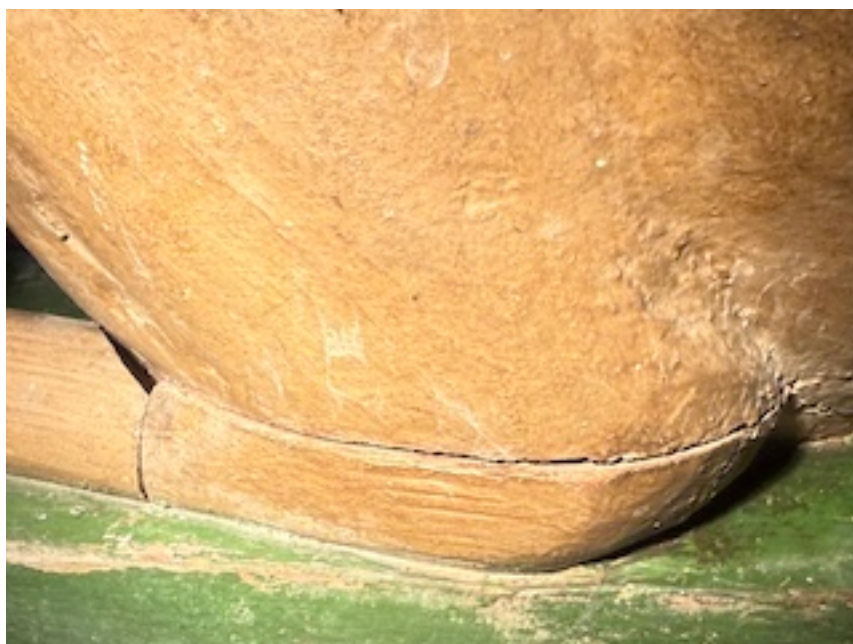
This and the following images show splits in the wood caused by drying of the figures as well as joins where pieces were added.

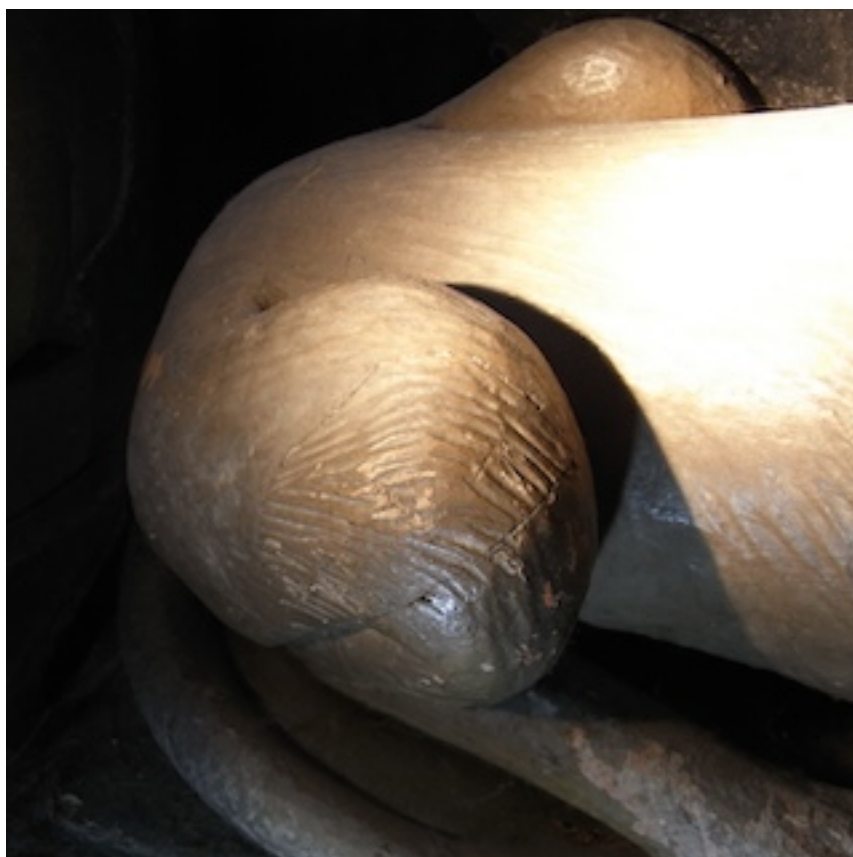
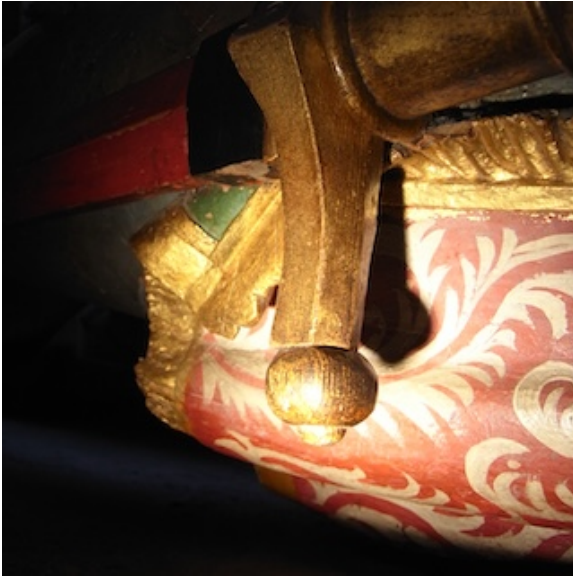
These two images illustrate areas where new wood has been inserted.

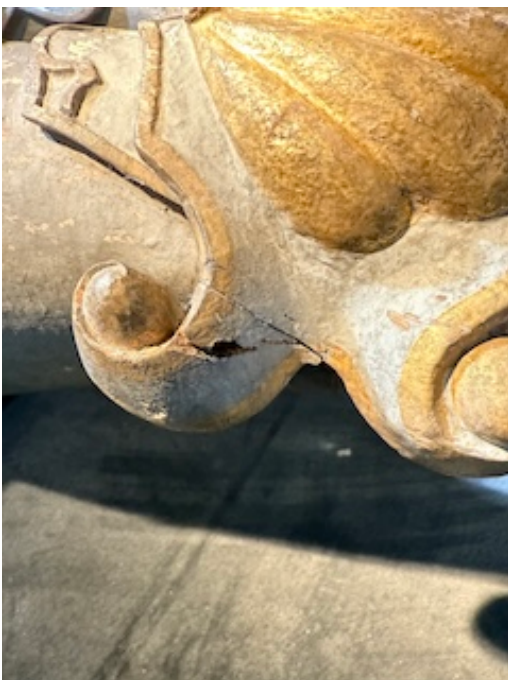
This foot was clearly not part of the same body of carving but appears to be original. It had come adrift from the sculpture and was re-attached.

Two of the feet of the dog on the effigy of Lady Constance were loose. These were removed, the old glue also removed and then re-adhered in place with polyvinyl alcohol glue (Evostick). A curl in the armour at the right knee of Sir Alexander was also consolidated with PVA.

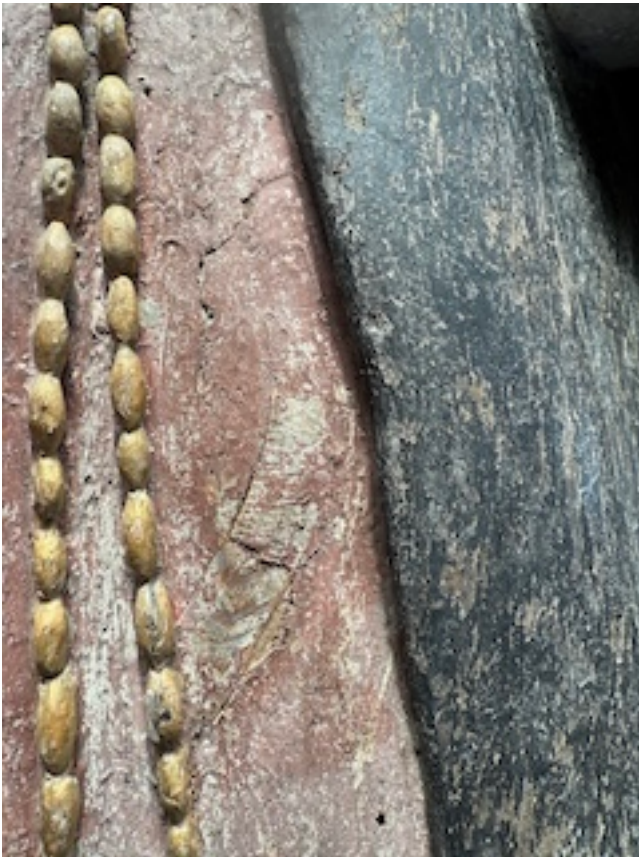
This is an example of a drying split in the wood as well as a piece which was added. The piece was loose and was re-adhered.

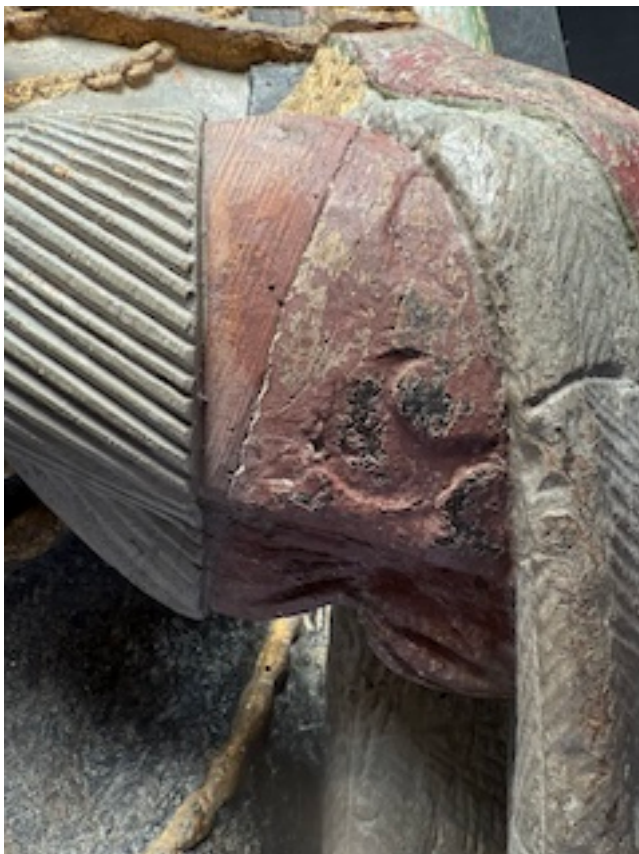
Another insert of wood is shown here in Constance Culpepper's gown.

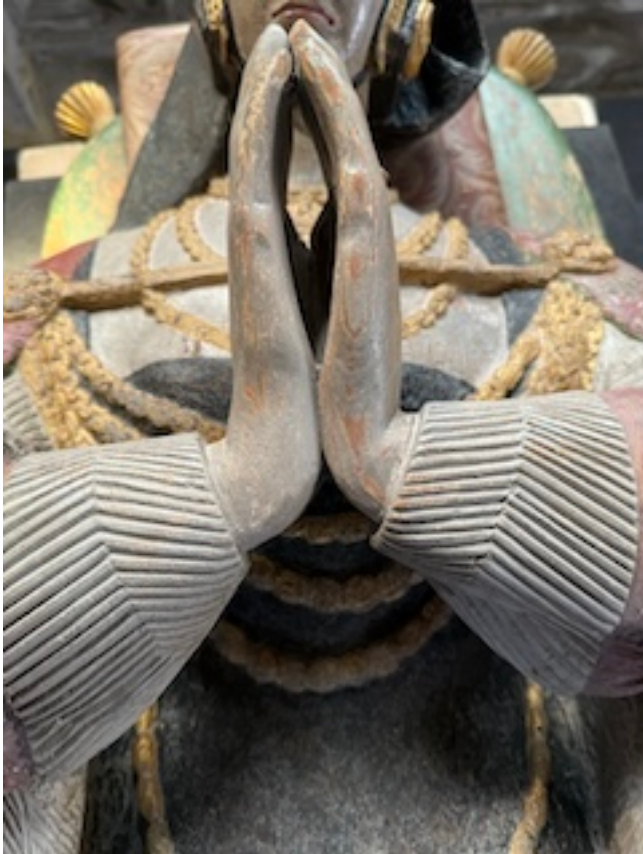
The cuffs of the female figure, when compared to the edge of her cloak, show a notable difference. The cuffs are more sharply carved and there is clearly a join in the left arm of the figure. It appears that this is a pine insert and given that the cuff of the other hand is similarly carved, it is suspected that both arms and the hands are not original. Furthermore, the gold of her jewellery and the gold on her gabled hood are markedly different. There is some suspicion that her head is also a later carving. There is a further wood insert in the inner skirt of her dress and in several parts of her dog however these may be part of the original sculpture.

The sleeve of her left hand illustrated here shows the join where a pine insert has been added. This is contiguous with the cuff and probably the hands as well. It is clear here that the carving of the cuff and the edge of her sleeve to the right are quite different and a cuff has very little preparation layer. The red of her sleeve to the right of the insert also has carved texture which has a preparation layer under the paint.

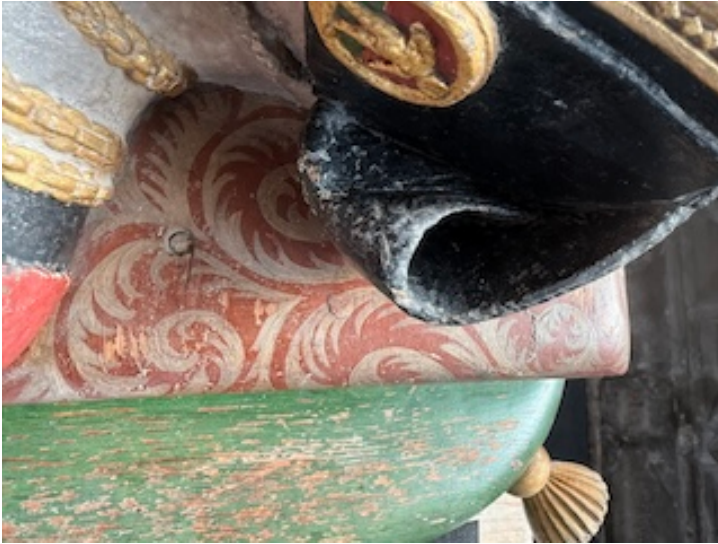
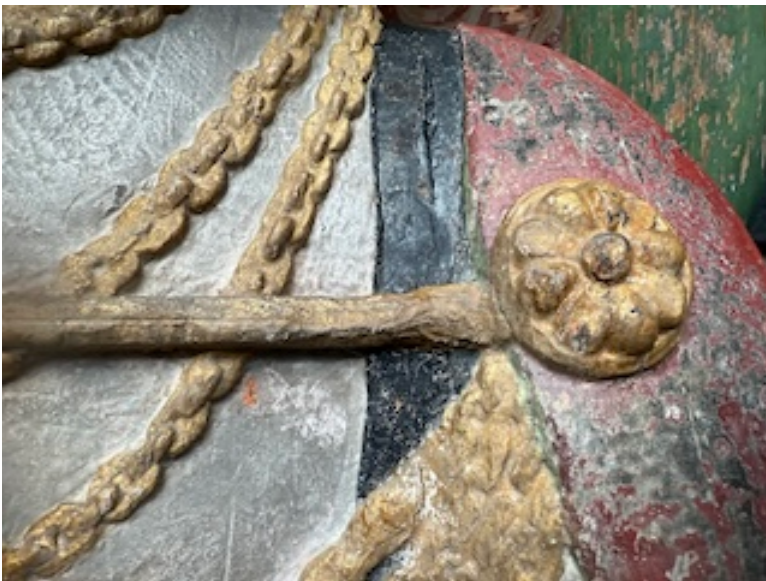
The carving style of the gold edging to her gable headdress and the lack of preparation layers is markedly different to the gold jewellery on her chest. Which has a softness similar to that of the cloak edging and which has a gesso layer. It is suspected that the two are not by the same hand. The carving of her hair and that of the tassles on the cushion beneath her head appear to be in the same style as the headdress and cuffs. Note also that, as with the hands, there is no preparation on her face.

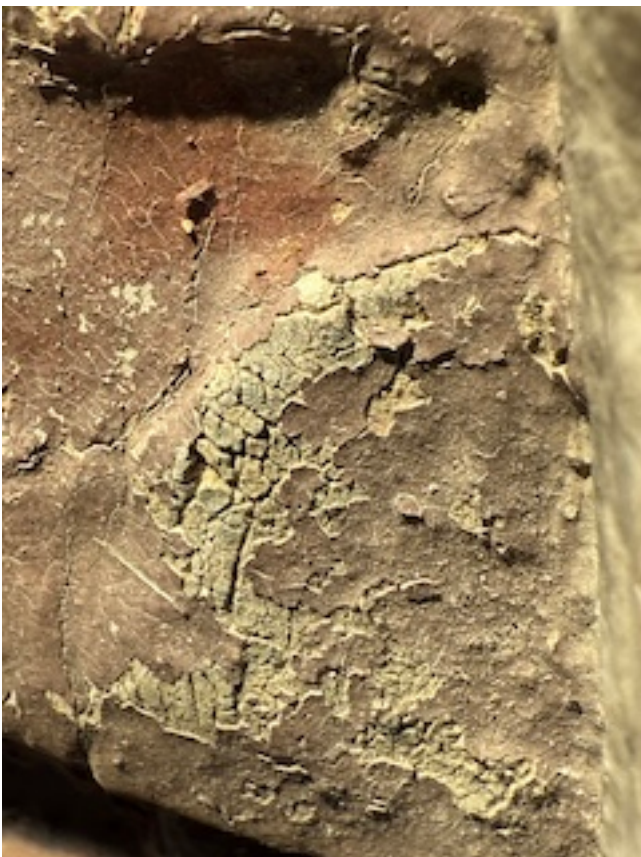
The difference in carving and the softness of this with gesso layers is clear here.

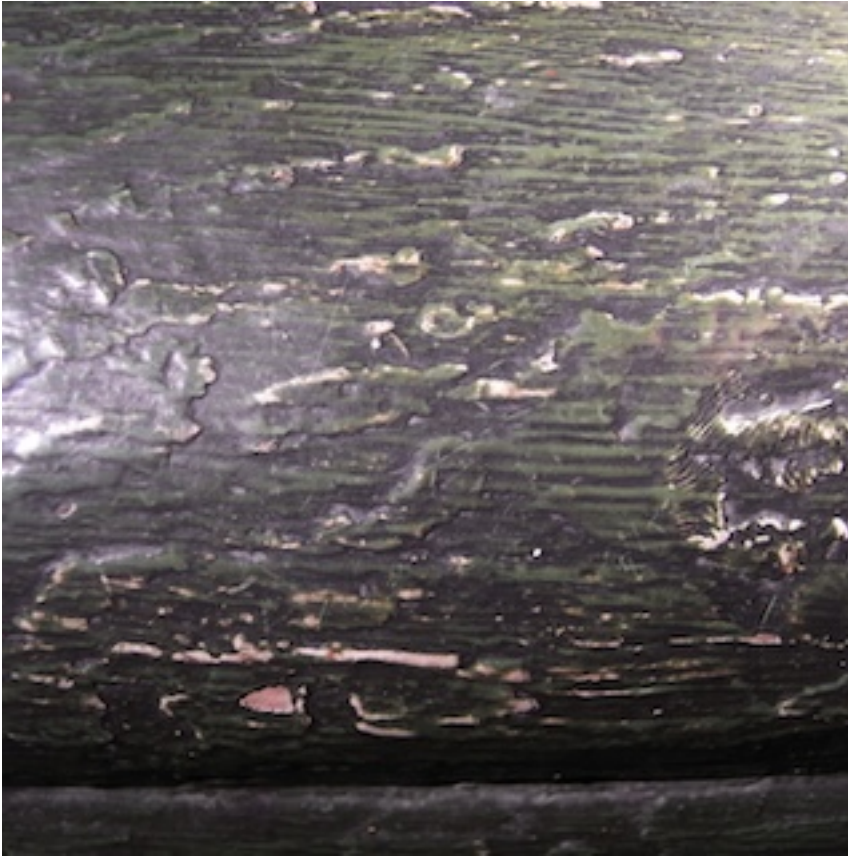
The gesso on the male figure was, in places, particularly dried out. Treatment with Isinglass was necessary to ensure its adhesion, as well as to treat the flaking paint which can be clearly seen here.

Consolidation was carried out using sturgeon glue (isinglass) with added fungicide. Where the paint was particularly dried out and the wood underneath was also very dry a small amount of BEVA was applied to consolidate the paint. This was mostly in the interior of Sir Alexander's helmet.

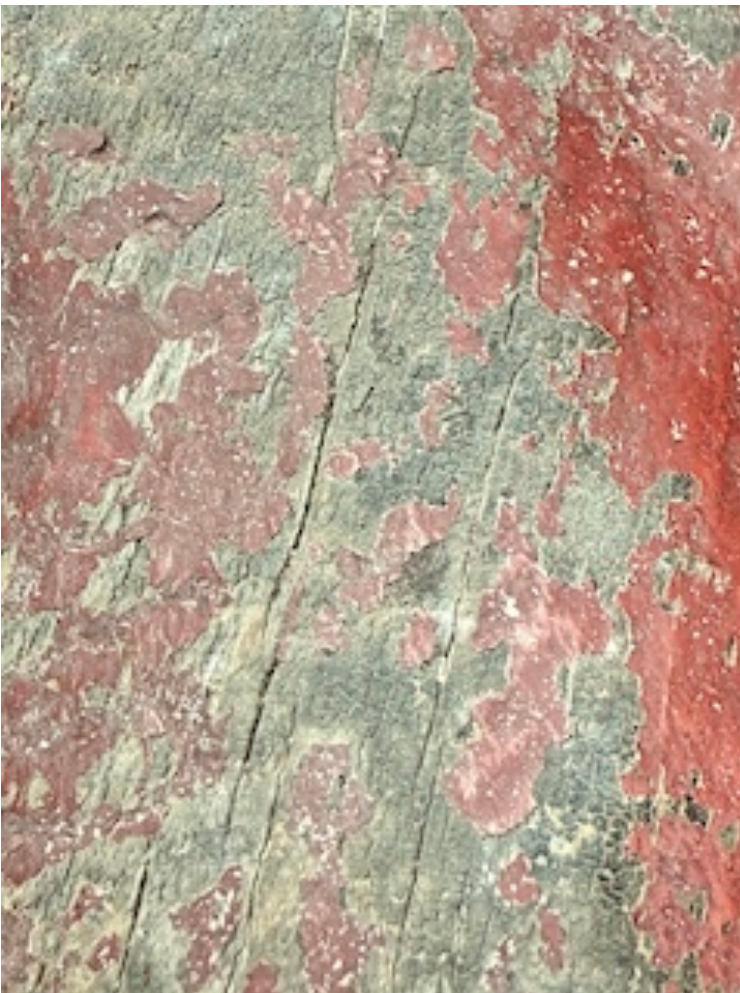
This image of green paint on the male figure shows clearly that it has been overpainted at some stage. Also the blackish stripes, which lie in the hollows of the paint, are a significant layer of dirt. This was reduced in the cleaning.

Note here that the original paint appears to be remaining in islands and the over paint has covered this.

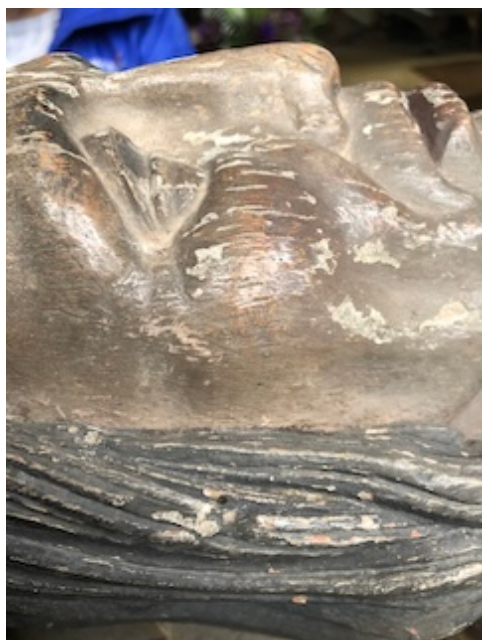
This is an area on the female figure where the paint islands remain and overpaint has not been applied as in the figure above. It also shows a lack of a ground layer

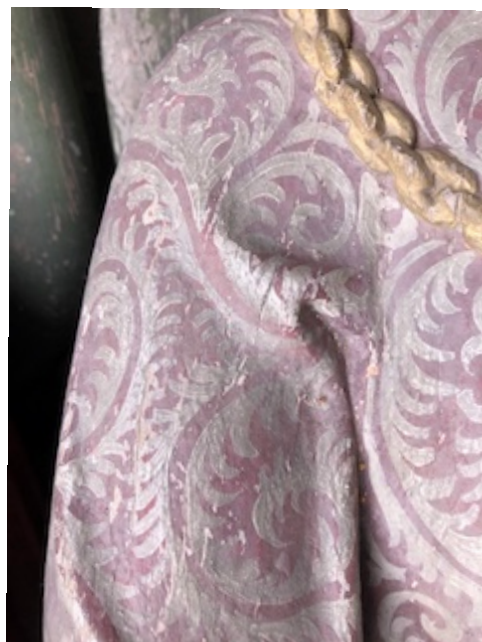
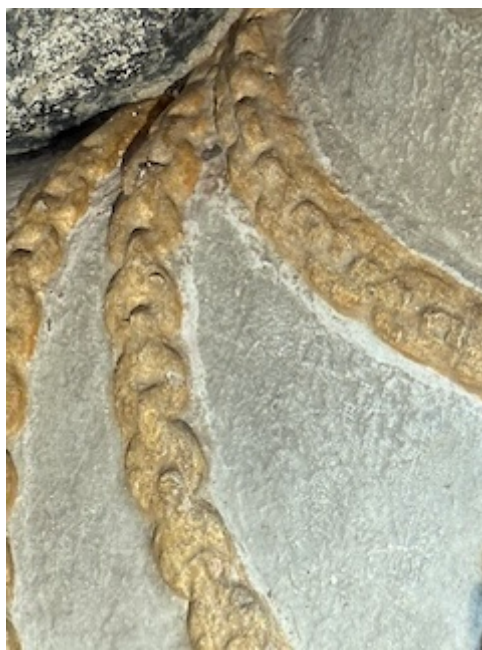
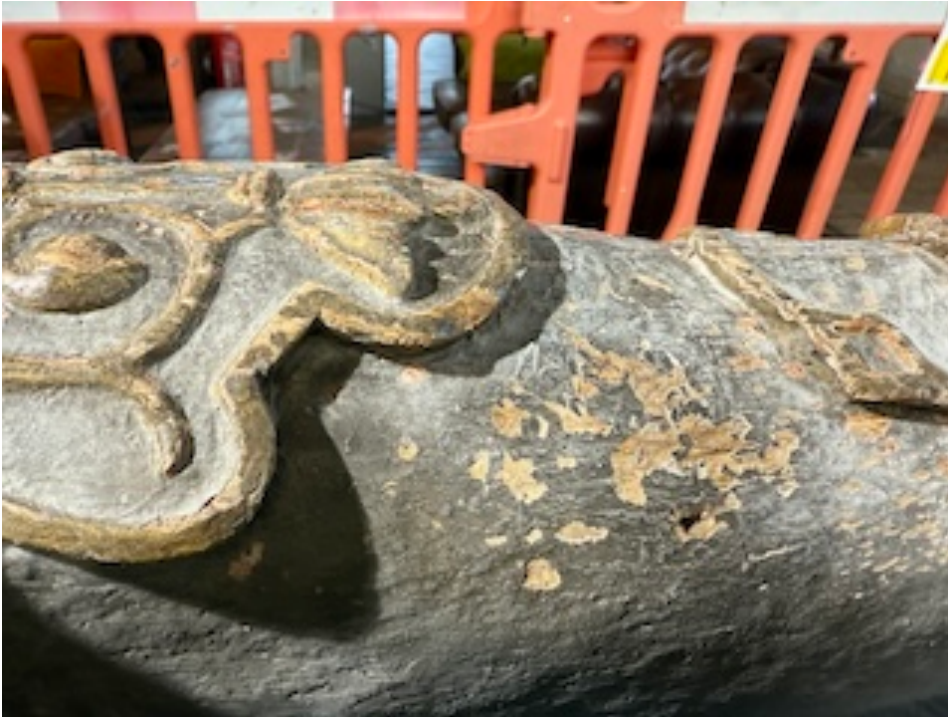
These three images show the extent of dirt that was on the surface of the sculptures. This has been reduced in the cleaning.

The figures were then superficially cleaned of dust and dirt. Further cleaning was then carried out with water with a slightly raised pH. It became clear that there is a thick layer of grey dirt overall but this was deemed not sensible to remove as it was not the intention of the work to 'restore' the figures.

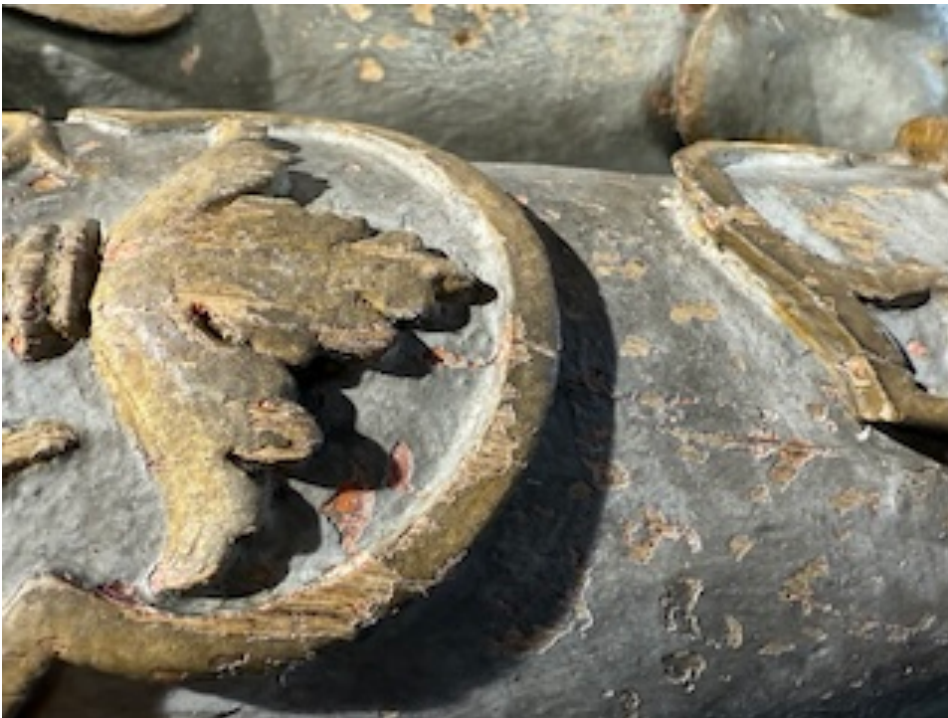
The above photo shows that, particularly after cleaning, paint losses were quite disturbing to the overall harmony of the sculptures. In order that this should not be visually distracting, a thin wash of watercolour was applied.

The most visually disturbing areas of loss were given a watercolour wash in order in order that they should not disturb the overall integrity of the figures.

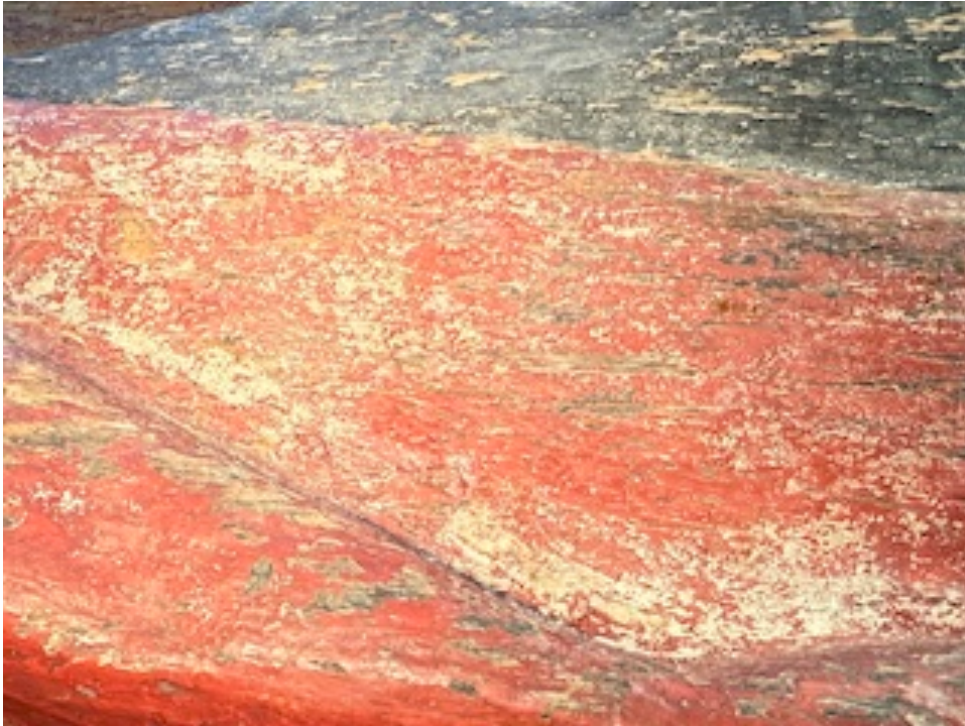
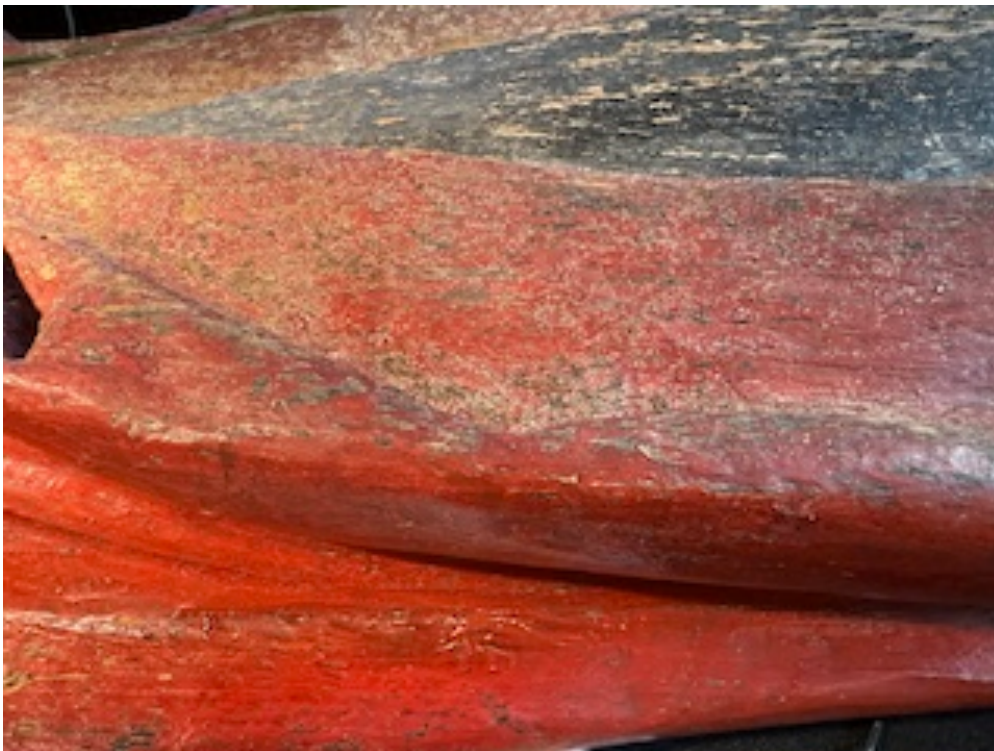
The image above shows, as with the previous two images, the disturbing nature of the areas of loss. This was also retouched with a thin wash of watercolour, as seen below .
