ST MARY'S, MOSELEY

Job Number: Drawing Number: Revision:
69601 SV 3.131 /

FINDINGS FROM TRIAL PITS FOR
ARCHAEOLOGICAL INVESTIGATIONS

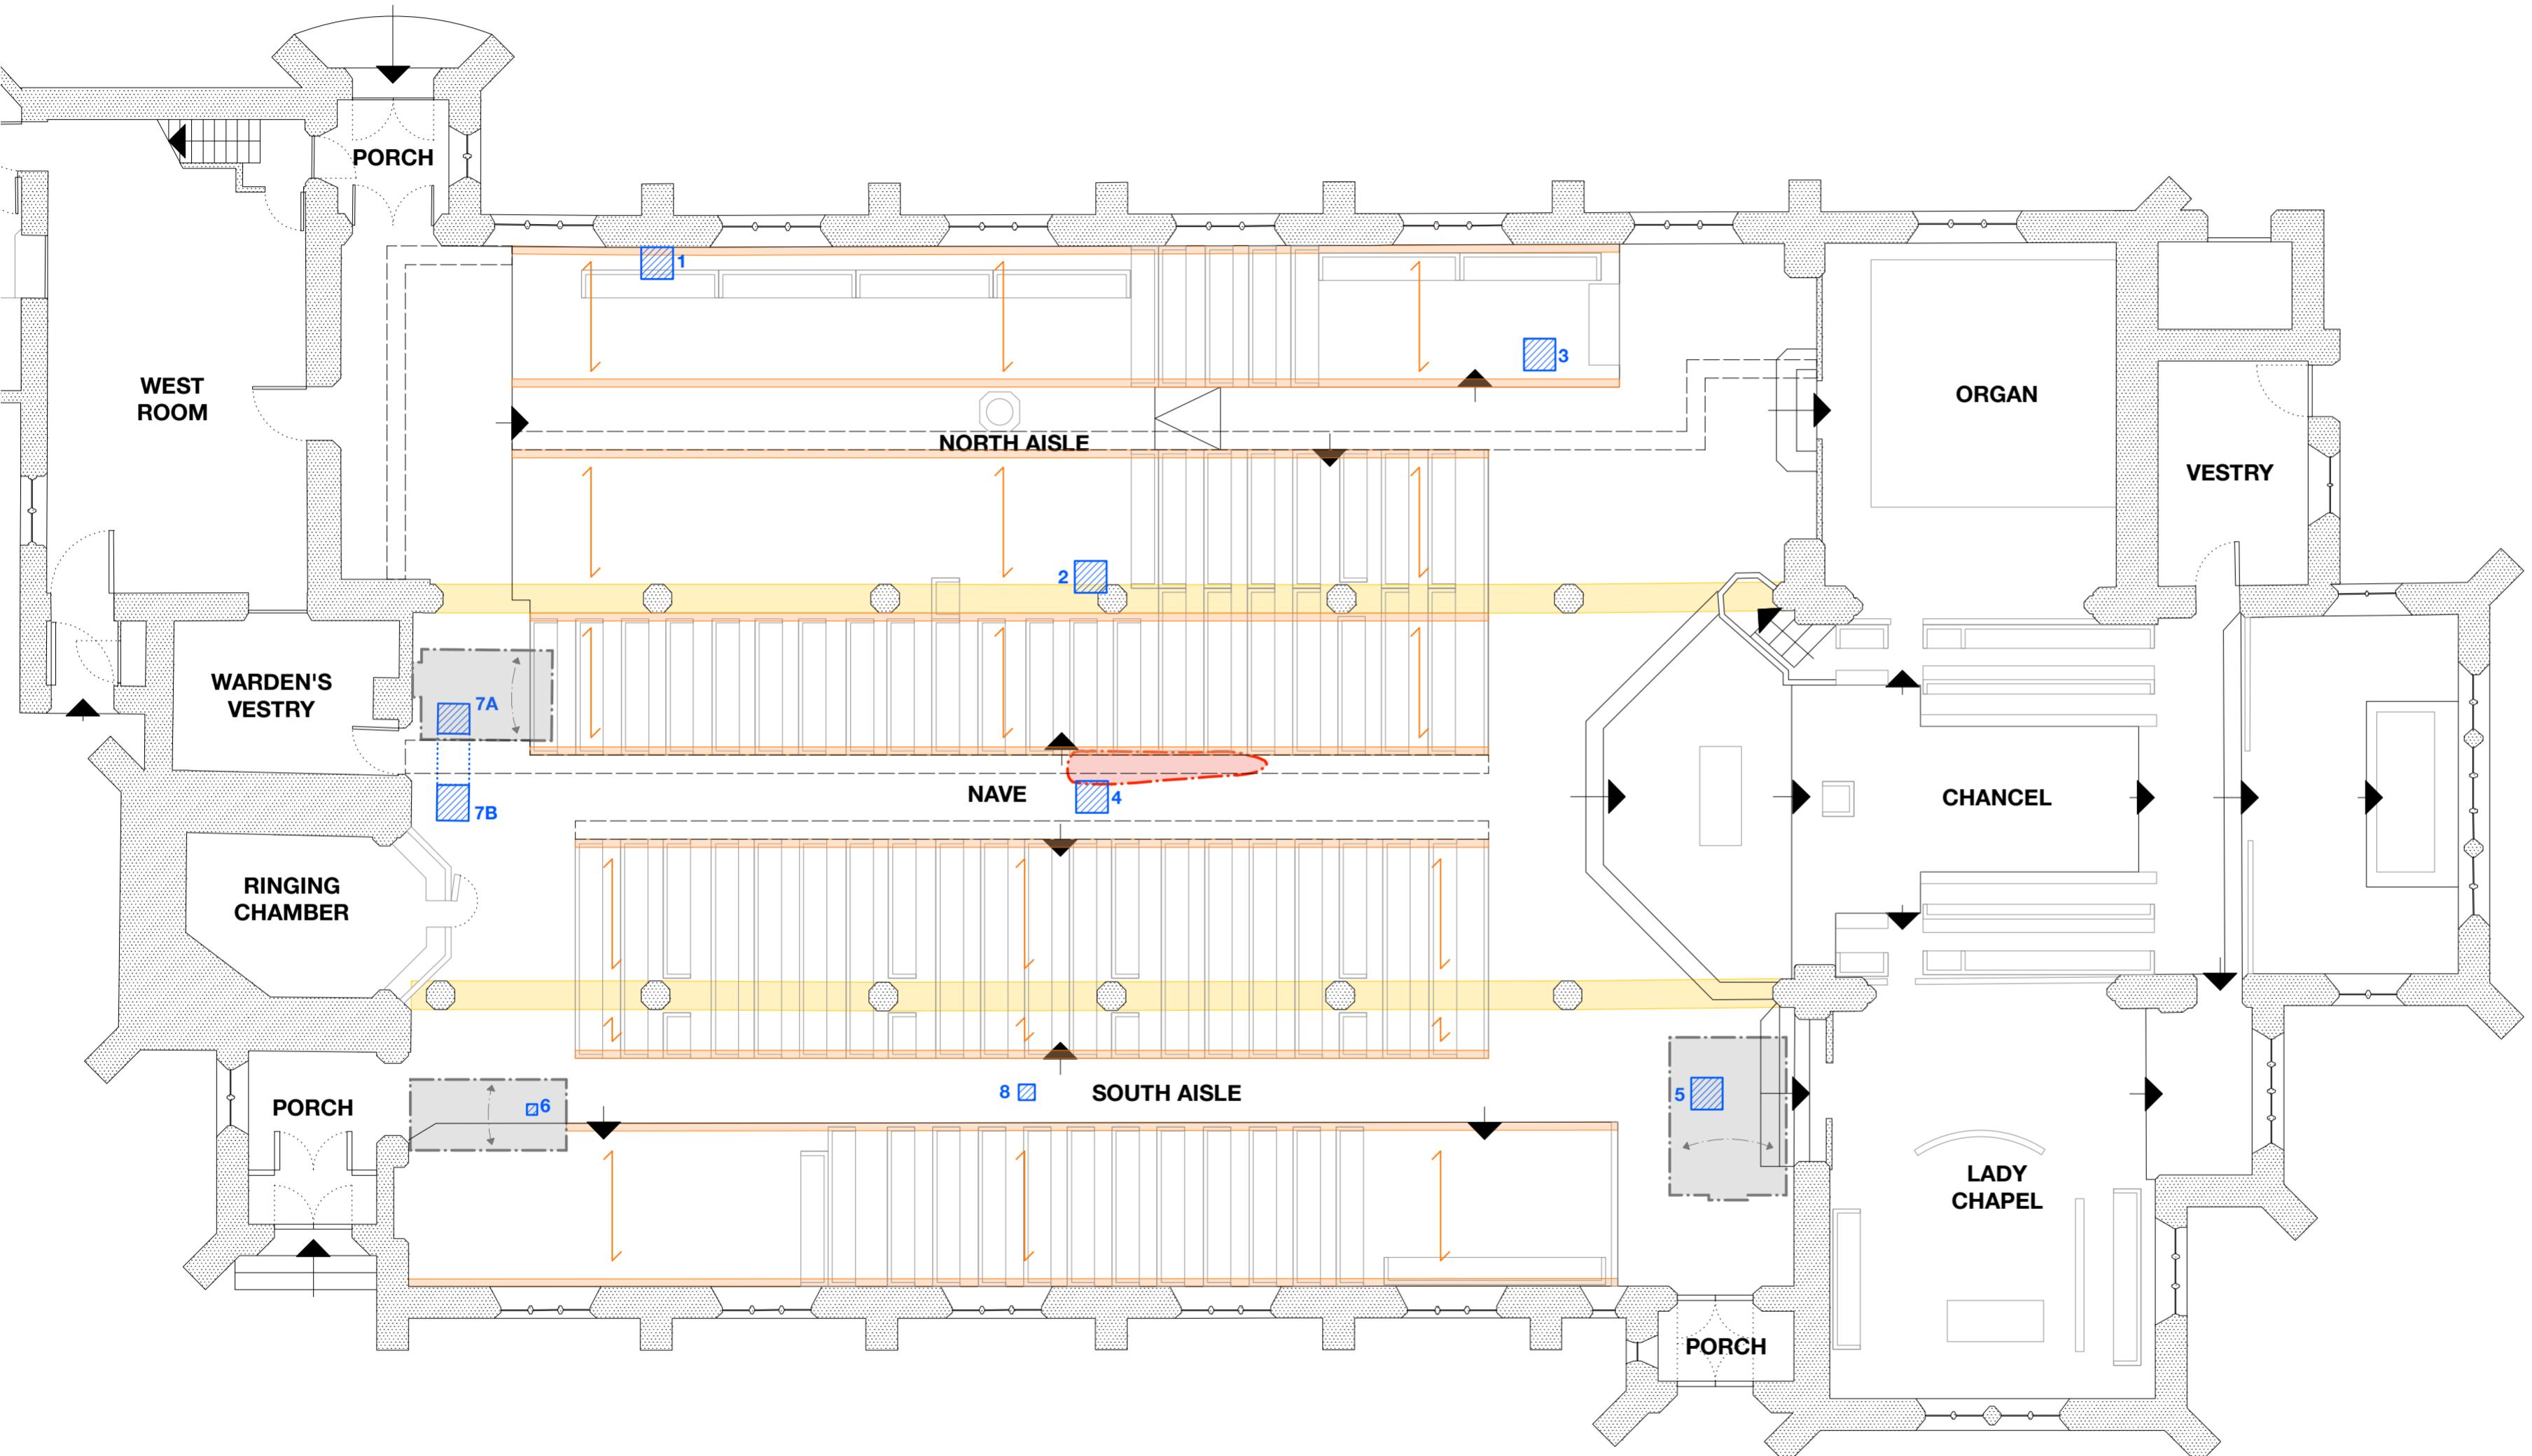
- 1) Trial hole in raised timber pew base area. Concrete slab with building debris (largely brick) as aggregate. Slab laid over soil (former church yard). No other findings.

- 2) Trial hole in raised timber pew base area. Concrete slab with building debris (largely brick) as aggregate. Slab laid over soil (former church yard). Columns sitting on foundation wall running the length of the building (likely remains of former exterior wall). No other findings.

- 3) Trial hole in raised timber pew base area. Concrete slab with building debris (largely brick) as aggregate. Slab laid over soil (former church yard). No other findings.

- 4) Trial hole in quarry tile floor area. Concrete slab beneath tiles. The concrete slab is laid over soil, however, in this location the trial hole has identified a large void in the soil. As a result the brick trough in which the heating pipework sits is suspended in the air. It is unclear how this void has formed, with the most likely cause being a leaking pipe washing away the soil.

- 5) Trial hole in quarry tile floor area. Concrete slab directly below tiles, below which there is arched brick ceiling. The trial hole went through the arched ceiling exposing the vault below. Vault was approximately 2.1m deep and contained coffins stacked on one another.

- 6) Trial hole in quarry tile floor area. Concrete slab directly below tiles, below which there is arched brick ceiling. The trial hole went through the arched ceiling exposing the vault below. Vault measured 1.5m deep but contained a lot of debris so is likely deeper. Coffins visible.

- 7A) Trial hole in quarry tile floor area. Concrete slab directly below tiles, below which there is arched brick ceiling. The trial hole went through the arched ceiling exposing the vault below. Vault appeared to contain 1 coffin which had been damaged by a falling timber (timbers are thought to be those used to support lead coffins when stacked). There is a large amount of building debris in the vault, potentially from the formation of the heating trenches.

- 7B) Trial hole in quarry tile floor area. Concrete slab beneath tiles. The concrete slab is laid over soil. Findings included some bone fragments, refer to archaeologist report for information.

- 8) Trial hole in quarry tile floor area. Concrete slab beneath tiles. The concrete slab is laid over soil.

It was observed that the concrete slab located beneath the timber pew bases are positioned lower (nom. 300mm) than the slabs under tiled floor areas.
