The Church of St Matthew, Morley.

Report on the Conservation of the Glazing.
Windows nIII and nIV.

JIM BUDD
STAINED GLASS

November 2025

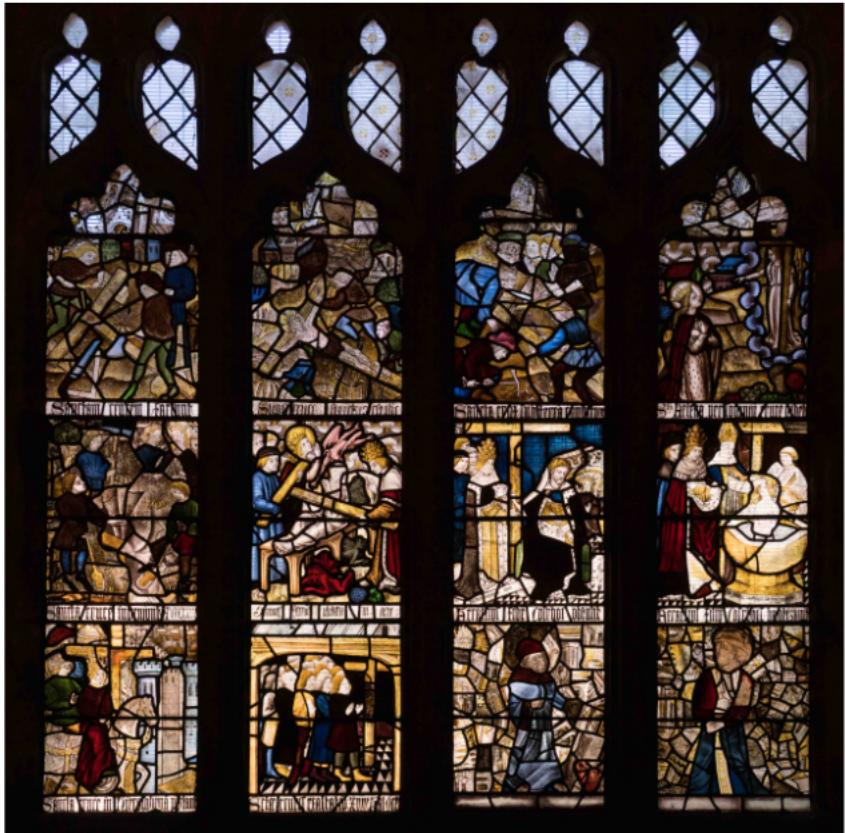
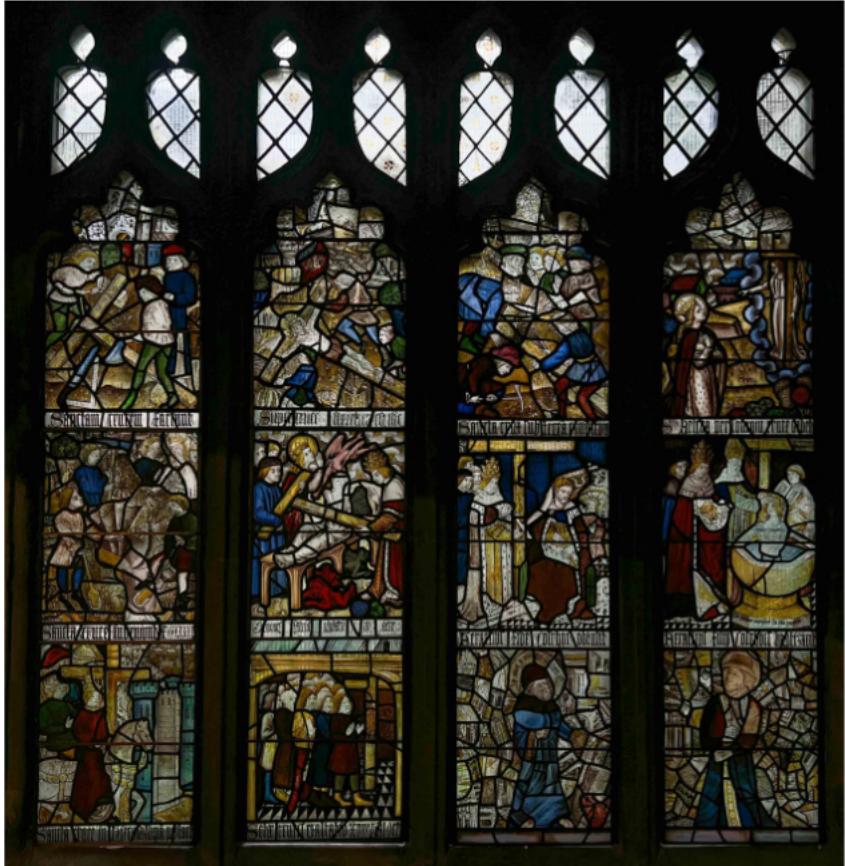
Window nIII. Before (above top) and after conservation.

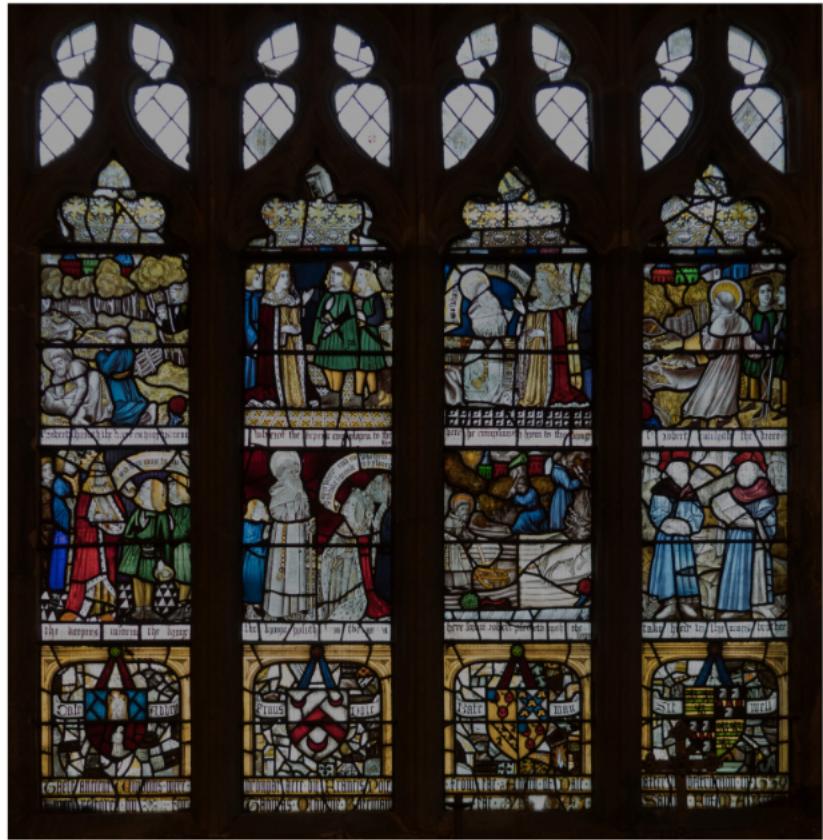
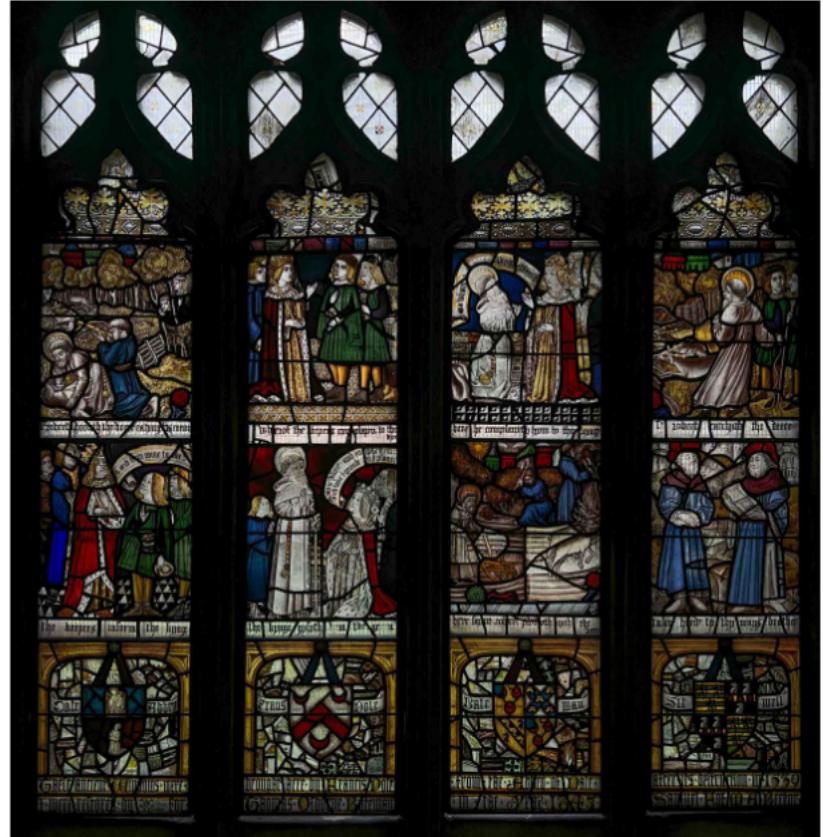
Window nIV. Before (above top) and after conservation.

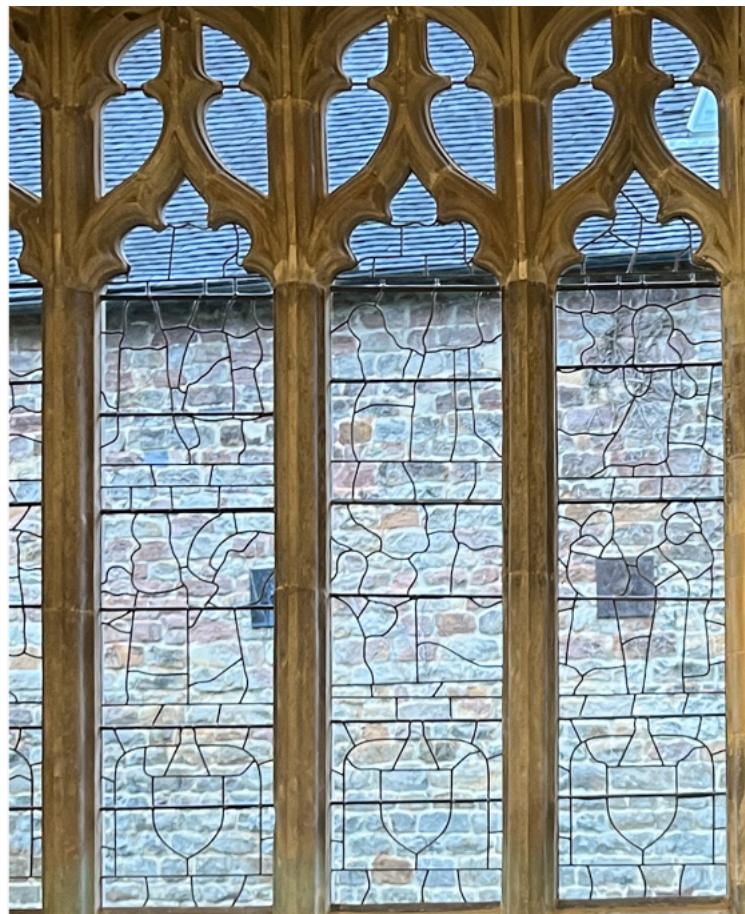
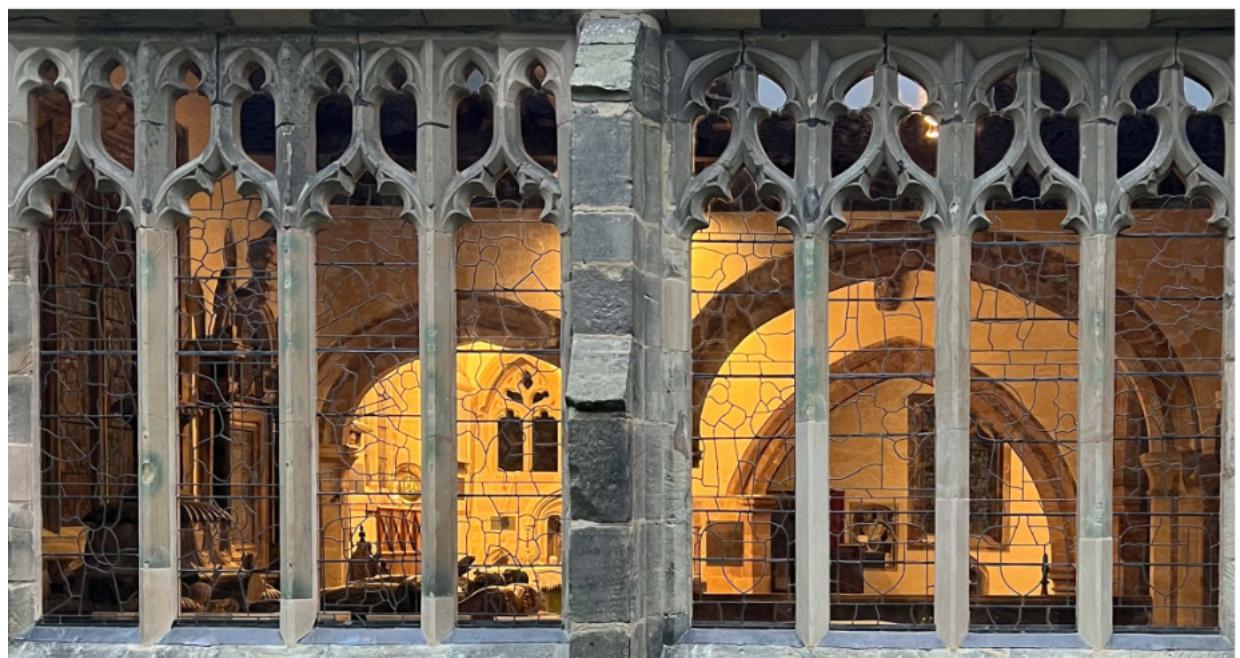
Above. nIV. nIII. Interior and exterior view of exterior secondary glazing prior to installation of the stained glass.

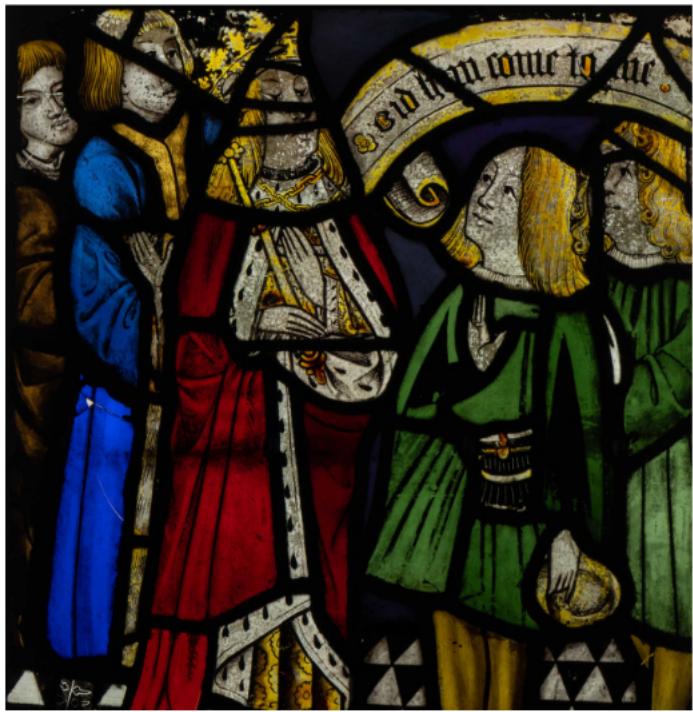
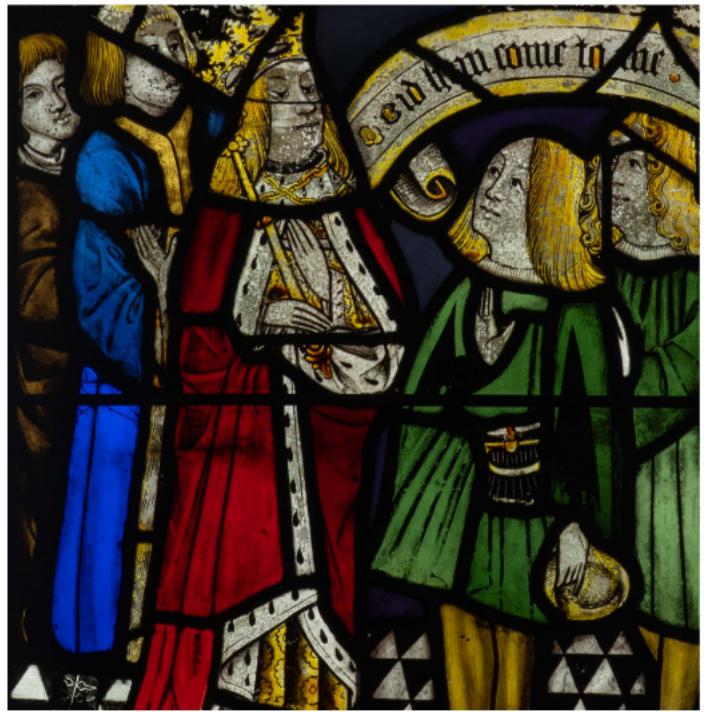
Above. nIV Panel 2a. Studio photographs. Before and after conservation.

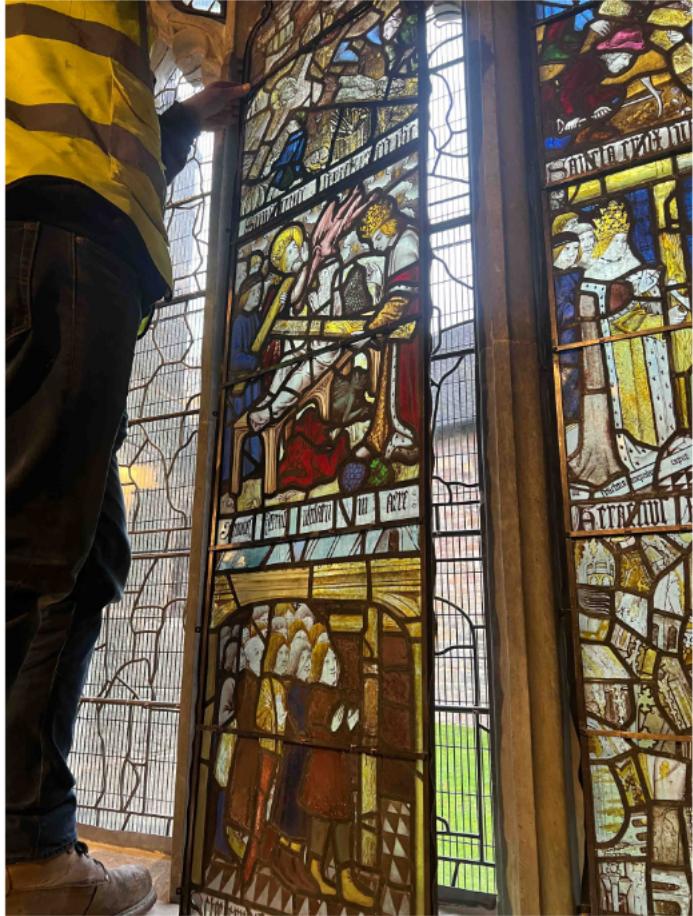
Above left. Installation of stained glass in bronze frames.
