The Church of St Matthew, Morley.

Report on the Conservation of the Glazing.  
Windows sII and nII.

**JIM BUDD**  
STAINED GLASS

July 2025

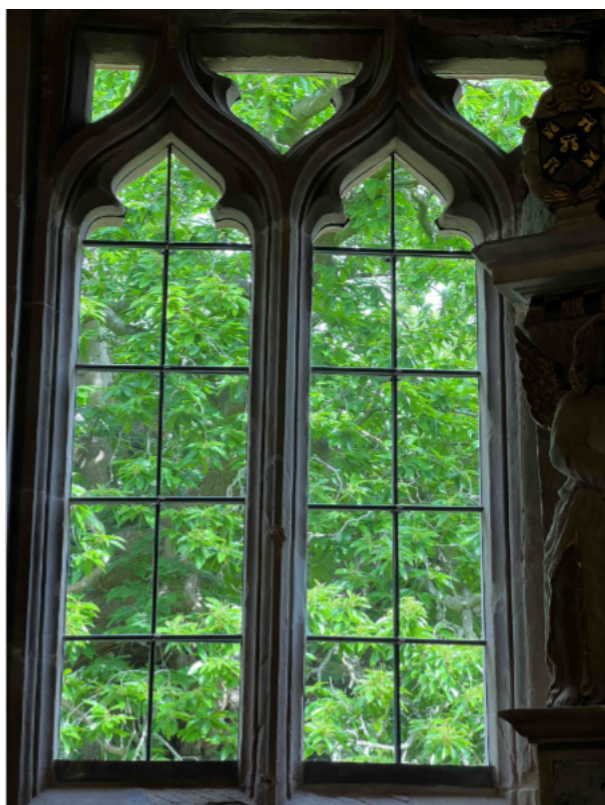
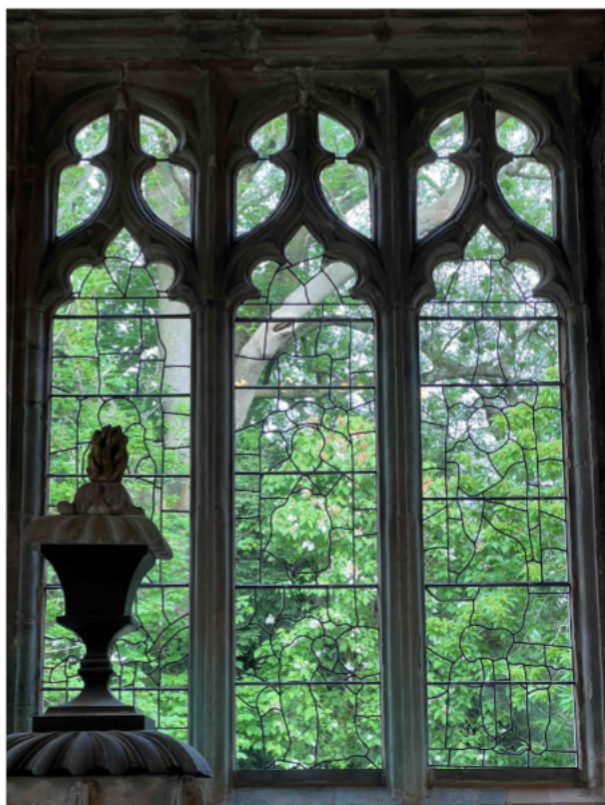
Above. sII. nII. Interior view of exterior secondary glazing prior to installation of the stained glass.

The exterior protective glazing was created using 3mm kiln-distorted glass, The glass was leaded to follow the main design lines of the stained glass panels in nII and to follow the ferramenta in nII.

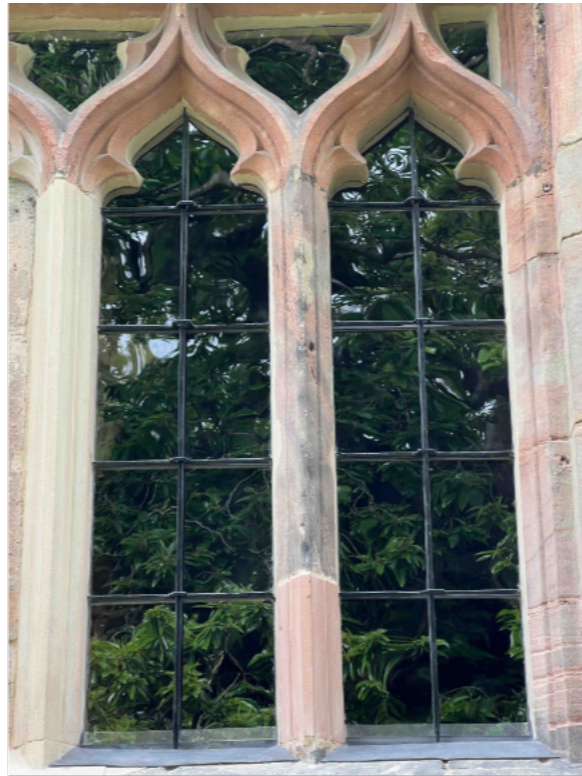
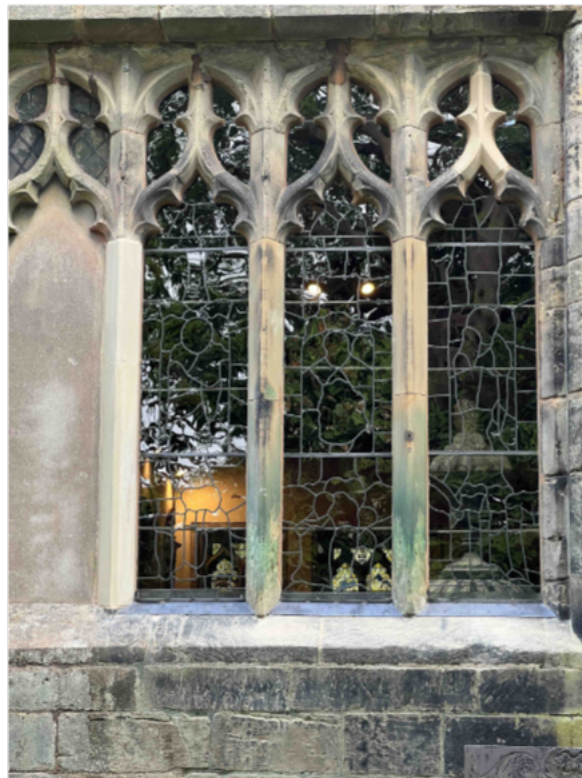
Above. sII. nII. Exterior view of exterior secondary glazing prior to installation of the stained glass.

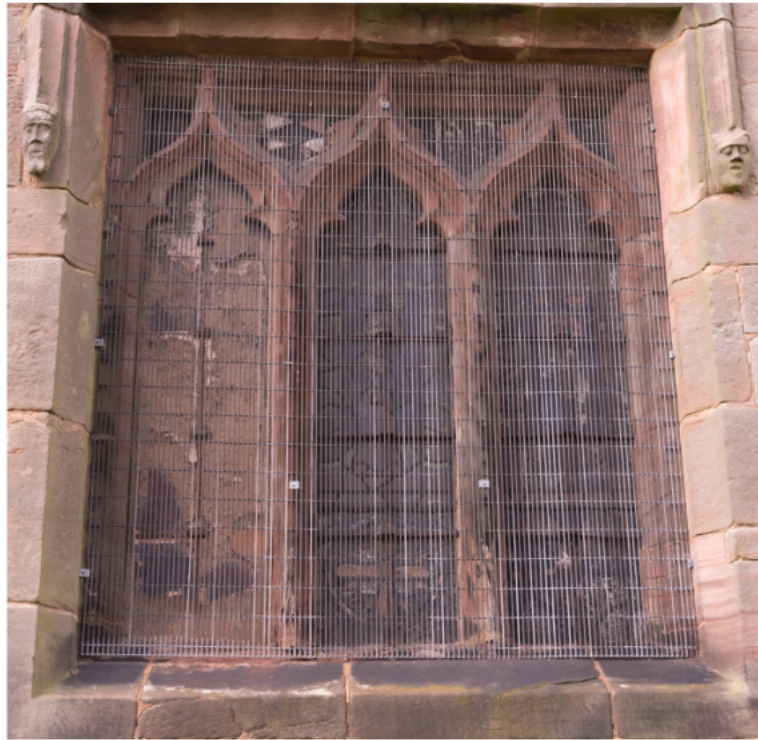
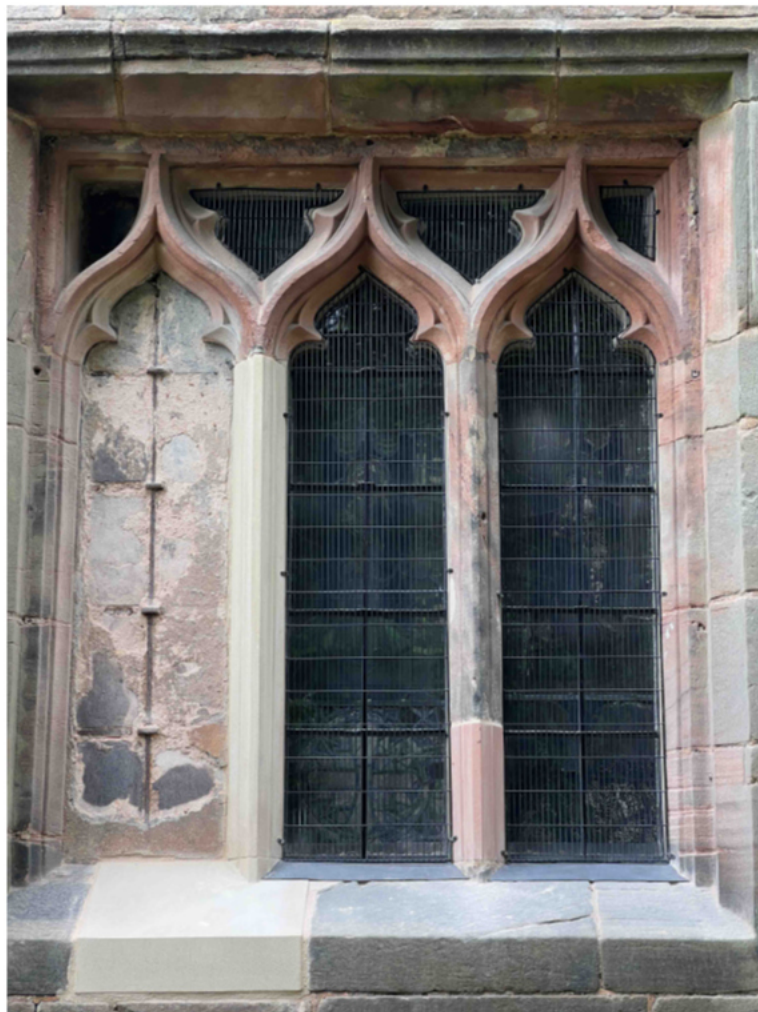
Above. sII. Exterior view of glazing. Before and after conservation.

The external ferramenta on window sII was found to be made of cast iron. Stainless steel tips were welded to each bar. Sections of bar were replaced where the profile was deemed to be inadequate due to corrosion. Both vertical stantions were replaced in forged stainless steel.

Wire guards were fabricated from stainless steel mesh and finished with satin black powder coating. The wire guards were fixed with stainless steel clips and screws and nylon plugs.

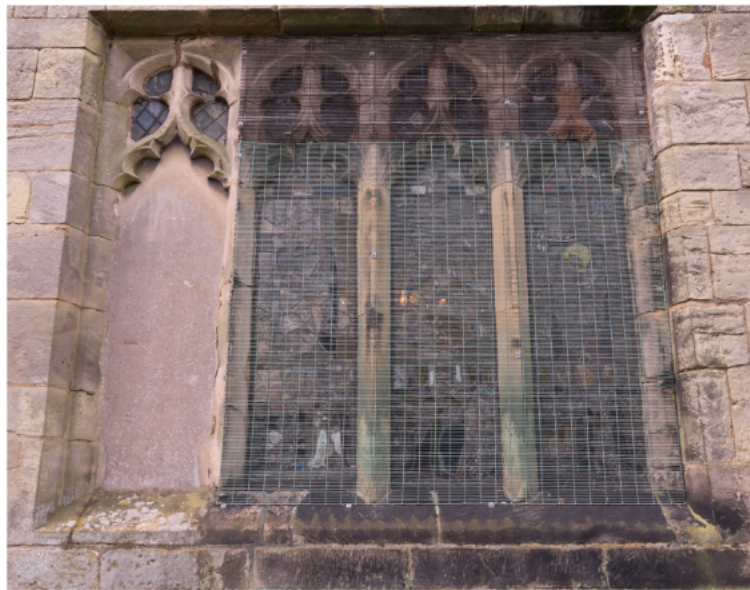
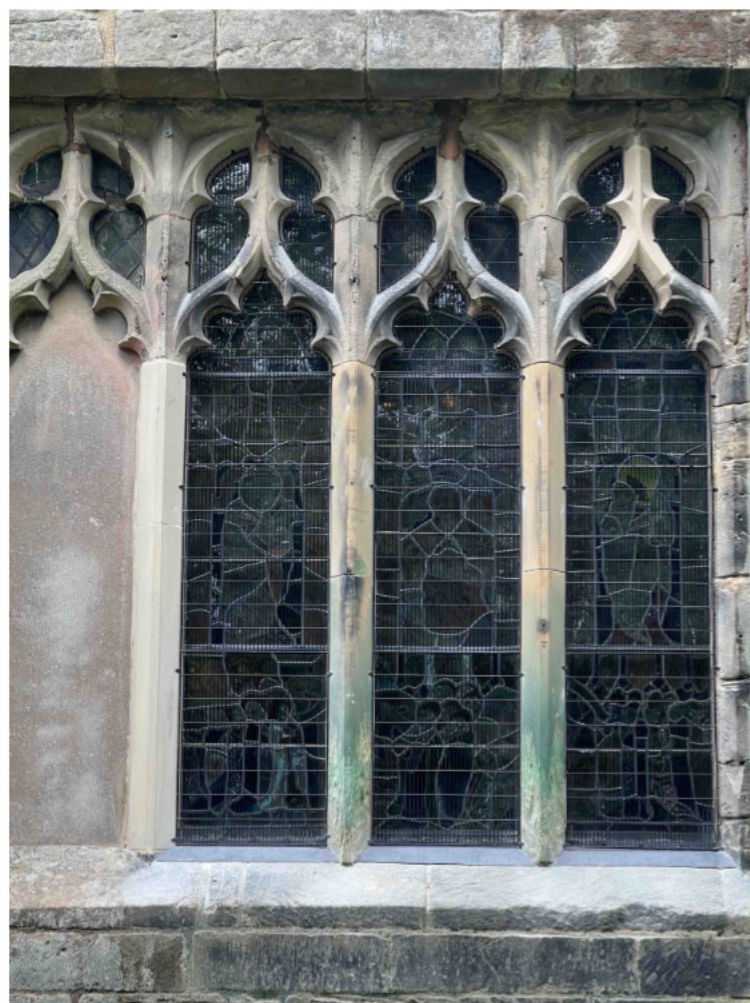
Above. nII. Exterior view of glazing. Before and after conservation.

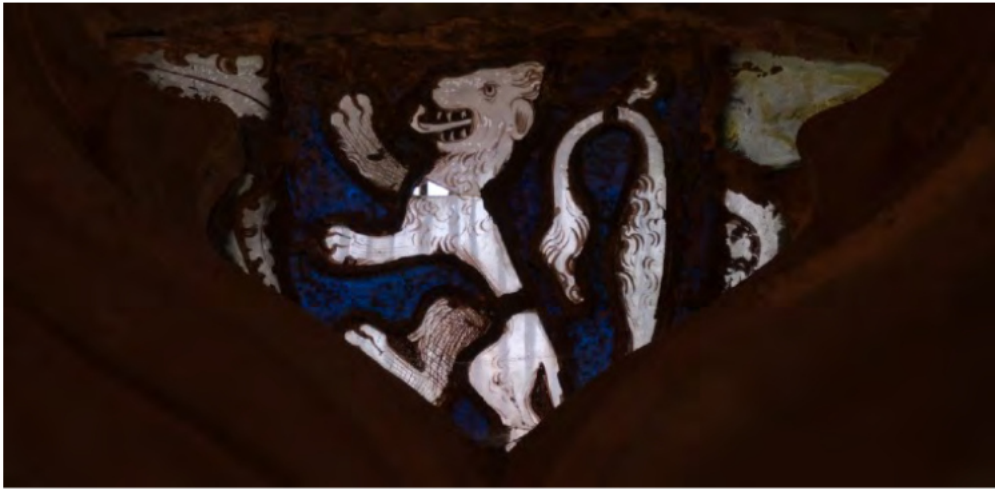
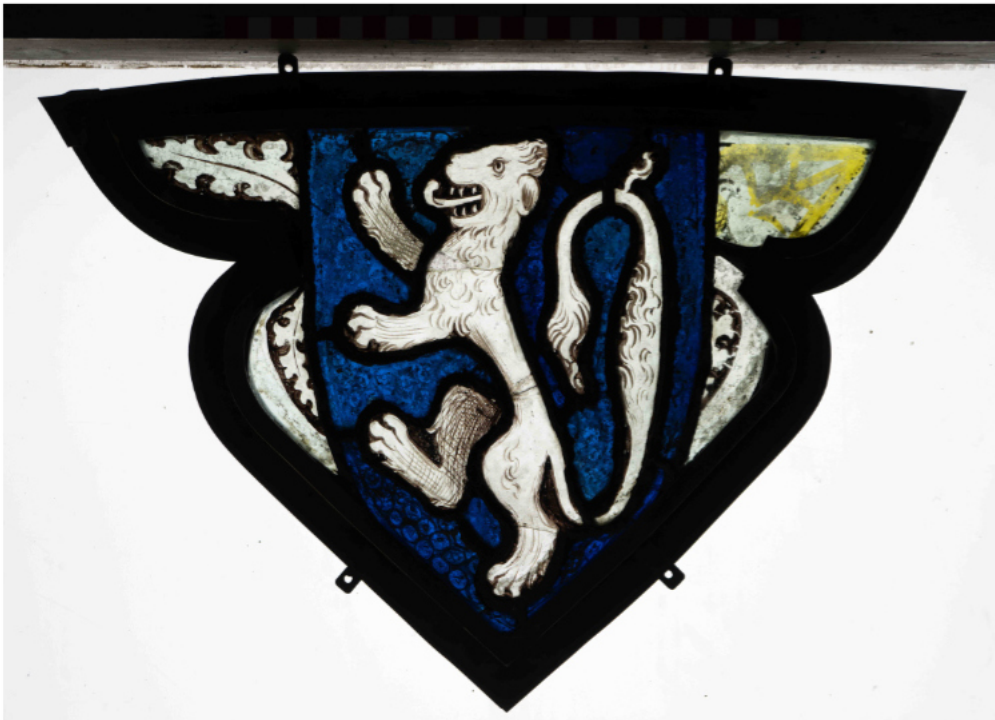
Above top. Panel A2. In situ, prior to removal.  
Above. Panel A2. Following conservation.
