CHADBURN CONSERVATION ARCHITECT

Architects instruction

Works: Repointing of the church tower.
 Contract dated: 28th March 2025

St Bridget Church, Bridgerule - Tower south east pinnacle.

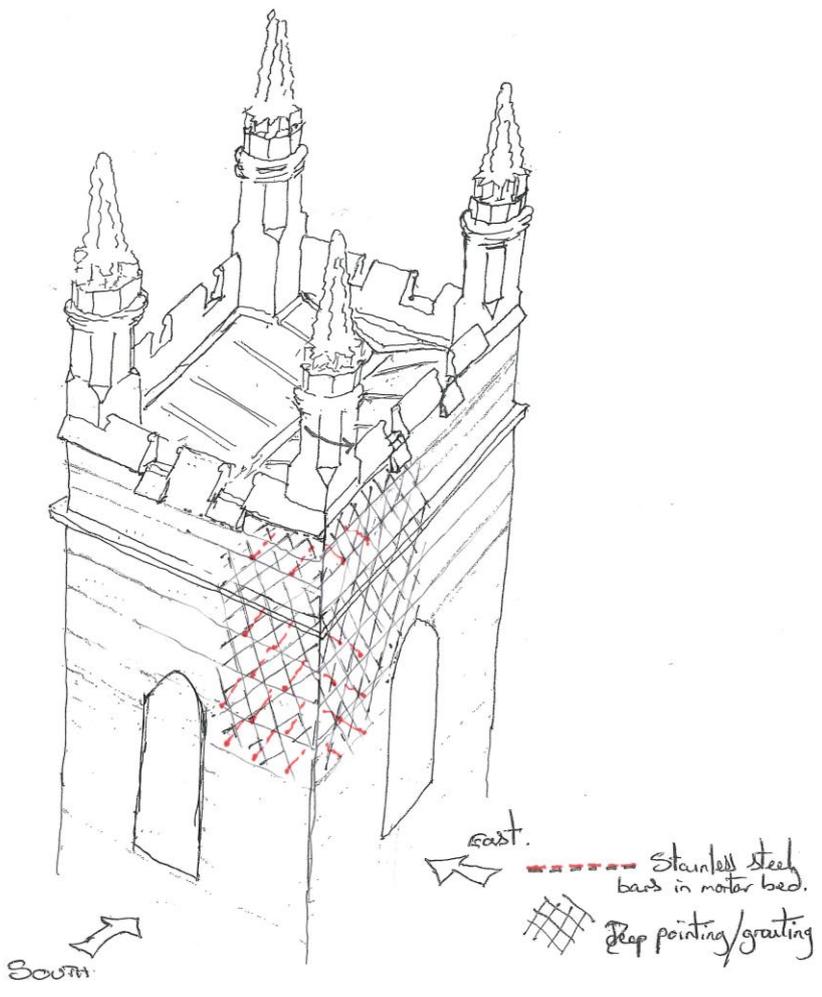
Suggested repair.
 13/2020/SK01 - 10.07.25

- It is evident that some delamination of the outer veneer of coarsed granite stones has occurred beneath the pinnacle shaft, also affecting the bell chamber window surround stones on the eastern elevation, which have move outwards slightly from the wall face.

- With respect to the pinnacle itself, the base stones of the upper tapered section of the pinnacle appear slightly displaced from the supporting stones, which may have occurred at the time of a lightning strike, but there is no evidence of further movement.

- We suggest 2 – 4/6mm diameter Heli-ties are introduced over the window height, on each side, to help secure the window surround stonework with the abutting walls. These should be inserted as generally discussed on site, positioned where wider stone joints allow.

- As outlined previously, we feel it would be sensible to pin the outer veneer of granite stones back to the core and inner stonework; this applies to the base of the pinnacle shaft and over the upper part of the bell chamber, beneath the pinnacle.

- During the repointing process, it should be possible to pin the base tapered stones to the stone course beneath, providing better connection at the base of the pinnacle.

- As discussed, it is important that the joints are very well repointed to a minimum depth of 50mm or 60mm, together with localised cavities and voids filled in and well packed, all as discussed on site.

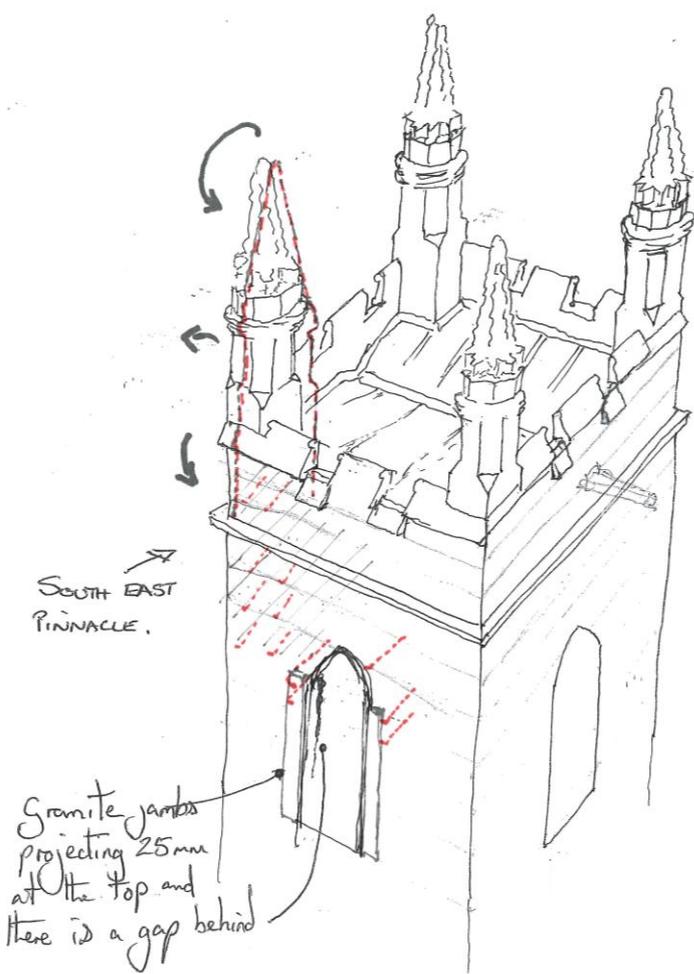
13/2020/SK02-10.07.25

OBSERVED MOVEMENT.

--- 4-6mm STAINLESS STEEL HELIFIX RODS 300mm LONG
