# **Report on Archaeological Monitoring during drainage work**

## **St Margaret's Church, Stanfield, Norfolk**

**ENF ref. 139399**

Sarah Bates (Report No. 31)

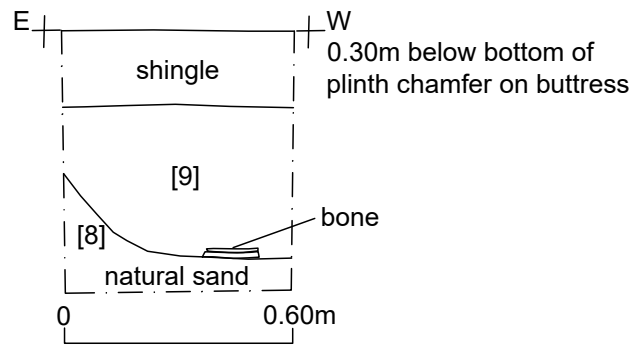
Figure 2: Trench 5; N facing section, scale 1:20

In the lowest part of the trench (at a depth of 0.75m from surface at the bottom of the dry area) was seen orange brown sand with occasional flint gravel (Plate 9). This was thought to be a natural deposit. In the excavated sloping south side of the trench a possible cut 'feature' [8] was filled with light brown silty sand with occasional small flints and rare flecks and small fragments of mortar [9] (Fig. 2, Plate 9,). At the bottom of this feature were some fragments of human bone two of which appeared to be articulated although their position and alignment did not support their being part of an *in situ* burial; it seems likely that they were redeposited together (The bone fragments were at a depth of 0.90m below the bottom of the chamfered plinth of the buttress). The extent and purpose of the recorded feature are unknown. It is possible that it related to the existing drains (although its firm homogenous fill did not include any modern brick or other material), or it may have related to other digging close to the church wall. It seemed that the 'feature' was cut to its south by the dry area within which was the existing ceramic drain pipe and shingle infill.

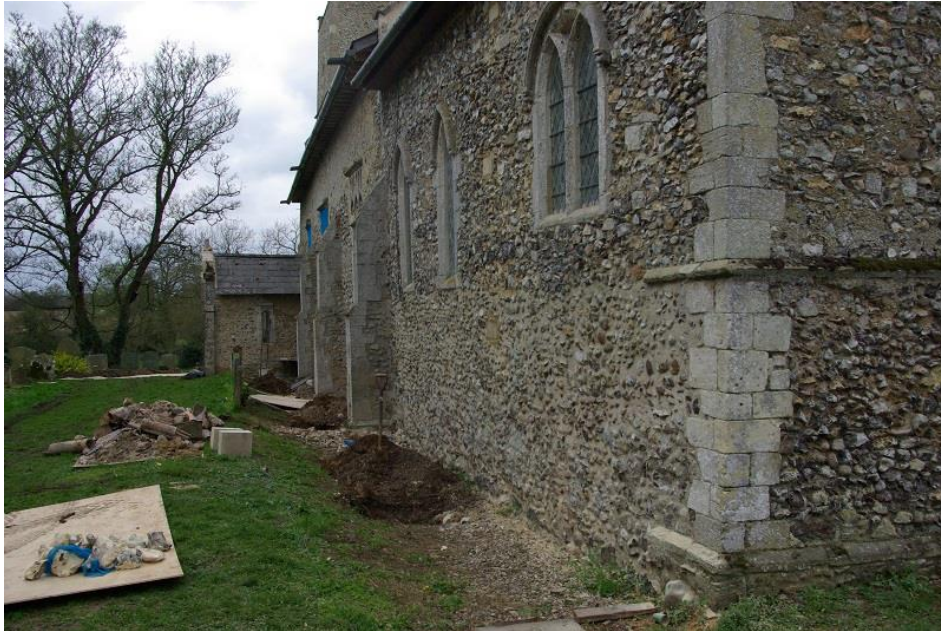
Four new gullies were installed along the south side of the building (Fig. 1, Plate 1). Apart from Trench [1] the gullies were positioned within the reduced 'dry area' alongside the church wall and were connected to an existing ceramic drain pipe which ran from west to east within the shingled area. This area is approximately 0.30m below the level of the surrounding grass churchyard at its west end and 0.50m deep at its east end. The footings of the buttresses were just exposed in the bottom of the dry area.

Plate 1: 'Dry area' and work in progress at S side of church, looking W

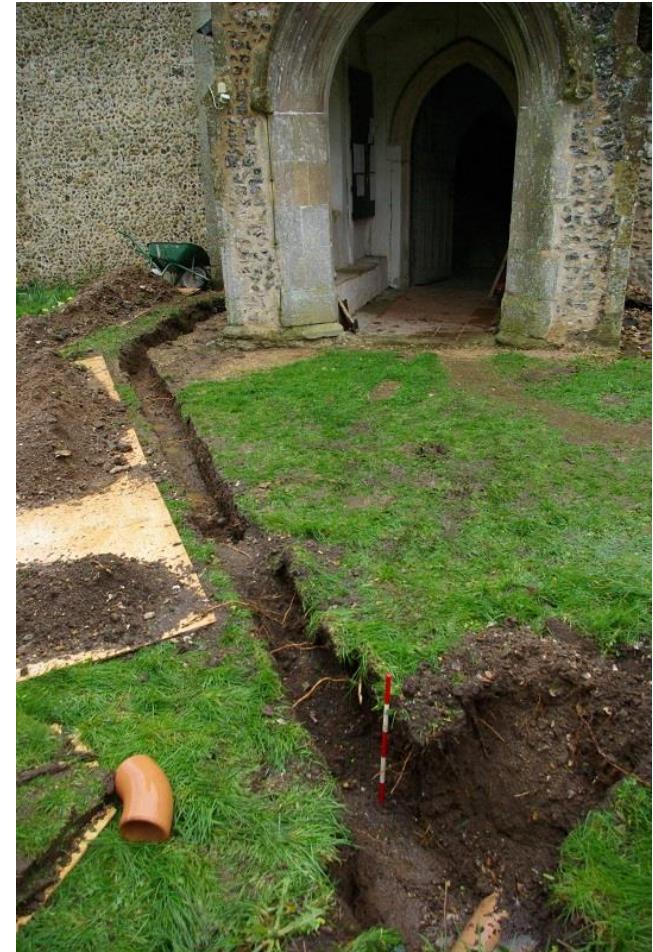
A trench was dug from the south side of gully [1] for a drain pipe to connect with an existing clay drain pipe which was exposed in a small trench approximately 7m to the SSE (Plate 2). The trench was 0.30m wide and between 0.28m and 0.35m in depth and the existing drain pipe was exposed at a depth of 0.40m. The orange brown churchyard soil (see above) was just seen in some areas but, mostly, only topsoil was excavated from the trench. A few fragments of human bone were found together in the bottom of the trench near the clay pipe. They probably represented the 'reburial' of bone found when the drain was laid.

Plate 2: Trench S of S porch, looking N,  
0.5m scale

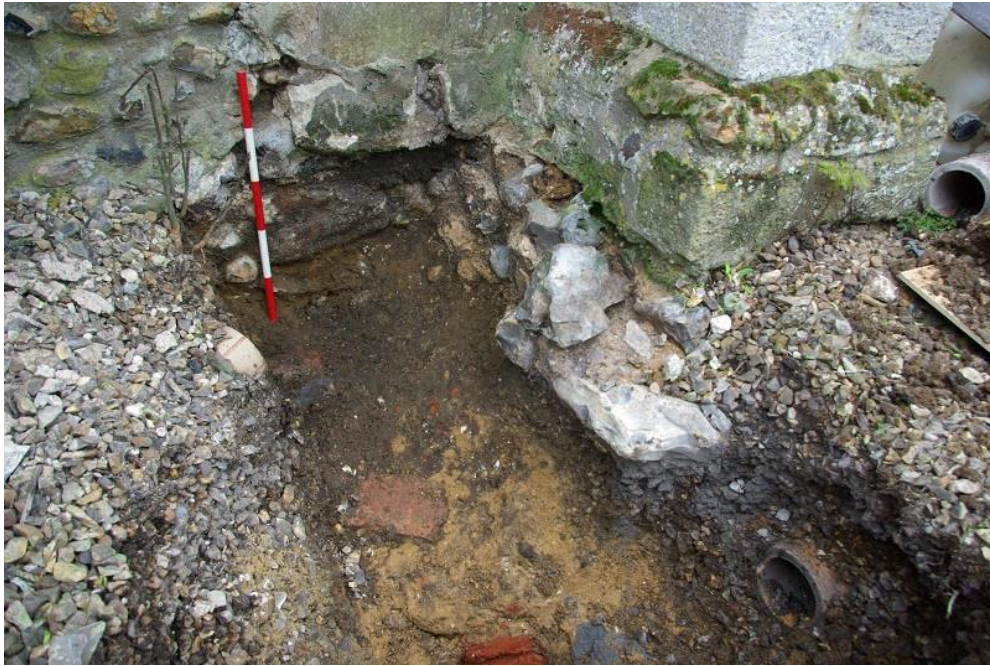
The footings of the nave and its buttress were exposed (Plate 3). The nave footing was flush with the wall above and comprised irregular medium sized flints and, also, a large block of possible carstone. The buttress footing included larger flints and protruded 0.15m from the bottom of the buttress with one very large tabular slab protruding up to 0.25m.

Plate 3: Trench [2]; nave and buttress footings, looking NNE, 0.5m scale

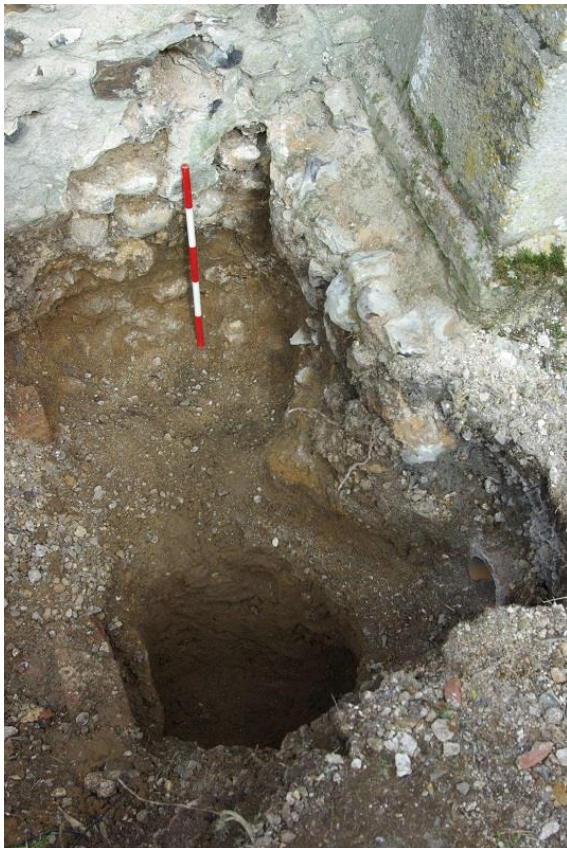
The nave and buttress footing were exposed (Plate 4). The nave footing comprised a lower part with flints and orange silty sand (the bottom of which was not reached) and, above that, and flush with the face of the wall, flints (mainly quite regular cobbles) in coarse gritty mortar. The buttress footing protruded 0.15m from the bottom of the buttress and consisted a lower deposit of flints and orange silty sand and an upper more substantial and solid part of mortared medium and large flints.

Plate 4: Trench [3]; nave and buttress footings, looking NNE, 0.5m scale

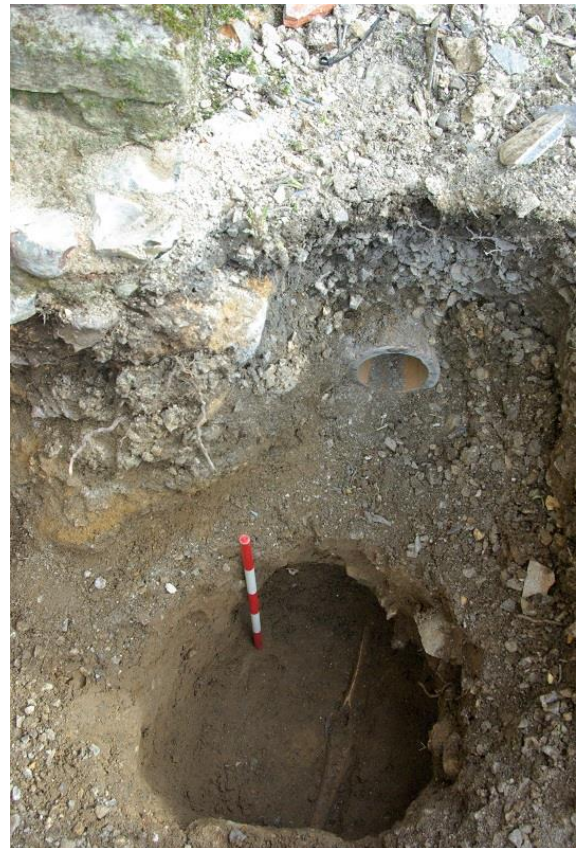
In the bottom of the pot hole, at a depth of 1.00m below the bottom of the plinth chamfer on the buttress and 0.85m south of the nave wall, the articulated leg bones (possibly left leg) of a skeleton were exposed (Plate 5). These bones (femur and tibia) were left *in situ* and some soil replaced upon them before the gully pot was positioned. Above the burial was light brown silty sand churchyard soil with occasional small flints and rare medium to large flints. Large fragments from two skulls and an almost complete femur, as well as some more fragmentary human bone, were found about 0.10m above the *in situ* leg bones. They had probably been disturbed and reburied here – perhaps when the existing drain was laid or, possibly, when the lower burial was interred. Above this was the shingle infill of the dry area. The west side of a brick feature was just exposed in the lower part of the east side of Trench [3] (visible in Plate 4). It was thought to be an inspection chamber relating to the existing drains.

Plate 5: Trench [3]; *in situ* leg bones, looking E, 0.5m scale

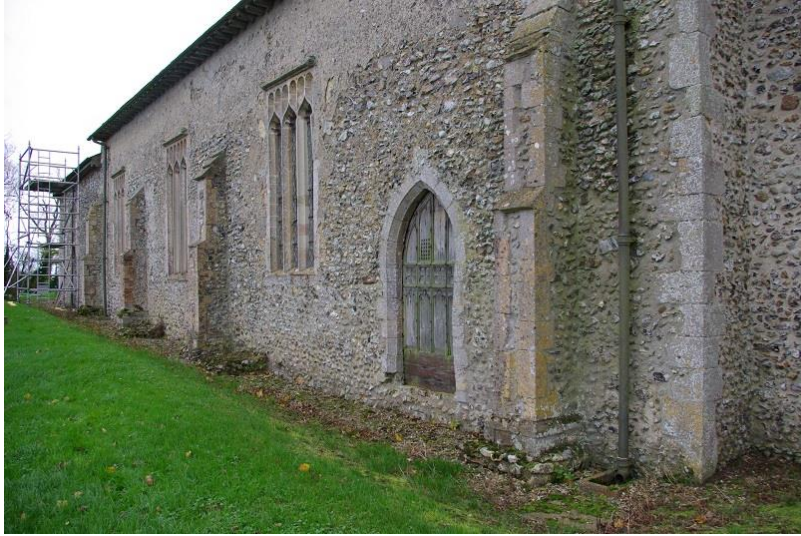
Four new gullies were also installed along the north side of the building, all but Trench [7] within the dry area there (Fig. 1). As at the south side of the building they were connected to an existing ceramic drain pipe which ran from west to east within the shingled area. The footings of the buttresses were just exposed in the bottom of the dry area and those of the former buttresses (see above) can also be seen just west of the two existing side buttresses of the nave (Plates 6 and 7).

Plate 6 'Dry area' at N side of church prior to work, buttress footings visible, looking SE,

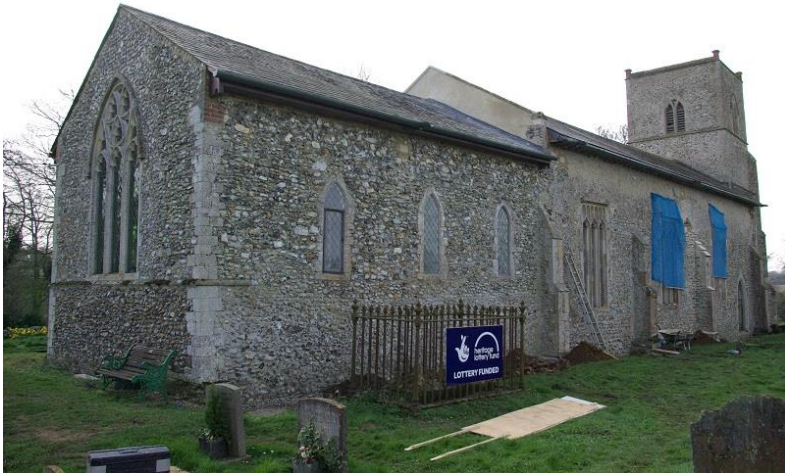
Plate 7: Work in progress N of church, looking SW

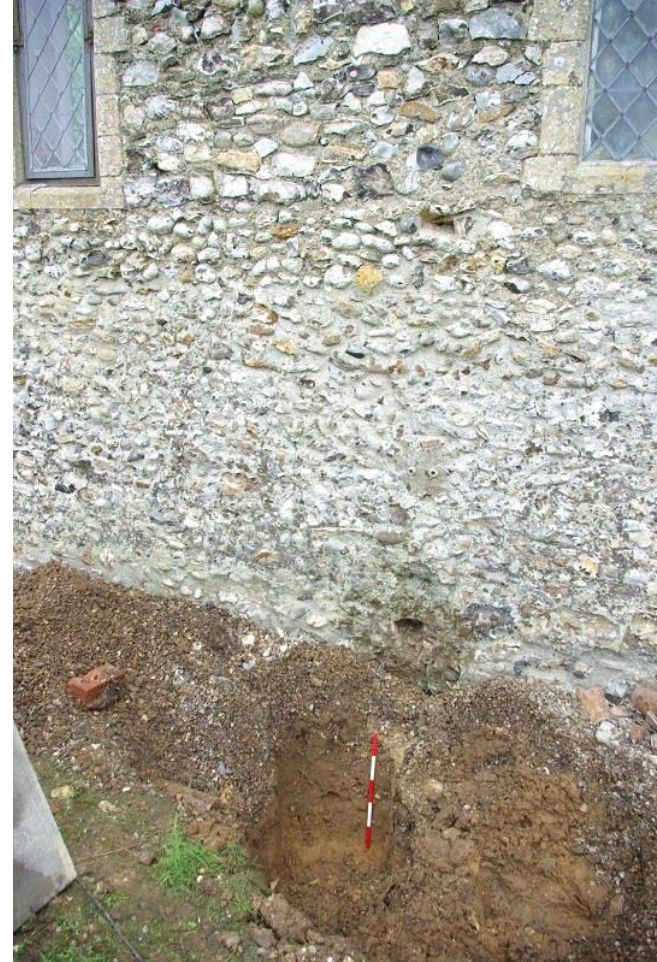
In the deepest part of the trench (about 0.60m below the lowest part of the dry area and about .90m below the grass to the north) some dark orange sand was seen and may have been a natural deposit (Plate 8). Above it was orange brown churchyard soil and the shingle infill of the dry area. Nothing of archaeological significance was seen.

Plate 8: Trench [4], looking SSE, 0.5m scale

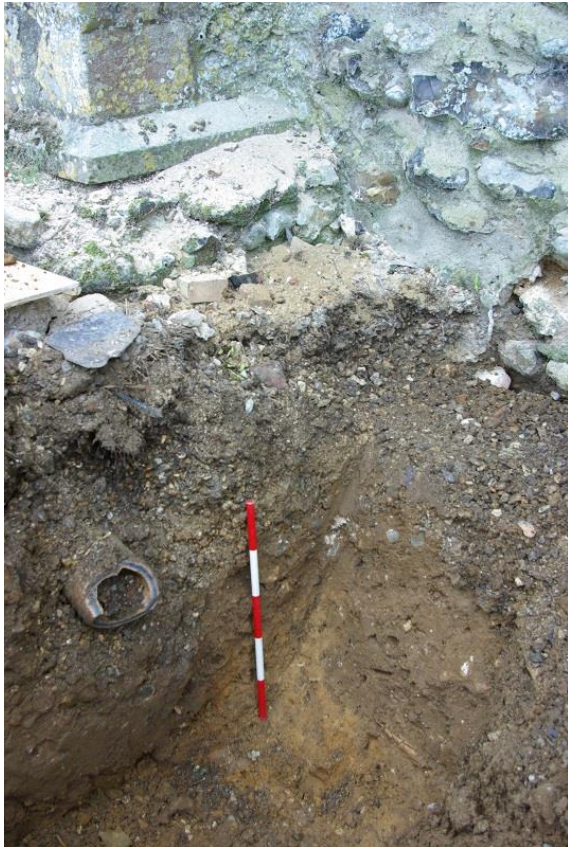
Plate 9: Trench 5; orange ?natural sand cut by possible feature [8], looking SE, 0.5m scale

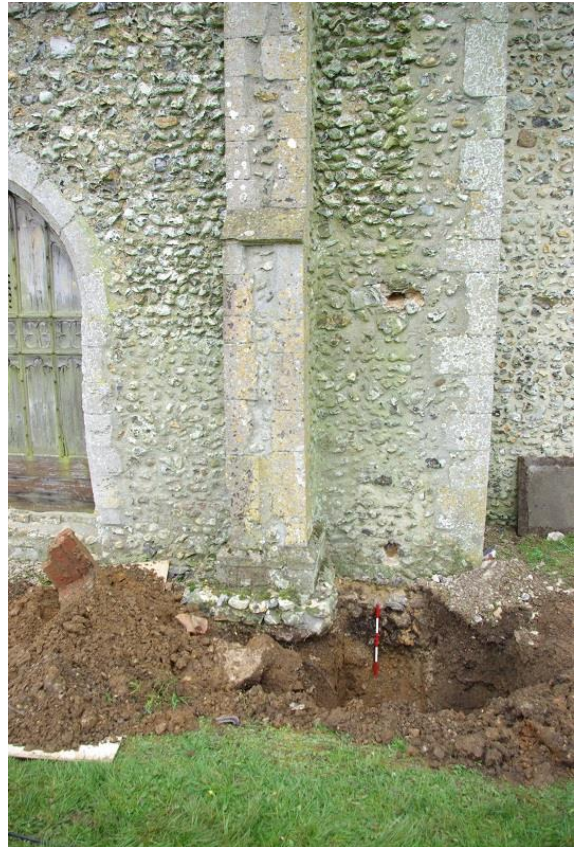
Trench [7] was located at the north-west corner of the nave. It was 1.60m x 1.20m in size and dug to a maximum depth of 0.90m (Plate 10). The sides and base of the trench were slightly irregular (and the trench larger than required for the new gully) due to the removal by the contractors of an existing brick inspection chamber.

Plate 10: Trench 7; buttress footings at NW corner of nave, 0.5m scale

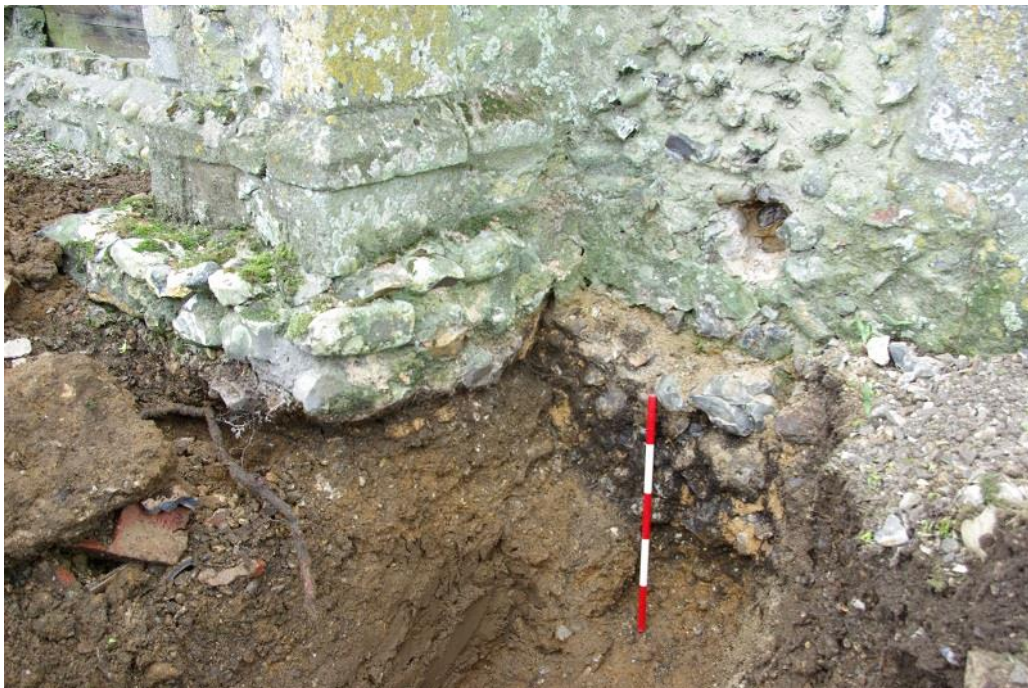
Slightly orange brown slightly clayey silty sand churchyard soil was seen in most of the lower part of the trench. At the south side, however, close to the church and beneath the buttress and nave wall footings was gritty brownish orange silty sand with moderate numbers of small and medium sized flints. This may have been within a construction cut the south side of which sloped up and out away from the church wall and was underneath the buttress (although this is uncertain) (no section recorded – see Plate 11). The bottom of this deposit was not reached in the excavated trench. The nave footing comprised flints of various sizes with cream mortar. It protruded 0.12m north from the bottom of the nave wall and it continued eastwards ‘behind’ the brownish orange soil below the buttress footing. Thus the buttress footing, which was of larger flints laid in regular courses, butted against the nave footing and was of later date. It appeared to be of relatively shallow depth; three courses of flints, and it protruded 0.15m from the bottom of the buttress (the footing was visible prior to excavation in the bottom of the dry area).

Plate 11: Trench 7; buttress and nave footings at NW corner of nave, looking SE, 0.5m scale
