**Conservation report for the reredos, communion rail,
candlesticks, vestry door, exterior chancel east wall, pinnacles and
coping stones**

**All Saints Church, Mackworth
Diocese of Derby**

July 2017

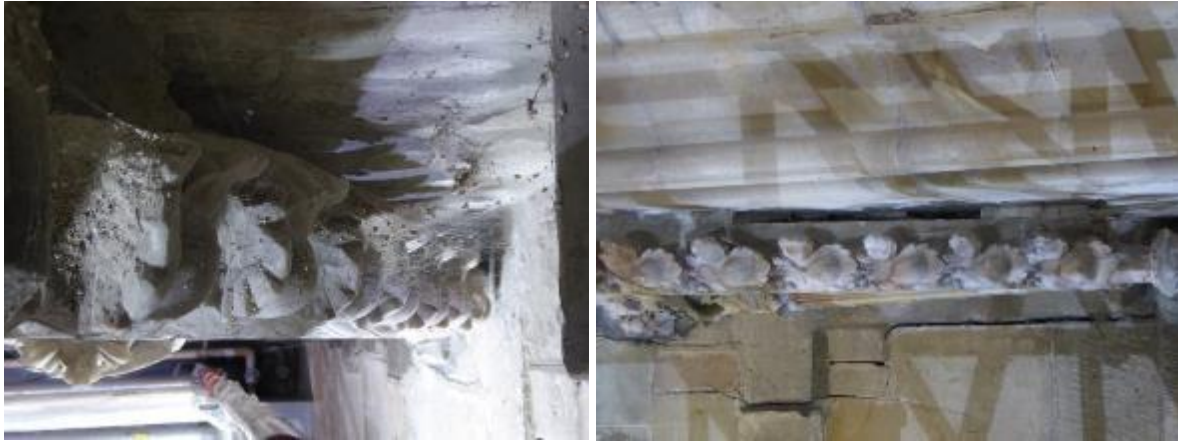
The reredos was firstly dry cleaned with brushes and vacuum cleaner. There were extensive amounts of cobwebs, dust and debris to the rear and sides of the upper sections.

Figure 3 Dust, cobwebs and debris before and after initial dry cleaning.

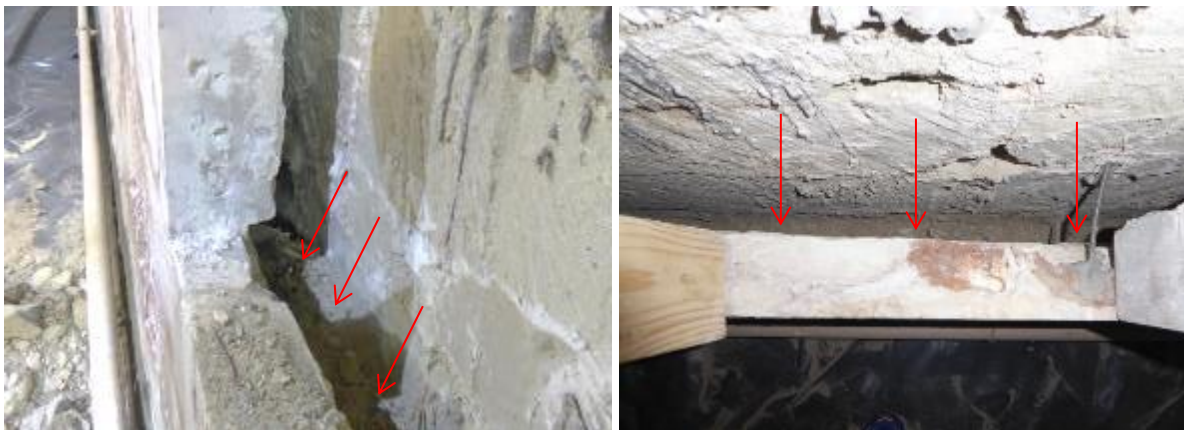
Once some of the blocks to the central area of the reredos were dismantled, the lower row of blocks were found to be filled with debris, which was manually removed and vacuumed.

Figure 4 Debris to rear of reredos before and after removal

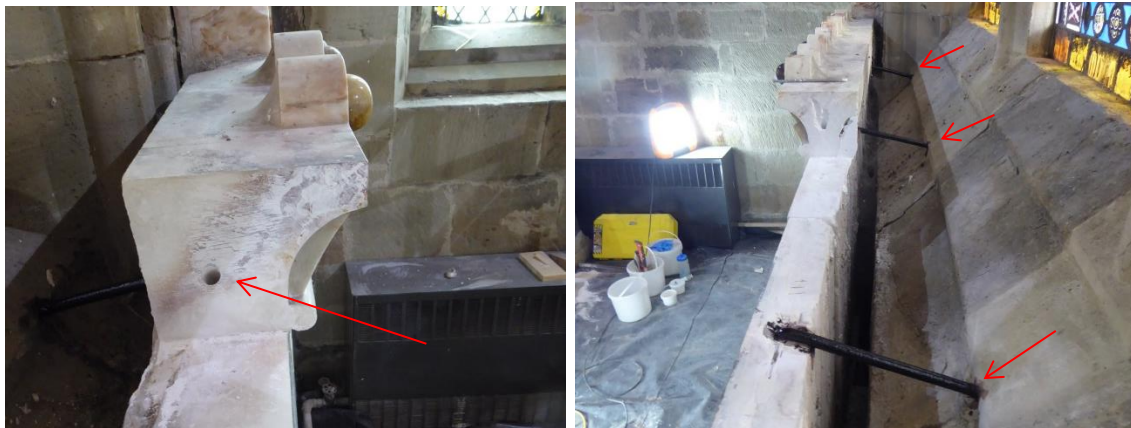
Figure 9 Pinning dismantled block and treated metal rods behind the reredos

Three large blocks of alabaster were removed from the upper section of the central area. They were loose and no metal cramps or rods were found in two of the three blocks. The two blocks located to the sides were pinned to the adjacent lateral blocks and all three blocks were also pinned to the lower row of blocks with stainless steel rods and polyester resin³. The alabaster blocks were relocated, bedded in gypsum with no aggregates.

Additionally, the metal rods joining the lower row of alabaster blocks and the east wall were cleaned of rust, treated with a rust convertor⁴ and painted with black metal paint⁵ to prevent further corrosion and expansion.

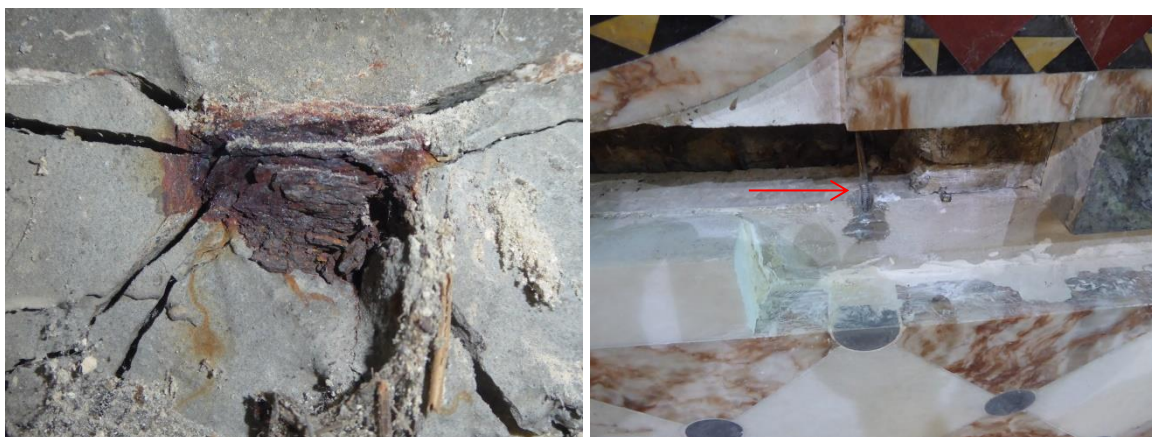
Figure 10 Condition of the ferrous cramps and cement based mortar. Replacement for stainless steel cramps

Two green marble blocks and twelve alabaster blocks were dismantled to the lower central section of the reredos. The rusted iron cramps and most of the cement based mortar used for their fixing to the wall were removed. See Appendix B for mortar analysis results. The blocks were fixed to the wall with stainless steel rods and polyester resin. The stone blocks were relocated, bedded in gypsum with no aggregates.

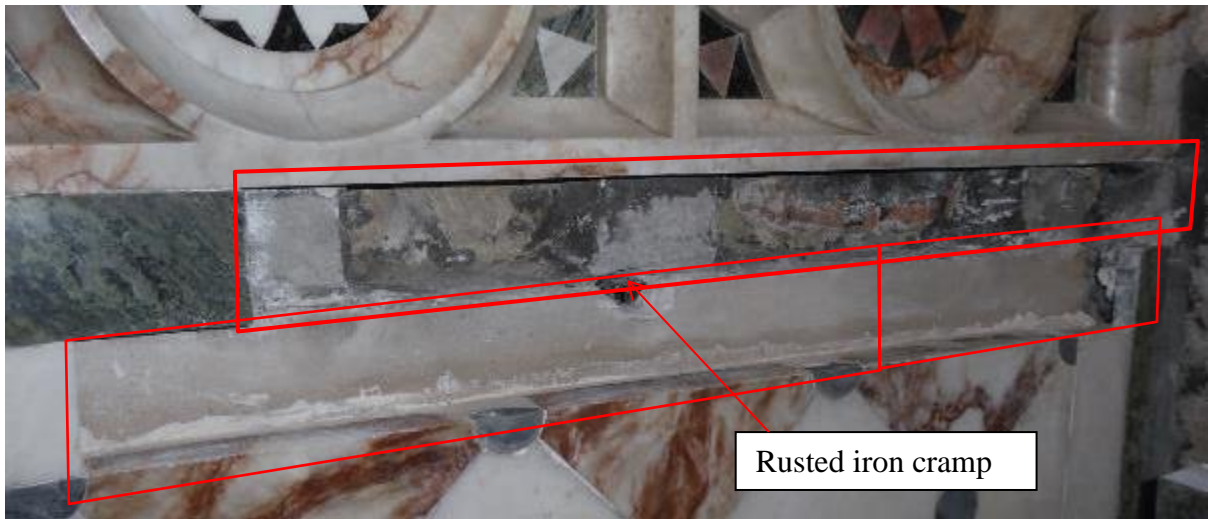
Figure 11 Dismantled blocks to right lower section

A large green marble block and two alabaster blocks to the right lower section of the reredos, as viewed, were carefully dismantled. The rusted iron cramps were removed and replaced for stainless steel rods fixed to the wall and stone with polyester resin. The stone blocks were relocated, bedded in gypsum with no aggregates.

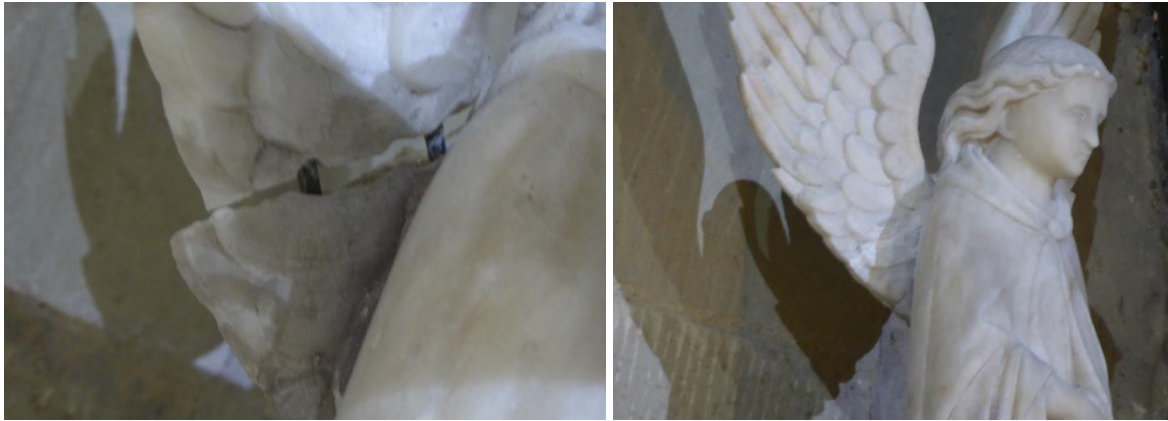
Figure 13 Angel wing before replacement of rods and after relocation

During the condition survey, the left wing to the upper right angel, as viewed, was dismantled as it was loose and was at risk of falling. The wing was cleaned of gypsum and the two rods replaced for stainless steel rods. The position was corrected and relocated bedded in gypsum.

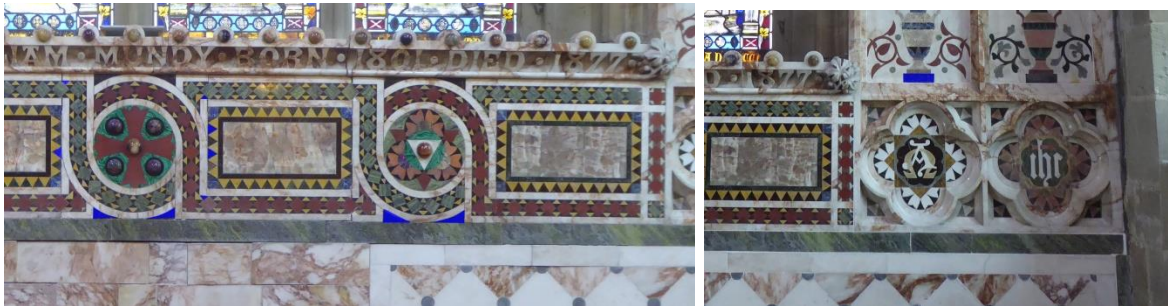
There were many stone geometric pieces to the lower section of the reredos that were loose. They were cleaned of gypsum and resin and re-fixed with a polyester resin (Jolly Vertical Straw).

Figure 14 Location of the loose sections (blue)

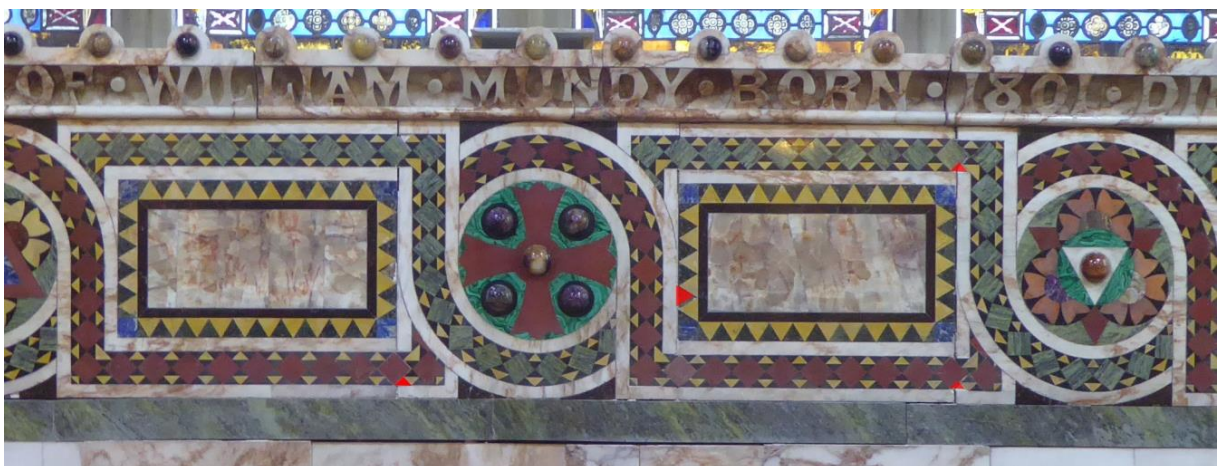
There were four geometric stone pieces missing to the lower section of the reredos. They were replicated in polyester resin with pigments and fixed with polyester resin to the reredos.

Figure 15 Location of the missing sections (red)

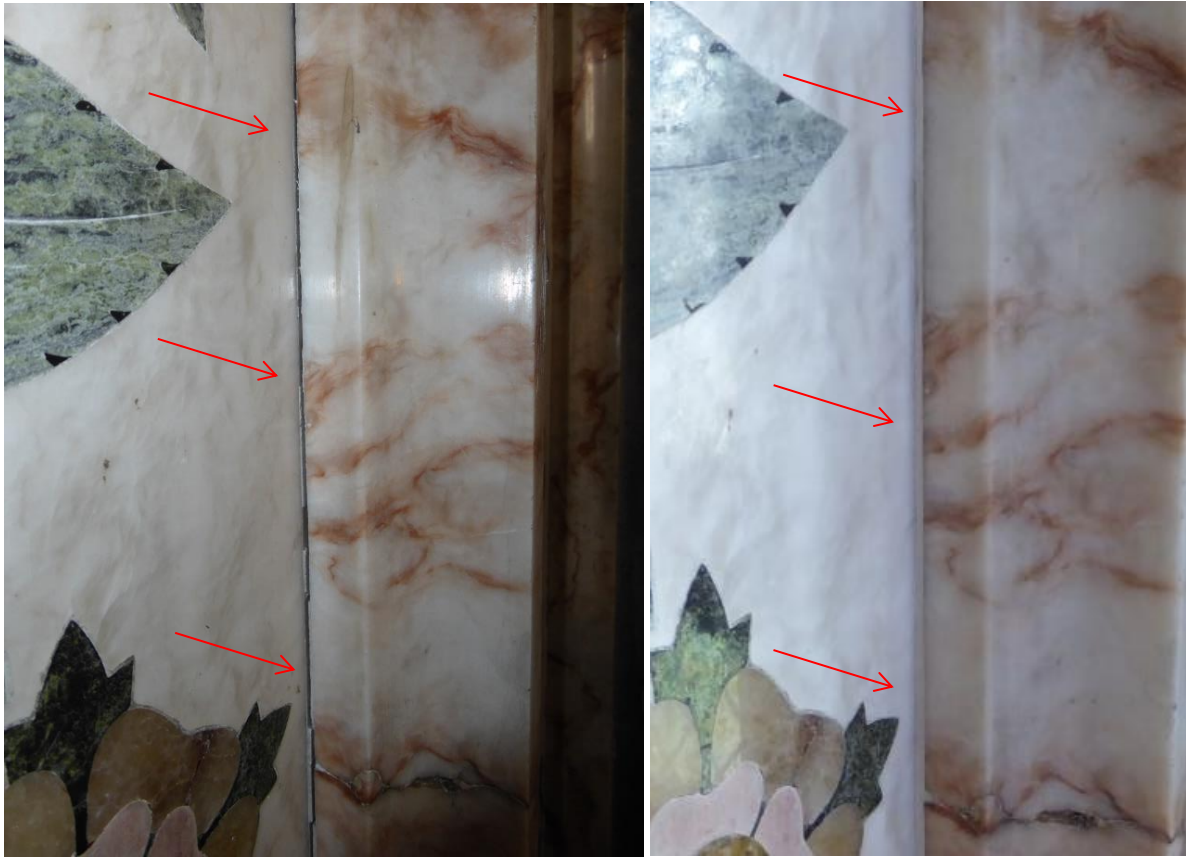
Much of the pointing mortar had failed due to the movement of the stone blocks, and some was totally missing. The failed pointing mortar was carefully raked out with very small chisels and scalpels. They were re-pointed with gypsum without any aggregate. For a larger image see Appendix A.

Figure 18 Joint before raking out and after repointing

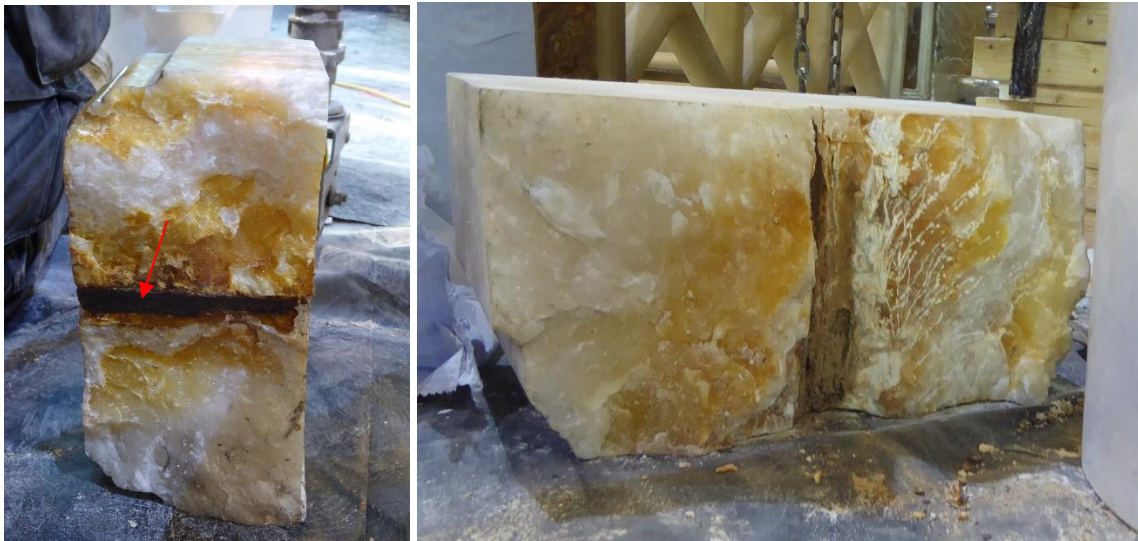
The plinth bases were both cracked as a result of the corrosion and expansion of the internal metal rod. These metal rods were in direct contact with the ground, absorbing moisture from the chapel floor and getting rusted. The plinths were slightly opened to candlestick A and widely opened to candlestick B.

Figure 20 Metal corrosion before and after removal from the bases

The shafts and plinths were carefully lifted from the ground and the bases were dismantled. All the metal corrosion was mechanically removed from the alabaster and metal rods. Approximately two centimetres of both rods were cut out to prevent further direct contact between the metal and the ground.

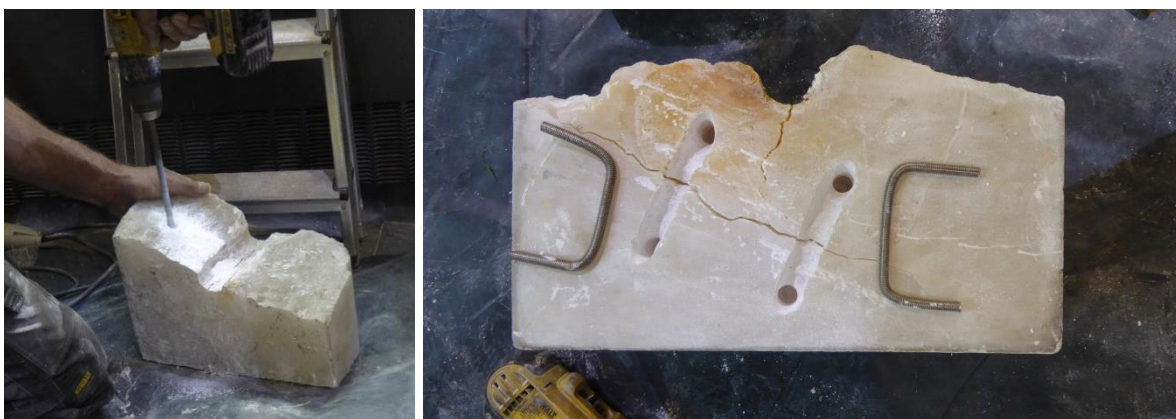
Apart from the cracks, there were also thin but large fissures to the bases. Pinning and cramps with stainless steel rods and polyester resin were used for fixing the bases together.

Figure 21 Drilling for pinning and view of base with stainless steel cramps ready to be fixed with resin

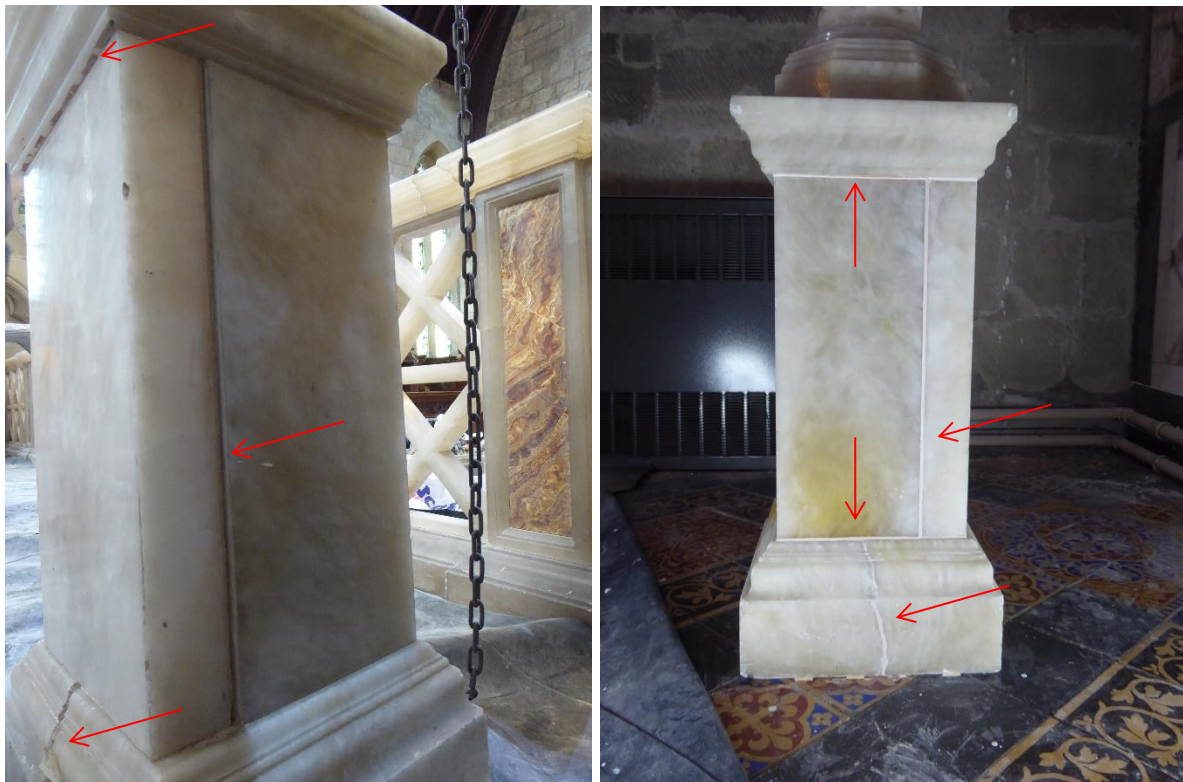
Figure 23 Plinth joints and cracks before raking out and after filling

The joints to the plinths were raked out to remove previous pointing repairs. The joints and cracks were filled with gypsum with no aggregates.

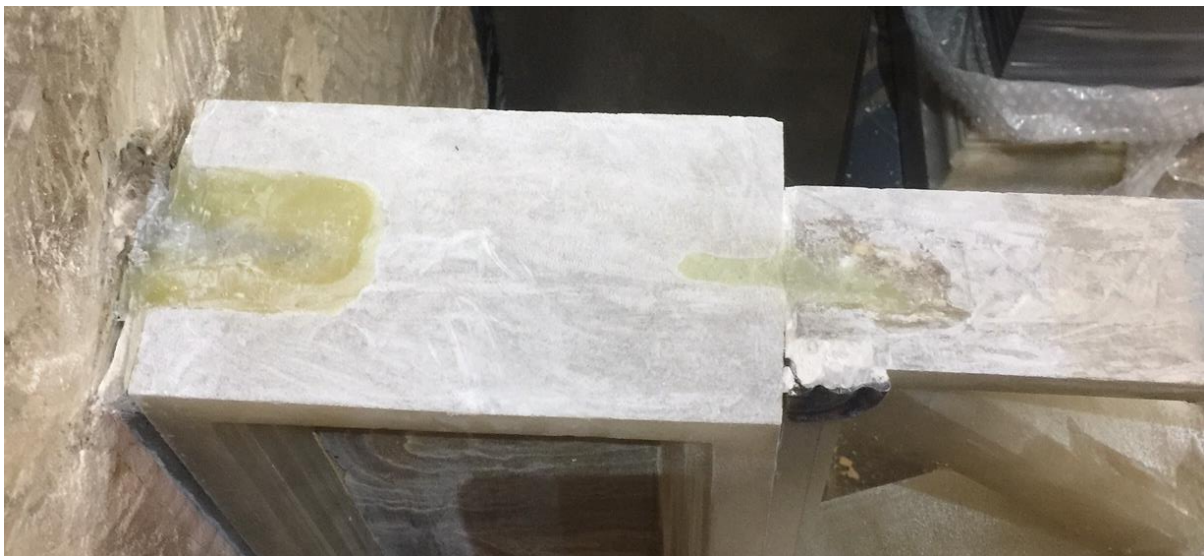
Figure 27 Replacement of ferrous cramps for stainless steel cramps and polyester resin

The treatment consisted of the removal and replacement of these iron cramps with stainless steel cramps, fixed with polyester resin. The alabaster block was relocated, bedded in gypsum without aggregates. The same material was used for pointing, toned down with water colours.

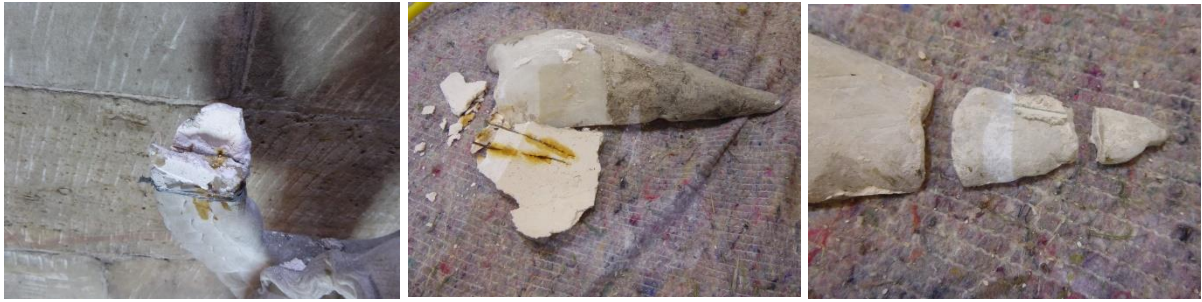
All the gypsum, resin and wire were removed and the wing was found to be in three separate pieces.

Figure 30 Dismantling of angel wing in three pieces

The pieces were cleaned and pinned together. The wing was double pinned and fixed with polyester resin to the angel. The crack and a small missing section were filled with gypsum. Finally the gypsum was toned down with water colours.

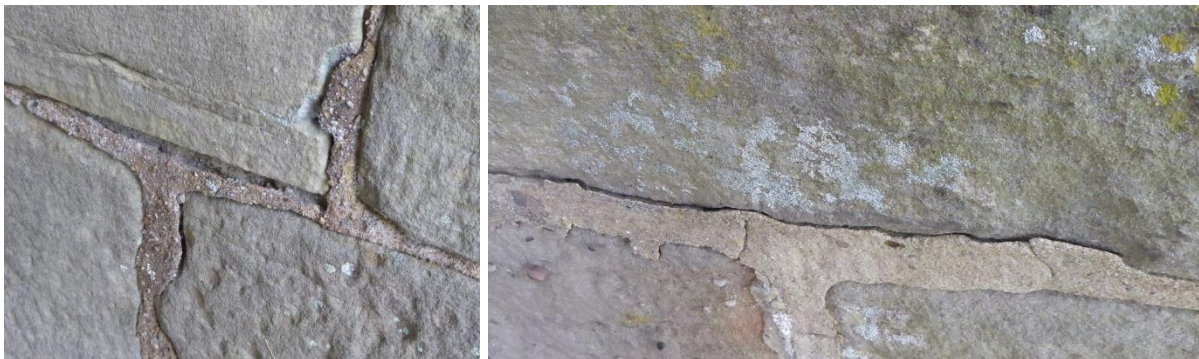
The exterior wall needed some re-pointing to areas where the previous pointing was missing or had already failed, allowing water ingress inside the wall.

Figure 34 Examples of failed pointing mortar to the exterior wall

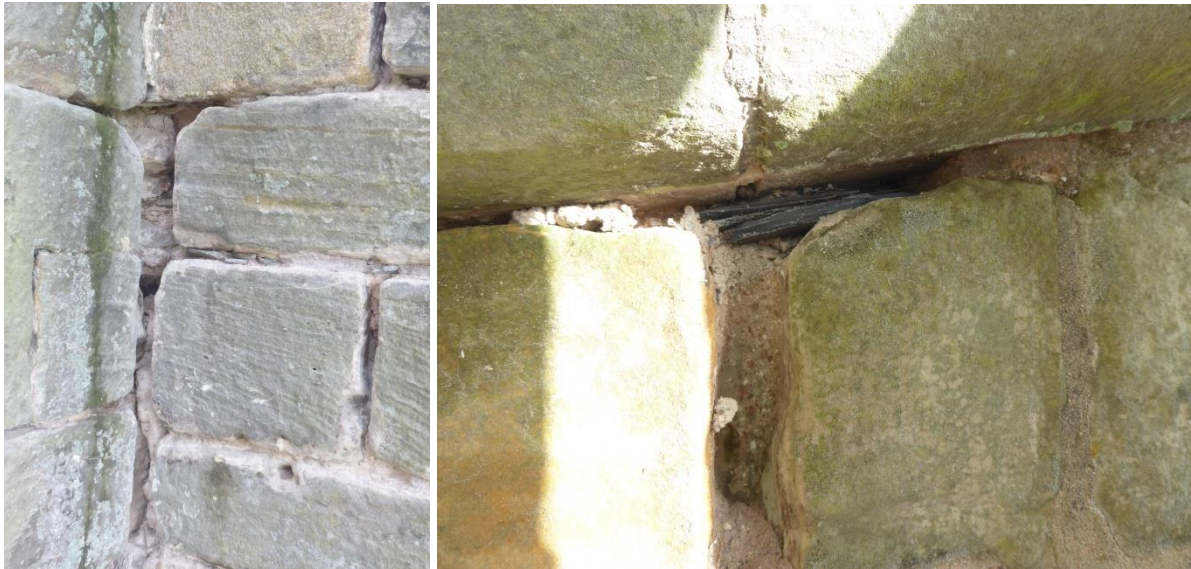
Figure 35 Failed pointing mortar raked out and filling of joints with slate fragments

The pointing mortar in bad condition was carefully raked out using hand chisels. The joints were very deep in many sections and needed filling with slate fragments and the bigger holes were filled with brick fragments.

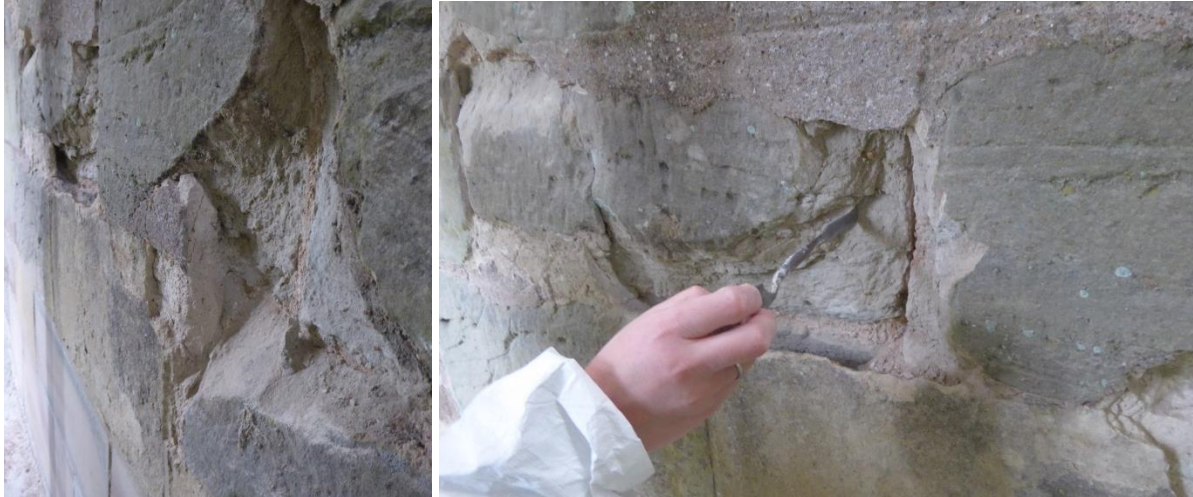
Some previous mortar repairs had also failed, and stone degradation to some ashlar blocks required capping repairs⁶ to prevent further degradation.

The failed mortar repairs were carefully cut out using hand chisels. The depth of some of the missing stone sections was over 10 cm in some areas.

Figure 39 Removal and depth of failed previous mortar repairs

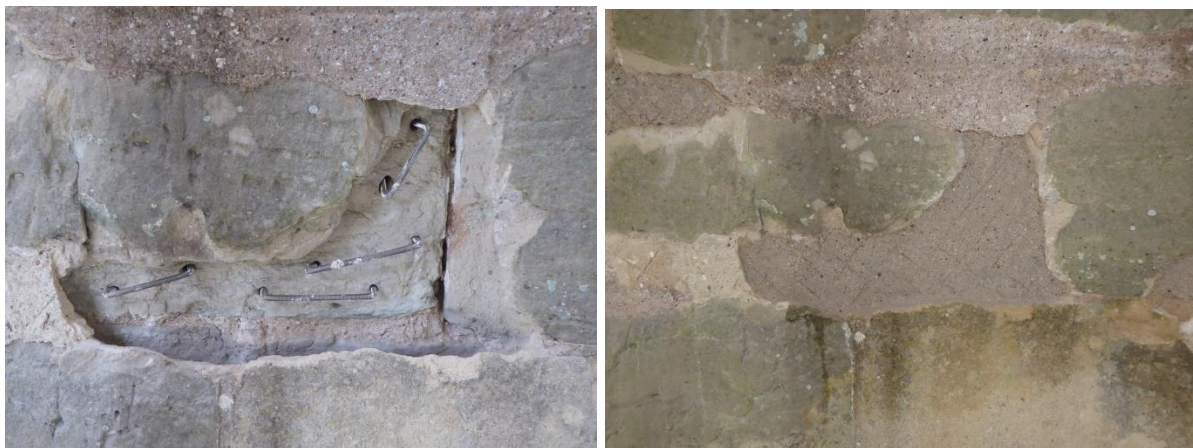
Figure 40 Preparatory armature and application of base coat

Due to the depth of the mortar repairs, stainless steel cramps were used to form an armature. A base coat mortar was applied; using the same composition as the pointing base coat mortar. Natural hydraulic lime 3.5, kiln dried sand and sieved sharp sand (yellowish) with a ratio of 1:2:1 were used for the top coat mortar. The top coat mortar was cut still wet to form the pointing lines which were filled with the same top coat pointing mortar used to the rest of the wall.

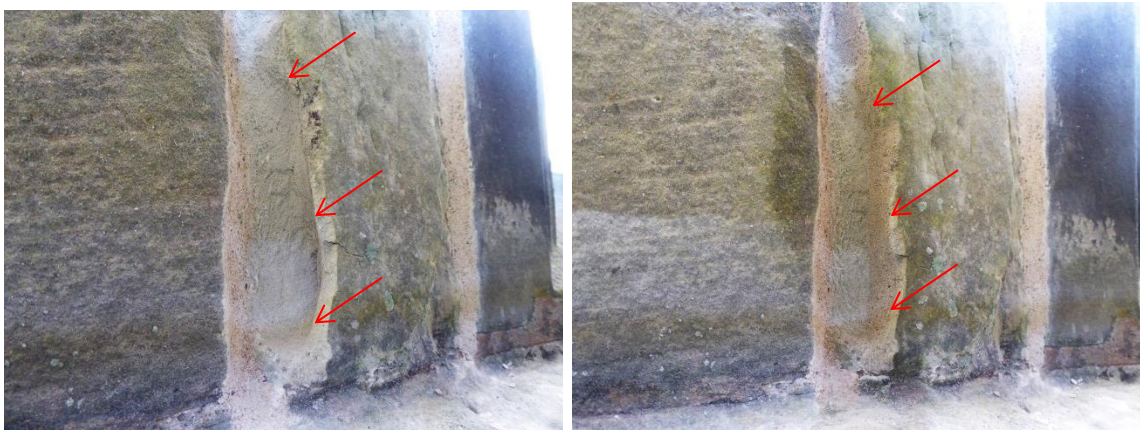
Figure 42 Before and after the capping repairs to stone

The same mortar composition as for the top coat of the mortar repairs was used to undertake the capping repairs to the stone.

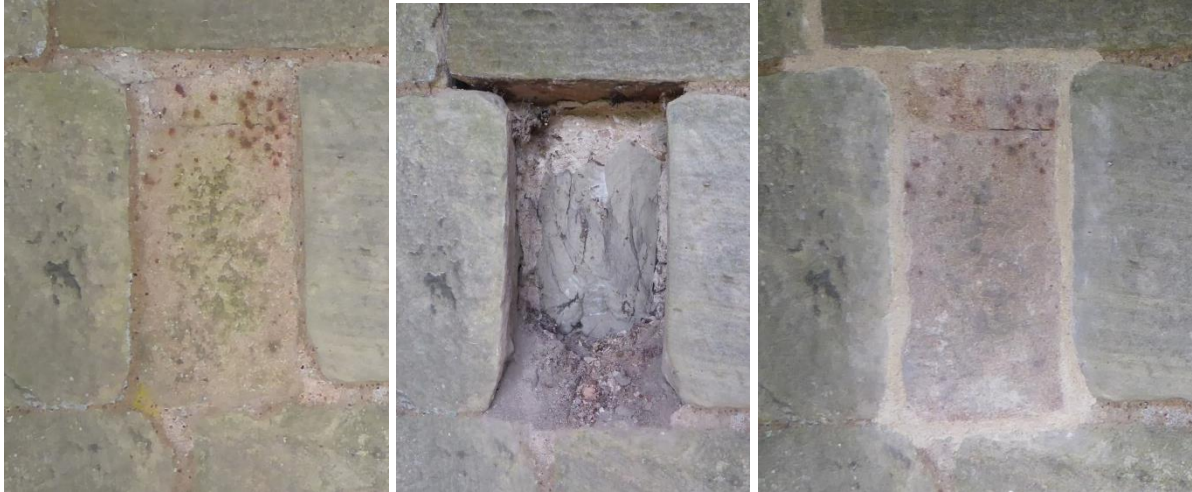
Figure 44 Dismantled block before, during and after relocation

One block needed dismantling and relocation after the failed pointing mortar was removed. It was cleaned of previous mortars and placed back bedded in mortar. See location in Appendix C.

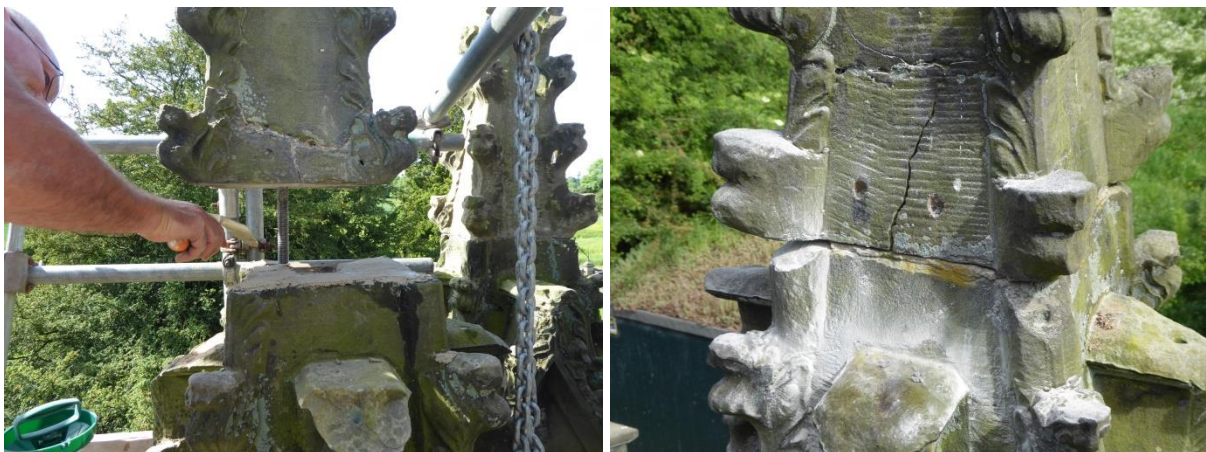
Figure 45 Relocation of the south pinnacle upper section and pinning to the north pinnacle

The pinnacle to the south was carefully lifted and a stainless steel rod was inserted through the centre, fixed with polyester resin. Two smaller pieces needed pinning. They were all relocated bedded in lime mortar and joints and cracks were filled with lime mortar: natural hydraulic lime 3.5 and aggregates (ratio 1:3).

The pinnacle to the north only needed pinning works to secure its position. Two stainless steel rods were pinned and injected with polyester resin. The holes and joint were filled with the same lime mortar used for the other pinnacle.

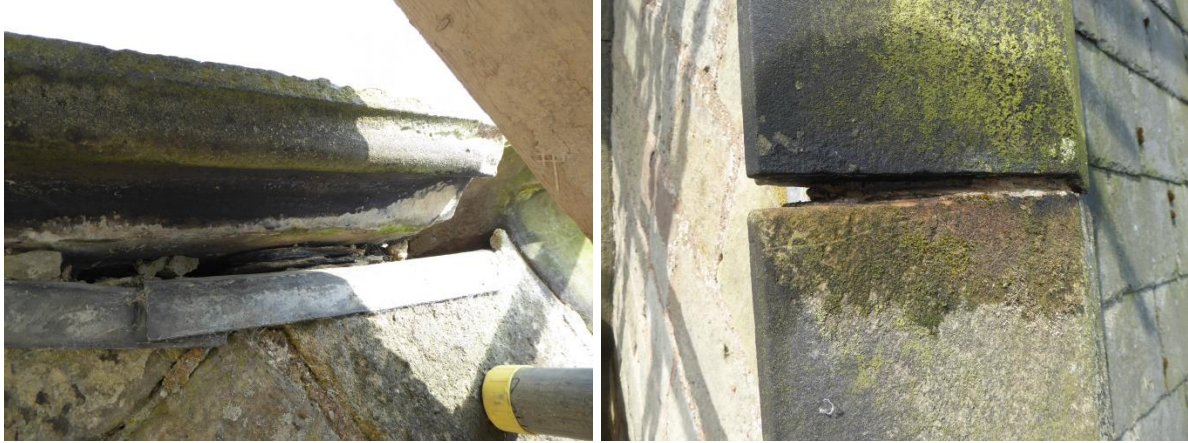
The pointing mortar to the coping stones on the east elevation had failed and there was a danger of possible water ingress coming into the roof and/or wall. All the pointing mortar was carefully raked out with small hand-held chisels.

Figure 46 Removal of failed pointing mortar to coping stones

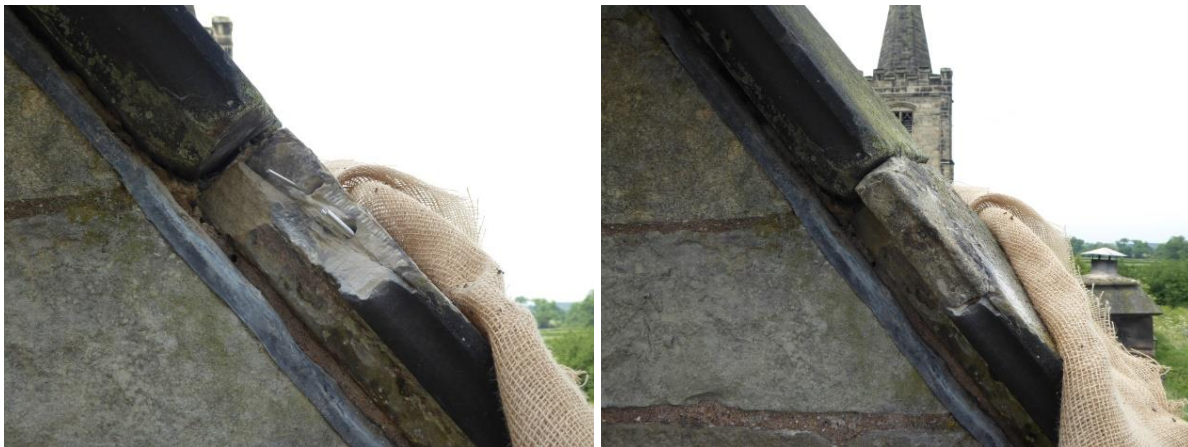
Some of the previous mortar repairs and cracked stone sections became loose during the pointing removal. These pieces were fixed with polyester resin and some were pinned with stainless steel rods. See Appendix C for location.

Figure 47 Pinning of failed previous mortar repair

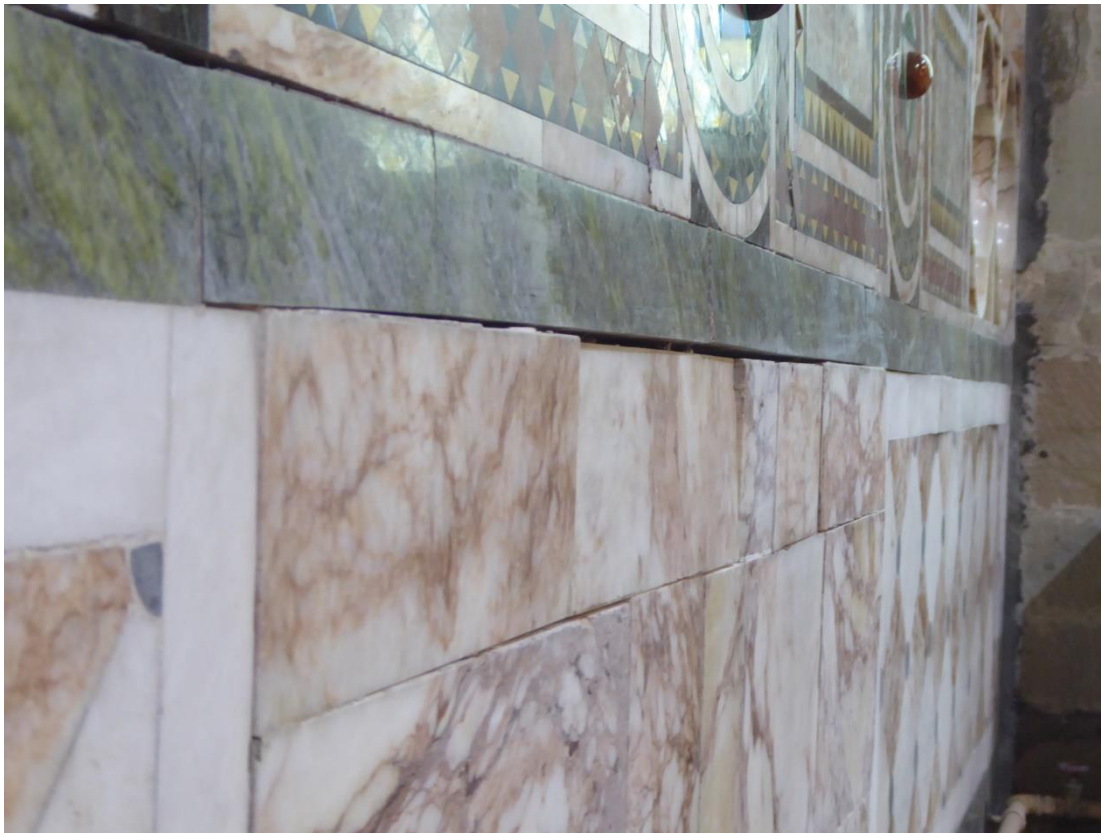
Figure 51 Initial condition of alabaster blocks to the central section

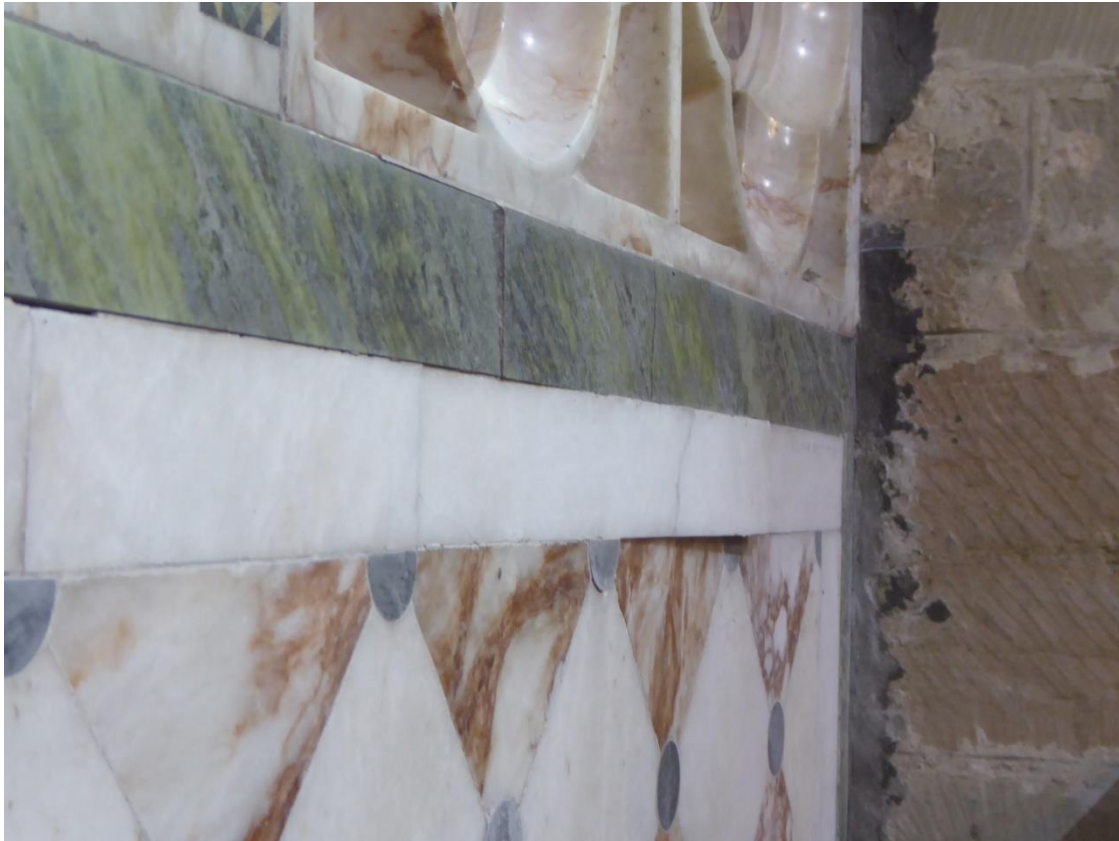
Figure 55 Initial condition of alabaster and marble blocks to right area of reredos

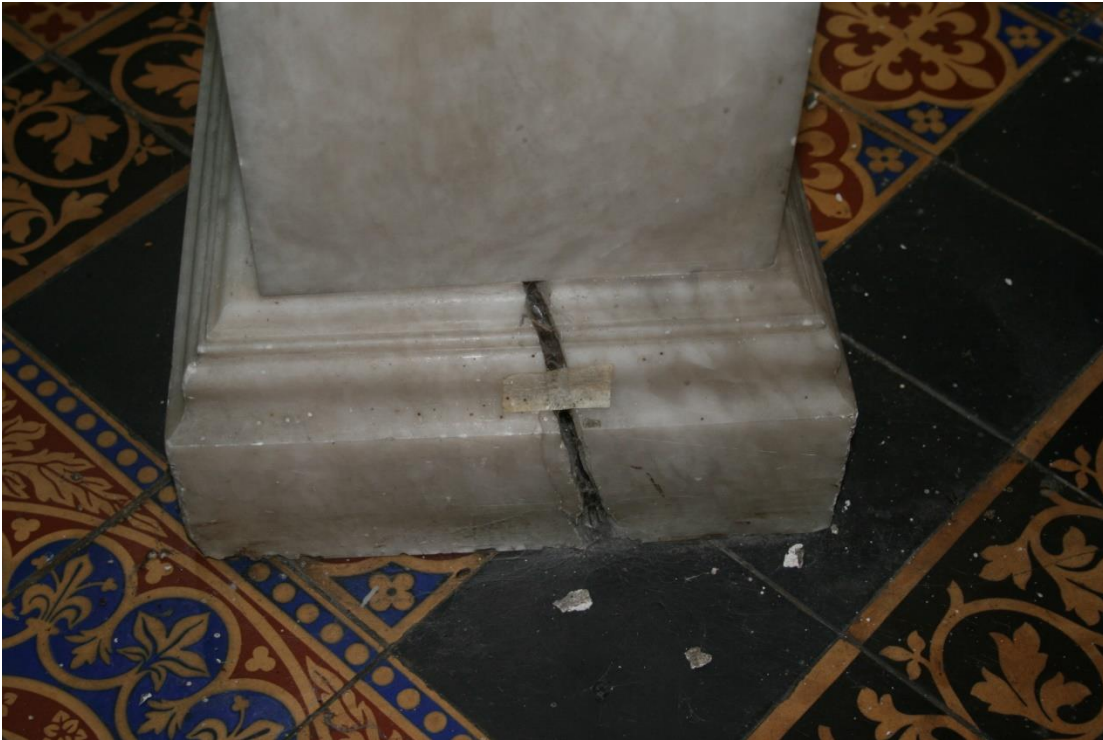
Figure 65 Initial condition of crack to the base of candlestick

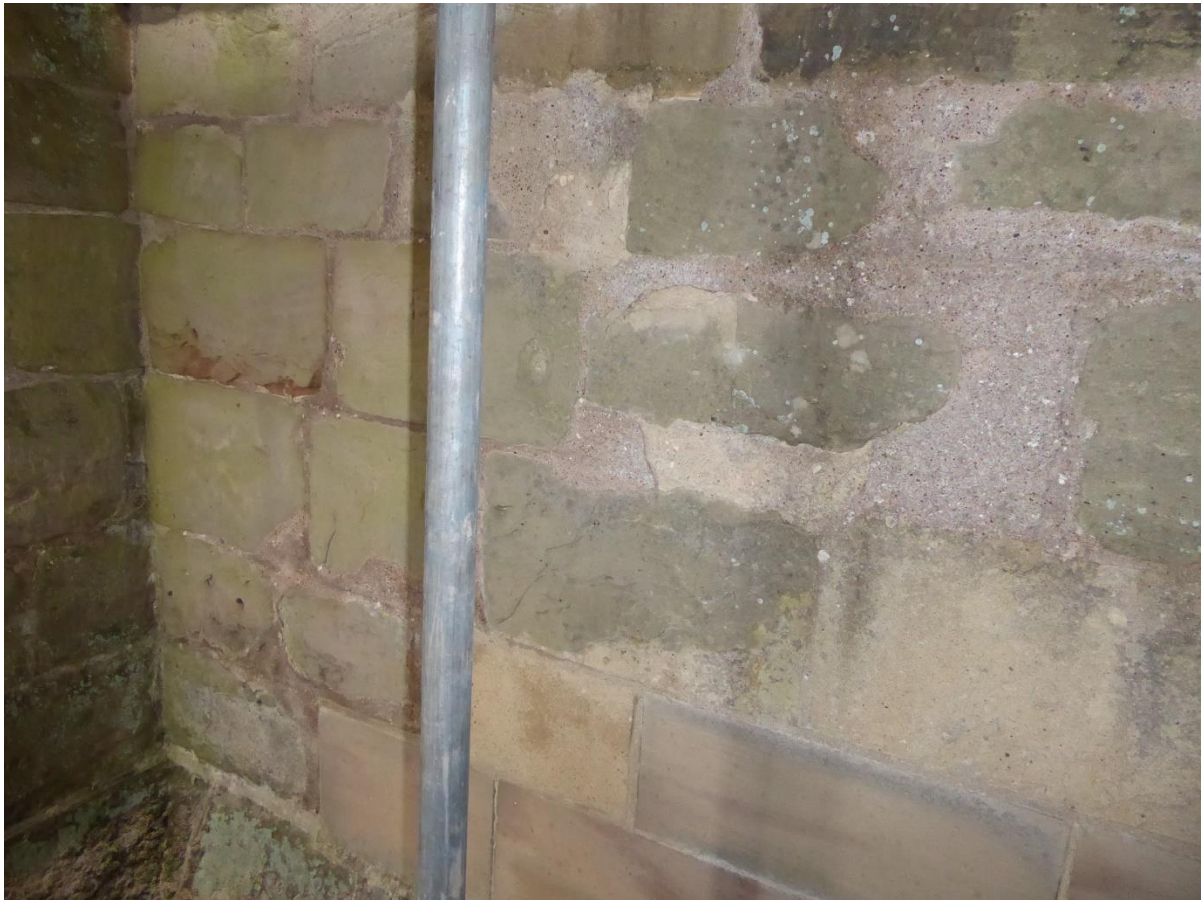
Figure 71 Initial condition of previous mortar repairs to exterior wall

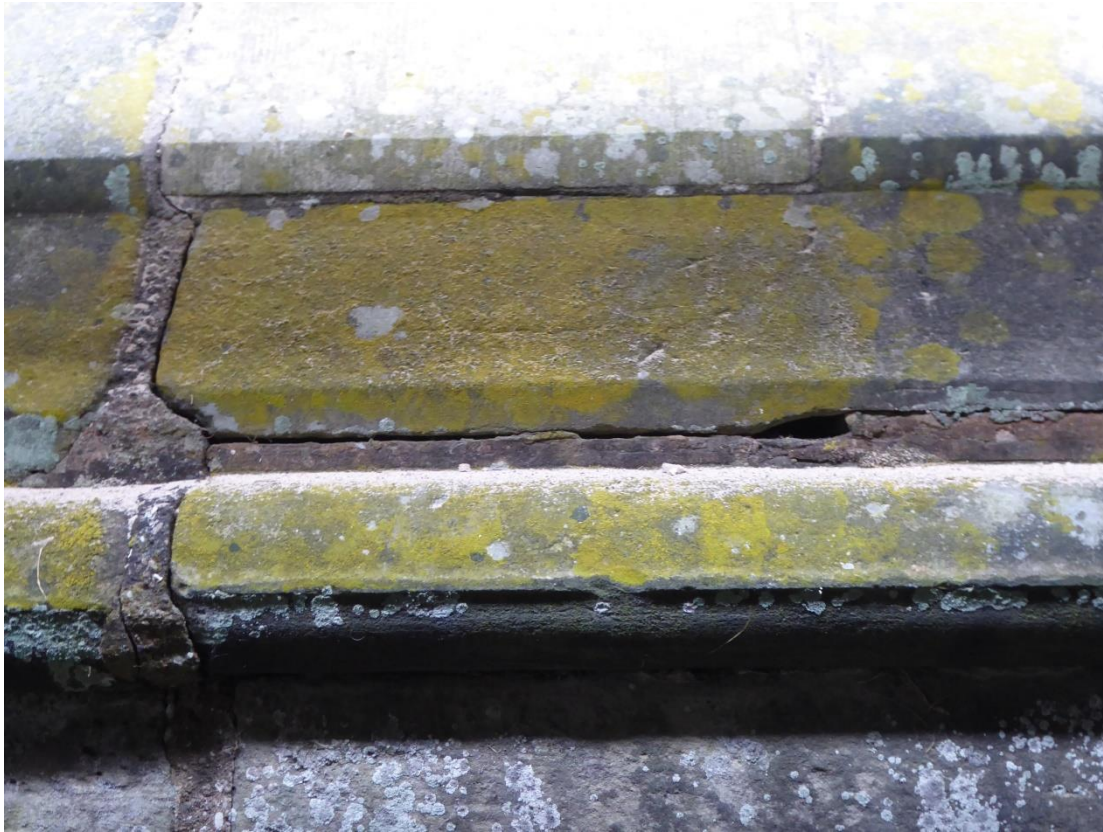
Figure 73 Initial condition of pointing mortars to exterior wall

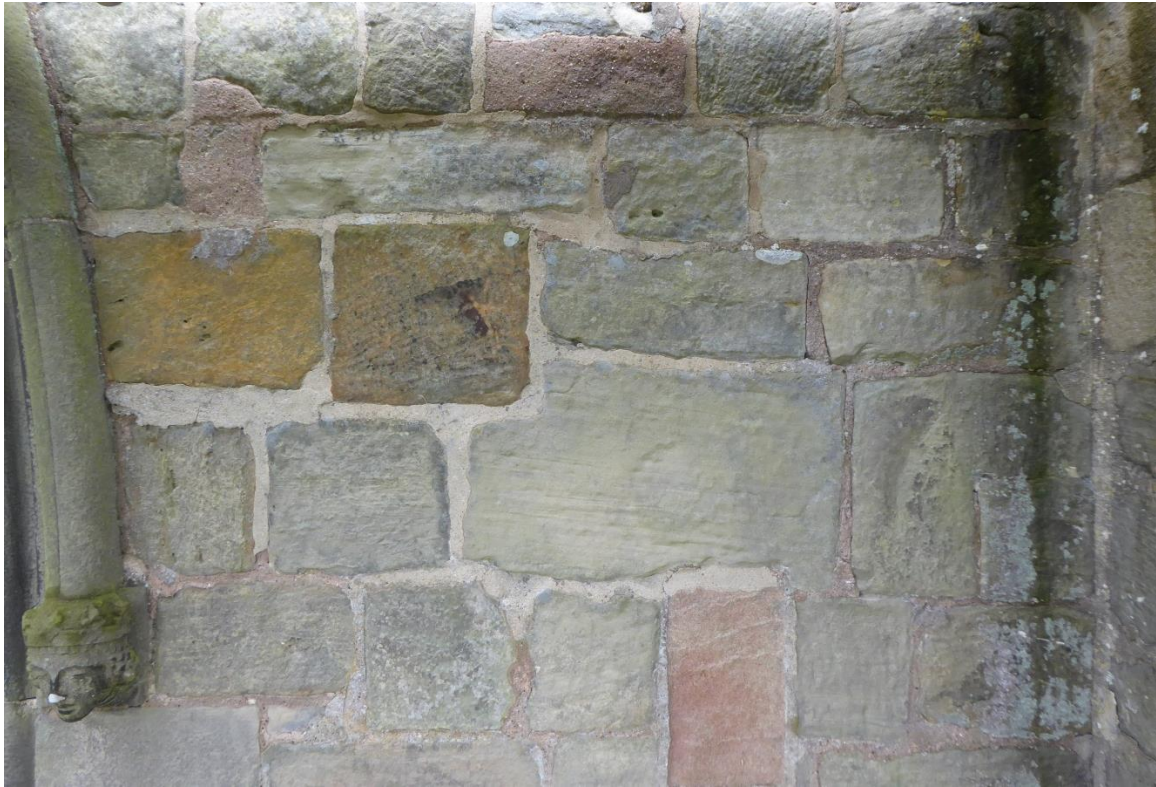
Figure 75 Initial condition of pointing mortars to exterior wall

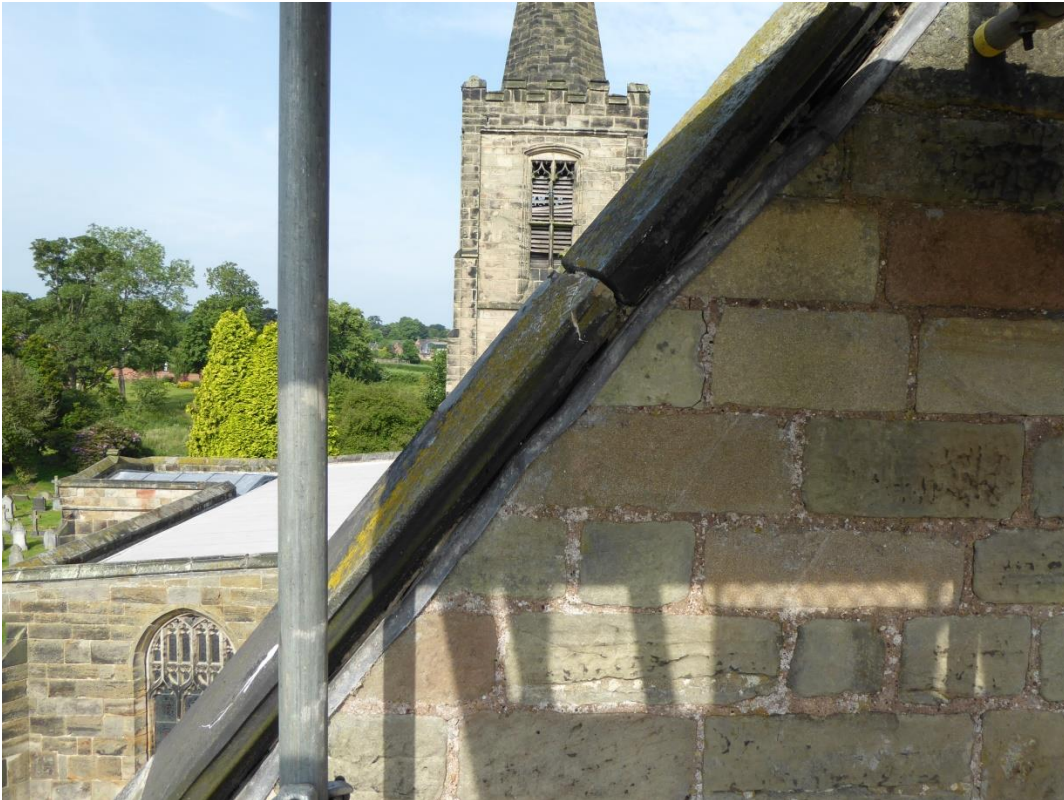
Figure 83 Initial condition of pointing to coping stones
