**Archaeological Watching Brief**

Issue No: 1 OA Reference No: 6674 NGR: SU 3900 9420

### St Mary's Church, Lyford, Oxfordshire

# Archaeological Watching Brief Report

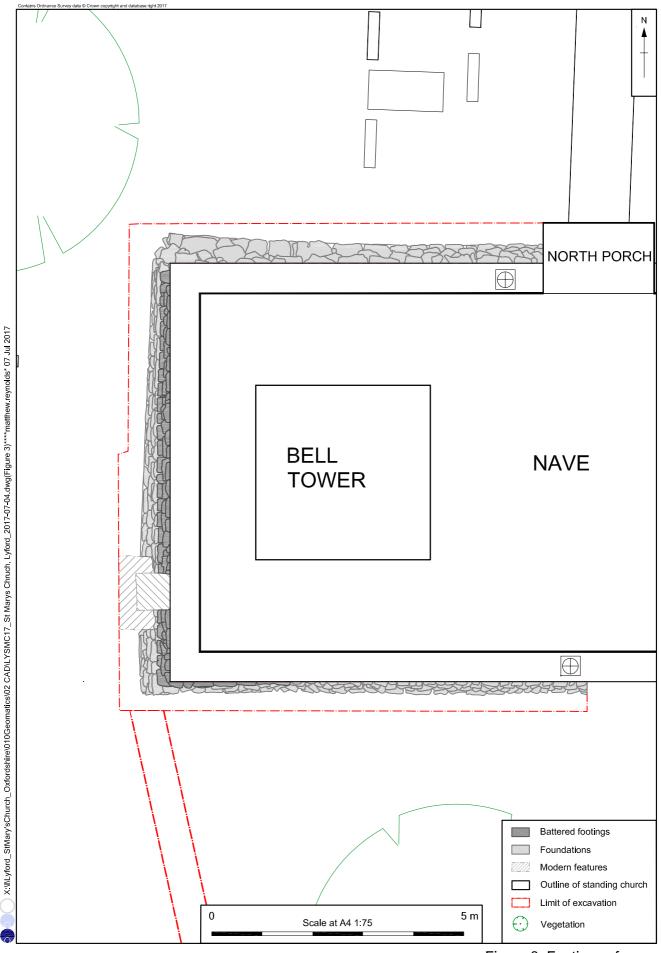
Figure 3: Footings of nave

3.3.3 The upper part of the footings of the nave were exposed on all three sides, offset from the face of the wall by 0.6m on the north side, 0.5m on the west side and 0.2m on the south. The footings at the north-west corner of the Nave were predominantly constructed of large limestone blocks (Plate 6), but the blocks used in all other parts of the exposed footing were generally smaller (Plates 3 and 8), although occasional larger blocks were also seen. The stones were only roughly shaped, and were laid in rough courses without mortar bonding. The foundations were not bottomed but five courses were observed on all sides, and the top of a sixth course was seen in places. Detailed photos, which can be linked to a plan, were taken of the entire exposed footings, and are available in the site archive.

4.3.1 Five courses of the footings of the nave were revealed on all three sides, offset slightly from the walls above. These consisted of roughly-shaped slabs of varying thickness laid in rough courses without mortar bonding, and were clearly not intended to be seen. They clearly did not belong to an earlier structure.

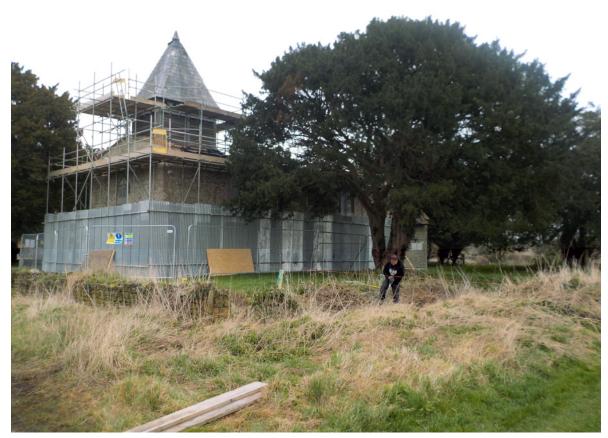
1.2.2 The area of work comprised the churchyard and the edge of an adjacent field just beyond the churchyard's southern boundary. The churchyard is elevated above the level of the surrounding ground due to repeated burials (Plate 1).

1.3.1 St Mary's church comprises a nave with clerestory, chancel and north porch. A timberframed bellcote rises from within the line of the west end of the nave (Plate 1). The building dates from the early 13th century and much of the original church remains today, although the bell tower and clerestory were added in the 15th or possibly the early 16th century. Extensive renovation was carried out in 19th century, when the north porch was added, incorporating a 15th century oak arch-headed doorway.

Plate 1: St Marys Church - looking NE

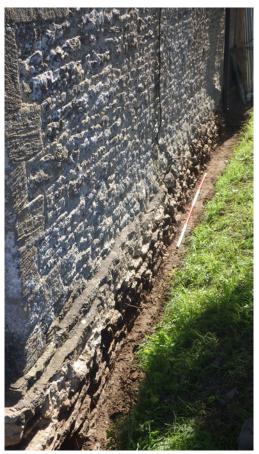
3.3.2 The trench was excavated for 7m along the south side, 6.5m along the north side and for the full length of the west end. Along the north side it was on average 0.75m wide (Plates 7 and 8), on the west side it was up to 0.85m wide (Plates 4 and 5) and on the south side it averaged 0.5m in width (Plates 2 and 3), and on The trench was 0.6m deep on all sides.

Plate 2: South Wall of Nave - looking ENE

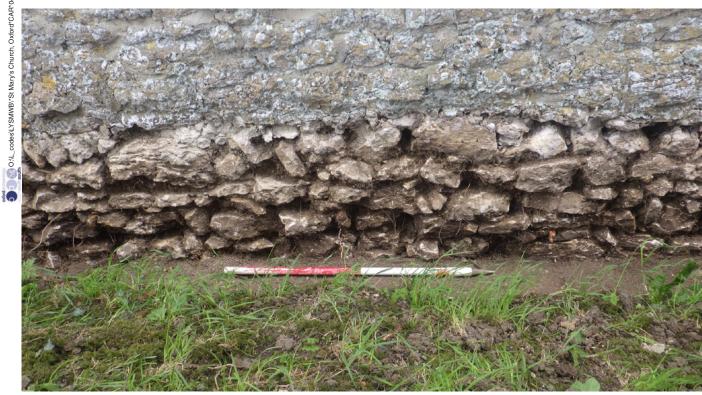
Plate 3: South Wall of Nave - looking N

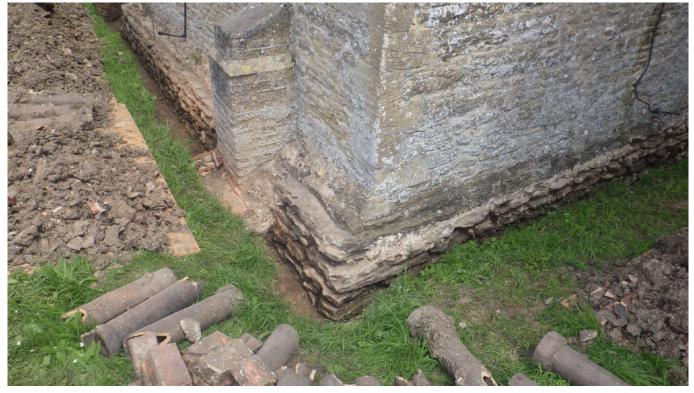
Plate 4: Southwest corner of Nave - looking north-east along west wall

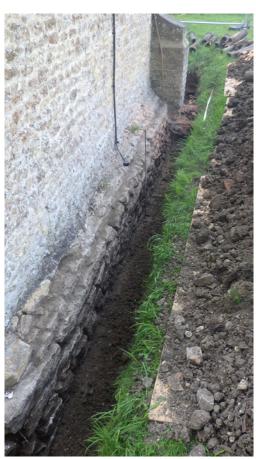
Plate 5: West Wall of Nave – looking SSE

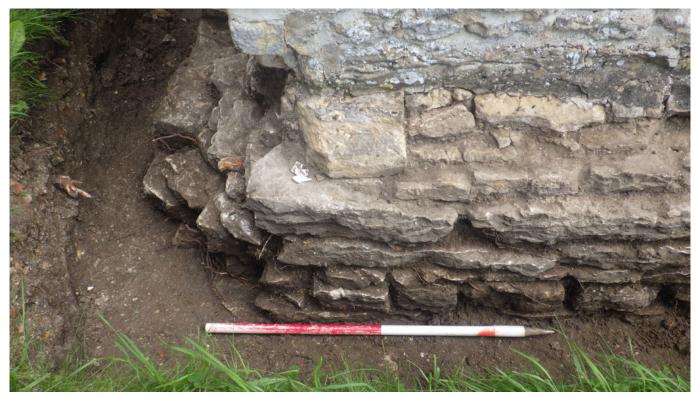
Plate 6: North-west corner of Nave - detail looking east

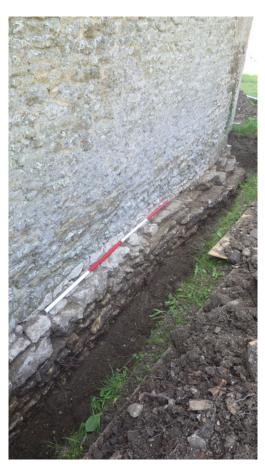
Plate 7: North Wall of Nave – looking south-west

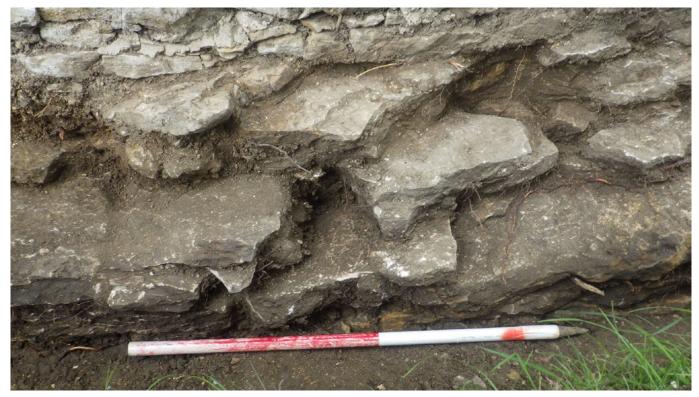
Plate 8: North Wall of Nave - looking south

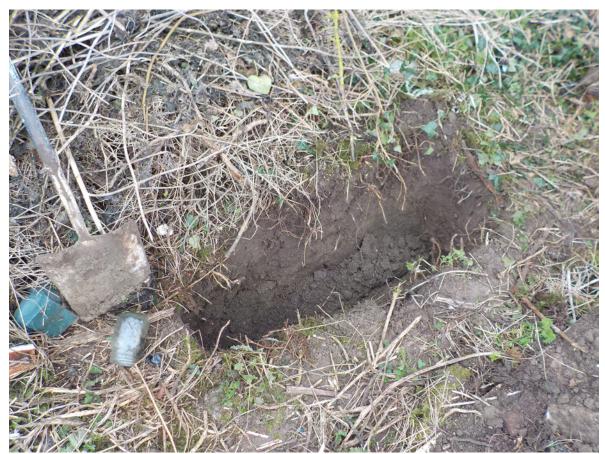
3.4.1 The trial pit was located directly outside the southern boundary of the churchyard, 4m east of its south-western corner. The trial pit was excavated by hand to locate the position of an existing drain and measured 1.1m x 0.3m. The trial pit was excavated to a depth of 0.6m and only revealed deposits of recent date similar to the topsoil. Although no drain was found, this indicated that the area had been disturbed.

Plate 9: Trail Trench Post Excavation - looking NE

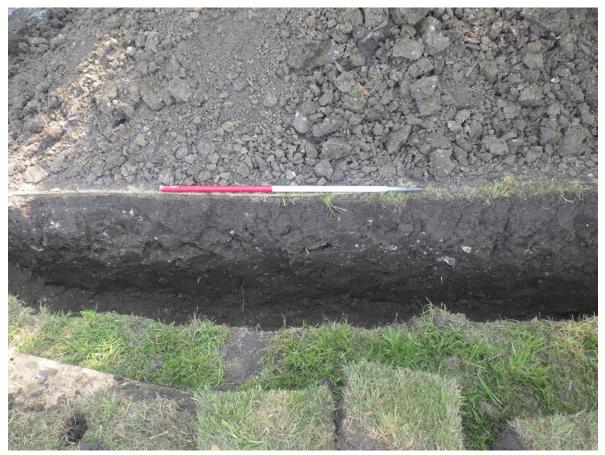
3.5.1 The trench (Plates 10 and 11) ran from the south-west corner of the nave for 12m until it crossed the boundary of the churchyard. It led into a soakaway (Plate 12) located just beyond the boundary, which measured at least 3m x 1.5 in plan.

Plate 10: Drainage Trench South of Church - looking NE

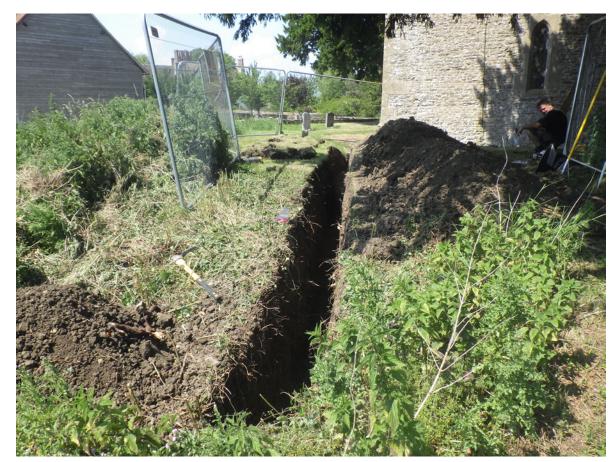
Plate 11: Drainage Trench – looking NNW

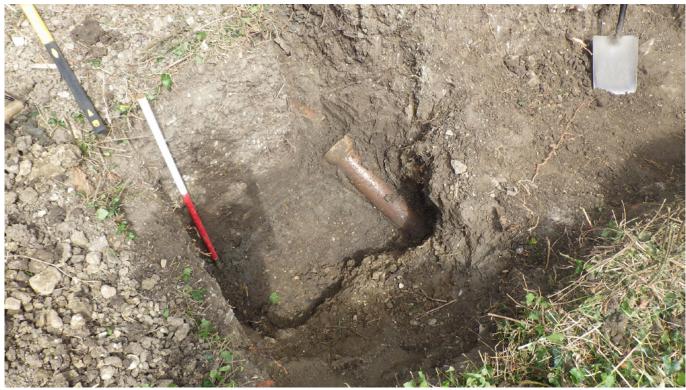
3.5.2 The trench had an average width of 0.5m and was excavated to a depth of 1-1.2m. The soakaway was dug to a maximum depth of 1.2m. Only topsoil and backfill were revealed in these excavations, as the trench was dug following an existing drainage trench (the drainage pipe searched for in the trial pit). The soakaway also revealed identical backfill layers. No natural geology, grave cuts or finds other than those of very recent date were observed.

Plate 12: Soakaway - looking north-west
