ARTEFACTS CONSERVATION SERVICES,

Stephen Umpleby ACR, 83 Wilverley Crescent, New Malden, Surrey KT3 5LW.

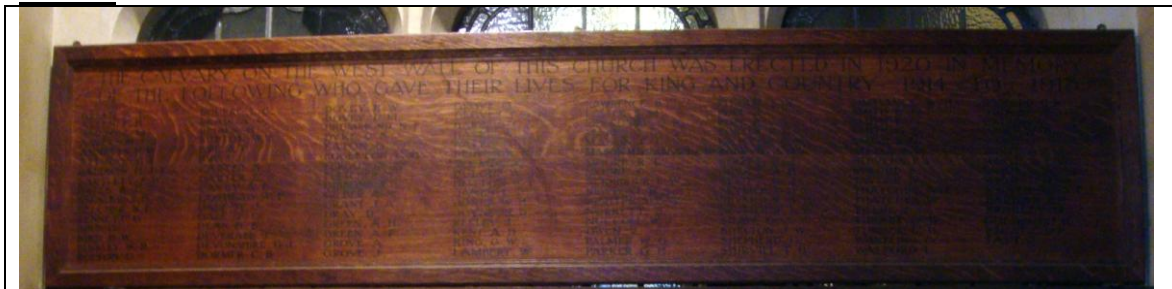
Overall view of Memorial Board in previous location, before conservation

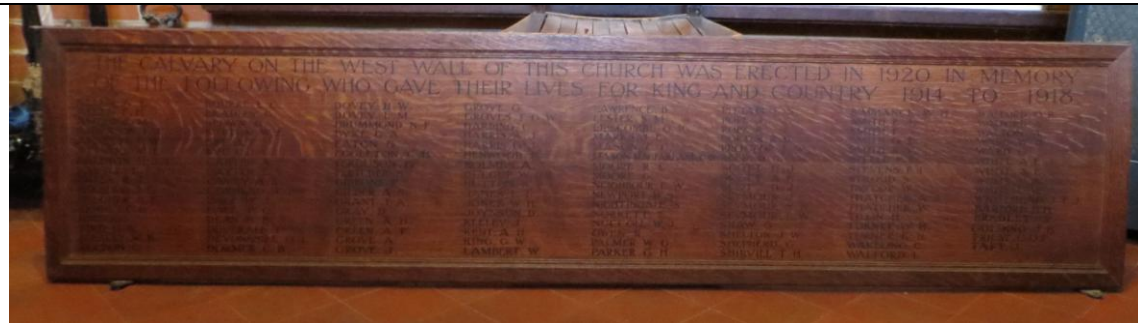
1. Overall view of memorial board before conservation, showing black-painted lettering on oak panels and darkening of wood from previous cumulative light damage

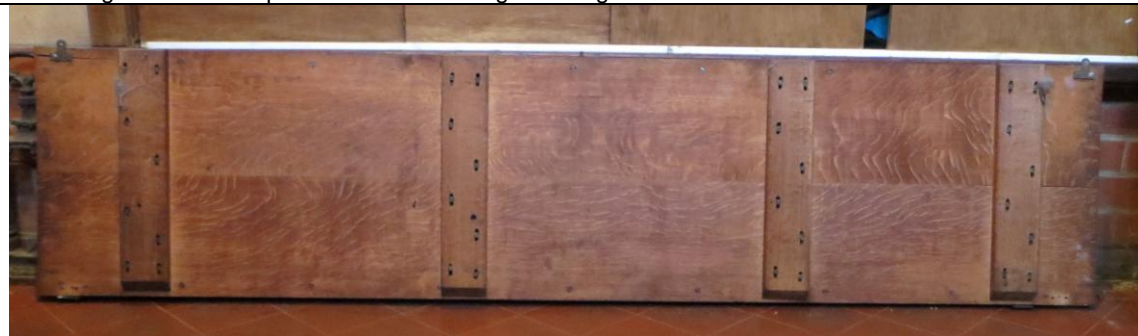
2. Overall view of memorial board before conservation, showing reverse with vertical wooden batons with slotted screw holes and showing details of construction

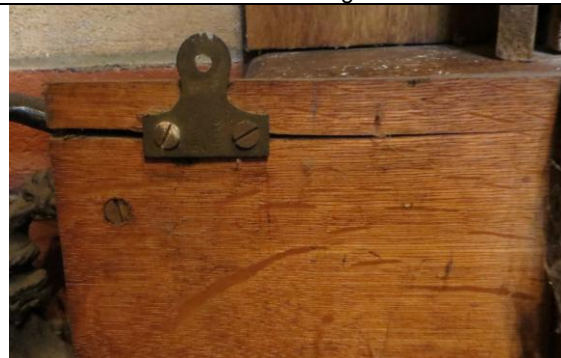
3. Detail of cracking in wood from screw fixings at mirror plate at top corner on reverse

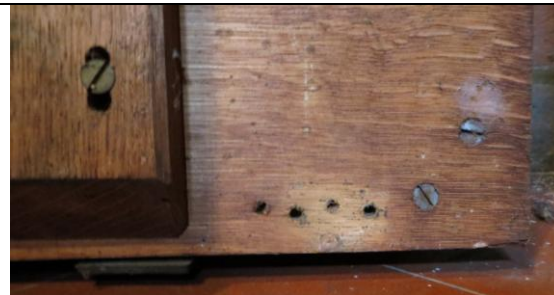
4. Detail of slotted screw holes in vertical batons, wood screws securing frame in position around edge of memorial board and previous position of mirror plates at bottom corner of board (notice light damaged oak in comparison with lighter oak surface where previously covered with mirror plate)

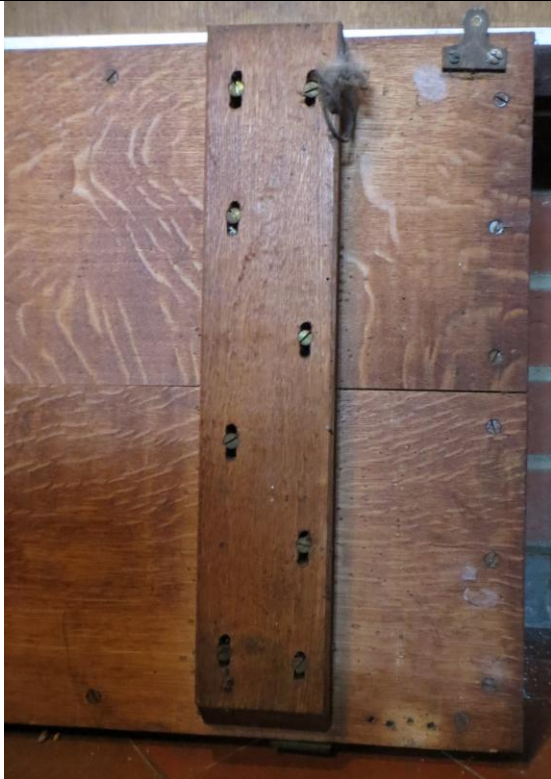
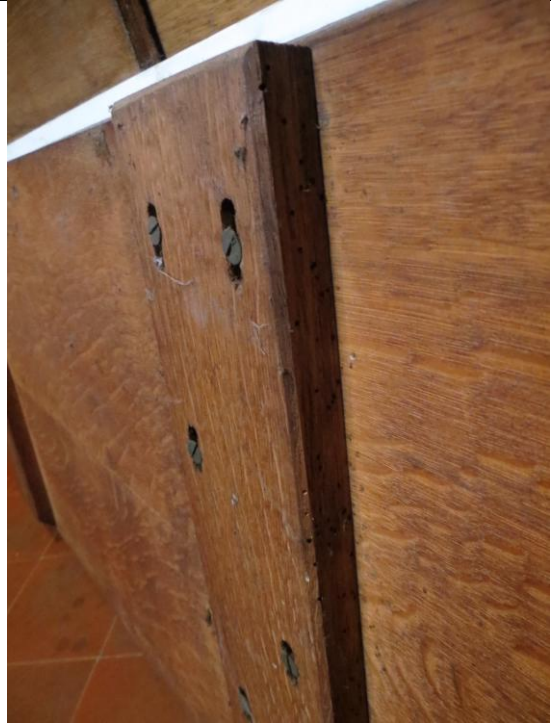
<p>5. Detail of vertical baton at reverse, showing woodworm damage</p>	<p>6. Detail of vertical baton at reverse showing woodworm damage</p>

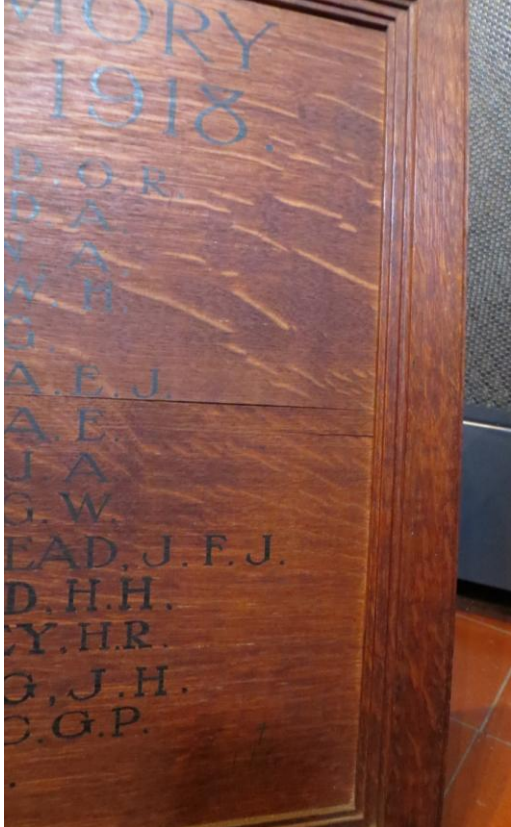
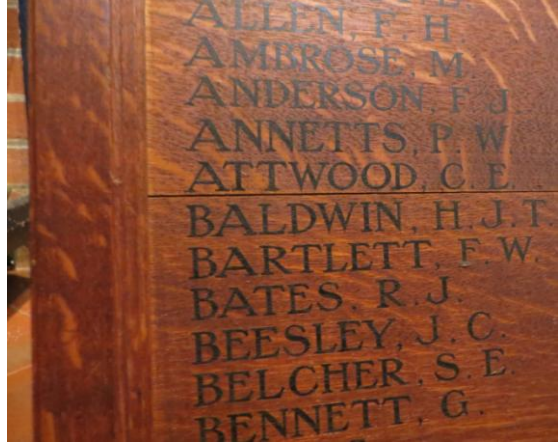
<p>7. Detail of split in lower horizontal board at right side</p>	<p>8. Detail showing gap between horizontal boards at left side</p>
