Brinkworth

At last the bells have come back from Soundweld and Taylors. They were taken out early December and returned on the 3rd October, so they have been away 10 months.

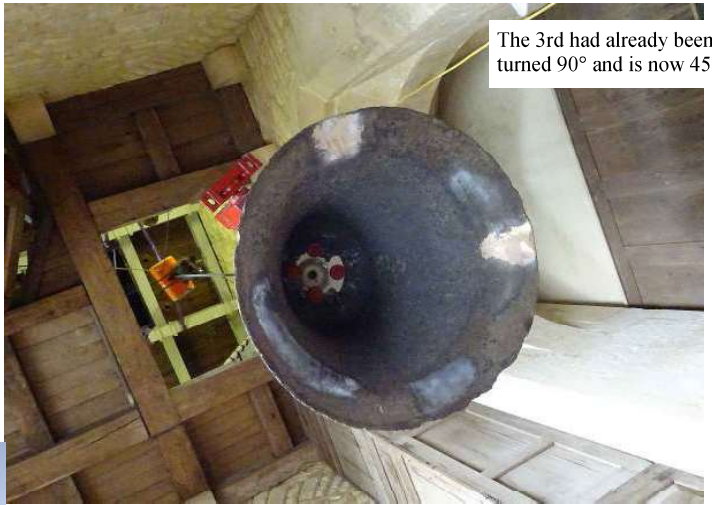
The 3rd had already been turned 90° and is now 45°.

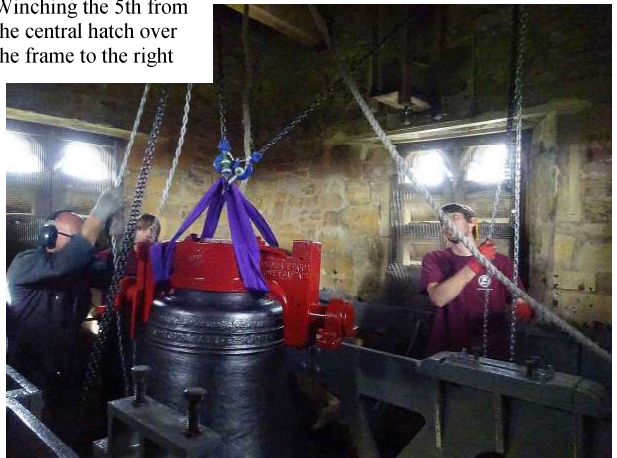
Winching the 5th from the central hatch over the frame to the right

the 5th's wheel is almost scraping the wall!

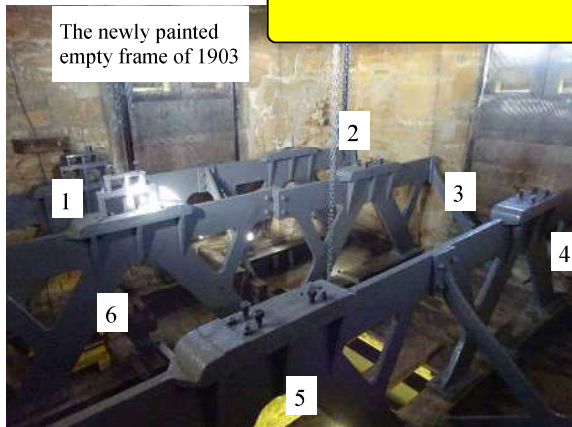
Already a minor problem had been spotted: near where the bearing housings were to be bolted to the frames there were already some other bolts holding something else. So another set of housings with shorter lugs had to be obtained from Loughborough.

The spacing on the 2nd's wheel, and those troublesome bearing blocks

The wheel on the 2nd had to be moved over an inch or so with some wood packing between it and the bracket on

the headstock so the rope did not have to pass through a steel beam.

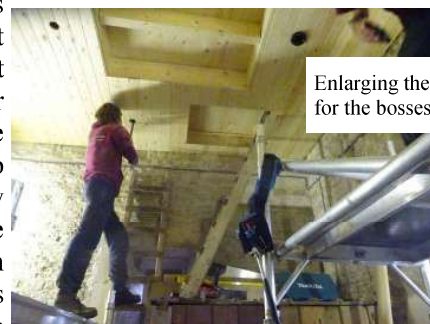
Enlarging the holes for the bosses

Another problem was with the rope bosses. There were two sets: plastic ones went in the belfry floor and steel

ones in the deadening chamber floor. After drilling the holes they found they were slightly different sizes (metric and imperial perhaps). So some work with a large half-round file was required!
